**CALIFORNIA REGIONAL WATER QUALITY CONTROL BOARD - SAN DIEGO REGION  
WATERSHED MANAGEMENT PROGRAM**

**FACILITY INSPECTION REPORT**

INSPECTION DATE: October 5, 2007 TIME: 9 am WDID: 9 37C322900

Sprinter Rail Project  
FACILITY OR DEVELOPER NAME (if different from owner)

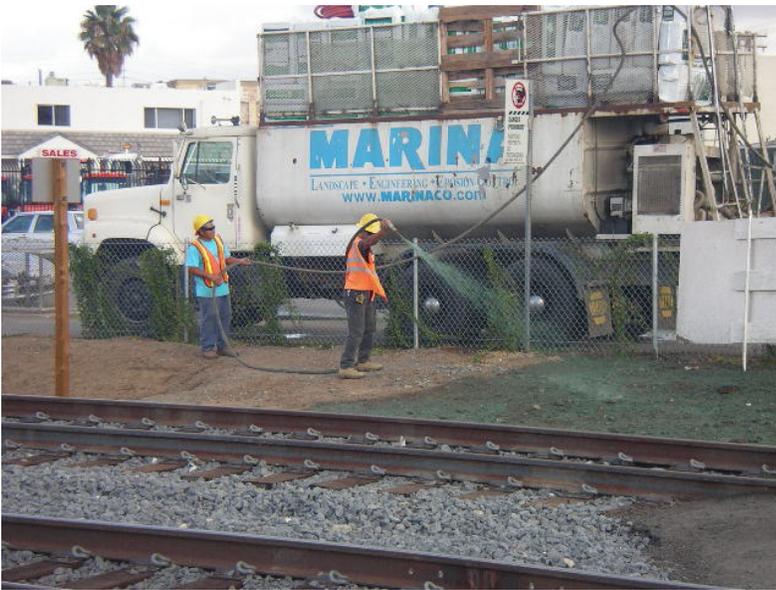
**1. Washington Avenue in Escondido** - The Sprinter tracks are south of and parallel to Washington Avenue from Hale Avenue, going west under I-15 to Mission Road. A low drainage ditch runs along the north side of the tracks between Washington Avenue and the rail line. Marin landscaping was busy applying hydroseed for erosion control along this drainage ditch (Photo 1). At several locations, the drainage ditch has storm drain inlets that were not protected with sediment controls (Photos 2, 3, 4, 5, 9). The drainage ditch also had trash accumulated near the inlets (Photos 2, 4, 5). At the intersection of Washington Avenue and Mission Road, a large area of soil was exposed with no sediment control BMPs or soil stabilization (Photo 6). Along Washington Avenue, two storm drain inlets were observed with broken up gravel bags that have not been maintained (Photos 7, 8).

1. Crew hydroseeding drainage ditch. Photo looking north across the tracks.

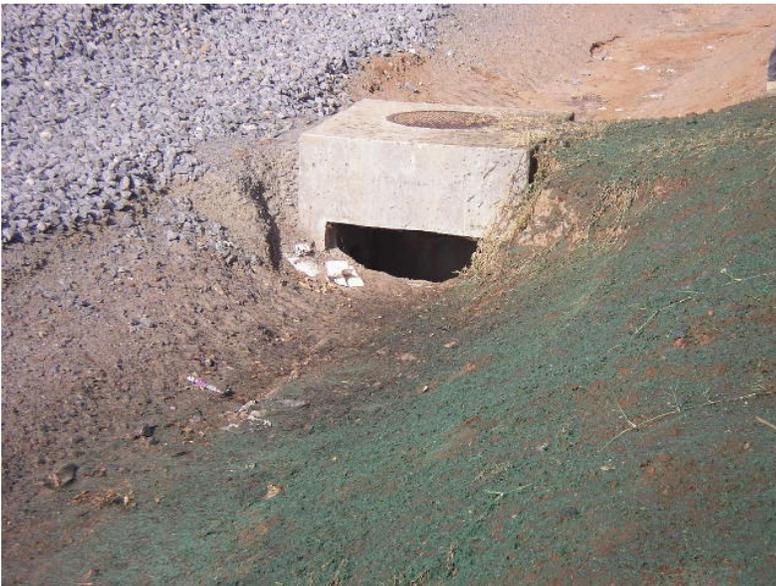
2. Storm drain inlet along the north side of the tracks is without sediment controls such as gravel bags. White trash is near the inlet. The drainage ditch was recently hydroseeded. Photo looking west.

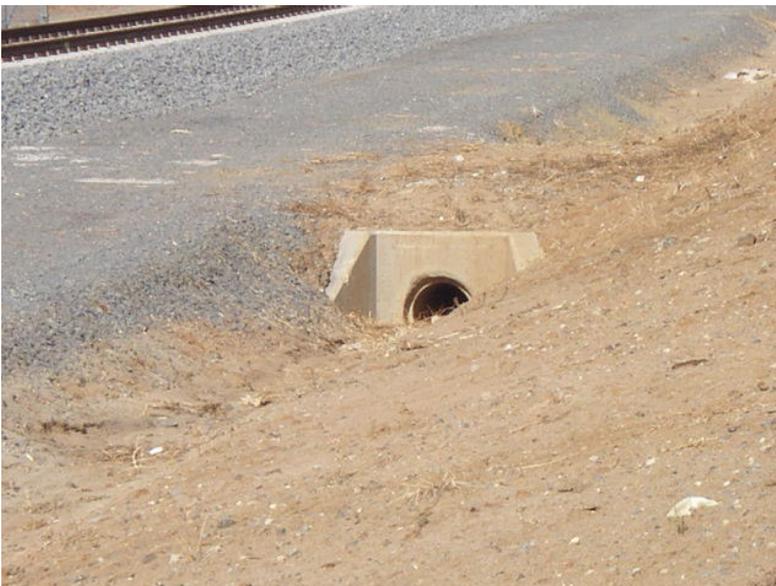
3. Another storm drain inlet along the north side of the tracks is without sediment controls such as gravel bags. Photo looking west.

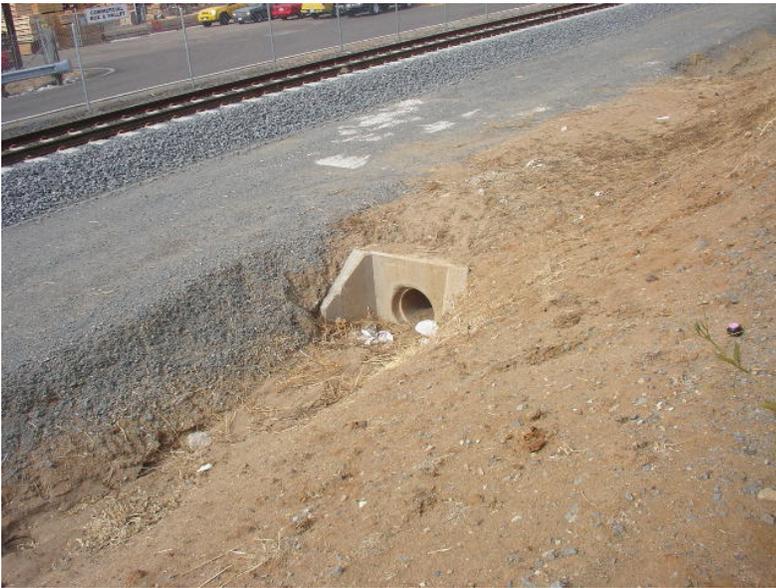
4. Another storm drain inlet along the north side of the tracks is without sediment controls such as gravel bags. Trash in the drainage ditch. Photo looking west.

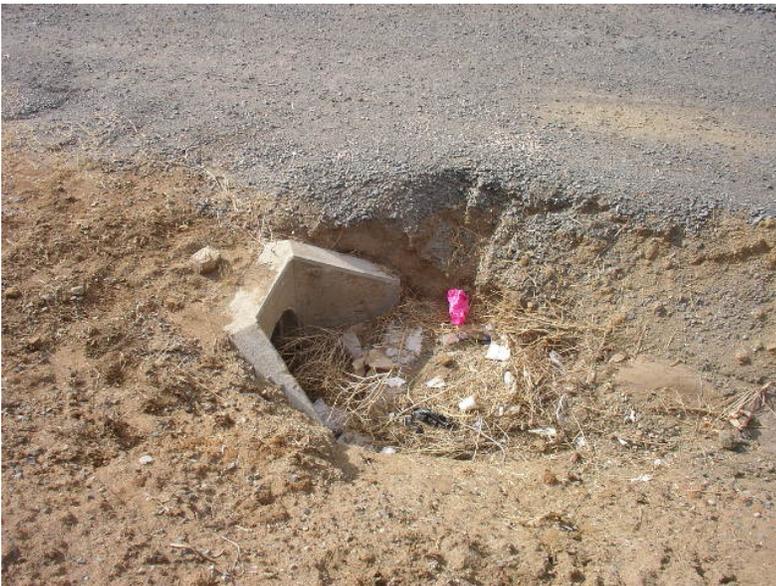
5. Another storm drain inlet along the north side of the tracks is without sediment controls such as gravel bags. Trash is in the drainage ditch. Photo looking east.

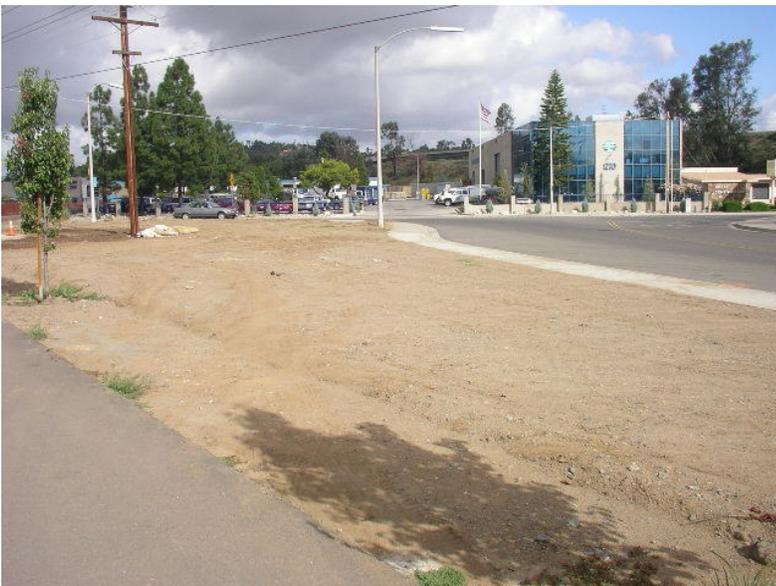
6. A large area of bare dirt has no sediment protections or soil stabilization. Photo is looking north.

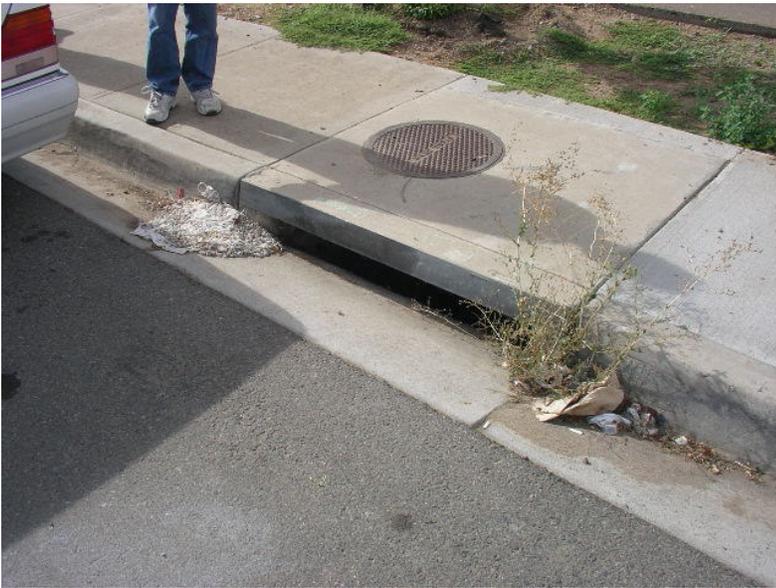
7. Storm drain inlet along the south side of Washington Avenue is without adequate storm drain inlet protection. The existing BMP has not been maintained. Photo looking south.

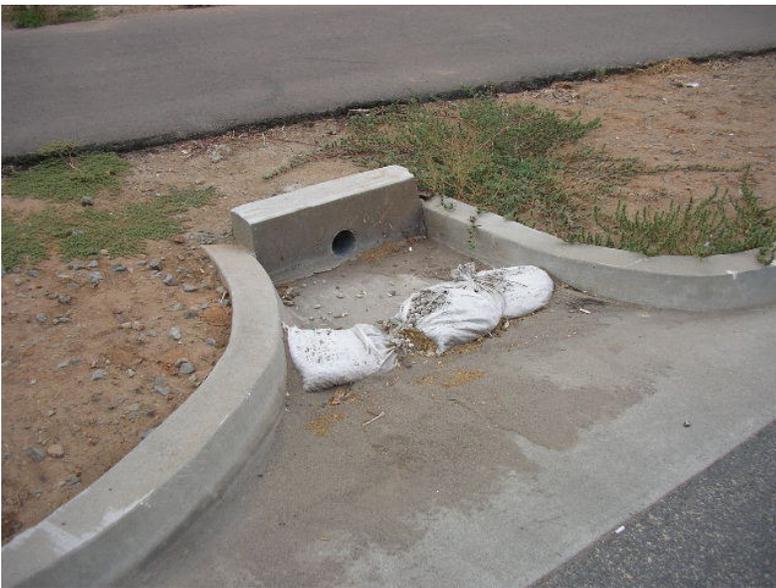
8. Storm drain inlet along the south side of Washington Avenue has BMPs that have not been maintained. Photo looking south.

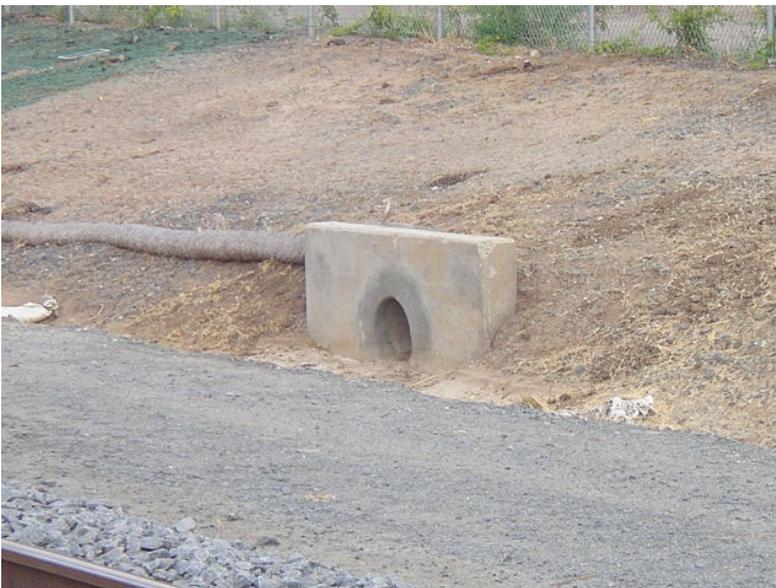
9. Storm drain inlet on the north side of the tracks without any sediment protections. Photo is looking north.

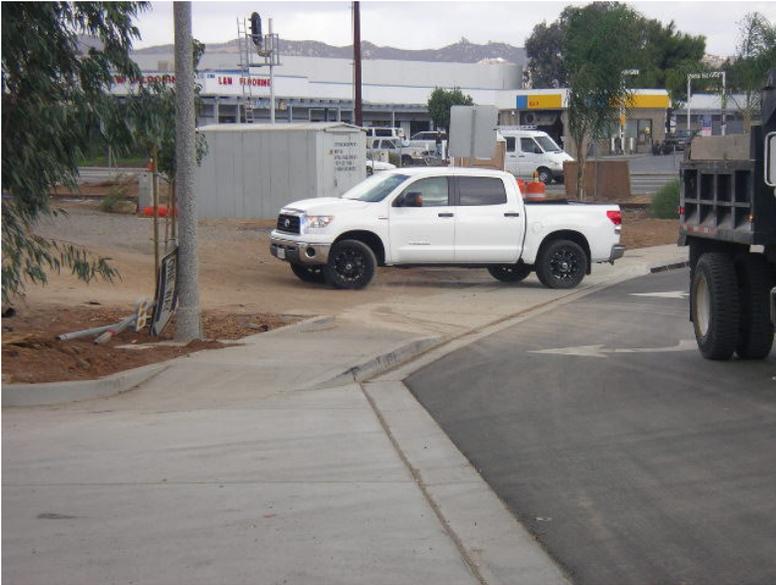
10. Construction site exit has no BMPs to prevent sediment tracking. Tracking is observed onto the adjacent paved public street, North Citracado Parkway. Photo looking north.

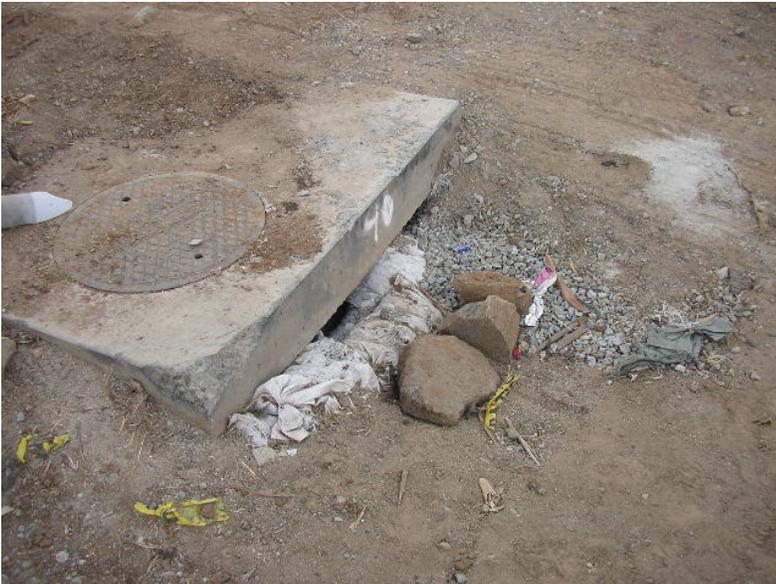
11. Storm drain inlet south of the tracks has BMPs that have not been maintained. Photo looking south.

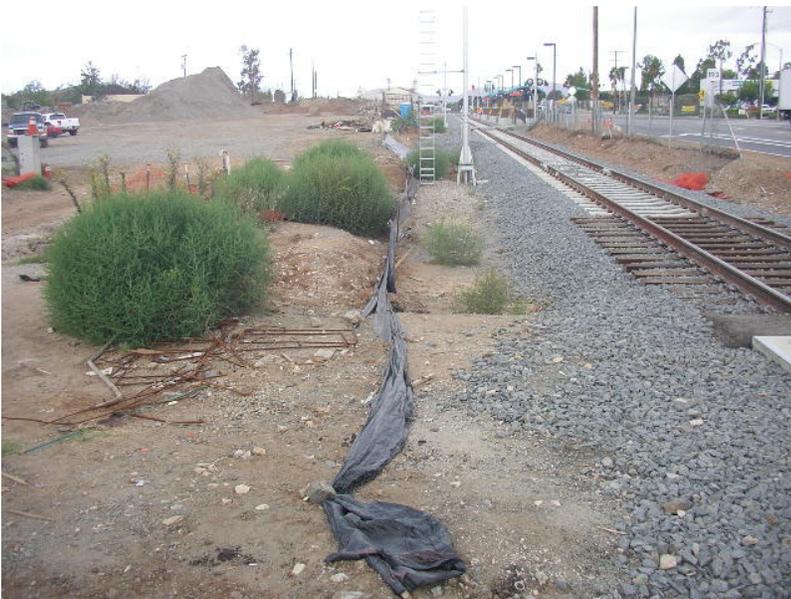
12. Silt fencing has not been maintained along the south side of the tracks. Photo looking west.

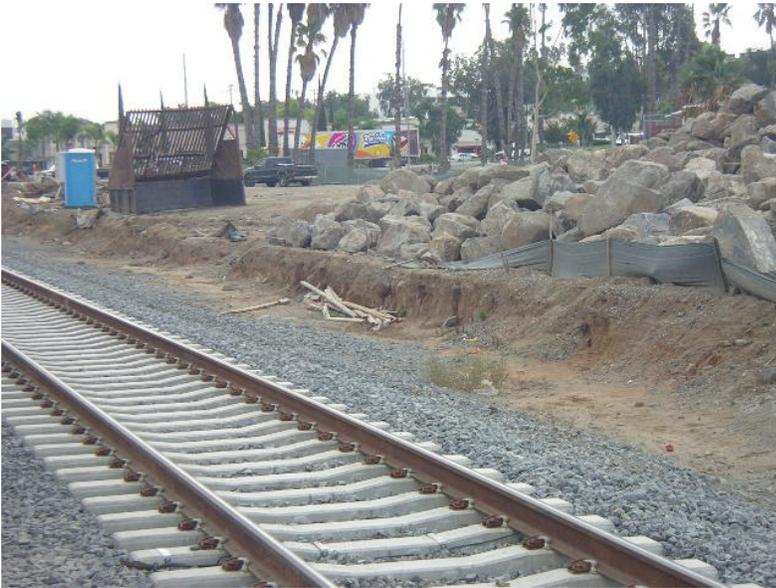
13. Silt fence south of the tracks is torn down and unmaintained. Photo looking south east.

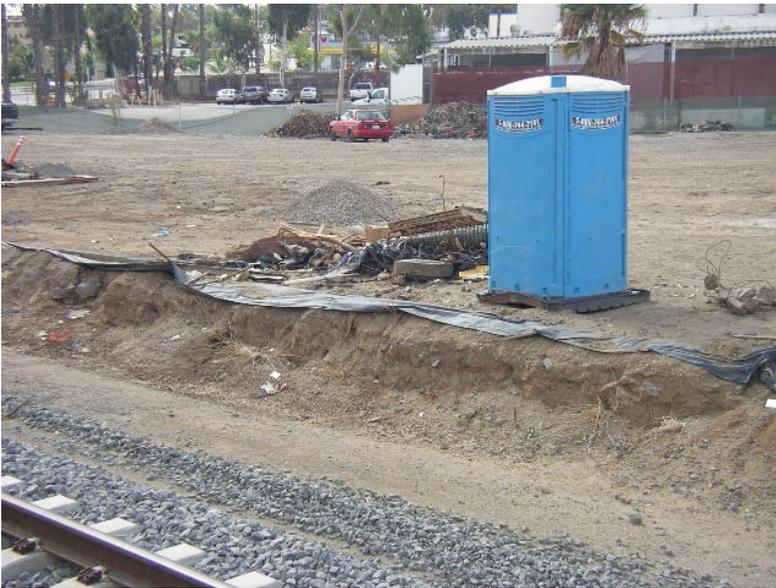
14. Silt fence is unmaintained. Construction debris and trash is not protected from storm water. Photo looking south.

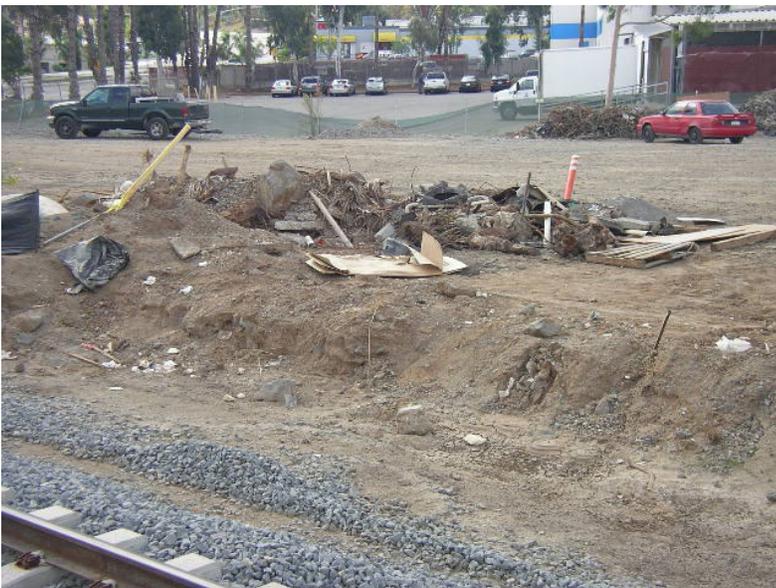
15. No silt fence is implemented in this area. Construction debris and trash is not protected from storm water. Photo looking south.

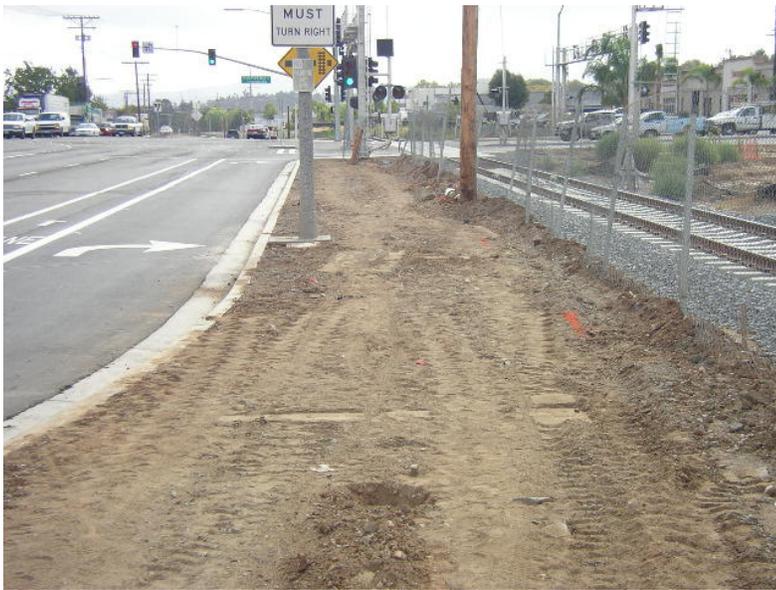
16. Bare soil north of the tracks does not have sediment controls or soil stabilization. Photo looking east.

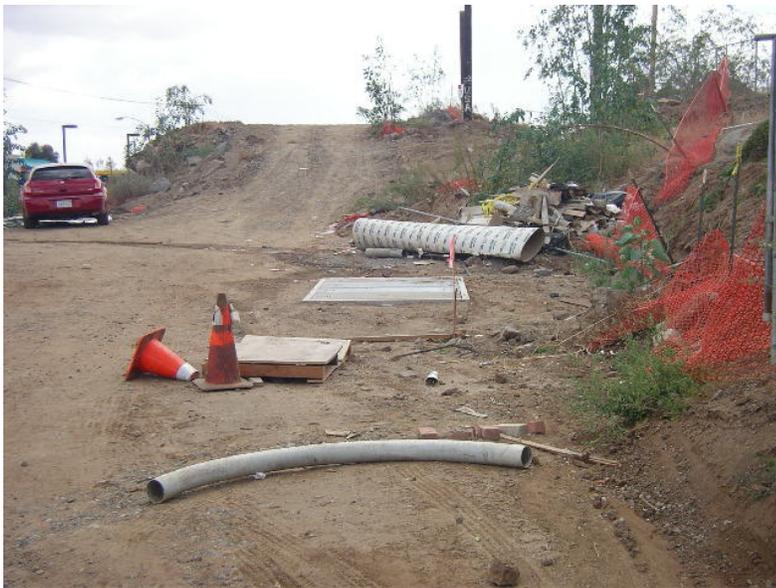
17. Construction trash is not protected with BMPs from storm water. Photo looking east.

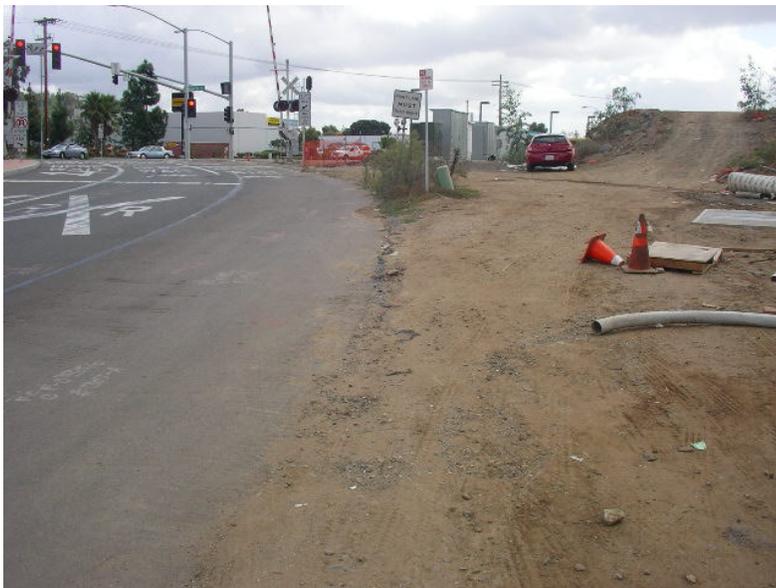
18. Sediment controls along the perimeter of south Barham drive have not been maintained. Photo looking north east.

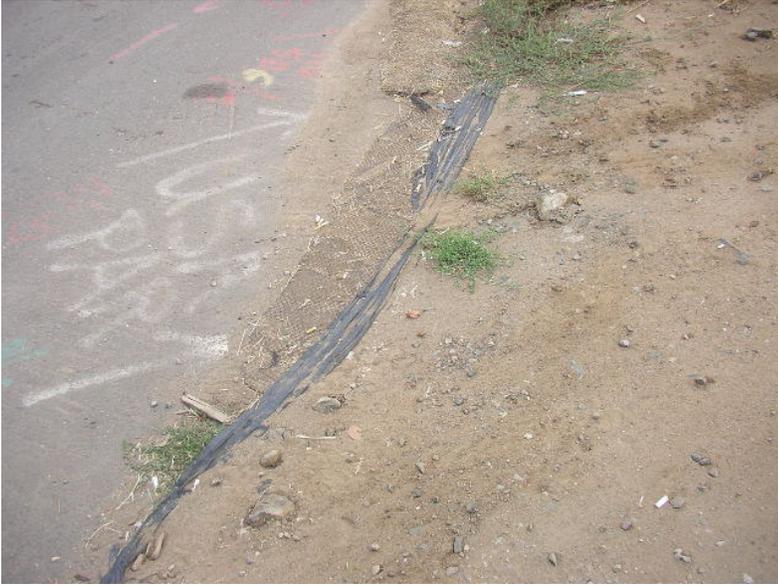
19. A closer view of the poorly maintained BMPs in photo 18 shows that the silt fence and fiber roll are flattened. Photo looking north.

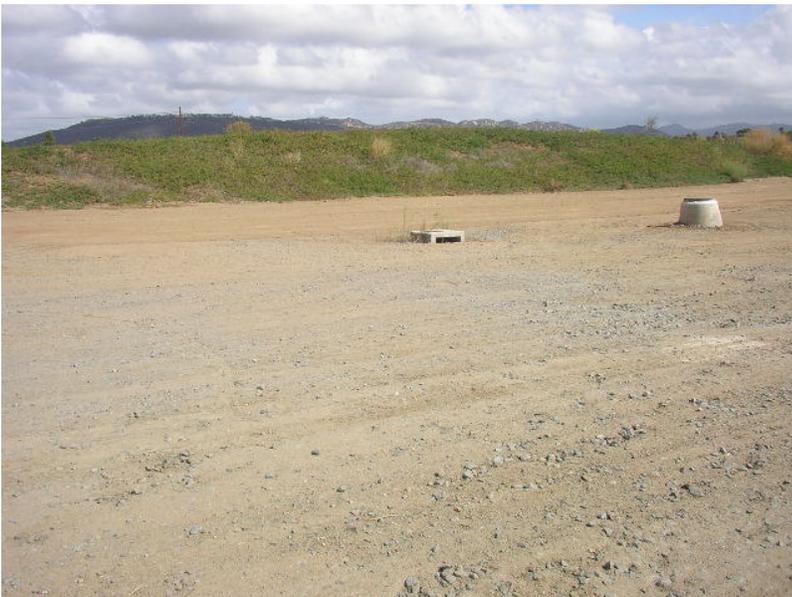
**3. Barham Drive near Shelley Drive in San Marcos** - This was one of the sites containing previous violations noticed in NOV R9-2007-0050 issued on March 19, 2007. A large area of disturbed soil was without any sediment controls or soil stabilization (Photo 21). In the middle of this disturbed area there was an unprotected storm drain (Photo 22).

21. A large area of bare soil is without soil stabilization. A storm drain inlet sits in the middle of this bare area.

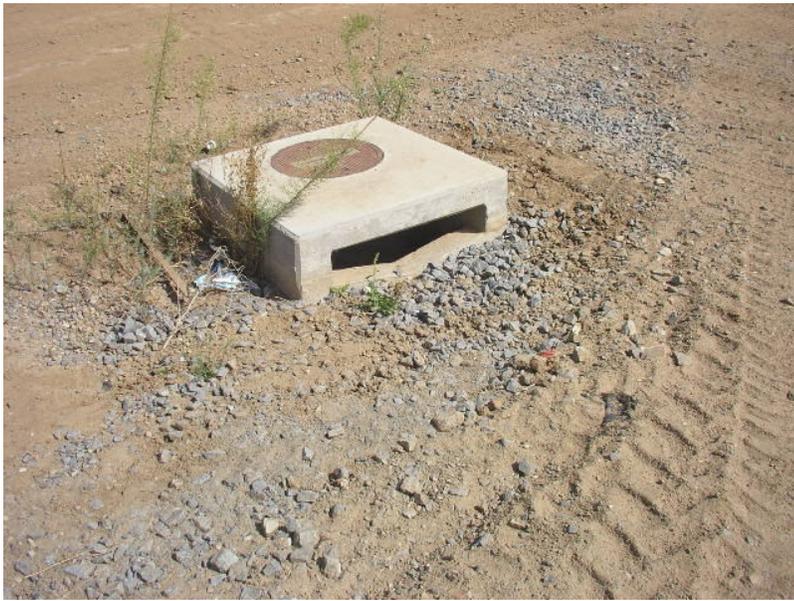
22. A closer examination of the storm drain inlet in photo 21 shows that the inlet has no sediment controls protecting the inlet. Photo looking north east.

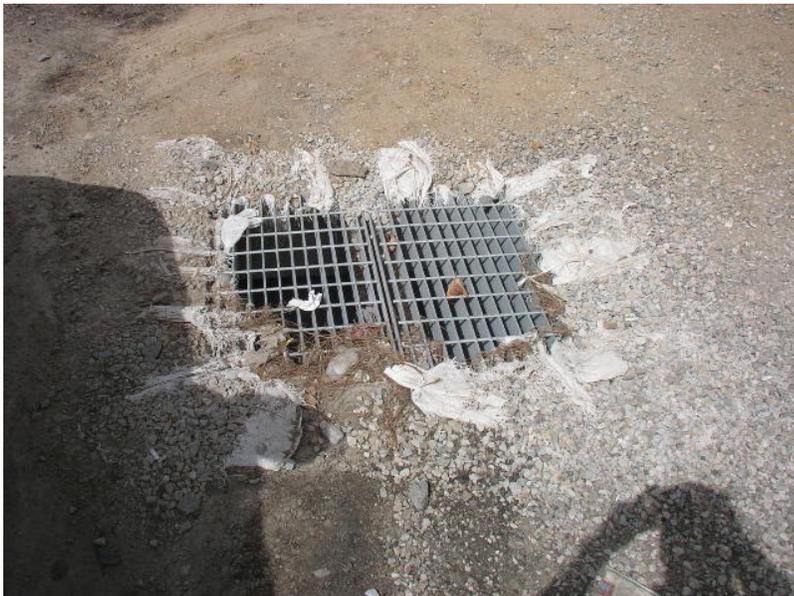
**4. Palomar College Station** - This was one of the sites containing previous violations noticed in NOV R9-2007-0050 issued on March 19, 2007. This station is south of W. Mission Rd, and north of Armorlite Dr. in San Marcos, across Mission Rd, from Palomar College. The site houses trailers for NCTD and their contractors. A storm drain inlet at the Armorlite Drive entrance to the trailers has gravel bags that are destroyed to the point that the gravel appears to be entering the inlet (Photo 23). A portable toilet is nearby and silt fencing has been partially removed (Photo 24).

23. Storm drain inlet just north of Armorlite drive has unmaintained BMPs. Photo looking west.

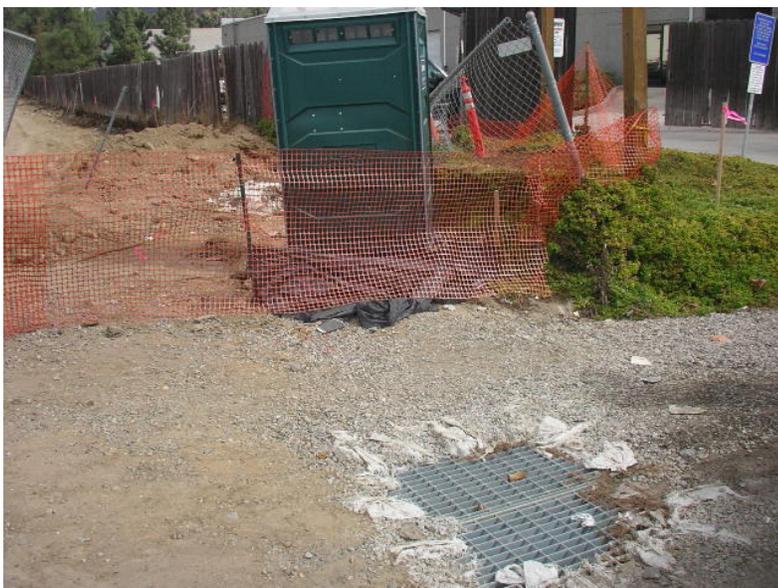
24. Another view of the inlet in photo 23 shows the proximity of a portable toilet and silt fencing that has been partially removed. Photo looking north.

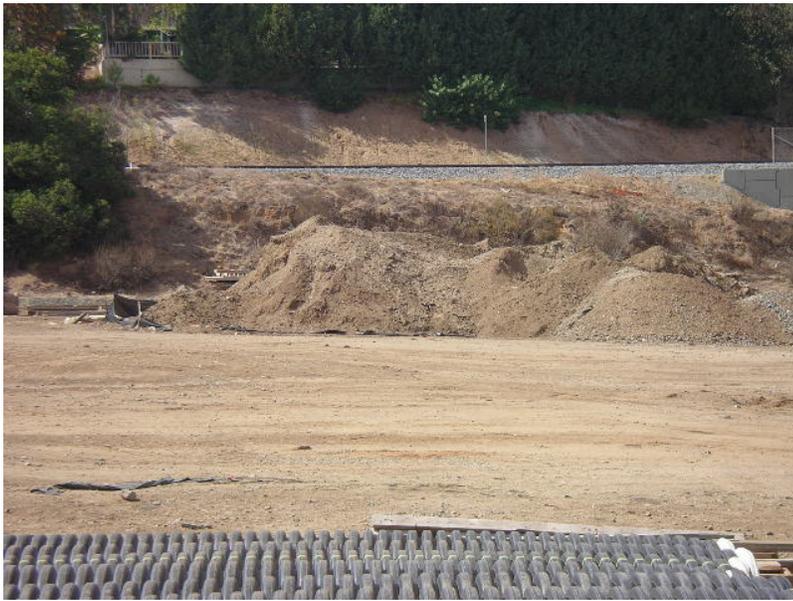
**5. Mar Vista drive storage yard in Vista** - This was one of the sites containing previous violations noticed in NOV R9-2007-0050 issued on March 19, 2007. This storage yard has a large soil stockpile that was not covered or contained to protect storm water runoff. Silt fence was not maintained around this stockpile. The silt fence was falling down on one side of the stockpile (Photo 25).

25. Silt fence around the soil stockpiles has not been maintained and has fallen down. Photo looking south.

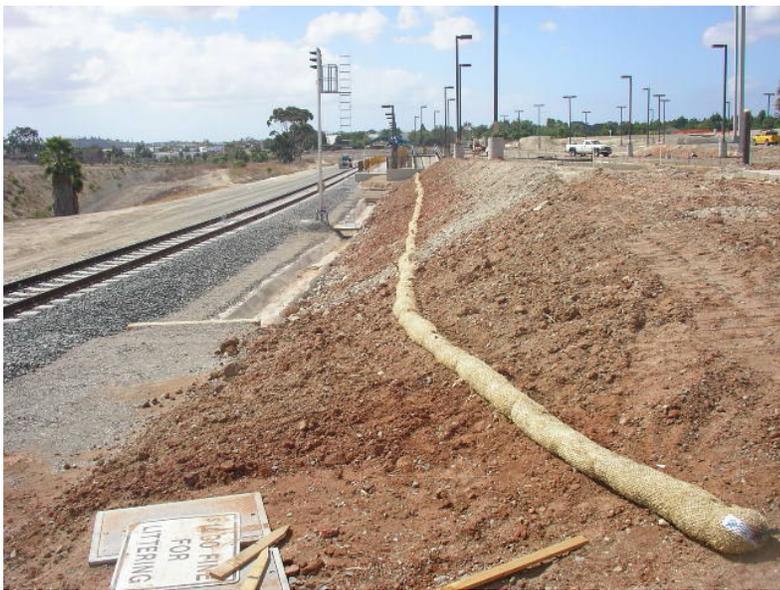
26. This slope north of the tracks does not have erosion controls in place. Fiber roll is not trenched in place. Photo looking west.

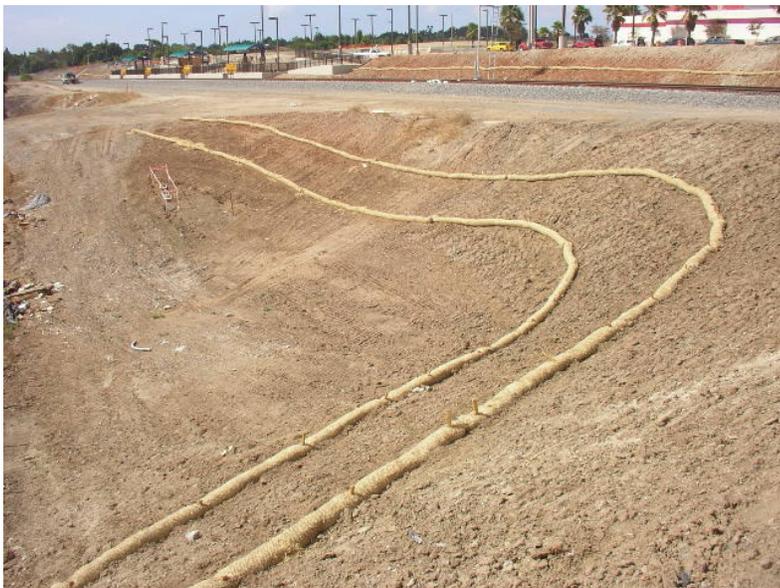
27. Slope south of the tracks does not have erosion controls. Photo looking north.

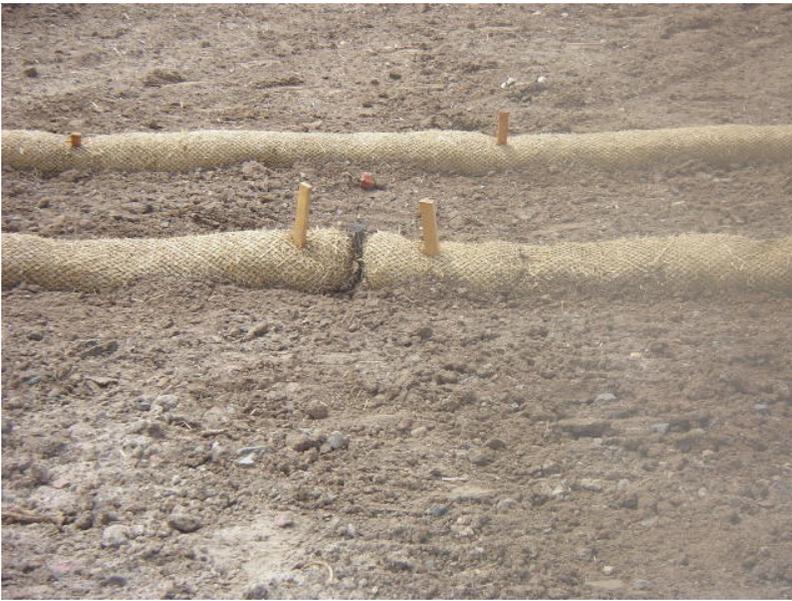
28. Fiber rolls on the slope in photo 27 are not overlapped. No erosion controls in place. Photo looking west.

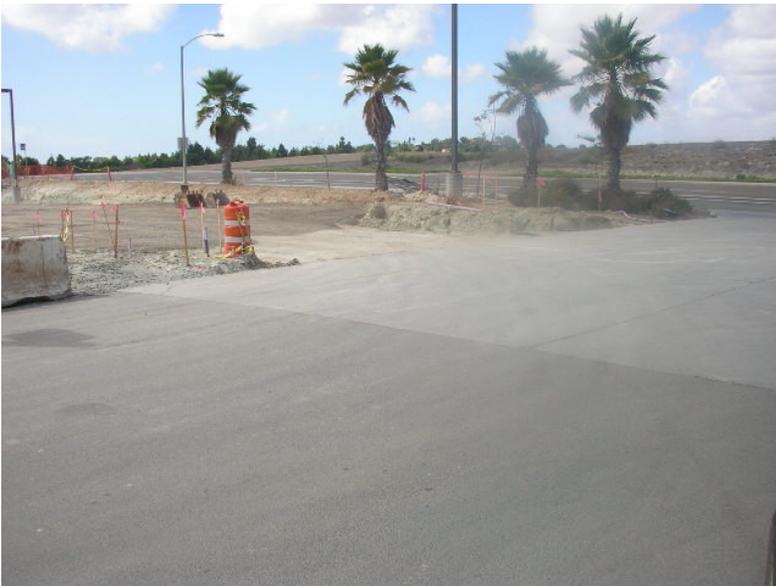
29. Construction exit is without BMPs to prevent sediment tracking onto the adjacent paved area of the convenience store. Photo looking north west.

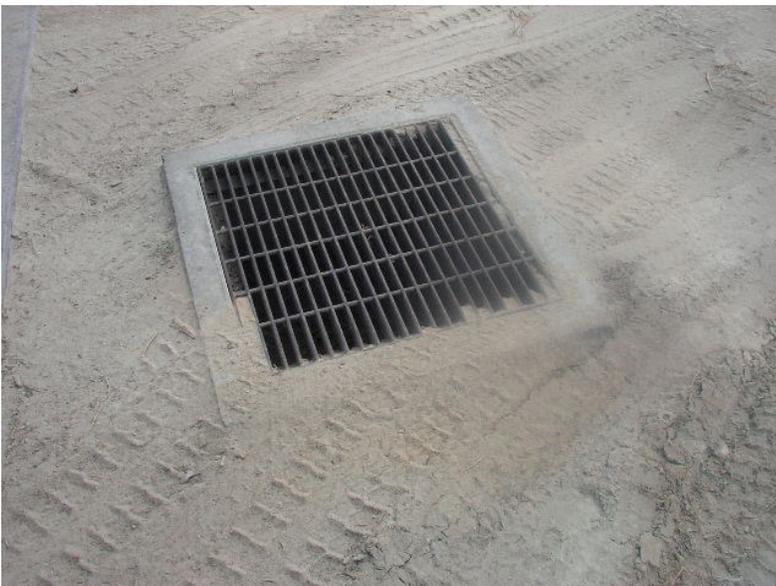
30. A storm drain inlet near the construction exit in photo 29 is without BMPs and sediment is falling into the drain. Photo looking west.

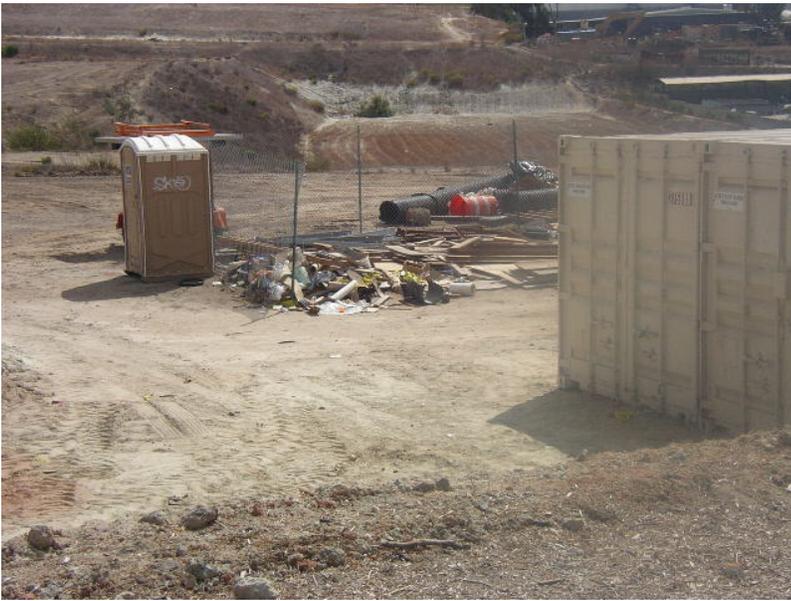
**6. Melrose Drive station in Oceanside-** This station is on the southwest corner of Melrose Drive and Oceanside Boulevard next to a convenience store. The headwaters to Loma Alta Creek flow adjacent to the south side of the tracks. This site did not have any erosion controls on slopes and fiber rolls were not implemented properly (Photos 26, 27, 28). The fiber rolls were not trenched in properly on a slope north of the tracks. A slope south of the tracks did not have the fiber rolls overlapping at the ends. The construction exit through the convenience store parking lot did not have any BMPs to prevent sediment tracking (Photo 29). At this exit a storm drain inlet was in the bare soil with no BMPs to protect it (Photo 30). The inlet has been repeatedly driven over tracking sediment into the inlet. At the western edge of the Melrose station construction, trash and debris was stored outside without cover or containment (Photo 31).

31. Construction trash is stored outside with no cover or containment to prevent contact with storm water. Photo looking south.

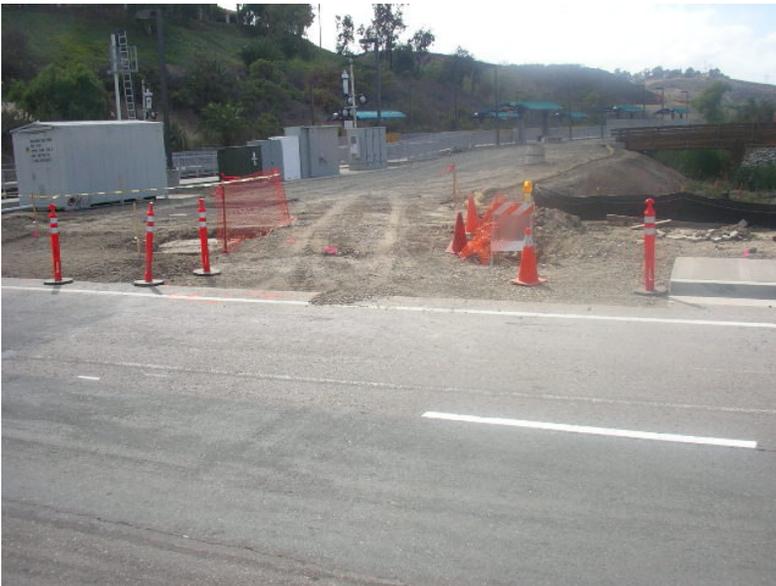
32. Construction exit is without BMPs to prevent sediment tracking onto the adjacent paved street. Photo looking west.

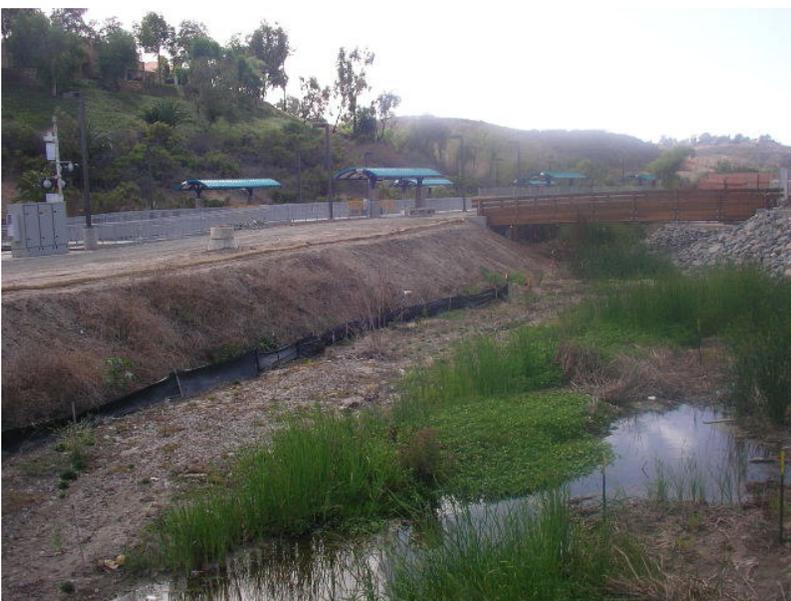
33. Slope adjacent to Loma Alta Creek is without erosion controls such as bonded fiber matrix or erosion control blankets. Silt fence does not extend the length of the slope. Photo looking south west.

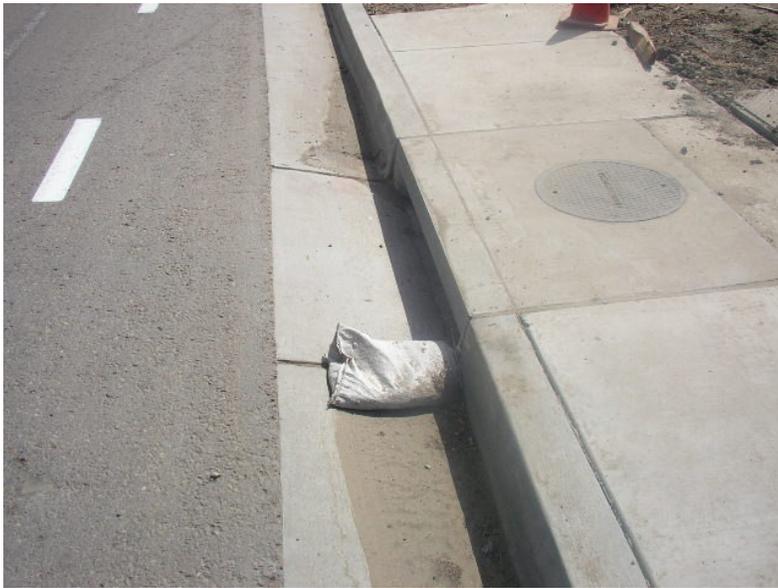
34. A storm drain inlet on the west side of Rancho del Oro Blvd. does not have adequate sediment controls and is not being maintained. Photo looking south.

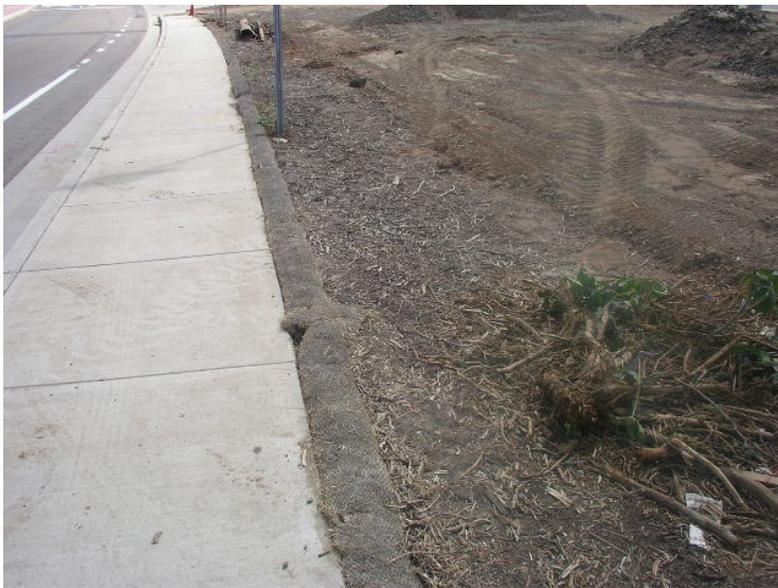
**7. Rancho del Oro station in Oceanside** - This station is bordered by Rancho del Oro Road to the east. Loma Alta Creek runs through the north of the station. A pedestrian bridge is being built over the creek to access the station. The construction site entrance/exit from Rancho del Oro Road does not have large gravel or shaker plates or a tire wash station to prevent sediment tracking onto the adjacent paved public road (Photo 32). The southern bank of Loma Alta creek does not have any erosion controls (Photo 33). This exposed bank appears to be vulnerable during high flow rates and volume. A storm drain along the west side of Rancho del Oro Road had a single gravel bag which appears to be inadequate to trap sediment from entering the inlet (Photo 34). Along the east side of Rancho del Oro Road, a fiber roll had not been maintained and was flattened from repeatedly being run over (Photo 35).

35. Fiber rolls along the east of Rancho del Oro Blvd have not been maintained and are flattened. Disturbed soil has not been stabilized. Photo looking north.

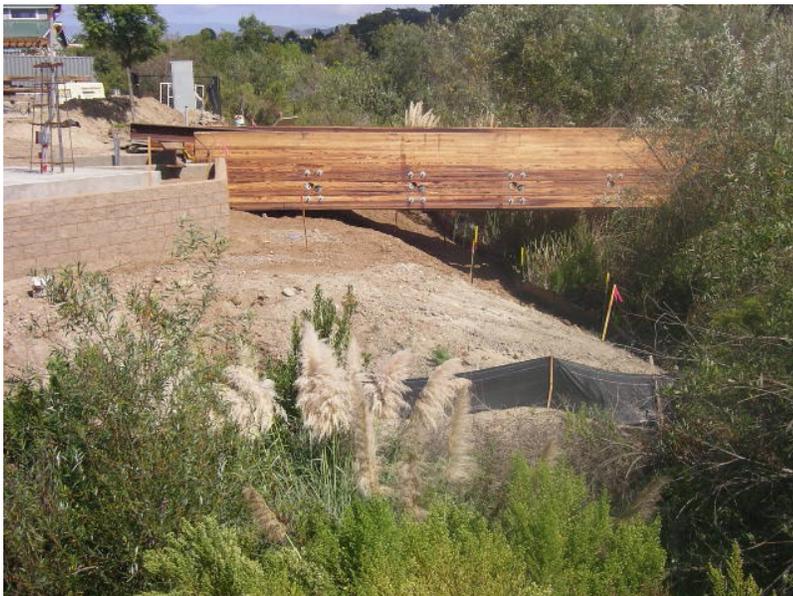
36. Slope next to Loma Alta Creek does not have erosion controls implemented. Photo looking east.

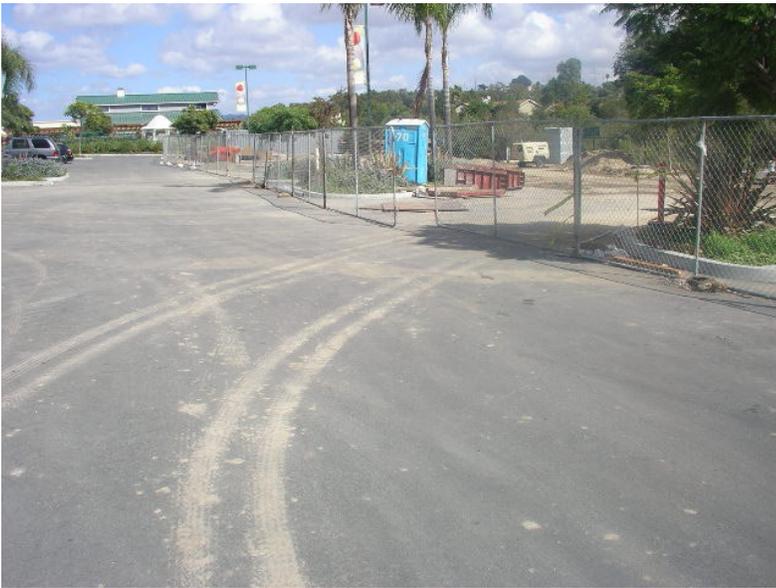
**8. College Blvd Station in Oceanside** - This station is next to Loma Alta Creek in a shopping center on the southwest corner of College Boulevard and Oceanside Boulevard. A pedestrian bridge is being built over Loma Alta creek. The creek's banks on either side of the pedestrian bridge have a silt fence at the base to provide sediment controls but is without erosion controls on the slope such as hydroseed or erosion control blankets (Photos 36, 39). These exposed banks appear to be vulnerable during post storm high flow rates. A portion of the shopping center's parking lot is used as a staging and storage area for construction activities. Significant sediment tracking was observed on the shopping center's paved parking lot (Photo 37). Soil stockpiles and construction trash storage was without cover and without containment (Photo 38).

37. Sediment tracking from the College Station construction onto the paved parking lot of the shopping center. Photo looking east.

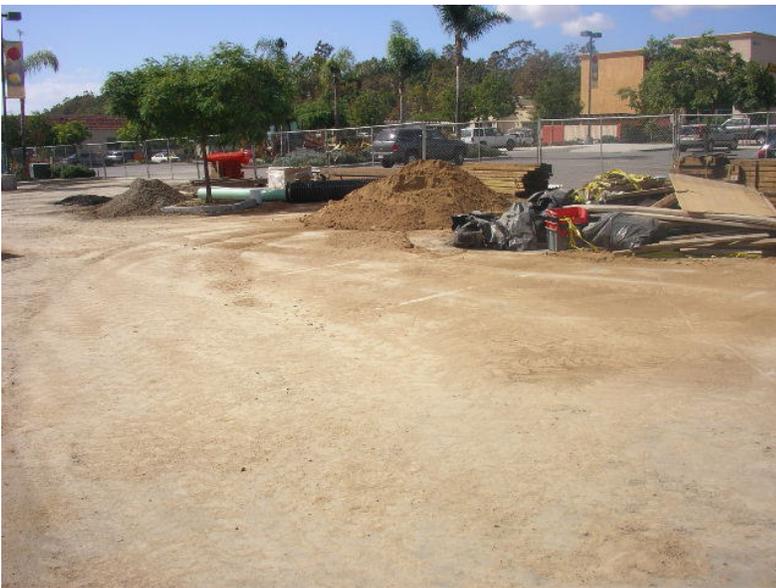
38. Material stockpiles and construction trash are stored without cover or containment. Photo looking north west.

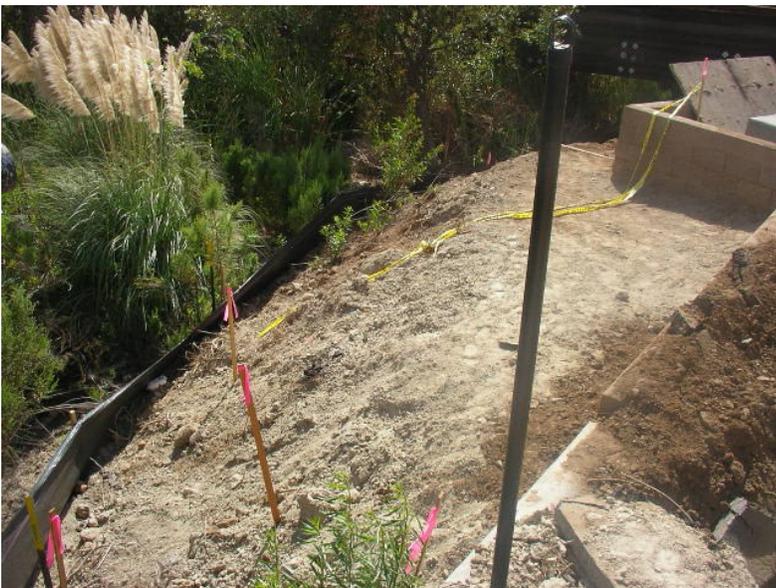
39. Slope next to Loma Alta Creek pedestrian bridge abutment is without erosion controls. Photo looking west.
