**CALIFORNIA REGIONAL WATER QUALITY CONTROL BOARD - SAN DIEGO REGION
WATERSHED MANAGEMENT PROGRAM**

FACILITY INSPECTION REPORT

INSPECTION DATE: December 7, 2007 TIME: 9 am WDID: 9 37C322900

Sprinter Rail Project
FACILITY OR DEVELOPER NAME (if different from owner)

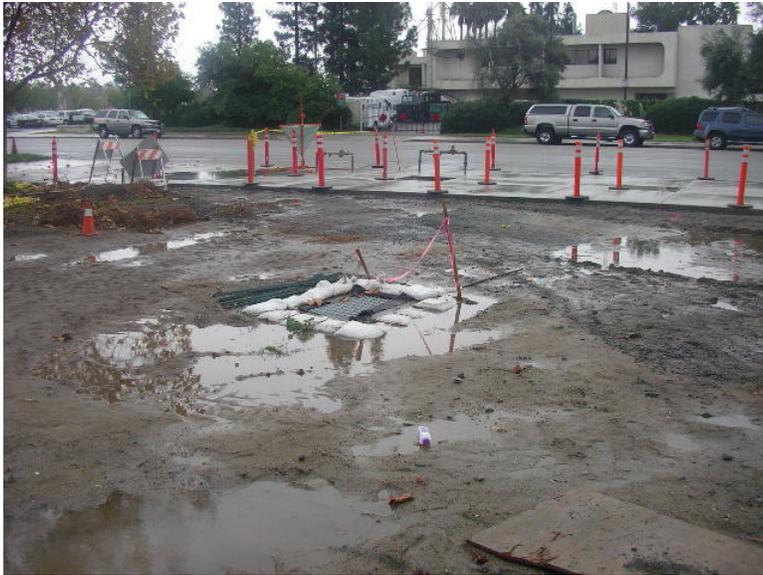
1. Escondido Transit Center in Escondido - This station is located on Valley Parkway near Quince Street. The station is near completion, but landscaping has not been installed. Photo 1 shows gravel bags protecting a storm drain inlet in the parking area. Only light rain was falling at this time and the water level was near the top of the gravel bags. This is of concern because it appears that water could overflow the gravel bags during a heavy rainfall event. Another gravel bag-protected drain in the parking area is shown in Photo 2. Photo 3 shows a hole in the ground where it appears that water has been draining to. This is suggested by the lack of ponding of water in this area and the large rill leading to the hole. It appears to be possible that sediment-laden water could be bypassing sediment controls and reaching storm drains through this hole. A similar situation was found at another storm drain in the parking lot. Again, it appeared that water had been draining onto a hole and possibly entering the storm drain or storm drain backfill or both. Slopes along the side of the tracks lacked erosion and sediment controls (Photo 4). Another storm drain with gravel bag protection is shown in Photo 5. A silt fence near the railroad tracks was almost completely dilapidated. This area also lacked erosion controls (Photo 6).

1. Gravel bags holding back
sediment-laden water.

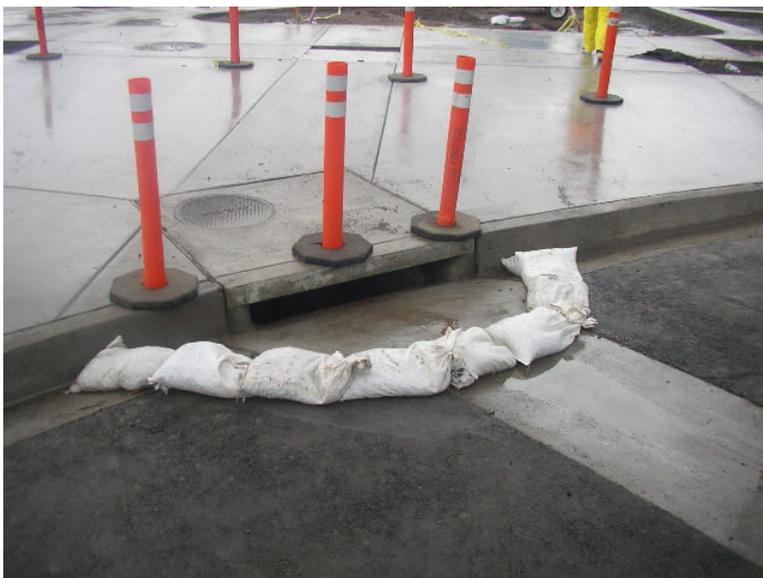
2. Parking lot drain inlet protected
with gravel bags.

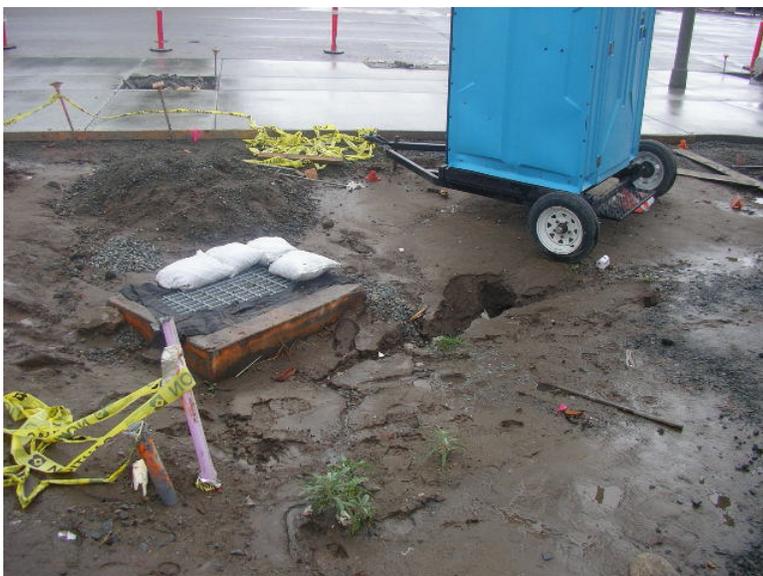
3. Rill leads to a hole in the
ground (below the port-a-potty)
where storm water appears to be
draining.

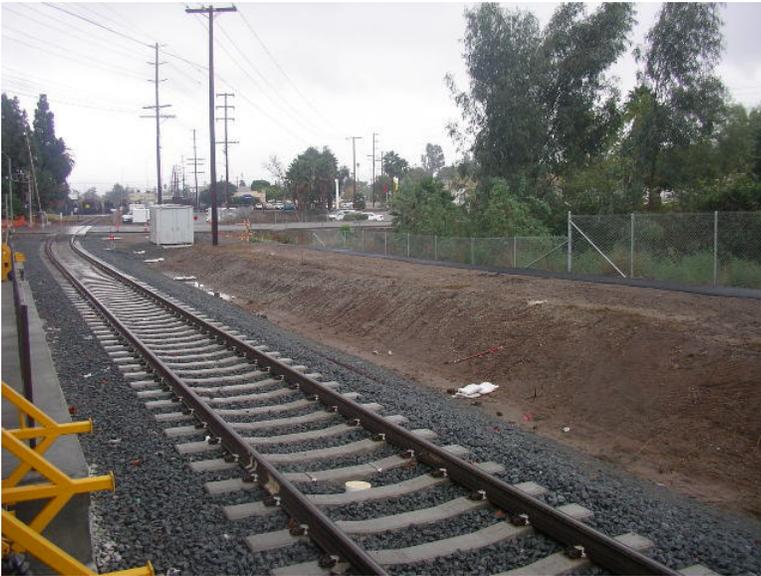
4. Slope lacks both erosion and sediment controls.

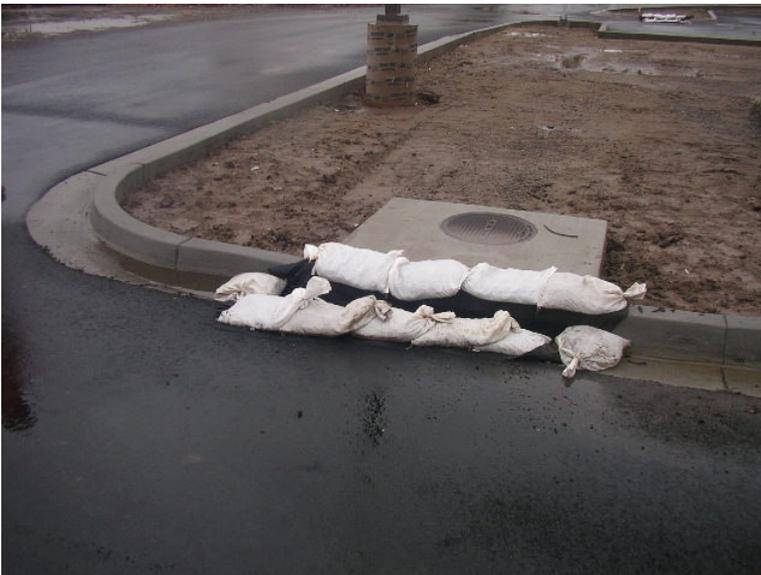
5. Gravel bags surrounding inlet in parking lot.

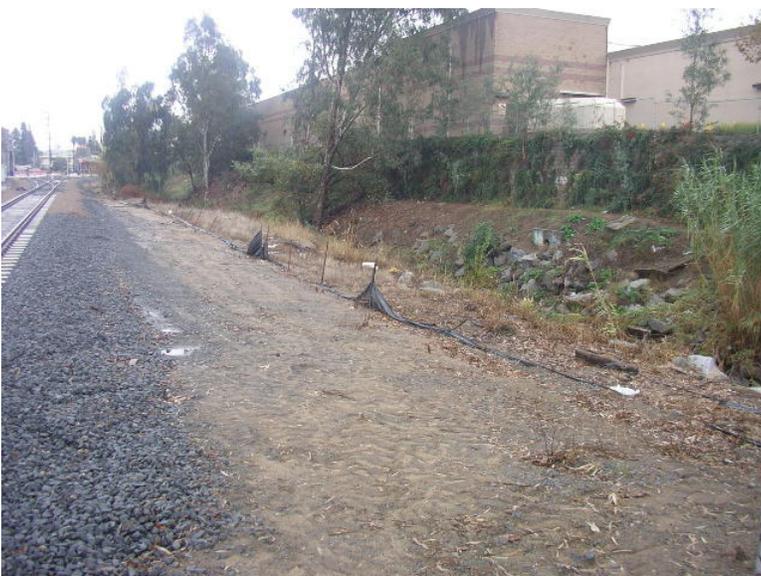
6. Silt fence in disrepair.

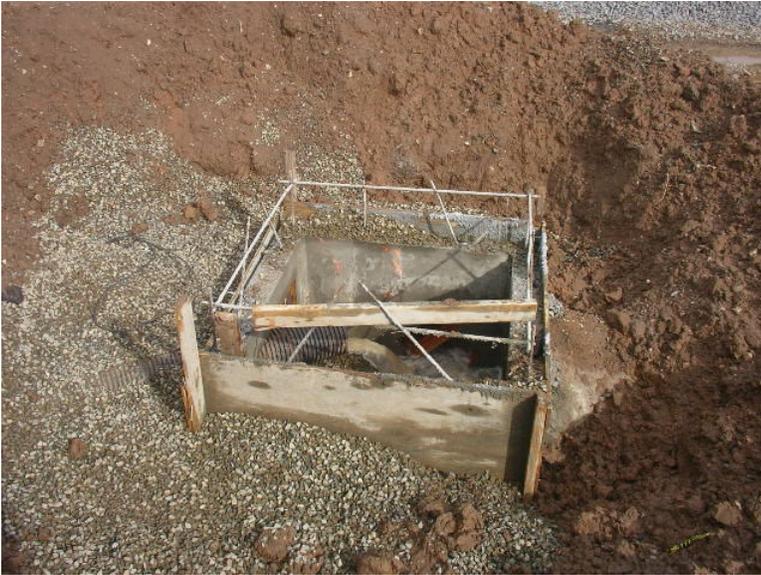
3. Nordahl Road Station in Escondido - This station is located at the intersection of Barham Drive and Mission Avenue. A drain that was under construction lacked inlet protection while bare soil that surrounded the drain was lacking erosion controls (Photo 7). Photo 8 shows a similar situation in which there is some inlet protection (rocks in front of the drain) but the protection is clearly inadequate. Photo 9 shows gravel bags that have been placed in front of a ponded area where a prior inspection had found the muddy pond to be bypassing the fiber rolls and flowing to the street. It is doubtful that the bags alone will be effective in preventing overflow during a rainfall event.

7. Drain still under construction, but inlet protection is needed and soil lacks erosion controls.

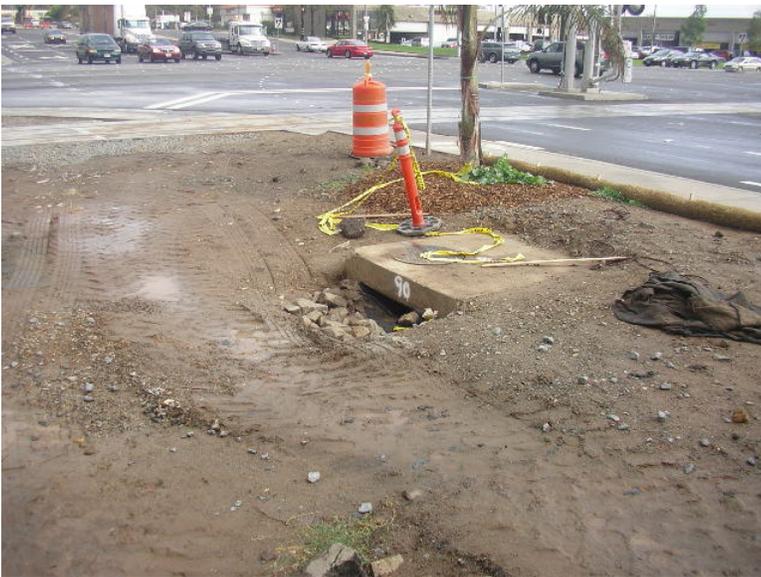
8. Rocks in front of storm drain inlet provide inadequate protection.

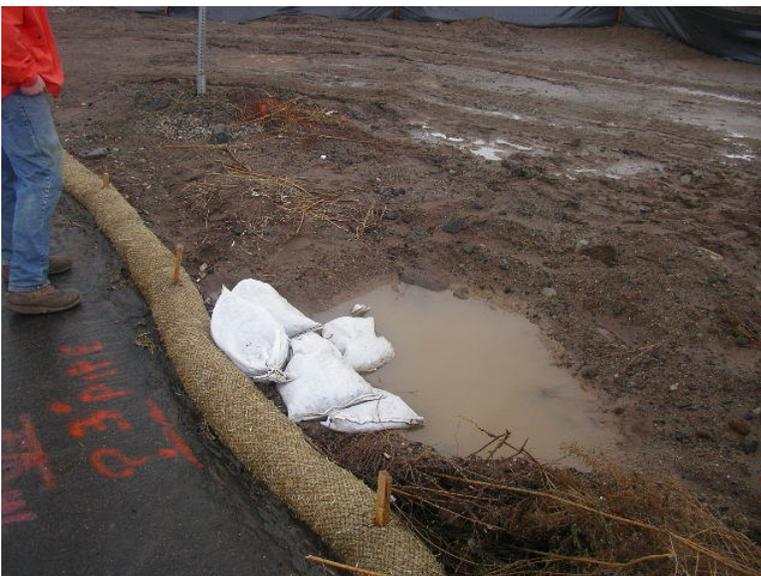
9. Gravel bags placed next to pond of turbid water to prevent overflow to the street.

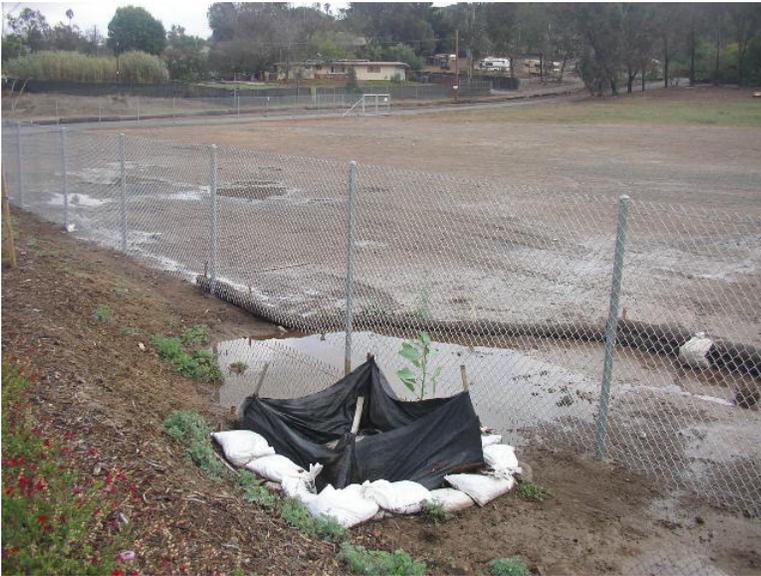
4. Barham Drive, east of Cal State San Marcos Station in San Marcos - This is a stretch of railroad tracks that run along Barham Drive between Cal State Marcos Station and Nordahl Road Station. Photo 10 shows a large field of exposed soil where storm water flows to a storm drain inlet that is protected by silt fence and gravel bags. Flows have been strong enough to knock down silt fences during past storm events, however, the inlet protection was holding up, so far, on this date. The field needs implementation of erosion controls as soon as possible. Further to the west of this area, fiber rolls were in need of maintenance. A section of fiber roll has been flattened to the elevation of the sidewalk (Photo 11).

10. Another area where soil is not stabilized.

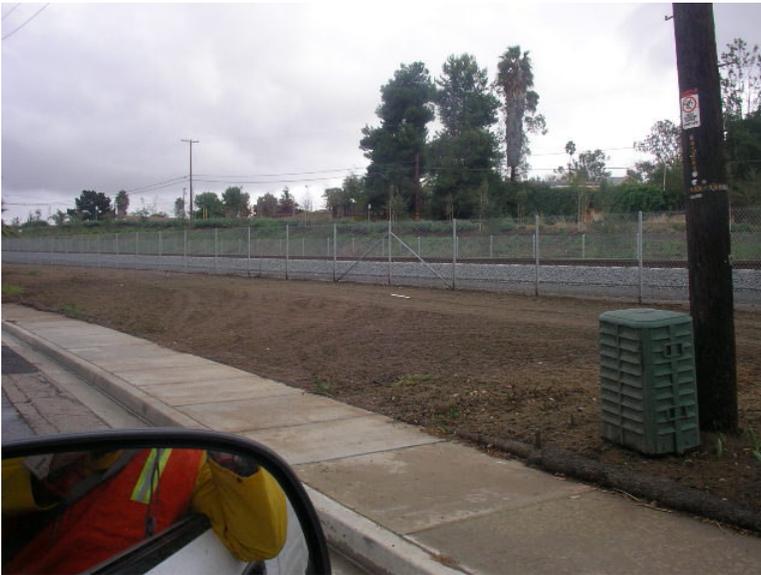
11. Fiber roll at toe of slope flattened to about the level of the sidewalk.

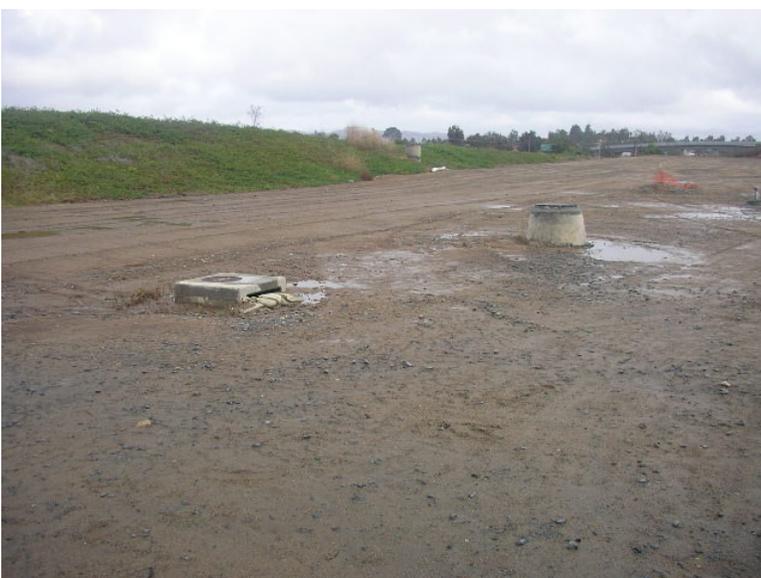
5. Near the intersection of Barham Drive and Shelly Drive in San Marcos - This is a location near a stretch of tracks further to the west on Barham Drive. A large expanse of unstabilized soil was evident here. A storm drain inlet surrounded by soil continues to be inadequately protected (Photo 12).

12. Large expanse of unstabilized soil surrounding a storm drain with inadequate inlet protection.

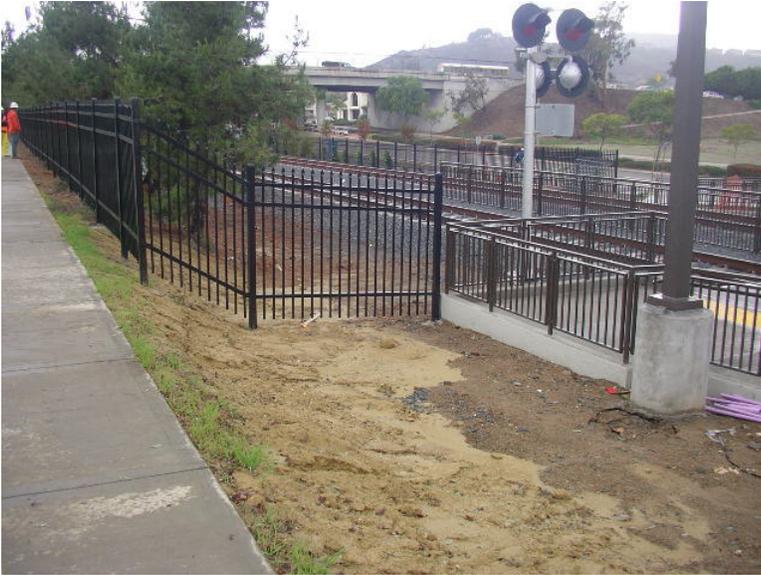
13. Soil lacks stabilization.

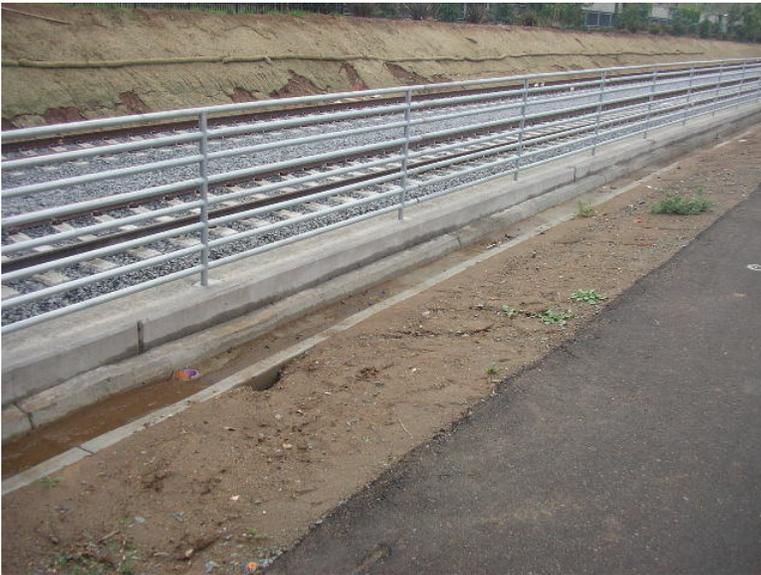
sections were slumping or sloughing off (Photo 14). At a location on Mission Avenue stabilization was needed in an area close to a storm drain (Photo 15).

14. Slopes on left side of picture exhibit hydroseeded areas that have slumped or sloughed off of the slope. Bare soil on the right side of picture lacks adequate stabilization.

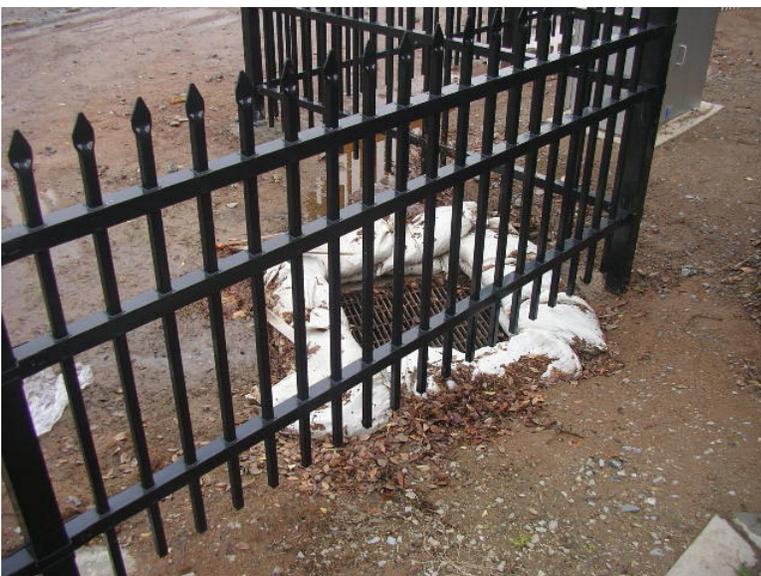
15. Gravel bags protecting inlet in an area that needs stabilization.

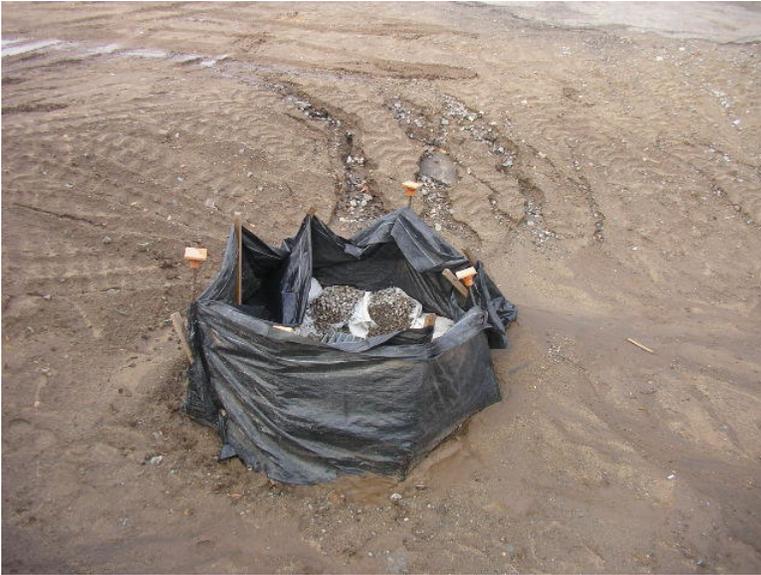
7. Buena Creek Station in San Diego County (Unincorporated) - This station is located at the intersection of Buena Creek Road and Santa Fe Avenue. Once again, station construction is near completion, but landscaping had not yet been installed. Photo 16 shows eroded soil near a drain inlet with dilapidated gravel bags. Stabilization is needed along with improved inlet protection.

16. Lack of erosion control in area surrounding storm drain inlet.

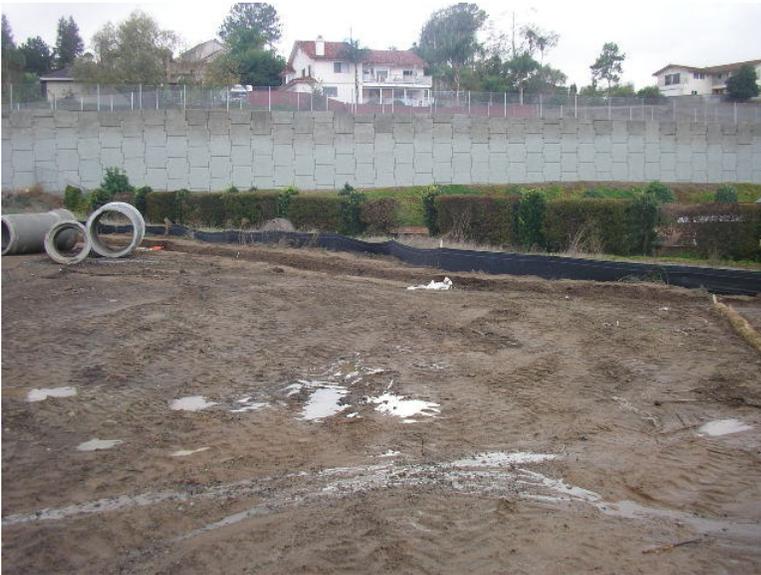
8. Mar Vista storage yard in Vista - This site is a storage yard located adjacent to the tracks at Mar Vista Drive. An outfall directs storm water from an off-site source onto the yard. NCTD has constructed an earthen channel to convey this water to a storm drain on the northwest corner of the site. This drain also handles the runoff from the rest of the site. Highly turbid water has been observed entering this drain during prior inspections. Rainfall had subsided and there was no flow of water occurring here during this inspection. No erosion controls have been employed in the earthen channel (Photo 17).

17. Channel leading from outfall at wall lacks stabilization or any erosion controls.

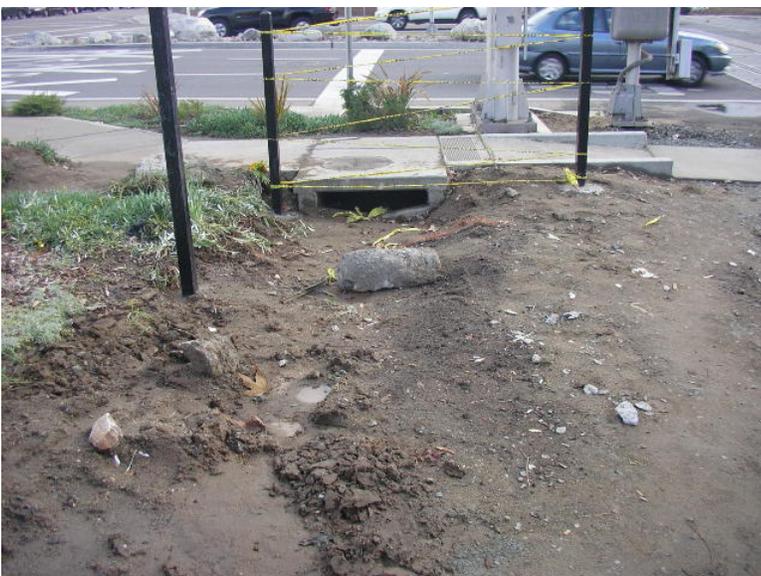
9. Vista Transit Center in Vista - The Vista Transit Center is located near the corner of Vista Village Drive and Santa Fe Avenue. A drain alongside of Vista Village Drive did not have any inlet protection and the soil outside the drain had no erosion or sediment controls (Photo 18).

18. No inlet protection and soil lacks stabilization.

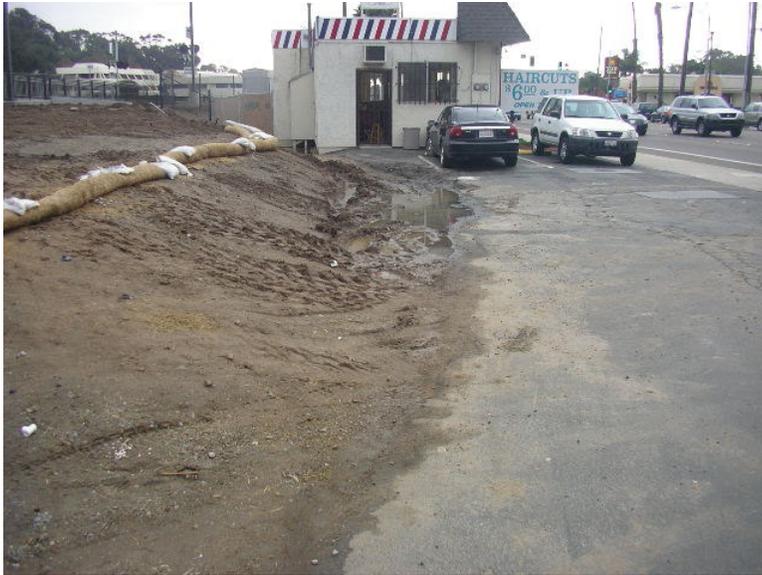
10. Crouch Street Station in Oceanside - This station is located near the intersection of Crouch Street and Oceanside Boulevard. Photo 19 shows a slope on the north side of the station where the lack of erosion and sediment controls has resulted in soil encroaching on the parking lot of an adjoining business establishment.

19. Lack of erosion control and inadequate sediment control on slope above a parking area. Soil is encroaching onto the parking lot.

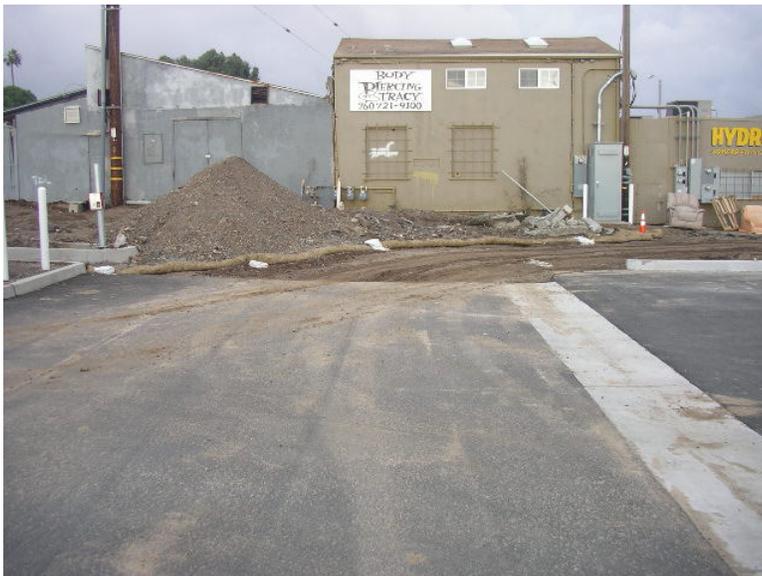
20. Sediment tracking on pavement with no tracking controls.

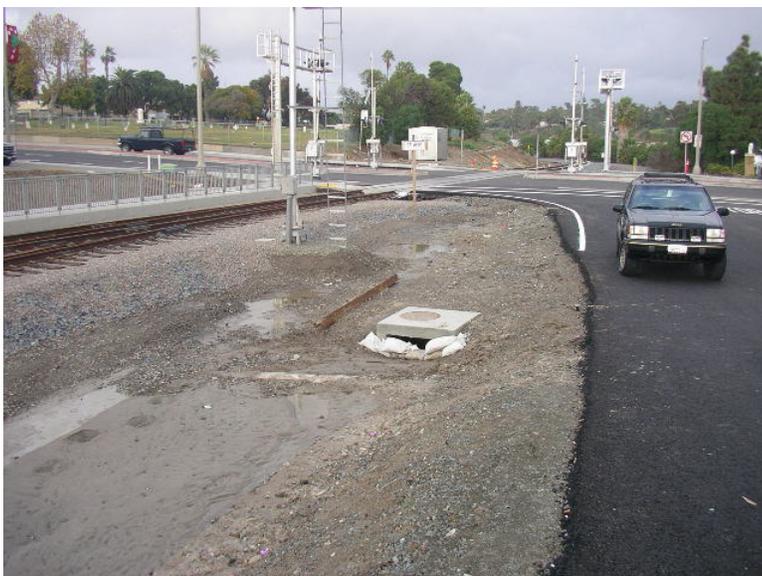
21. Soil near tracks lacks stabilization. Accumulated sediment is visible in front of the drain inlet.

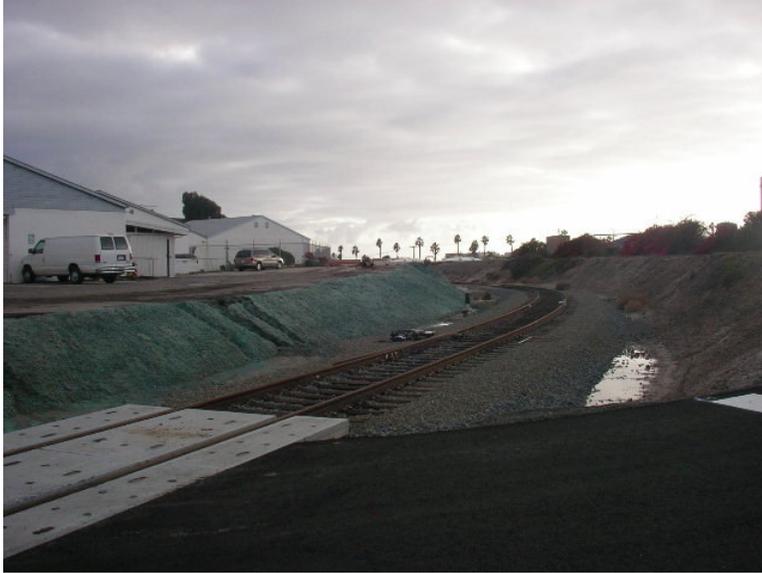
22. No erosion or sediment controls on south-facing slopes. North-facing slopes have been hydroseeded. Gullies formed prior to hydroseeding need repair.

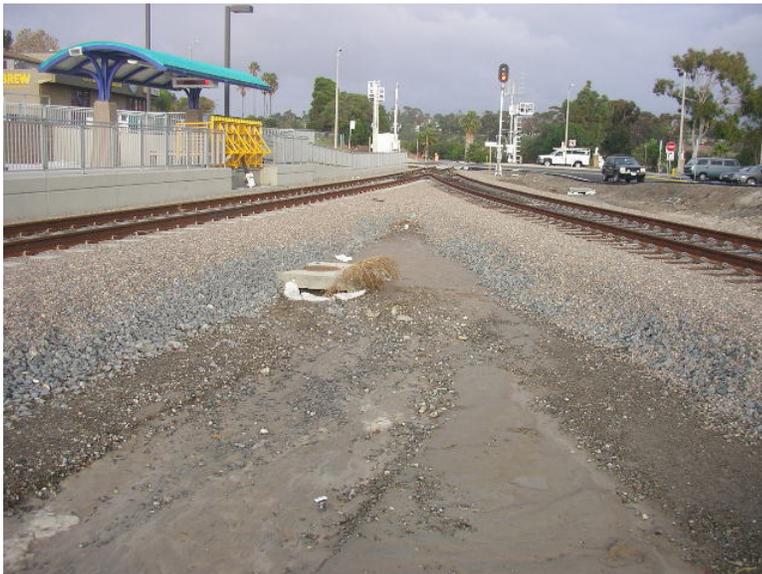
23. Inadequate inlet protection. Earthen channel lacks erosion controls.
