**CALIFORNIA REGIONAL WATER QUALITY CONTROL BOARD - SAN DIEGO REGION
WATERSHED MANAGEMENT PROGRAM**

FACILITY INSPECTION REPORT

INSPECTION DATE: December 19, 2007 TIME: 9 am WDID: 9 37C322900

Sprinter Rail Project
FACILITY OR DEVELOPER NAME (if different from owner)

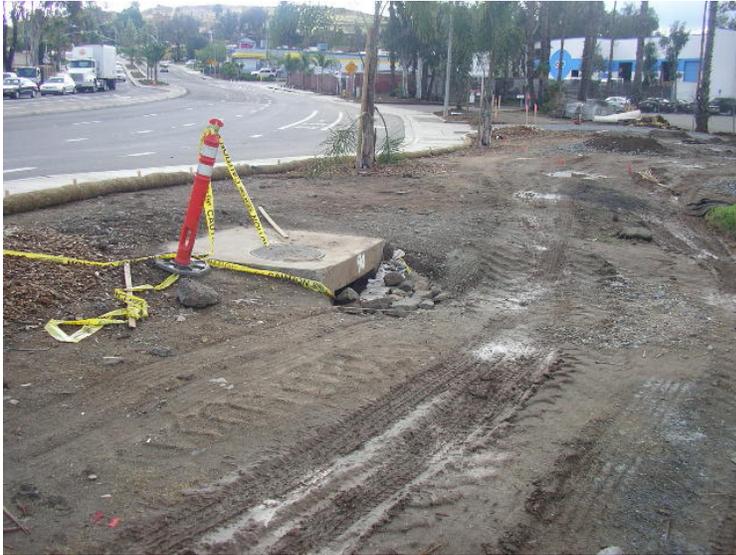
Photo 1 was taken at the Nordahl
Road Station.

- 1. Nordahl Road Station in Escondido** - This station is located at the intersection of Barham Drive and Mission Avenue. A drain at the west side of the station which had during the last inspection (on December 7, 2007) been identified as lacking inlet protection was found to still be inadequately protected (Photo 1). Gravel bags sit in a depression in front of the drain allowing for easy entry of storm water flows. In addition, there are no erosion controls in the area around the drain.

1. Poorly protected storm drain
inlet and surrounding soil with no
erosion controls.

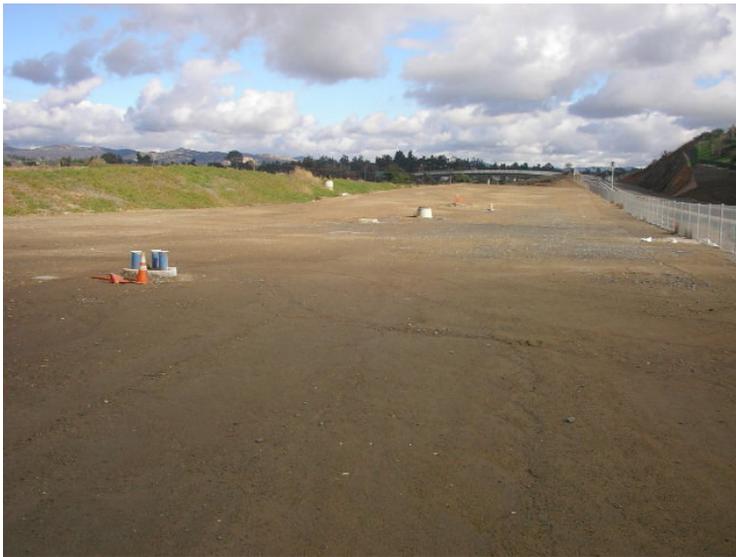
- 2. Near the intersection of Barham Drive and Shelly Drive in San Marcos** - This is a location near a stretch of tracks further to the west on Barham Drive. The large area of unstabilized soil found in past inspections (e.g., on November 30, 2007 and December 7, 2007) persists at this location without any erosion controls (Photo 2). A storm drain inlet surrounded by soil continues to be inadequately protected, the same situation observed during the December 7, 2007 inspection (Photo 3). The inadequacy of the inlet protection is shown by the sediment that sits on top of the bags. A slope between the barren field and the tracks exhibits rills (Photo 4).

2. Wide area south of the tracks
which lacks erosion controls.

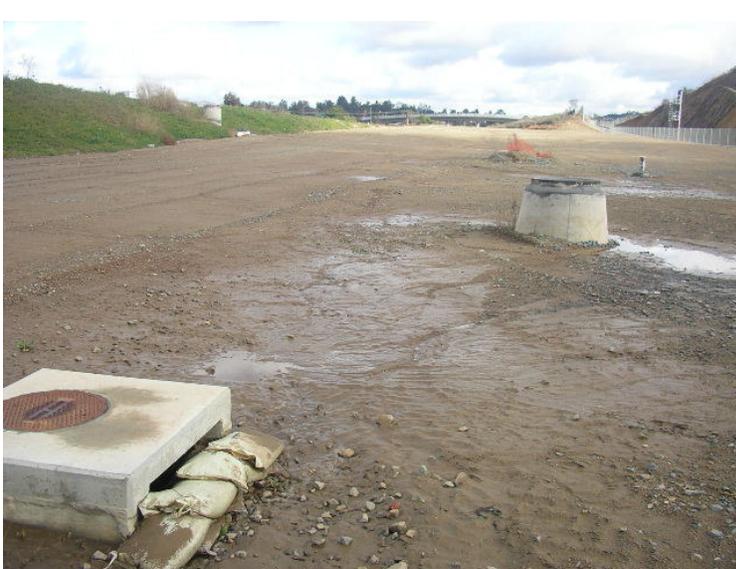
3. Inlet continues to have
inadequate protection. Gravel
bags show evidence of being
over-topped by sediment.

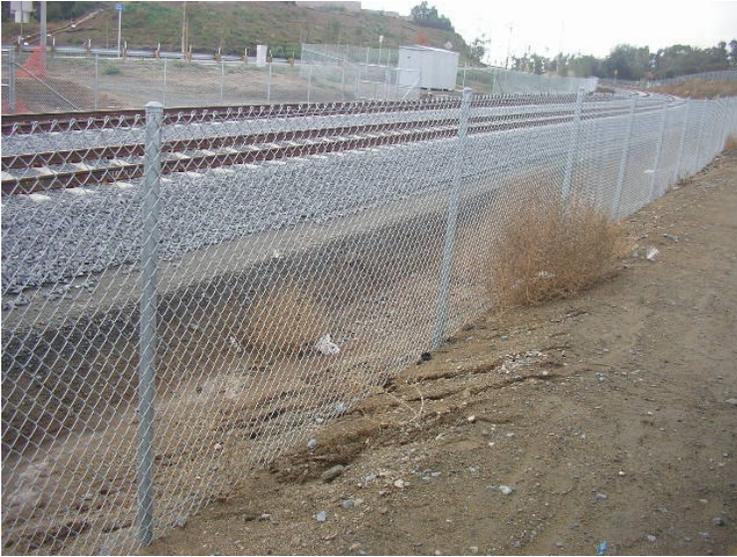
4. Rills discharging to ditch that runs along the tracks.

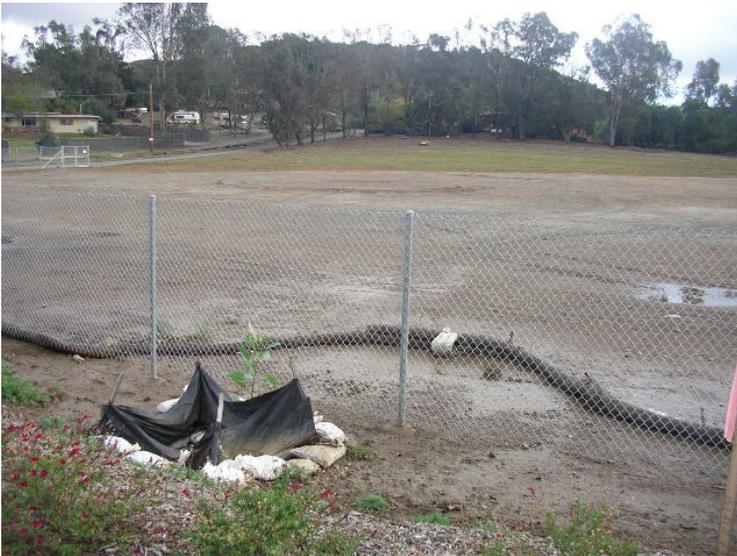
- 3. Barham Drive, east of Cal State San Marcos Station in San Marcos** - This is a stretch of railroad tracks that runs along Barham Drive between Cal State Marcos Station and Nordahl Road Station. The property has been used by NCTD as a storage yard. The yard continues to lack stabilization as observed during prior inspections (Photos 5 and 6). Inlet protection is in need of maintenance (as it was during the inspection on December 7, 2007).

5. Field south of tracks previously used to store equipment continues to lack erosion controls.

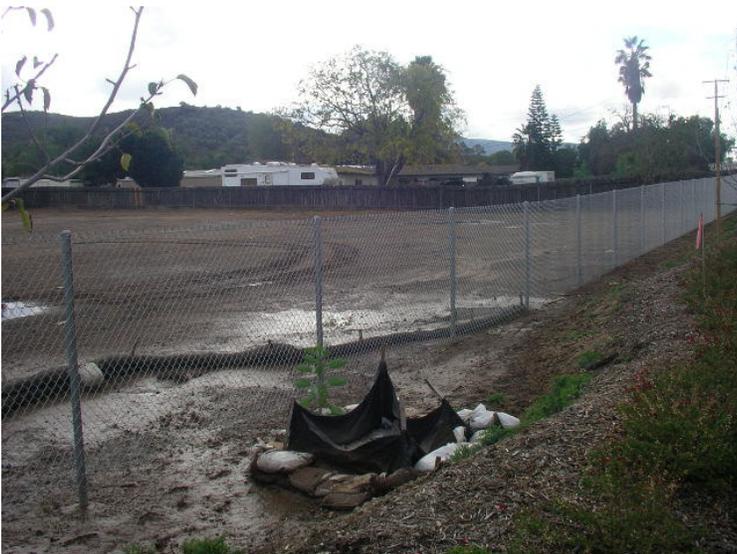
6. Another view of the unstabilized field (looking to the west).

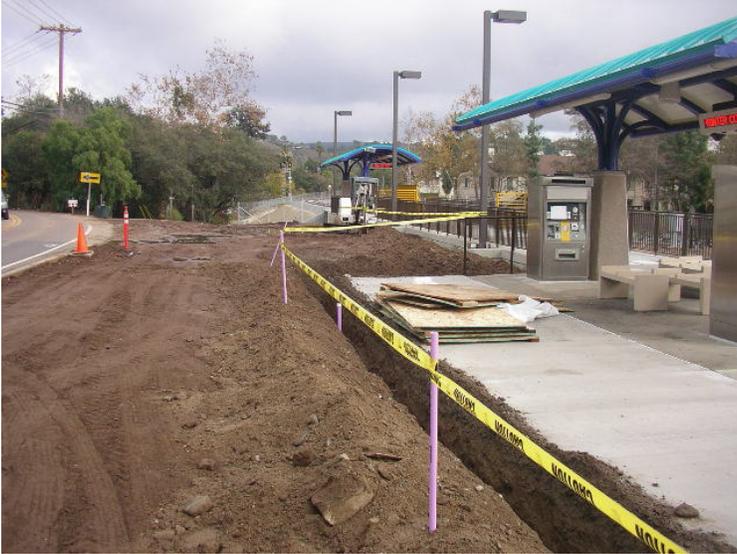
Photo 7 was taken at the Buena Creek Station.

- 4. Buena Creek Station in San Diego County (Unincorporated)** - This station is located at the intersection of Buena Creek Road and Santa Fe Avenue. Station construction is near completion, but landscaping has not yet been installed. Photo 7 shows an area of bare soil that is still without sediment or erosion controls (as it was during the inspection on December 7, 2007).

7. Continued lack of erosion and sediment controls next to station.

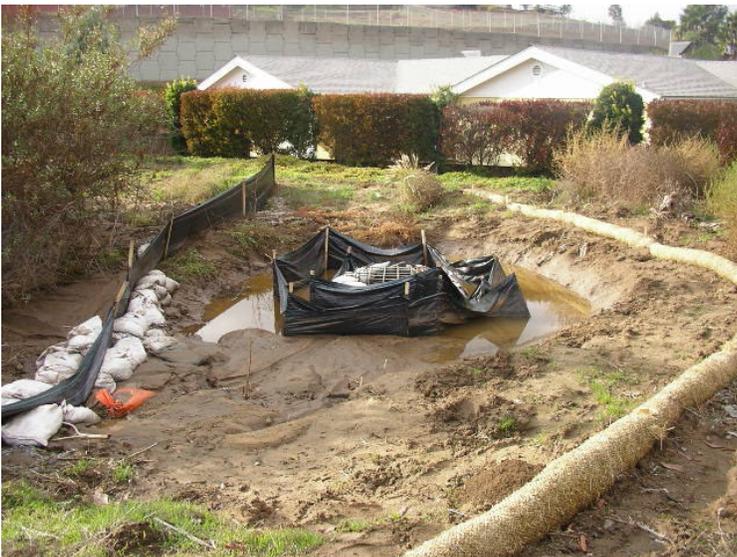
- 5. Mar Vista storage yard in Vista** - This site is a storage yard located adjacent to the tracks at Mar Vista Drive. An outfall directs storm water from an off-site source onto the yard. NCTD has constructed an earthen channel to conduct the discharge from the outfall to a storm drain located on the northwest corner of the property. Erosion controls had yet to be employed in the earthen channel (A picture of the channel was taken, but it did not develop properly). The storm drain inlet in the northwest corner of the yard is shown in Photo 8. Photo 9 shows the yard looking to the southeast. Once again there was no stabilization of a wide area of exposed soil.

8. Silt fence and gravel bags in need of maintenance after the storm.

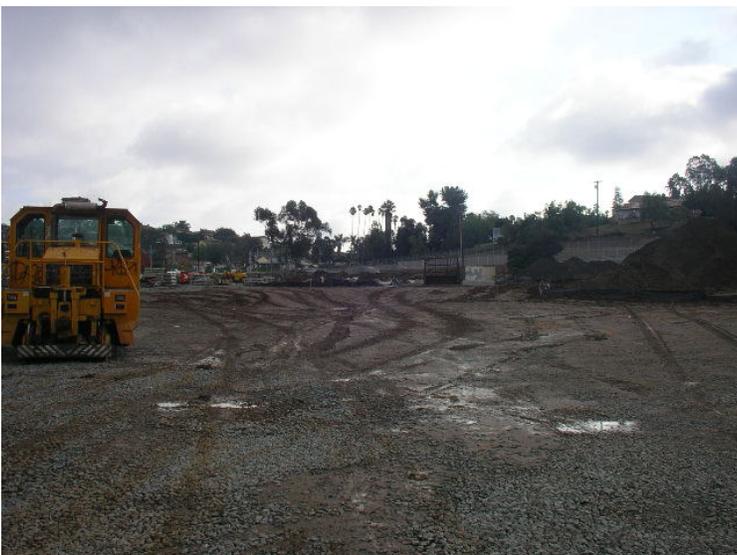
9. Yard continues to lack both erosion and sediment controls.

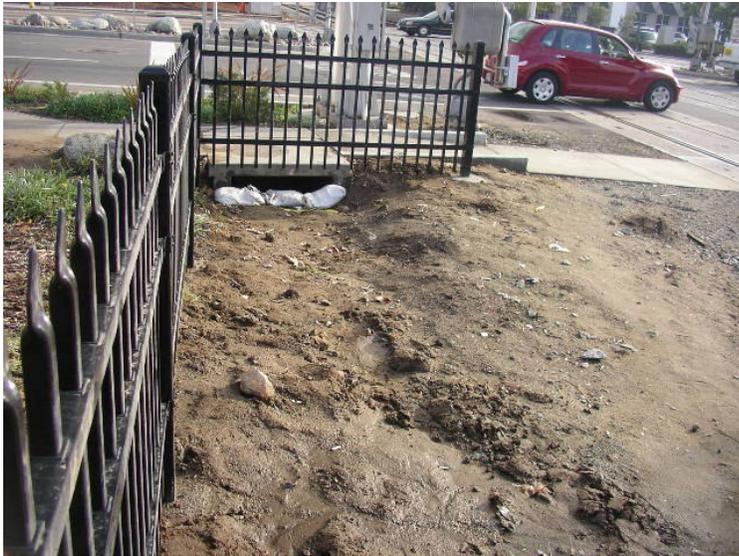
- 6. Vista Transit Center in Vista** - The Vista Transit Center is located near the corner of Vista Village Drive and Santa Fe Avenue. A drain which previously did not have any inlet protection (inspection on December 7, 2007) was protected by gravel bags, however soil in front of the inlet continues to be exposed (i.e. not stabilized) as shown in Photo 10. Photo 11 shows the north parking area. Cement bags which had previously been leaking (inspection on November 27, 2007) have been removed.

10. Soil in front of storm drain lacks erosion controls.

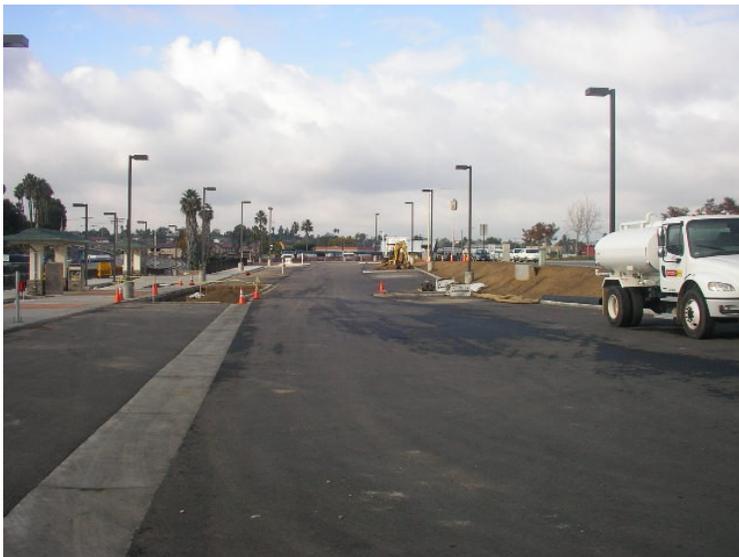
11. Bags of cement which had been leaking have been removed from the parking lot.

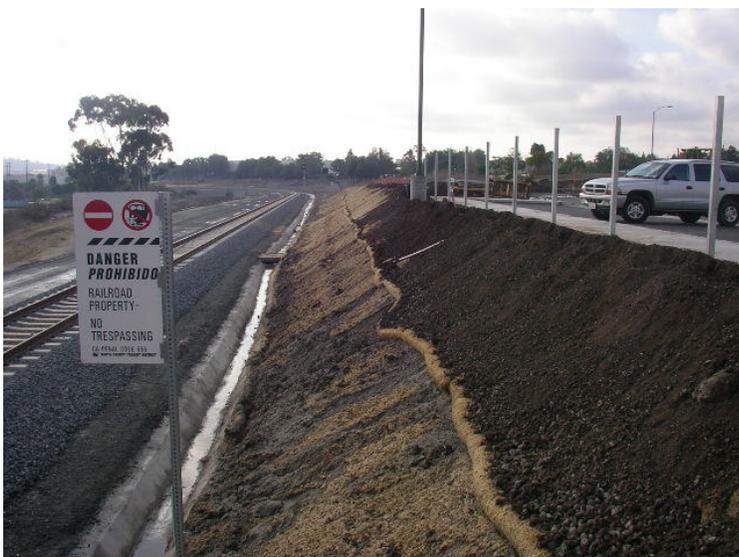
Photo12 was taken at Melrose Station.

- 7. Melrose Station in Oceanside**. This station is on the southwest corner of Melrose Drive and Oceanside Boulevard next to a convenience store. The headwaters to Loma Alta Creek flow adjacent to the south side of the tracks. South-facing slopes were found to have not been stabilized during prior inspections. Photo 12 shows that a south-facing slope has been hydroseeded, but the upper half of the slope is covered with soil that was removed from a ditch that was recently dug out in order to install an irrigation line. Some of the soil has also rolled into the storm drain ditch at the toe of the slope.

12. Soil that was removed at the top of the slope for installation of an irrigation pipe has covered hydroseed all the way down to the fiber roll at mid-slope.
