CALIFORNIA REGIONAL WATER QUALITY CONTROL BOARD
SAN DIEGO REGION

TECHNICAL ANALYSIS

Proposed Administrative Civil Liability
Contained in Complaint No. R9-2007-0093
North County Transit District
Sprinter Rail Project
San Diego County

August 31, 2007

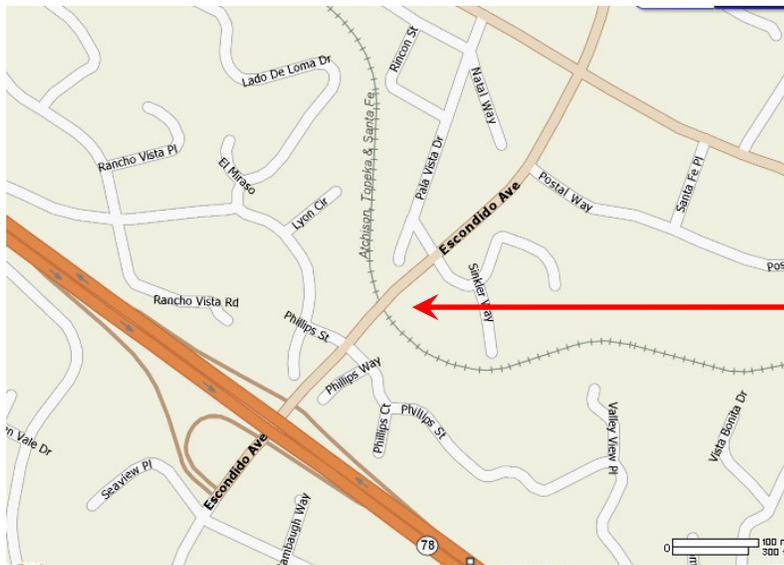
Figure 2: Approximate location of the inlet for discharge #1.

1. MS4 inlet east of Escondido Avenue in the City of Vista which discharges into Buena Vista Creek and downstream into Buena Vista lagoon.

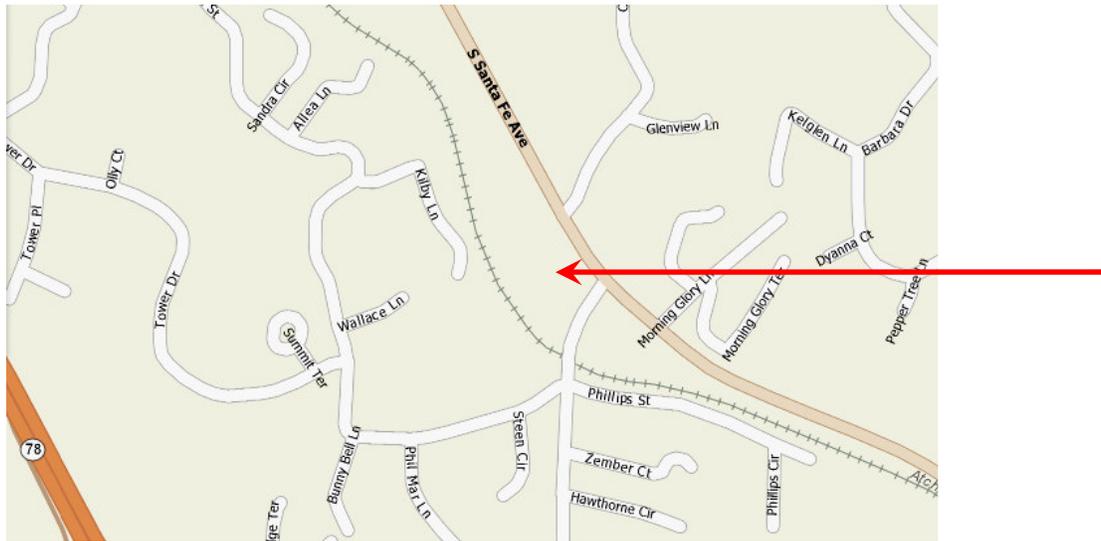
Figure 3: Approximate location of the inlet for discharge #2.

2. MS4 inlet at the Mar Vista Drive storage yard in the City of Vista which discharges into Buena Vista Creek and downstream into Buena Vista lagoon.

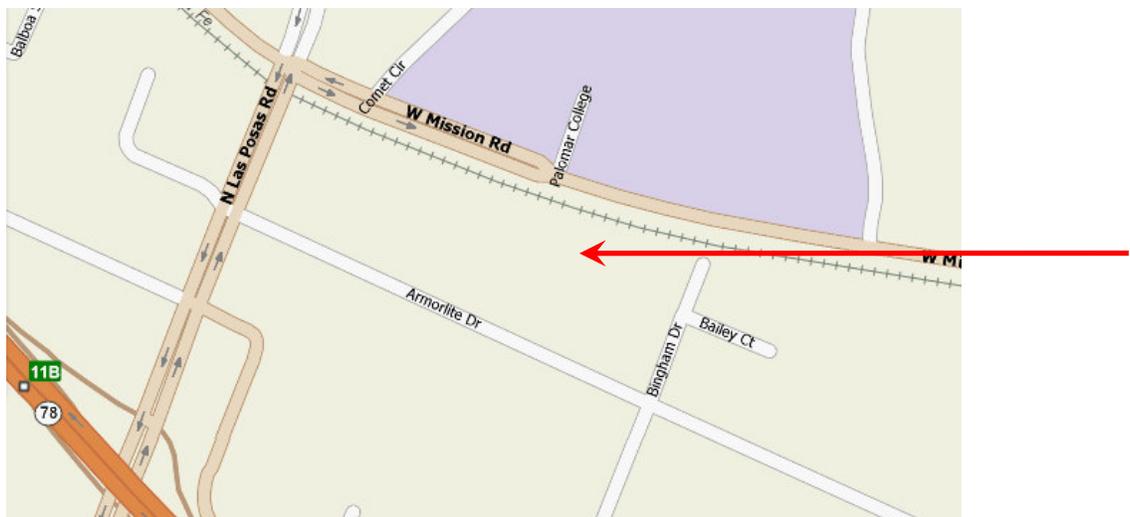
Figure 4: Approximate location of the inlet for discharge #3.

3. MS4 inlet at the Armorlite Drive storage yard in the City of San Marcos which discharges into San Marcos Creek and downstream into Lake San Marcos.

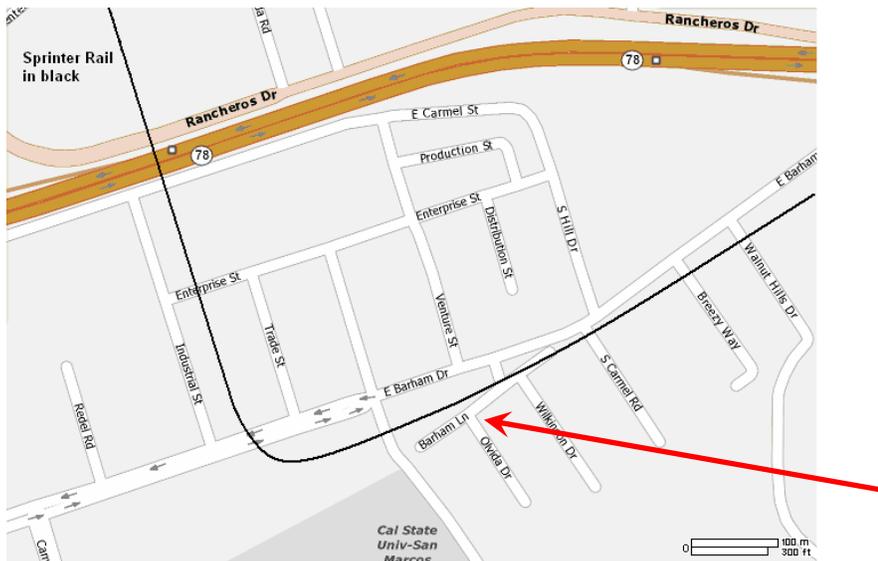
Figure 5: Approximate location of the inlet for discharge #4.

4. MS4 inlet, south of Barham Lane, west of Wilkinson Drive, within the City of San Marcos which discharges into San Marcos Creek and downstream into Lake San Marcos.

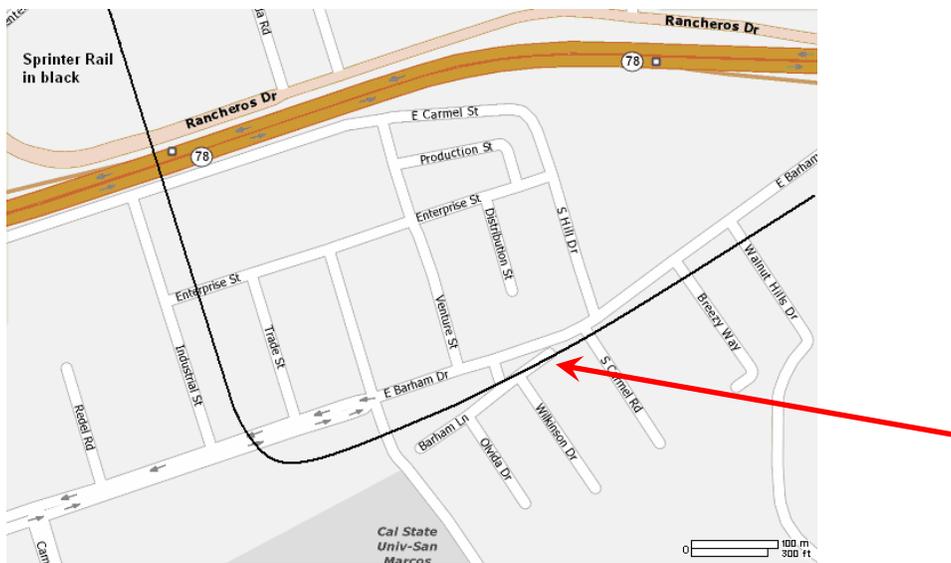
Figure 6: Approximate location of the inlet for discharge #5

5. MS4 inlet, south of Barham Lane, east of Wilkinson Drive, within the City of San Marcos which discharges into San Marcos Creek and downstream into Lake San Marcos.

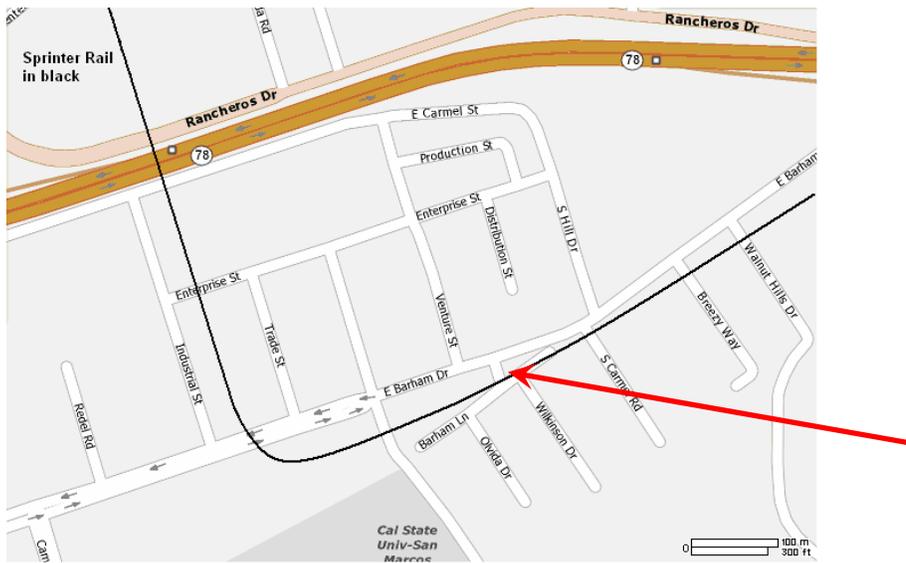
Figure 7: Approximate location of the inlet for discharge #6.

6. MS4 inlet, north of Barham Lane, south of the tracks, within the City of San Marcos which discharges into San Marcos Creek and downstream into Lake San Marcos.

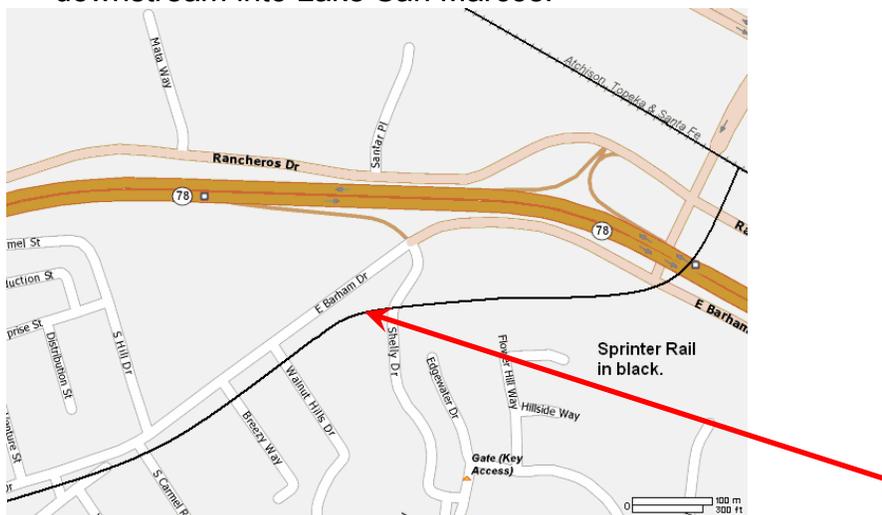
Figure 8: Approximate location of the inlet for discharge #7.

7. MS4 inlet, west of Shelley Drive, south of tracks, within the City of San Marcos which discharges into San Marcos Creek and downstream into Lake San Marcos.

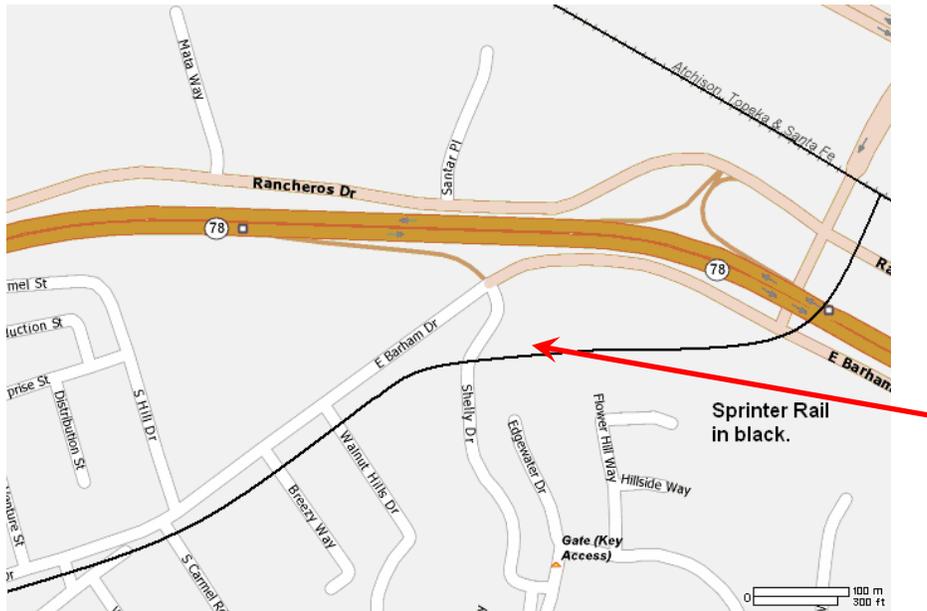
Figure 9: Approximate location of the inlet for discharge #8.

8. MS4 inlet, east of Shelley Drive, north of tracks, within the City of San Marcos which discharges into San Marcos Creek and downstream into Lake San Marcos.

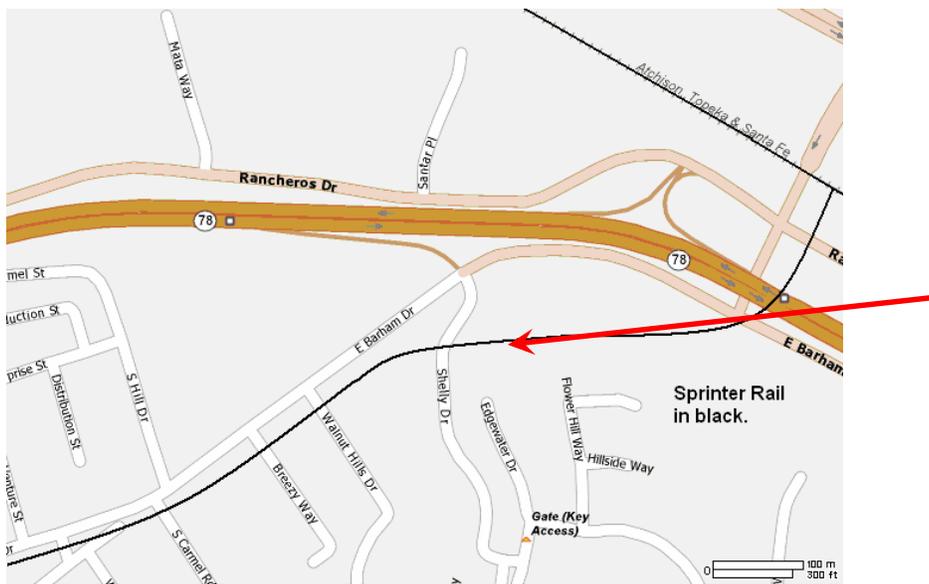
Figure 10: Approximate location of the inlet for discharge #9

9. MS4 inlet, east of Shelley Drive, south of tracks, within the City of San Marcos which discharges into San Marcos Creek and downstream into Lake San Marcos.

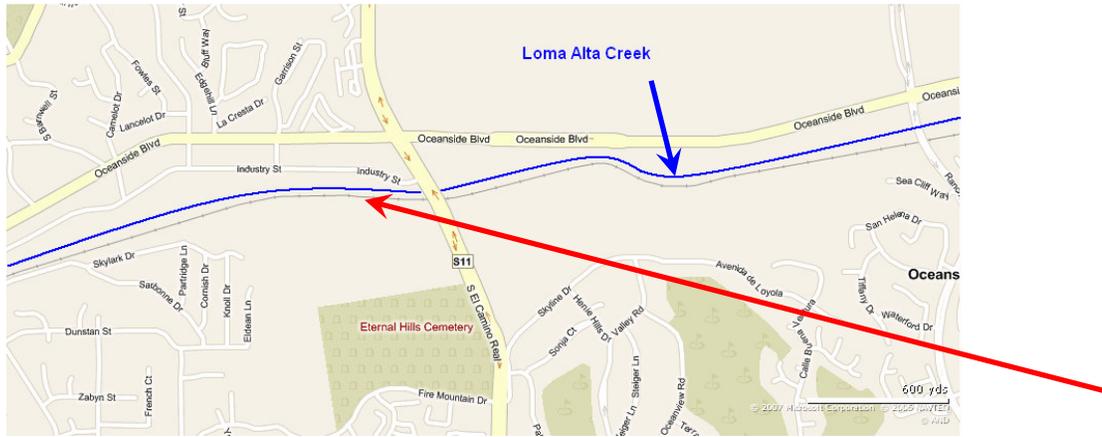
Figure 11: Approximate location of discharge #10 into Loma Alta Creek.

On March 21, 2007:
10. Loma Alta Creek, near the El Camino Real Bridge in the City of Oceanside.
