City of Vista

April 23, 2007

**DISCHARGER RESPONSE TO INVESTIGATIVE ORDER NO. R9-2007-0060, DISCHARGE OF
UNTREATED SEWAGE INTO THE BUENA VISTA LAGOON WITHIN THE CITY OF
CARLSBAD SAN DIEGO COUNTY
(Reference: NCRU:01-0743.02 & 01-0764.02:ebecker)**

City of Carlsbad

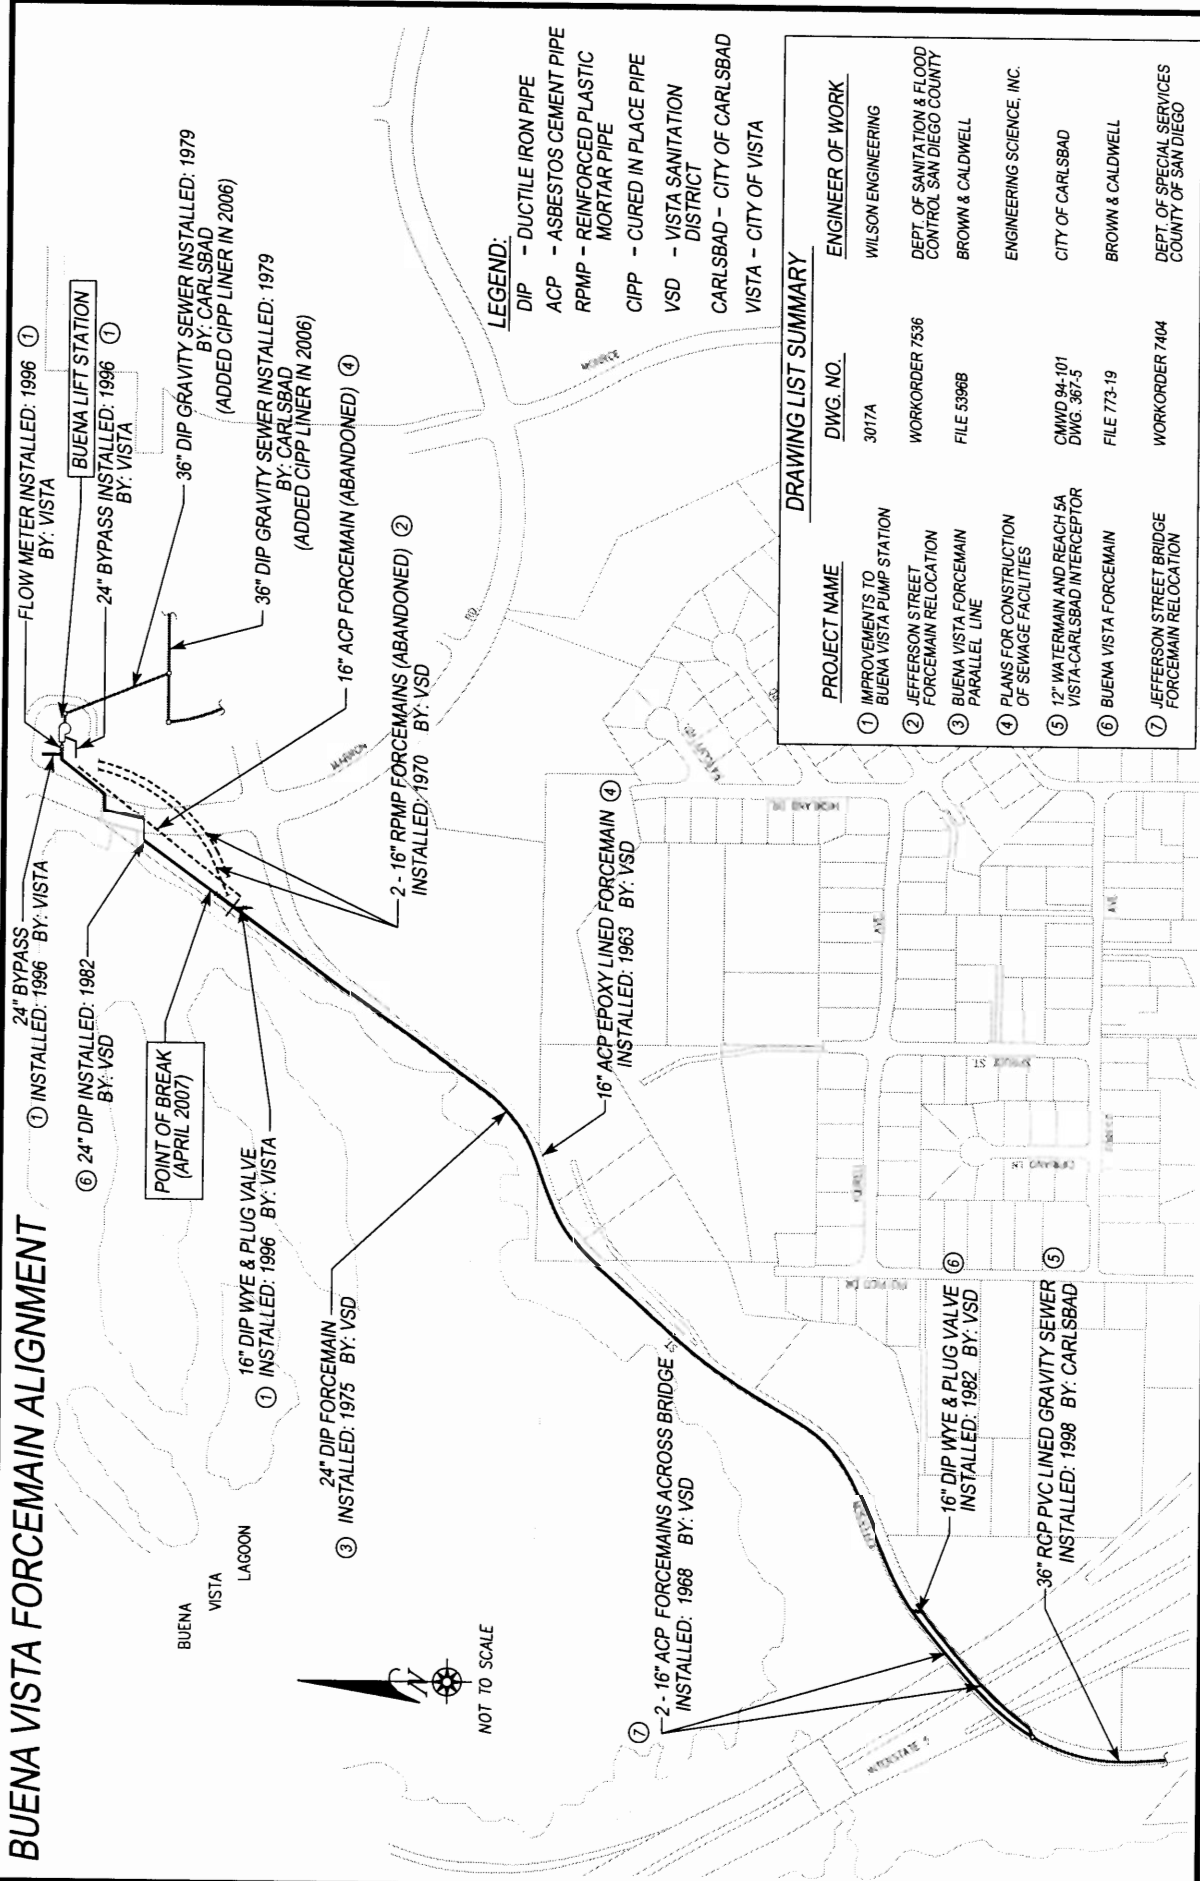
BUENA VISTA FORCEMAIN ALIGNMENT

The 1982 24-inch DIP force main was designed by the firm of Brown and Caldwell Consulting Engineers through an agreement with Vista Sanitation District (Appendix 2c). The location of the pipe was not constructed in the lagoon, but followed and was within the Jefferson Street alignment where it replaced a 16-inch diameter force main.

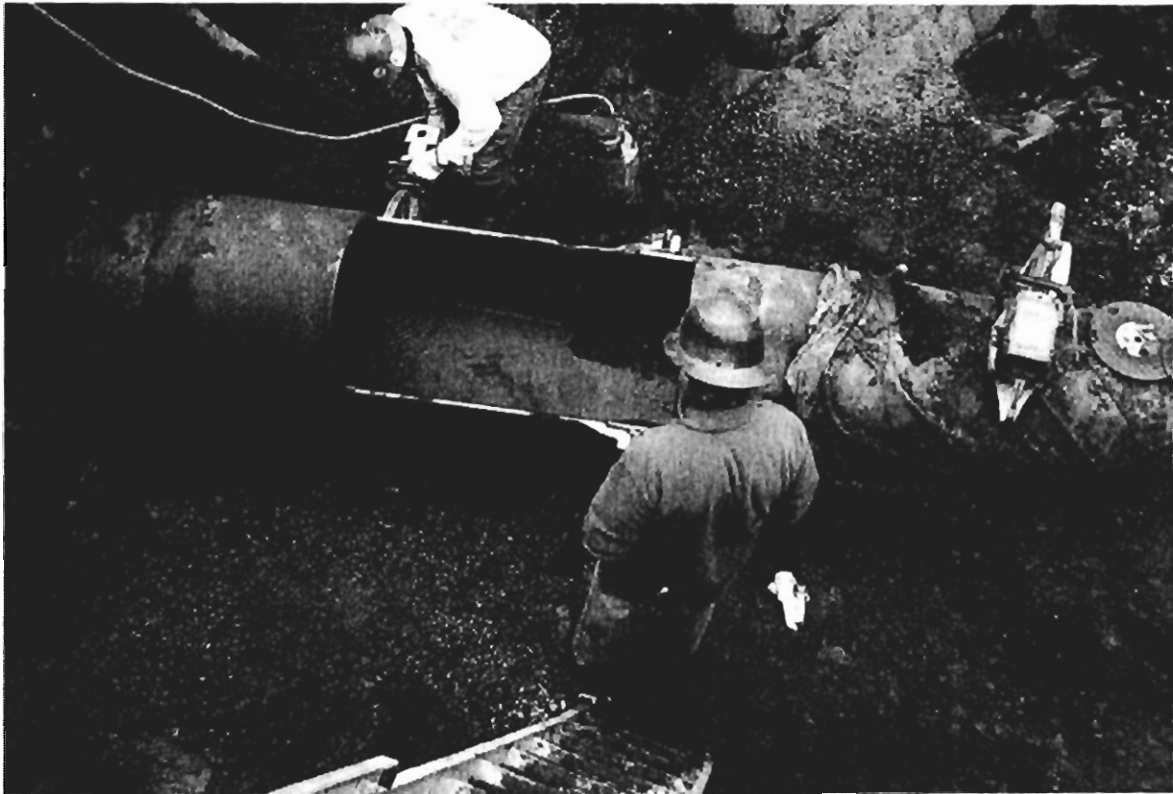
It does preliminarily appear that the cause of the failure was external corrosion. The early testing of soils from the site by Schiff Associates, Inc. indicates a highly corrosive

In order to perform properly and obtain maximum protection, the polyethylene encasement must be installed correctly. This requires correct wrapping and sealing of encasement sections. It also requires care be given to prevent rips or tears during installation. By examination of available design documentation for the pipeline construction and testing that has been performed on the *in situ* pipe and polyethylene liner materials, there is nothing to suggest that corrosion damage is more widespread than that found on the specific segment of the pipe where the failure occurred. In fact, the pipeline extending in both directions from the 3'9" segment that was removed and replaced is in excellent condition and shows no corrosion (see photo).

Corroded segment of pipe being removed.
