San Diego Regional Water Quality Control Board

DATE: September 28, 2015

SUBJECT: INTERNAL PRELIMINARY SITE INVESTIGATION MEMORANDUM-RAMONA MUNICIPAL WATER DISTRICT SANTA MARIA WASTEWATER TREATMENT PLANT

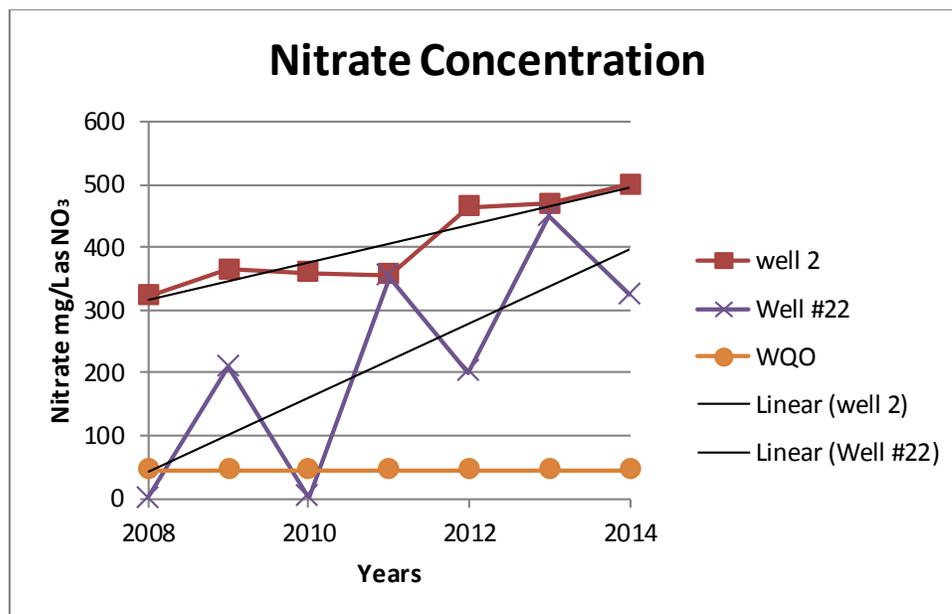
Figure 3: Nitrate Concentration vs. time Plot

monitoring data submitted by the Discharger were compiled from the 2008-2014 annual monitoring reports. Results were plotted (concentration vs. time) for both nitrate and TDS in groundwater. Table 1 lists the historical groundwater concentrations of nitrate and Figure 3 shows a graph of trends as concentration vs. time and a trendline line for those data in well Nos. 2 and 22. The groundwater data for TDS are listed in Table 2 and graphed in Figure 4 for the same two wells. The average nitrate concentrations are 405 mg/L and 256 mg/L in groundwater samples collected from Monitoring Wells Nos. 2 and 22 for the years 2008-2014. The average TDS concentrations are 1714 mg/L and 1250 mg/L in groundwater samples collected from Monitoring Wells Nos. 2 and 22 for the years 2008-2014. The data presented in both of the concentration vs. time plots (Figures 3 and 4) are also compared to the applicable groundwater water quality objectives.

The trends in concentrations for both nitrate and TDS appear to be increasing with time in Monitoring Wells Nos. 2 and 22. The 2014 monitoring period contains the highest concentration reported for both nitrate and TDS concentrations in Monitoring Well No. 2. The highest concentrations of nitrate and TDS in Monitoring Well No. 22 were reported in the 2013 annual monitoring period.

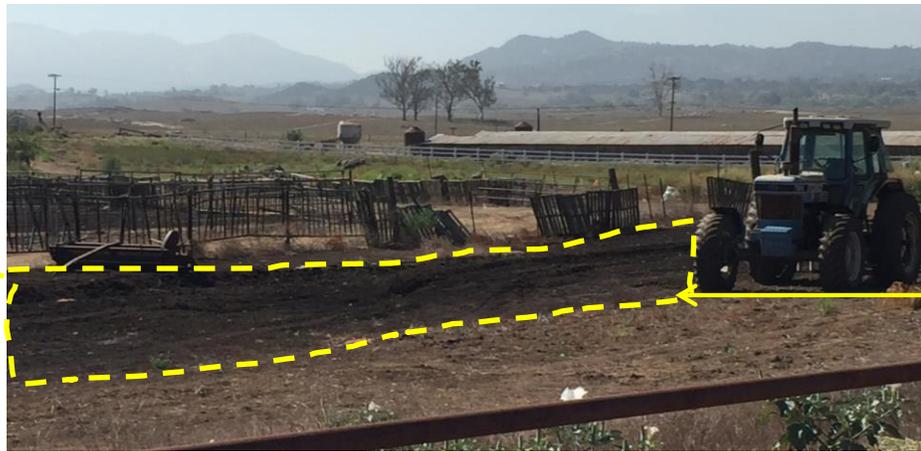
Figure 5- Stained Soil Observed

4. **18409 Rangeland Road.** Staff attempted to contact the land owner, Mr. Steve Dowle, prior to the inspection for access to the property to assess the surface conditions related to the from former or current confined animal operations. Contact attempts with Mr. Dowle were unsuccessful. After concluding the inspection with the Discharger, the Staff attempted to *make contact with a woman who appeared to be the homeowner, however* Staff were unsuccessful with making contact with the land owner. After unsuccessful attempts to contact property owners, the Staff left the property and made observations from Rangeland Road. Figure 5 shows stained and wet soil in comparison with the surrounding soil, and a tractor connected to a disk plow. This stained and wet soil may indicate that either waste is being applied to the site or a composting operation is occurring at the site. A slight manure odor was observed from the property line, but not a strong odor, coming from the direction of the stained soil in Figure 5. In Figure 6 a close-up image of the stained soil that is show in Figure 5.

Stained soil
observed
from
Rangeland
Road

The Staff will consult with other San Diego Water Board staff assigned to confined animal and the Land Disposal Program to develop options for addressing other issues observed during the inspection. Specifically, the possibility of animal waste being used as a soil amendment and the possibility of an ongoing composting operation at 18409 Rangeland Road (Figures 5 and 6).

Staff recommends developing a water quality investigative order for the owner of the property at 8409 Rangeland Road. The purpose of the water quality investigative Order would be to provide additional information about the observed stained soil and any waste is being applied as a soil amendment and for composting operations are occurring onsite.

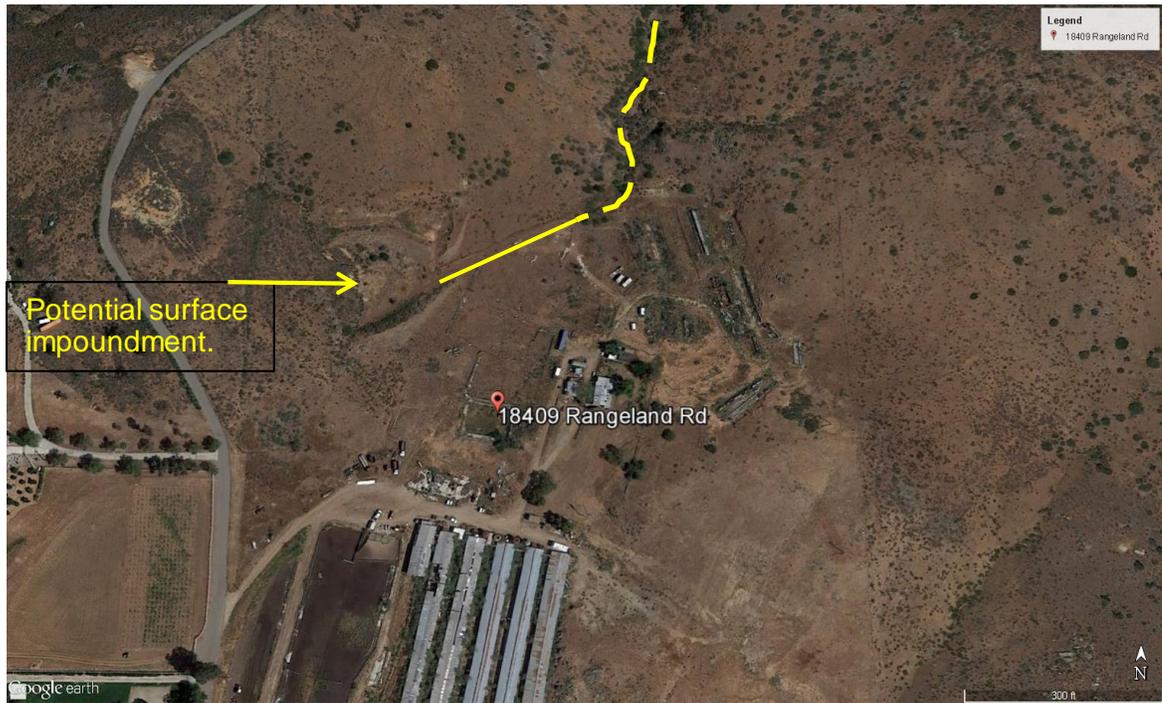
Figure 7- Aerial Photo of 18409 Rangeland Road

5. **Potential Surface Water Impoundment.** Observations from Rangeland Road and on aerial photos (Figure 7) indicate the possibility of a surface impoundment located on the creek north of 18409 Rangeland Road. It appears that a man-made berm may be present altering the natural drainage course of the creek that appears to empty into the surface impoundment located up-gradient from the berm.

3. **Surface Water Impoundment.** Based on observations made and discussed in Finding No. 3, the San Diego Water Boards' Clean Water Act Section 401 Water Quality Certification Program (401 Program) will be advised of conditions and observations regarding the possible surface water impoundment. Follow-up actions concerning the surface water impoundment would be referred to the Staff assigned to the 401 Program.
