**CALIFORNIA REGIONAL WATER QUALITY CONTROL BOARD
SAN DIEGO REGION**

In the matter of:)	
)	
San Diego County)	Order No. R9-2019-0020
Sanitation District)	
)	
February 2017 Sanitary Sewer)	
Overflow, Los Coches Creek,)	Settlement Agreement and
San Diego River)	Stipulation for Entry of
)	Administrative Civil Liability
)	Order
Place ID: 631623)

**CONCEPTUAL MITIGATION PLAN
SIERRA ALTA WAY WASTEWATER EMERGENCY PIPE REPLACEMENT PROJECT
LAKESIDE, SAN DIEGO COUNTY, CALIFORNIA**

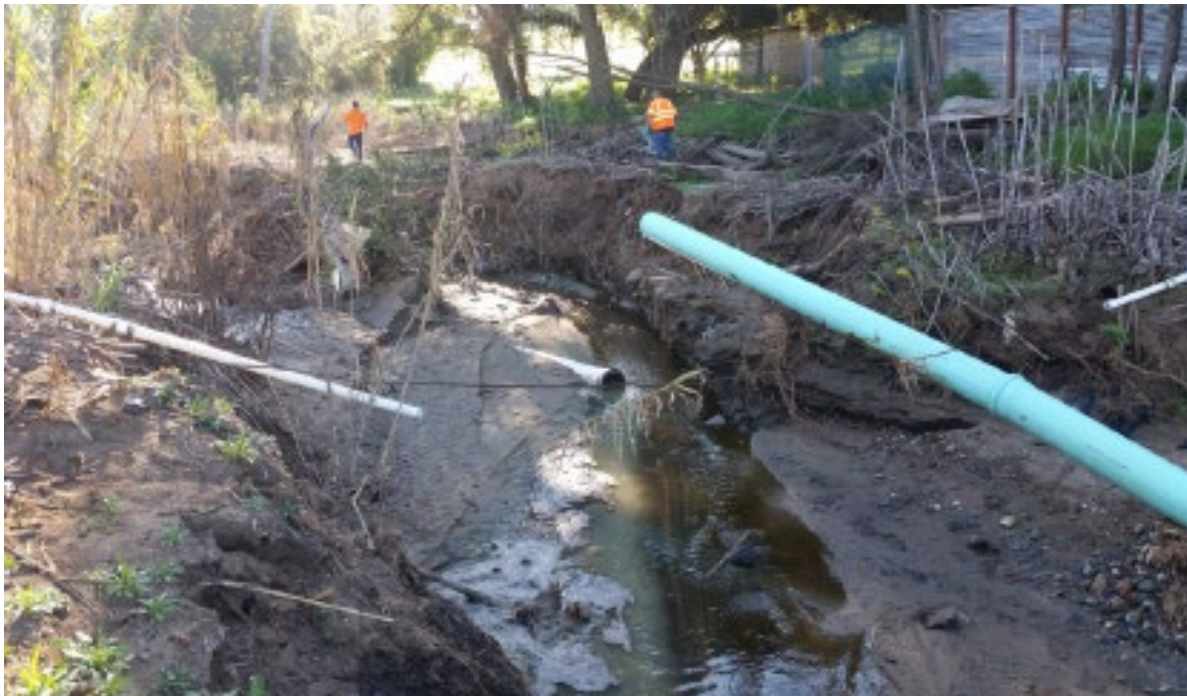
From February 28, 2017 to March 17, 2017 (18 days of discharge) a San Diego County Sanitation District (District) owned and operated sewer main discharged **762,739 gallons** of untreated raw sewage into Los Coches Creek, a water of the United States, in the vicinity of Sierra Alta Way in El Cajon, CA. The sewer main was damaged as result of stream bank erosion that occurred during a 25-year, 24-hour storm event near then end of February 2017 (see Photo 1). The damaged sewer main was discovered by District Staff during a routine maintenance inspection on March 17, 2017. The starting date of the SSO was determined by information obtained from a nearby property owner who noticed the pipe break on February 28, 2017. The eyewitness failed to contact any agency to report the pipe break.

PHOTO 1: Damaged 12-inch PVC sewer line in Los Coches Creek. (photo by SD Sanitation District)

Upon discovery of the damaged pipe, the District set up a bypass of the line, ceasing the discharge within 2 hours of their arrival on the scene. On March 18, 2017, the District hired an outside contractor to repair the line. The County of San Diego acting on behalf of the District applied for and received an emergency Clean Water Act Section 404 permit under Regional General Permit 63 (RGP 63) to conduct repair work in the creek. The repair activities resulted in permanent impacts to 0.05 acre (234 linear feet) within the channel of Los Coches Creek through the discharge of riprap to protect the repaired line, which remains in the creek, and temporary impacts to 0.1 acre (60 linear feet) (see Photo 2).

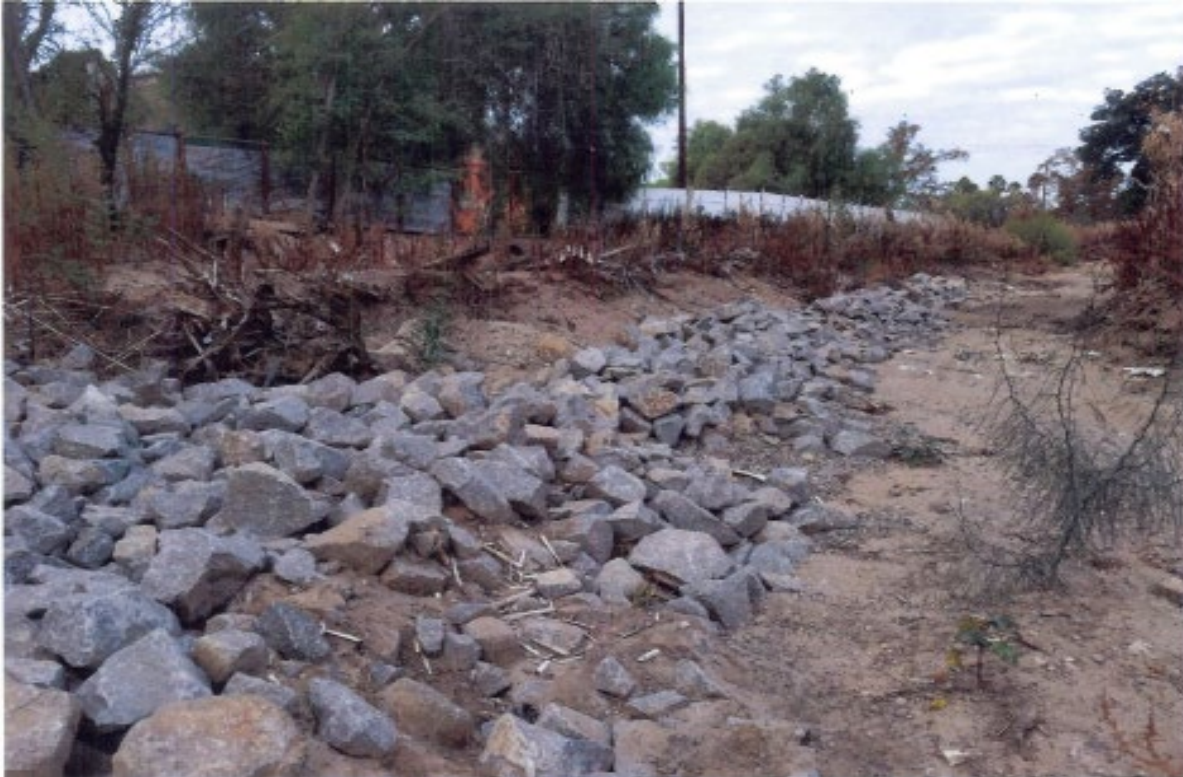
PHOTO 2: Rip rap protection installed in Los Coches Creek channel.

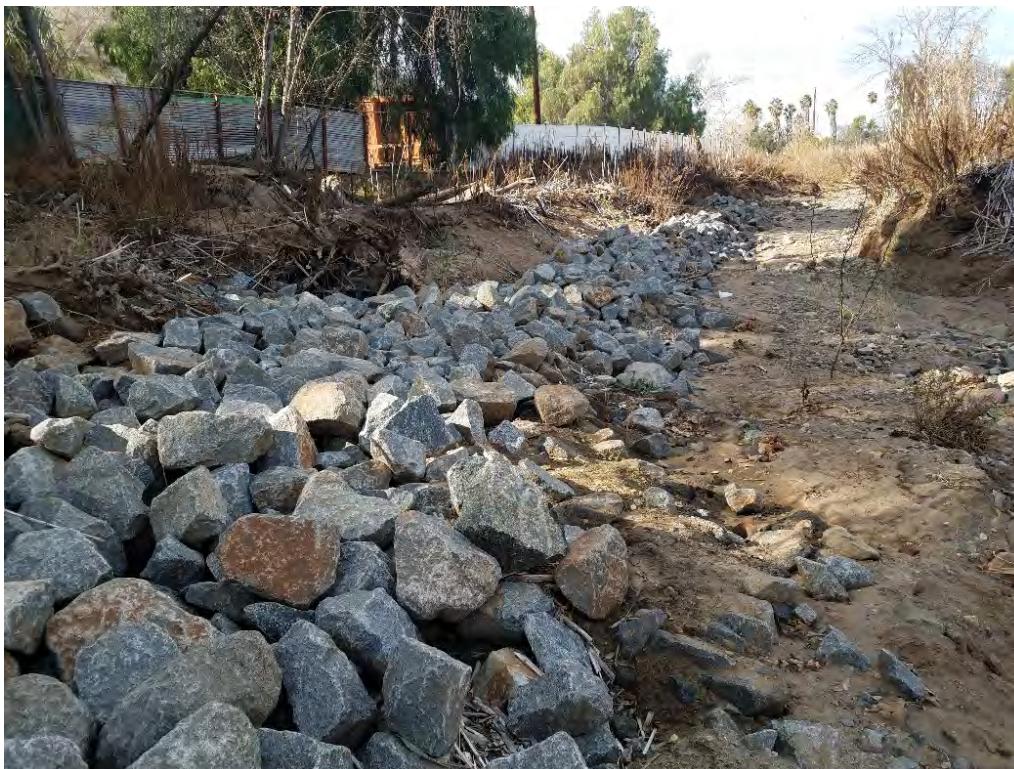
Photograph 1: Riprap Installed within Los Coches Creek. Facing West.

The broken section of sewer line was replaced and a total of 174 cubic yards of crushed rock (riprap) was installed on top of the replacement pipe to prevent future erosion and pipe failure. Overall, emergency maintenance activities were completed in compliance with avoidance and minimization measures, guidelines, and conditions of Regional General Permit No. 63, and the verification letter for the Sierra Alta Way Wastewater Emergency Pipe Replacement Project (File No. SPL-2017-00194-WSZ) issued April 3, 2017.

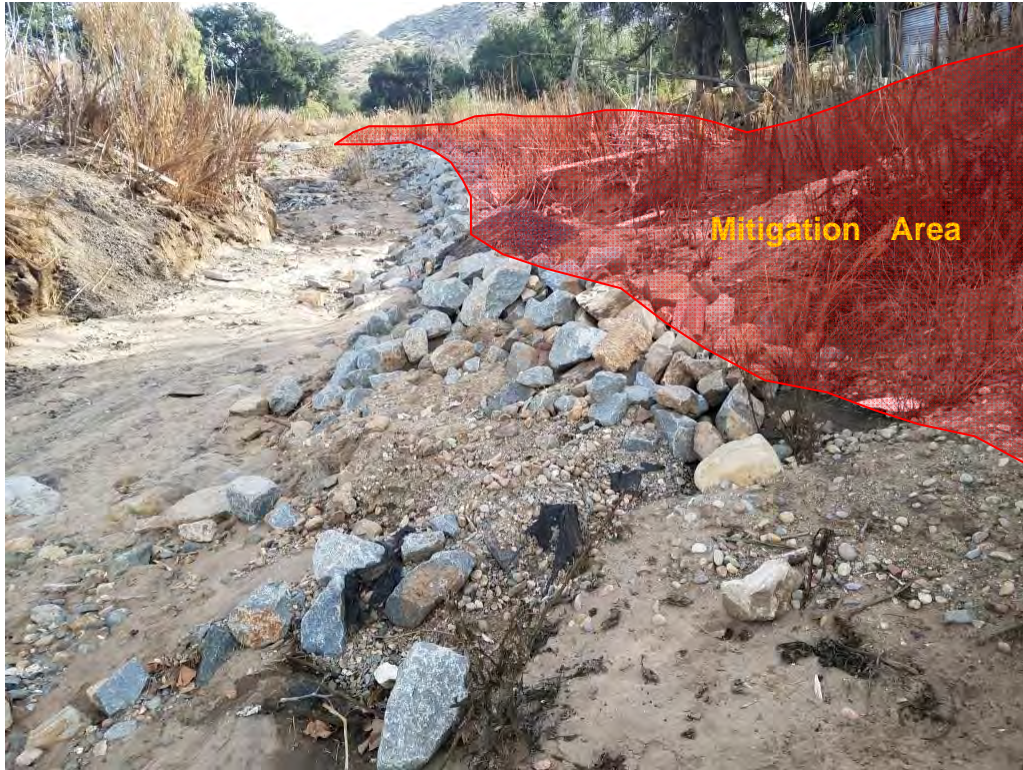
Photograph 2: Mitigation Area 1 along Southern Bank with Installed Riprap. Facing East.

At approximately 275 linear feet (0.06 acre) and 427 linear feet (0.09 acre) respectively, on-site re-establishment within Area 1 and Area 2 would mitigate permanent project impacts of 234 linear feet (0.05 acre) at a 3:1 ratio. Prior to the commencement of restoration activities, the boundaries of mitigation area will be field-verified to ensure that at least 702 linear feet of wetland and riparian habitat will be re-established along Los Coches Creek on-site.

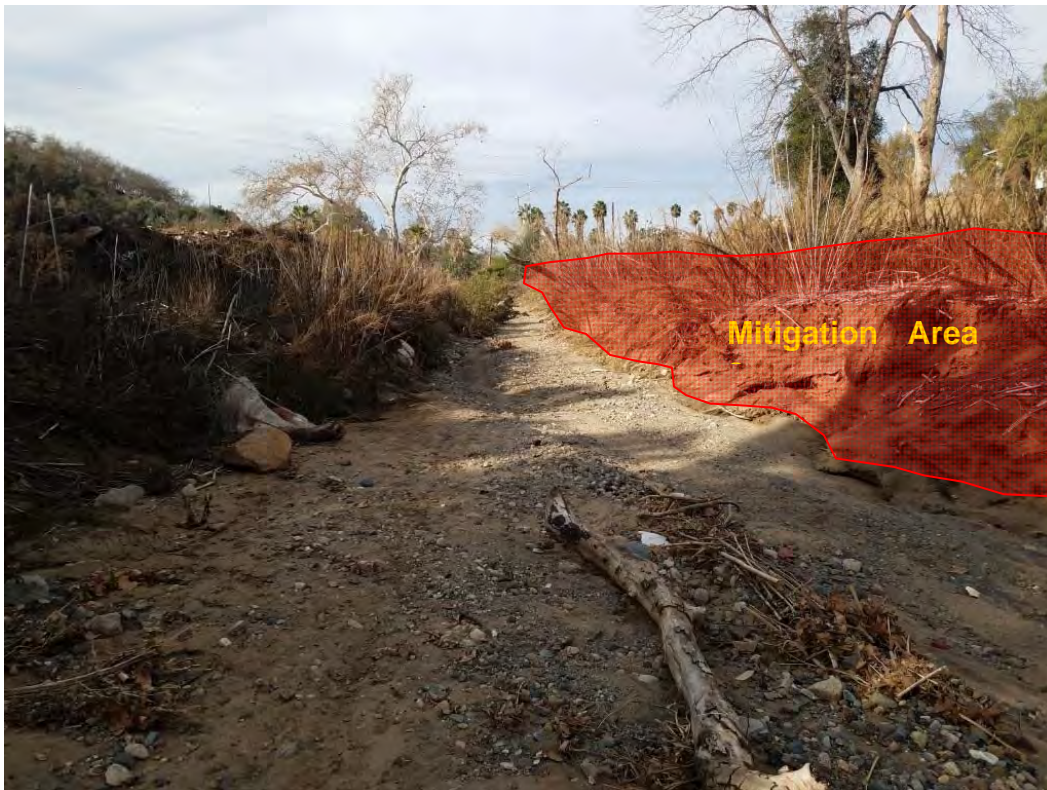
Photograph 3: Mitigation Area 2 along Northern Bank. Facing West.

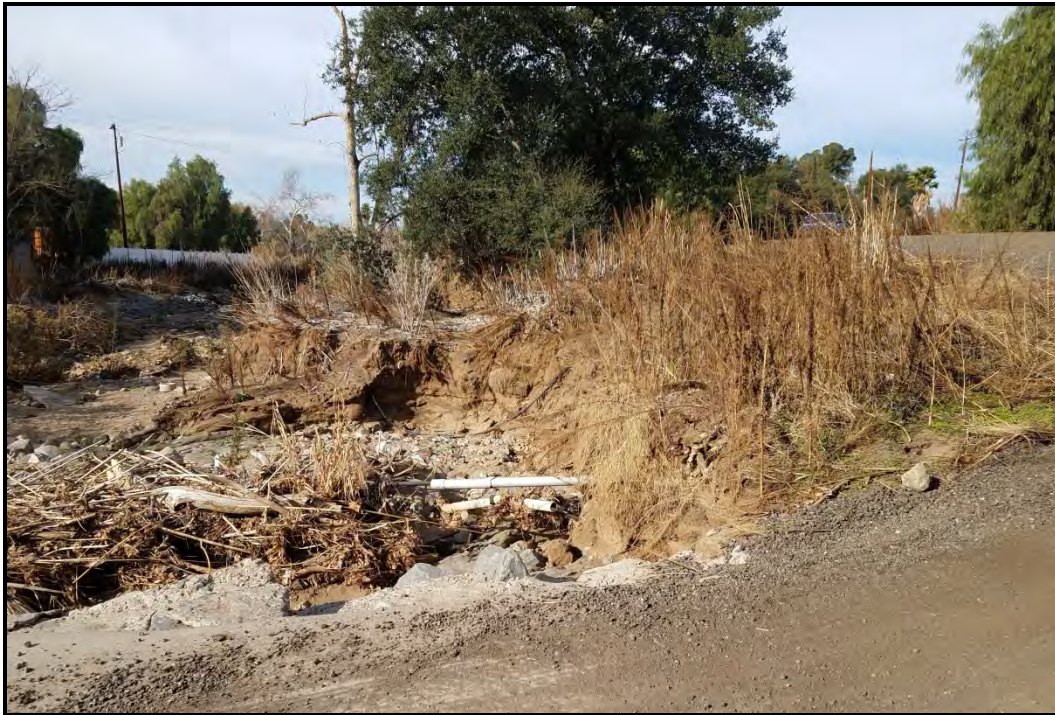
PHOTOGRAPH 1
View of Los Coches Creek and Disturbed Habitat within Survey Area
Facing West, January 30, 2018

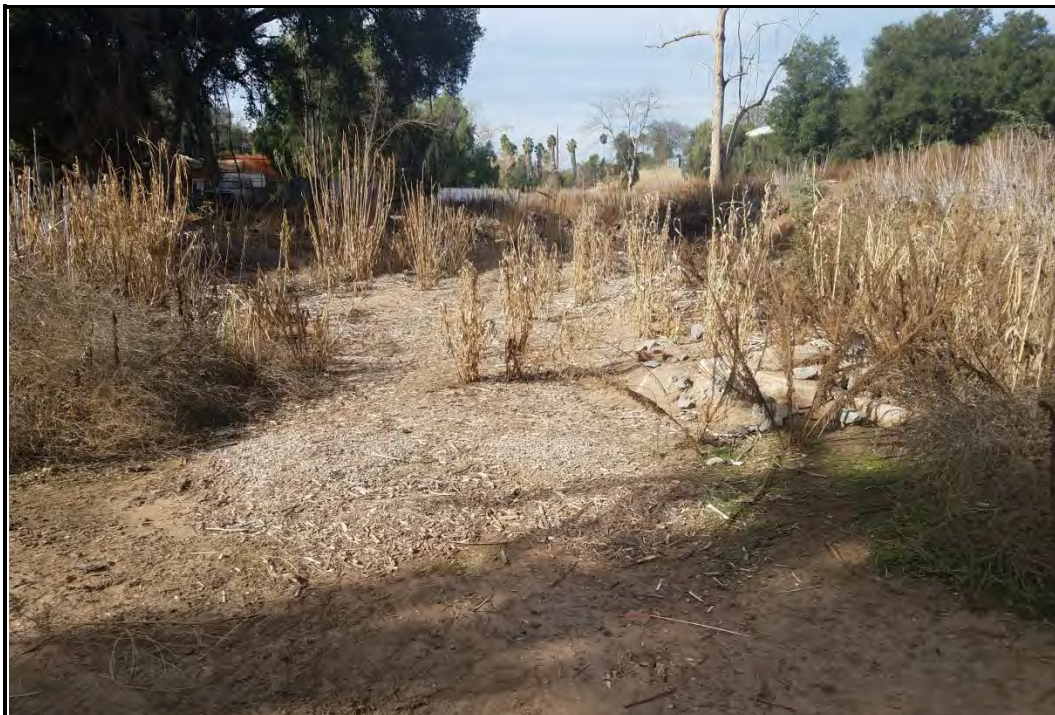
PHOTOGRAPH 2
View of Dead Giant Reed and Mulch in Disturbed Habitat South of
Los Coches Creek within Survey Area, Facing West, January 30, 2018

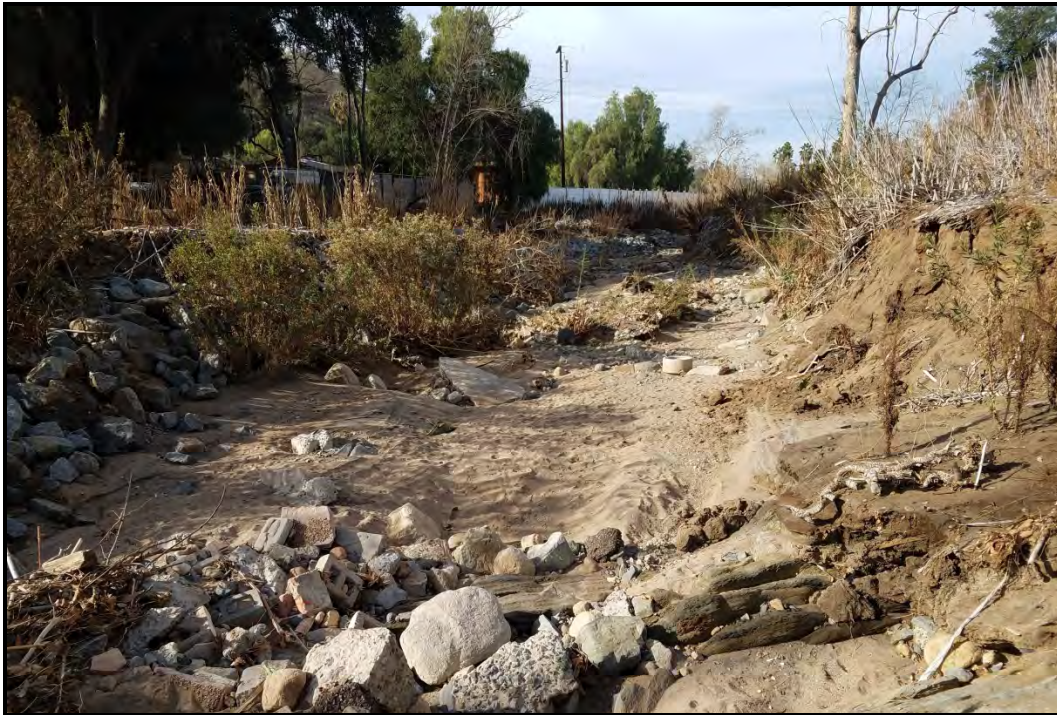
PHOTOGRAPH 3
View of Los Coches Creek within Project Area, Facing West
January 30, 2018

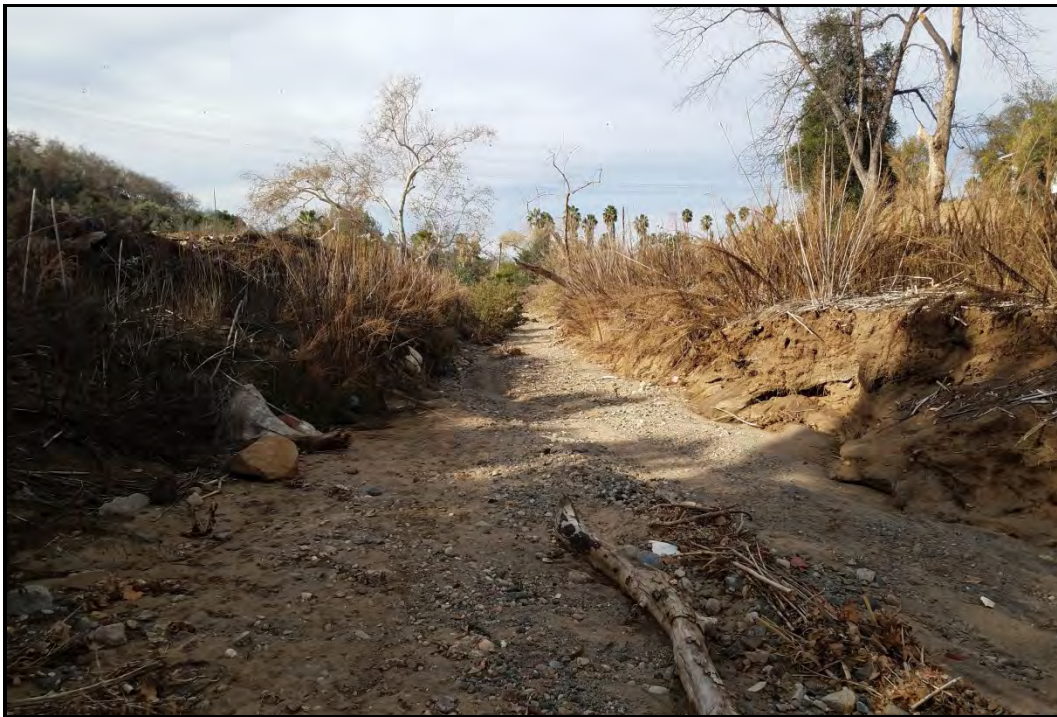
PHOTOGRAPH 4
View of Los Coches Creek Downstream of Project Area
within Survey Area, Facing West, January 30, 2018
