# ASSET MANAGEMENT PROGRAM – YEAR 2

## Vulnerability Assessment

County of San Diego

8 FEBRUARY 2018

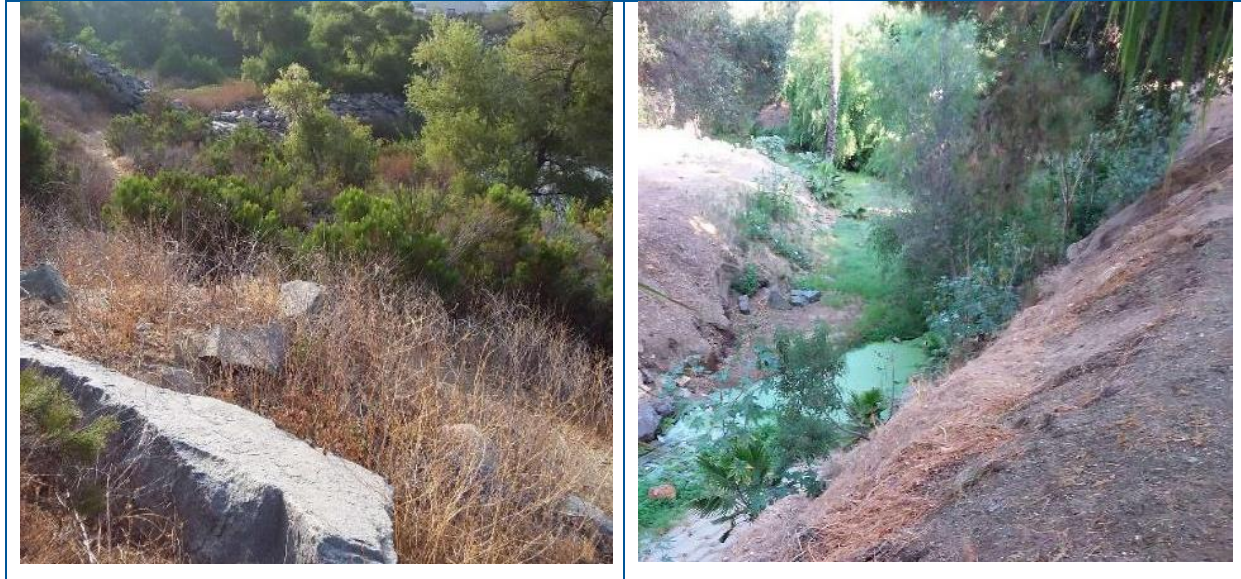
**Figure 9** Examples of stream bank slopes classified as “good” (left) and “poor” (right)

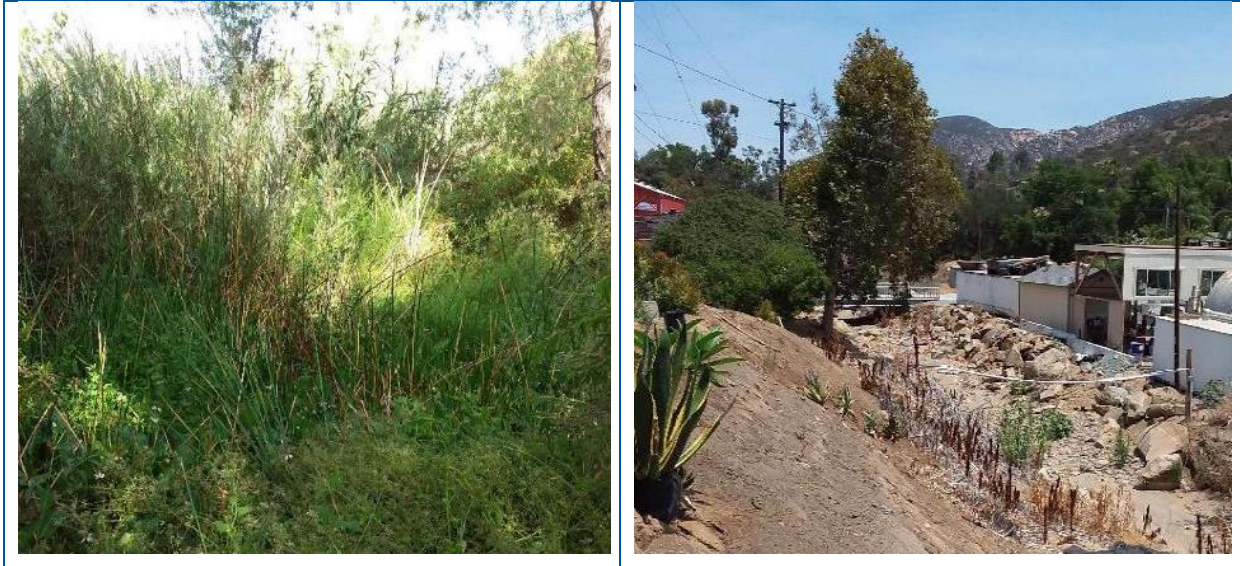
**Figure 10** Examples of a well-developed understory layer (left) and poorly developed or bare soil (right)

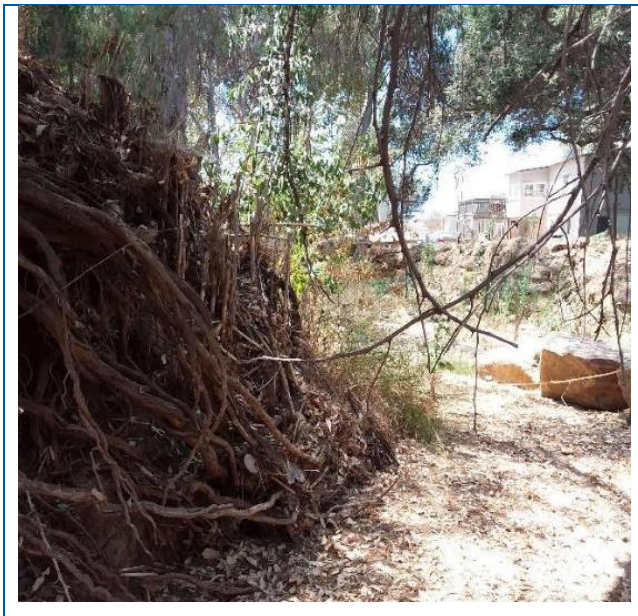
**Figure 11** Example of excessive root exposure due to stream bank erosion

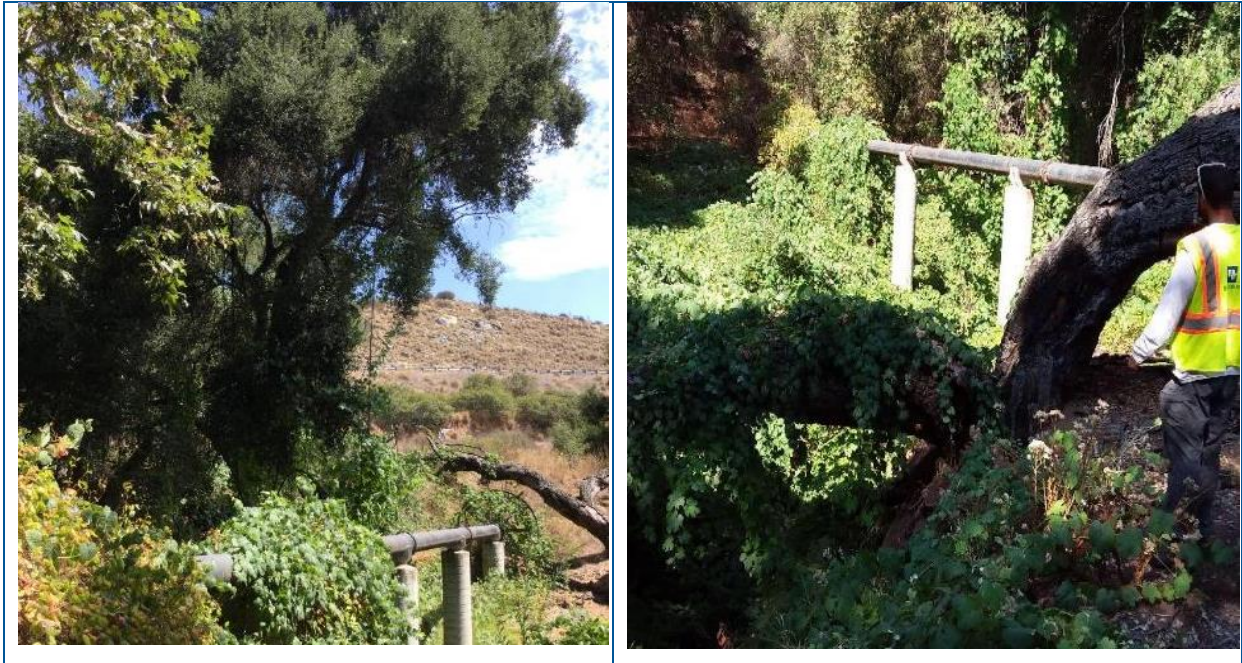
**Figure 12**      **Examples of trees leaning into a stream because of stream bank erosion**

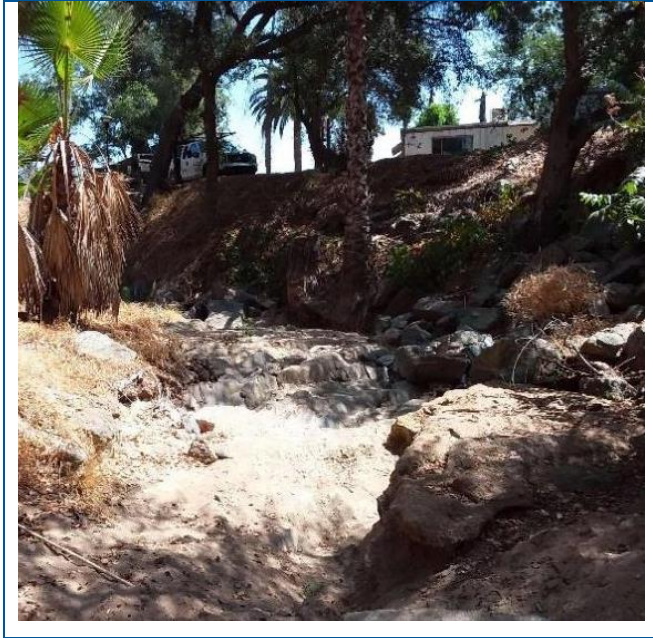
**Figure 13** Example of significant stream bank cutting

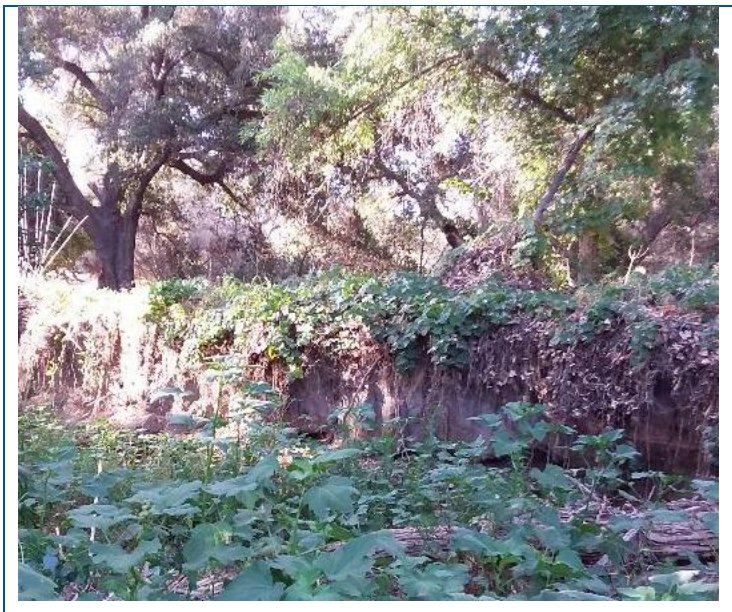
**Figure 14** Example of significant stream bank mass wasting
