**CALIFORNIA REGIONAL WATER QUALITY CONTROL BOARD - SAN DIEGO REGION
WATERSHED MANAGEMENT PROGRAM**

FACILITY INSPECTION REPORT

INSPECTION DATE: October 5, 2007 TIME: 9 am WDID: 9 37C322900

Sprinter Rail Project
FACILITY OR DEVELOPER NAME (if different from owner)

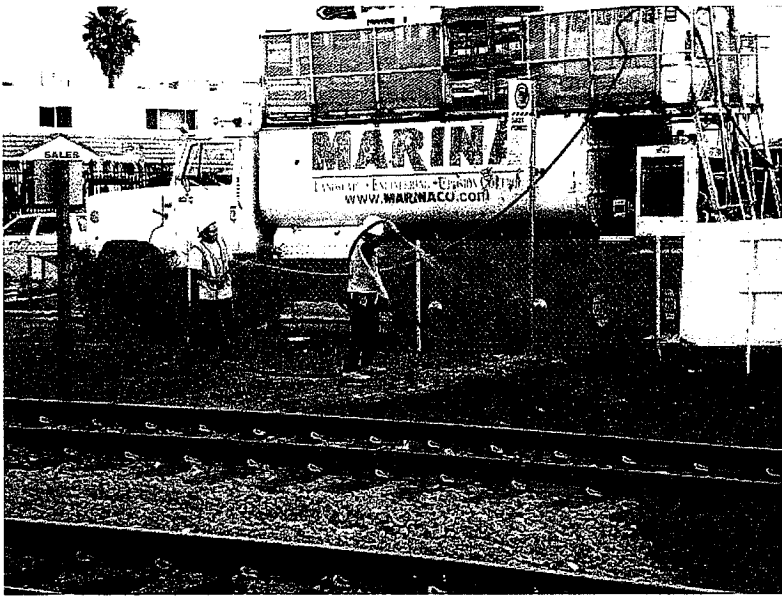
1. Crew hydroseeding drainage ditch. Photo looking north across the tracks.

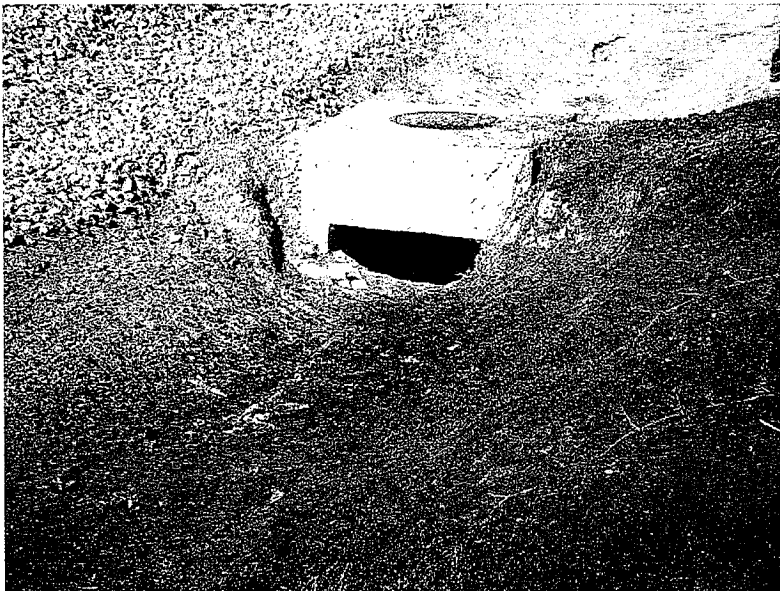
2. Storm drain inlet along the north side of the tracks is without sediment controls such as gravel bags. White trash is near the inlet. The drainage ditch was recently hydroseeded. Photo looking west.

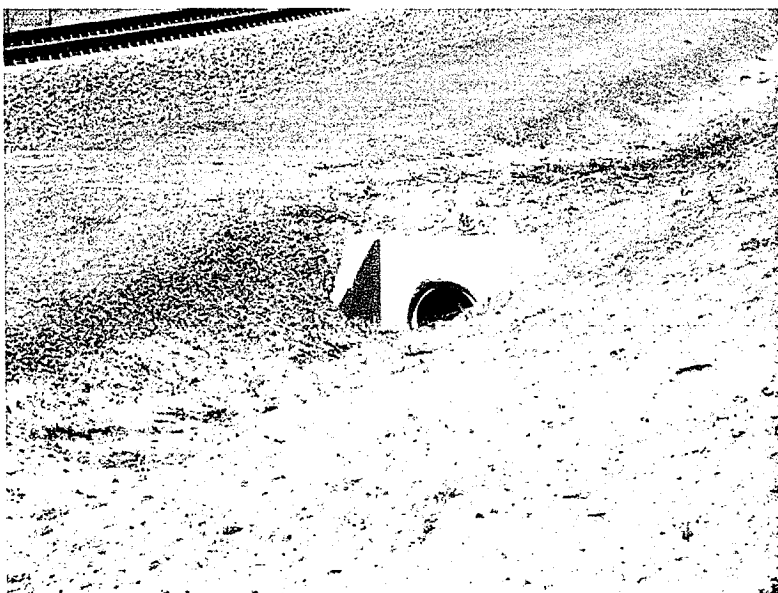
3. Another storm drain inlet along the north side of the tracks is without sediment controls such as gravel bags. Photo looking west.

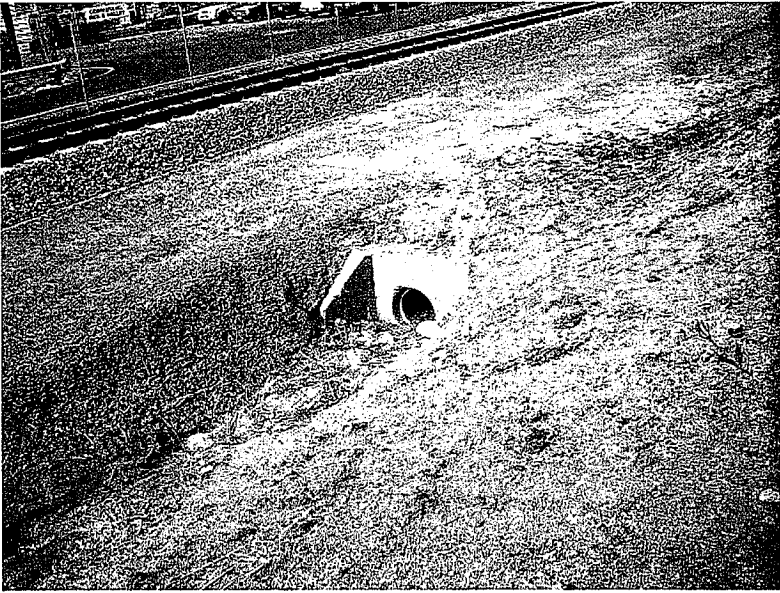
4. Another storm drain inlet along the north side of the tracks is without sediment controls such as gravel bags. Trash in the drainage ditch. Photo looking west.

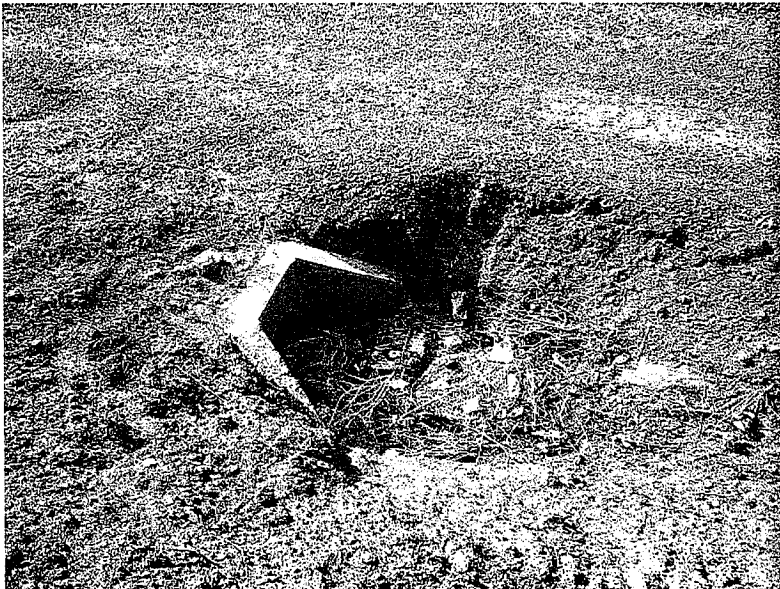
5. Another storm drain inlet along the north side of the tracks is without sediment controls such as gravel bags. Trash is in the drainage ditch. Photo looking east.

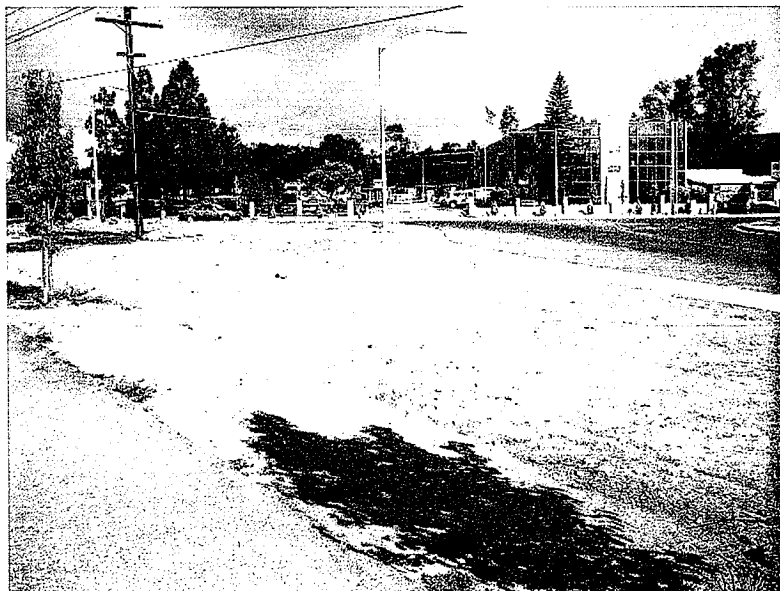
6. A large area of bare dirt has no sediment protections or soil stabilization. Photo is looking north.

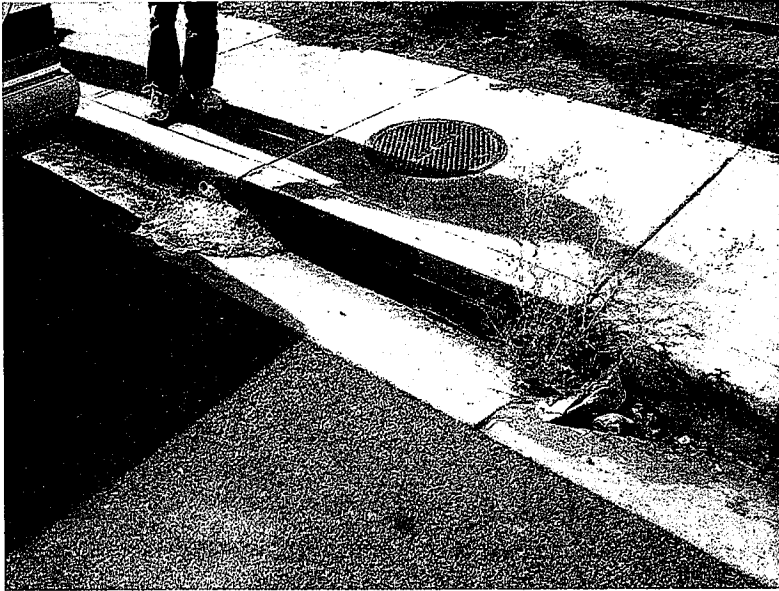
1. Washington Avenue in Escondido - The Sprinter tracks are south of and parallel to Washington Avenue from Hale Avenue, going west under I-15 to Mission Road. A low drainage ditch runs along the north side of the tracks between Washington Avenue and the rail line. Marin landscaping was busy applying hydroseed for erosion control along this drainage ditch (Photo 1). At several locations, the drainage ditch has storm drain inlets that were not protected with sediment controls (Photos 2, 3, 4, 5, 9). The drainage ditch also had trash accumulated near the inlets (Photos 2, 4, 5). At the intersection of Washington Avenue and Mission Road, a large area of soil was exposed with no sediment control BMPs or soil stabilization (Photo 6). Along Washington Avenue, two storm drain inlets were observed with broken up gravel bags that have not been maintained (Photos 7, 8).

7. Storm drain inlet along the south side of Washington Avenue is without adequate storm drain inlet protection. The existing BMP has not been maintained. Photo looking south.

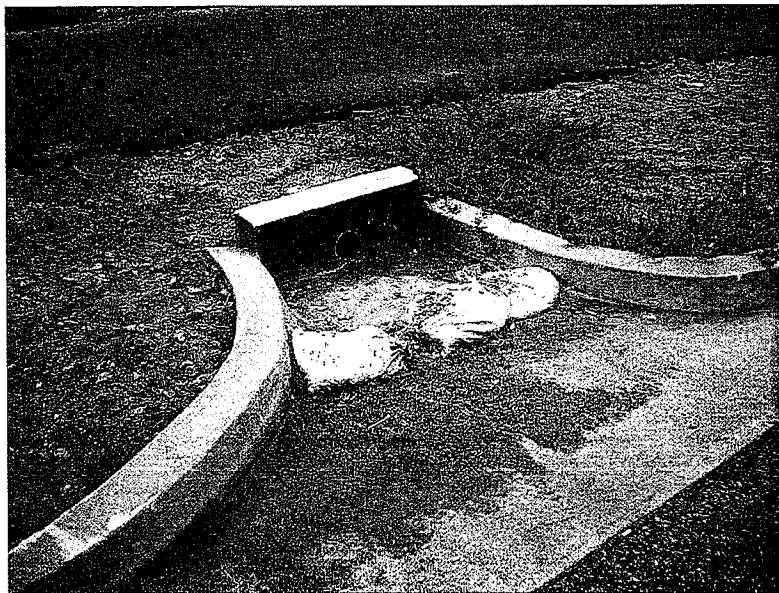
8. Storm drain inlet along the south side of Washington Avenue has BMPs that have not been maintained. Photo looking south.

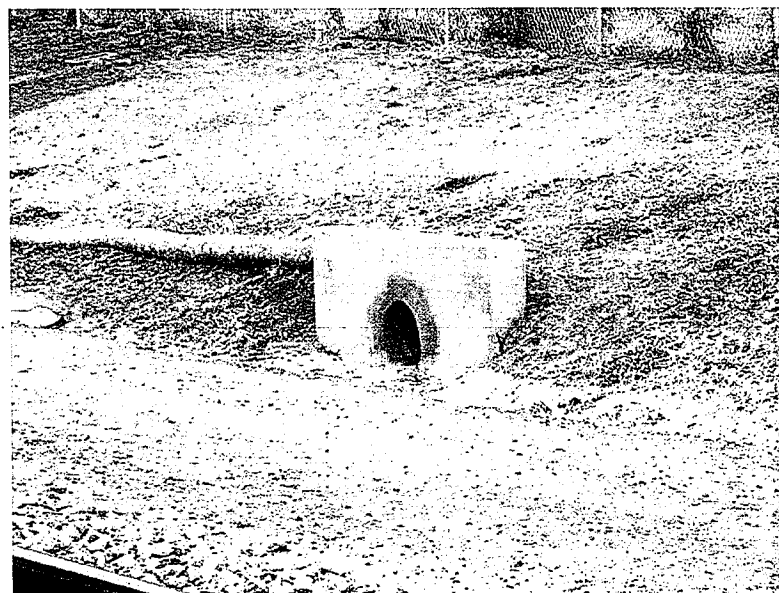
9. Storm drain inlet on the north side of the tracks without any sediment protections. Photo is looking north.

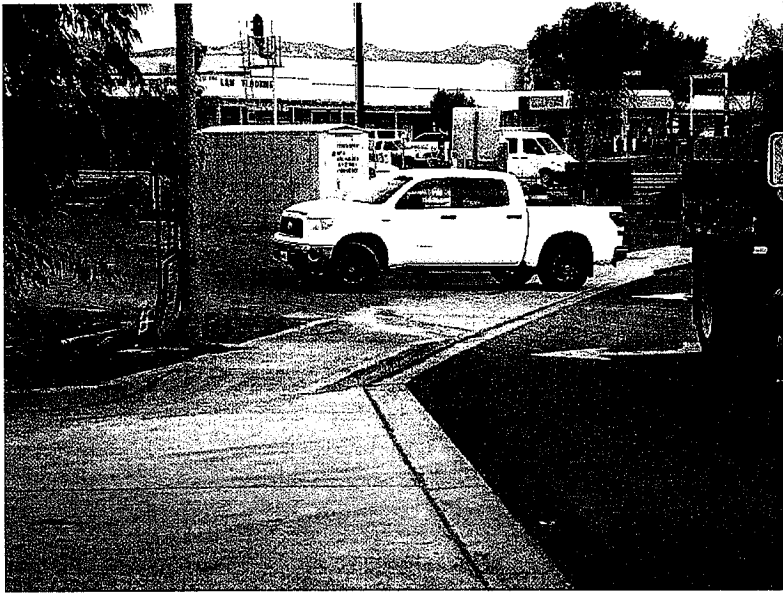
10. Construction site exit has no BMPs to prevent sediment tracking. Tracking is observed onto the adjacent paved public street, North Citracado Parkway. Photo looking north.

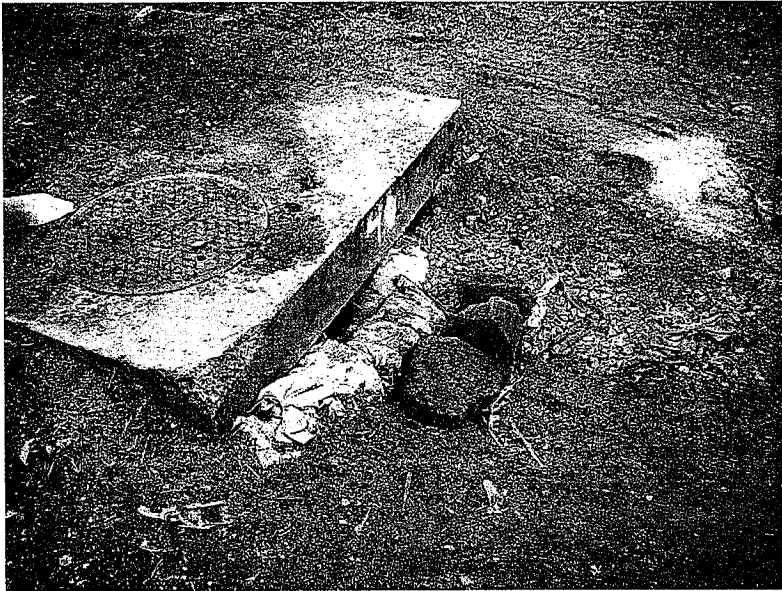
11. Storm drain inlet south of the tracks has BMPs that have not been maintained. Photo looking south.

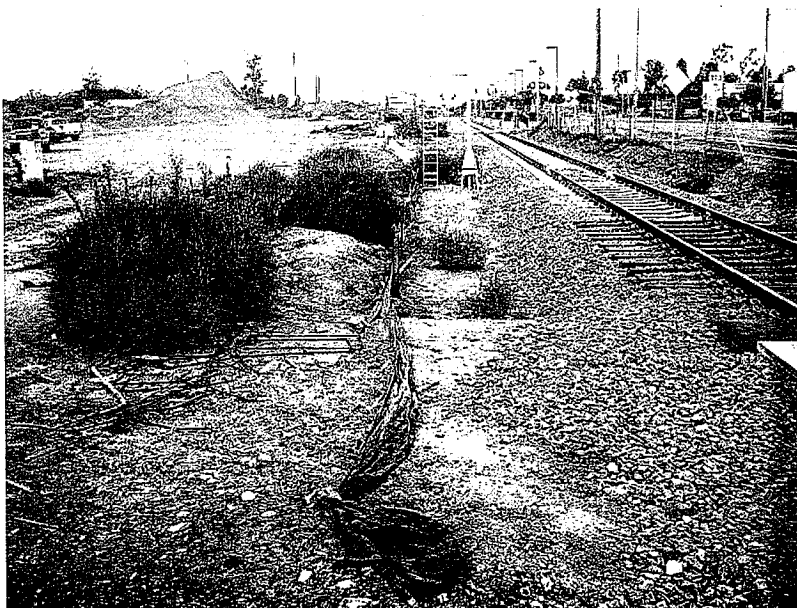
12. Silt fencing has not been maintained along the south side of the tracks. Photo looking west.

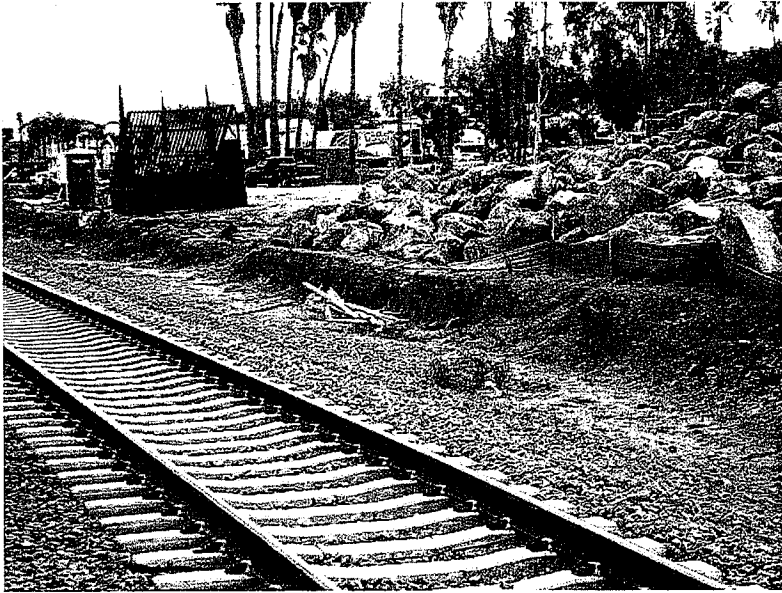
13. Silt fence south of the tracks is torn down and unmaintained. Photo looking south east.

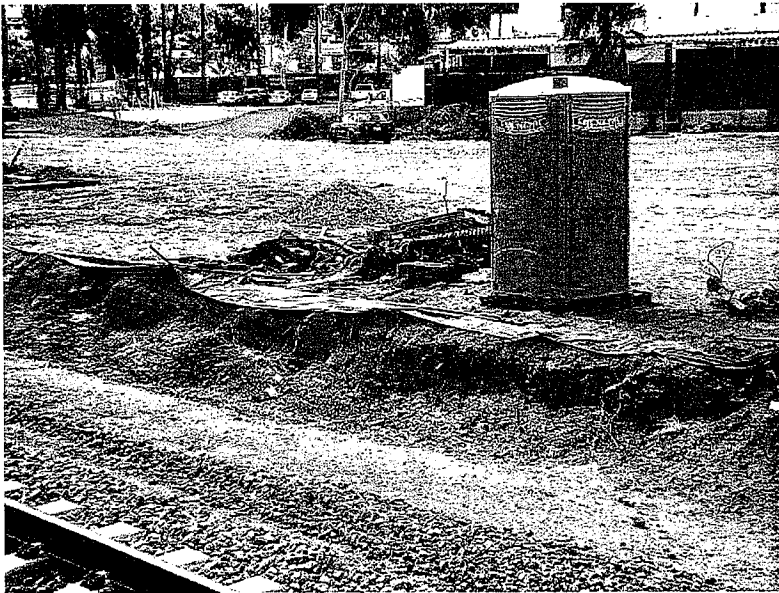
14. Silt fence is unmaintained. Construction debris and trash is not protected from storm water. Photo looking south.

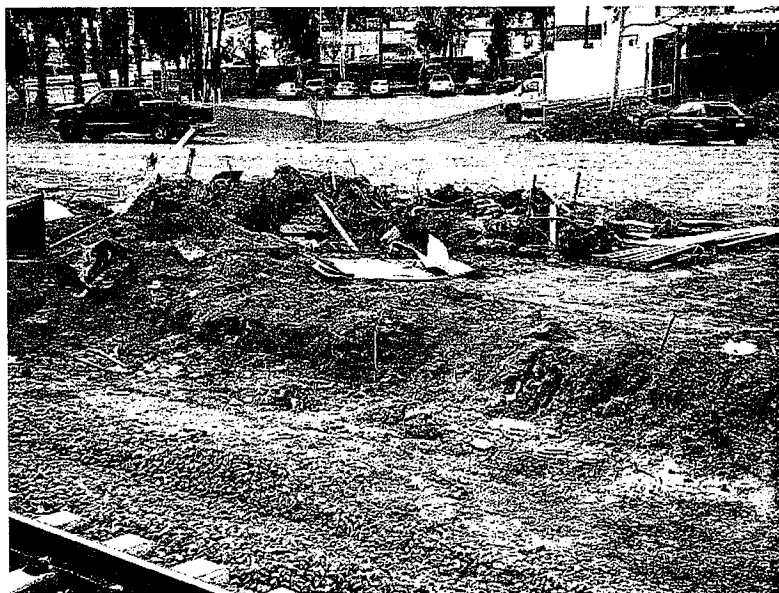
15. No silt fence is implemented in this area. Construction debris and trash is not protected from storm water. Photo looking south.

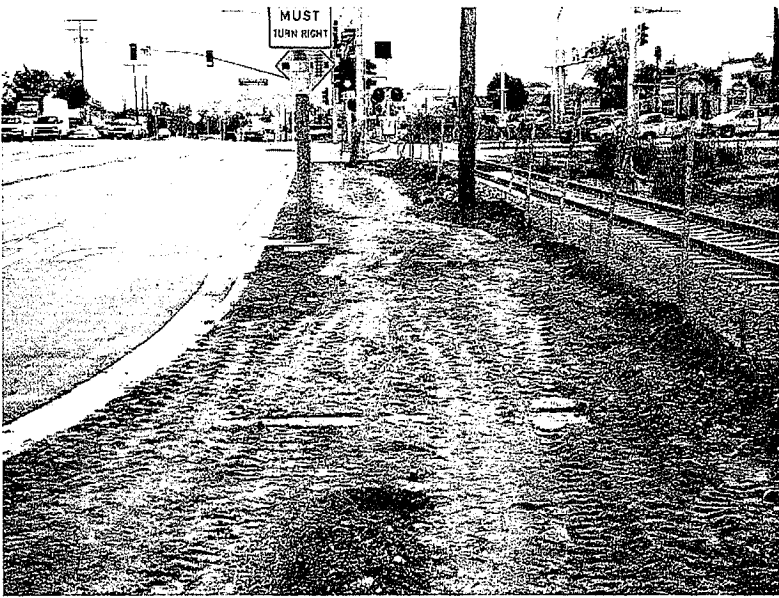
16. Bare soil north of the tracks does not have sediment controls or soil stabilization. Photo looking east.

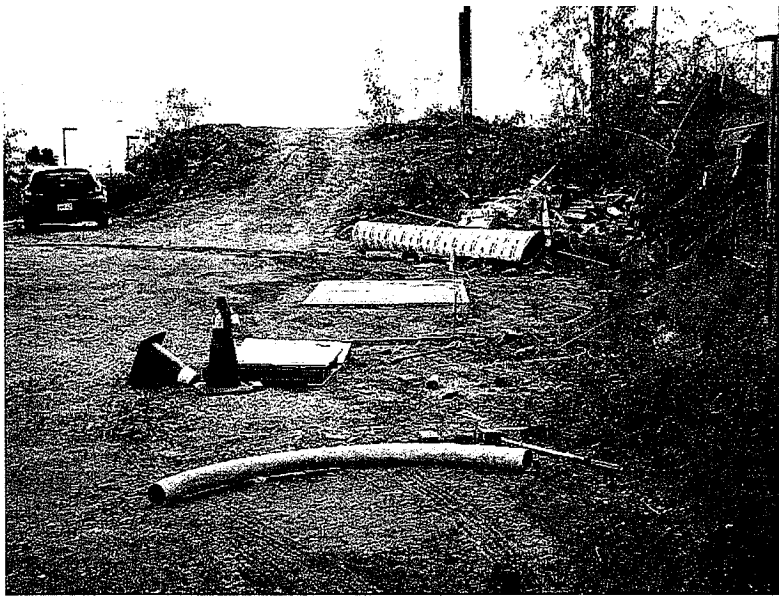
17. Construction trash is not protected with BMPs from storm water. Photo looking east.

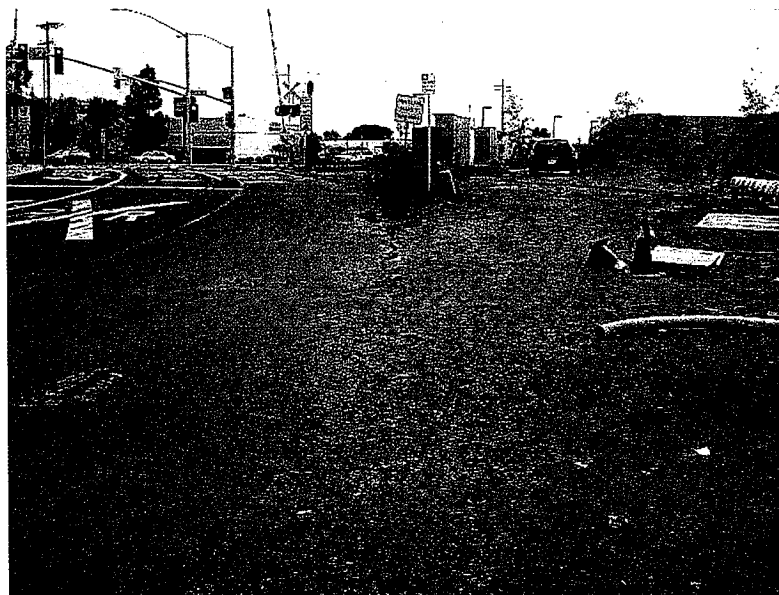
18. Sediment controls along the perimeter of south Barham drive have not been maintained. Photo looking north east.

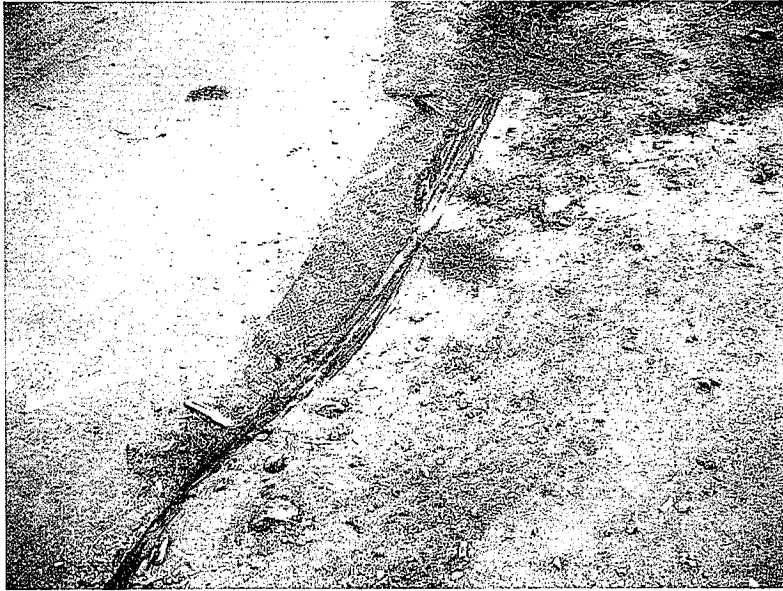
19. A closer view of the poorly maintained BMPs in photo 18 shows that the silt fence and fiber roll are flattened. Photo looking north.

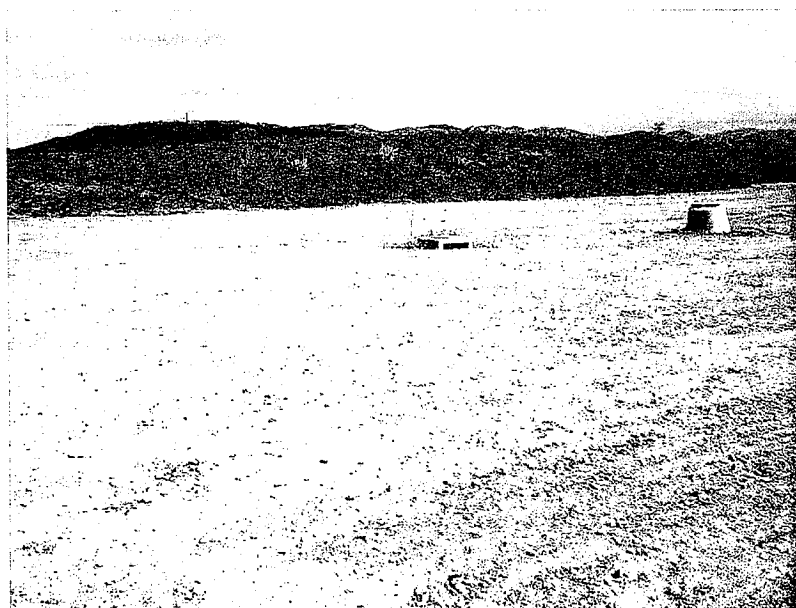
3. Barham Drive near Shelley Drive in San Marcos - This was one of the sites containing previous violations noticed in NOV R9-2007-0050 issued on March 19, 2007. A large area of disturbed soil was without any sediment controls or soil stabilization (Photo 21). In the middle of this disturbed area there was an unprotected storm drain (Photo 22).

21. A large area of bare soil is without soil stabilization. A storm drain inlet sits in the middle of this bare area.

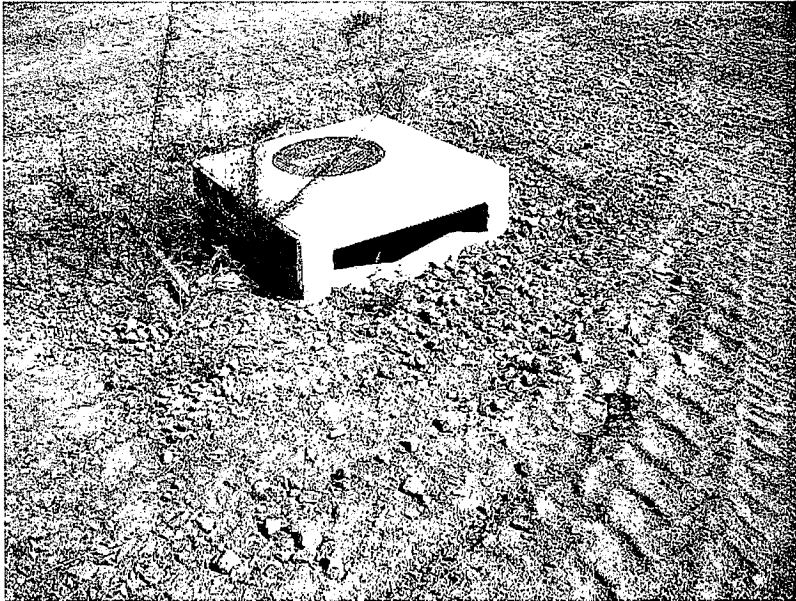
22. A closer examination of the storm drain inlet in photo 21 shows that the inlet has no sediment controls protecting the inlet. Photo looking north east.

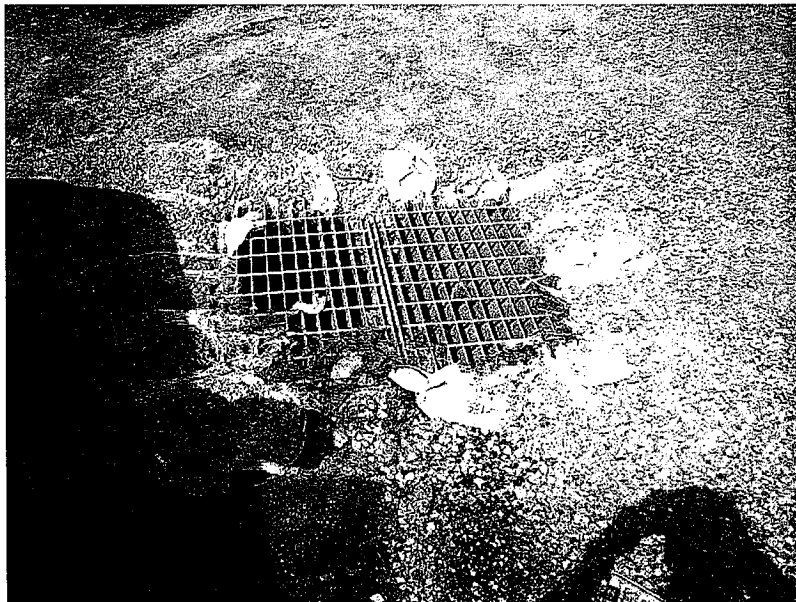
4. Palomar College Station - This was one of the sites containing previous violations noticed in NOV R9-2007-0050 issued on March 19, 2007. This station is south of W. Mission Rd, and north of Armorlite Dr. in San Marcos, across Mission Rd, from Palomar College. The site houses trailers for NCTD and their contractors. A storm drain inlet at the Armorlite Drive entrance to the trailers has gravel bags that are destroyed to the point that the gravel appears to be entering the inlet (Photo 23). A portable toilet is nearby and silt fencing has been partially removed (Photo 24).

23. Storm drain inlet just north of Armorlite drive has unmaintained BMPs. Photo looking west.

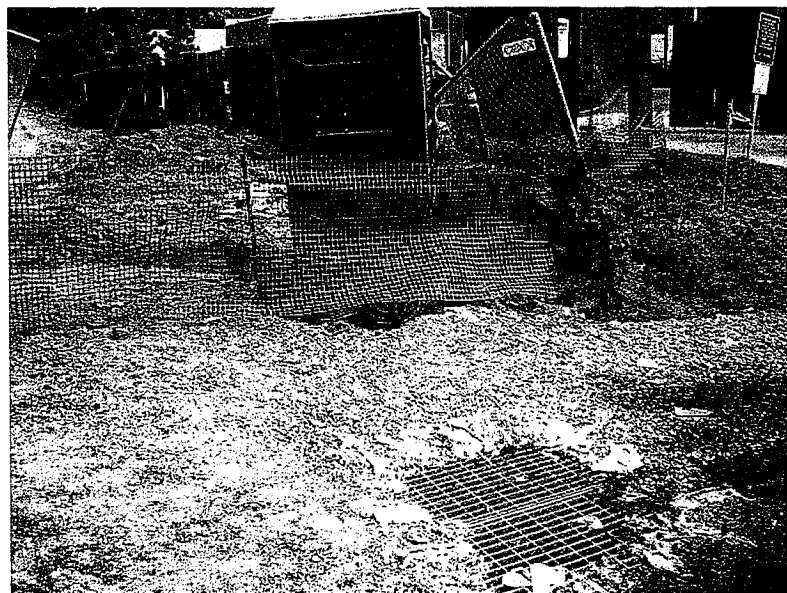
24. Another view of the inlet in photo 23 shows the proximity of a portable toilet and silt fencing that has been partially removed. Photo looking north.

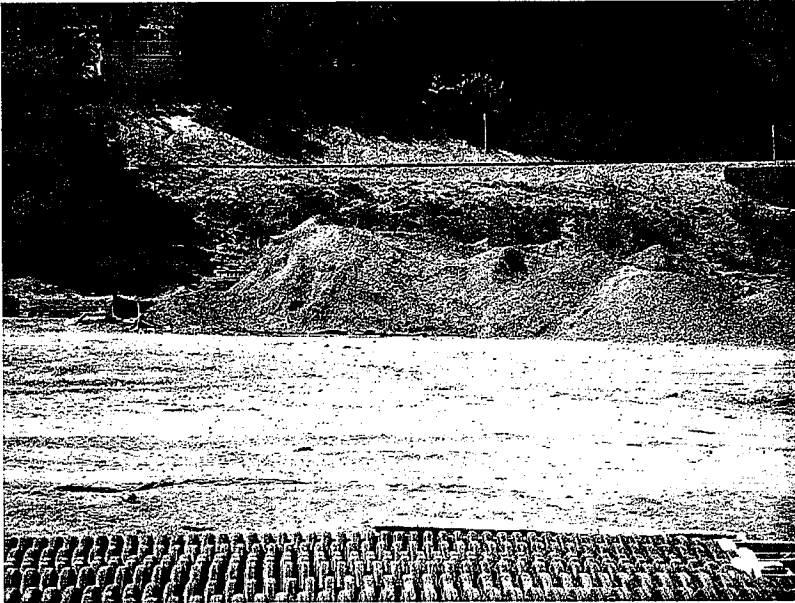
5. Mar Vista drive storage yard in Vista - This was one of the sites containing previous violations noticed in NOV R9-2007-0050 issued on March 19, 2007. This storage yard has a large soil stockpile that was not covered or contained to protect storm water runoff. Silt fence was not maintained around this stockpile. The silt fence was falling down on one side of the stockpile (Photo 25).

25. Silt fence around the soil stockpiles has not been maintained and has fallen down. Photo looking south.

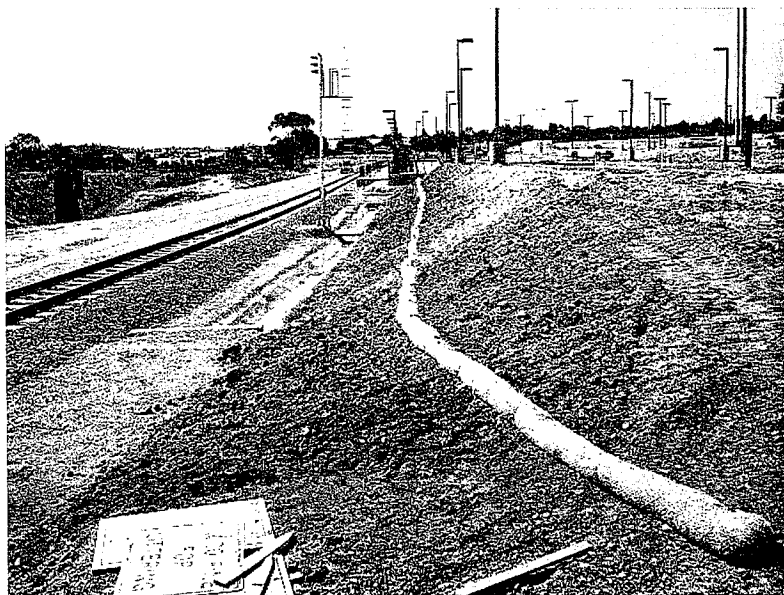
26. This slope north of the tracks does not have erosion controls in place. Fiber roll is not trenched in place. Photo looking west.

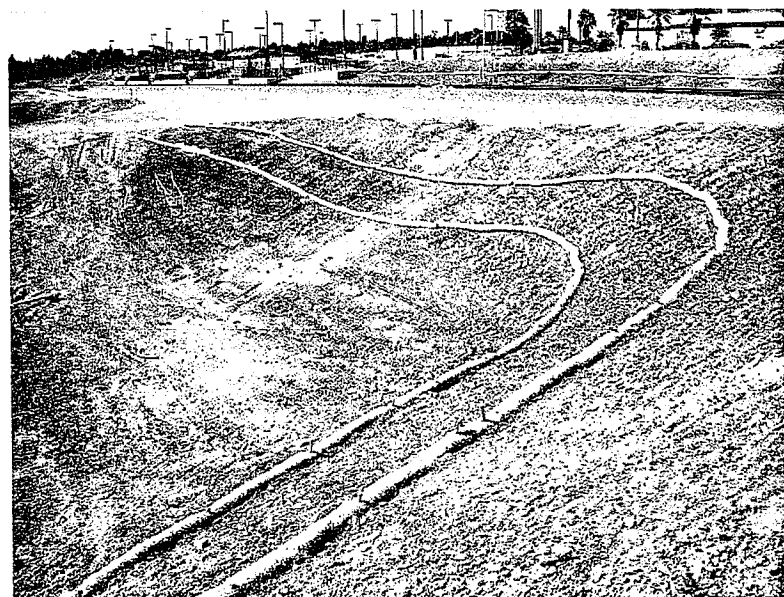
27. Slope south of the tracks does not have erosion controls. Photo looking north.

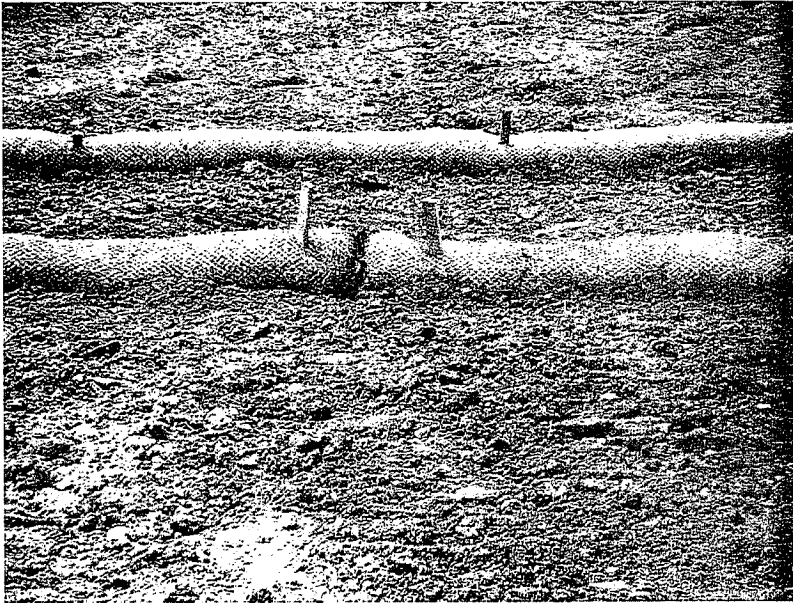
28. Fiber rolls on the slope in photo 27 are not overlapped. No erosion controls in place. Photo looking west.

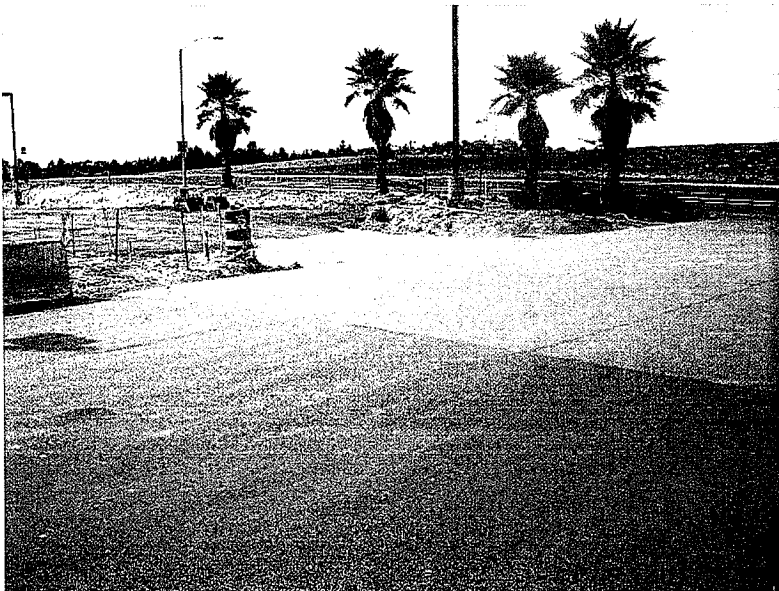
29. Construction exit is without BMPs to prevent sediment tracking onto the adjacent paved area of the convenience store. Photo looking north west.

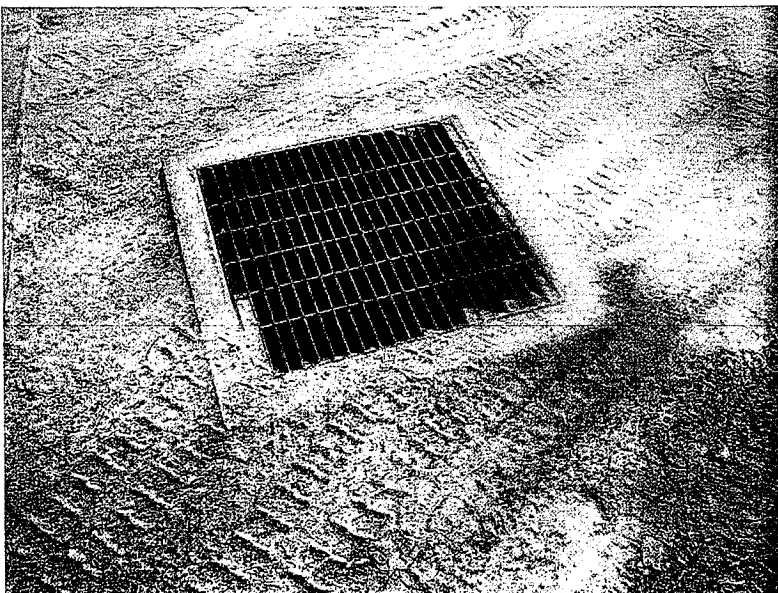
30. A storm drain inlet near the construction exit in photo 29 is without BMPs and sediment is falling into the drain. Photo looking west.

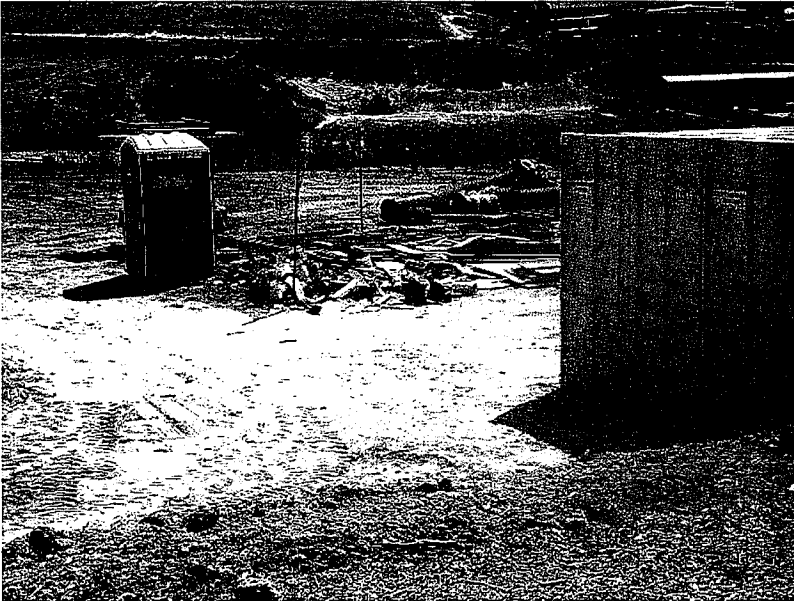
6. Melrose Drive station in Oceanside- This station is on the southwest corner of Melrose Drive and Oceanside Boulevard next to a convenience store. The headwaters to Loma Alta Creek flow adjacent to the south side of the tracks. This site did not have any erosion controls on slopes and fiber rolls were not implemented properly (Photos 26, 27, 28). The fiber rolls were not trenched in properly on a slope north of the tracks. A slope south of the tracks did not have the fiber rolls overlapping at the ends. The construction exit through the convenience store parking lot did not have any BMPs to prevent sediment tracking (Photo 29). At this exit a storm drain inlet was in the bare soil with no BMPs to protect it (Photo 30). The inlet has been repeatedly driven over tracking sediment into the inlet. At the western edge of the Melrose station construction, trash and debris was stored outside without cover or containment (Photo 31).

31. Construction trash is stored outside with no cover or containment to prevent contact with storm water. Photo looking south.

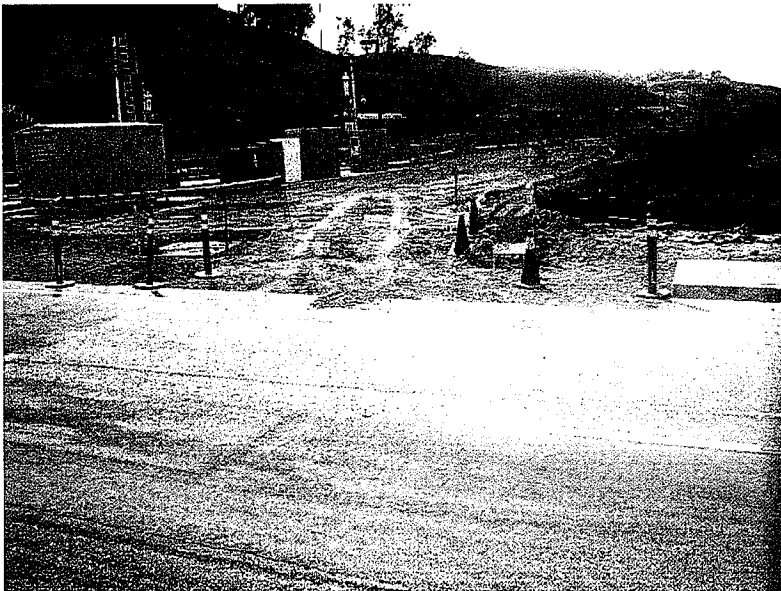
32. Construction exit is without BMPs to prevent sediment tracking onto the adjacent paved street. Photo looking west.

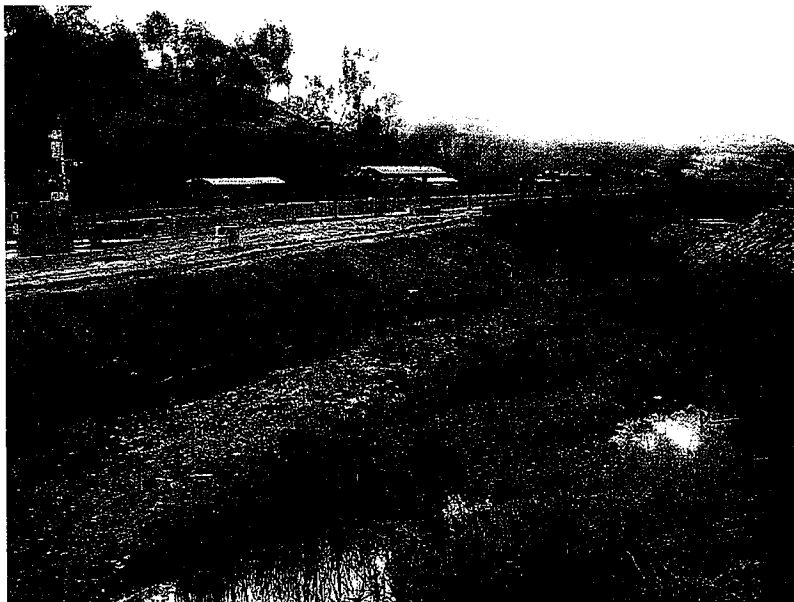
33. Slope adjacent to Loma Alta Creek is without erosion controls such as bonded fiber matrix or erosion control blankets. Silt fence does not extend the length of the slope. Photo looking south west.

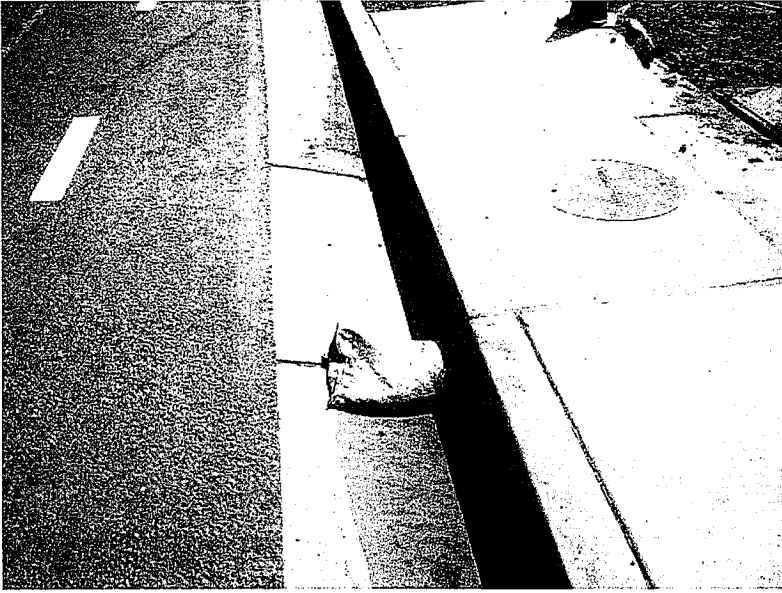
34. A storm drain inlet on the west side of Rancho del Oro Blvd. does not have adequate sediment controls and is not being maintained. Photo looking south.

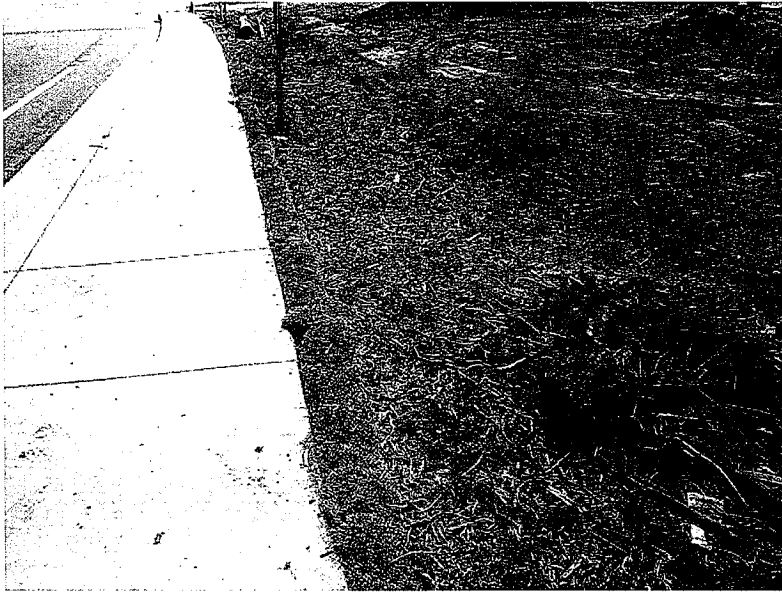
7. Rancho del Oro station in Oceanside - This station is bordered by Rancho del Oro Road to the east. Loma Alta Creek runs through the north of the station. A pedestrian bridge is being built over the creek to access the station. The construction site entrance/exit from Rancho del Oro Road does not have large gravel or shaker plates or a tire wash station to prevent sediment tracking onto the adjacent paved public road (Photo 32). The southern bank of Loma Alta creek does not have any erosion controls (Photo 33). This exposed bank appears to be vulnerable during high flow rates and volume. A storm drain along the west side of Rancho del Oro Road had a single gravel bag which appears to be inadequate to trap sediment from entering the inlet (Photo 34). Along the east side of Rancho del Oro Road, a fiber roll had not been maintained and was flattened from repeatedly being run over (Photo 35).

35. Fiber rolls along the east of Rancho del Oro Blvd have not been maintained and are flattened. Disturbed soil has not been stabilized. Photo looking north.

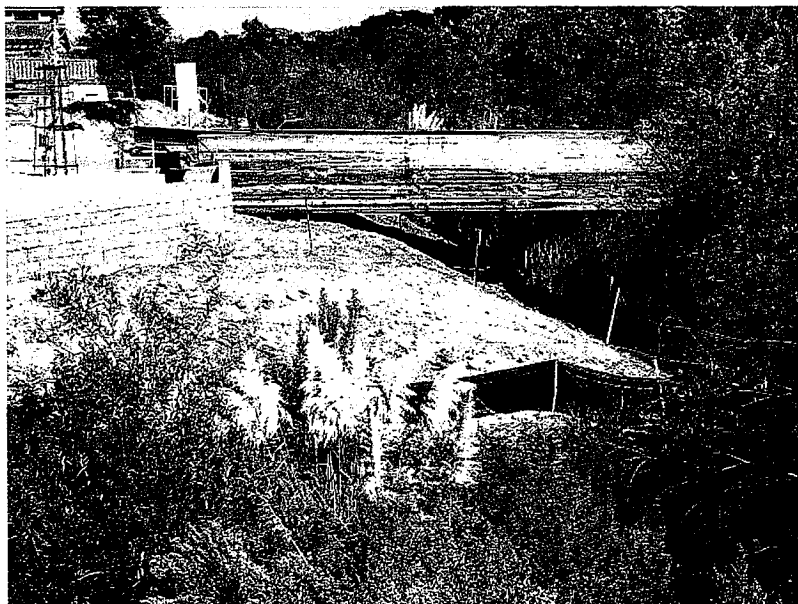
36. Slope next to Loma Alta Creek does not have erosion controls implemented. Photo looking east.

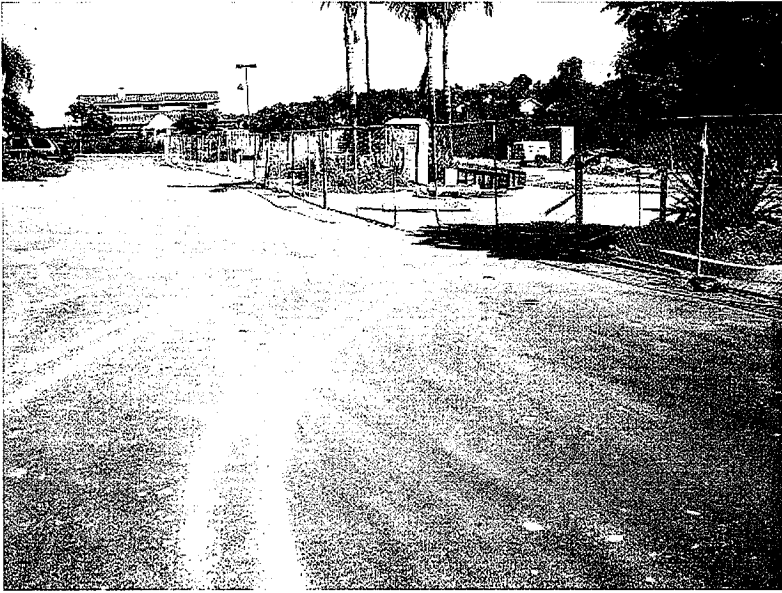
37. Sediment tracking from the College Station construction onto the paved parking lot of the shopping center. Photo looking east.

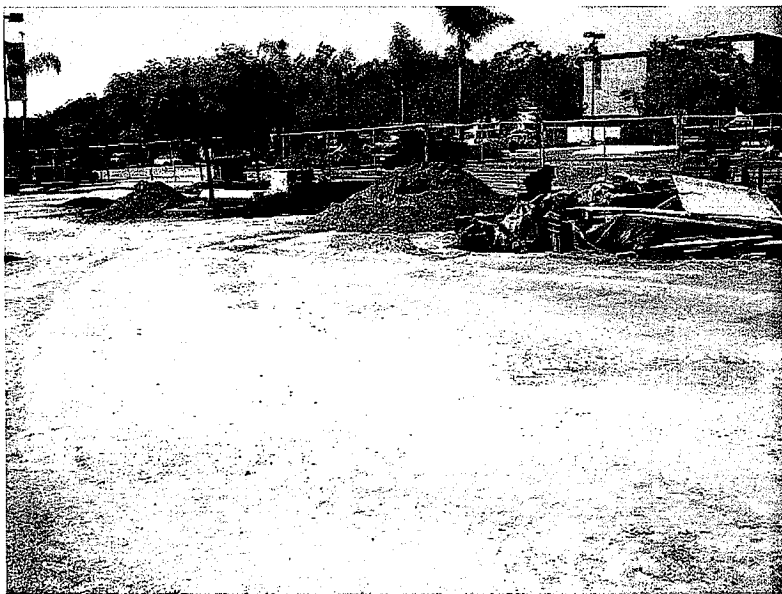
8. College Blvd Station in Oceanside - This station is next to Loma Alta Creek in a shopping center on the southwest corner of College Boulevard and Oceanside Boulevard. A pedestrian bridge is being built over Loma Alta creek. The creek's banks on either side of the pedestrian bridge have a silt fence at the base to provide sediment controls but is without erosion controls on the slope such as hydroseed or erosion control blankets (Photos 36, 39). These exposed banks appear to be vulnerable during post storm high flow rates. A portion of the shopping center's parking lot is used as a staging and storage area for construction activities. Significant sediment tracking was observed on the shopping center's paved parking lot (Photo 37). Soil stockpiles and construction trash storage was without cover and without containment (Photo 38).

38. Material stockpiles and construction trash are stored without cover or containment. Photo looking north west.

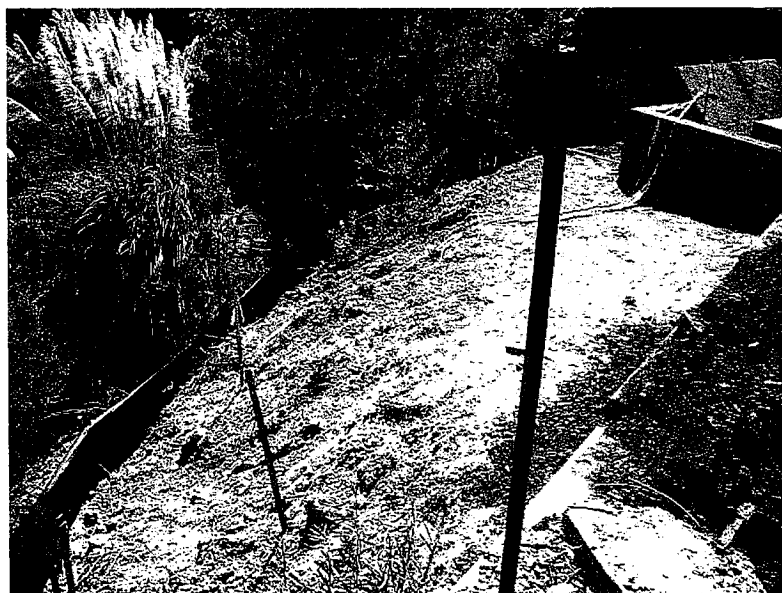
39. Slope next to Loma Alta Creek pedestrian bridge abutment is without erosion controls. Photo looking west.
