**CALIFORNIA REGIONAL WATER QUALITY CONTROL BOARD - SAN DIEGO REGION
WATERSHED MANAGEMENT PROGRAM**

FACILITY INSPECTION REPORT

Sprinter Rail Project
FACILITY OR DEVELOPER NAME (if different from owner)

FACILITY: __North County Transit District Sprinter Rail_ (WDID)_9 37C322900__ INSPECTION DATE: _11/30/07__

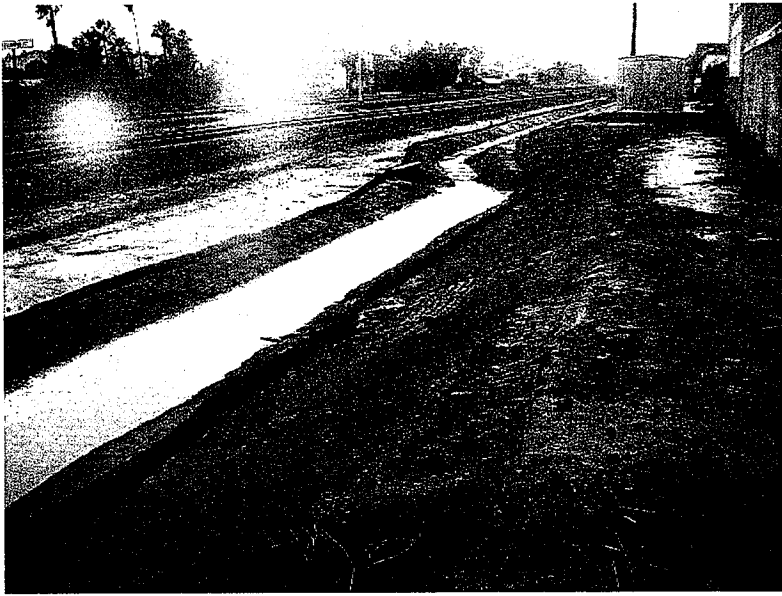
669. Unlined dirt storm drain channel full of sediment laden water.

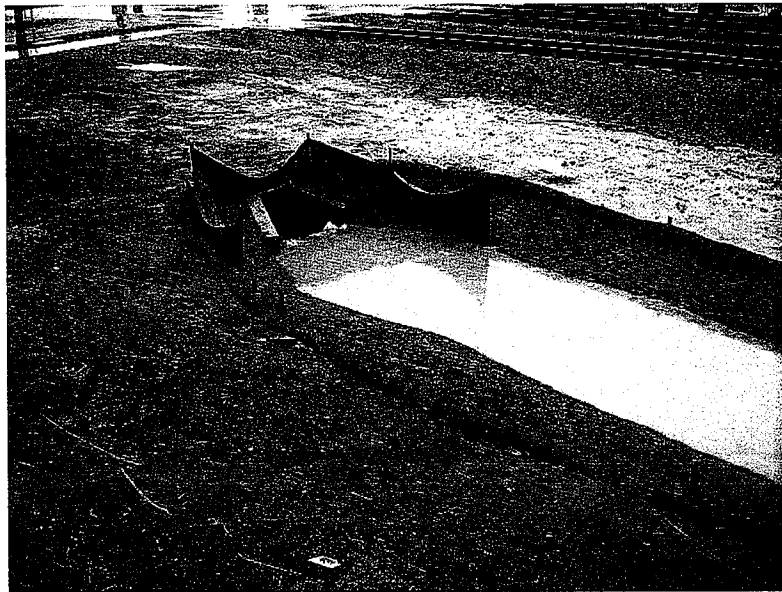
670. The sediment laden water pours into this inlet with inadequate sediment control protection. This deficiency was also noted on Tuesday, November 27, 2007.

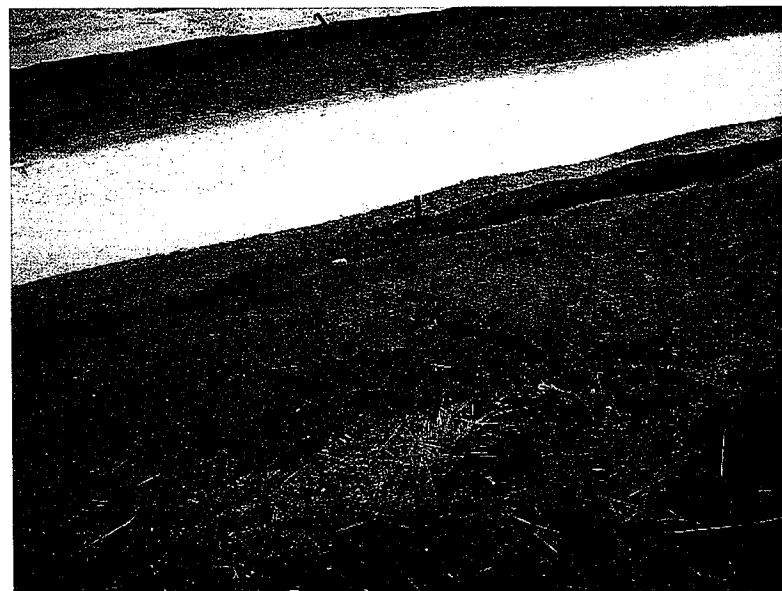
671. Slope erosion from offsite runoff not being addressed.

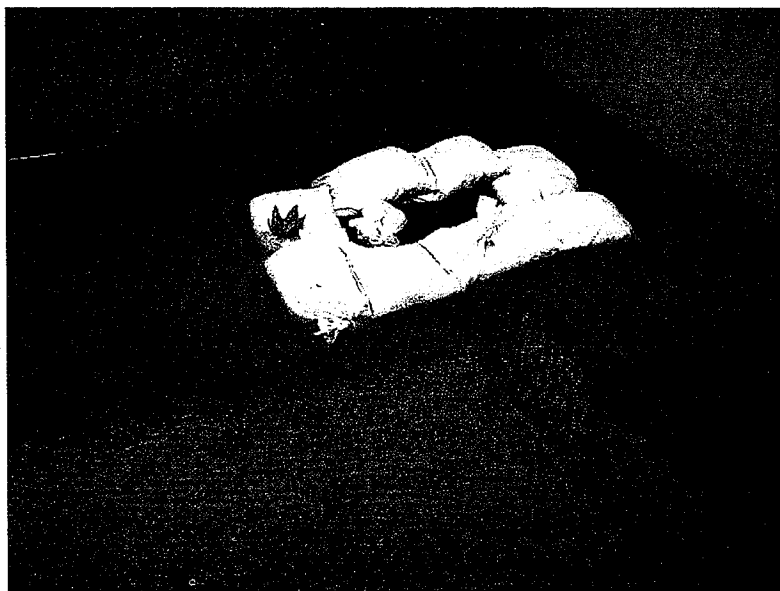
677. Station platform inlet has been protected. This inlet was previously not protected on Tuesday, November 27, 2007.

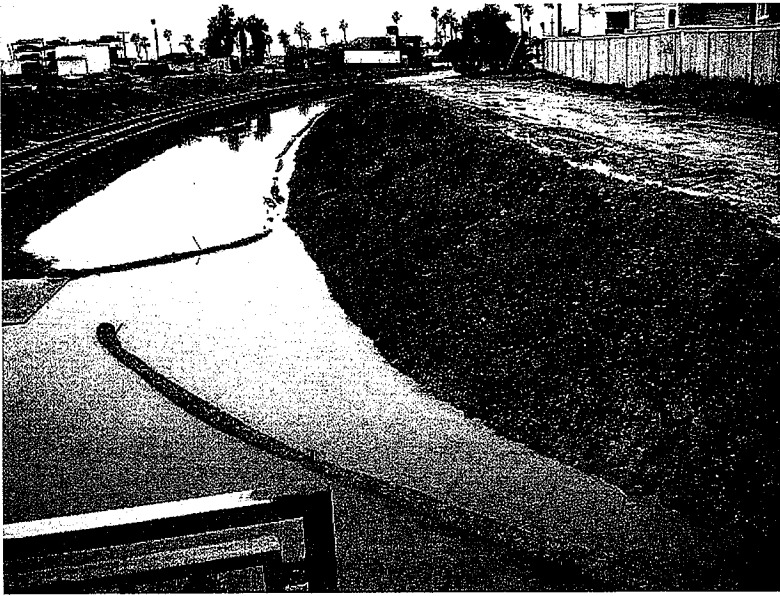
678. Unlined dirt channel is backed up with sediment laden water. Slope has been sprayed with erosion control but erosion gullies are present from concentrated flows. Fiber roll is ineffective.

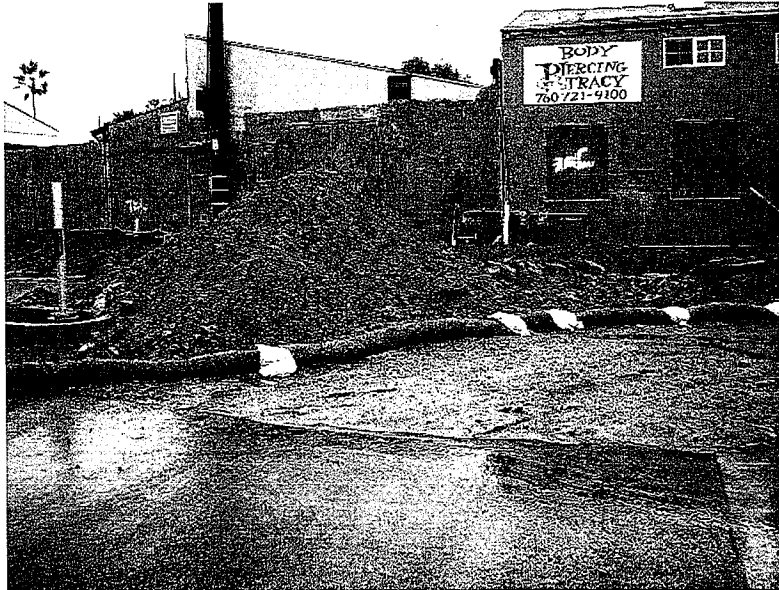
683. Stockpile has a fiber roll around it. Construction exit does not have BMPs to prevent sediment tracking. These deficiencies were also noted on Tuesday, November 27, 2007. Sediment on the pavement has since been swept up.

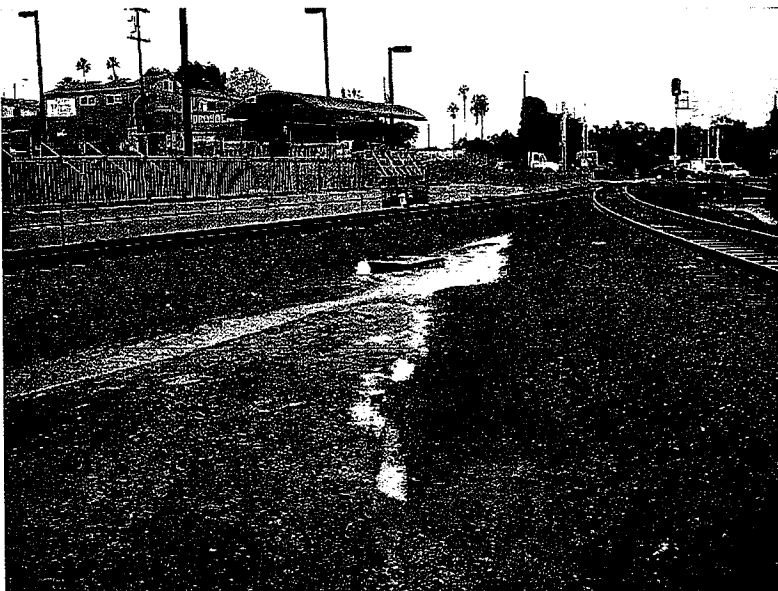
684. A storm drain inlet without adequate protection is receiving a sediment laden water discharge.

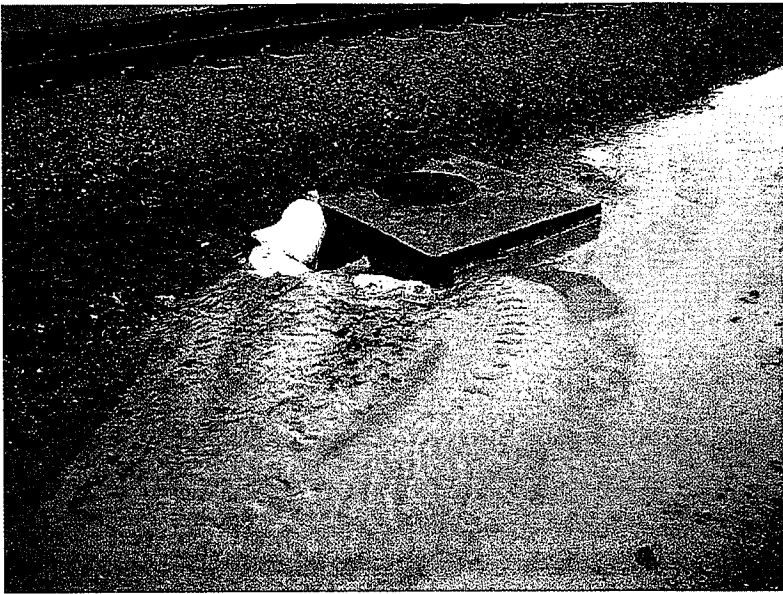
685. A closer look at the storm drain inlet in photo 684.

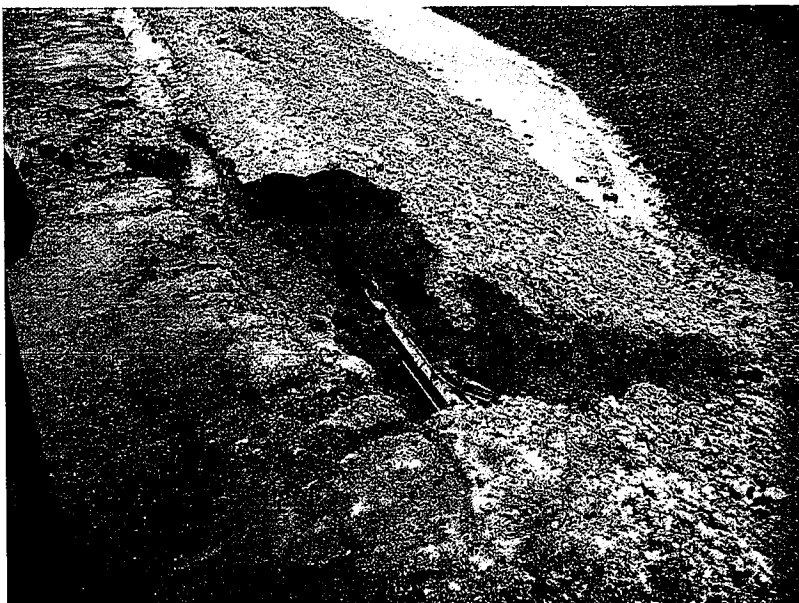
688. A closer look at one of the erosion gullies in photo 686 shows exposed irrigation pipes.

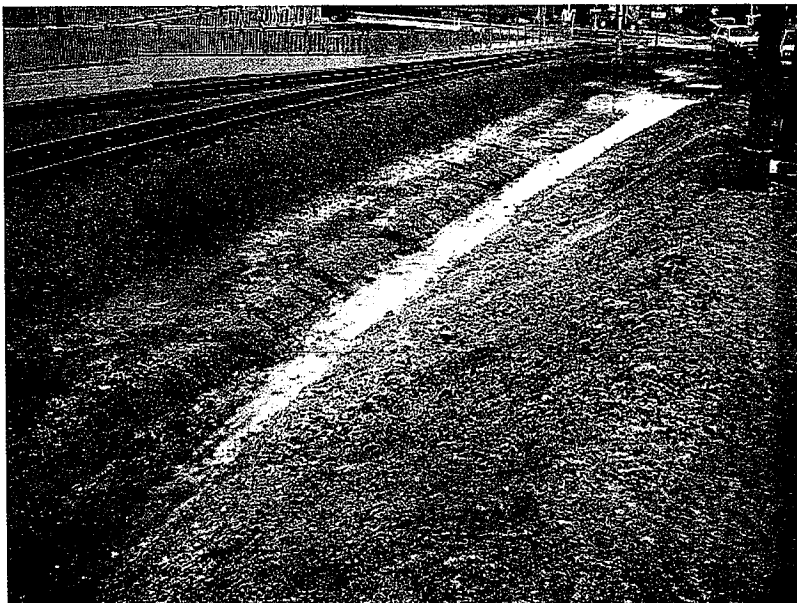
691. The same dirt channel in the previous photo leads to the far storm drain inlet.

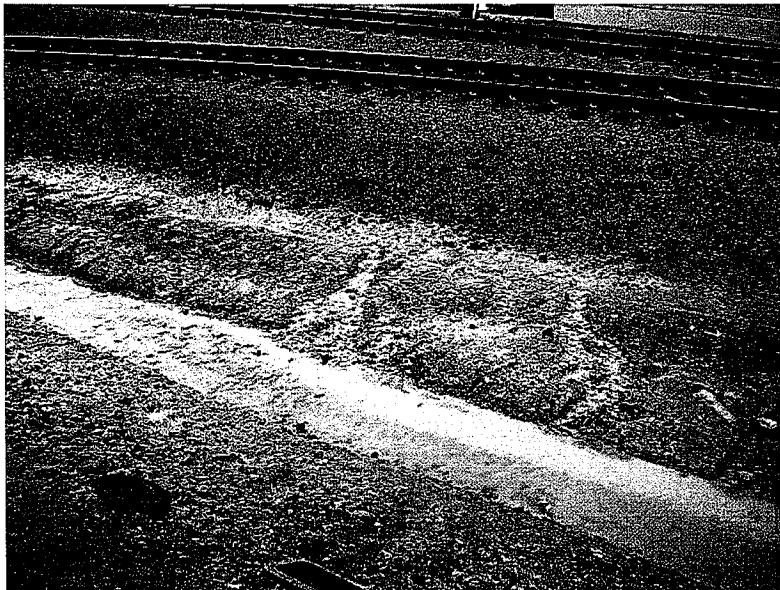
693. Another look at photos 690 and 691 shows the clear water on the left and the plume of sediment laden water on the right.

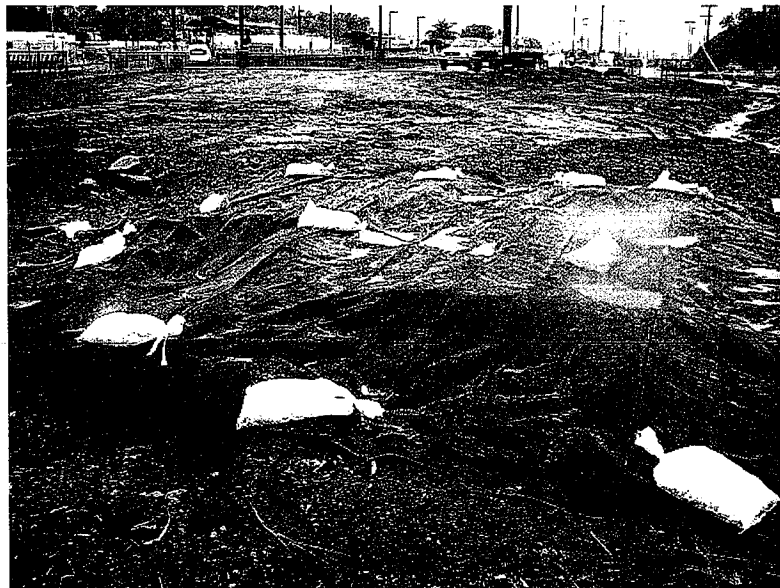
694. Remnants of an asphalt cold mix stockpile have been covered with plastic. This was in response to a deficiency noted on Tuesday, November 27, 2007.

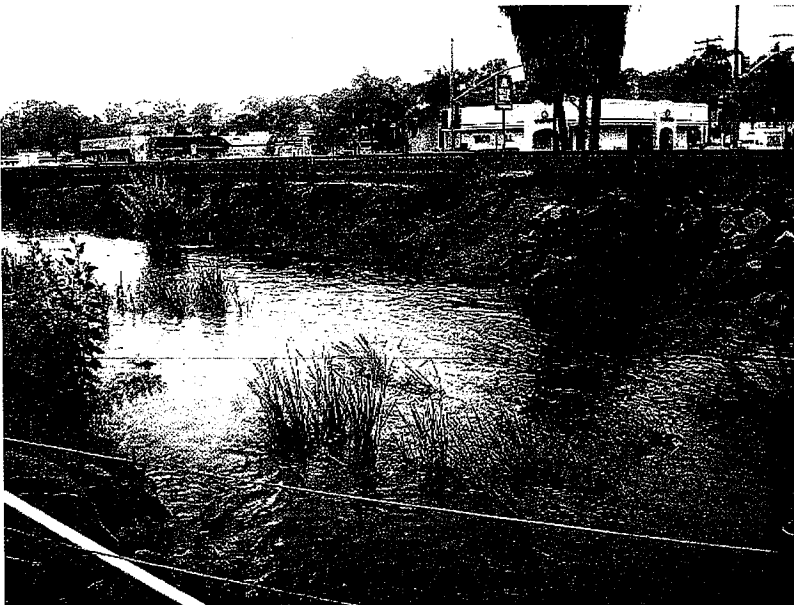
698. The far slope has been sprayed with erosion control. This was subsequent to deficiencies noted on Tuesday Nov. 27, 2007.

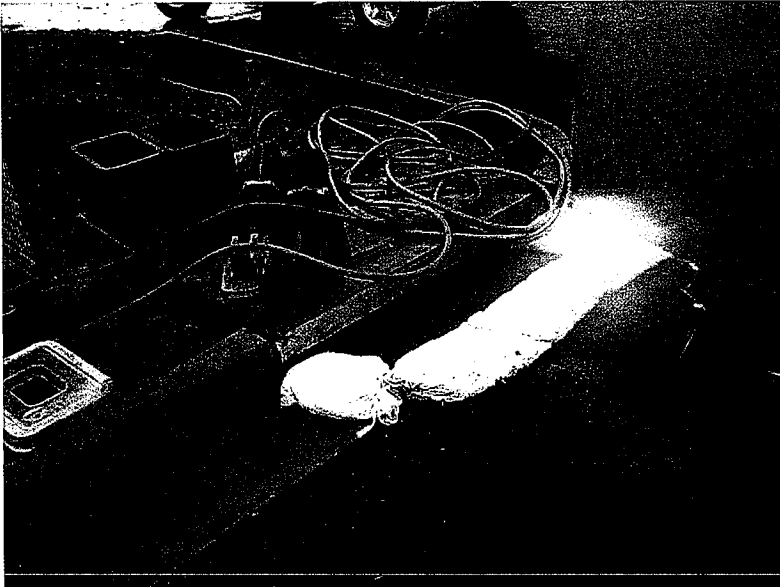
699. Storm drain inlet has been protected. This was in response to deficiencies noted on Tuesday, November 27, 2007.

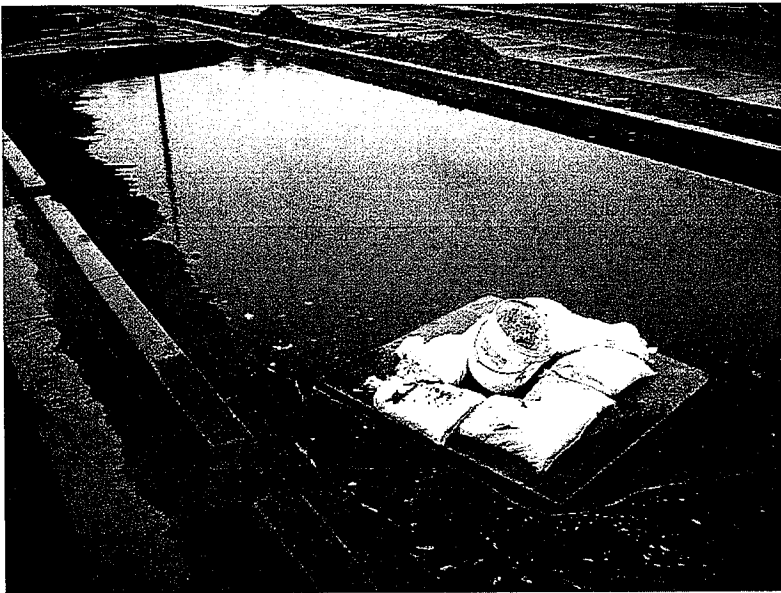
700. Storm drain inlet has been protected. This was in response to deficiencies noted on Tuesday, November 27, 2007.

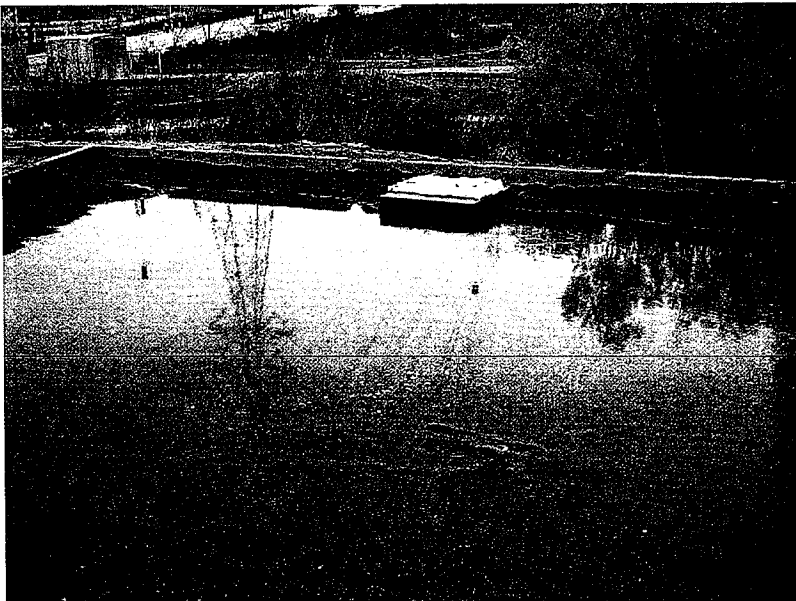
701. Storm drain inlet has been protected. This was in response to deficiencies noted on Tuesday, November 27, 2007.

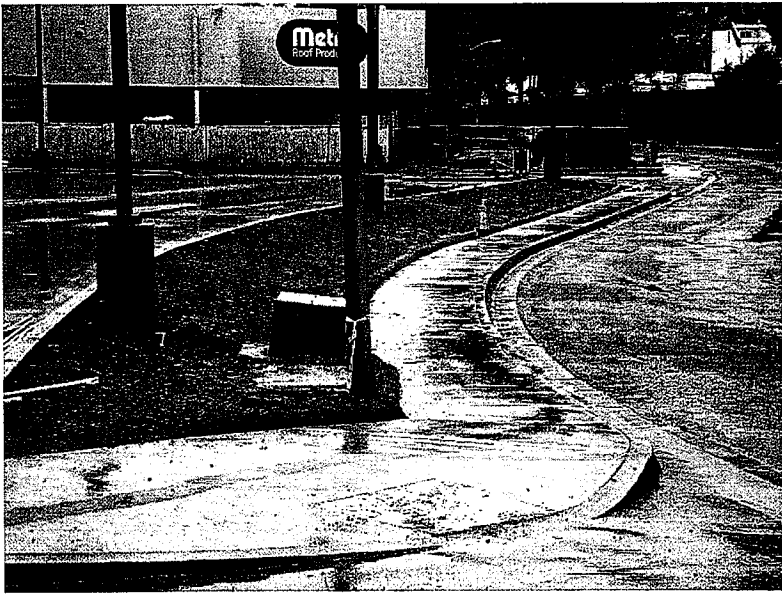
705. Fiber roll has been implemented behind the sidewalk. This was in response to deficiencies noted on November 27, 2007.

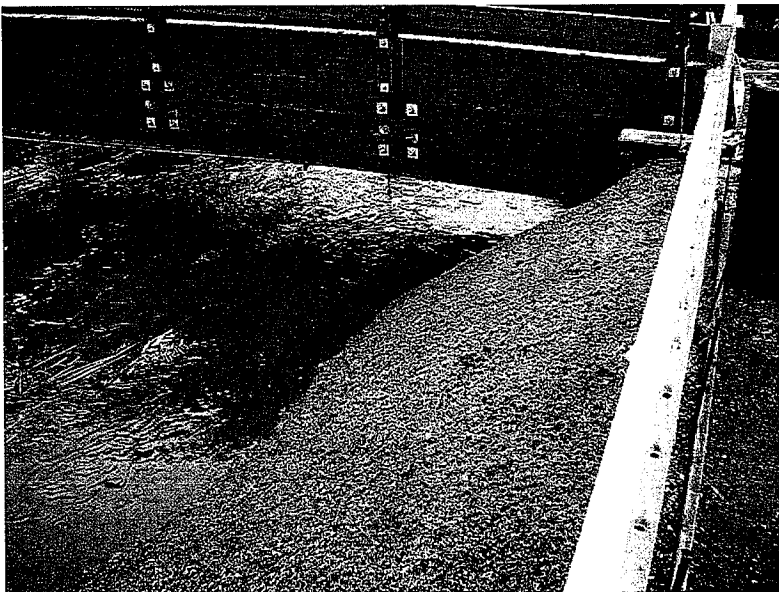
706. Erosion control has been sprayed on the banks of Loma Alta Creek near the pedestrian bridge. This was in response to deficiencies noted on Tuesday, November 27, 2007. The application looked light.

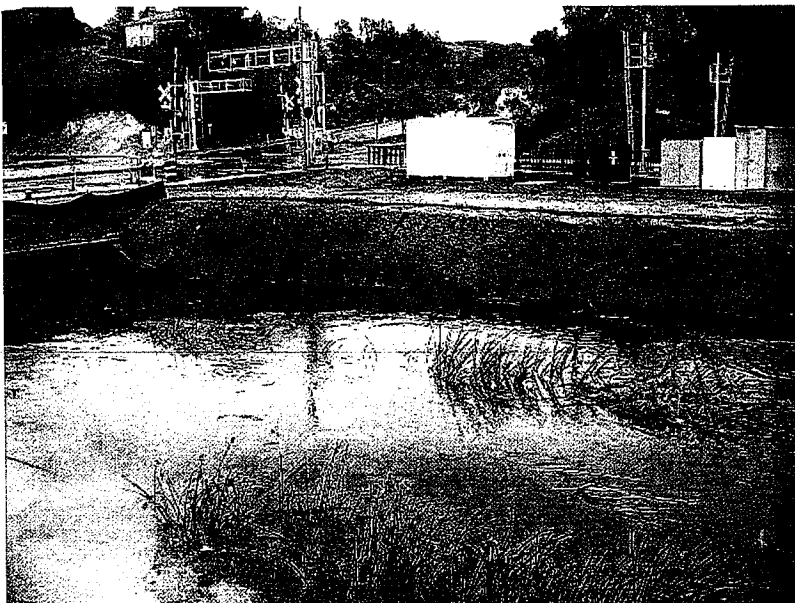
707. The bank of Loma Alta Creek has been sprayed. This was in response to deficiencies noted on Tuesday, November 27, 2007. The application appeared light.

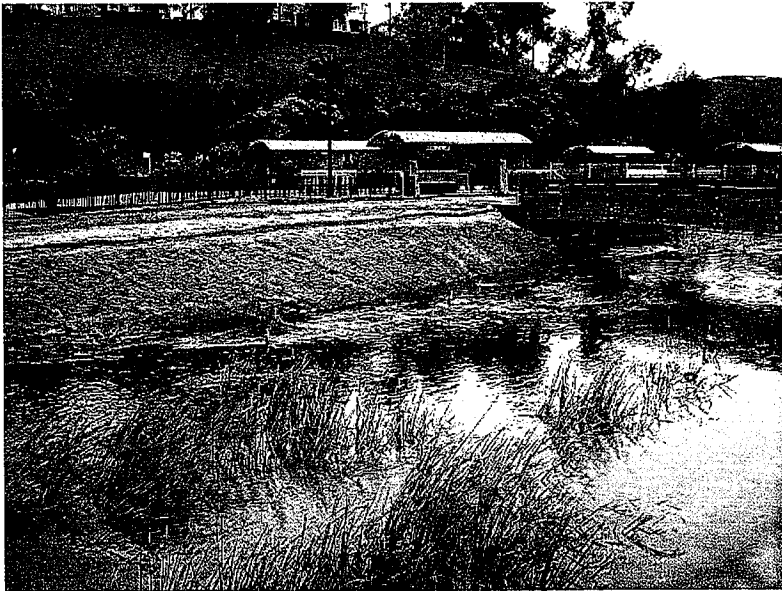
708. The bank of Loma Alta Creek has been sprayed with erosion control. The application appeared to be light. This was in response to deficiencies noted on Tuesday, November 27, 2007.

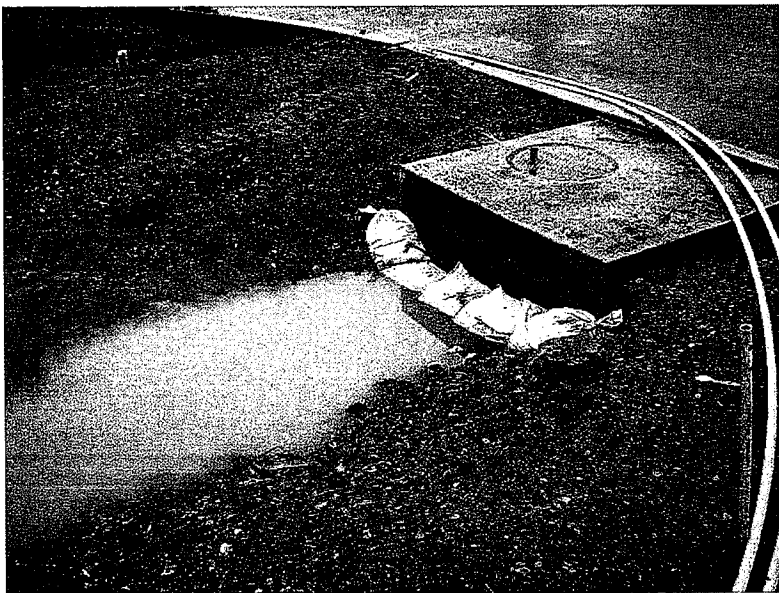
709. A storm drain inlet that appears to have been overtopped earlier in the day due to the sediment present on top of the gravel bags.

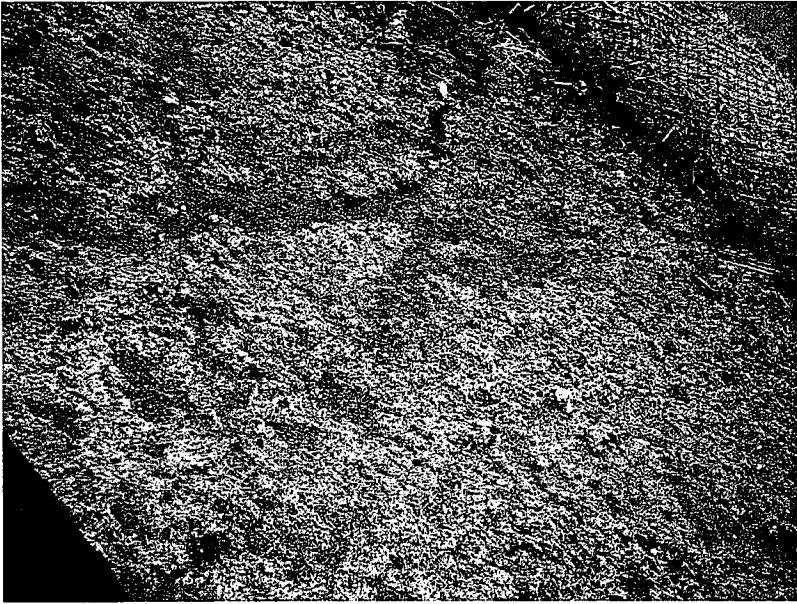
712. A closer look at the erosion control on the banks shows the inconsistent application.

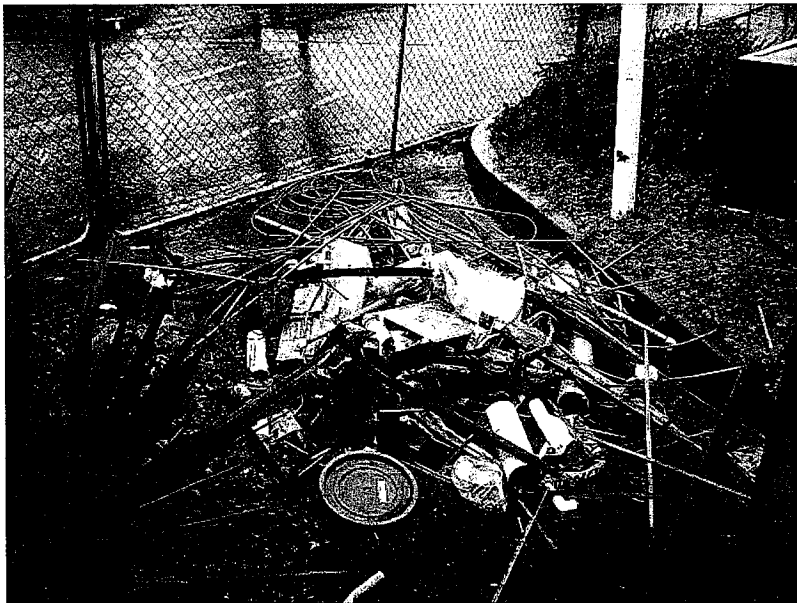
713. Construction trash left exposed to storm water.

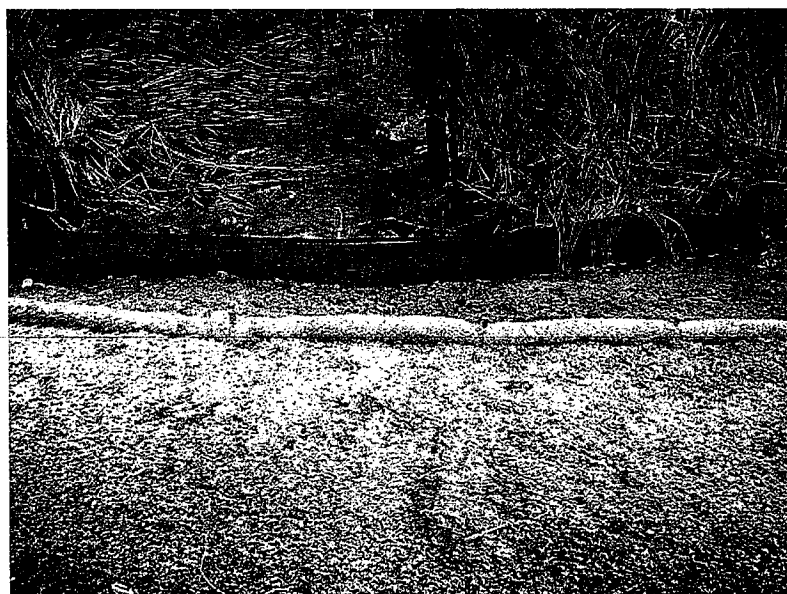
714. A light application of erosion control spray on the bank above Loma Alta Creek.

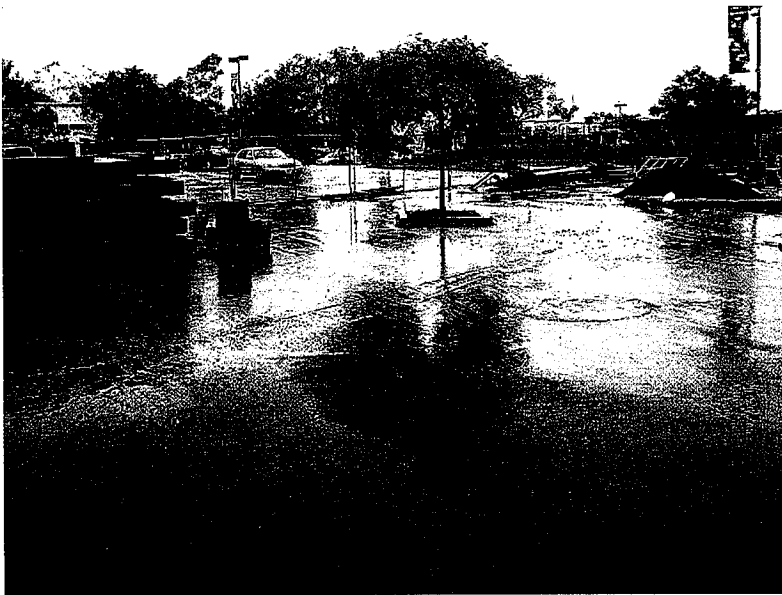
715. Sediment has not been swept up prior to rainfall on a parking lot used as a staging area for construction.

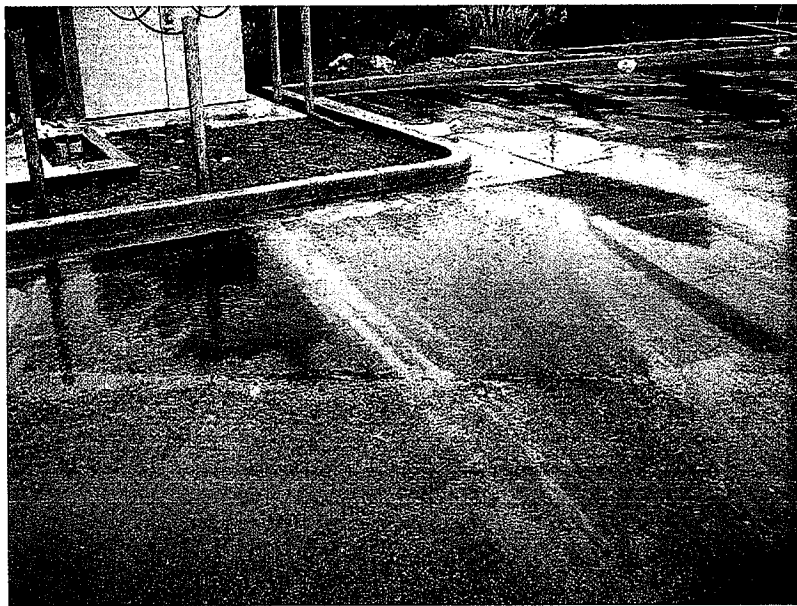
716. Another look at sediment on the parking lot that has not been swept up.

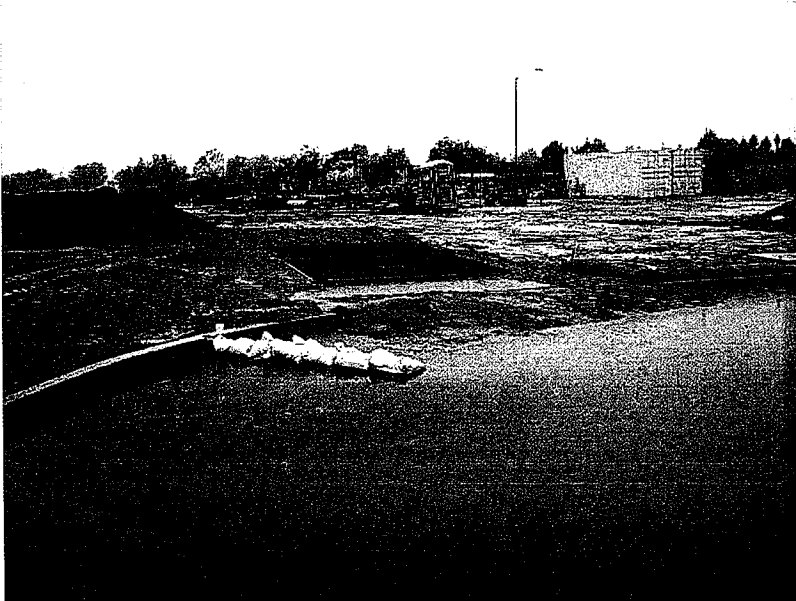
719. Gravel bag chevron has been deployed. Shaker plates and rock has been implemented at the construction exit. This was in response to deficiency noted on Tuesday, Nov. 27, 2007.

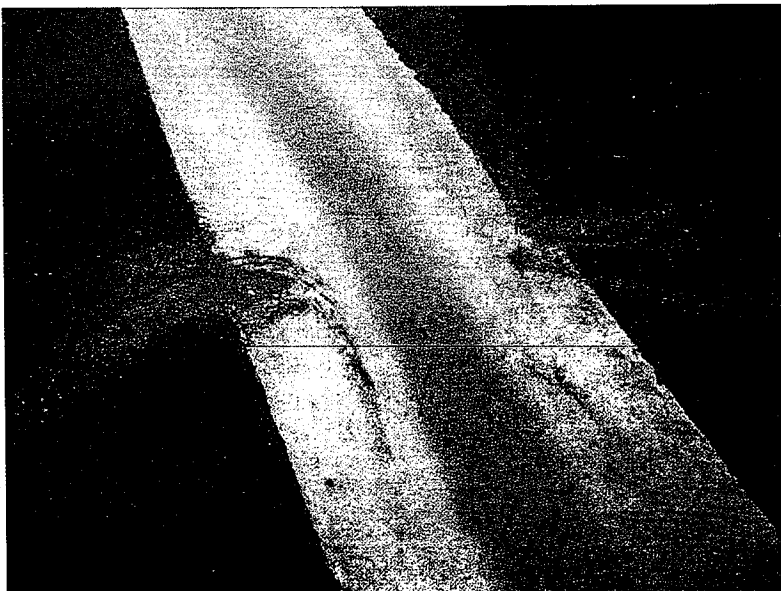
720. Sediment laden storm water in the parking lot drainage swale.

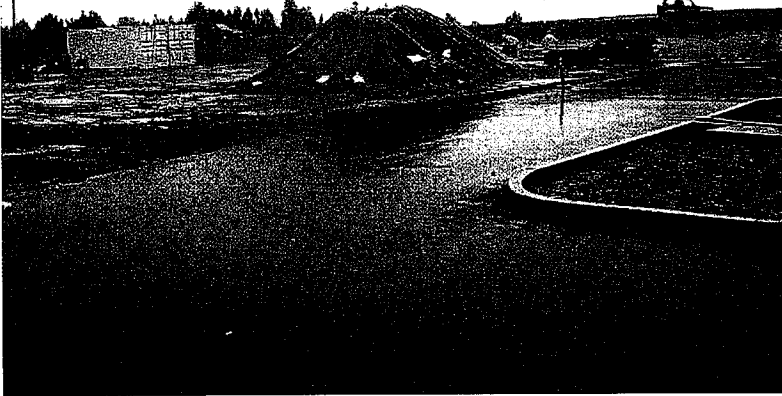
721. Soil stockpile has been covered. This was in response to deficiency noted on Tuesday, November 27, 2007.

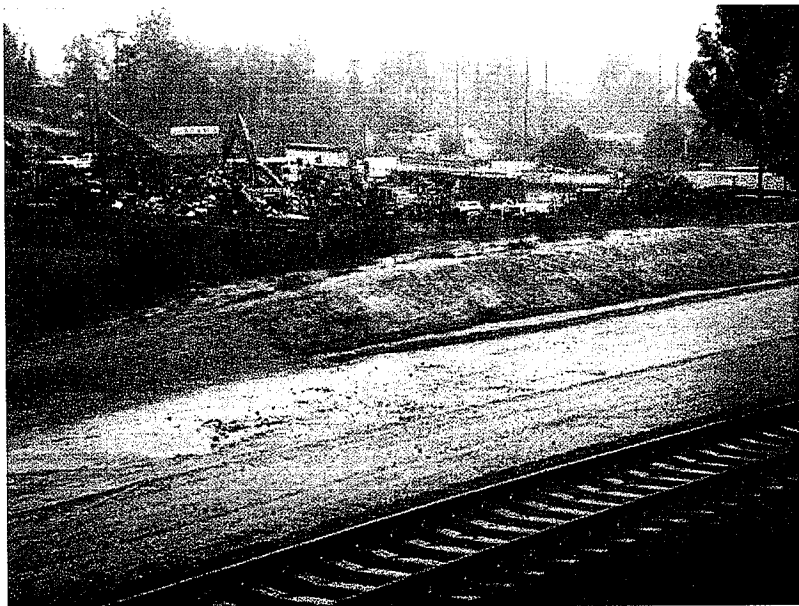
722. Erosion control stops along this slope.

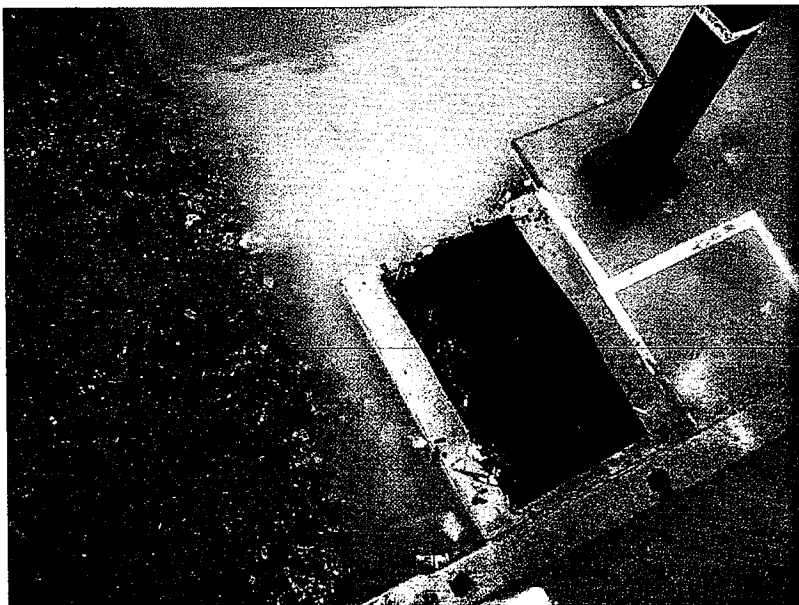
723. Storm drain inlet has been protected with filter fabric. This was in response to deficiency noted on Tuesday, Nov. 27, 2007.

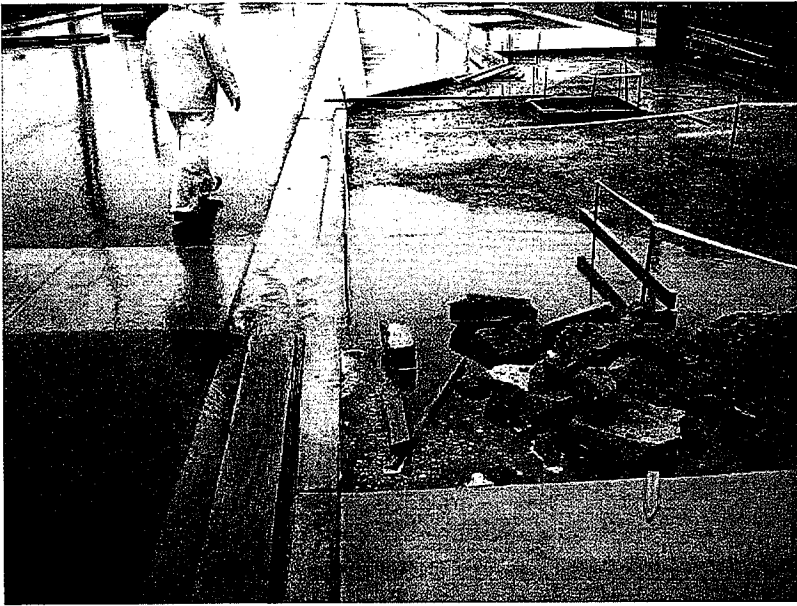
724. Source of sediment entering storm water in photo 720.

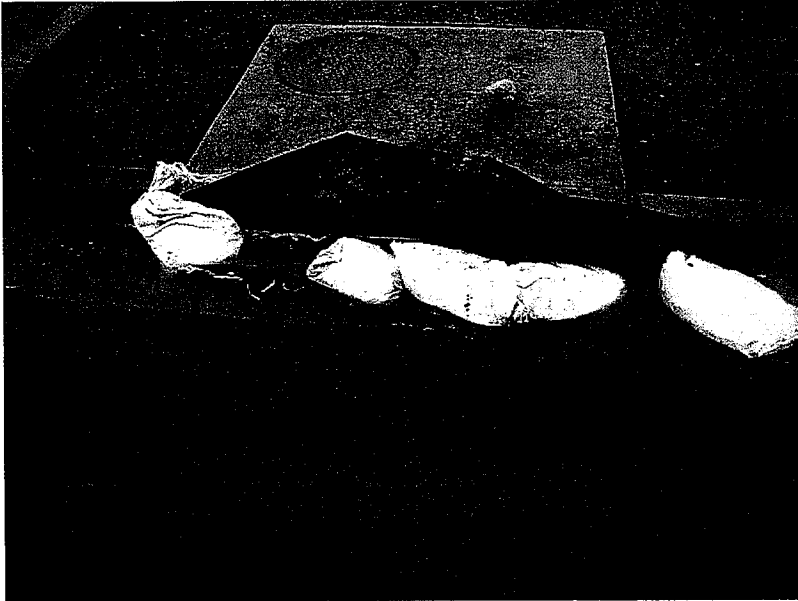
725. Storm drain inlet in need of maintenance.

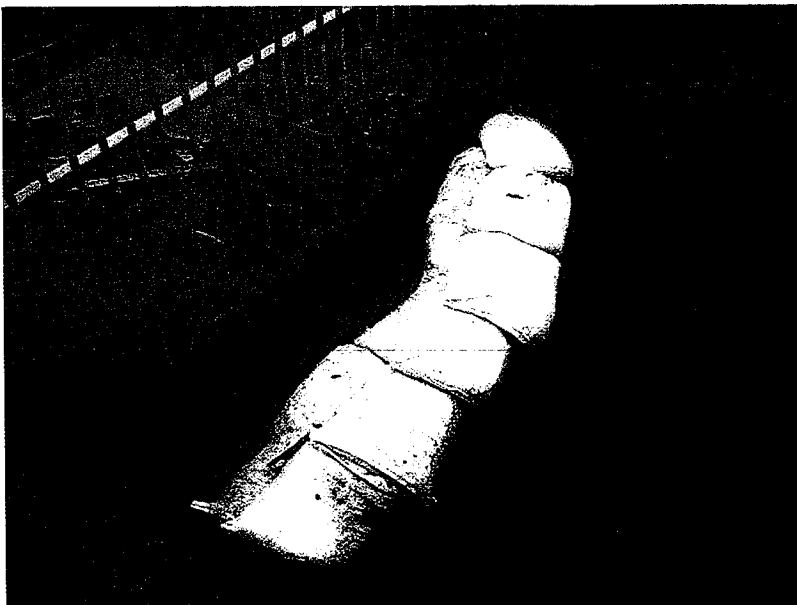
726. A protected storm drain inlet.

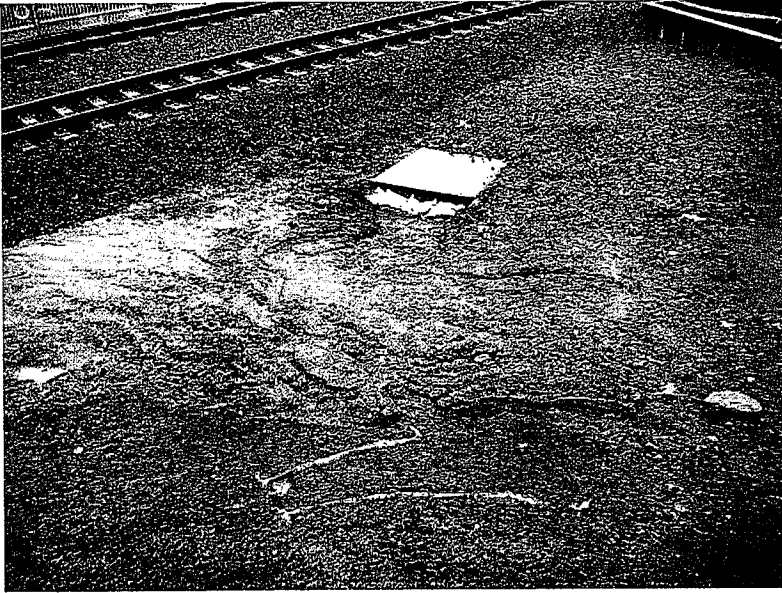
727. Storm drain inlet is blocked off with gravel bags. No ponding water suggests that storm water flowed elsewhere.

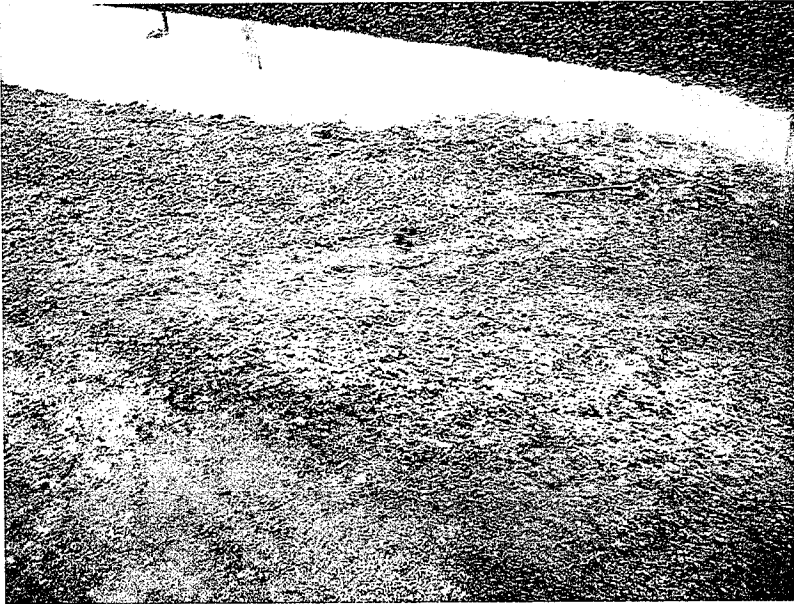
728. Erosion control sprayed along the slope is a light application.

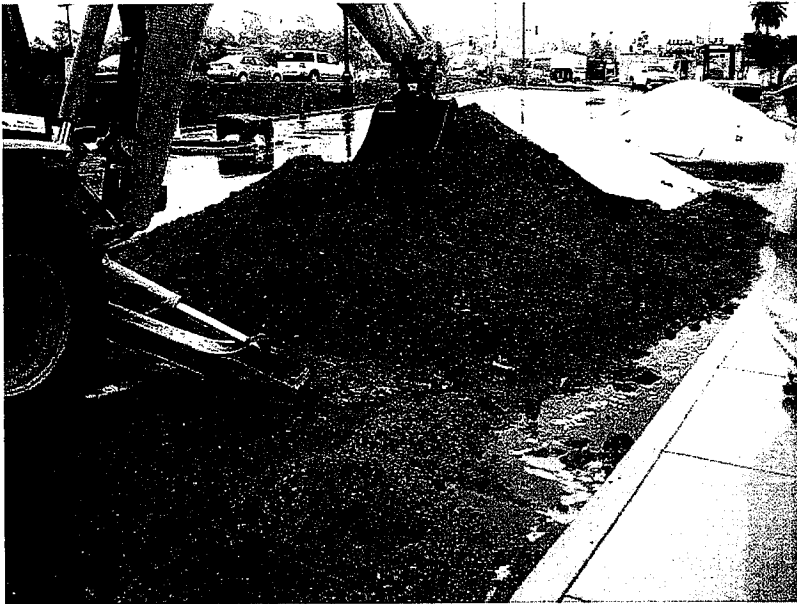
730. Soil stockpile is not covered or protected from storm water.

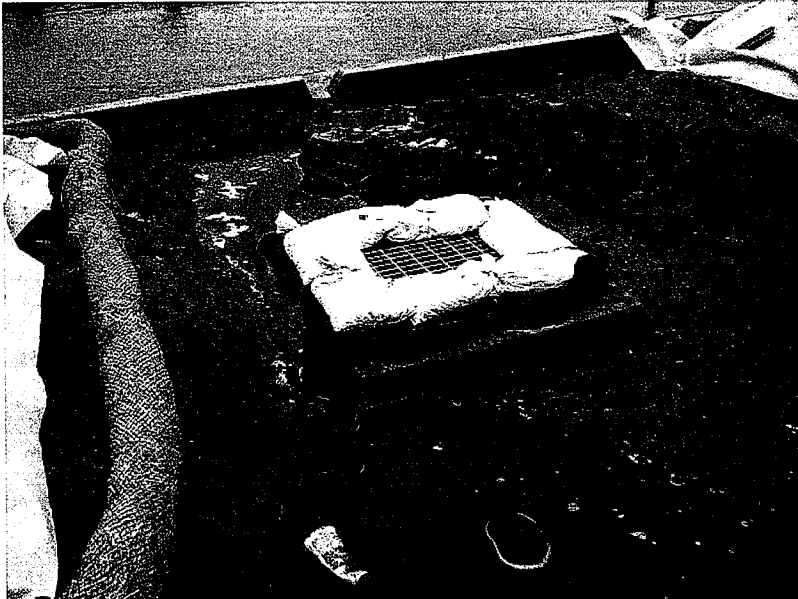
731. Storm drain inlet is protected.

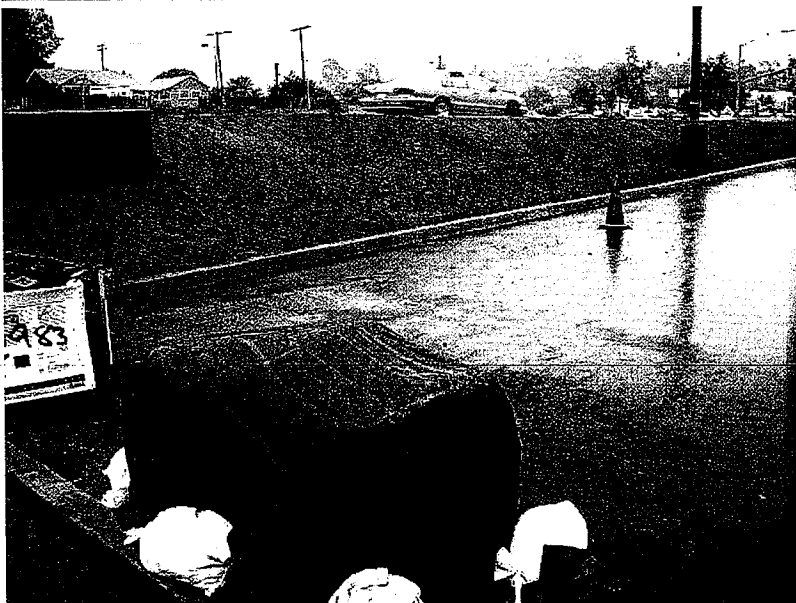
732. Construction materials are covered. The slope is sprayed with erosion control.

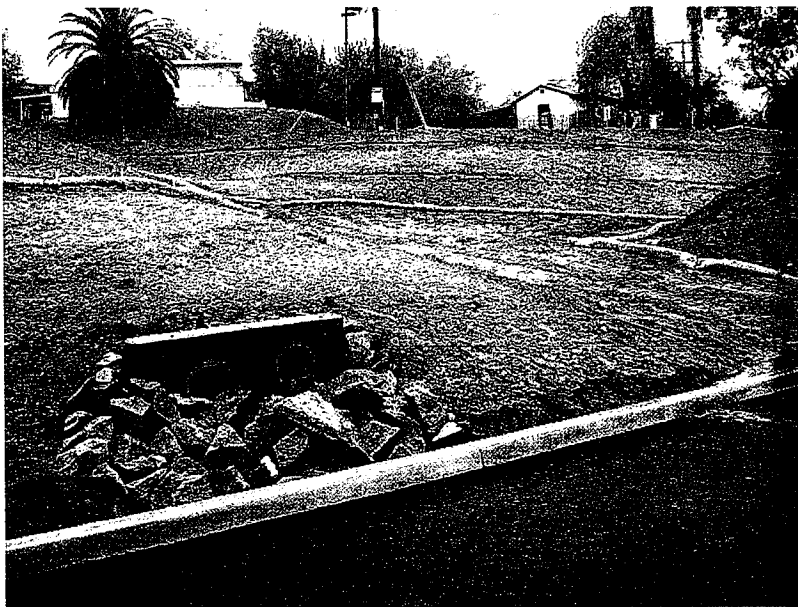
735. Slopes around the station have been sprayed with erosion control and fiber roll was implemented.

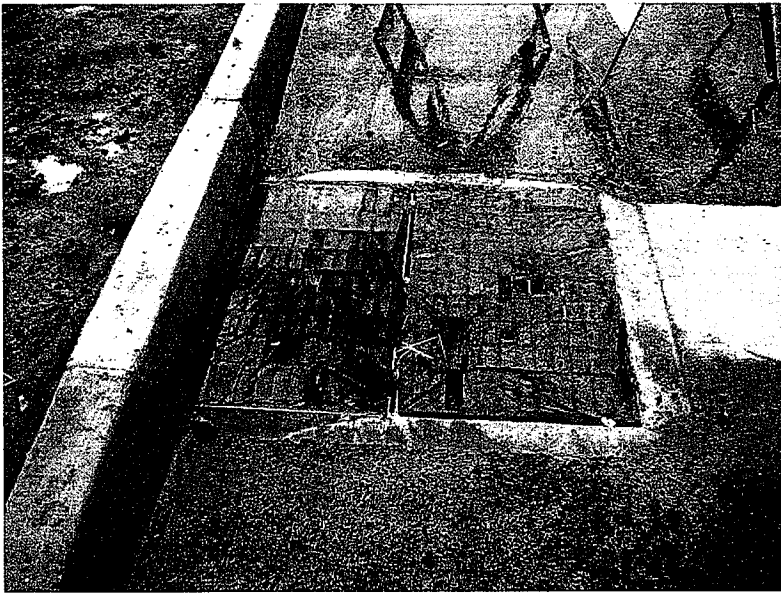
736. Filter fabric alone failed as storm drain inlet protection.

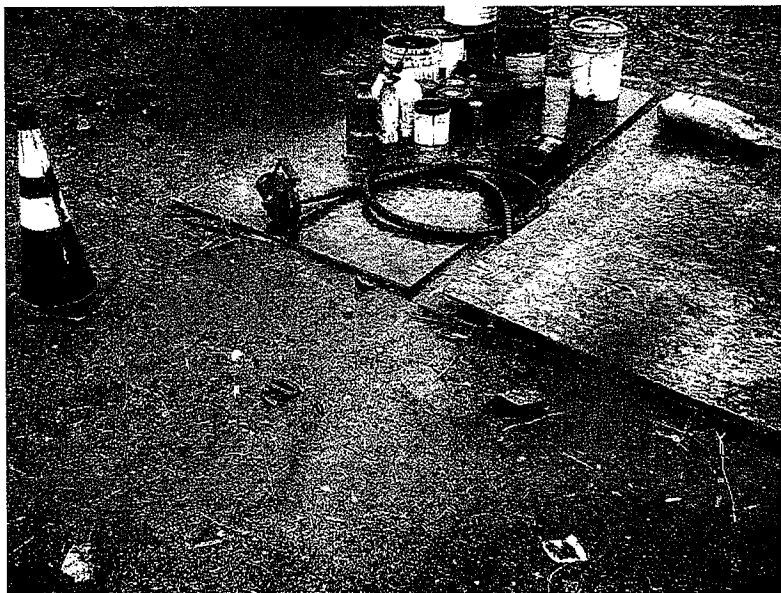
739. Construction materials left out in the rain give off a rainbow sheen of pollutants in the runoff.

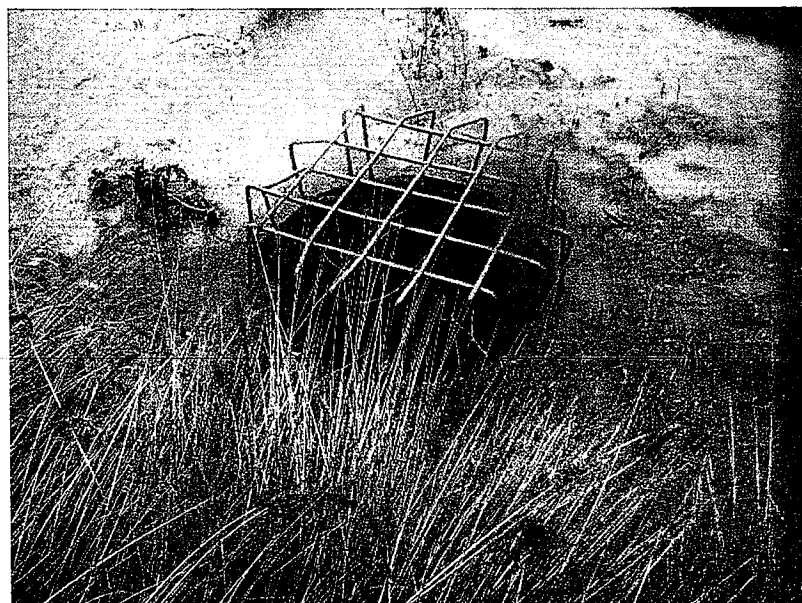
740. Storm drain inlet with no protections. Sediment laden water is discharging into the inlet.

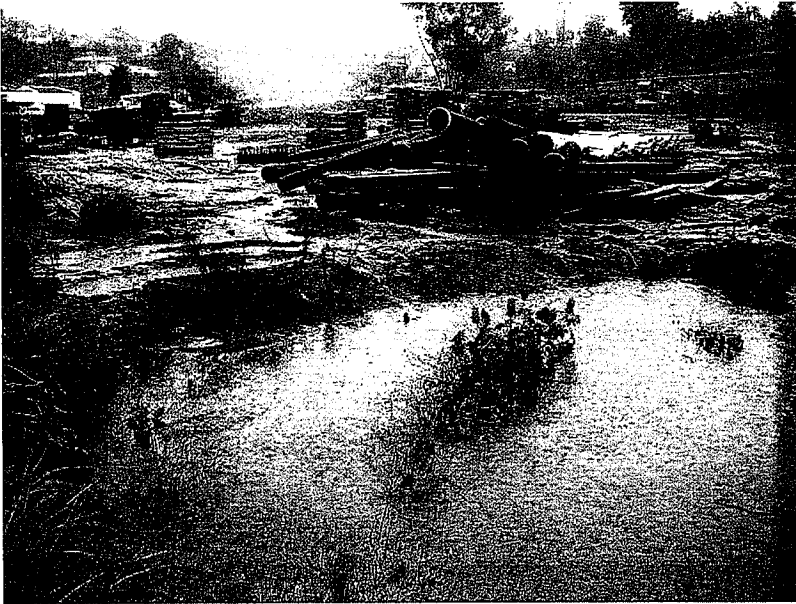
741. Runoff from the construction storage yard leading to the unprotected storm drain inlet in photo 740.

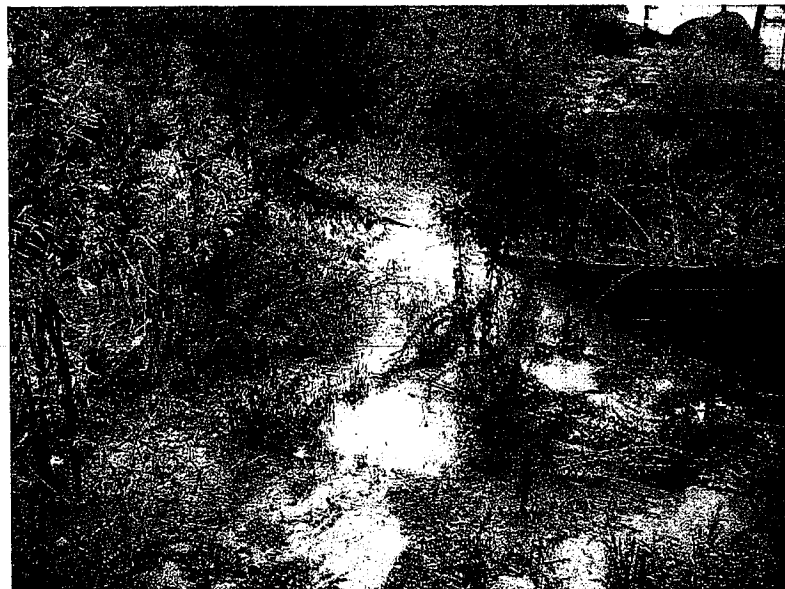
743. Silt fence failing from the sediment laden water in photo 742.

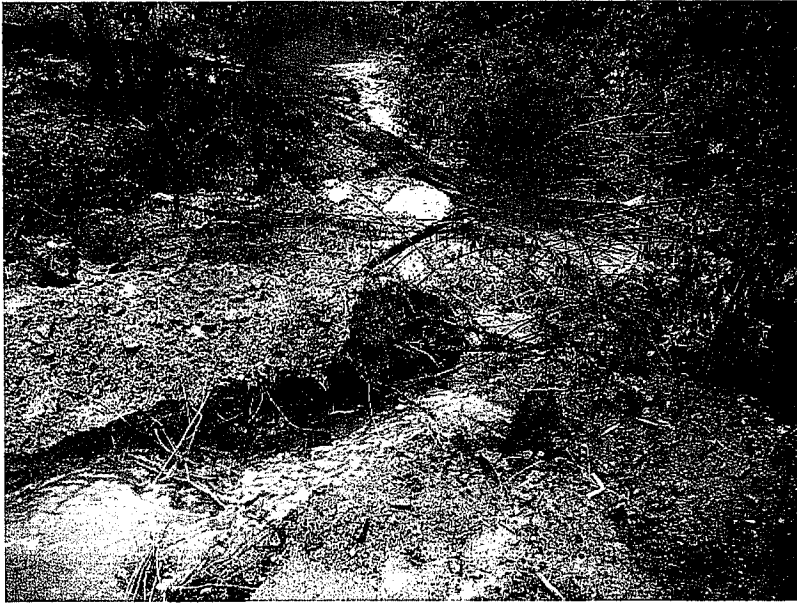
744. Gully erosion and silt fence failing from the sediment laden water.
