**CALIFORNIA REGIONAL WATER QUALITY CONTROL BOARD - SAN DIEGO REGION
WATERSHED MANAGEMENT PROGRAM**

FACILITY INSPECTION REPORT

Sprinter Rail Project
FACILITY OR DEVELOPER NAME (if different from owner)

FACILITY: __North County Transit District Sprinter Rail_ (WDID)_9 37C322900__ INSPECTION DATE: _11/30/07__

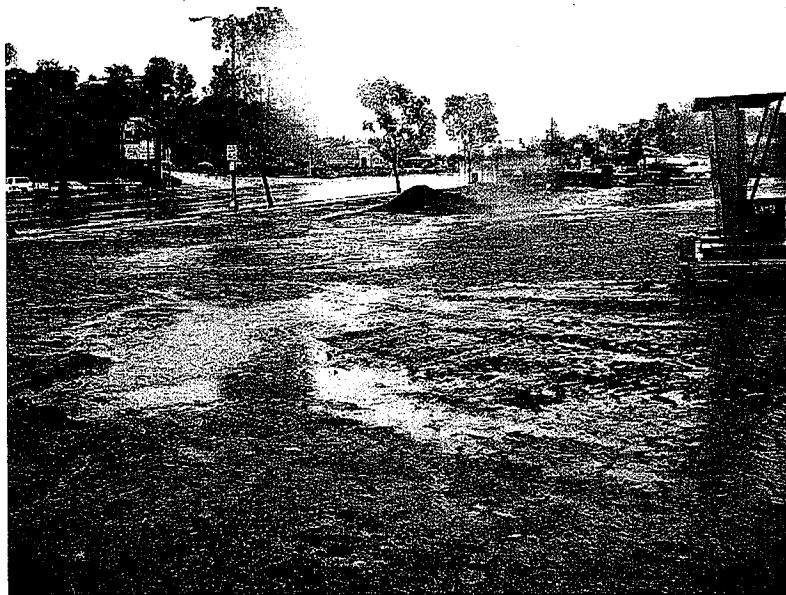
745. Sediment laden water flowing across the construction storage yard to the inlet in photo 746.

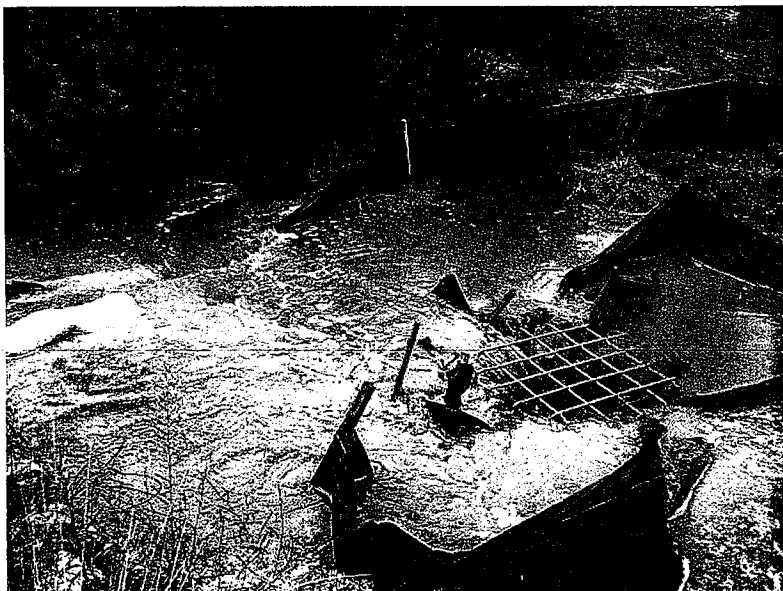
746. Discharge of sediment laden water to a storm drain inlet. Silt fence failed.

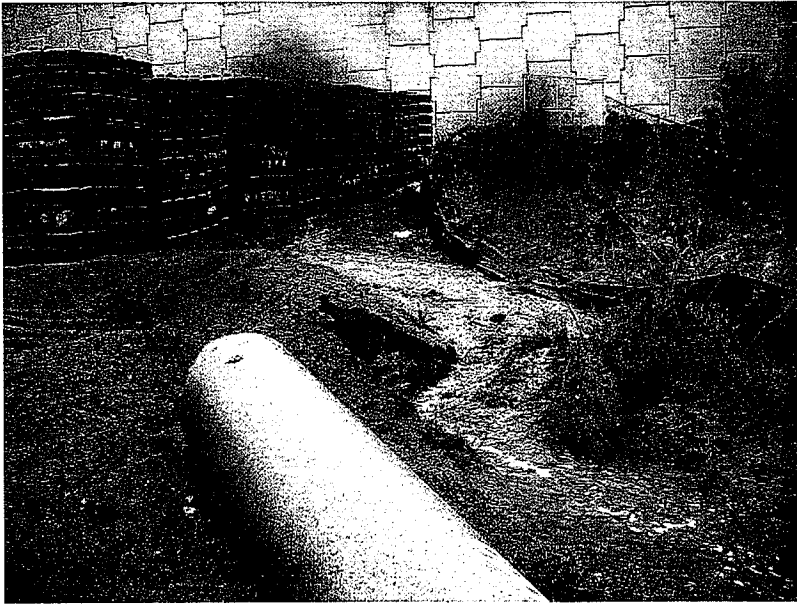
748. Runon from offsite flows through the construction storage yard picking up sediment. Sediment laden water flowing through the construction storage yard.

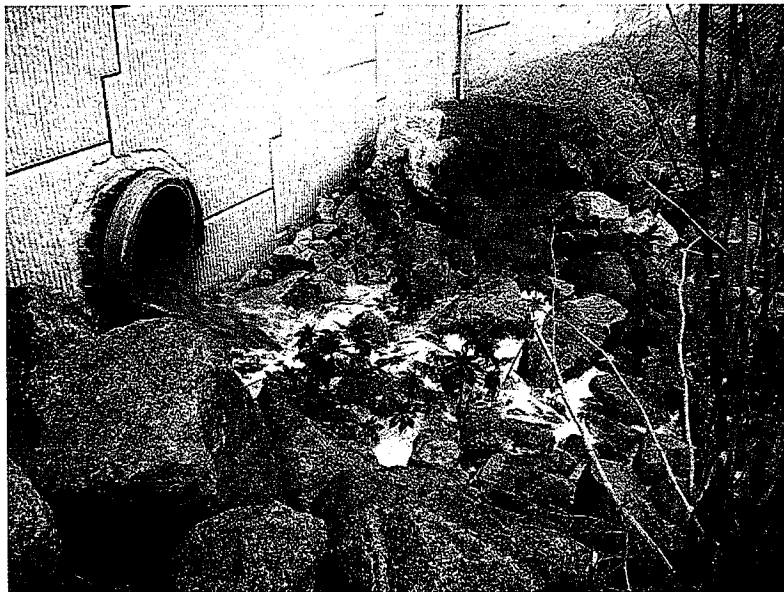
749. Storm water run on not addressed to prevent contact with disturbed soil areas in the construction storage yard.

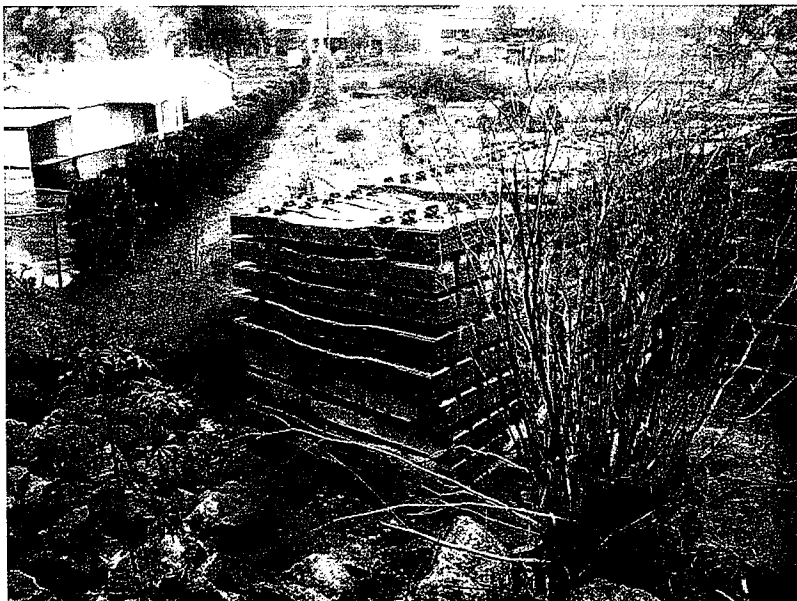
750. Run on from photo 749 flows through the construction storage yard.

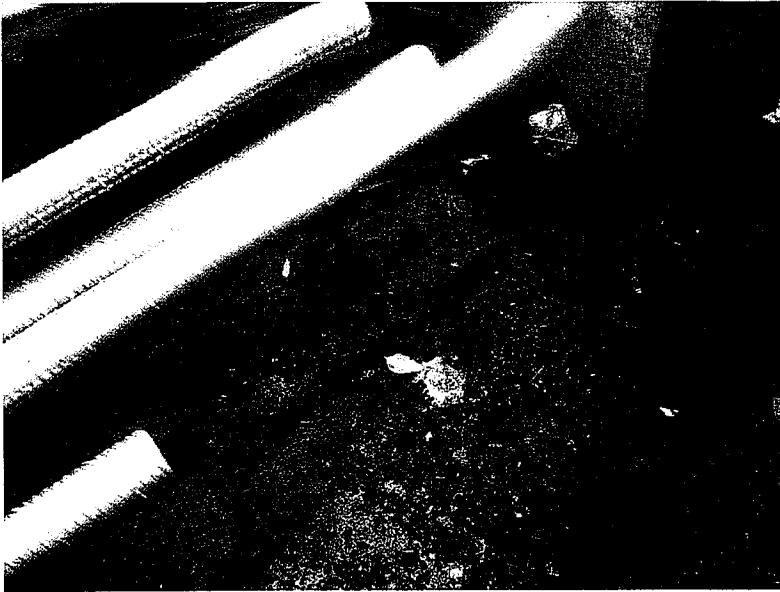
752. Construction materials are staining the storm water fluorescent blue.

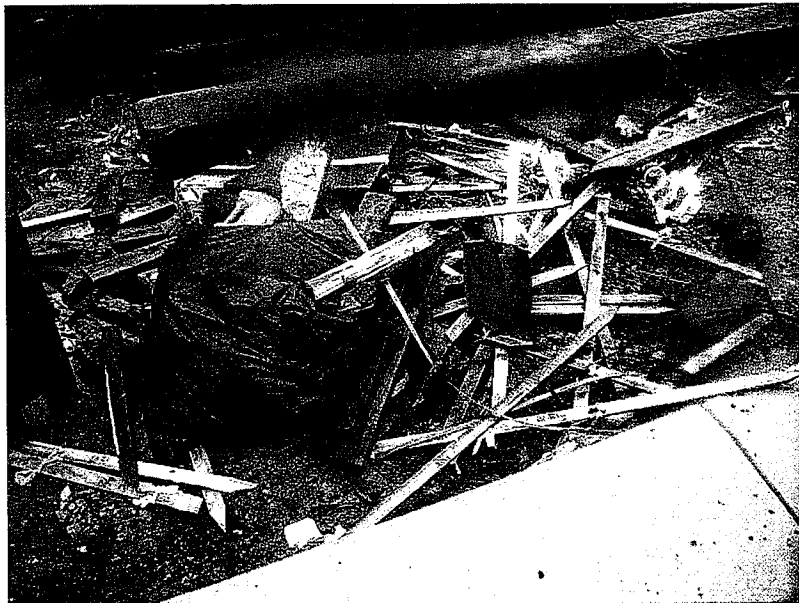
753. Construction waste stored outside without cover or containment to prevent contact with storm water.

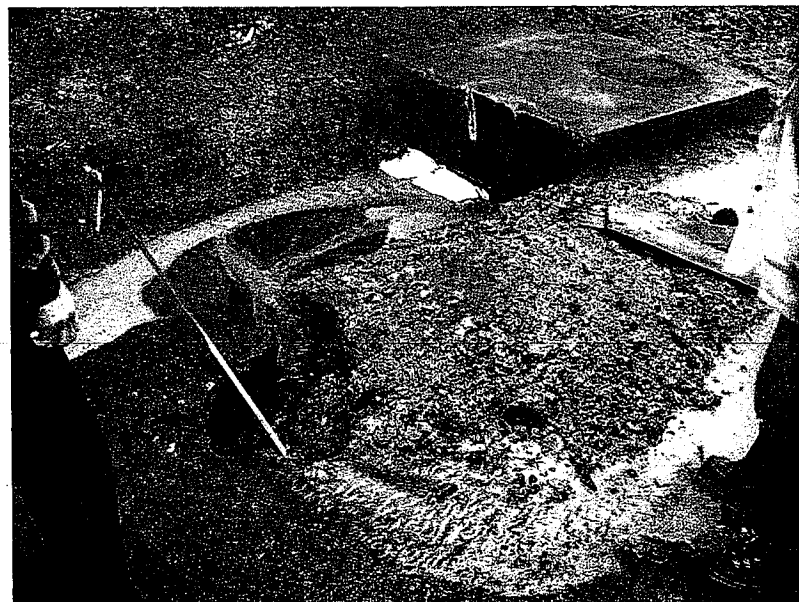
754. Storm drain inlet does not have adequate controls. Sediment laden water and sediment are discharging into the inlet.

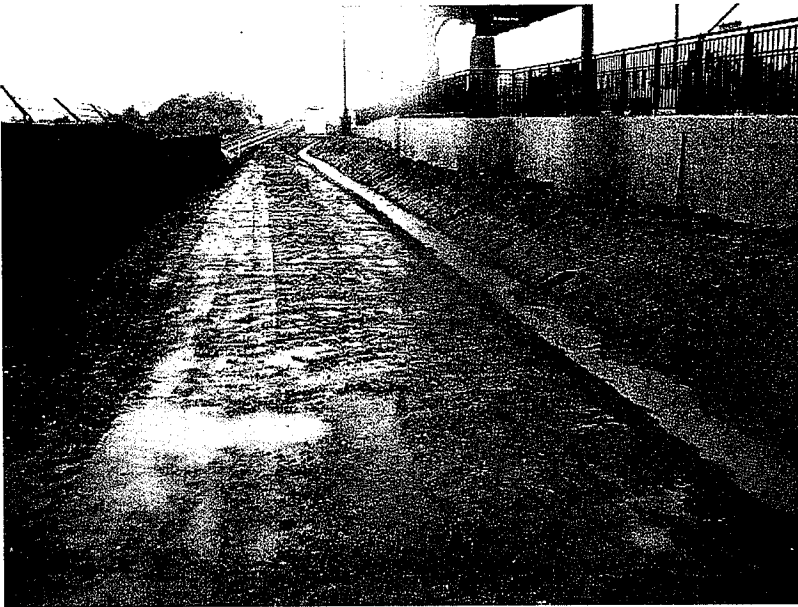
756. Unlined dirt channel leading to the inlet in photo 754 is running with sediment laden water.

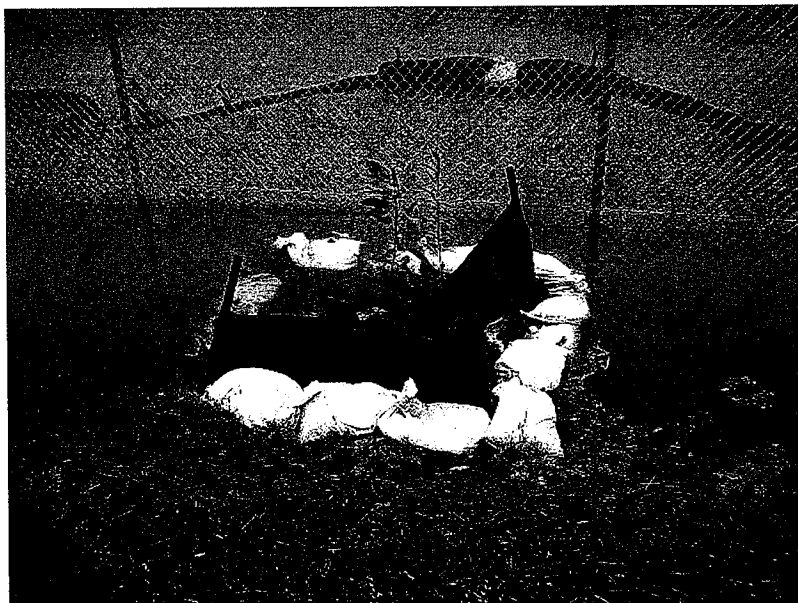
757. Storm drain inlet protection is over topped and sediment laden water is discharging into the inlet.

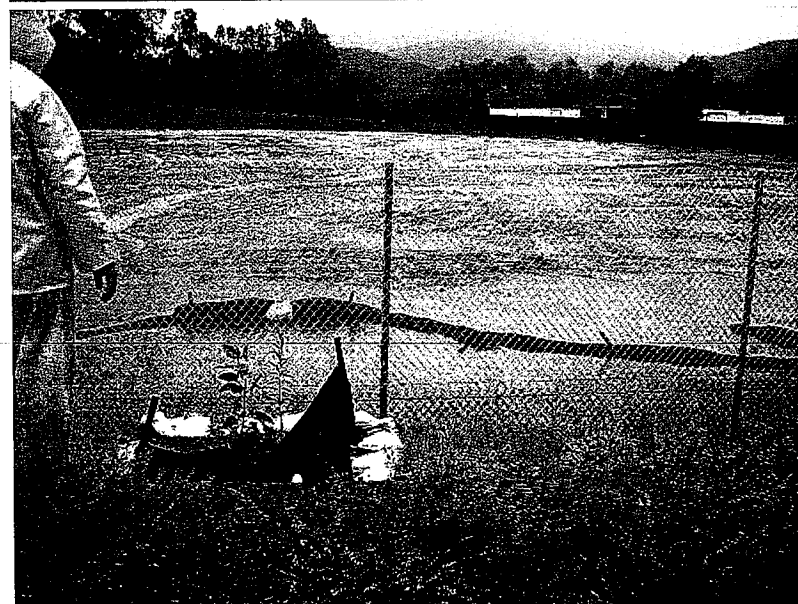
758. Another view of the inlet in photo 757 shows a large amount of disturbed soil around the inlet.

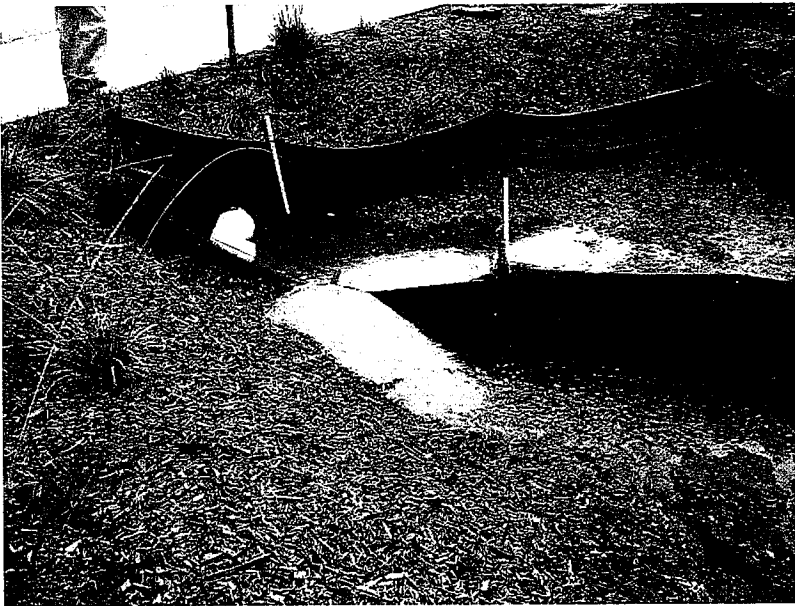
760. Sediment laden water discharging into storm drain inlet.

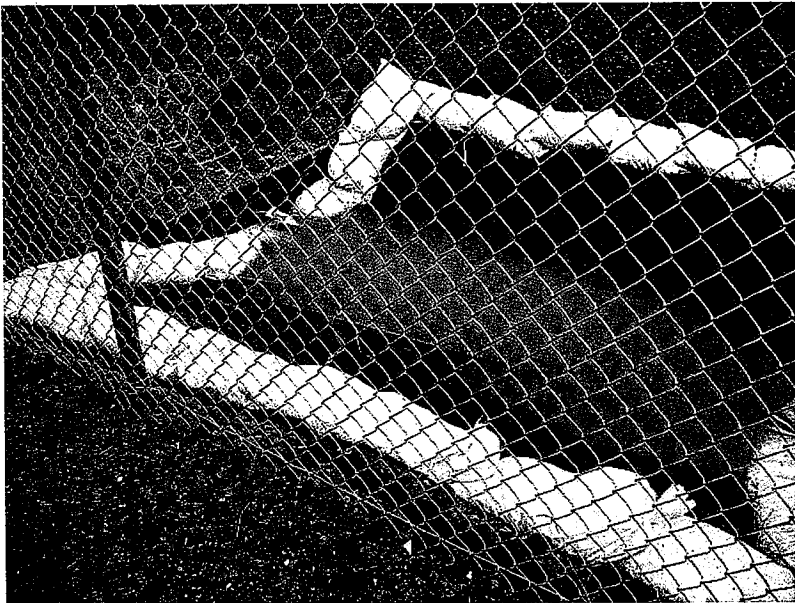
761. Sediment laden water discharging into storm drain inlet.

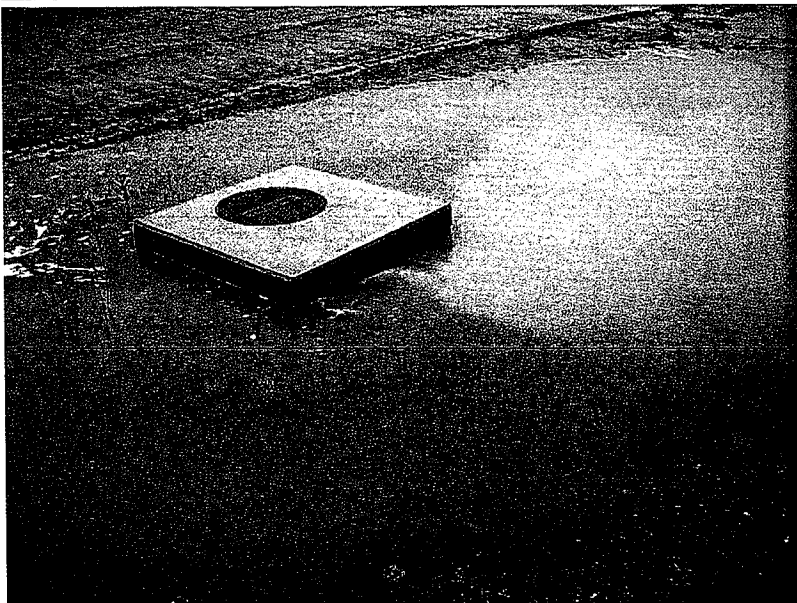
762. Sediment laden water discharging into storm drain inlet.

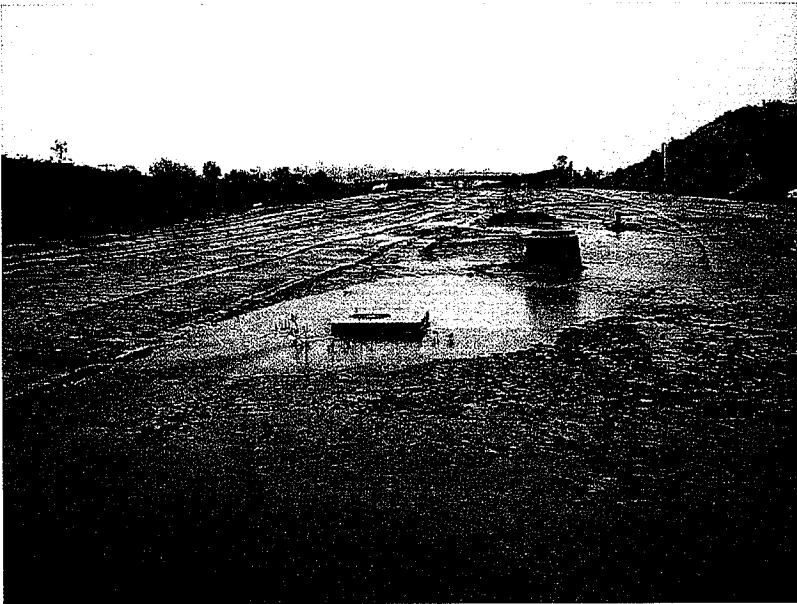
763. Another view of the inlet in photo 762 shows the large expanse of disturbed soil surrounding the inlet without soil stabilization.

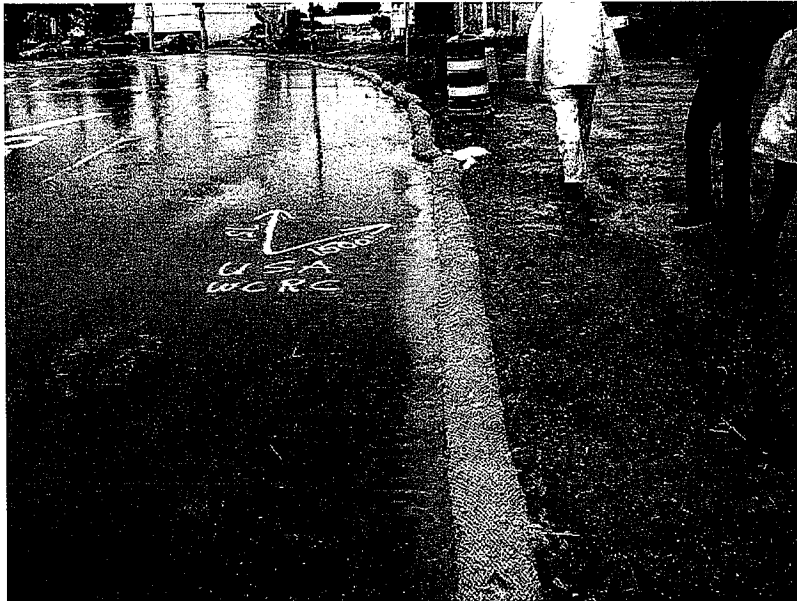
764. Sediment laden water is discharging from the site to the gutter. Fiber roll is not trenched and is ineffective.

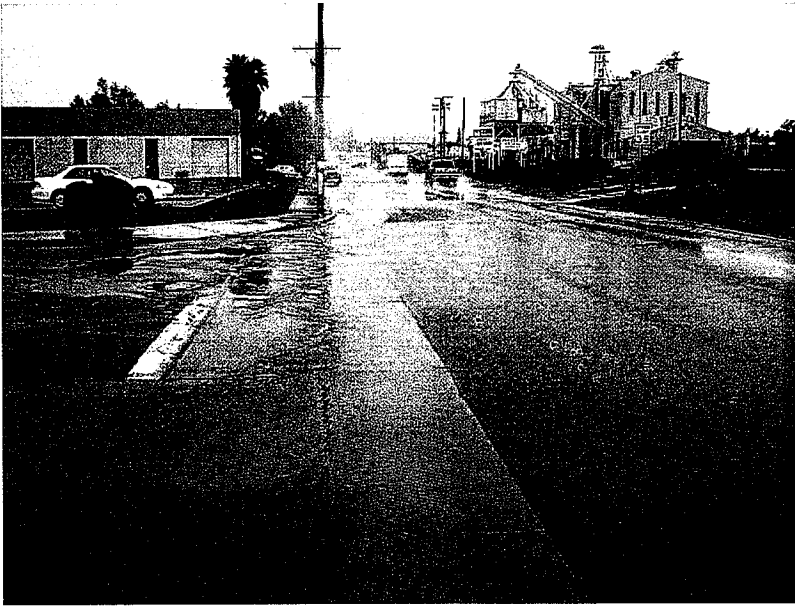
766. The sediment laden water in photos 765 and 764 flows down the street's gutter.

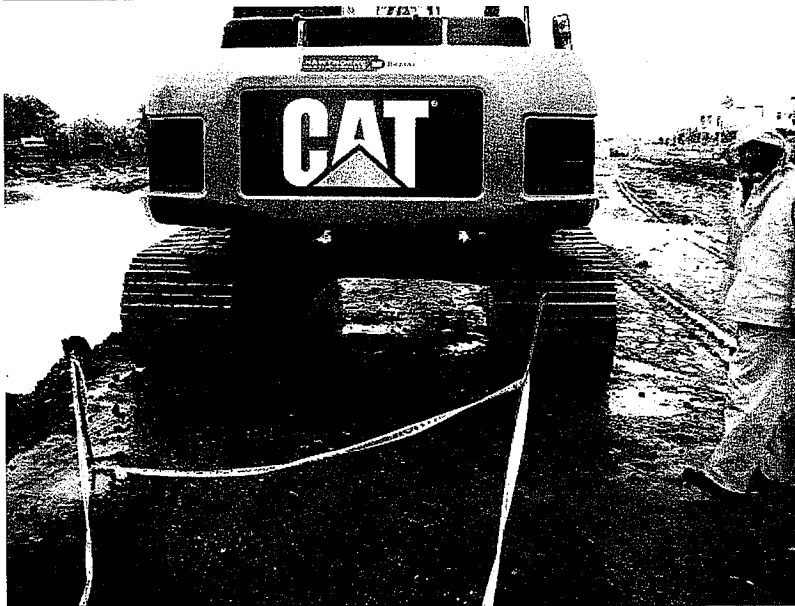
770. Construction equipment is stored without drip pans. No drip pans were present under any construction equipment. This is just one example.

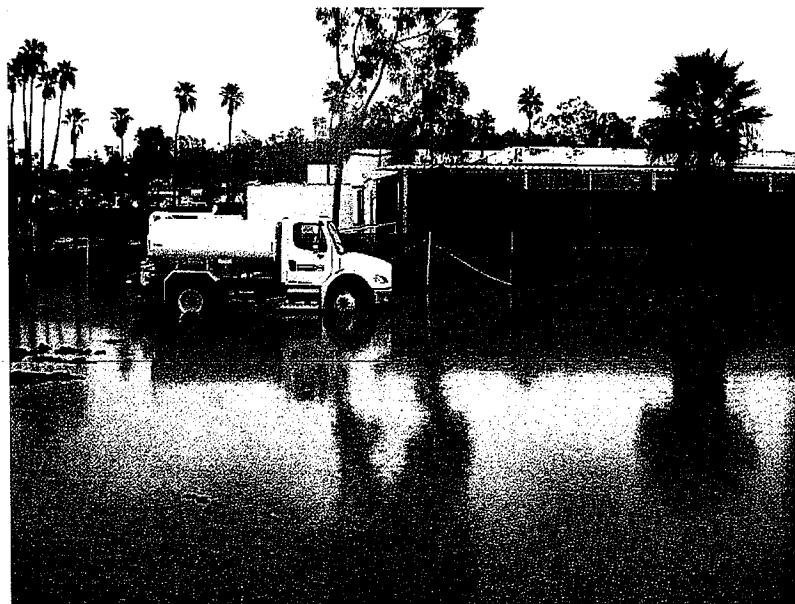
772. A water truck was improperly stored in a low area that ponds storm water.
