**CALIFORNIA REGIONAL WATER QUALITY CONTROL BOARD - SAN DIEGO REGION
WATERSHED PROTECTION PROGRAM**

FACILITY INSPECTION REPORT

FACILITY: Casa Mira View **INSPECTION DATE/TIME:** 10/25/2010; 1330

WDID/FILE NO.: 9 37C353628

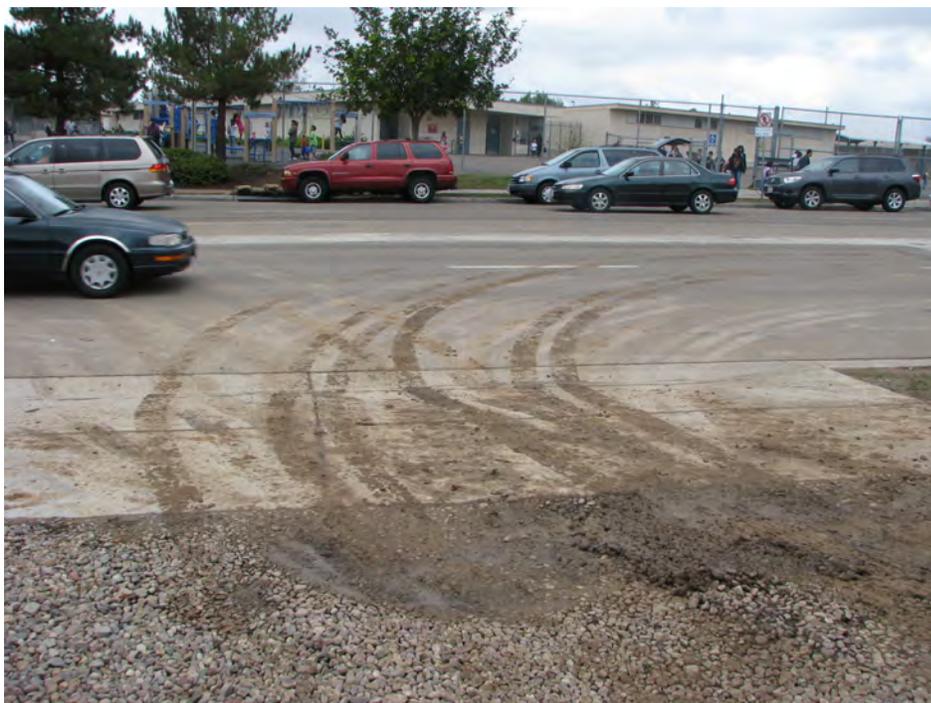
Figure 1. Construction site entrance

Note sediment on street. Gravel BMP in poor condition and in need of maintenance.

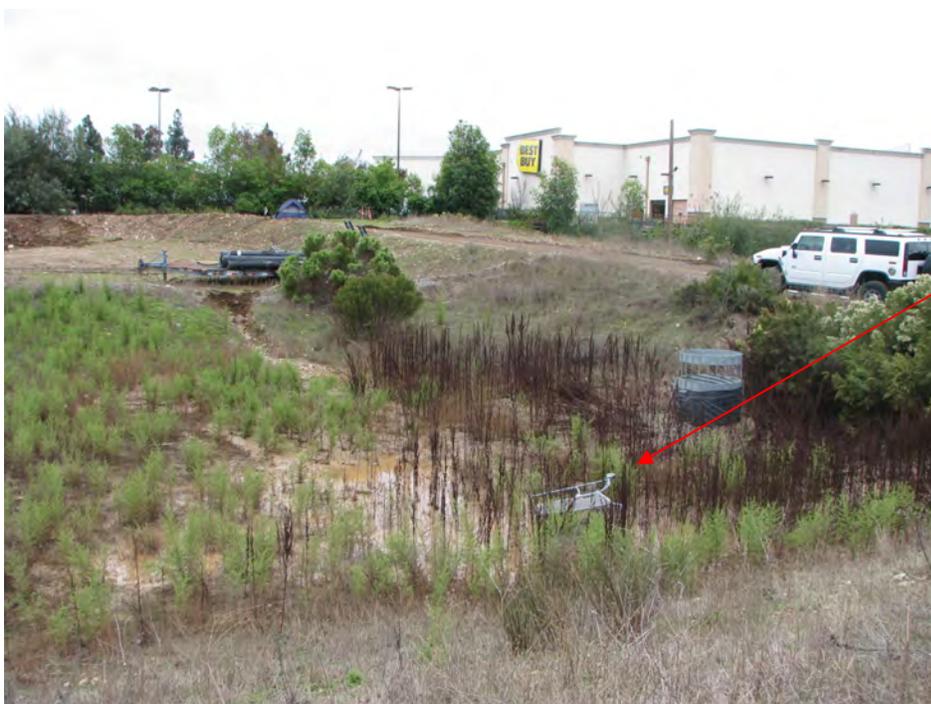
Figure 2. Desilting basin inside project boundaries

Shopping cart in desilting basin should be removed.

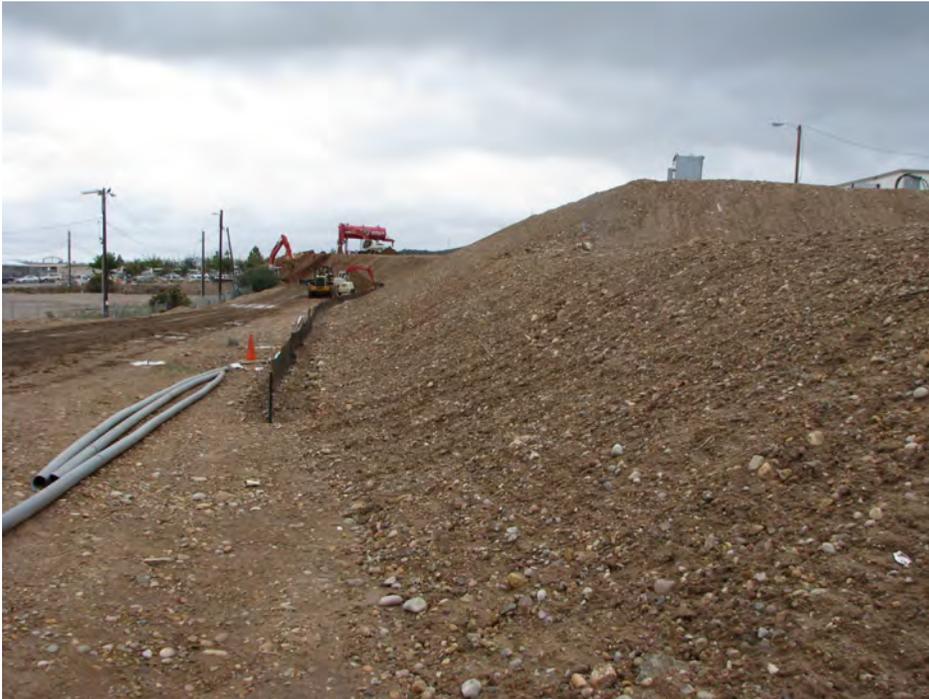
Figure 3. Uncovered slope (inside property)

Erosion control measures must be applied to slopes.

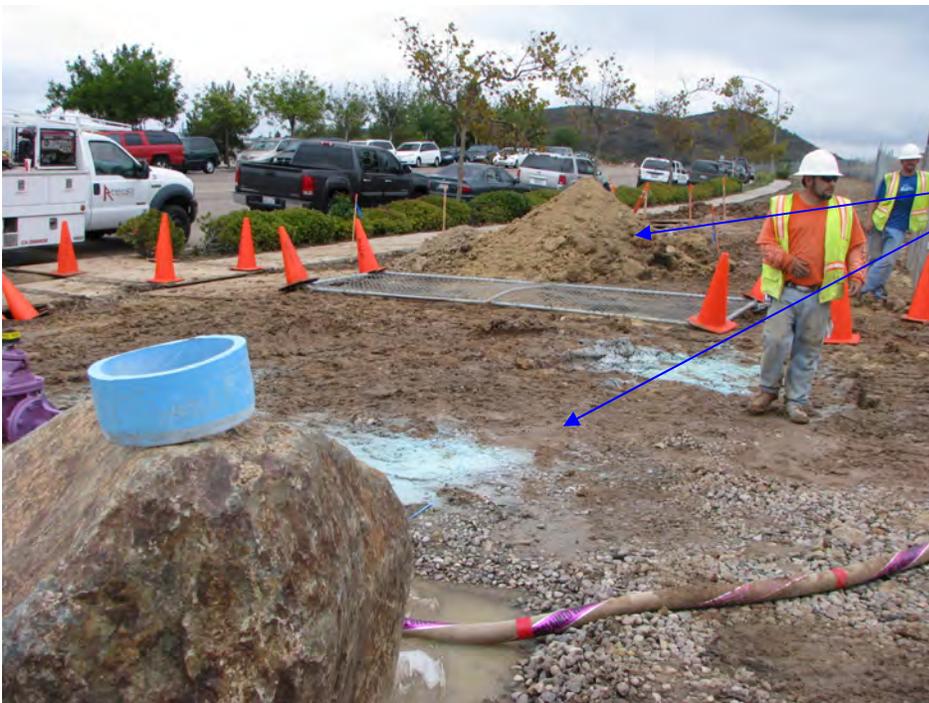
Figure 4. Project site at street level

Note uncovered stockpile and blue dust from pipe cutting

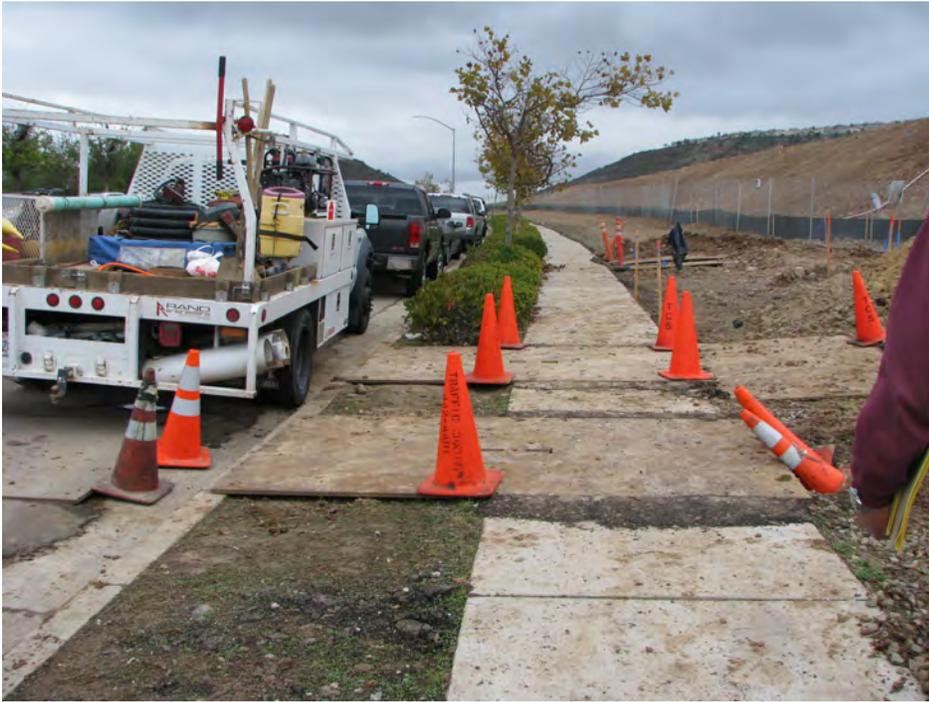
Figure 5. Sidewalk adjacent to project site

Project sediment is on sidewalk and street.

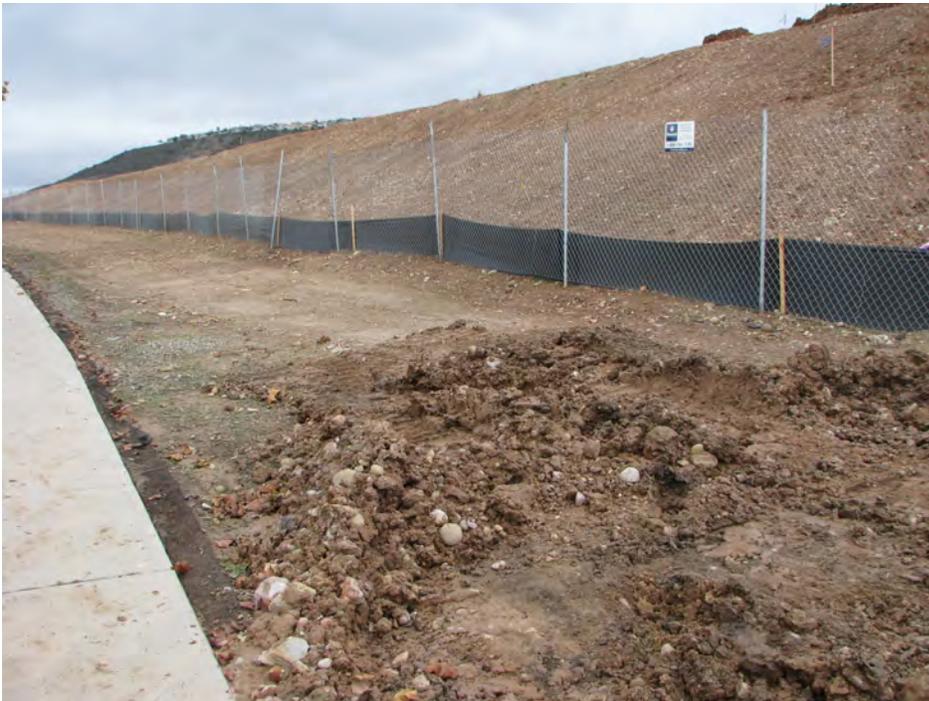
Figure 6. Slope and project material at perimeter

Slopes on West side (perimeter) of site have no erosion control BMPs. Also, disturbed sediment near sidewalk should be covered or removed.

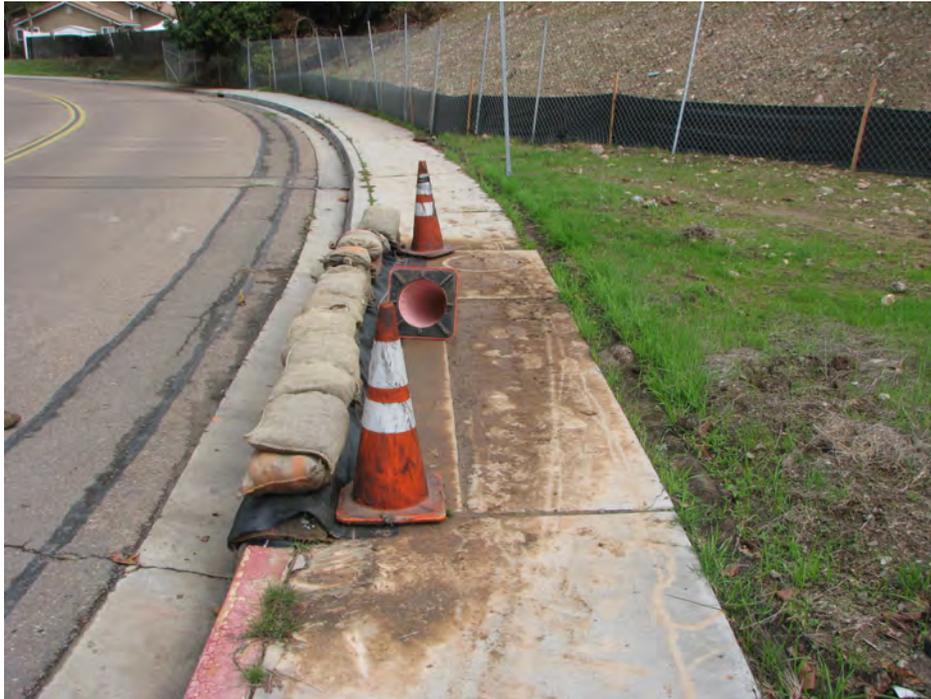
Figure 7. Storm drain inlet at North side of property

Area near storm drain inlet should be swept.

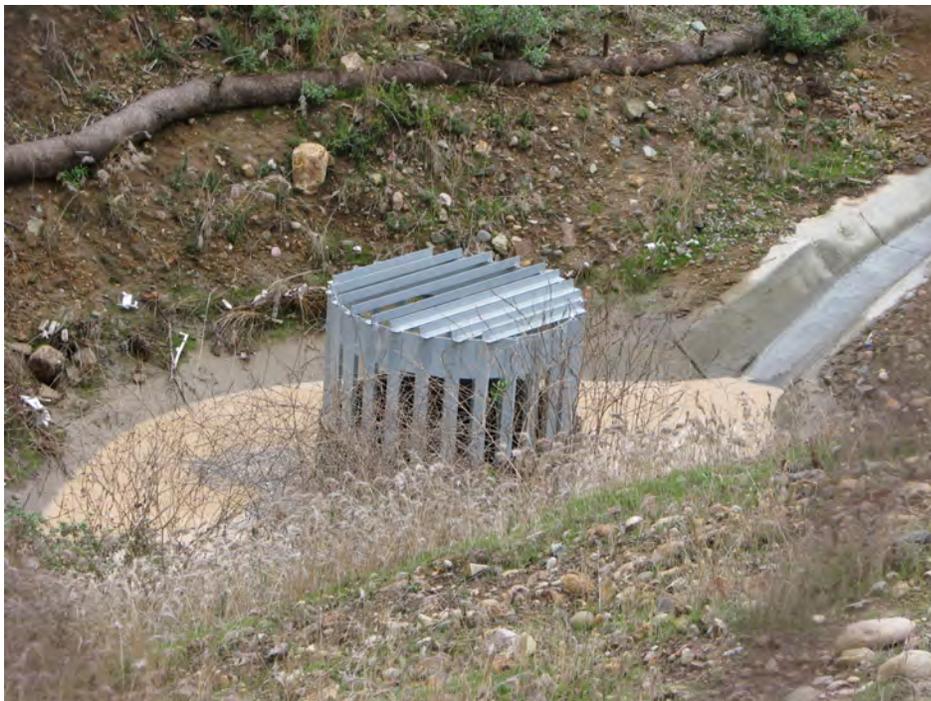
Figure 8. Storm drain on Caltrans right of way (East side project boundary)

Riser pipe is wrapped with filter fabric. Note turbid water surrounding pipe entering via concrete swale.

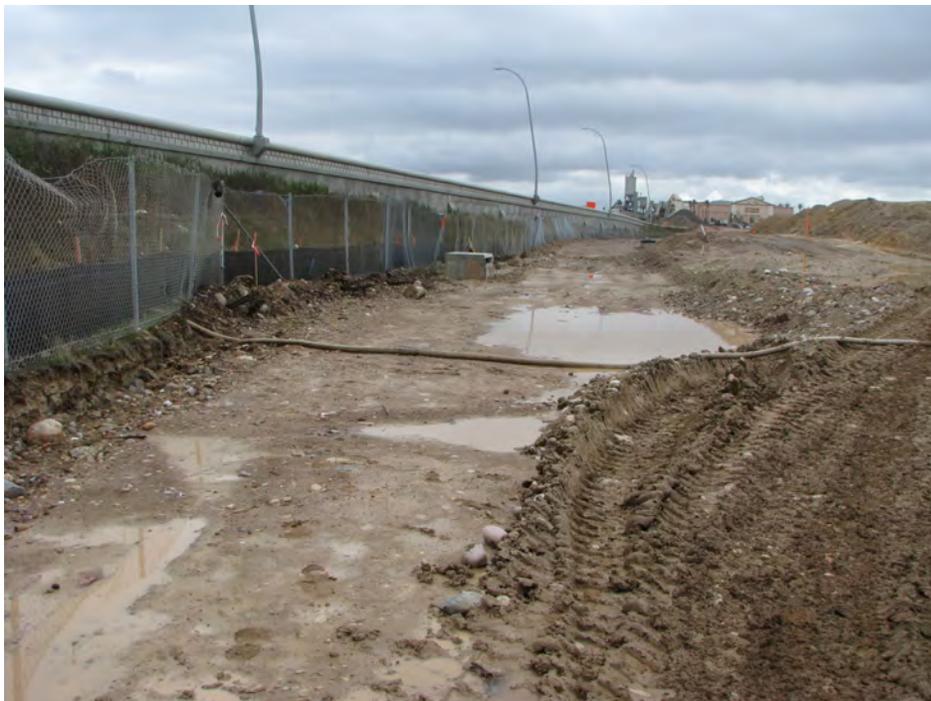
Figure 10. Pipe leading off property (from pump)

Pipe from project site was placed through chain link fence to concrete swale.
