**CALIFORNIA REGIONAL WATER QUALITY CONTROL BOARD - SAN DIEGO REGION
WATERSHED PROTECTION PROGRAM**

CONSTRUCTION INSPECTION

Development: Paseo Pointe

Inspection Date: 03/05/2014

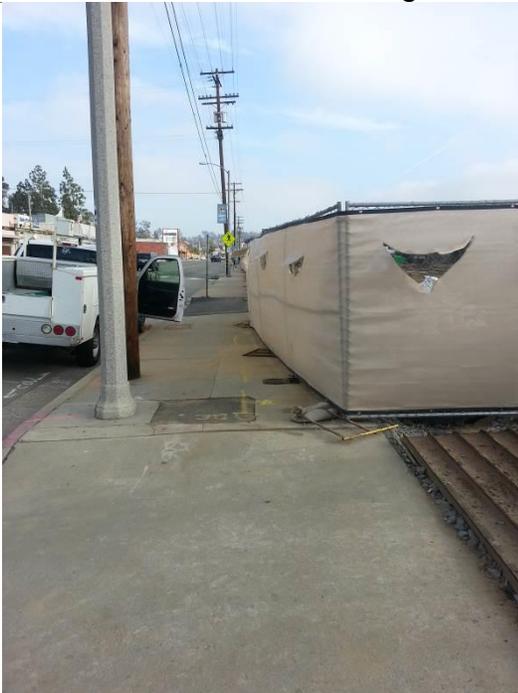
As seen in Figures 2, 4 and 5, sufficient erosion and sediment control BMPs were not installed throughout the Site prior to the rain event that began on February 28, 2014. Sufficient erosion control and sediment control BMP materials were not stockpiled onsite and ready for deployment prior to the forecasted rain event. Failure to have the required erosion and sediment control BMPs properly installed prior to the rain event resulted in a discharge from the Site.

2. The discharger is in violation of Attachment D, provision F for failing to effectively manage all runoff within the Site and all runoff that discharges off the Site (see Figure 2-5, and 8).
3. The discharger is in violation of Attachment D, provision D.2, for failing to provide effective soil cover for inactive areas and all finished slopes, open space, utility backfill, and completed lots (see Figures 2-5, and 8).
4. The discharger is in violation of provision E.1 for failing to establish and maintain effective perimeter controls to sufficiently control erosion and sediment discharges from the site.
5. The discharger is in violation of Attachment D, provision E.3, for failing to implement sufficient erosion control BMPs (runoff control and soil stabilization) in conjunction with sediment control BMPs for areas under active construction (see Figures 2-5).

Figure 2: Site entrance show signs of sediment discharged from the site as evident by the sediment on the sidewalk

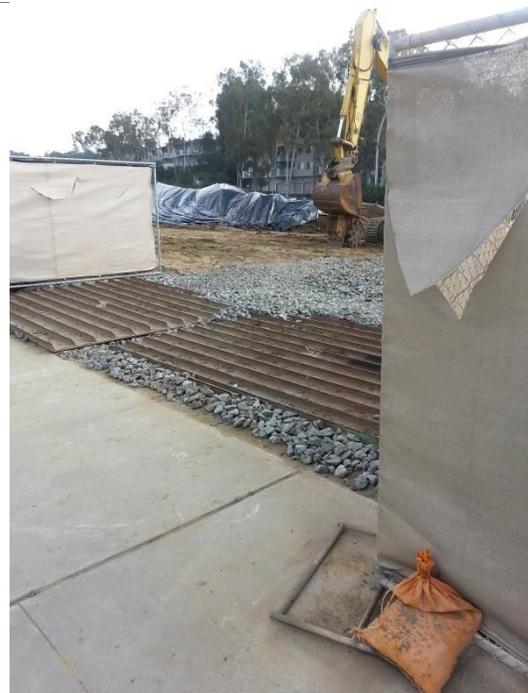
Figure 3: Site entrance tracking BMPs shown. Shaker plates and crushed rock.

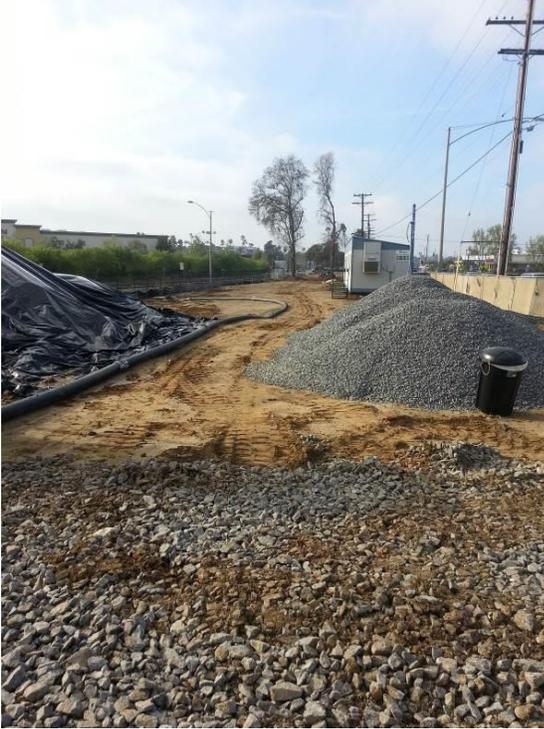
Figure 4: Looking south through the Site. No erosion control present on site.

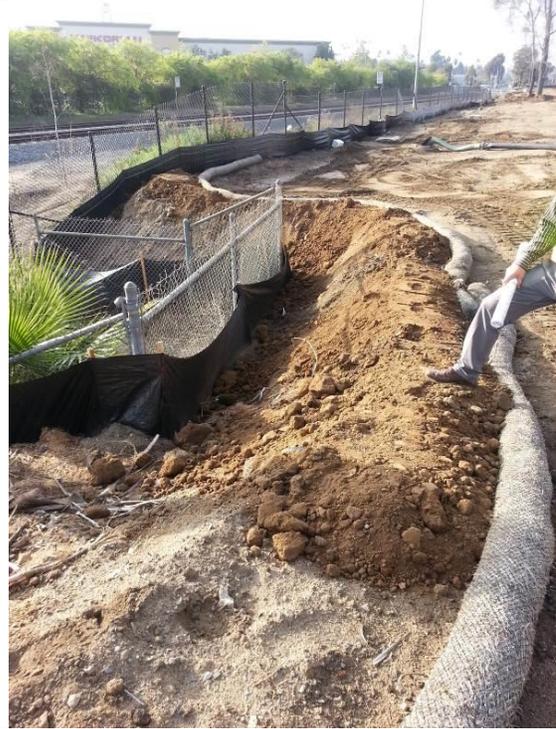
Figure 5: Looking west at the site. Fiber rolls resting on dirt, not staked in. Burms looked recently created and silt fence recently installed. No erosion control present at the site.

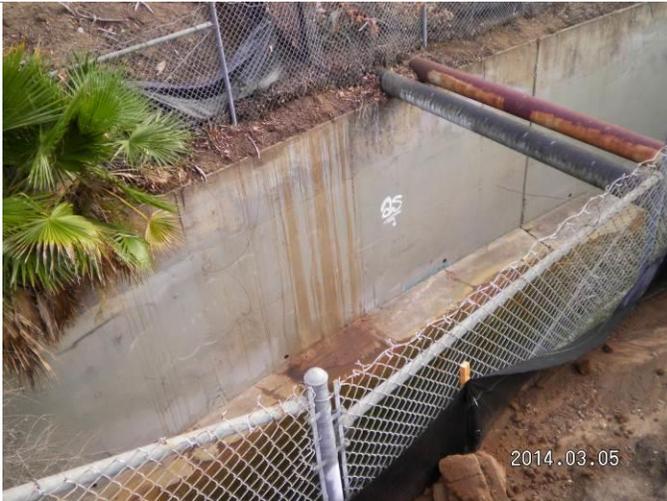
Figure 6: Discharge of sediment occurred beyond silt fence and under the chain link fence into storm water channel below as is evident from staining on side wall of channel and channel invert.

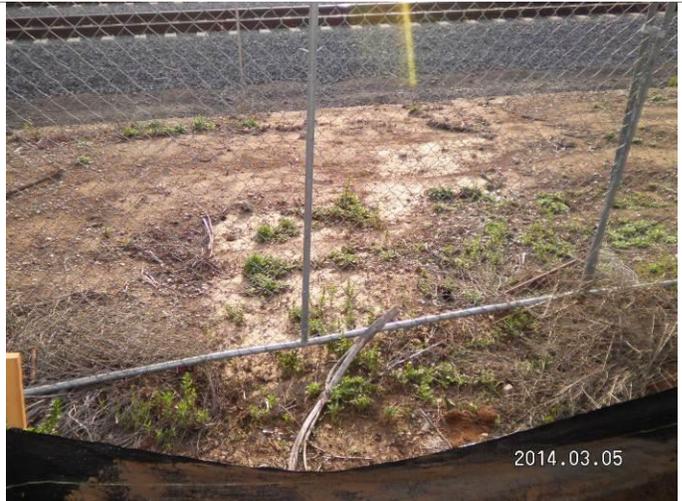
Figure 7: Close up to area where silt fence was resurrected. Evidence of discharge from the site towards the railroad tracks.

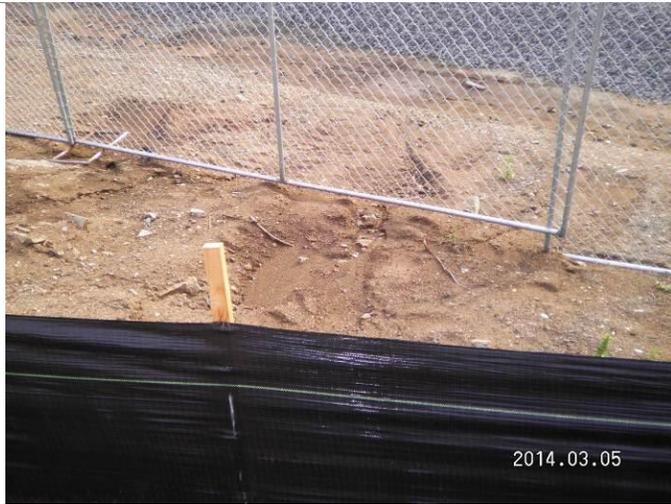
Figure 8: Evidence of discharge leaving the site under the silt fence due to improper installation and failure to have proper erosion control BMPs in place prior to the scheduled rain event.

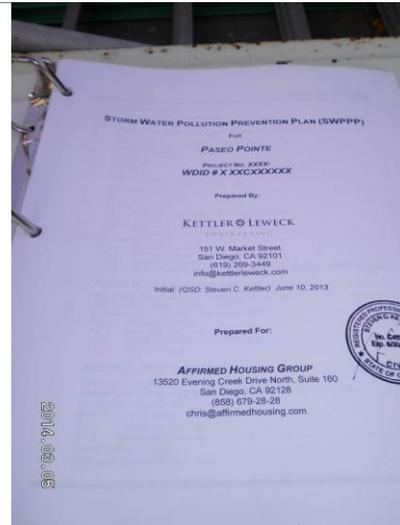
During the Site inspection, the QSP/QSD was not onsite. The SWPPP was presented to the San Diego Water Board staff upon request as there was no trailer onsite. The SWPPP was not signed and did not include WDID # or a copy of the NOI (see Figure 9). The SWPPP did not include documentation of training for all individuals responsible for implementing the SWPPP.

Figure 9: On site SWPPP did not include WDID # and copy of the NOI was not available for review.
