## California Regional Water Quality Control Board, San Diego Region

**Subject: Inspection of Cactus Park Landfill  
Order No. R9-2012-0003**

**Cactus Park Landfill**

**Pictures Taken by Mr. Alex Cali on November 19, 2014**

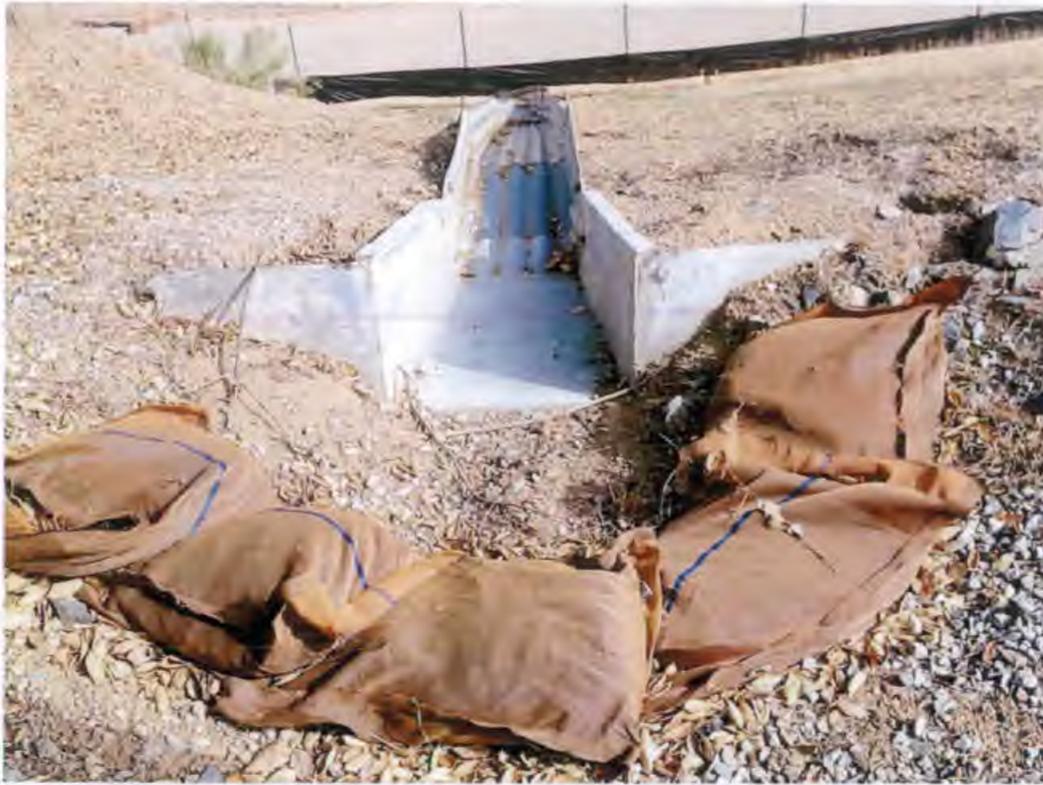
**Figure 1- Drainage Flume with Gravel Bags**

1. San Diego Water Board inspectors, Mr. Alex Cali and Ms. Leah Canada were accompanied by County of San Diego staff, Mr. Jason Forga.
2. Drainage flumes and drainage inlets were observed to be clear of debris. One flume had a minimal amount of sediment at the base but was held in place due to functioning BMPs, gravel bags and silt fence (Figure 6, 7, and 8).
3. Rodent holes were observed at the Facility, however bait stations and an owl tower was installed at the facility to address the issue (Figure 2, 3, and 4).

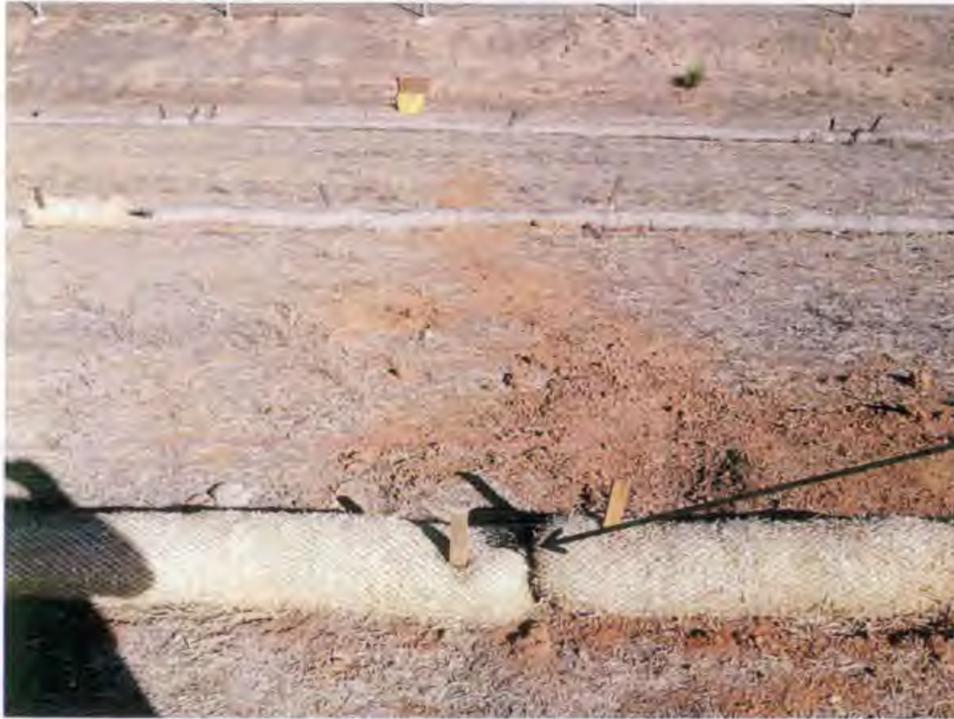
Figure 5- Slope Facing Northwest

- 2. San Diego Water Board Staff observed straw wattles that were placed end to end instead of overlapping one another (Figures 5 and 6). This condition should be corrected and addressed in the Site Conditions Re-Certification Report.

Straw wattles  
installed end to end.

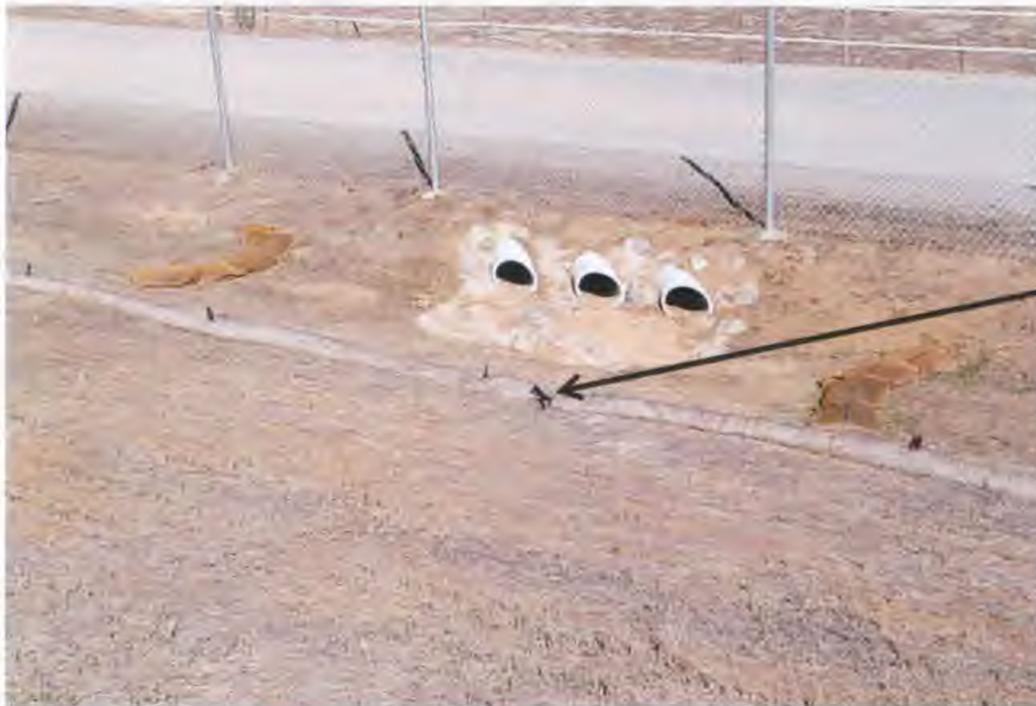
Figure 6- West Drainage Inlet

Straw wattles  
installed end to end.
