San Diego Regional Water Quality Control Board

Subject: August 11, 2015 San Diego Water Board Inspection Report

**MUNICIPAL SEPARATE STORM SEWER SYSTEM (MS4)
AUDIT INSPECTION REPORT**

FACILITY: City of Escondido MS4

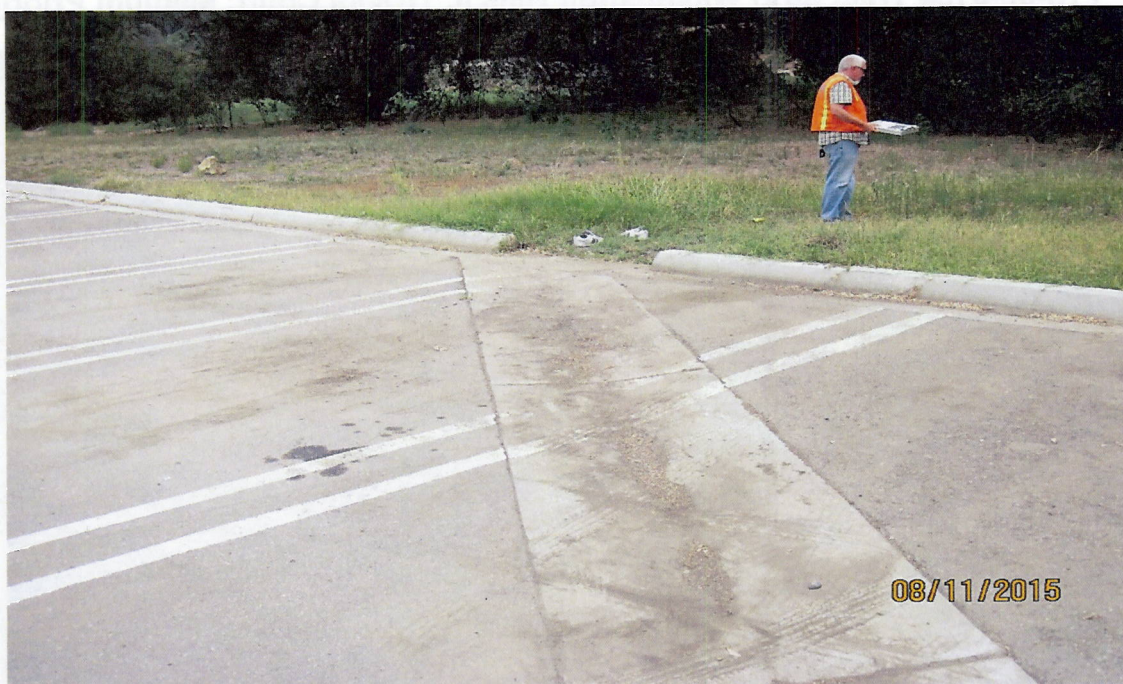
Photo 1(b): Inlet to bioswale from parking lot, ground higher than inlet preventing flow to enter swale, trash present, needs maintenance and contouring to allow flow to enter swale. Evidence of sediment buildup at inlet. Parking lot could use a sweeping.

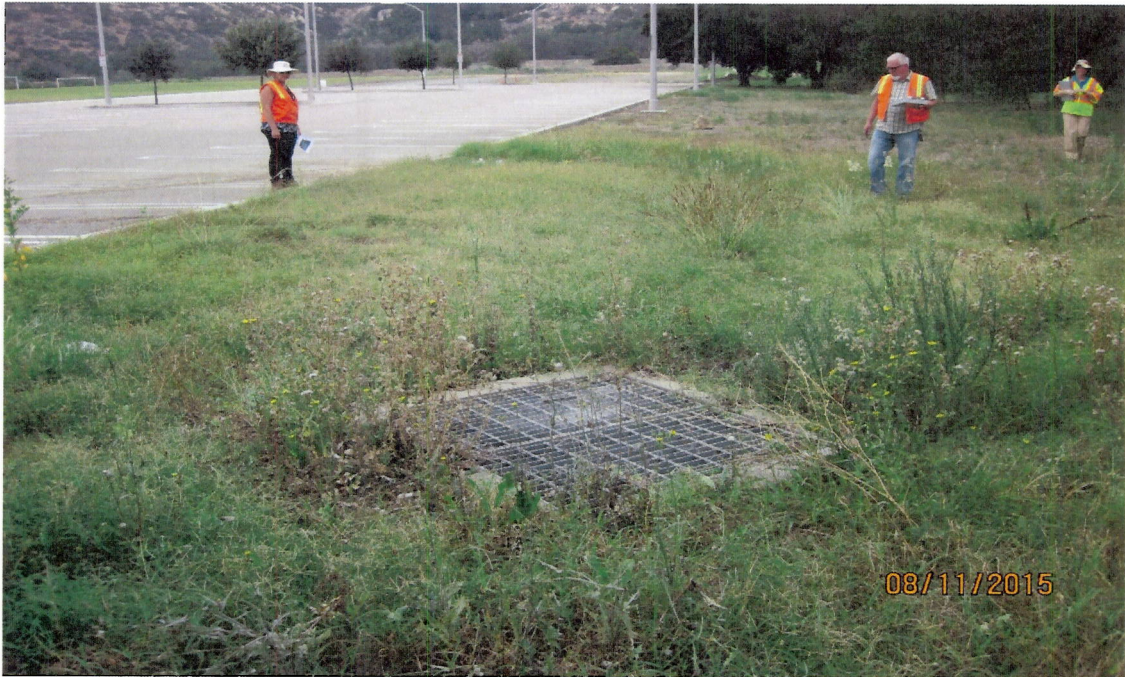
Photo 1(c): Bioswale is fully vegetated, but flow path tends to be slightly uphill from inlet to outlet. Entire area may function to allow infiltration of runoff. But re-contouring necessary to allow bioswale to perform as designed. City should inform Public Works Dept. that swale is in need of maintenance.

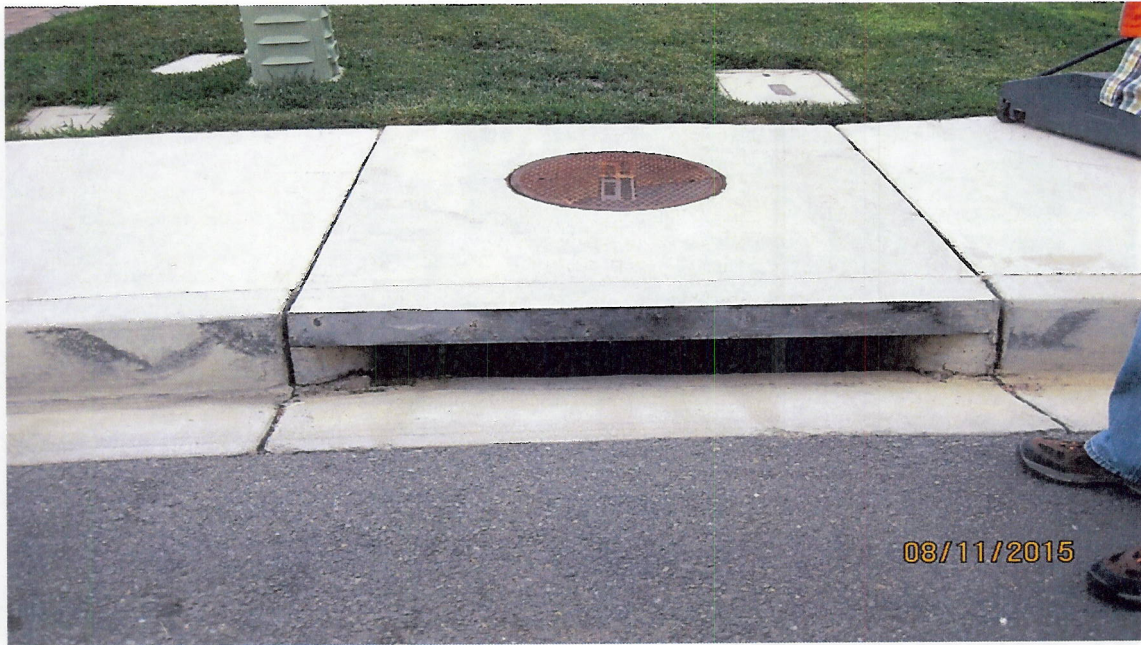
Photo 2(b): Single drainage inlet at end of Trovita Court. Inlet picks up flow from entire subdivision. According to the City there is a low flow inlet and high flow bypass associated with the inlet.

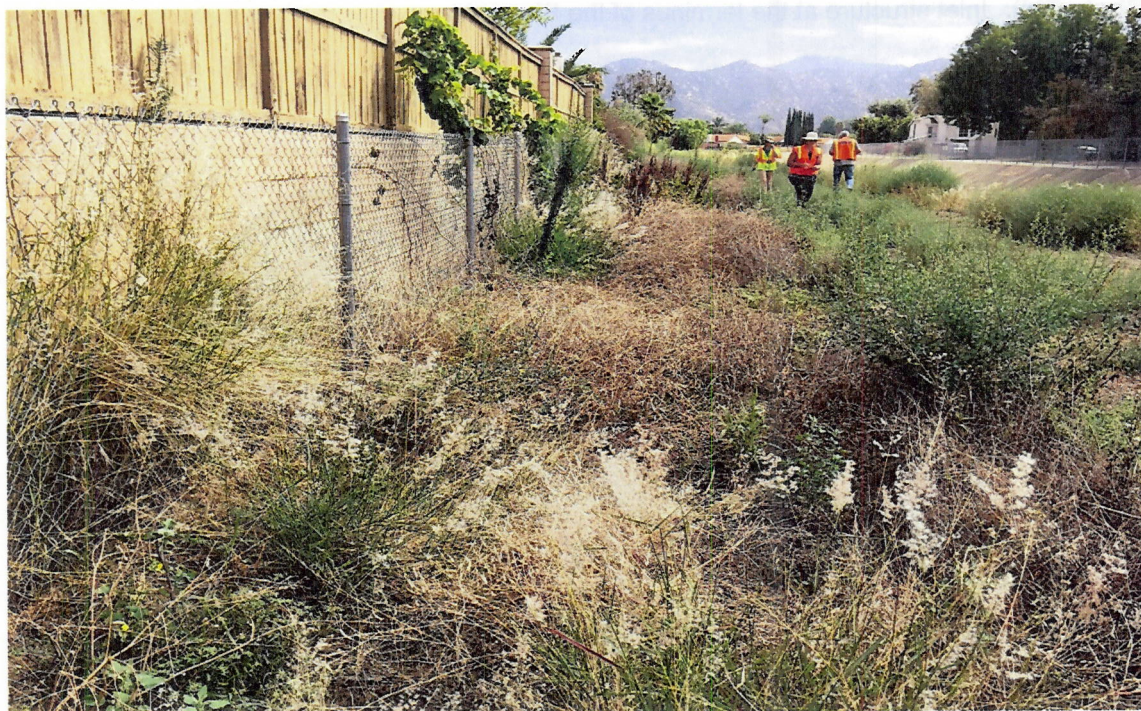
Photo 2(c): Bioswale area along Escondido Creek behind Trovita Court. Bioswale area is fully vegetated.

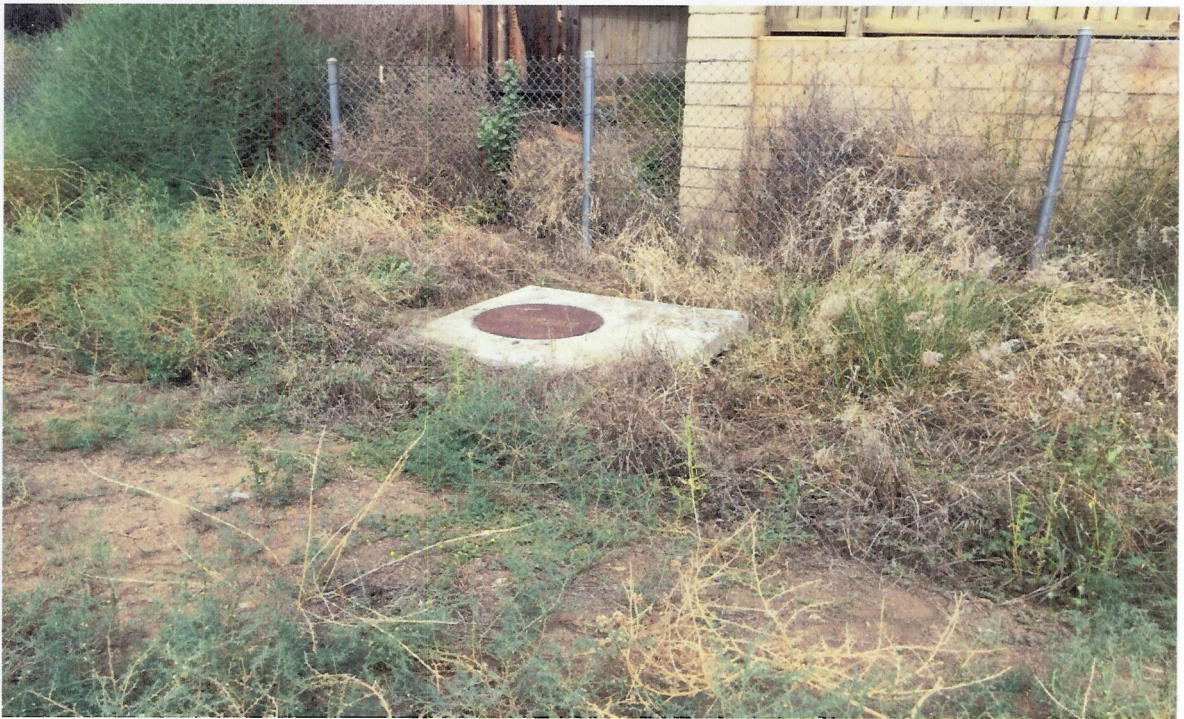
Photo 2(d): Inlet structure at the terminus of the Bioswale.

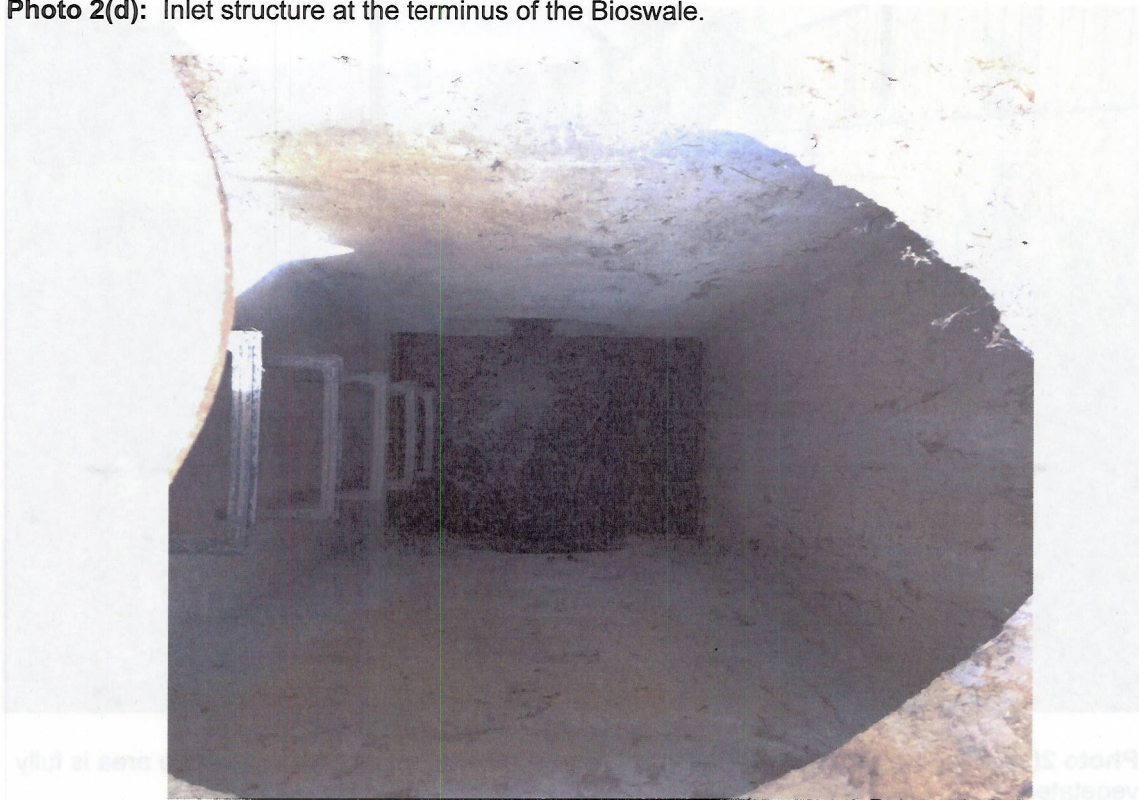
- City stated that photo-documentation is not required for self-certification submittals.
- Observed active over-irrigation illicit discharge in residential area. Helen Davies approached the property owner who proceeded to terminate the discharge.
- Accessed bioswale area through City right of way behind the residential area. Bioswale was covered in dense vegetation (see photo 2(c)). After a thorough search inspectors were unable to locate the pipe or point where the low flow discharge enters swale.
- Inspectors opened adjacent manhole at bioswale terminus (see photo 2(d)), and observed low-flow illicit discharge directly to Escondido Creek (i.e. bypassing the bioswale) (see photos 2(e) and 2(f)).
- Trash in swale.

Photo 2(e): Inspectors removed manhole and observed water having discharged through hi-flow bypass directly into Escondido Creek. Unable to determine if low-flow bypass to bioswale is present or functional.

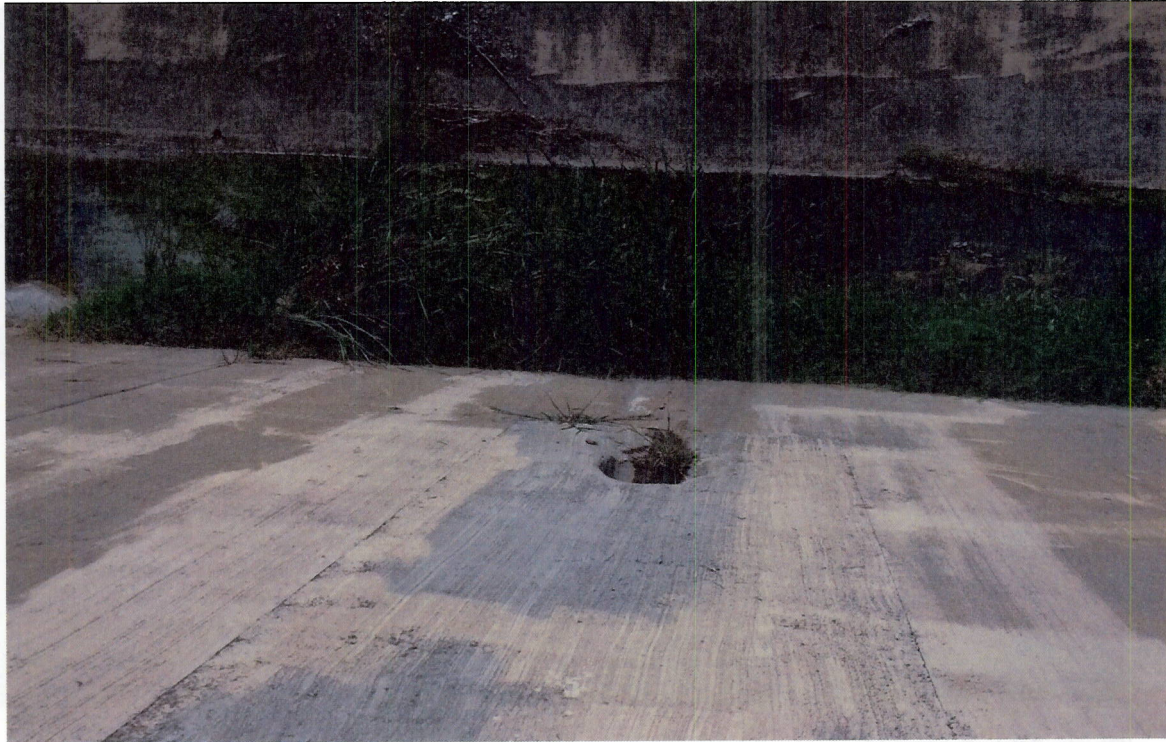
Photo 2(f): Hi flow outlet to Escondido Creek showed signs of moisture at terminus. Potential bypass of low flow outlet to swale.

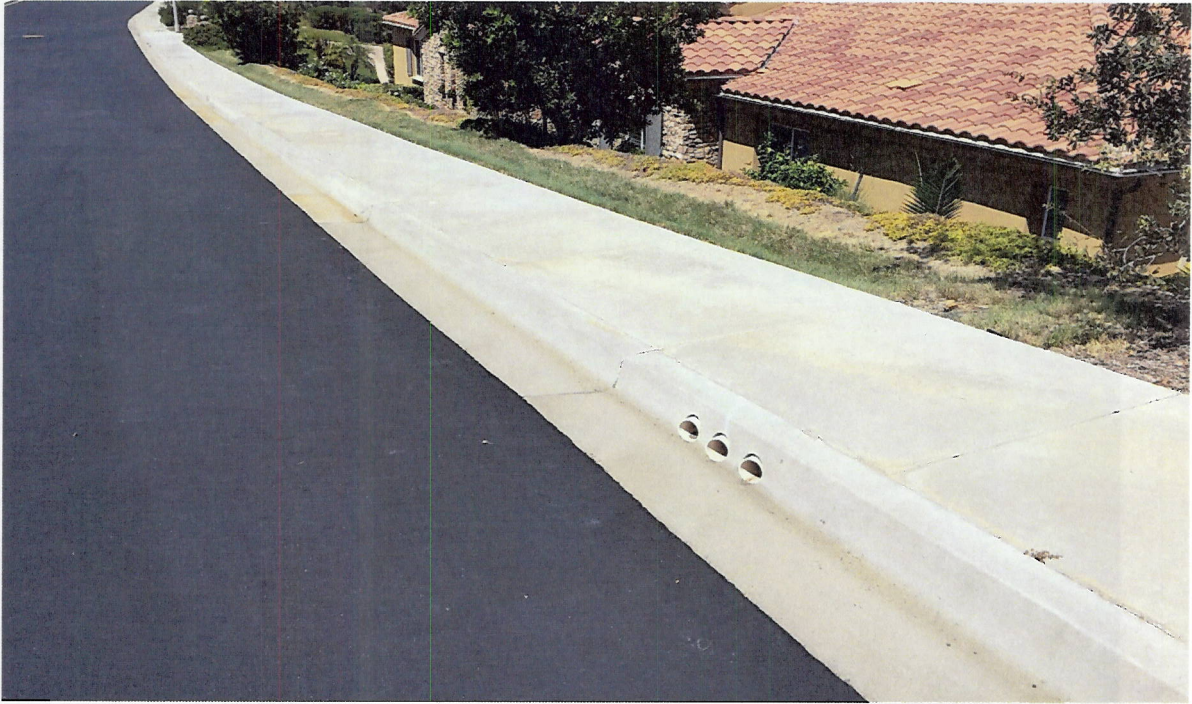
Photo 3(b): Typical bioswale set up with three inlet pipes and vegetated swale running along street.

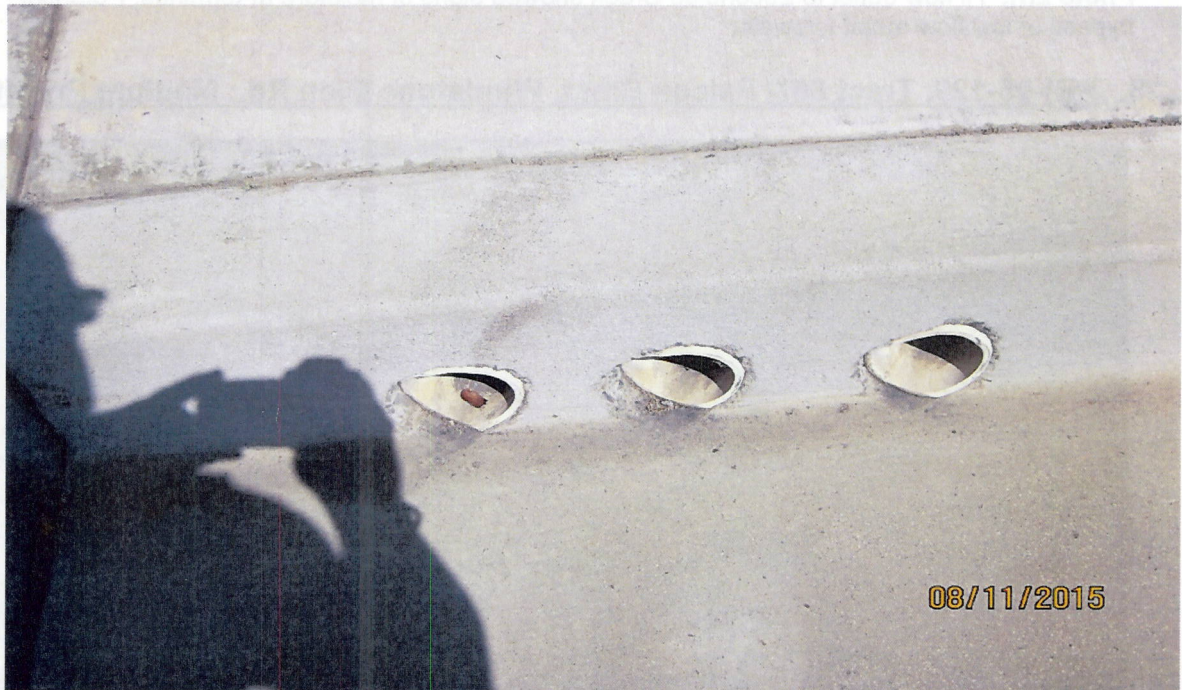
- A majority of the curb inlet pipes' outer flanges were broken off from where they extended into the gutter, leaving them flush with the curb (see photo 3(c)). This reduces the ability of the inlet pipes to convey stormwater to the bioswales. This is a poor design for the inlets and could be improved upon.
- A majority of the inlet pipes were obstructed with sediment and debris (see photos 3(d) and 3(e)). This further reduces the ability of stormwater to enter the bioswale and receive treatment. This observation is consistent with previous City inspection findings in 2011 and 2012.

Photo 3(c): A majority of the inlet pipes' outer flanges extending into the gutter were broken off (likely from cars parking along the street). This reduces the ability of the inlet pipes to collect stormwater flow and passes it down the street.

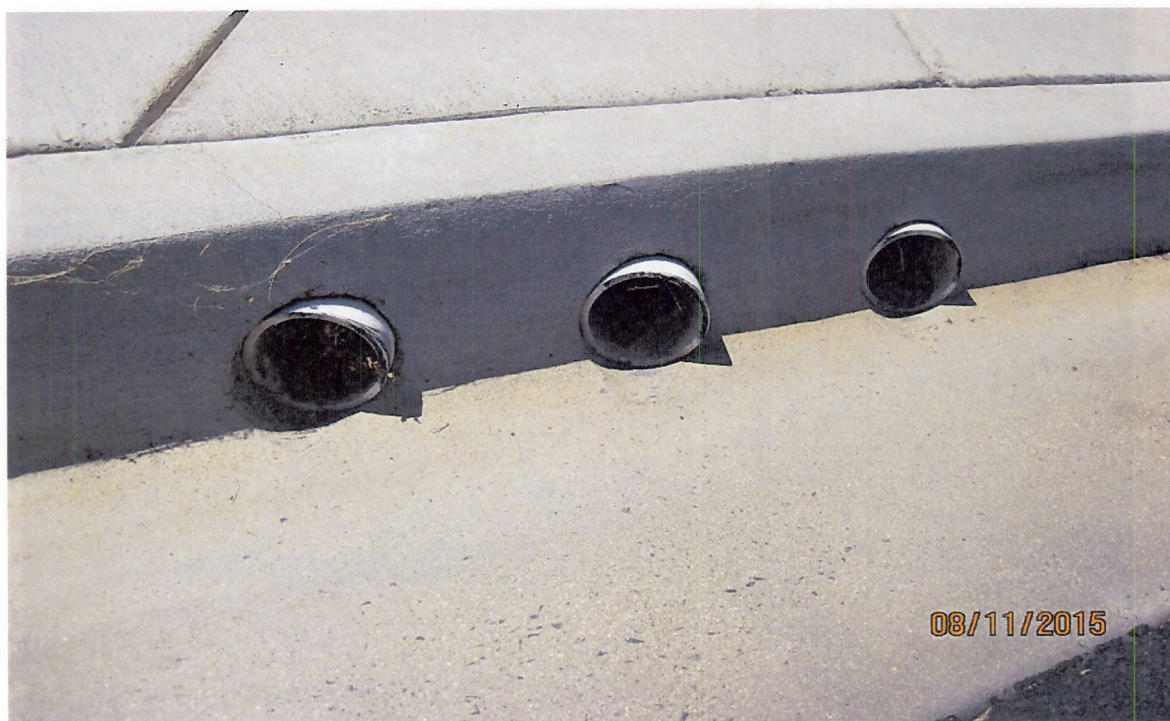
Photo 3(d): Inlet pipes clogged with sediment. Flow is not able to get into swale, backs up and some sediment is deposited.

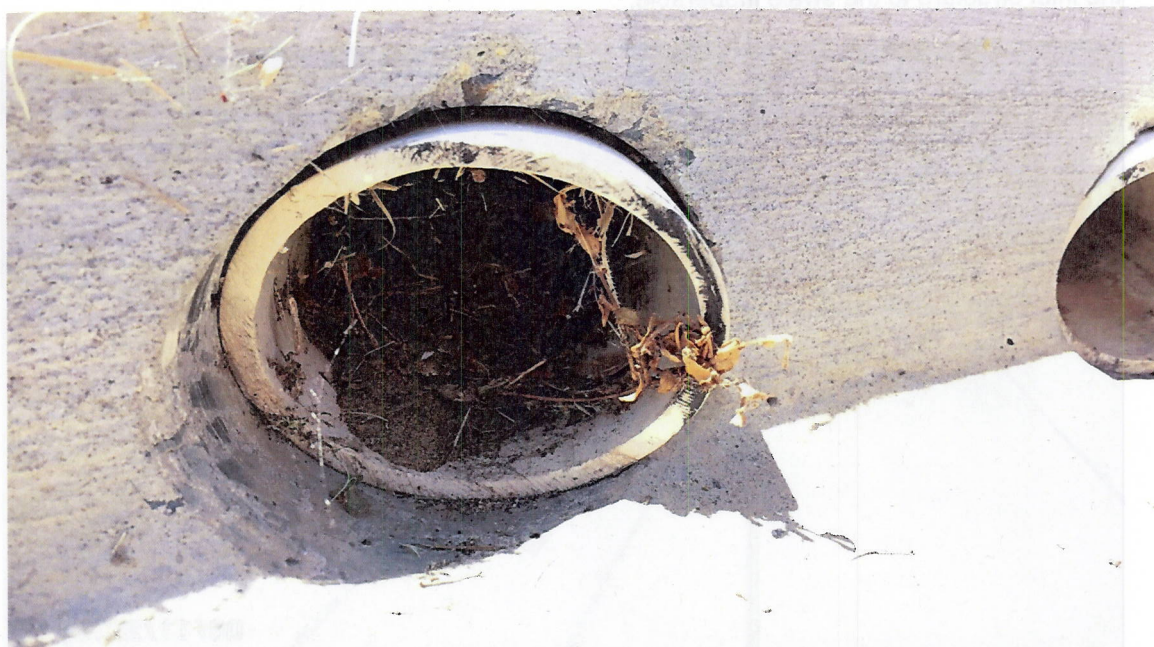
Photo 3(e): Closeup of typical bioswale inlet pipe clogged with sediment.

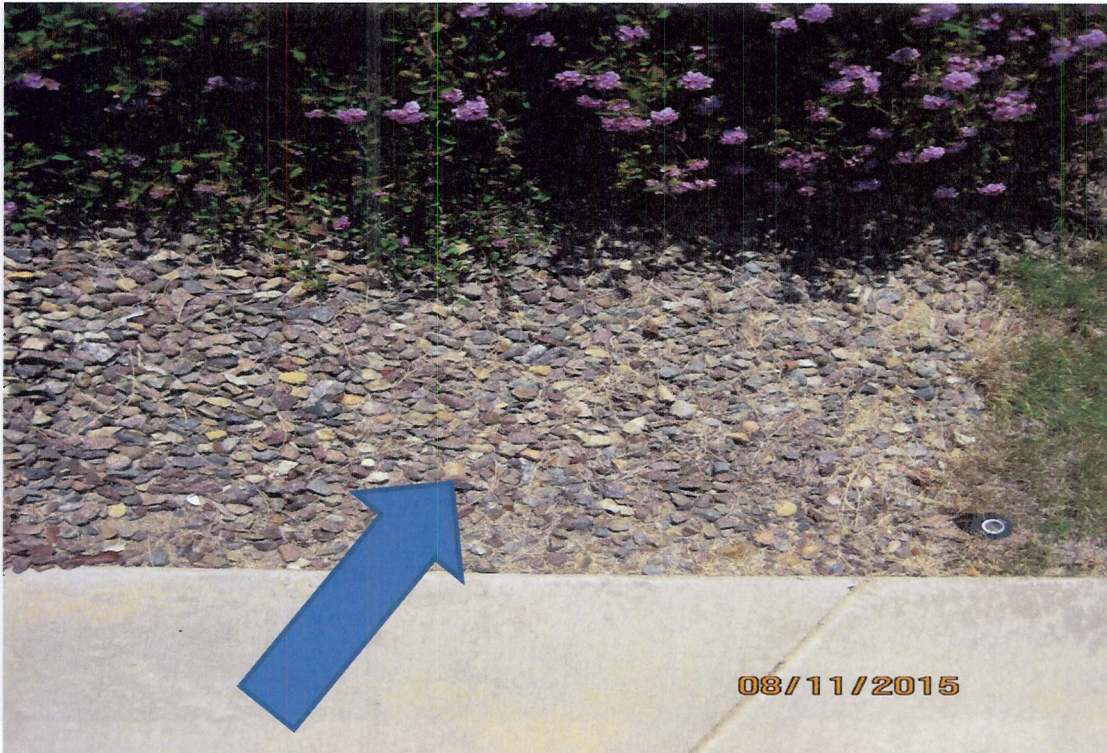
Photo 3(f): Inlet pipes upgradient of swale are buried beneath hard packed dirt and gravel rendering the inlet structure to the swale inoperable.

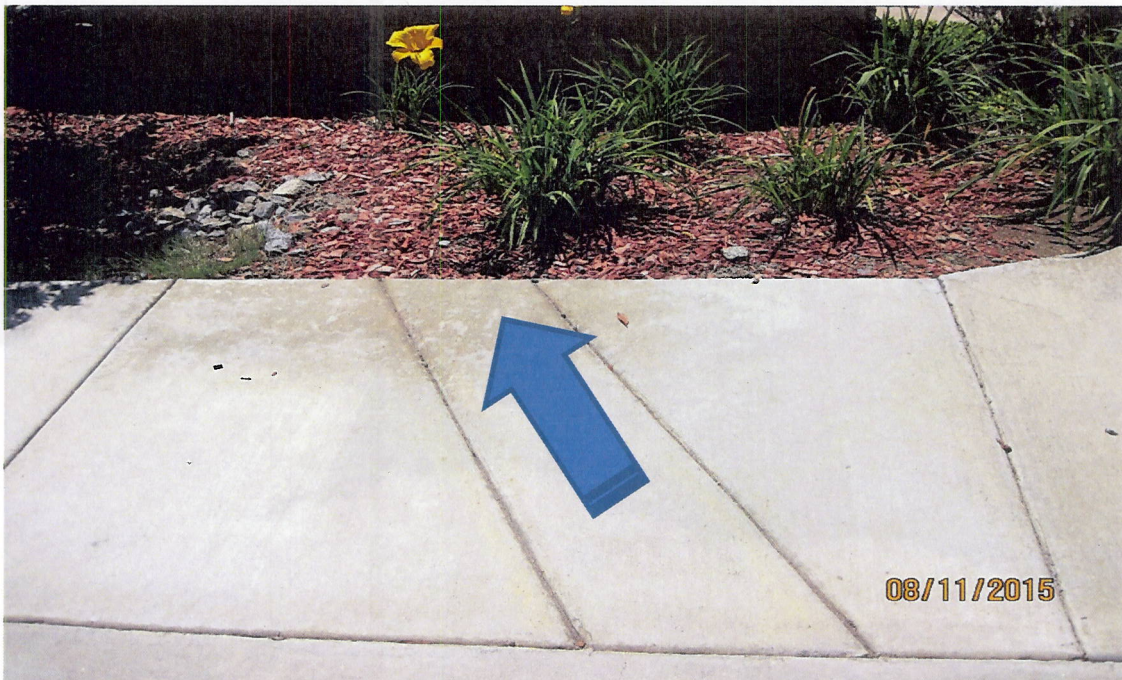
Photo 3(g): Inlet pipes upgradient of swale are buried beneath ornamental landscaping rendering the inlet structure to the swale inoperable.

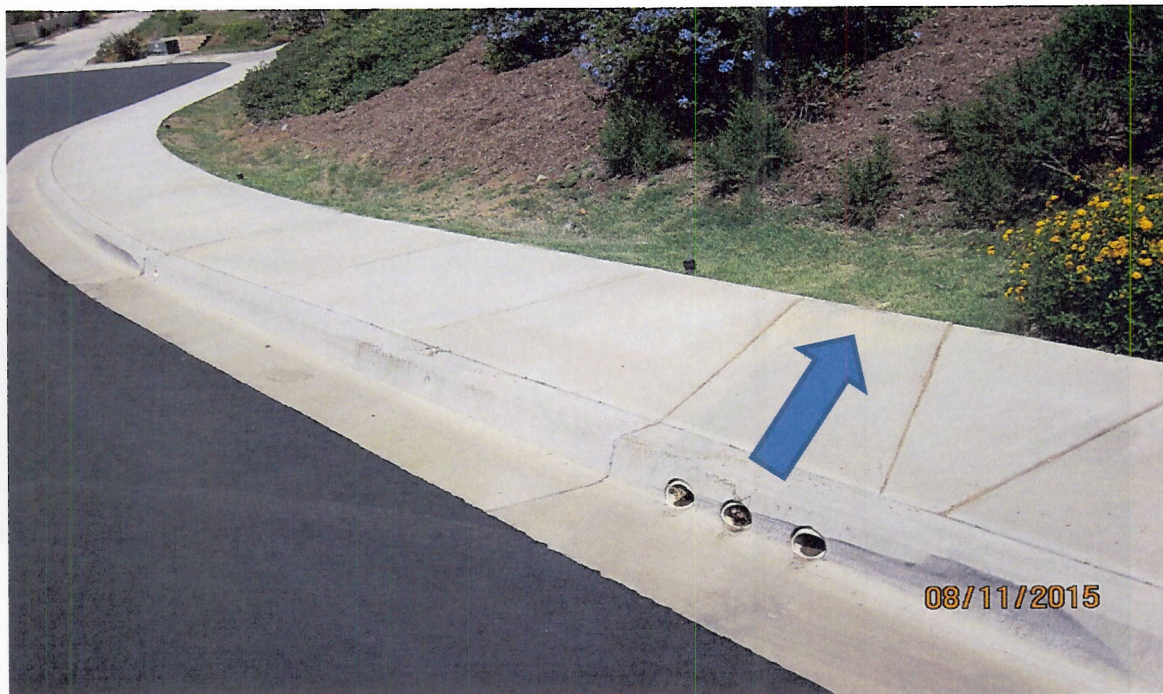
Photo 3(h): Inlet pipes upgradient of swale are buried beneath turf rendering the inlet structure to the swale inoperable.

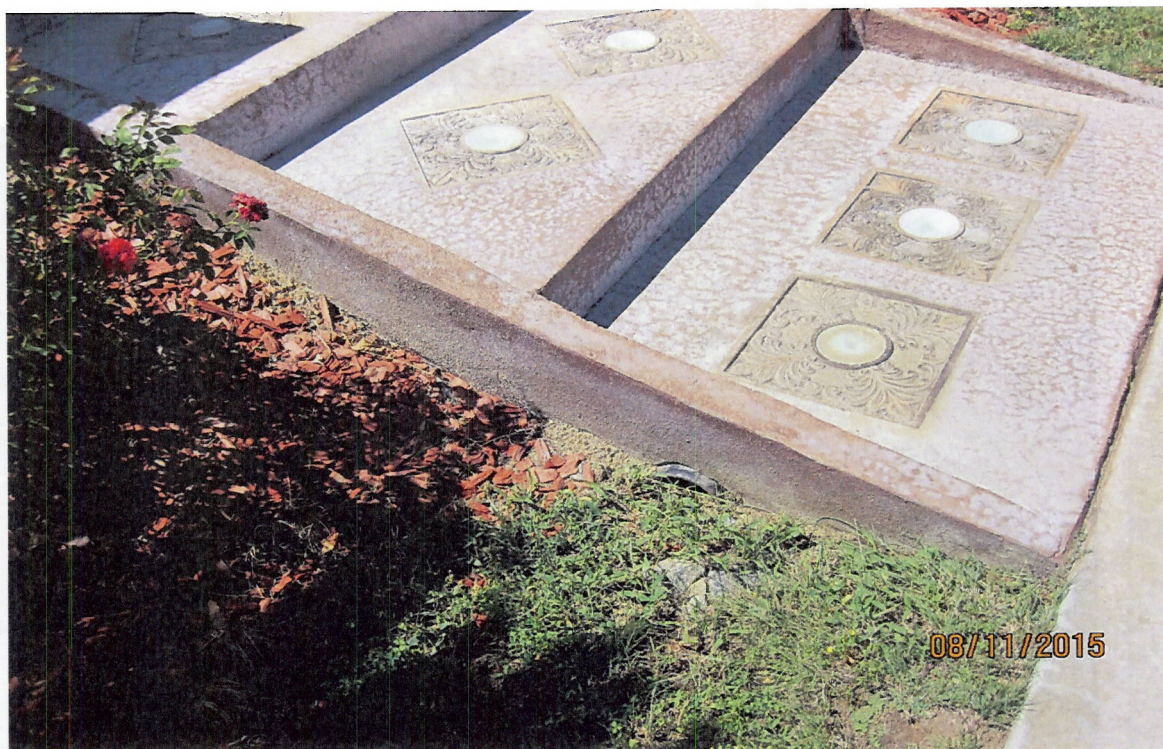
Photo 3(i): Stairs constructed in the middle of bioswale. Flow through pipe is buried 2/3 of the way below swale.

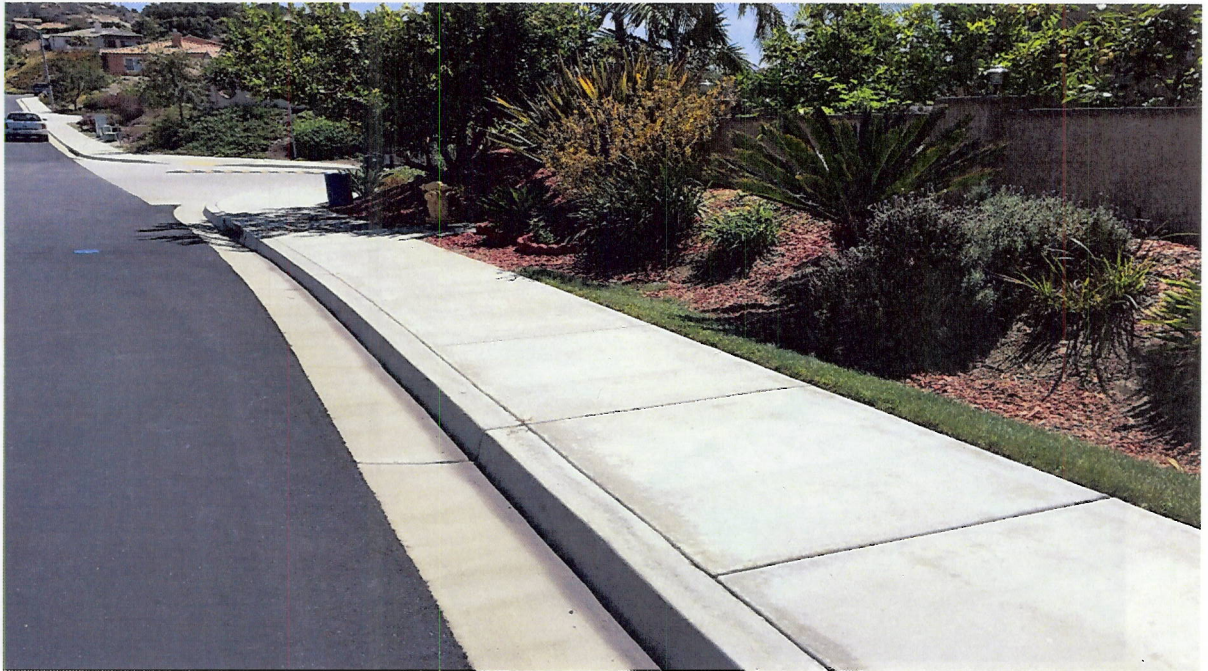
Photo 3(j): Landscaping with ornamental bark covers the upper side of the swale, reducing ability to treat stormwater.

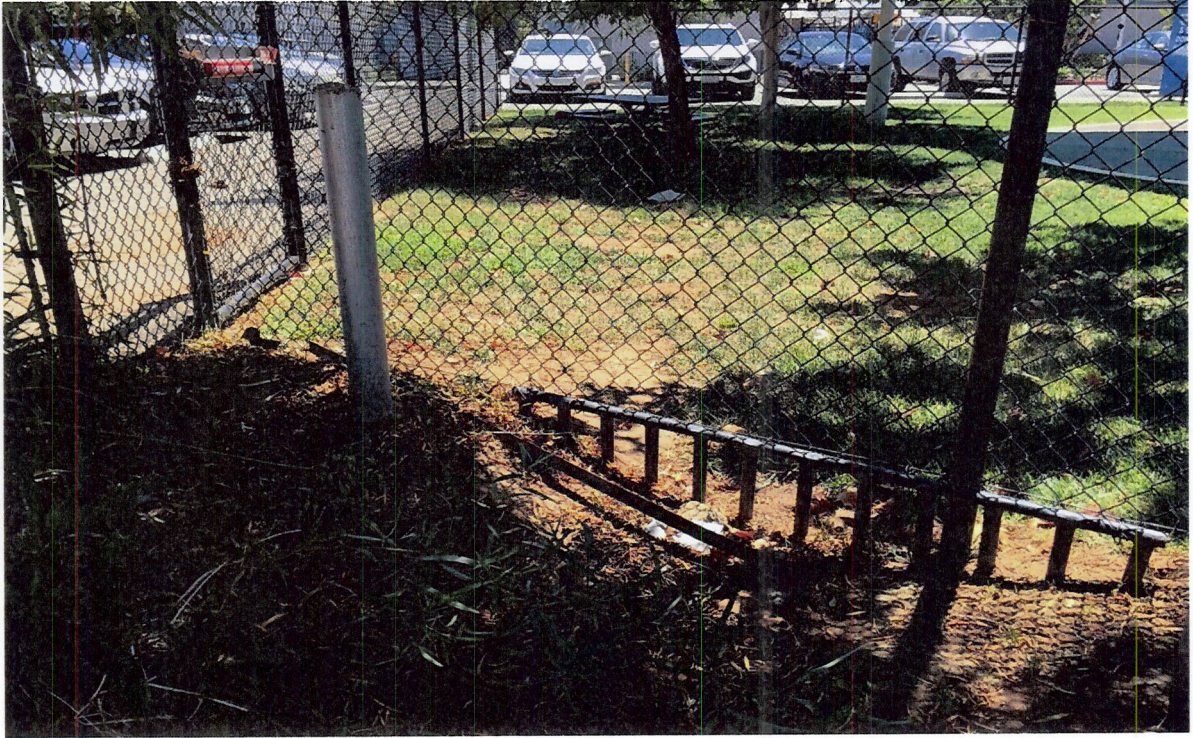
- Playground bioswale installed as designed and operational (see photo 4(b)).
- Plans called for a second parking lot bioswale, but the designated area for that BMP lacks surface vegetation and does not appear to be properly graded to capture and treat flows. This treatment BMP is effectively missing (see photo 4(c)).
- Inlet filters are in place but need maintenance (see photo 4(d)).

Photo 4(b): Bioswale running through children's playground is vegetated and functional per plans.

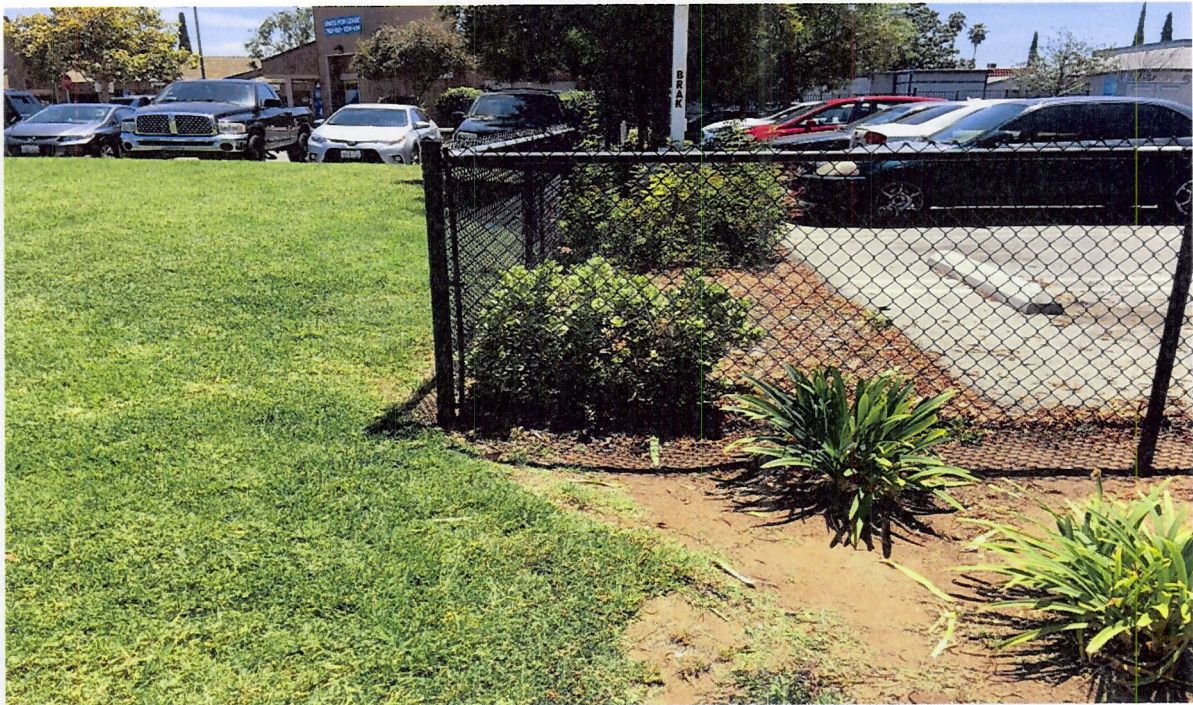
Photo 4(c): Second bioswale should be in line with white post, but area lacks vegetation and is not contoured as a swale. Missing BMP.

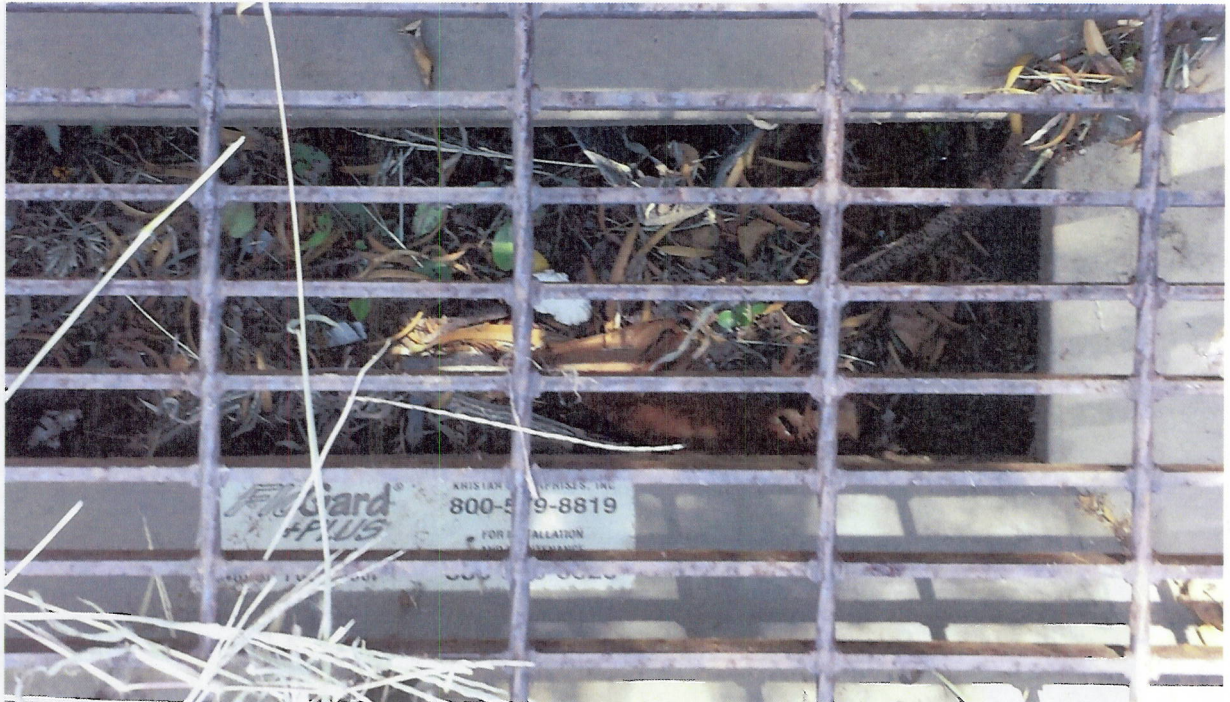
Photo 4(d): Inlet filter in place on street outside of property, and in need of maintenance.

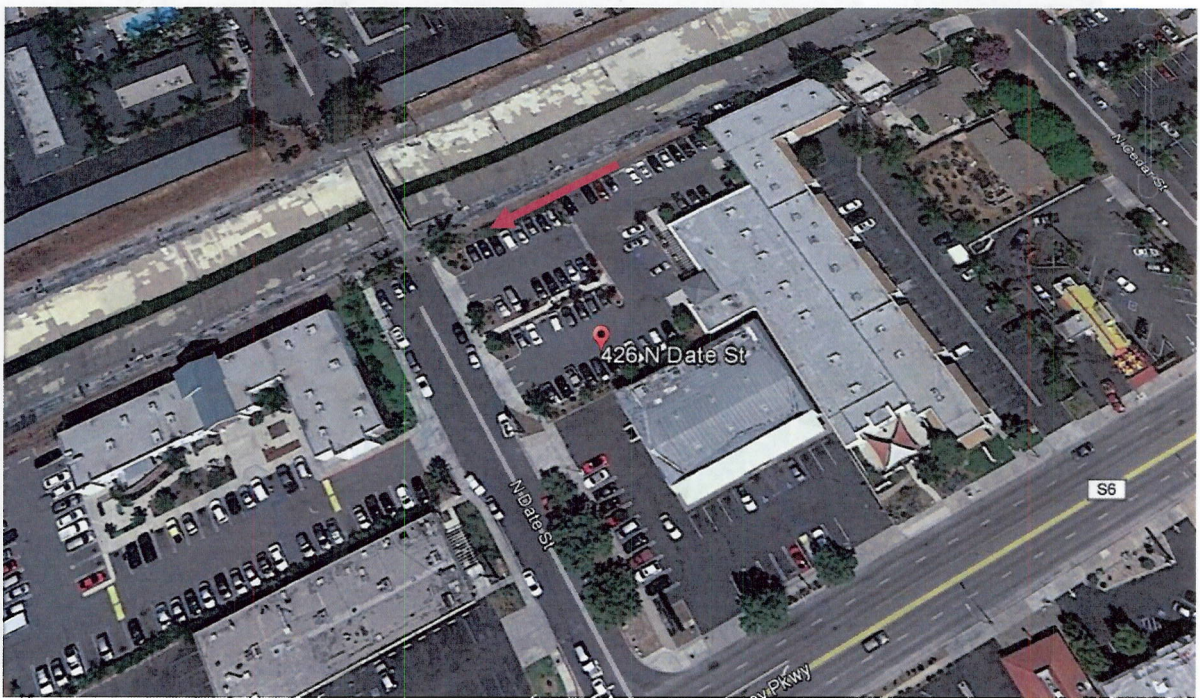
Photo 5(a): Google aerial view of 426 Date Street. Red arrow indicates where BMP should be located.

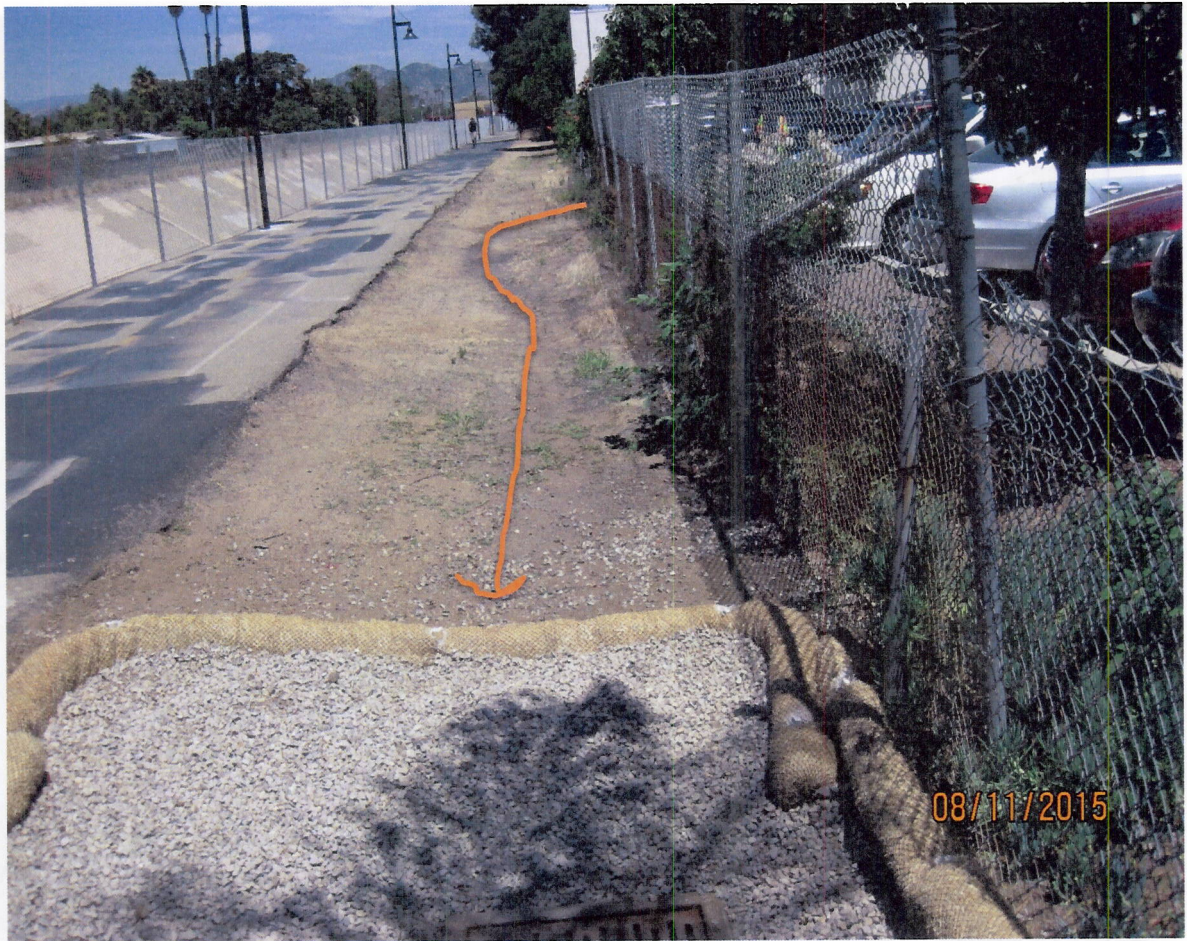
Photo 5(b): Past location of bioswale within City right away adjacent to Escondido Creek. Orange line shows the approximate flow path of stormwater exiting parking lot through single curb cut. Flow would tend to pass at a right angle through lightly vegetated area at the top of arrow, flow through unvegetated area and eventually enter protected storm drain inlet at bottom of picture. Stormwater runoff would receive little or no treatment.

The City should contact the property owners and request that the vegetated area within the project boundaries be regraded and revegetated to become a functioning bioswale. Until such a time as these improvements are made the BMP should be considered missing and in violation of Order R9-2007-0001.

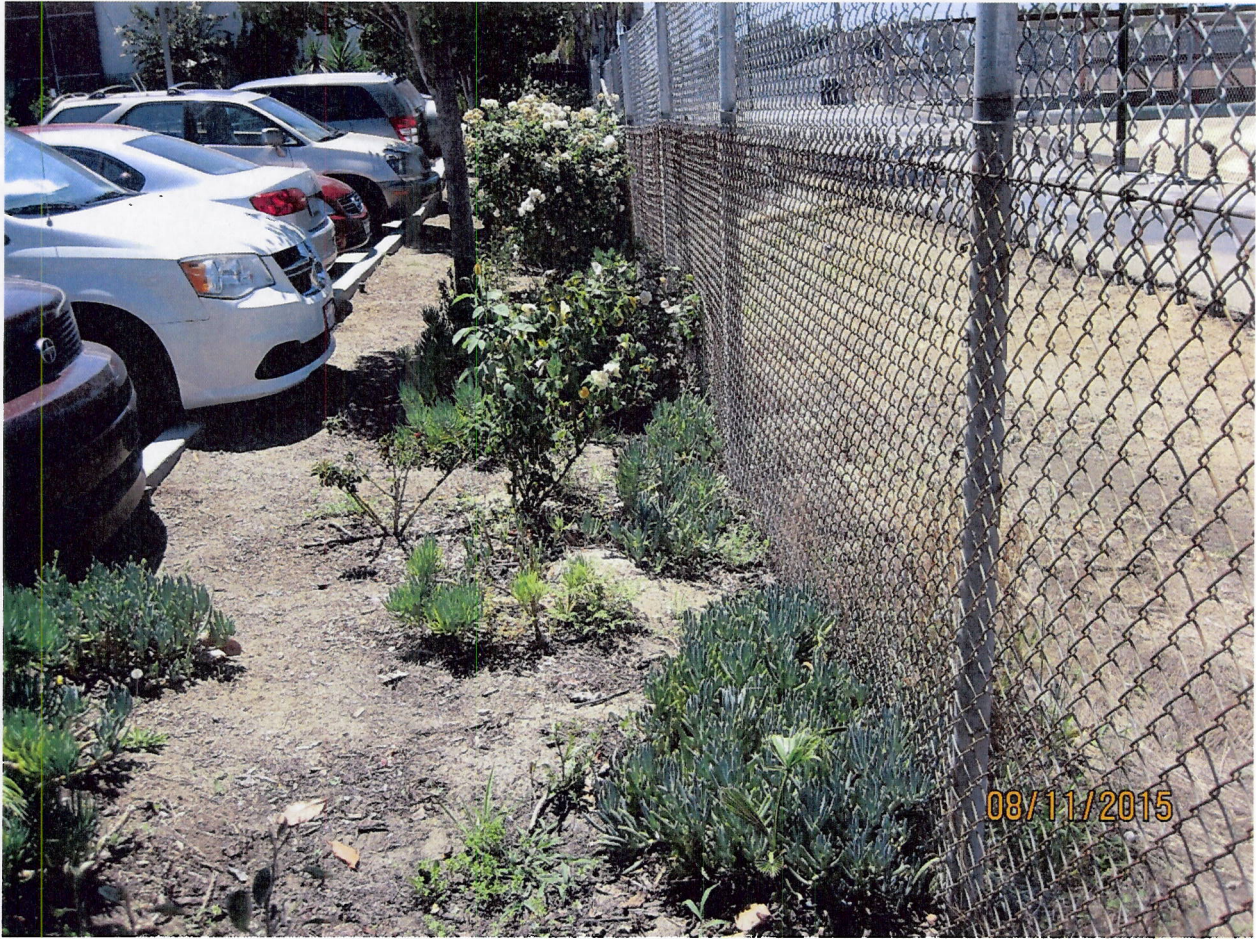
Photo 5(c): Area of parking lot on site that appears to be the actual location of the bioswale per the original plans. This area could be re-graded and planted with vegetation to better serve as a treatment control BMP for the site. As it exists now, the area slopes downward towards the fence and the offsite dirt area beyond the property boundary.

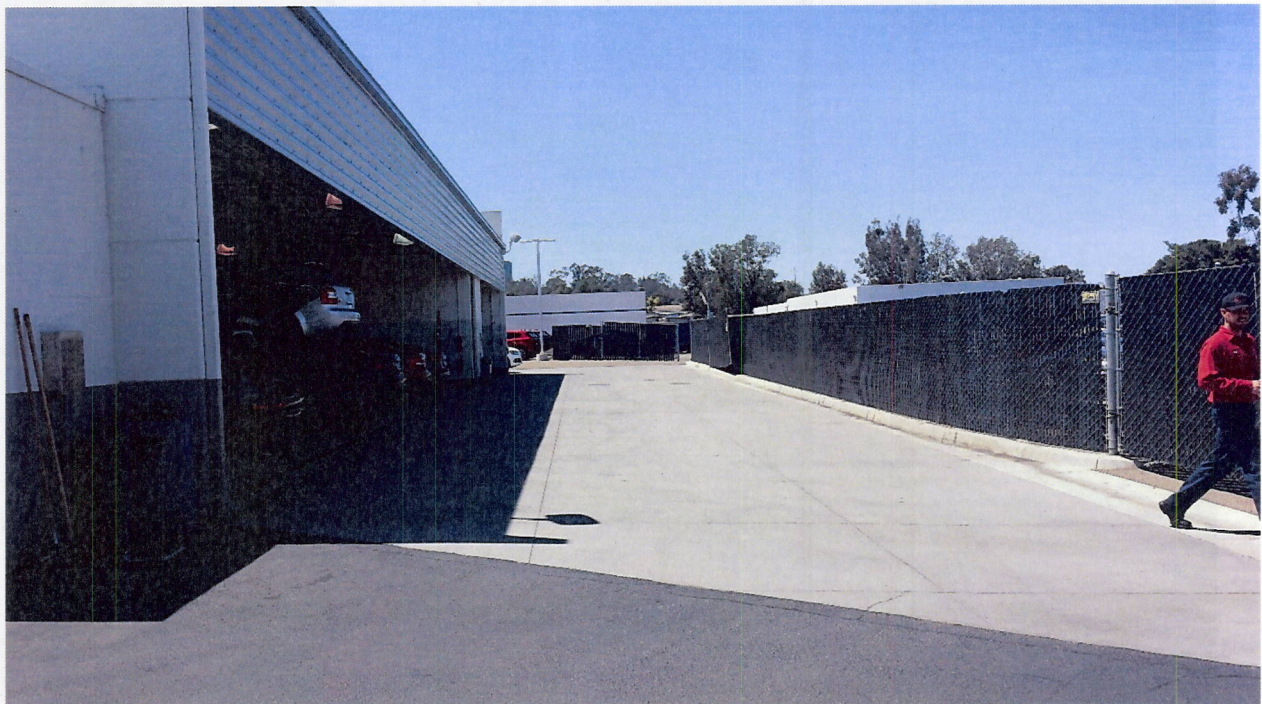
Photo 6(b): Back service bay that feeds into smaller swale in back of dealership. Questions remain if car storage lot to the right of the fence is part of dealership and needs treatment.

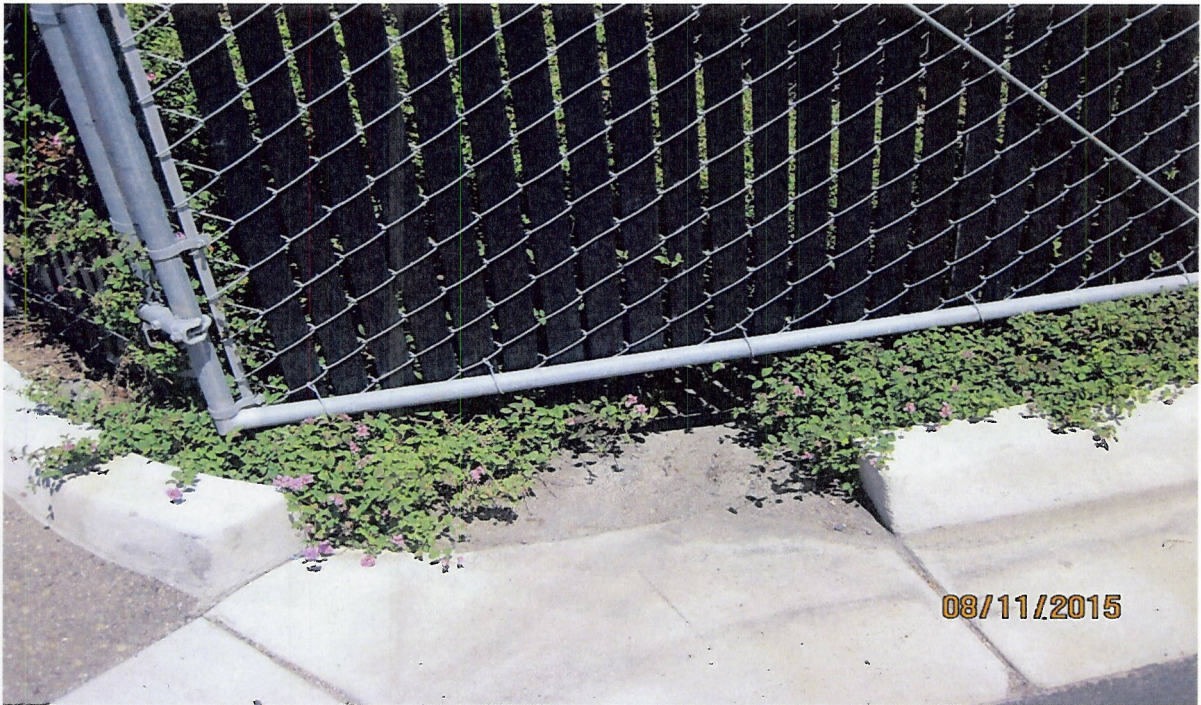
Photo 6(c): Curb cut that serves as the inlet to the smaller swale in back of dealership.

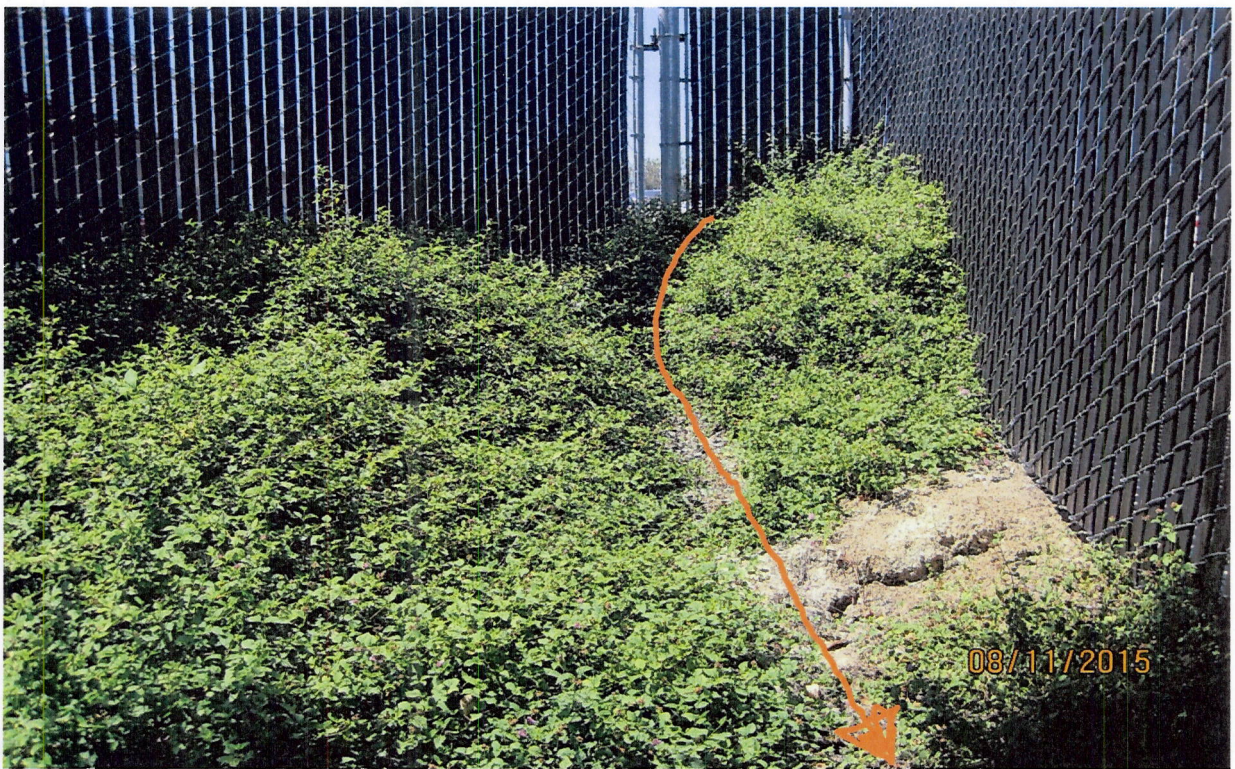
Photo 6(d): Bioswale is situated on steep slope with no vegetation in the flow path. Poor design.
