San Diego Regional Water Quality Control Board

Subject: August 11, 2015 San Diego Water Board Inspection Report

**MUNICIPAL SEPARATE STORM SEWER SYSTEM (MS4)
AUDIT INSPECTION REPORT**

FACILITY: City of Escondido MS4

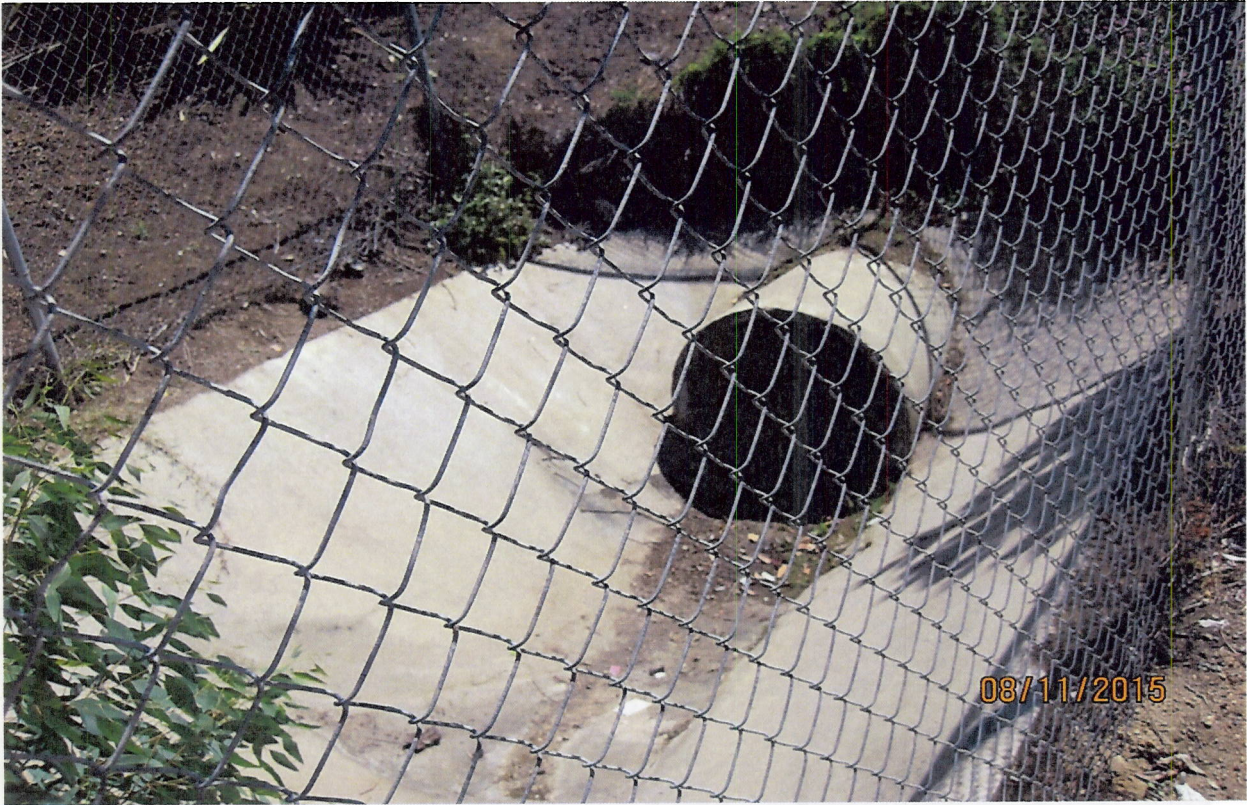
Photo 6(e): Small swale discharges directly into City of Escondido MS4 system.

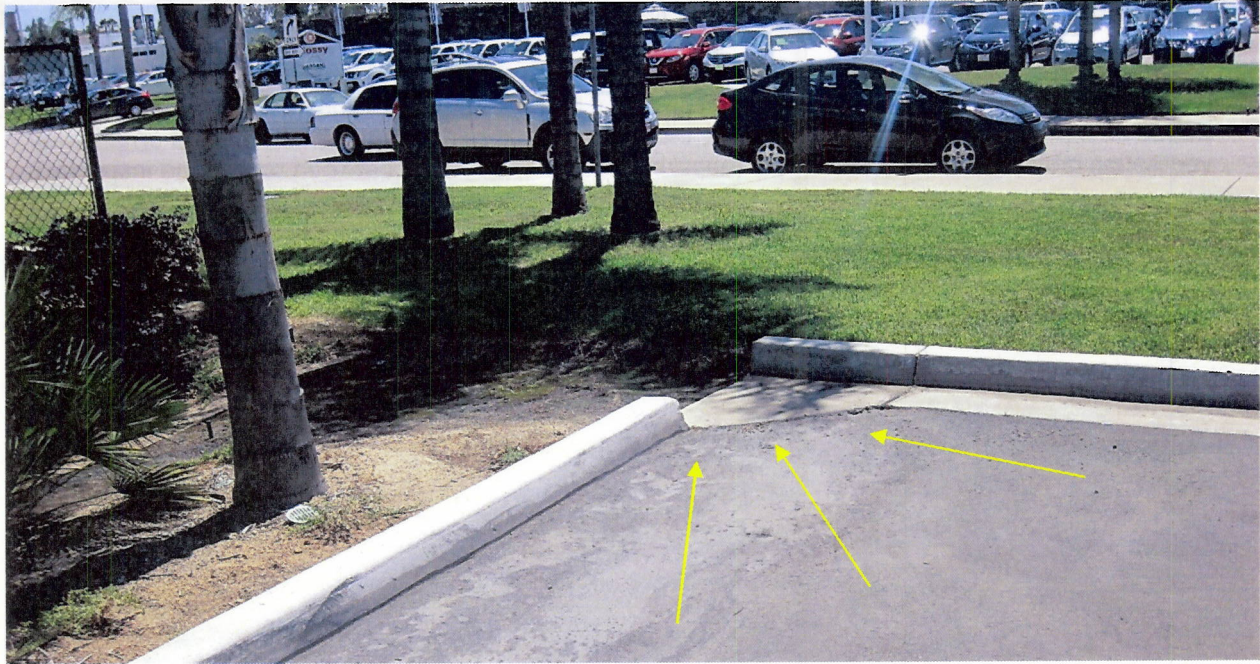
Photo 6(f): Single curb cut inlet to larger bioswale from front of dealership parking lot.

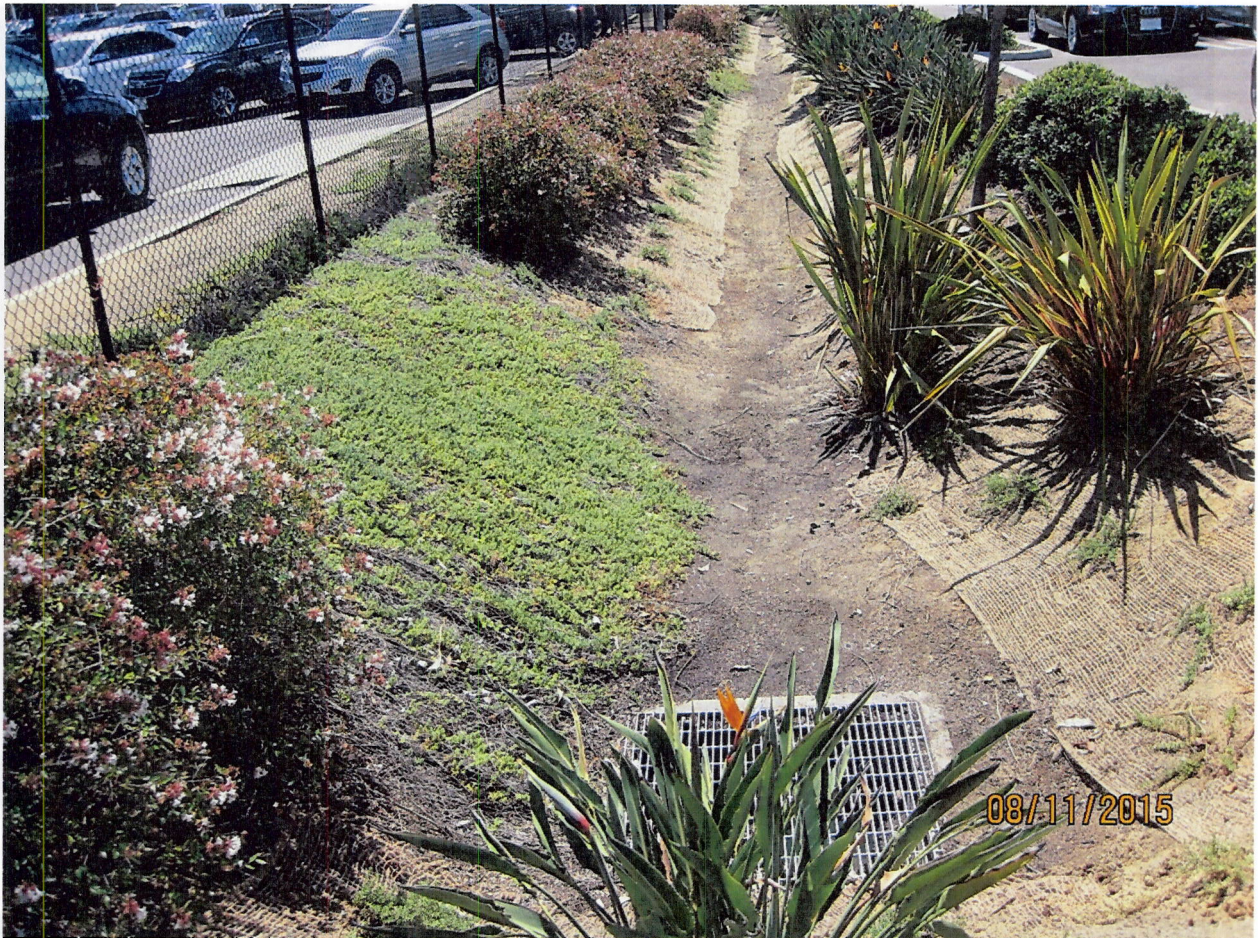
From the viewpoint of San Diego Water Board inspectors, the larger swale in front appears to have never been planted with vegetation of any sort. In its observed condition, the unvegetated swale is deemed an ineffective BMP. Yet the City, in attachment 2 finds the current condition of the BMP to be "Satisfactory". The historic inspection findings of the City, coupled with their assessment of the current condition of the bioswale again casts serious doubt on the adequacy of their inspection program, and the technical expertise of their inspectors. The City should provide any available historic documentation of the presence of vegetation within the larger swale.

Photo 6(g): Larger bioswale at southerly boundary of auto dealership. Floor of the bioswale channel is hard packed earth which showed no indication that it had ever been previously planted with vegetation. Based on input from City inspector in 2015, the owner added burlap matting and planted ornamental vegetation on the sides of the bioswale (apparent miscommunication between owner and inspector).

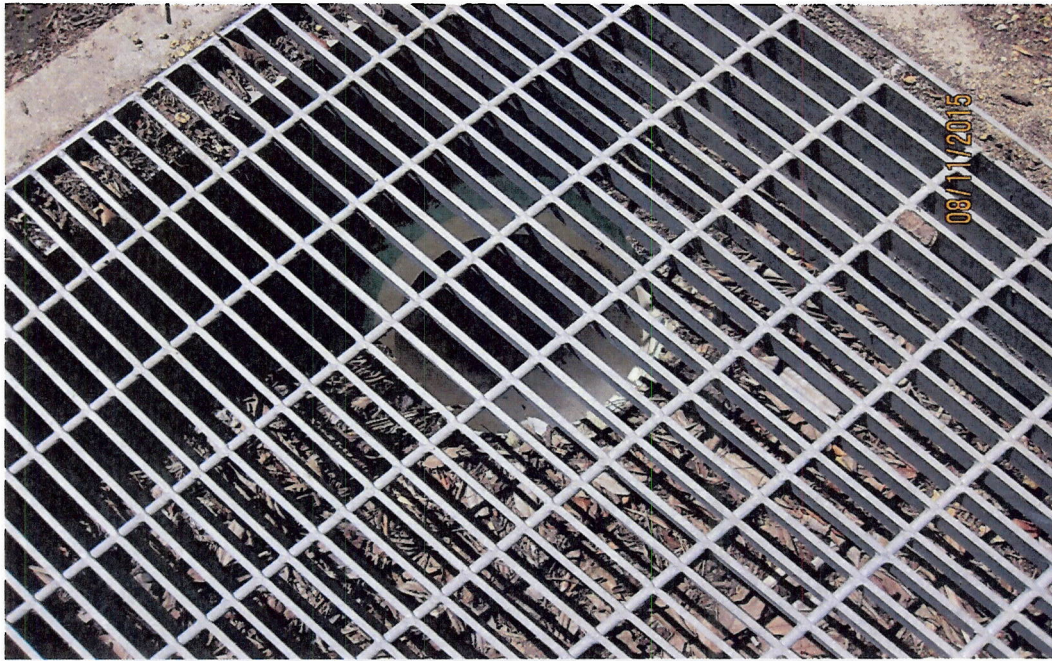
Photo 6(h): Drain inlet to MS4 from larger swale contained organic debris and should be maintained prior to rainy season.

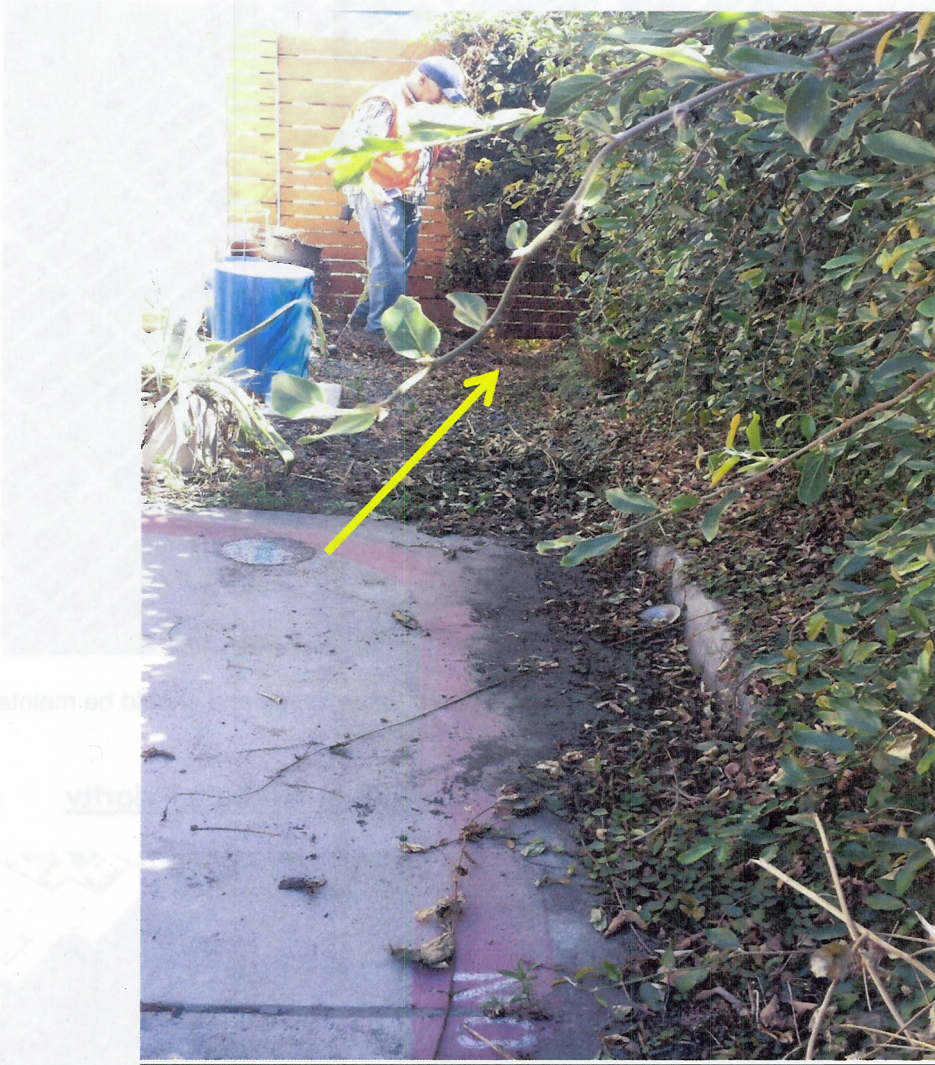
Photo 7(b): End of impervious surface in the interior of the apartment complex. Sediment build up is apparent. Arrow shows the inlet to the bioswale under the fence of a resident's private side yard.

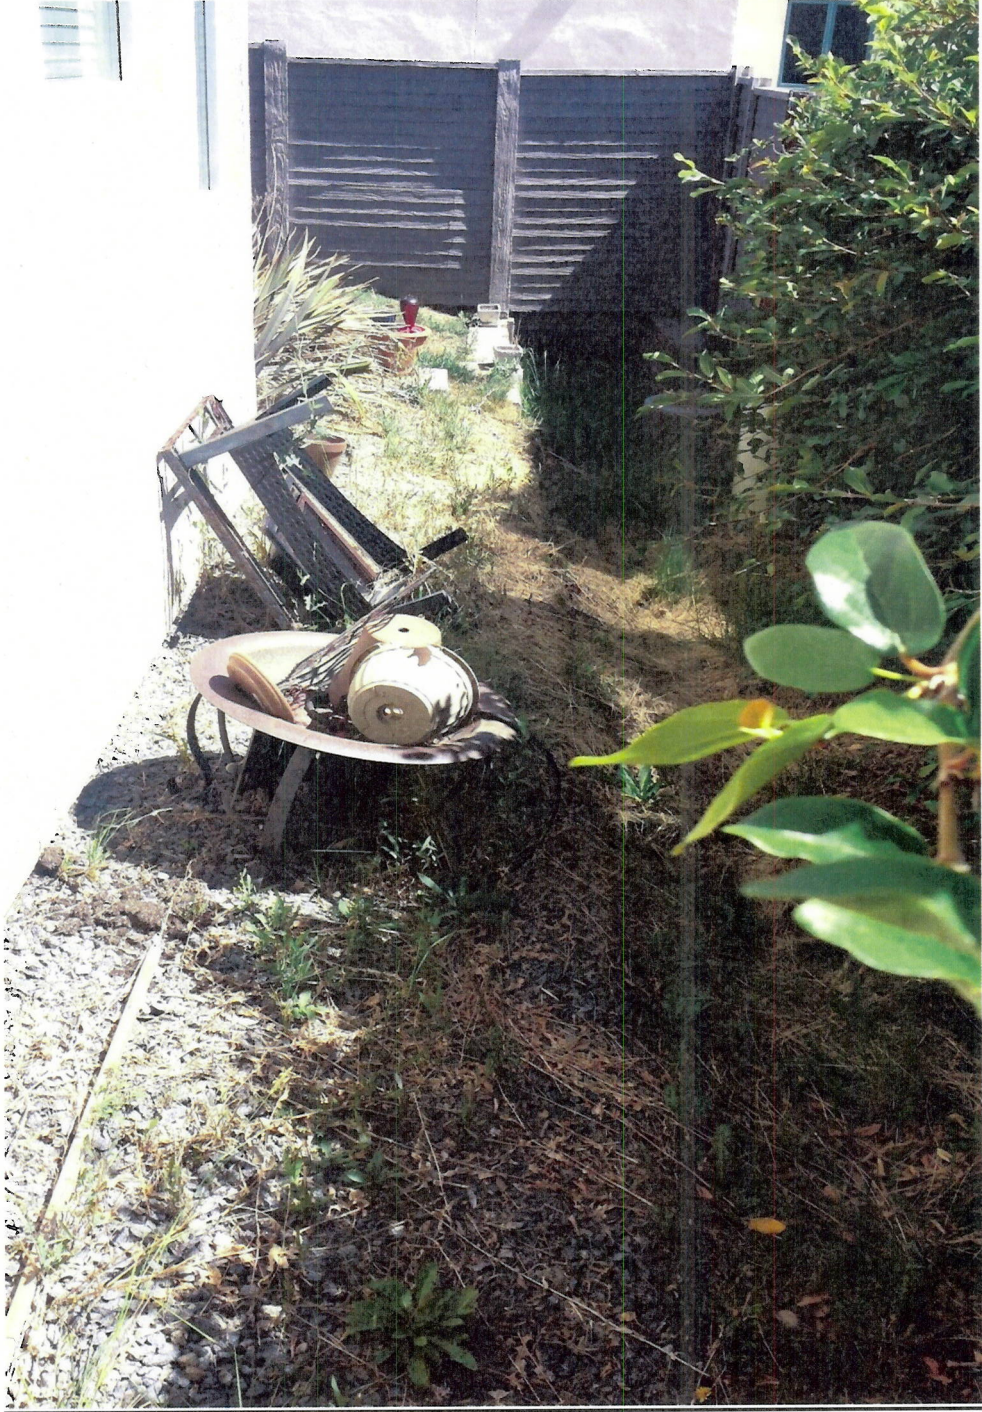
Photo 7(c): Bioswale located in the side yard of residence.
