**SUBJECT: Notice of Violation No. R9-2015-0154 for Construction Storm Water Violations at the LOSSAN/Mid Coast Corridor Rail Project in Rose Canyon (WDID 937C373277)**

**NOTICE OF VIOLATION**  
**No. R9-2015-0154**

**FACILITY INSPECTION REPORT**

**FACILITY:** LOSSAN-Mid Coast Corridor Project      **INSPECTION DATE/TIME:** 9/15/2015; 2:00 pm  
**WDID/FILE NO.:** 937C373277

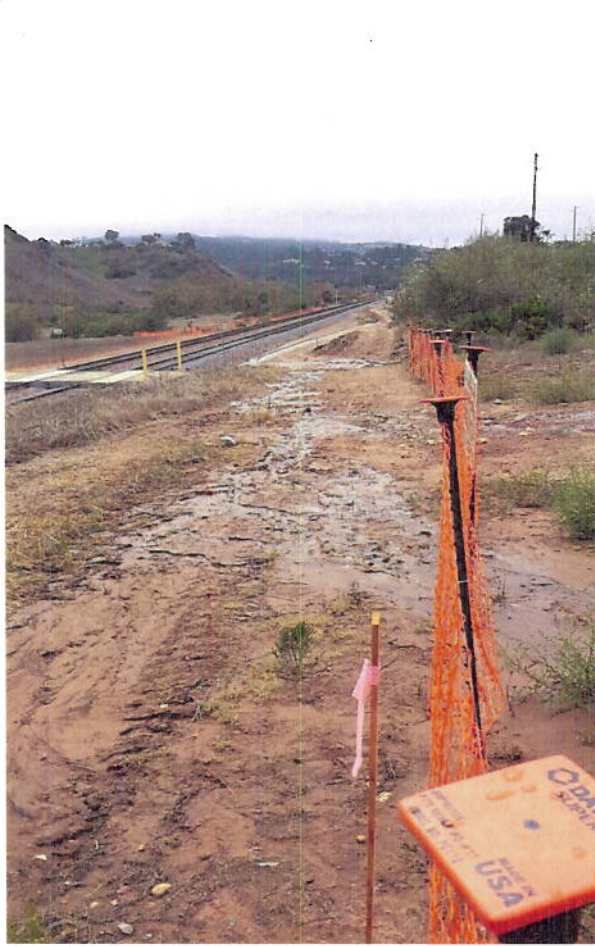
Photo 1

1. Missing and/or ineffective perimeter control- project boundaries were only partially identified with construction fencing. Construction fencing alone is an ineffective form of perimeter control because it does not provide any form of erosion control.

2. Inadequate runoff/runoff controls- Evidence of runoff without BMPs was noted throughout northern project boundary. All construction sites are required to effectively manage runoff, all runoff within the site, and all runoff that discharges off the site.

Photos 1 and 2 show runoff onto project site and inadequate perimeter control.

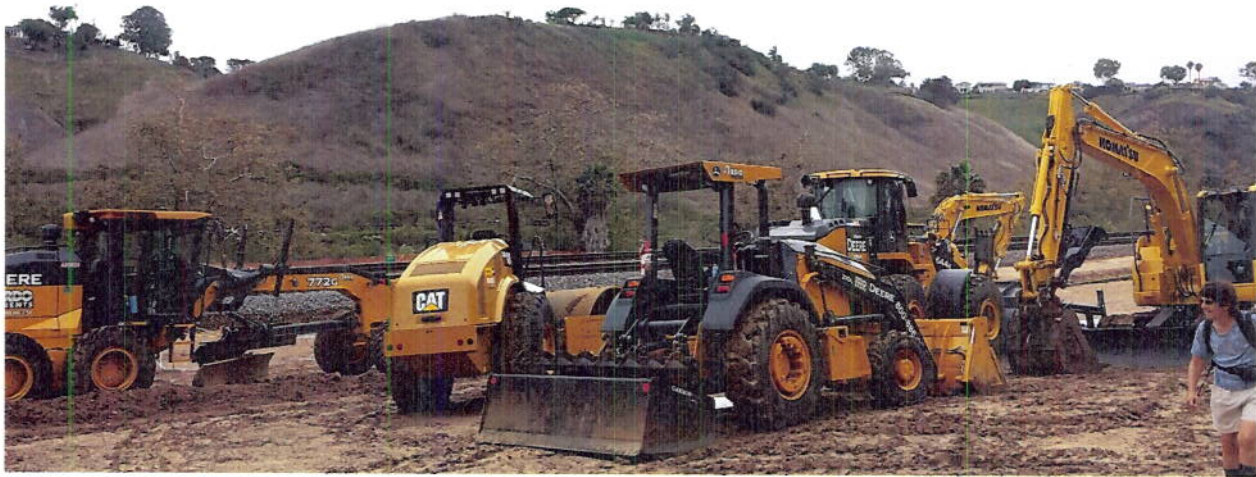
Photo 3

3. Construction equipment and vehicles observed without appropriate BMPs (e.g. drip pans) to prevent oil, grease, or fuel to leak into the ground, storm drains, or surface waters. All construction sites are required to prevent oil, grease or fuel to leak in to the ground, storm drains, or surface waters, and to place all equipment and vehicles, which are to be fueled, maintained and stored in a designated area fitted with appropriate BMPs.

Photos 3 and 4 show construction vehicles without appropriate BMPs (e.g. drip pans) to prevent oil, grease, or fuel to leak into the ground, storm drains, or surface waters. Photo 4 shows that (some) BMPs were present but not in use.

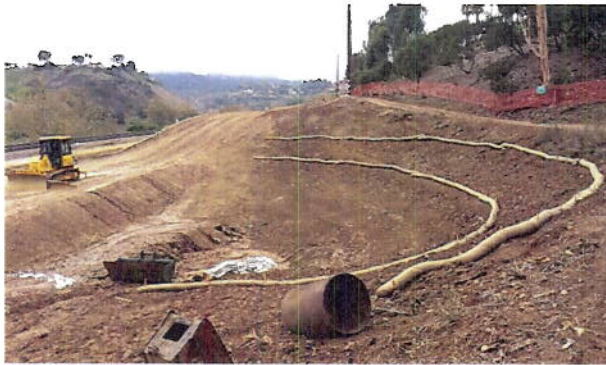
Photo 5

4. Missing and/or ineffective erosion control BMPs- Multiple slopes showed evidence of rilling and erosion. Although site representatives stated that slopes were sprayed with tackifier as part of their REAP, it was not evident from the site visit. It is likely that the tackifier was applied inappropriately, not given sufficient time to cure, and/or may have washed off during the storm.

**Photos 5 through 8** show several slopes lacking effective soil cover for erosion control.

Photos 5 & 6 show rilling on the north and south bank of a constructed bowl.

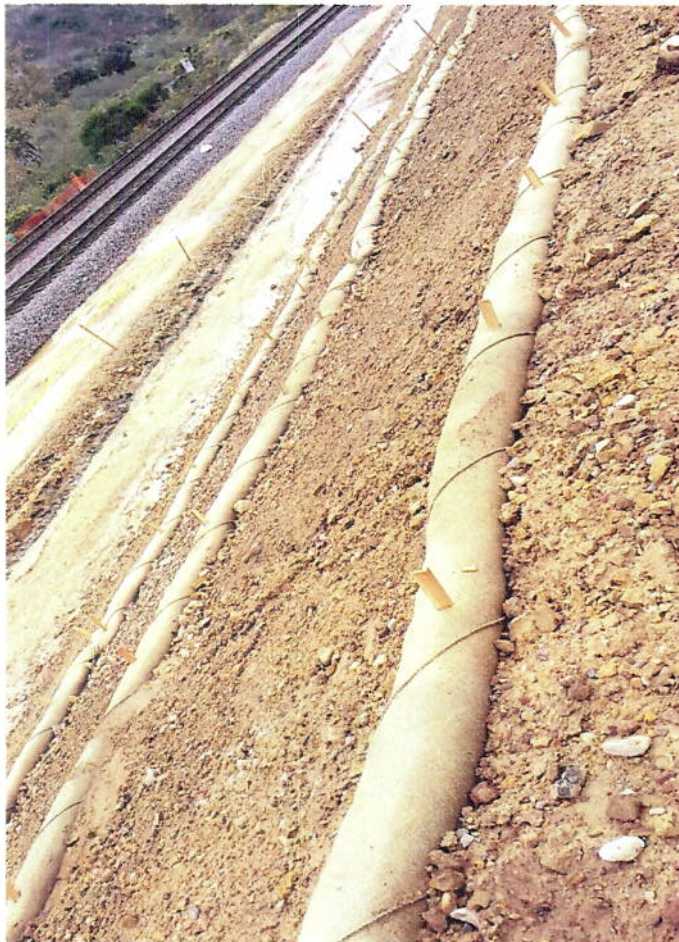
Photo 7 shows what appears to be a finished (i.e. inactive) slope with rilling.

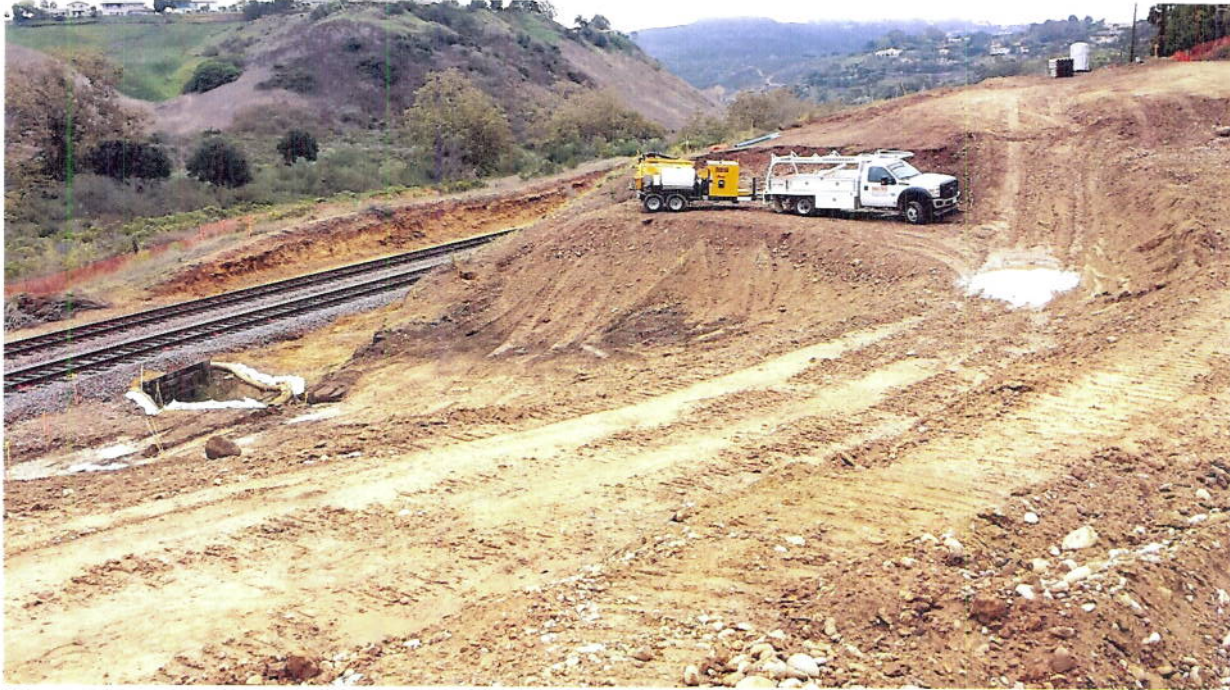
**Photo 8**

5. Missing and/or ineffective sediment control BMPs- Several slopes throughout the site were observed to lack linear sediment controls along the toe and grade breaks of exposed slopes. Some slopes had wattles that were improperly staked as evidenced by sagging and rilling. Risk Level 2 construction sites are required to apply linear sediment controls along the toe of the slope, face of the slopes, and at the grade breaks of exposed slopes to comply with sheet flow lengths given in Table 1 of Attachment D to the CGP.

Photo 8 shows another constructed bowl with no sediment or erosion control.

**Photos 8-11** show missing or ineffective sediment control BMPs. Photo 8 contains no sediment or erosion controls. Photos 9 and 10 show slopes with no linear controls along the toe and grade breaks. Photo 9 also demonstrates that wattles that were improperly installed, as evidenced by sagging and rilling. Photo 11 shows rilling due to missing linear controls at grade breaks.

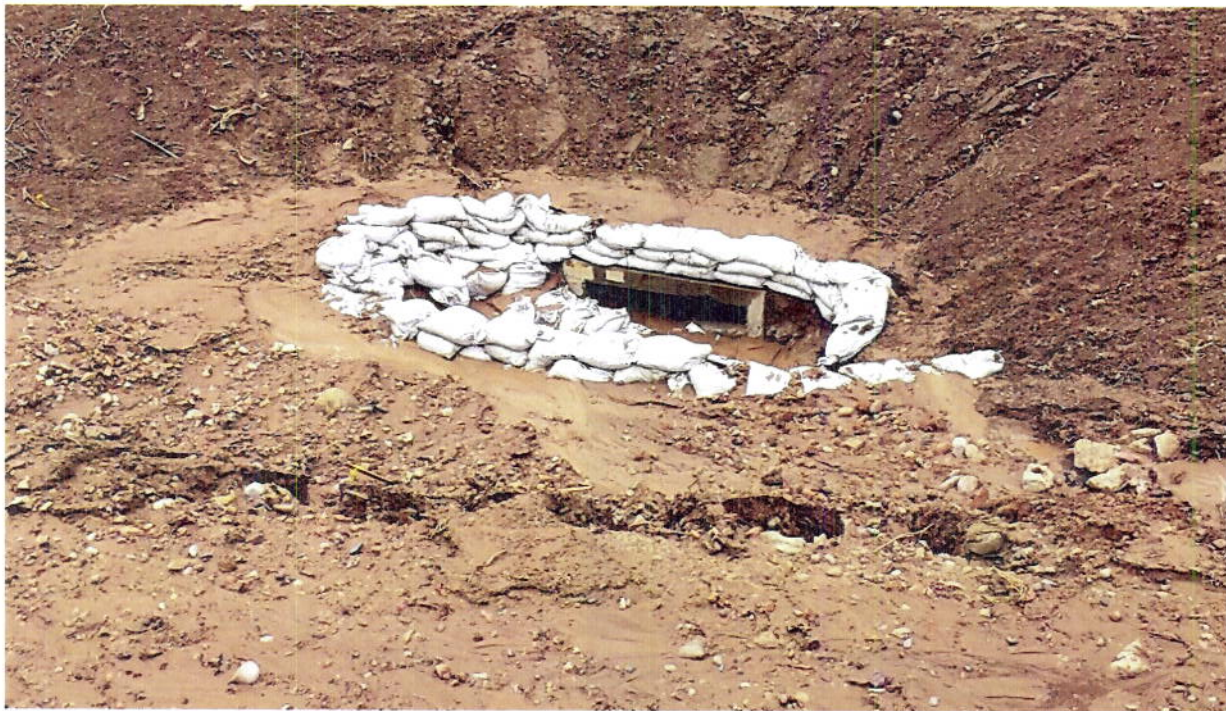
6. Unauthorized discharges- Multiple unauthorized discharges of sediment and sediment laden stormwater to Rose Creek were observed due to missing or ineffective BMPs.

**Photos 12 -15** show unauthorized discharges of sediment and sediment laden storm-water from the site to Rose Creek due to missing and ineffective BMPs.

**Photo 12** shows discharge from easternmost "bowl" due to inadequate perimeter, sediment, erosion, and runoff controls.

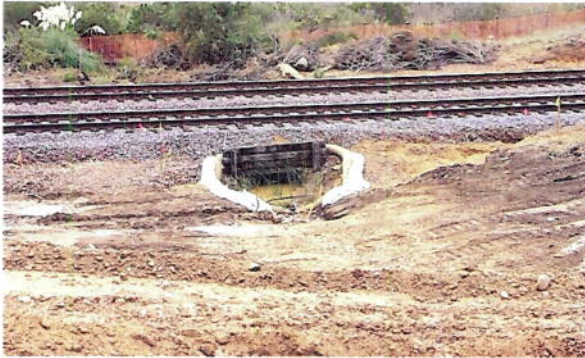
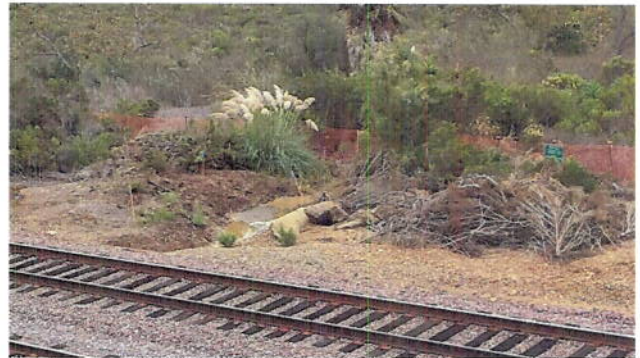
**Photo 13 and 14** show discharge from bowl #2 (shown in Photo 8), due to missing sediment or erosion controls.

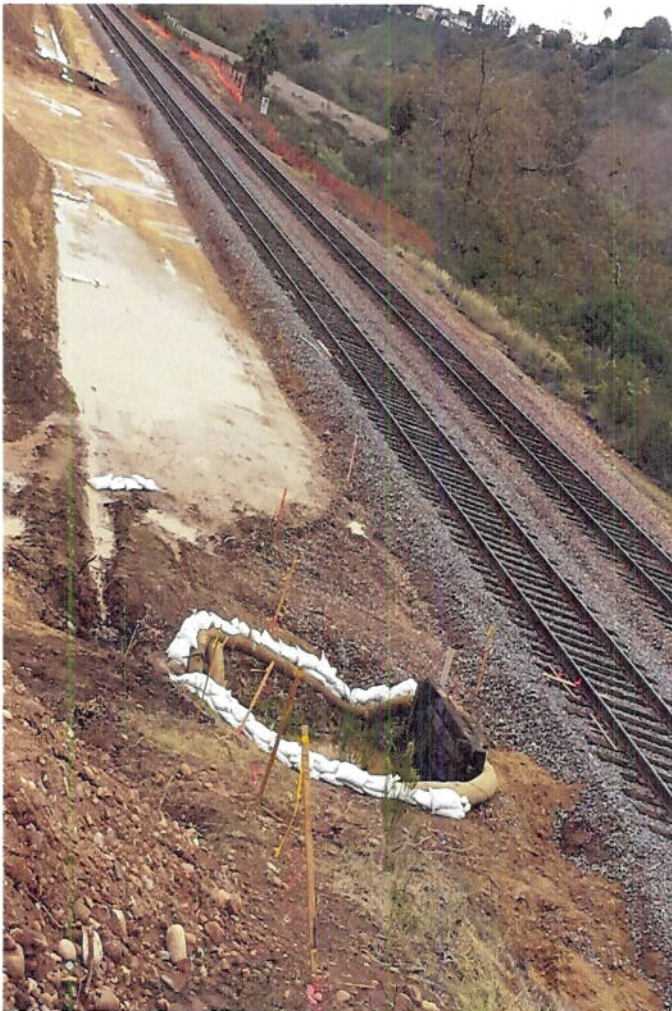
**Photo 15** shows discharge point #3 due to inadequate sediment and erosion control (shown in Photo 7).

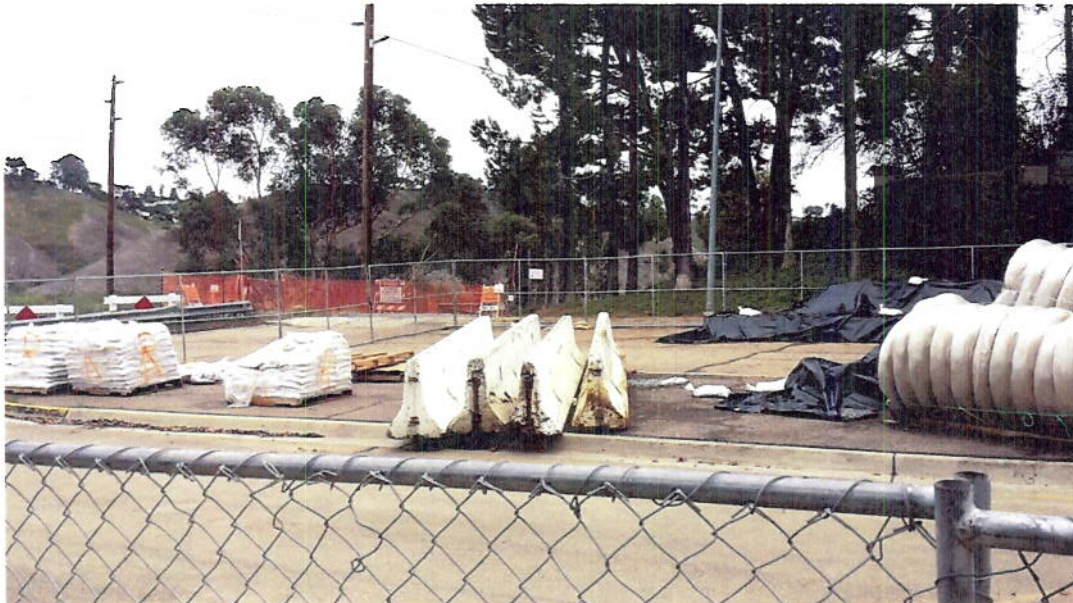
**Photo 16** shows additional BMPs (gravel bags and wattles) on site, but not in use.
