CONDITIONS AT POINT BUCKLER

RESPONSE TO CLEANUP AND ABATEMENT ORDER R2-2015-0038

October 16, 2015

Prepared by:
Applied Water Resources Corporation
2363 Mariner Square Dr., Suite 245, Alameda CA 94501

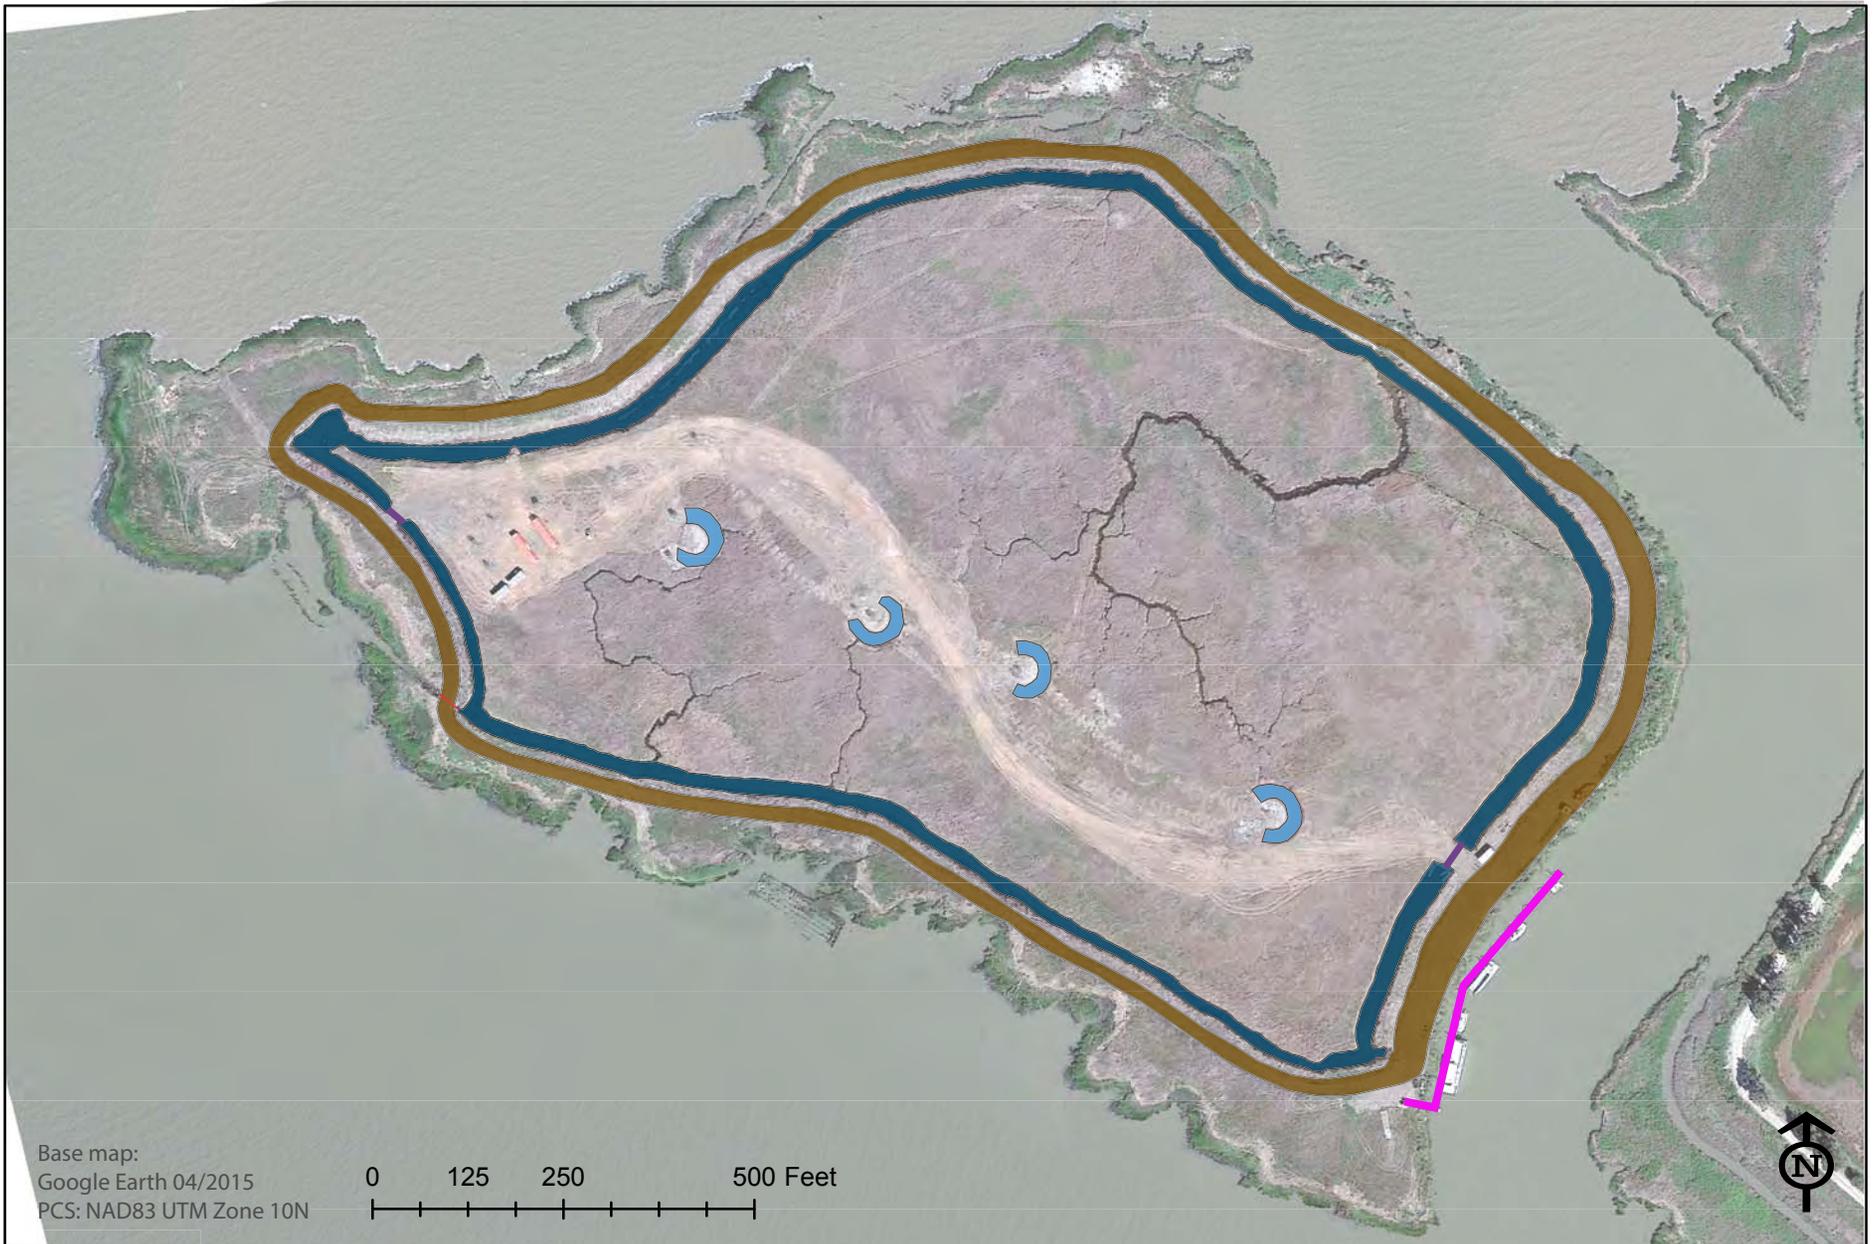
Figure - 1
**Locations of
 Recent Activities**
 Point Buckler, CA

This section discusses the recent activities at the Island. Locations of these activities are shown on Figure 1.

Levee repair activities occurred in 2014. The repaired levee system is approximately 4,730 feet in length and spoils from the excavation of the repaired ditch system were used for the repair. Approximately 58% of the repaired levee system is located in its historical location, while approximately 42% is located further inland to avoid filling in the bay. Approximately 305 feet of the repaired levee system was located in the old ditch system's footprint.

Ditch repair activities occurred at the same time as levee repair activities because spoils were used to repair the levee system. A functional 24-inch floodgate was found in the southwest portion of the Island and was replaced with new flaps on each end to allow for water to enter the ditch system. Two 24-inch diameter steel pipe culverts were also installed to allow for water circulation on the Island.

Two arc-like shaped ponds were dug in late 2014 and two more were in the process of being dug at the Island when work was stopped prior to completion. The two completed ponds are approximately 4-5 feet deep.

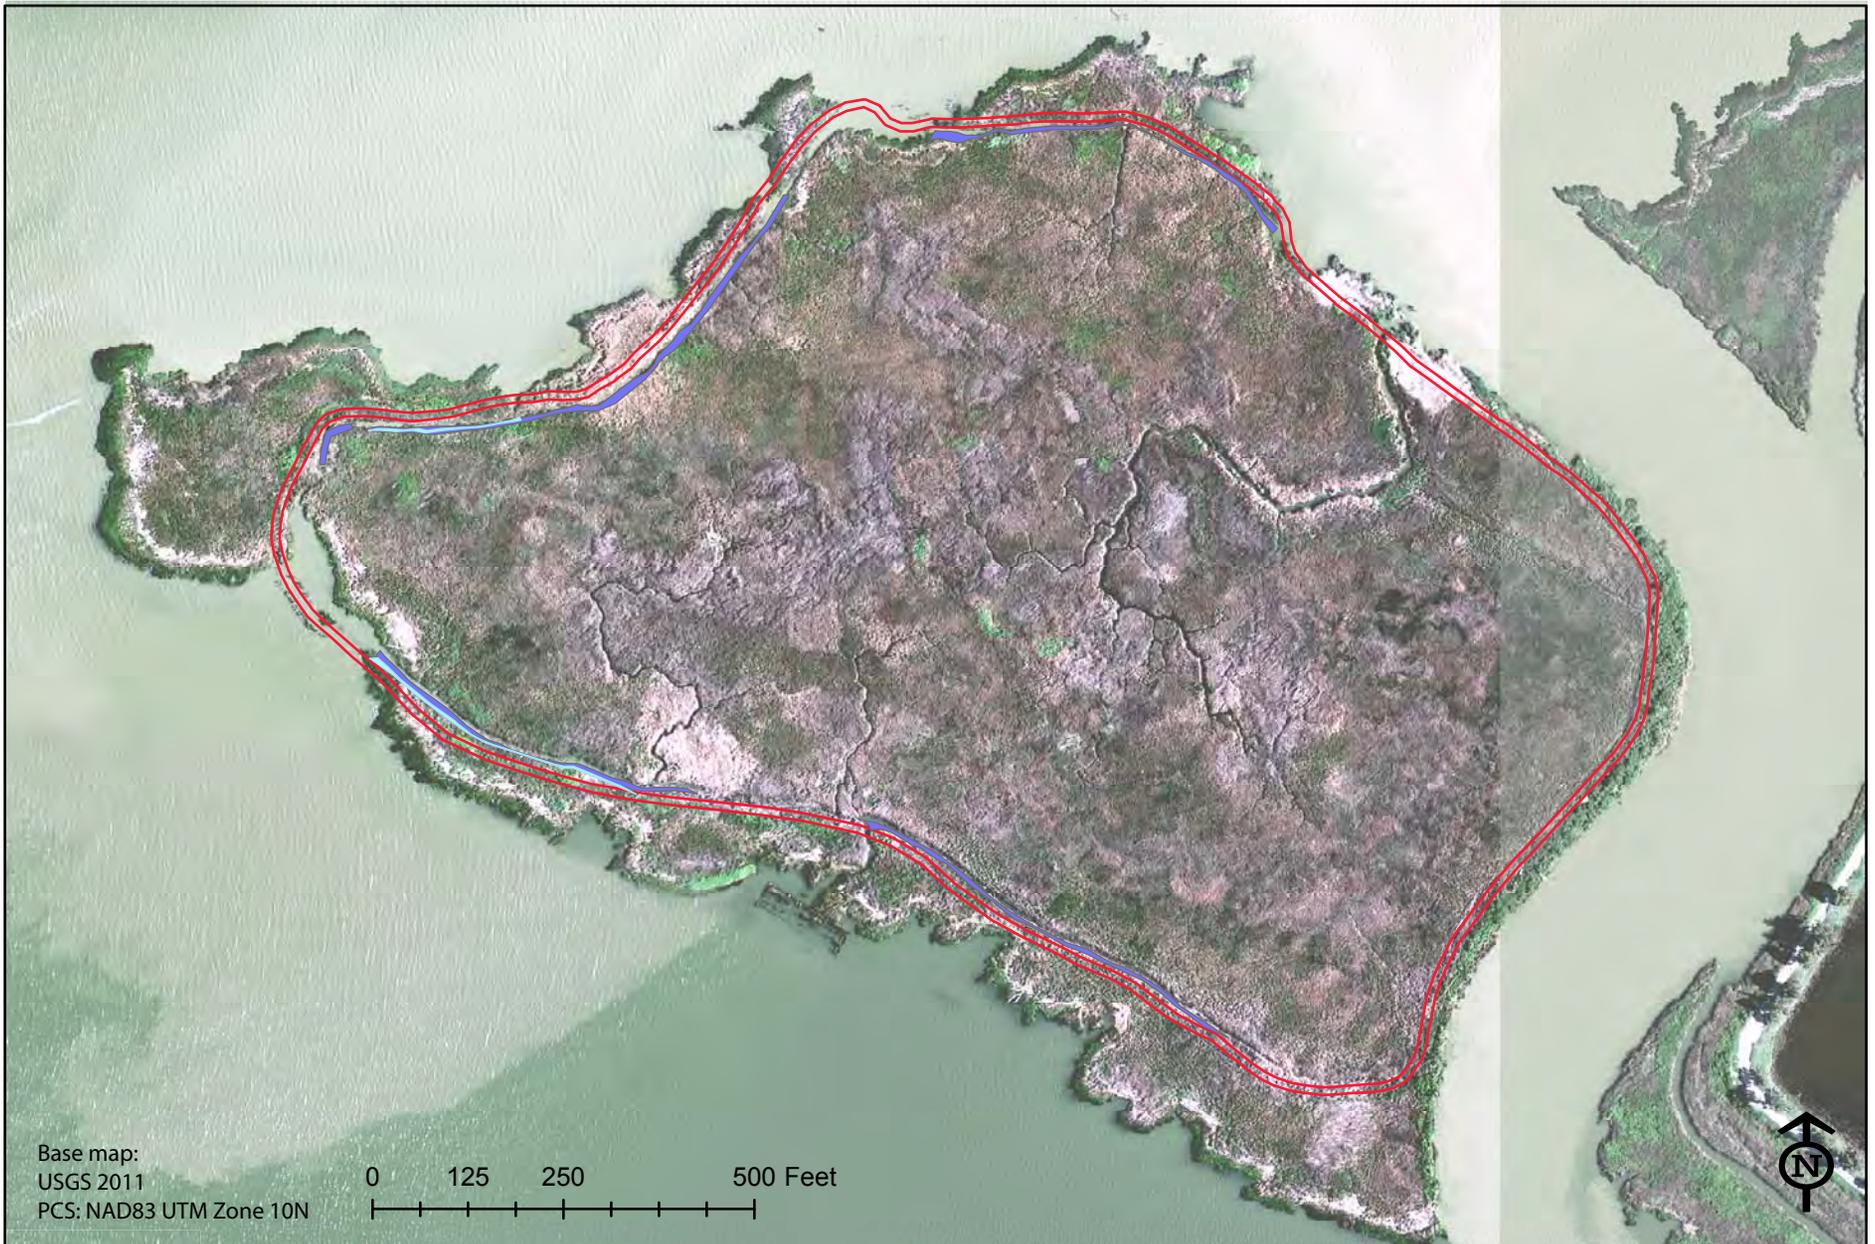
Figure - 2
 Extent of Water in
 Old Ditch System

Figure 2 depicts the extent of water present in the old ditch system at MLLW and MHW. Figure 3 depicts the extent of water present in the channels at MLLW and MHW. Figure 4 depicts the areas where fill materials were placed into waters of the State.

Prior to the recent repair of the levee and ditch systems, there was approximately 4,200 feet of old ditch system that was bounded on both sides by land. Of this, approximately 601 feet of the old ditch system contained water at MLLW and 2,321 feet of the old ditch system contained water at MHW, per the 2013 NOAA photos.

Biologists consider the wetted edge of a channel to provide potential habitat and nutrient exchange between ground water and surface water. Evaluated from the perspective of a wetted edge, approximately 1,203 feet of the old ditch system provided a wetted edge at MLLW and 4,642 feet of the old ditch system provided a wetted edge at MHW, per the 2013 NOAA photos. Recent activities at the Island have repaired the ditch system, which now consistently contains water all the time. As a result, the current length of the repaired ditch system is 4,380 feet, which provides approximately 9,058 feet of wetted edge.

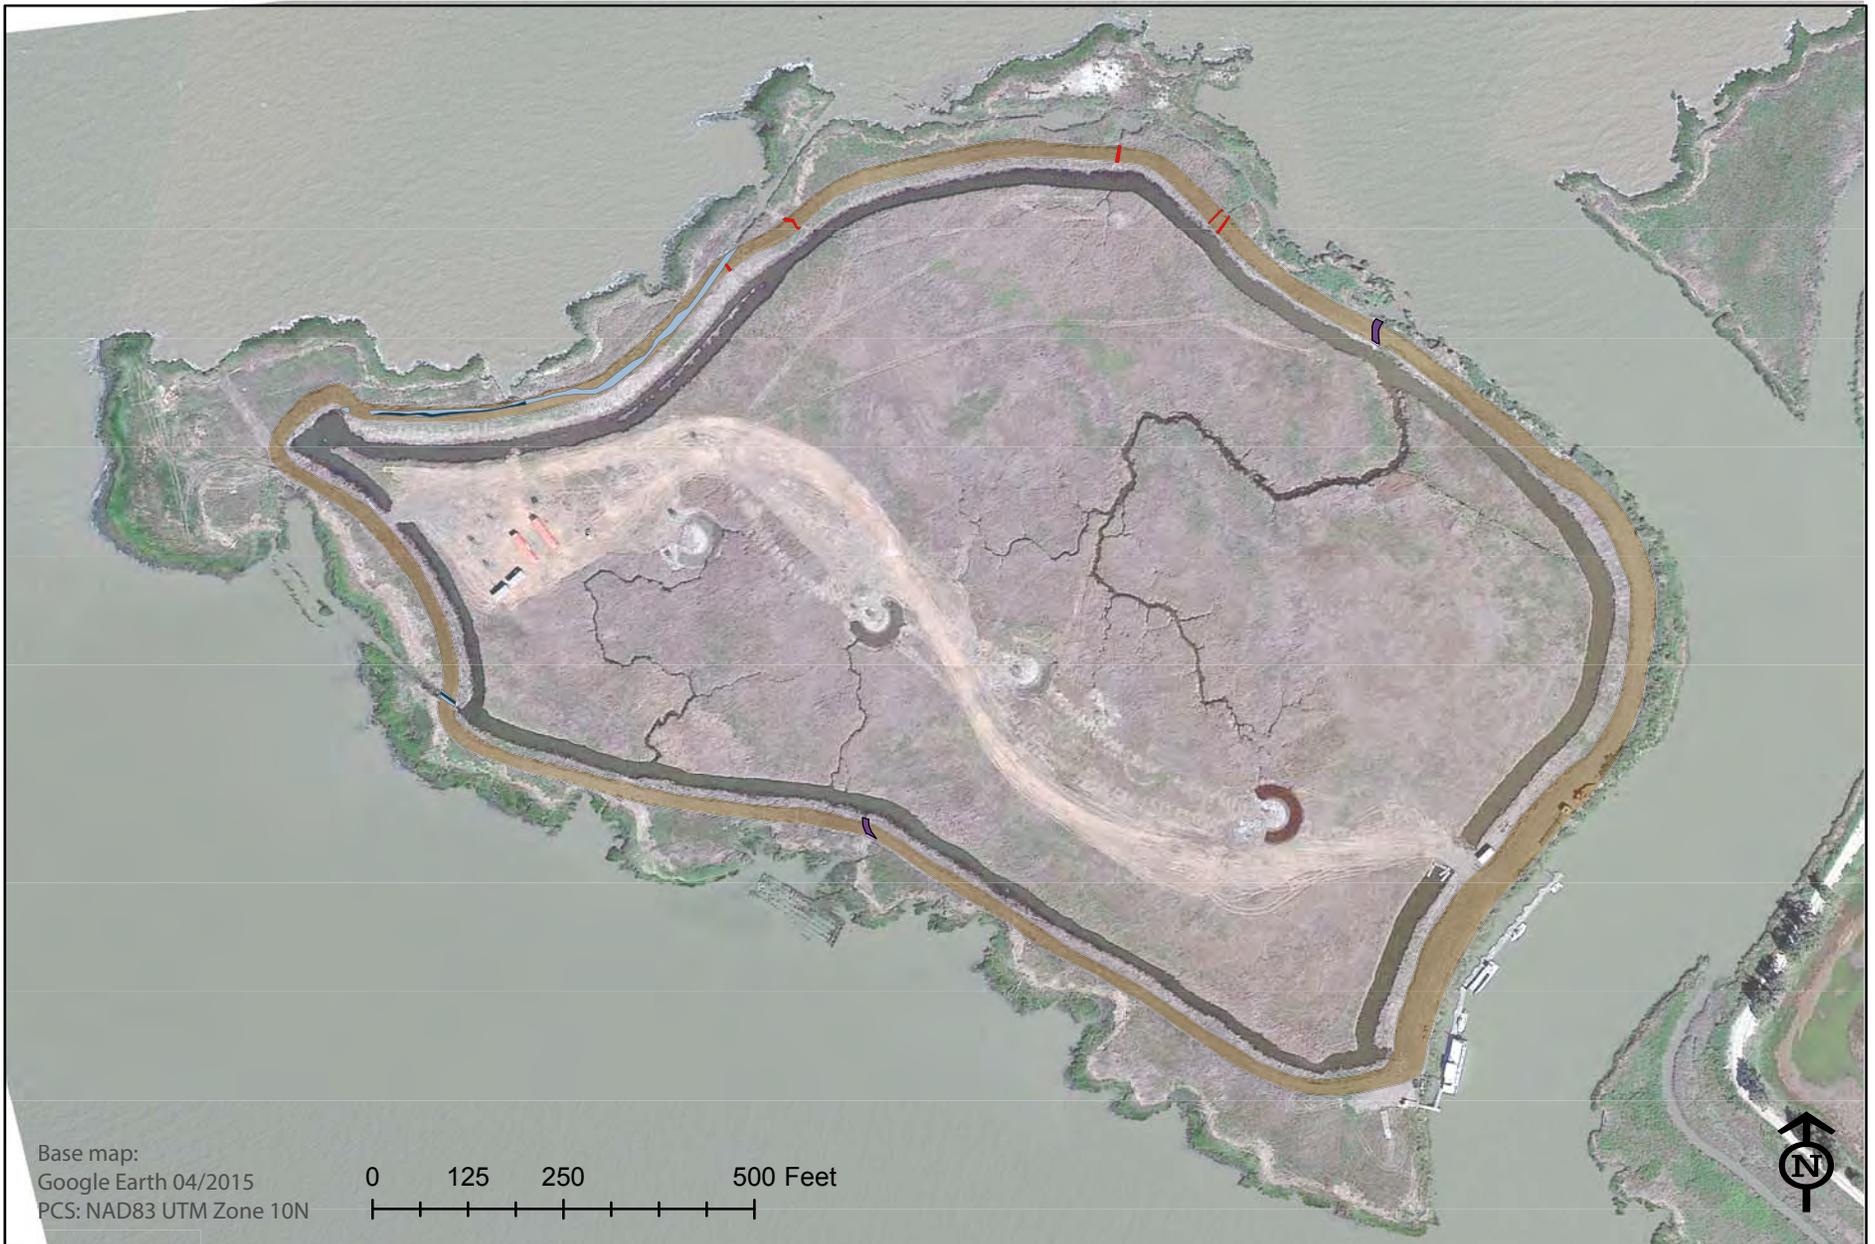
Figure - 4
 Areas of Fill Placed into
 Waters of the State
 Point Buckler, CA

The area of fill was identified by overlaying the aerial photos showing the extent of water (2013 NOAA photos) and the current conditions (2015 GEarth). Areas where the extent of water in old ditch system and channel are co-located with fill used to repair the levee system are considered the area where fill was placed into waters of the State. The thickness of fill is assumed to be the full tidal range plus 1 foot in areas where water is present at both MHW and MLLW. The thickness of fill is assumed to be at half the tidal range in areas where the old ditch system and channel appear to have water at MHW but have no water at MLLW. The calculation of the volume of fill material placed into waters of the State is simply the product of multiplying the area by the thickness.

The NOAA 2013 photos reveal reaches of the old ditch system where no water appears to be present at MHW and MLLW, such as along the eastern margin of the Island. It appears that these areas silted in over time, and based on the 2011 and 2013 aerial photos many of the areas appear to be vegetated. Consequently, in areas where the repaired levee system overlies these silted in portions of the old ditch system, no fill was introduced to waters of the State.

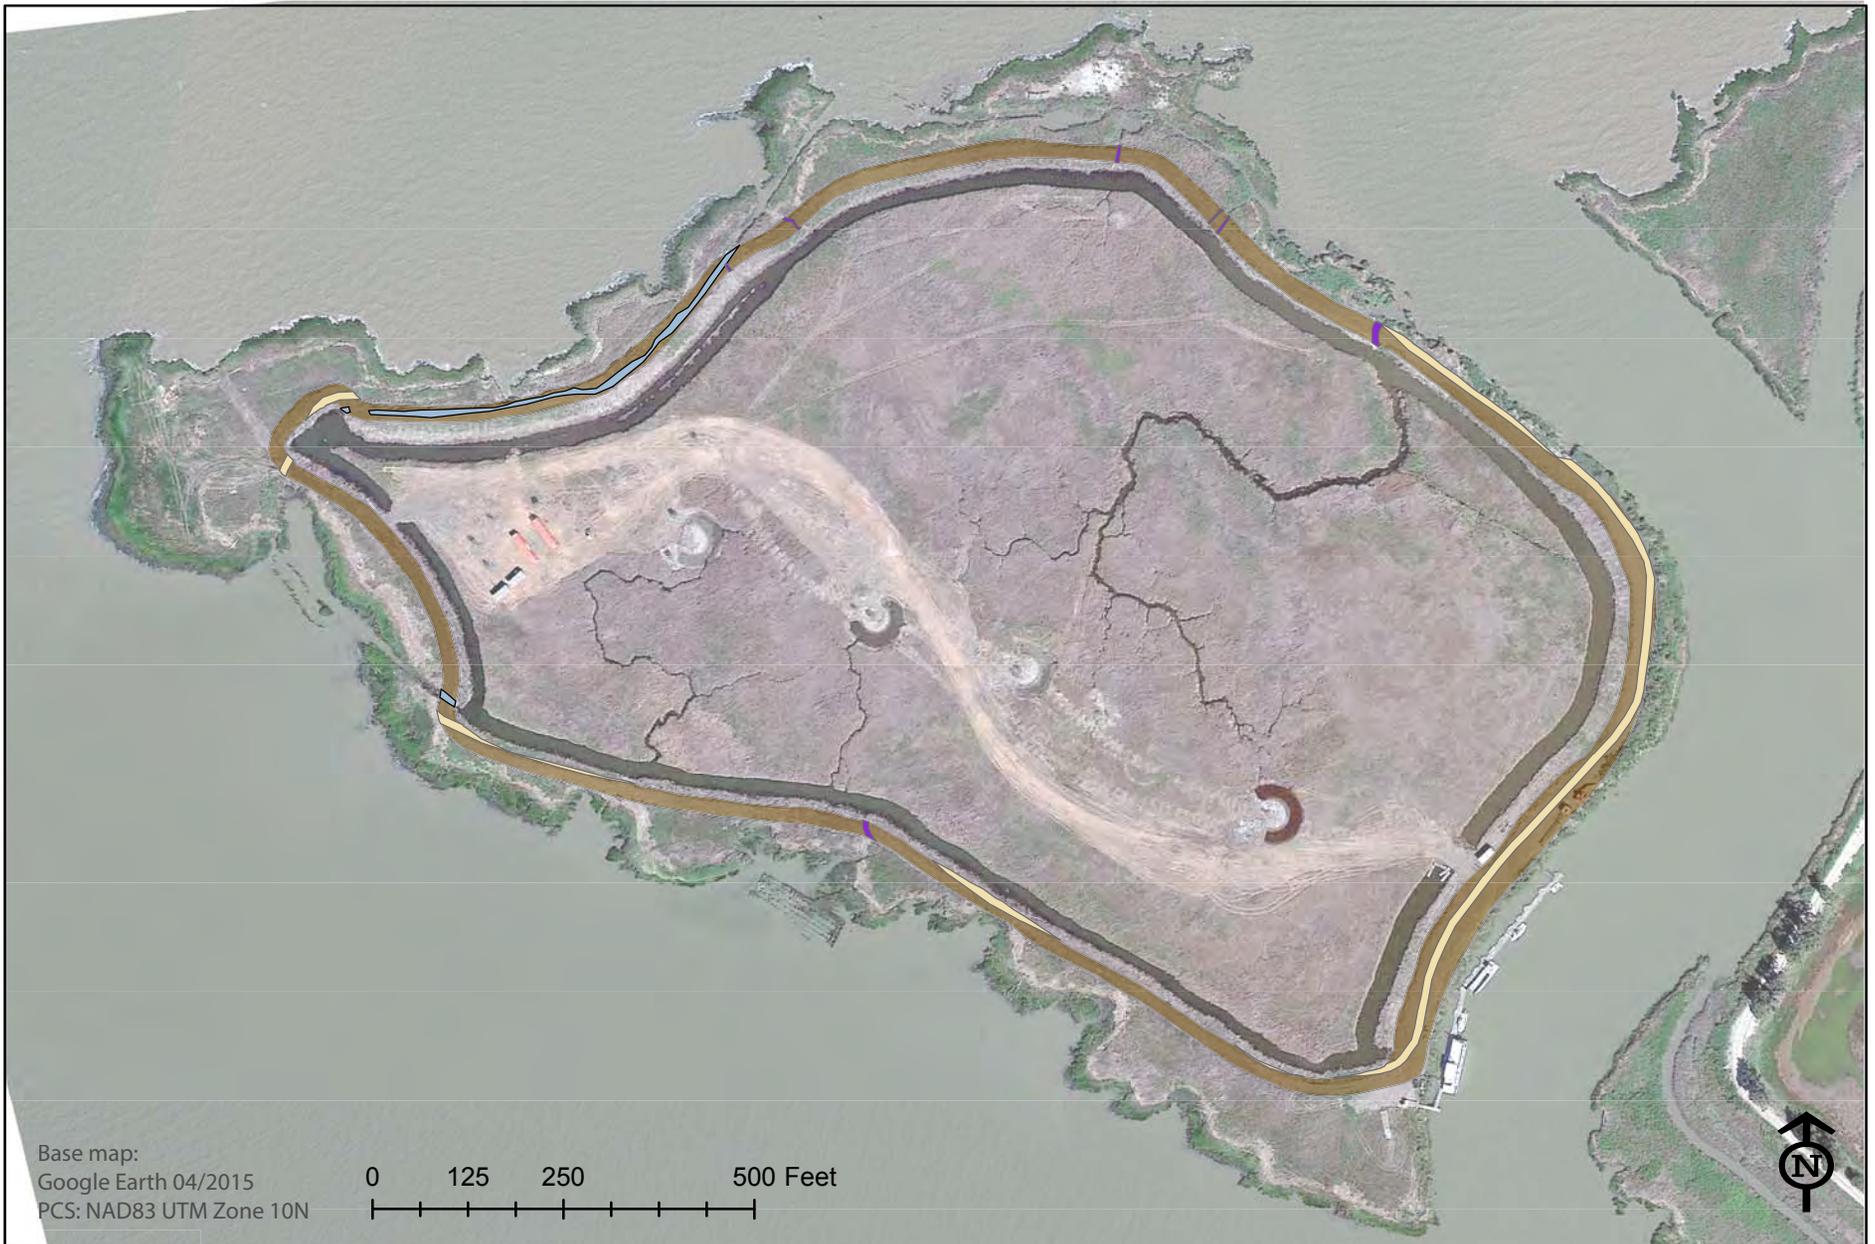
Per conversation with John Sweeney, approximately 50% of the area of the old levee system was covered with vegetation, therefore 50% of the area of coincidence of old levee system and repaired levee system is interpreted to be removed vegetation. Vegetation is also interpreted to have been removed where the repaired levee system is located on areas of the Island that were not previously ditch or levee, as shown on Figure 6.
