Photo Log for Greg Gearheart on January 13, 2010
San Leandro Plastics Facilities
San Leandro, CA

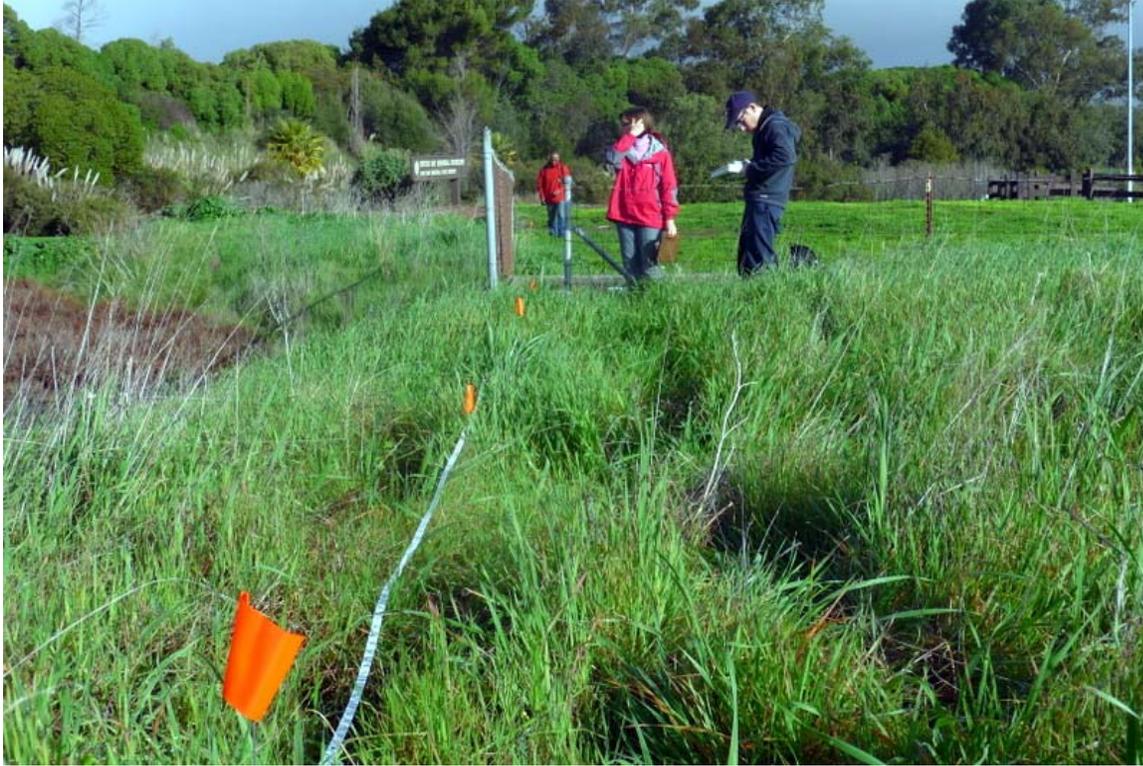
Figure 1 – Sampling near Northern Outfall on Neptune Drive

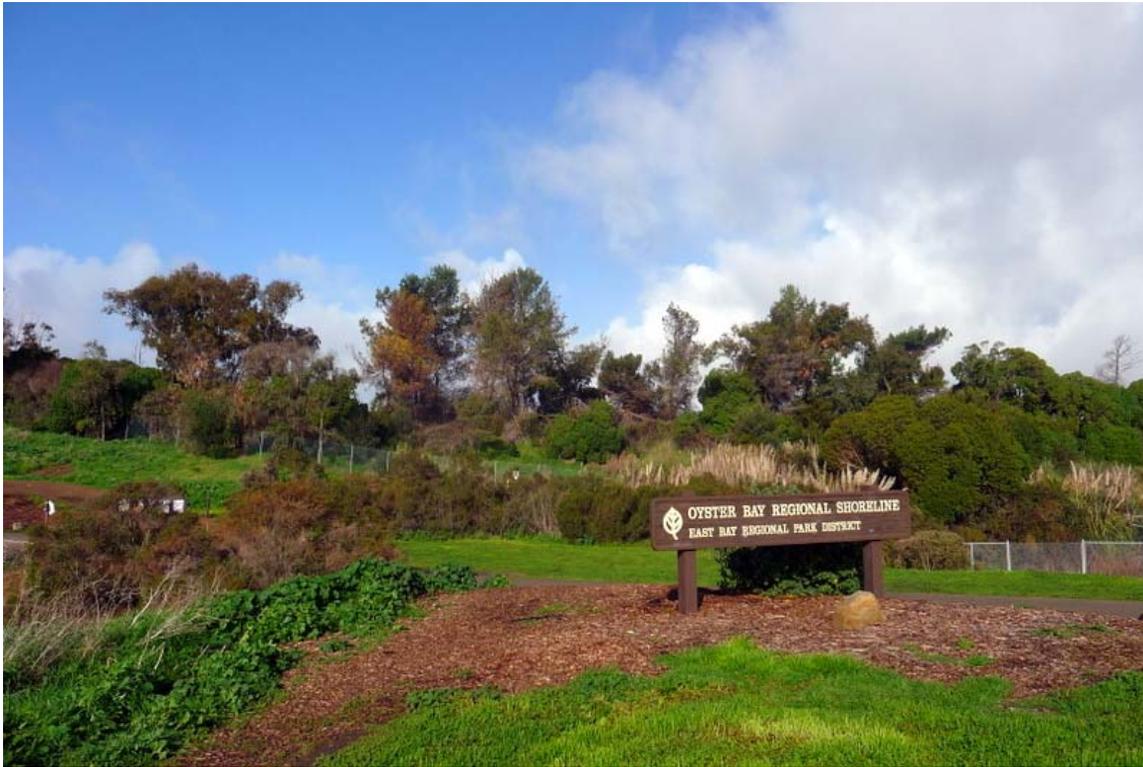
Figure 2 - General Area of Northern Outfall on Neptune Drive

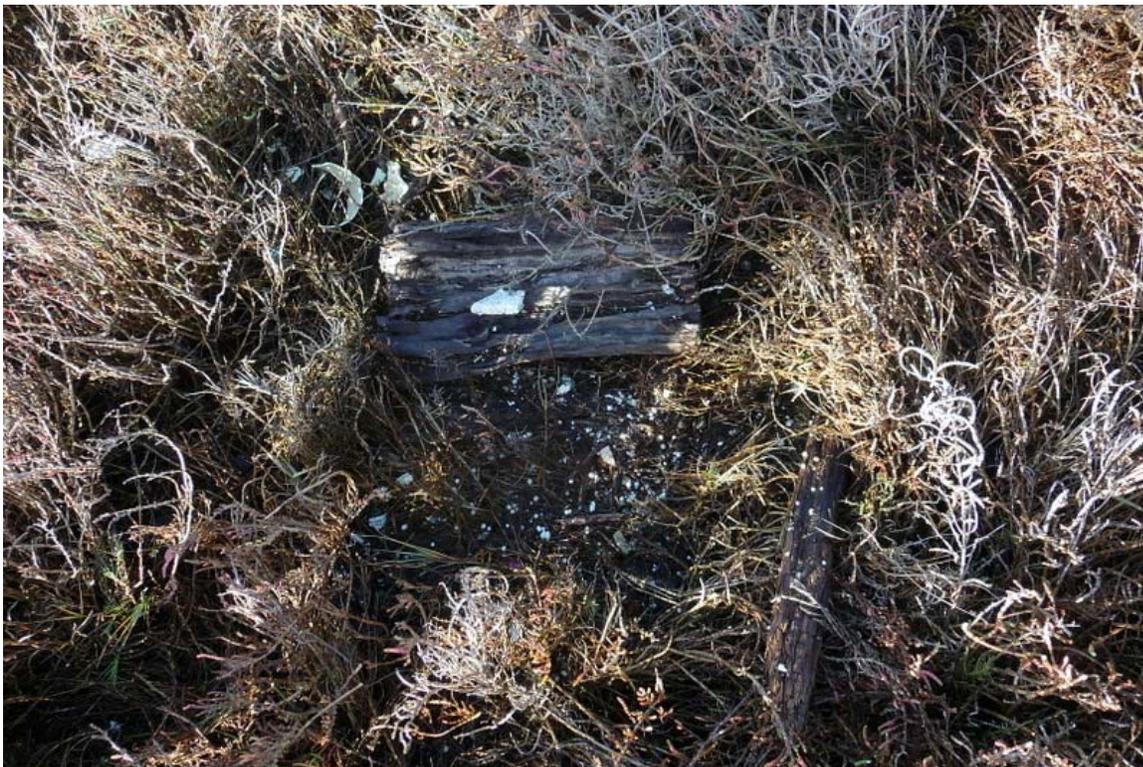
Figure 3 - Plastic Pellets and Debris in the Tidal Area near Northern Outfall on Neptune Drive

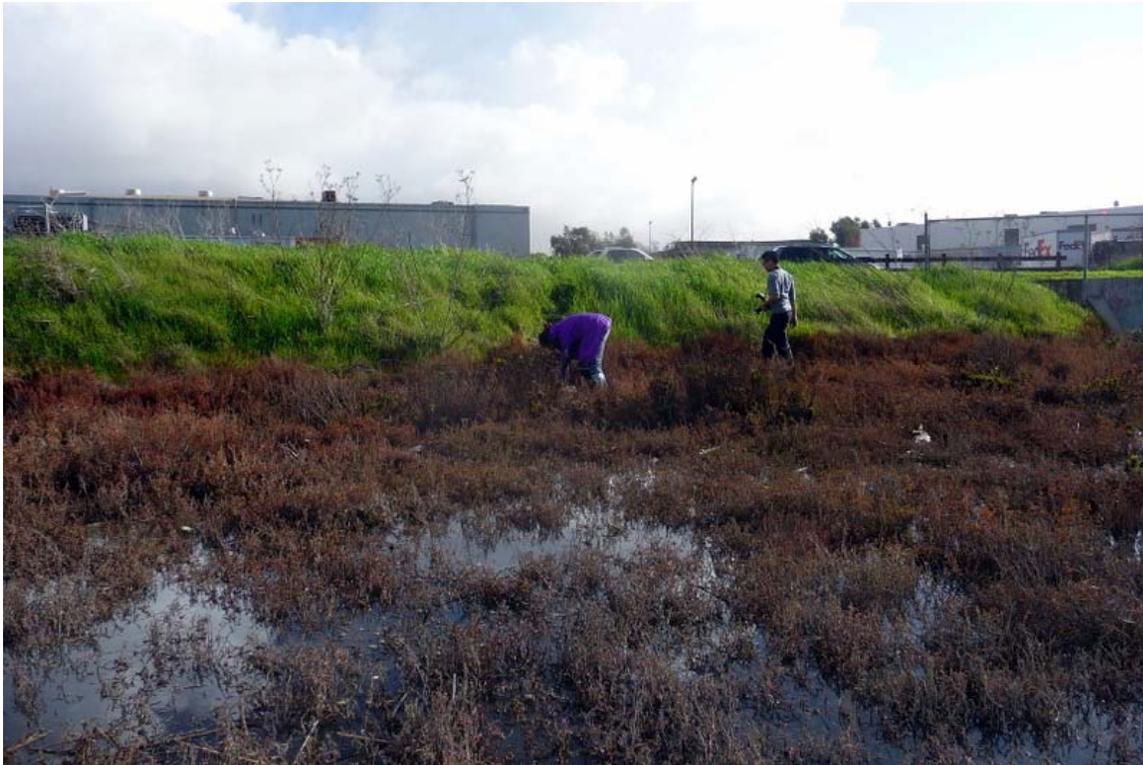
Figure 4 - Sampling the Northern Outfall Area on Neptune Drive

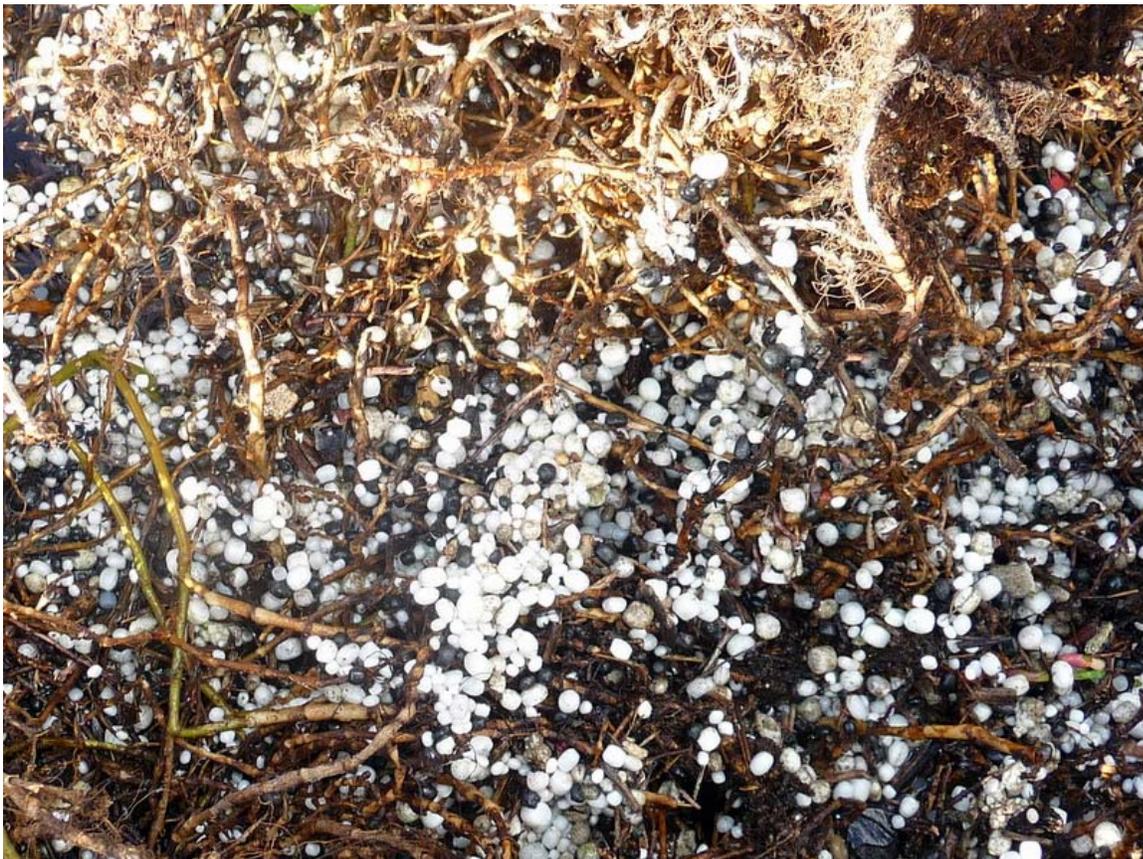
Figure 5 - Plastic Pellets in the Pickleweed at Northern Outfall on Neptune Drive

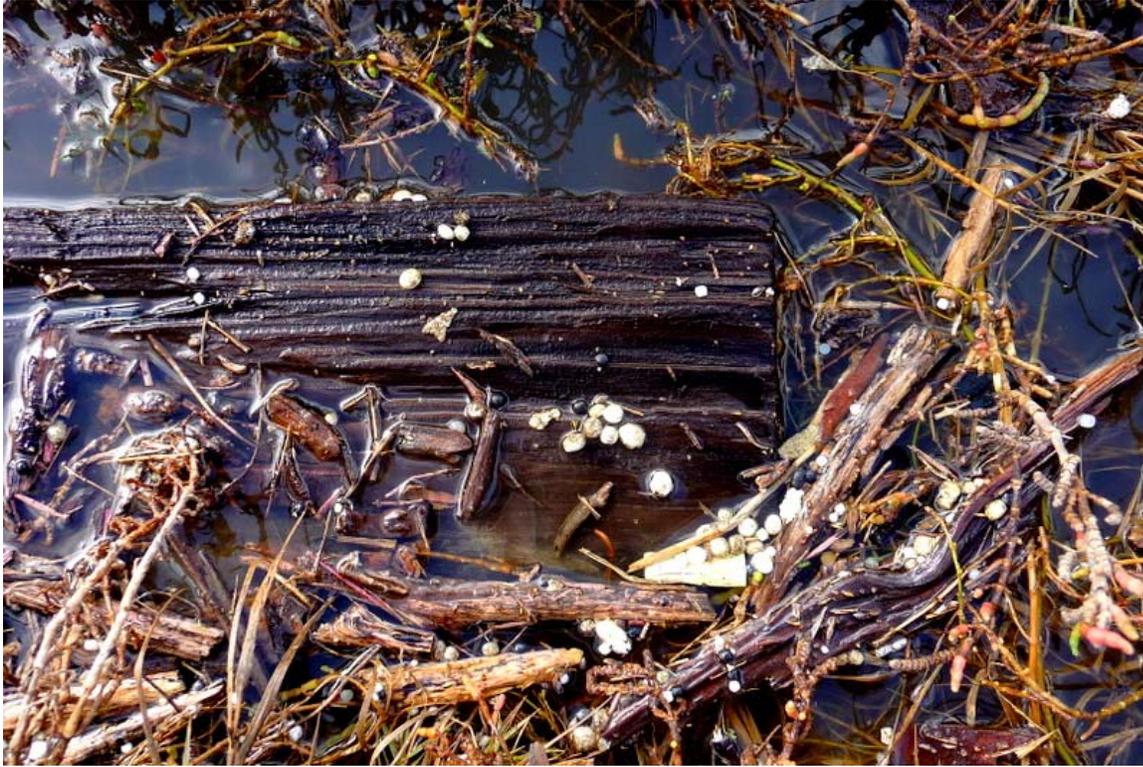
Figure 6 - Plastic Pellets in the San Francisco Bay Water Near Northern Outfall on Neptune Drive

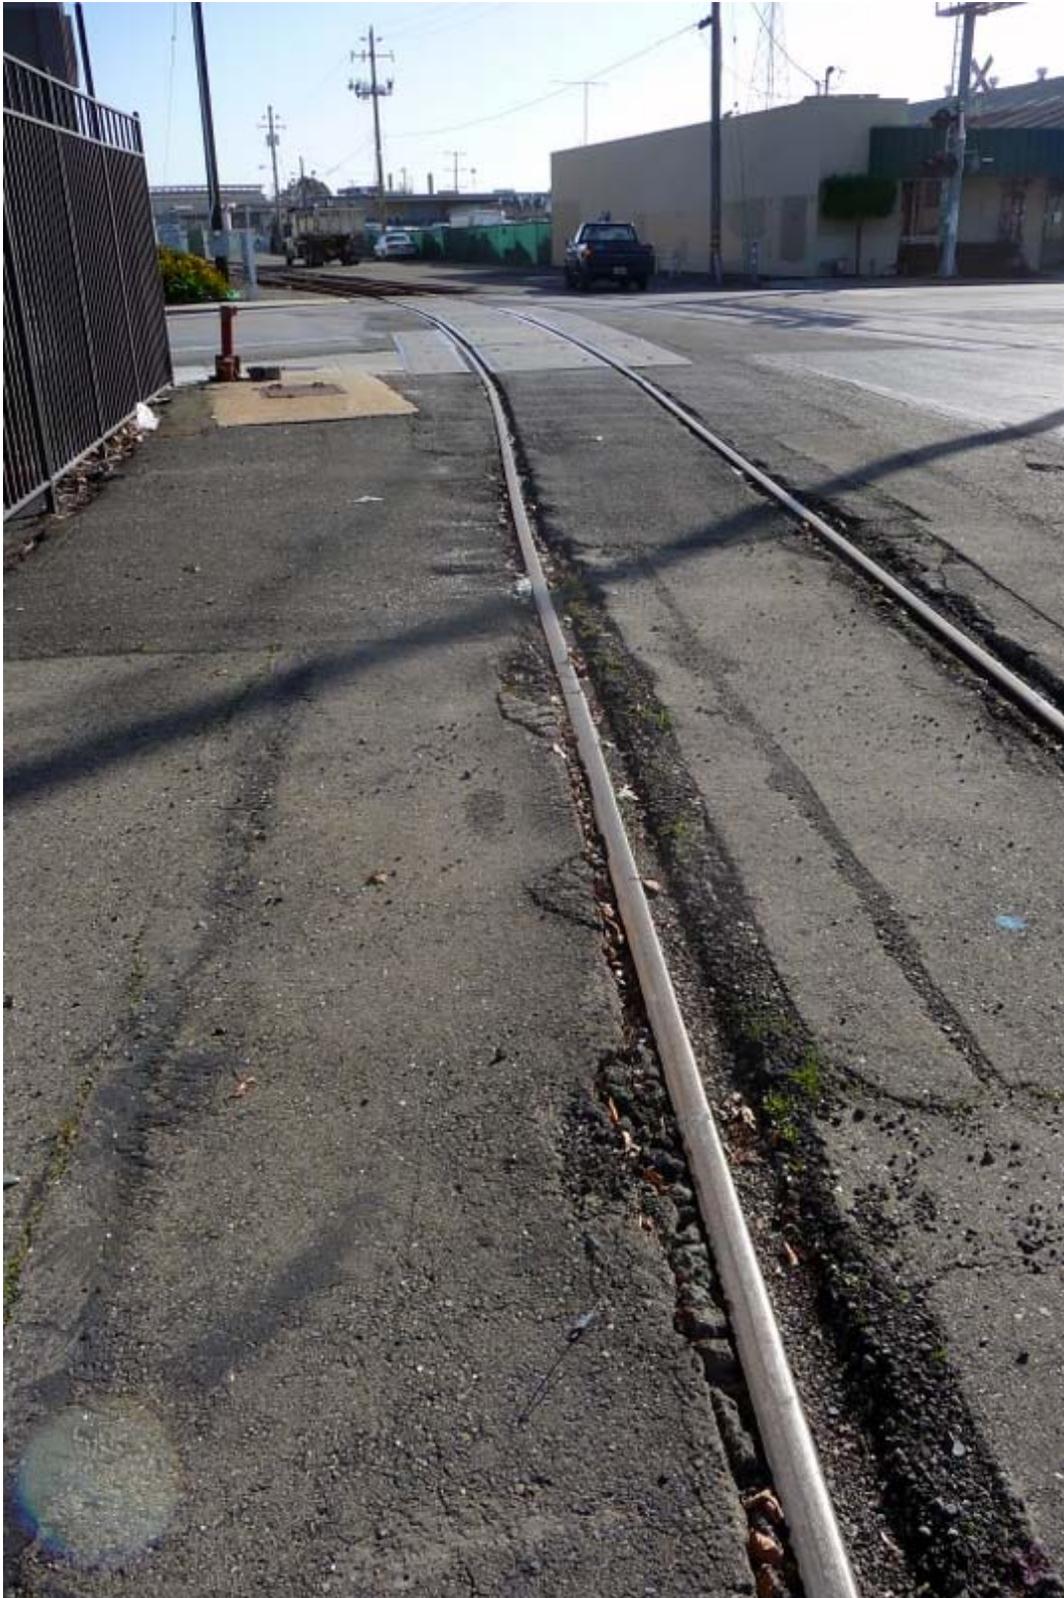
Figure 7 - Plastic Pellets on Paved Area Near Rail Siding West of Metro/Uni Poly Facility on Williams Street

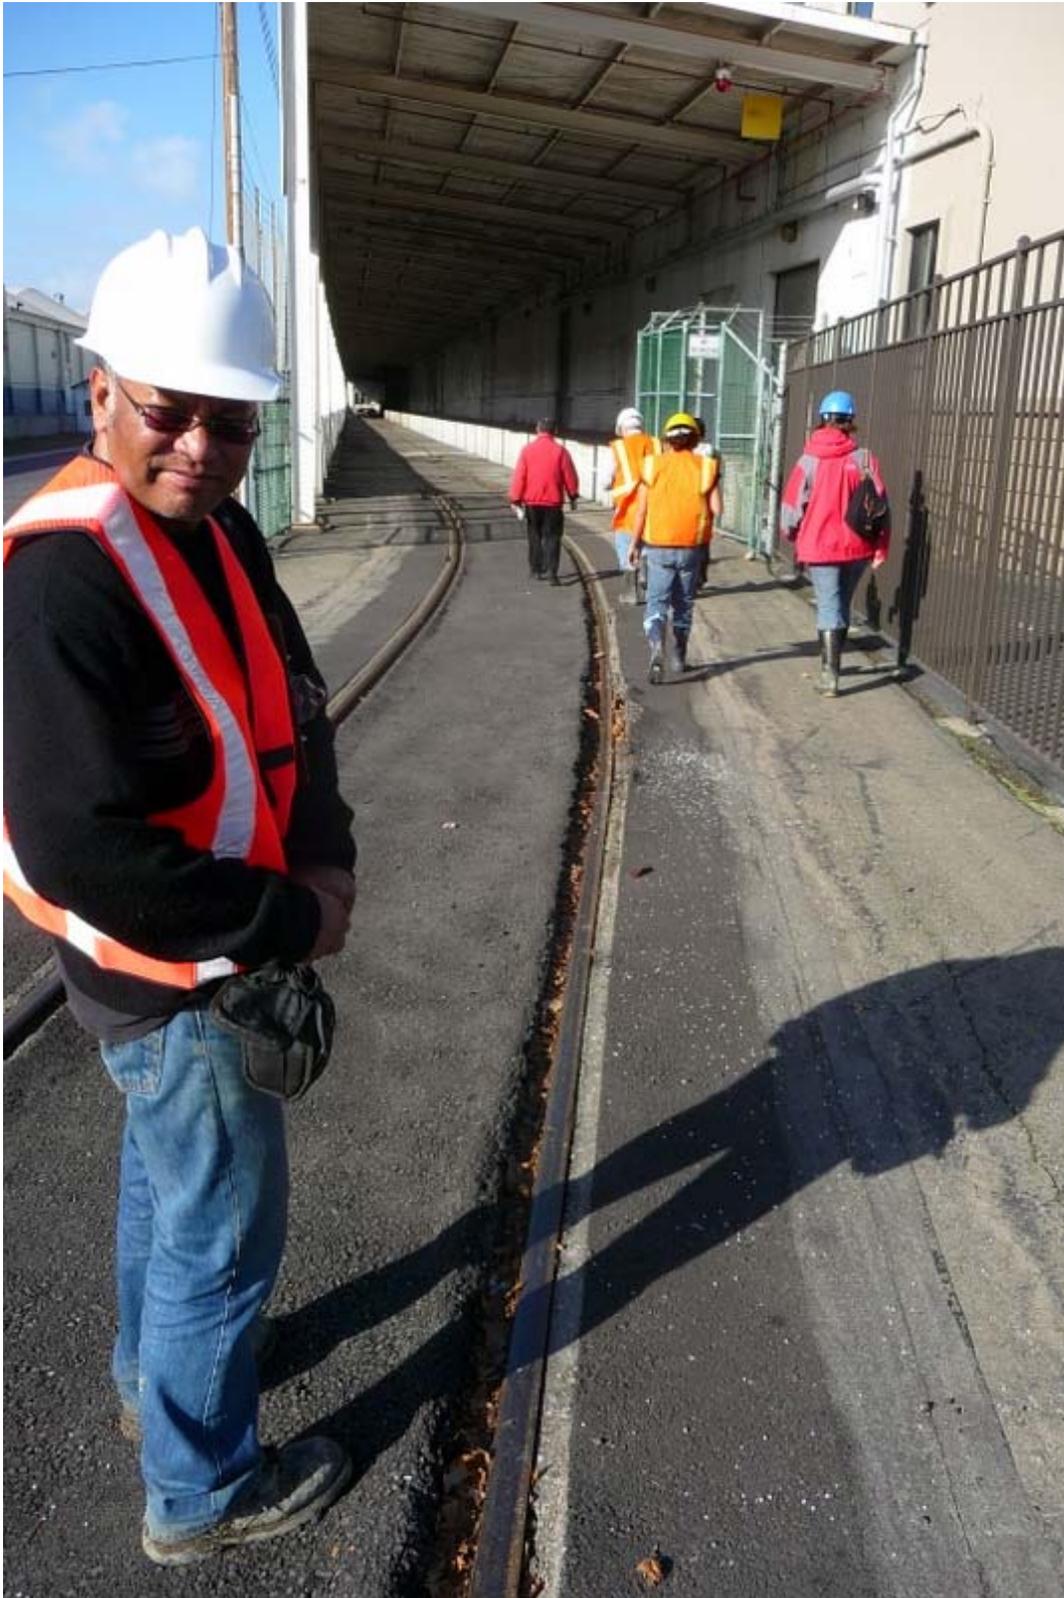
Figure 8 - Plastic Pellets on Paved Area Near Rail Siding West of Metro/Uni Poly Facility on Williams Street

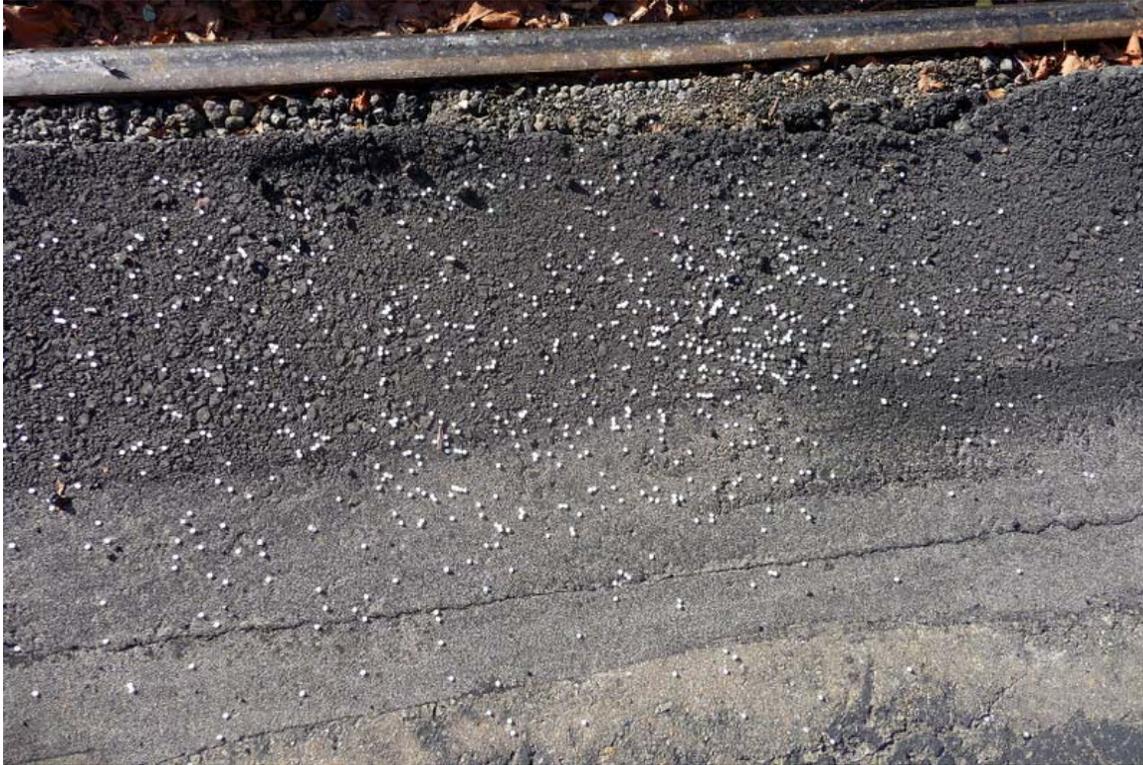
Figure 9 - Plastic Pellets on Paved Area Near Rail Siding West of Metro/Uni Poly Facility on Williams Street

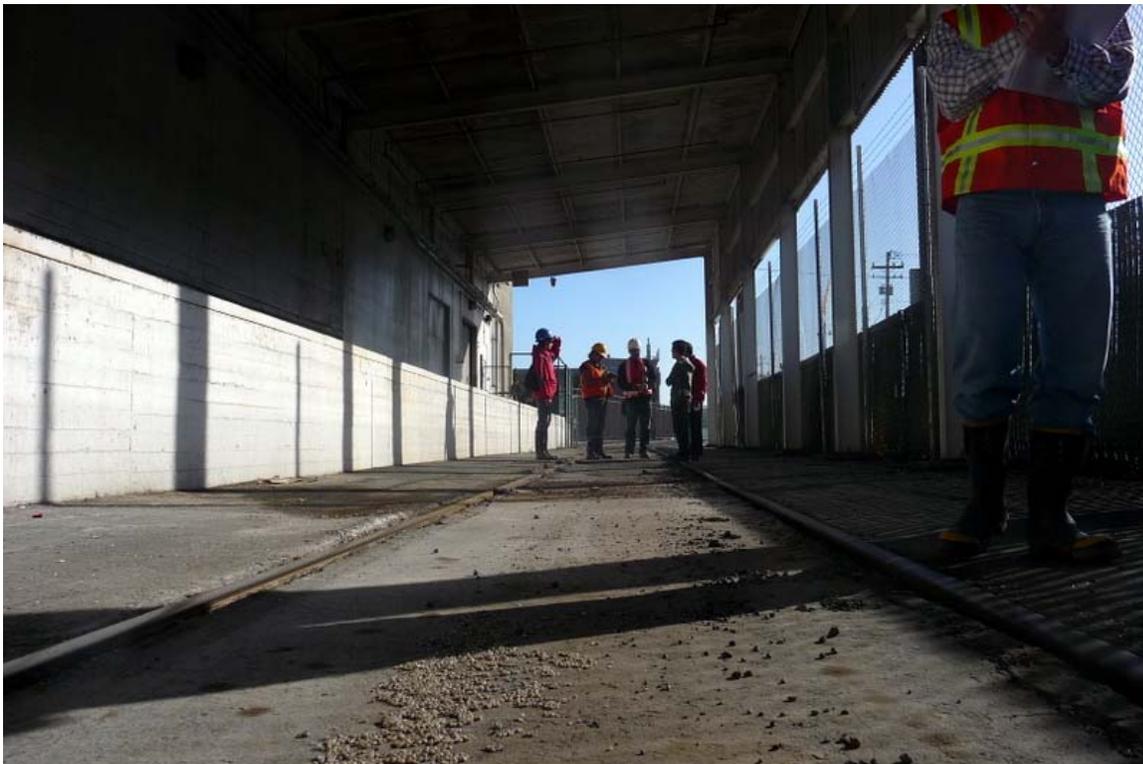
Figure 10 - Plastic Pellets on Paved Area Near Rail Siding West of Metro/Uni Poly Facility on Williams Street

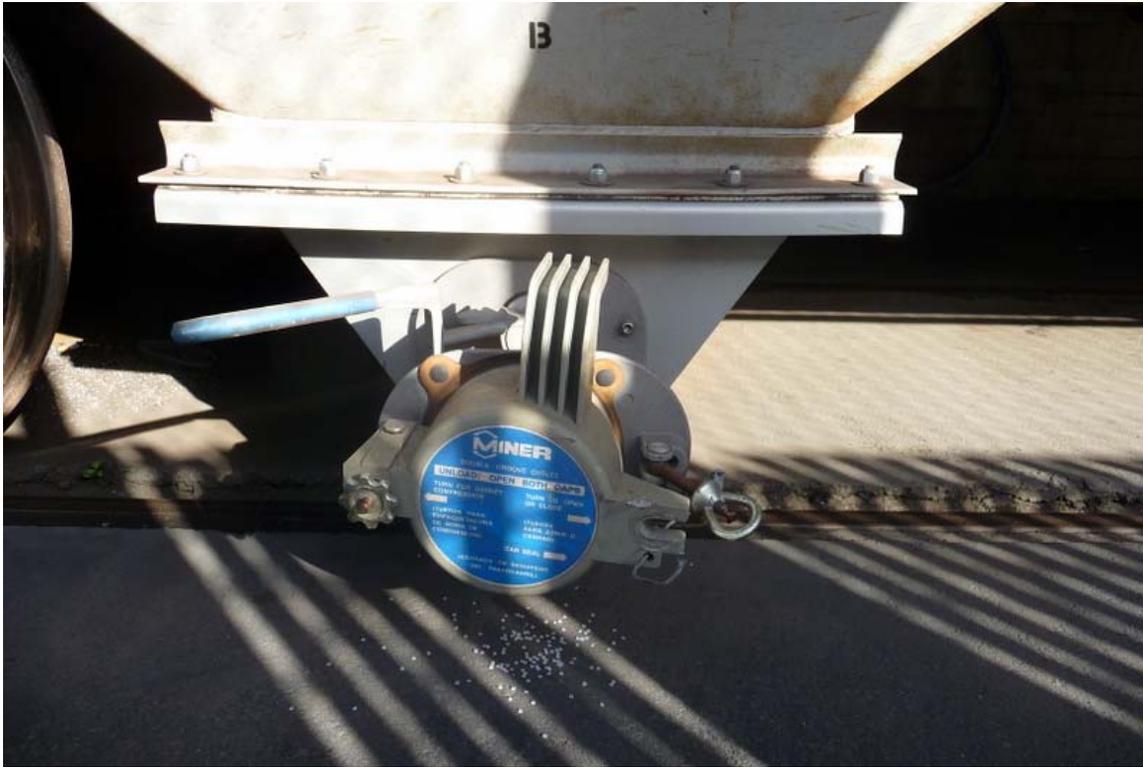
Figure 11 - Plastic Pellets under Hopper Car Valve on Rail Siding West of Metro/Uni Poly Facility on Williams Street

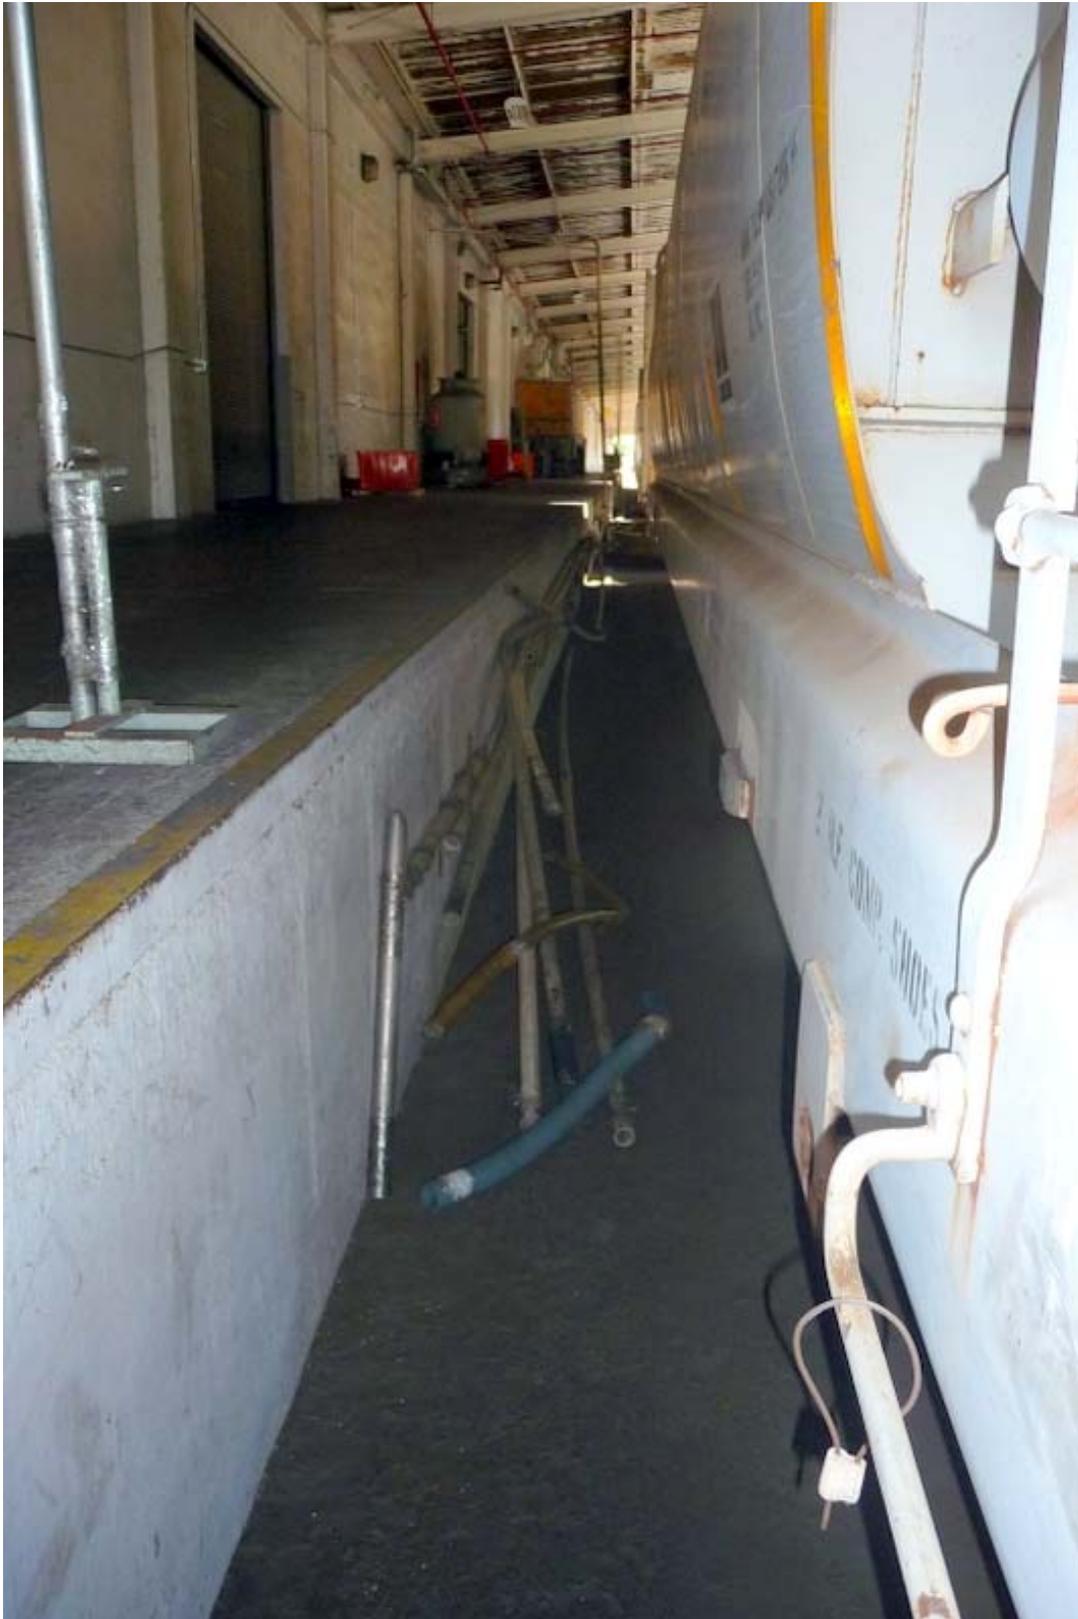
Figure 12 – Hose Assemblies and Hopper Car on Rail Siding West of Metro/Uni Poly Facility on Williams Street

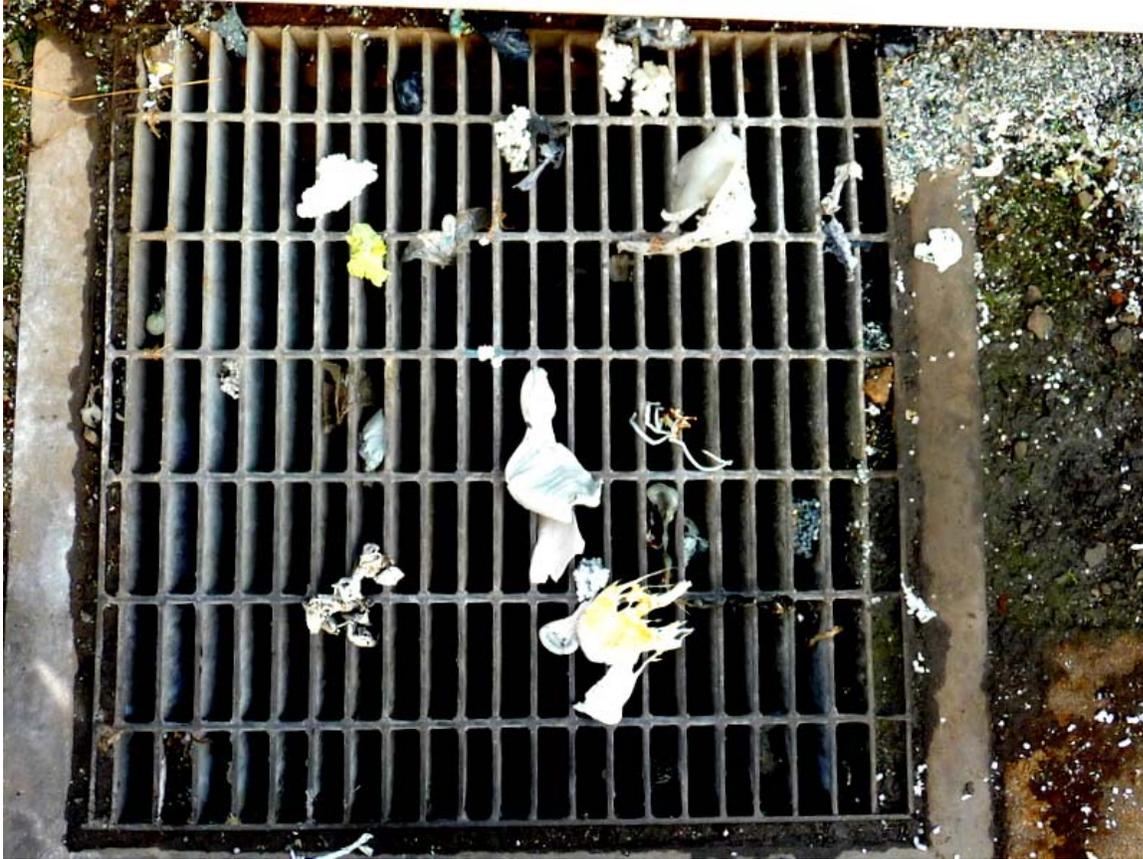
Figure 13 - Plastic Pieces, Pellets and Debris Resting on Top of and Near Drain Inlet on Western Side of Metro/Uni Poly Facility on Williams Street

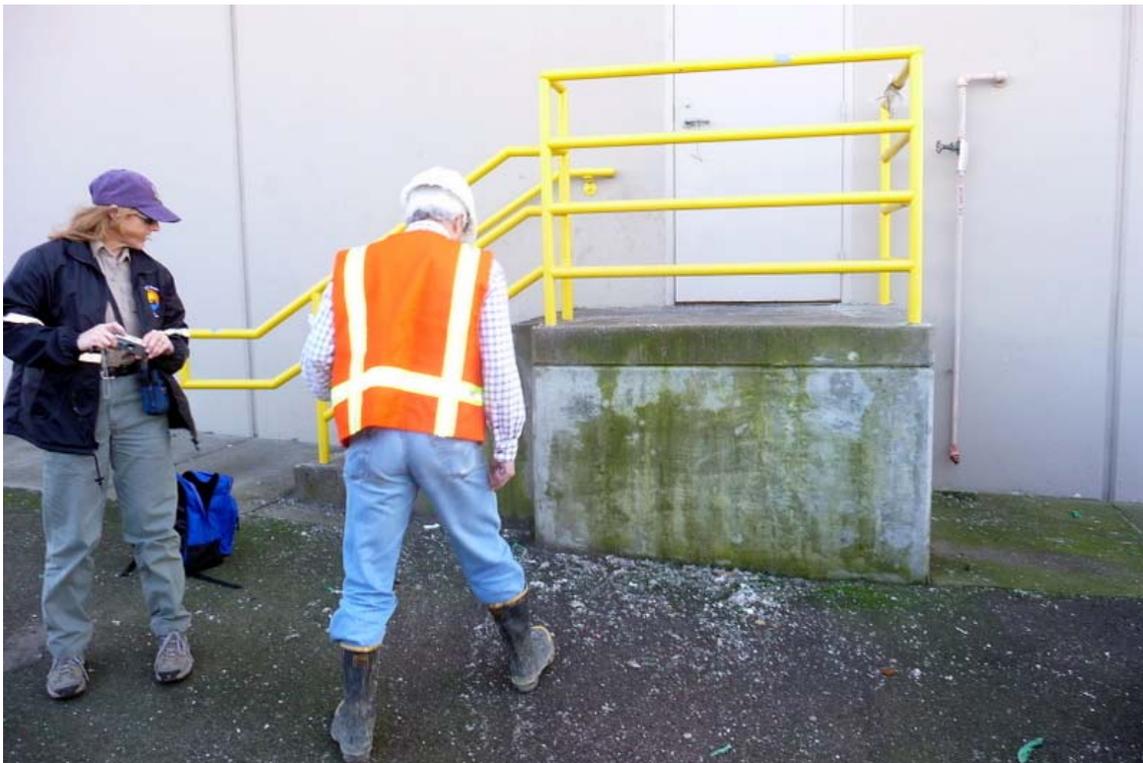
Figure 14 - Plastic Pieces, Pellets and Debris Rail Sidings North of Metro/Uni Poly Facility on Williams Street

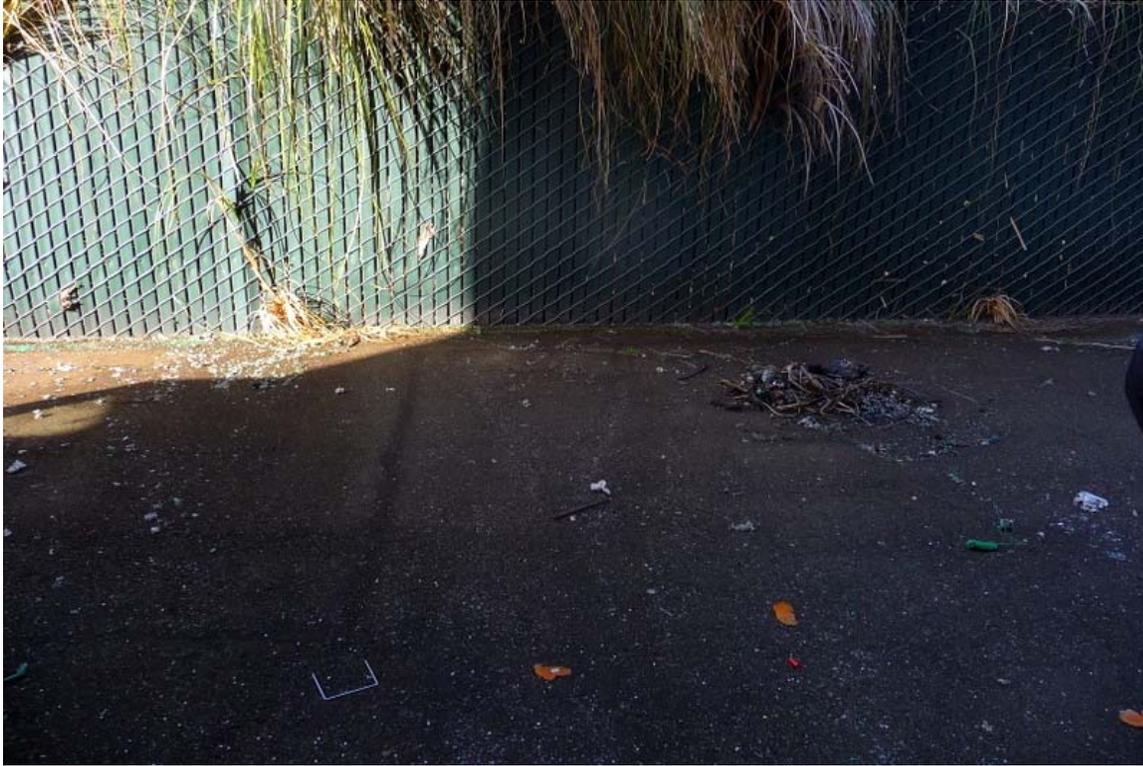
Figure 15 -Plastic Pieces, Pellets and Debris Rail Sidings North of Metro/Uni Poly Facility on Williams Street

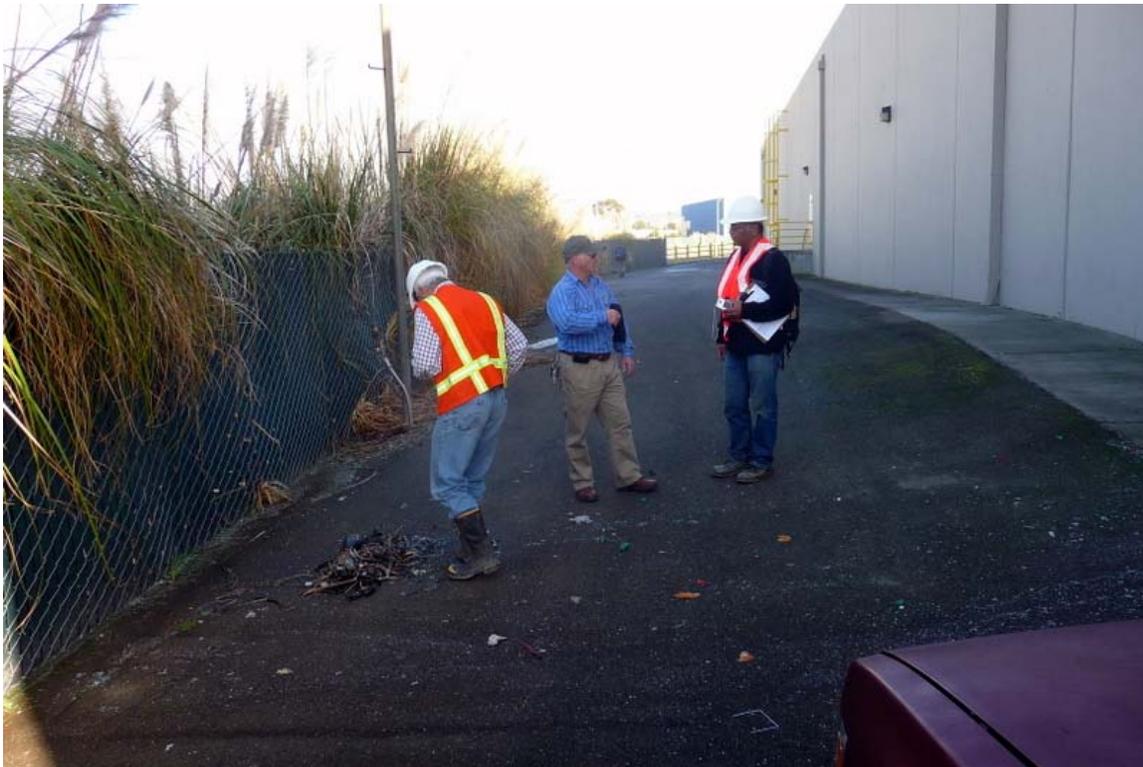
Figure 16 - Plastic Pieces, Pellets and Debris Rail Sidings North of Metro/Uni Poly Facility on Williams Street

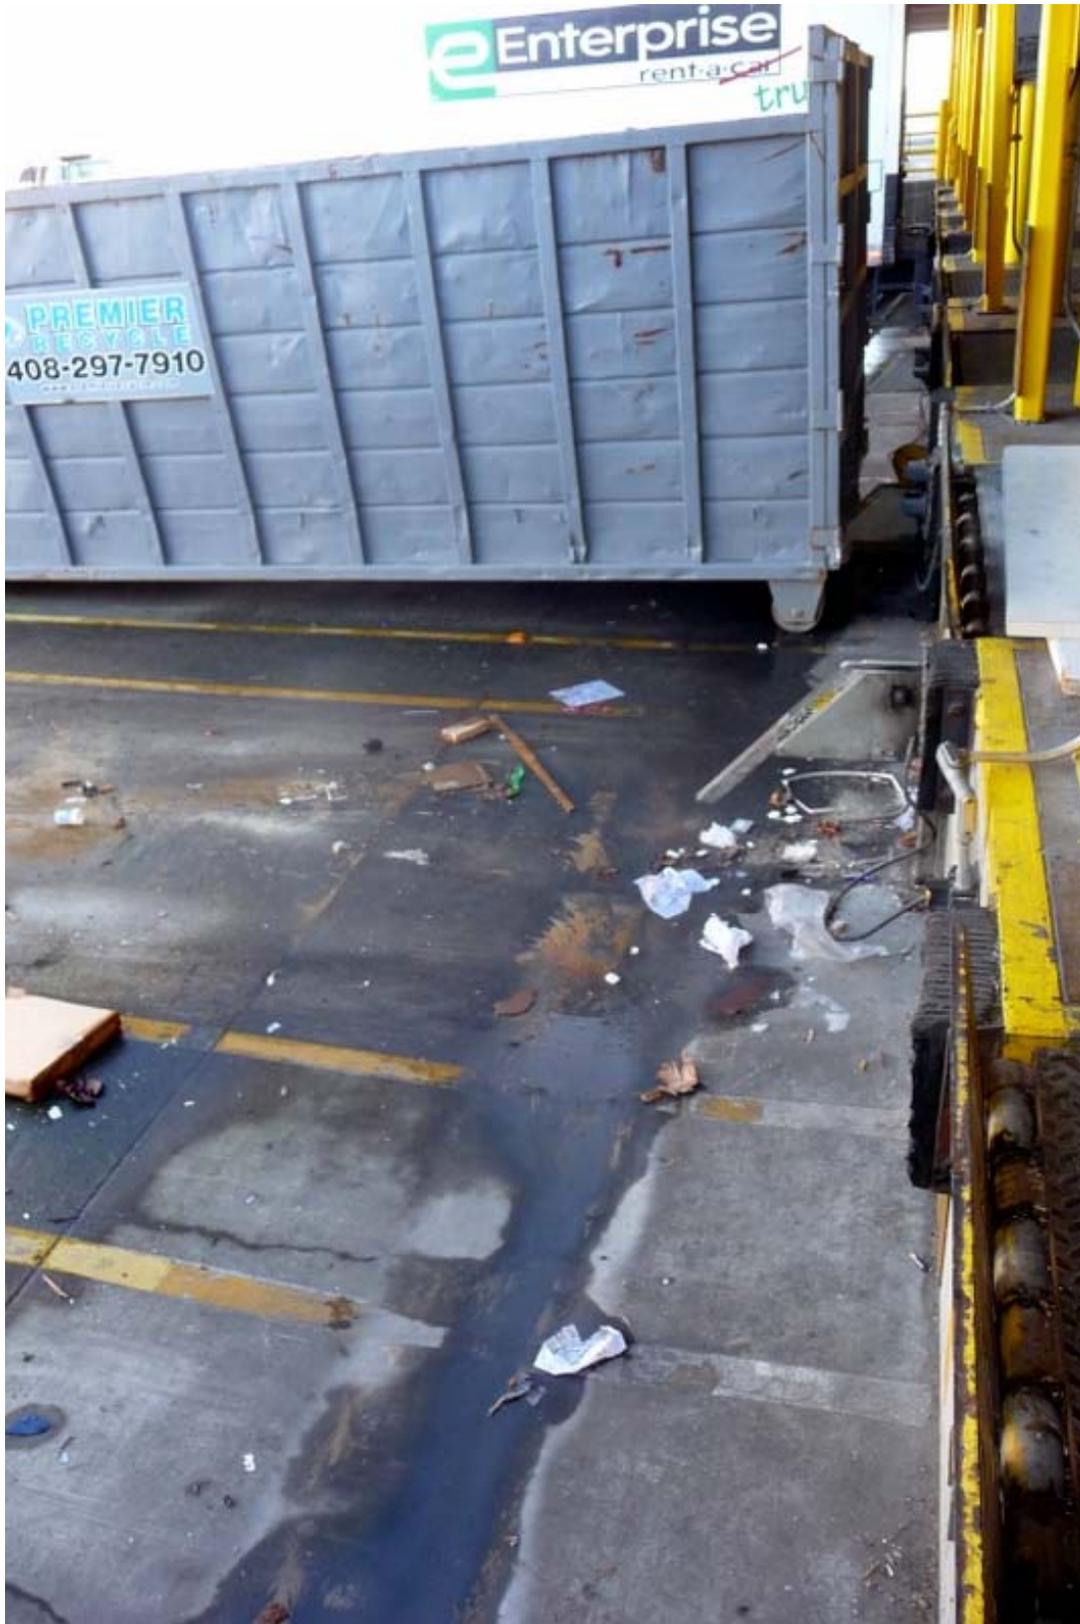
Figure 17 - Debris and Litter on Loading Docks of Metro/Uni Poly Facility on Williams Street

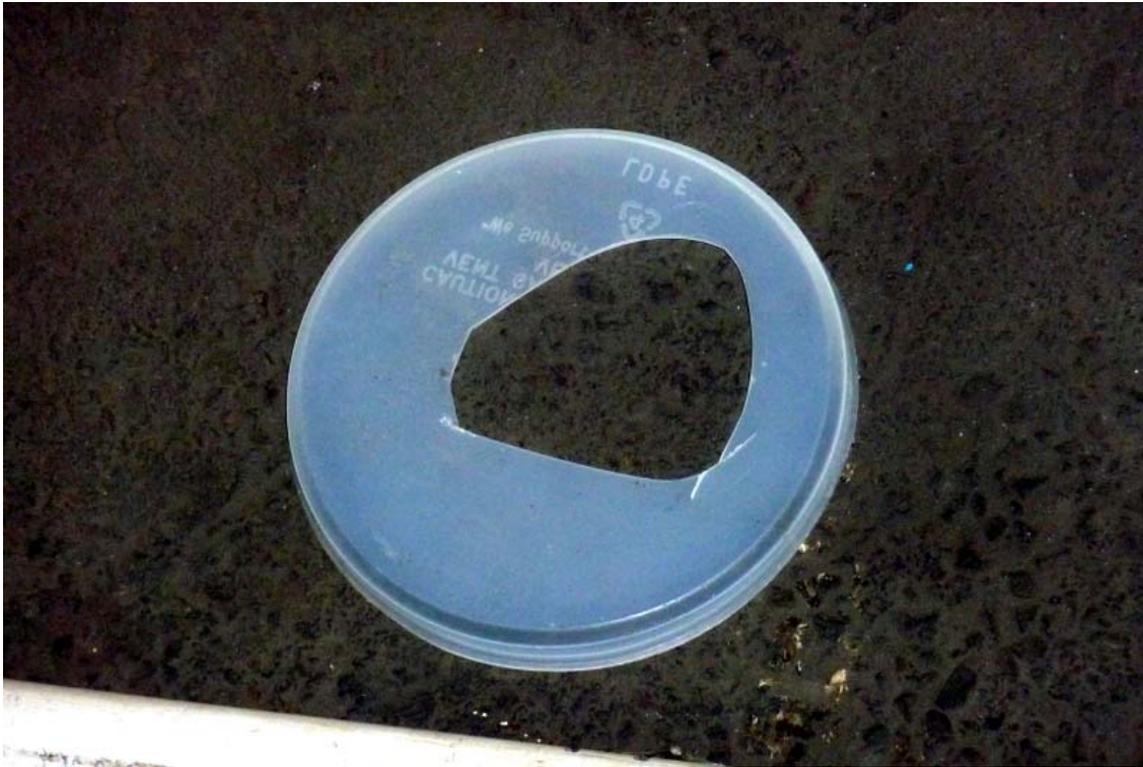
Figure 18 - A Modified Valve Seal Used to Try and Control Plastic Pellet Losses from Valve on Hopper Cars in Rail Siding Area West of Metro/Uni Poly Facility on Williams Street

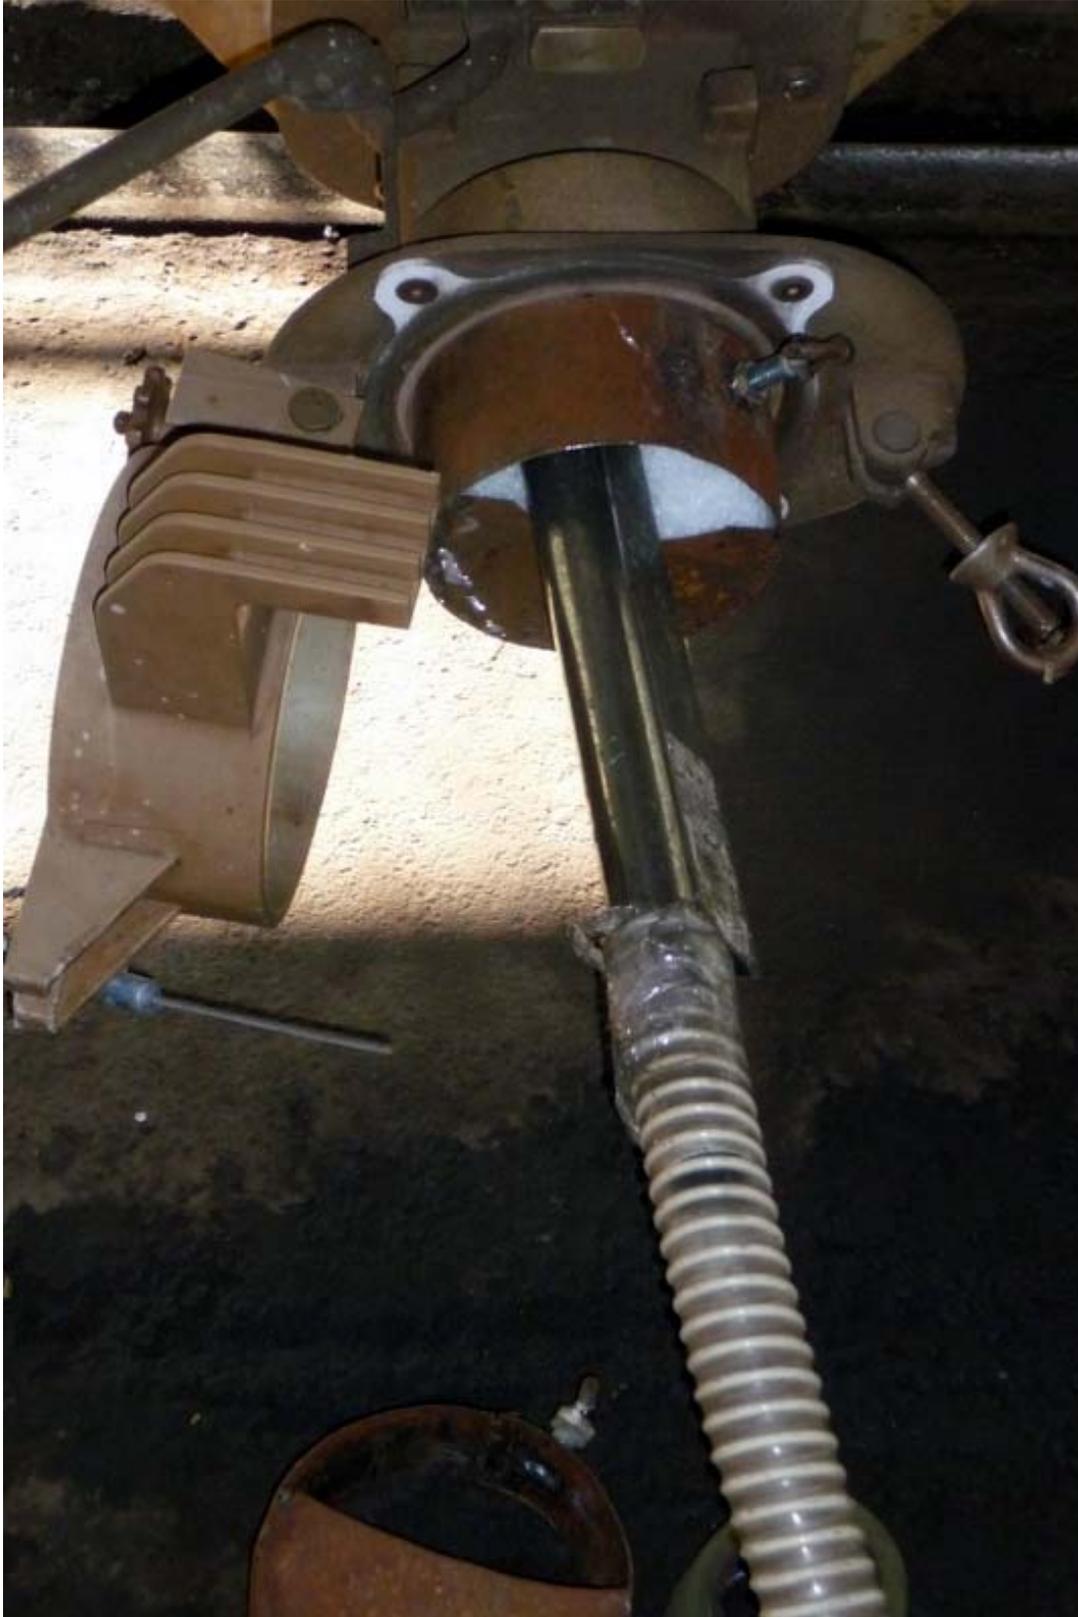
Figure 19 - Plastic Pellet Transfer from Hopper Cars to Internal Processes in Rail Siding Area West of Metro/Uni Poly Facility on Williams Street

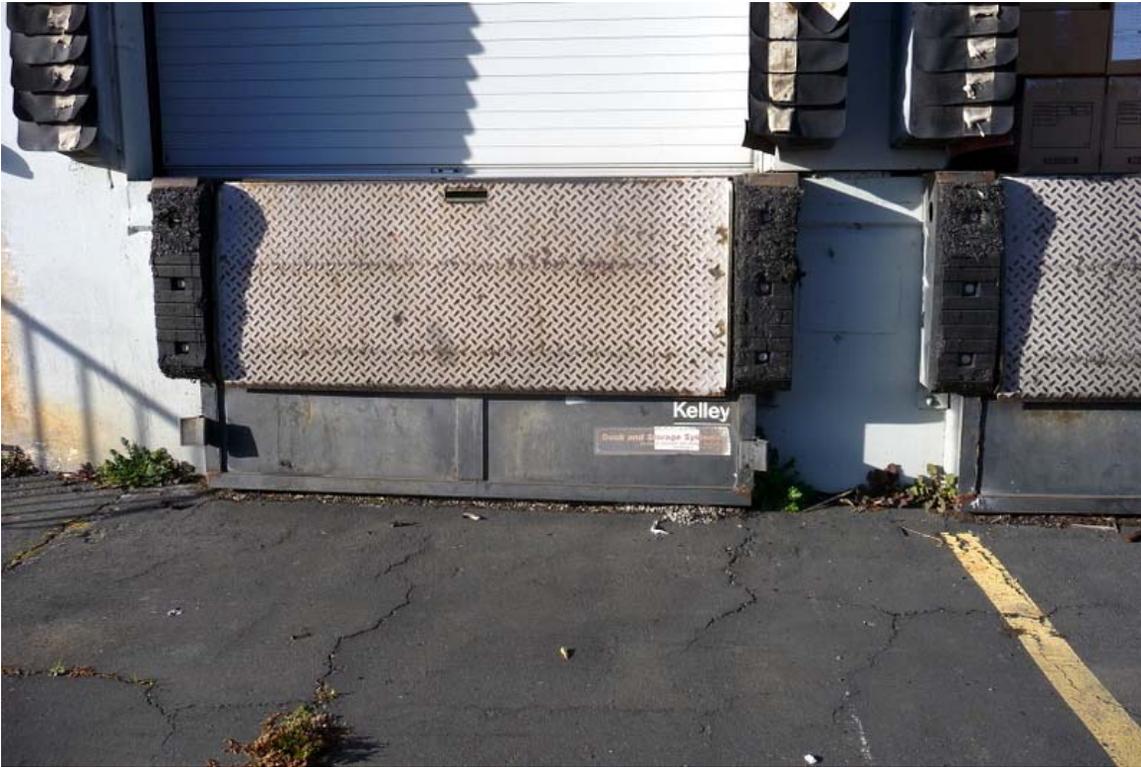
Figure 20 - Loading Dock at Kaneka Facility on Pulverosa Drive
