Photo Log for Greg Gearheart on January 13, 2010
San Leandro Plastics Facilities
San Leandro, CA

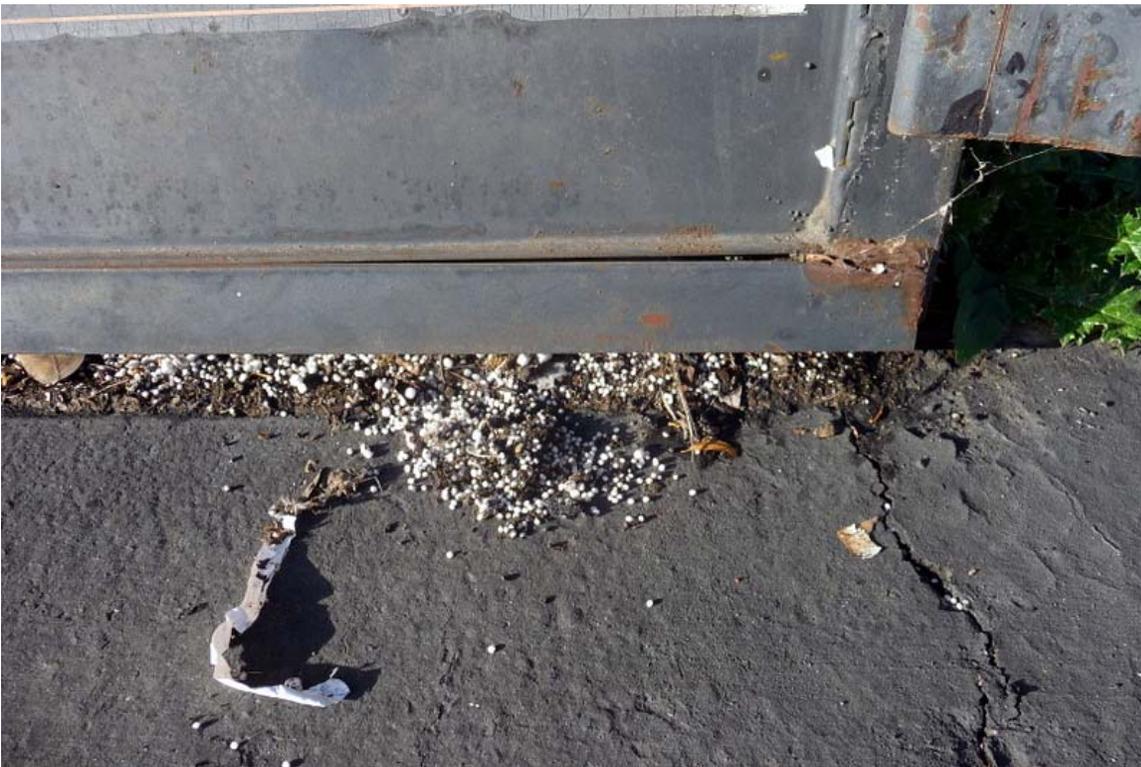
Figure 21 - Plastic Pellets Under Loading Dock at Kaneka Facility on Pulverosa Drive

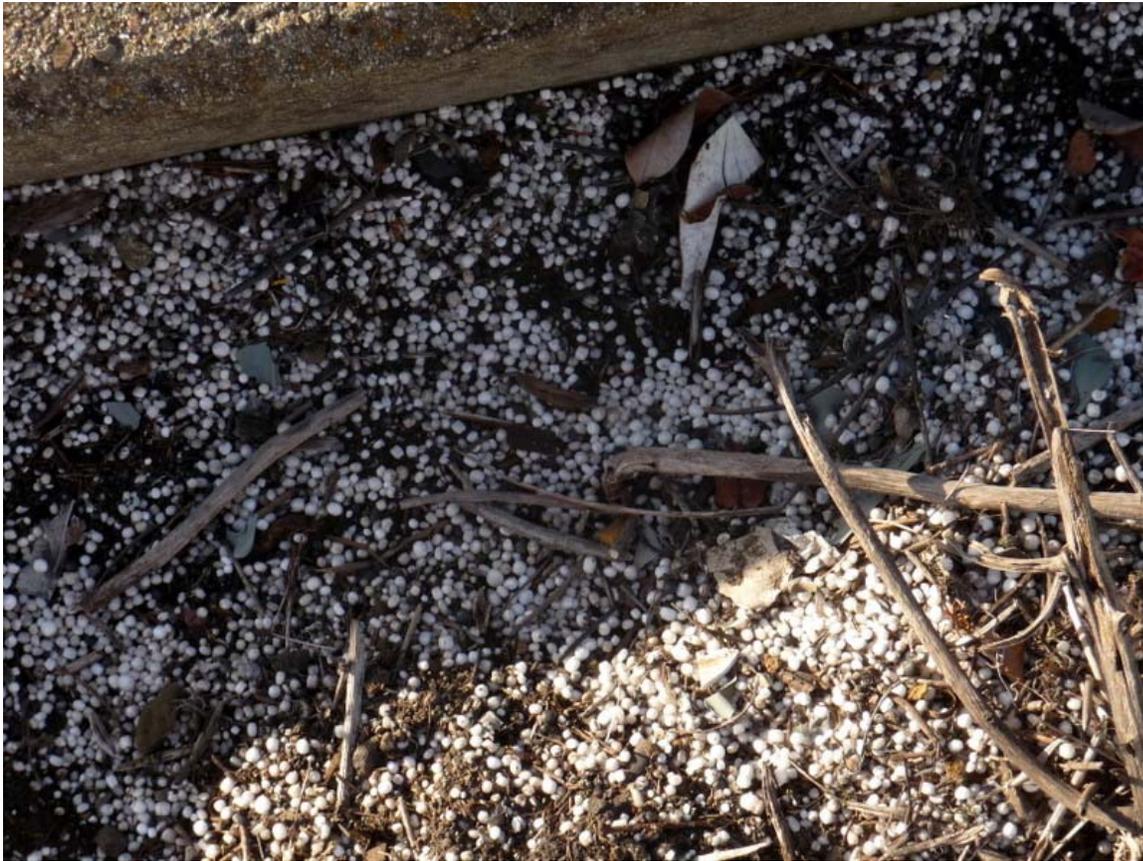
Figure 22 -Plastic Pellets Under Loading Dock at Kaneka Facility on Pulverosa Drive

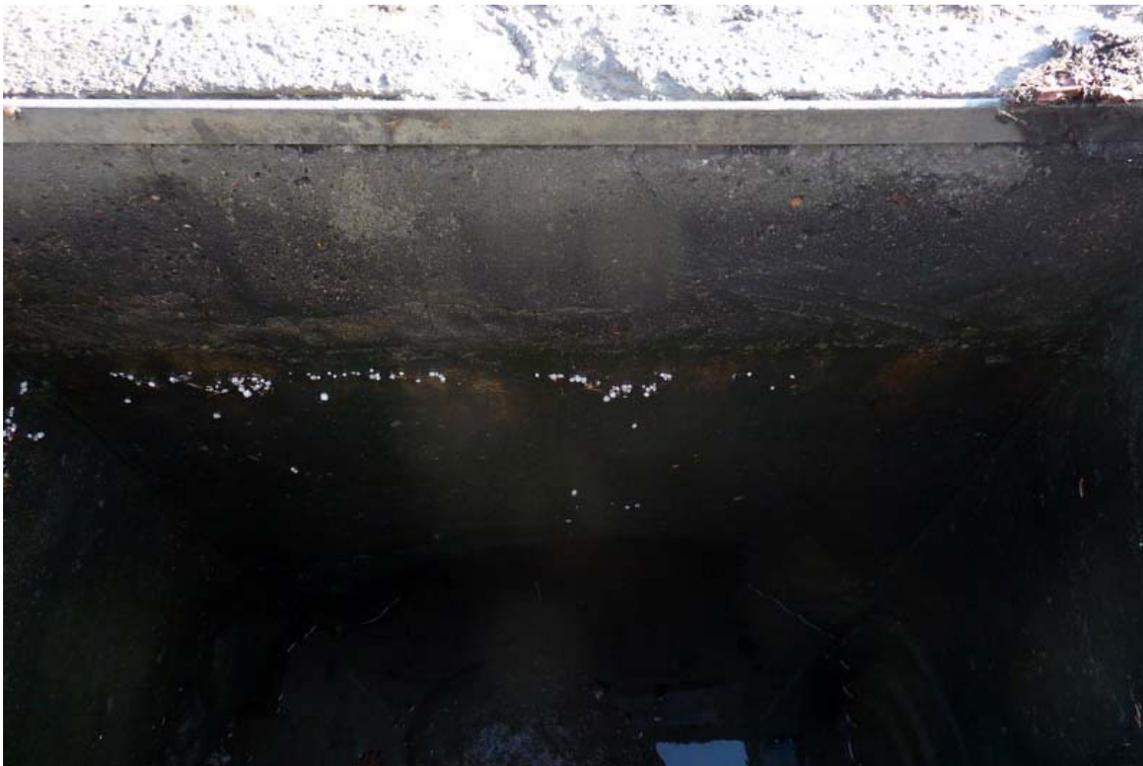
Figure 23 - Plastic Pellets in Drain Inlet and Storm Water in Parking Lot at Kaneka Facility on Pulverosa Drive
