California Regional Water Quality Control Board  
Santa Ana Region

June 1, 2001

**SUBJECT:** Administrative Civil Liability Complaint No. 01-64, Dynamic Details, Inc., Anaheim, Orange County

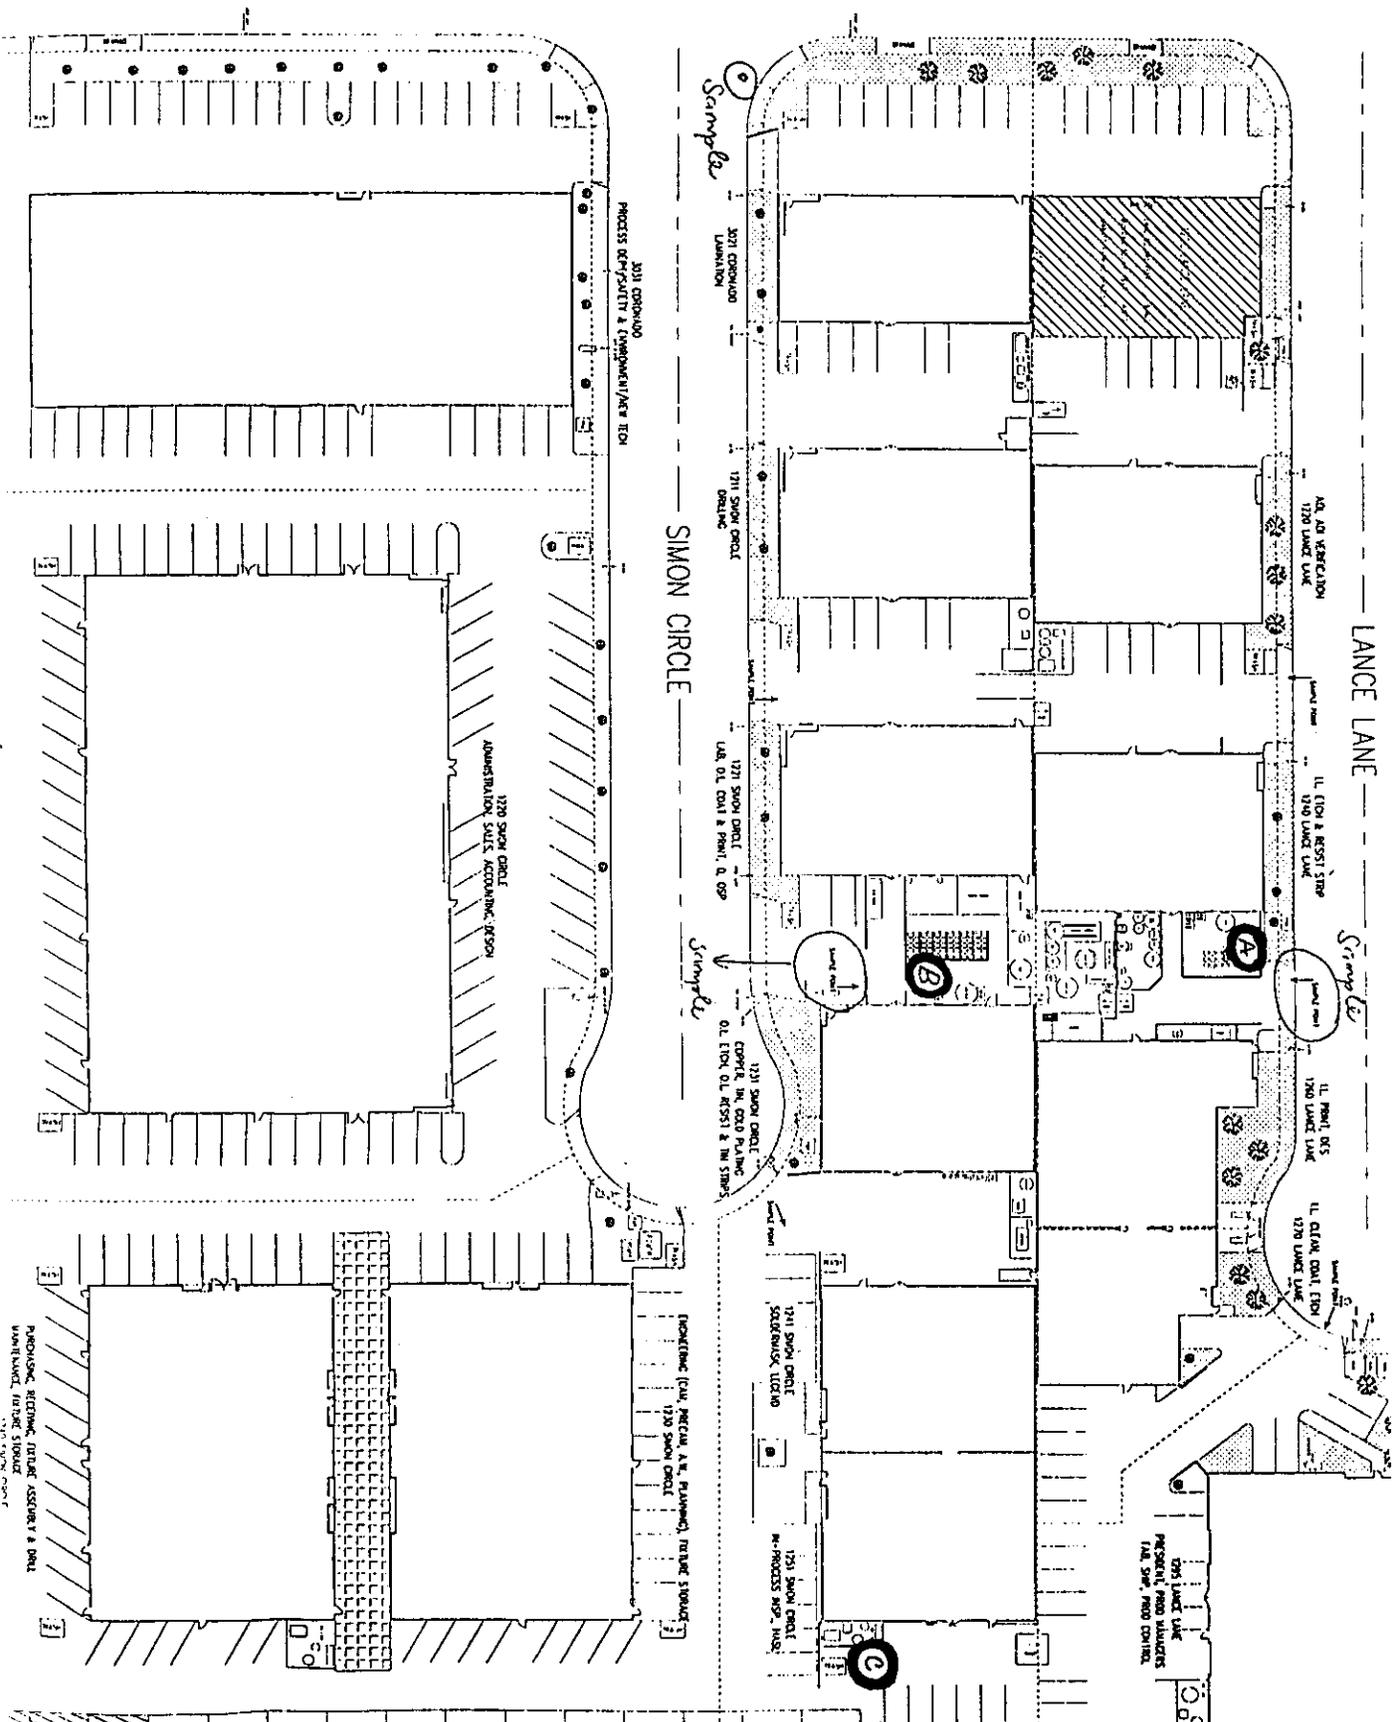
Attachment 1

On January 9, 2001, Board staff initiated an inspection of the facility and observed that a significant amount of hazardous wastes were being improperly stored between 1240 and 1260 Lance Lane (location A on Attachment 1), adjacent to the storm drain system. Adequate Best Management Practices (BMPs) designed to prevent the commingling of hazardous wastes and other pollutants with storm water and non-storm water runoff had not been implemented. Multi-colored stains were observed between the storage area and the outside storm drain system (location A, Attachment 1). Oily liquid and oil-soaked adsorbent were found under the compressor outside the facility at 1251 Simon Circle (location C, Attachment 1). There was evidence that oily liquid had been discharged to

the nearby storm swales. Dynamic Details was requested by Regional Board staff (staff) to immediately remedy these problems.

During the inspection, staff observed an overflow from the secondary containment berm (location B, Attachment 1) serving the wastewater pretreatment system and the hazardous waste storage area located between 1221 and 1231 Simon Circle. The previously contained liquid was observed discharging to the storm drain system (location B, Attachment 1). Analytical results of the runoff at this location indicated the presence of copper (4.50 mg/L), lead (1.78 mg/L), and zinc (0.776mg/L), at elevated concentrations. The sample had a pH of 5.71. The problem was discussed with Dynamic Details' representative. The representative instructed his staff to pump the liquid into a container. Board staff reminded Dynamic Details' representative that the facility SWPPP had identified secondary containment and covers as the BMPs to reduce/eliminate contaminants in runoff. The representative stated that there was a shortage of manpower at the facility and he did not expect such a big storm in the area. The representative agreed to remedy the problem and fully implement the additional BMPs identified in the facility's SWPPP.

On February 27, 2001, during a heavy storm event, staff re-inspected the facility and observed another discharge of liquid from the contained hazardous waste storage area (location B, Attachment 1) between 1231 and 1221 Simon Circle to the storm drain system. A sample of the runoff was taken by the staff. The analytical results indicated that the runoff had elevated concentrations of copper (3.65 mg/L), lead (2.41 mg/L), and zinc (0.360 mg/L). During this inspection, while it was observed that some efforts were made to cleanup the site, many of the earlier violations continued, including improper storage of hazardous wastes and inadequate BMPs to prevent commingling of pollutants with runoff. Board staff informed Dynamic Details' representative that they had to immediately address the problems to prevent discharge of contaminants in storm water. The representative agreed to comply.
