EROSION CONTROL IN REDWOOD NATIONAL PARK,
NORTHERN CALIFORNIA, 1980

Gregory J. Bundros, Terry Spreiter, Kenneth Utley, Ed Wosika¹

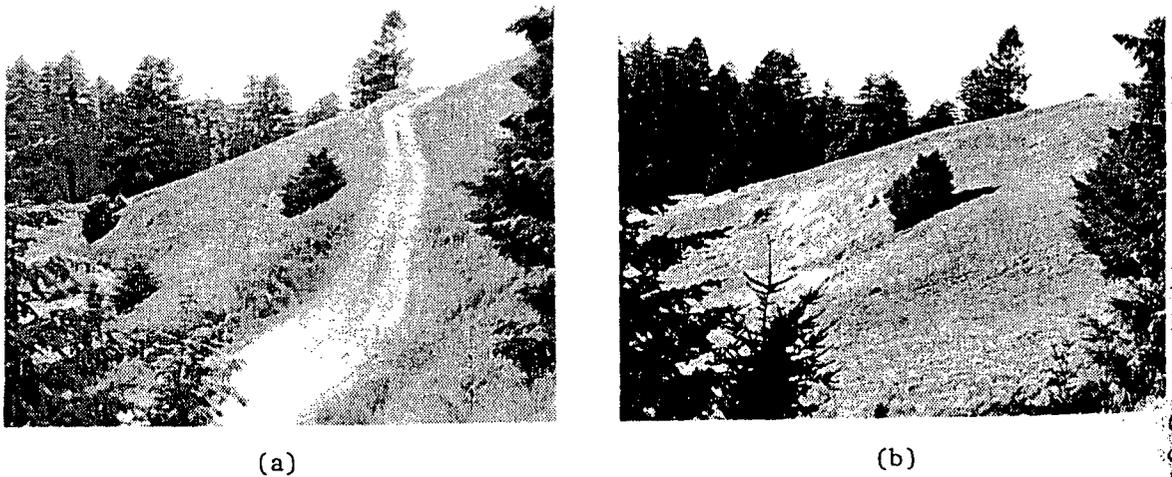
FIGURE 2. Before (2-a) and after (2-b) sequence of prairie road removal (complete outsloping). A hydraulic excavator and crawler tractor retrieved sidecast material from below the outer edge of the road and piled the material against the road cutbank. The crawler tractor then spread the piled material to blend with the surrounding slope morphologies.

Drainage networks were redirected by removing haul roads, excavating road and skid trail crossings, treating log landings, and constructing waterbars. The degree of road removal considered road bench stability, proximity to stream channels, and road location (prairie or forest). Road removal utilized combinations of dragline cranes, hydraulic excavators, crawler tractors, backhoes and/or dump trucks. Typically, road surfaces were decompacted (ripped) to a depth of 50 cm using chisel teeth mounted to a D-8 (or equivalent) crawler tractor at an average cost of \$427/km. Road benches were then either; 1) cross-road drained (closely spaced, deep troughs cut across the road bench to decrease concentrated inboard ditch runoff), 2) partially outsloped, or 3) completely outsloped. In 1980, 23.5 km of haul roads were removed. Of this total, backhoe-tractor teams cross-road drained 14.6 km of forest roads at an average cost of \$1515/km. Partial outsloping was performed on 5.8 km of forest roads by hydraulic excavator-backhoe-tractor teams at an average cost of \$1750/km. In the prairies, where aesthetics were also considered, excavator-tractor teams completely outsloped 3.1 km of roads at a cost of \$4297/km (fig. 2).
