**BUREAU OF RECLAMATION SEEPAGE INVESTIGATIONS ALONG
THE SAN LUIS CANAL / CALIFORNIA AQUEDUCT
NEAR EAGLE FIELD ROAD**

MEMORANDUM TO THE TECHNICAL FILES

SUBJECT: Seepage Investigations Along the San Luis Canal/California Aqueduct at Mile 89.5 (approximate Station 1040+00) Near Eagle Field Road - Central Valley Project, California

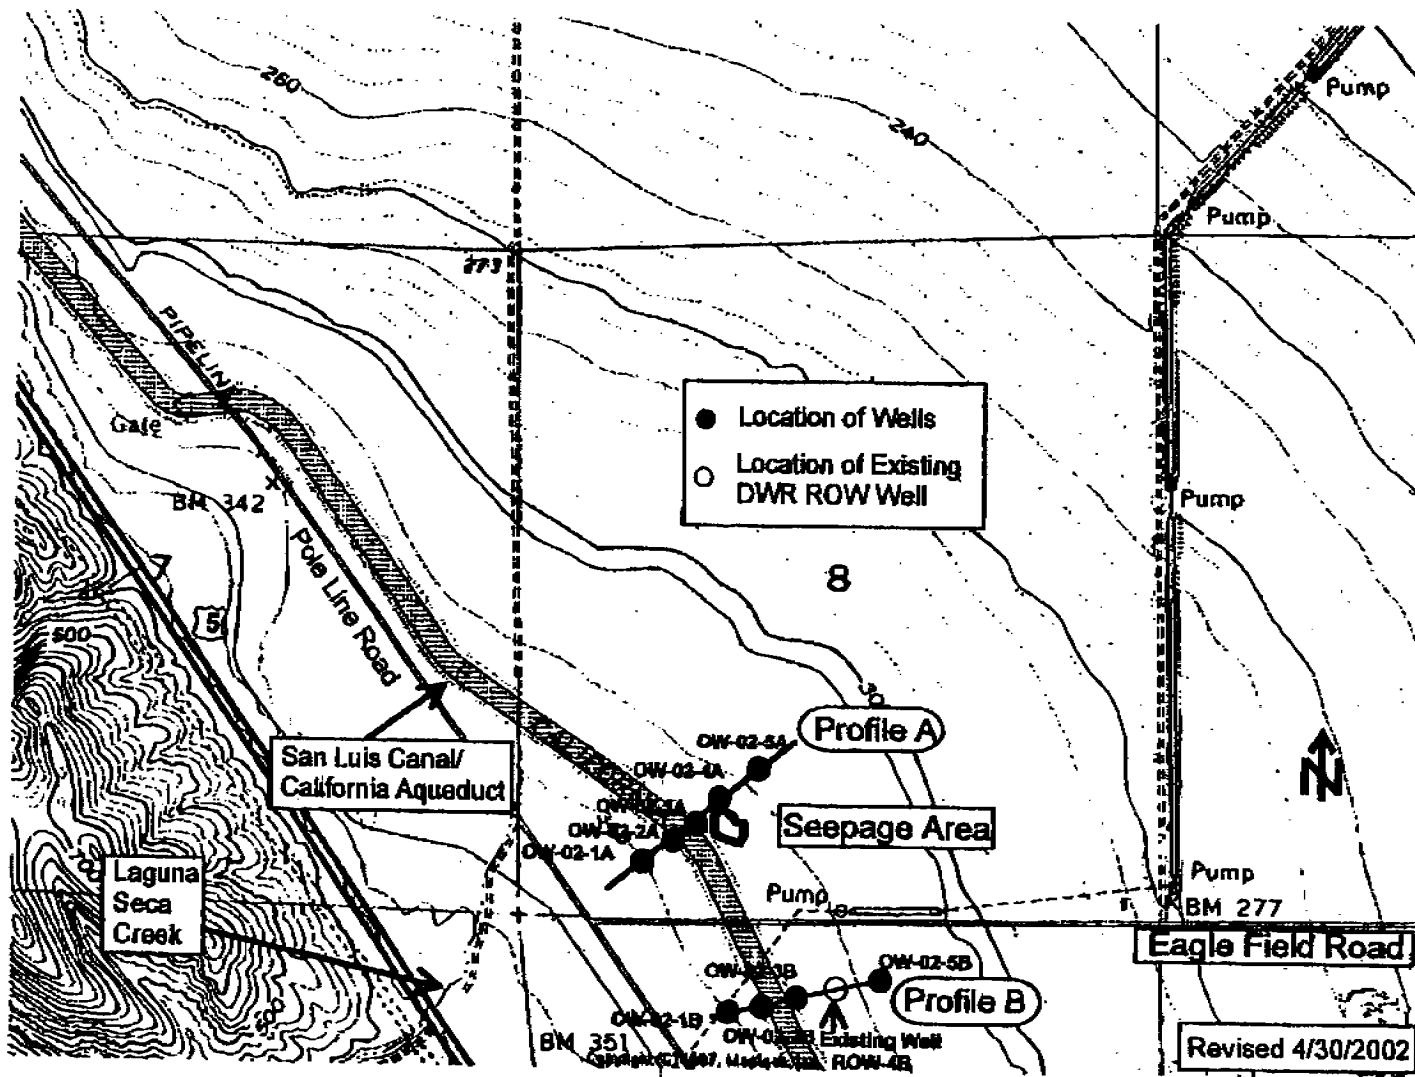
Figure 1: Eagle Field Road Seepage - General Location of Wells Along the San Luis Canal/California Aqueduct Near Mile 89.5

The seepage area of concern is just north of Eagle Field Road on the left (northeast toe) of the canal embankment (see Figure 1) in an area of some past land subsidence due to hydrocompaction. The seepage area encompasses an area on the left canal embankment of about 20 feet perpendicular to the canal and about 200 feet long. The slope is heavily vegetated due to the seepage. On June 3, 2002, a small seep of clear water flowing at about one gal/min is present about halfway up the slope. During the drilling of the new observation wells, it was discovered that the ponded seepage and the associated vegetation (at the toe of the embankment) lies above an old asphalt roadway. This asphalt surface prevents the local infiltration of seepage water. The water level in the ponded area fluctuated about three-inches daily (nearly drying the area in the late afternoon) in response to evaporation during the hot daytime hours.

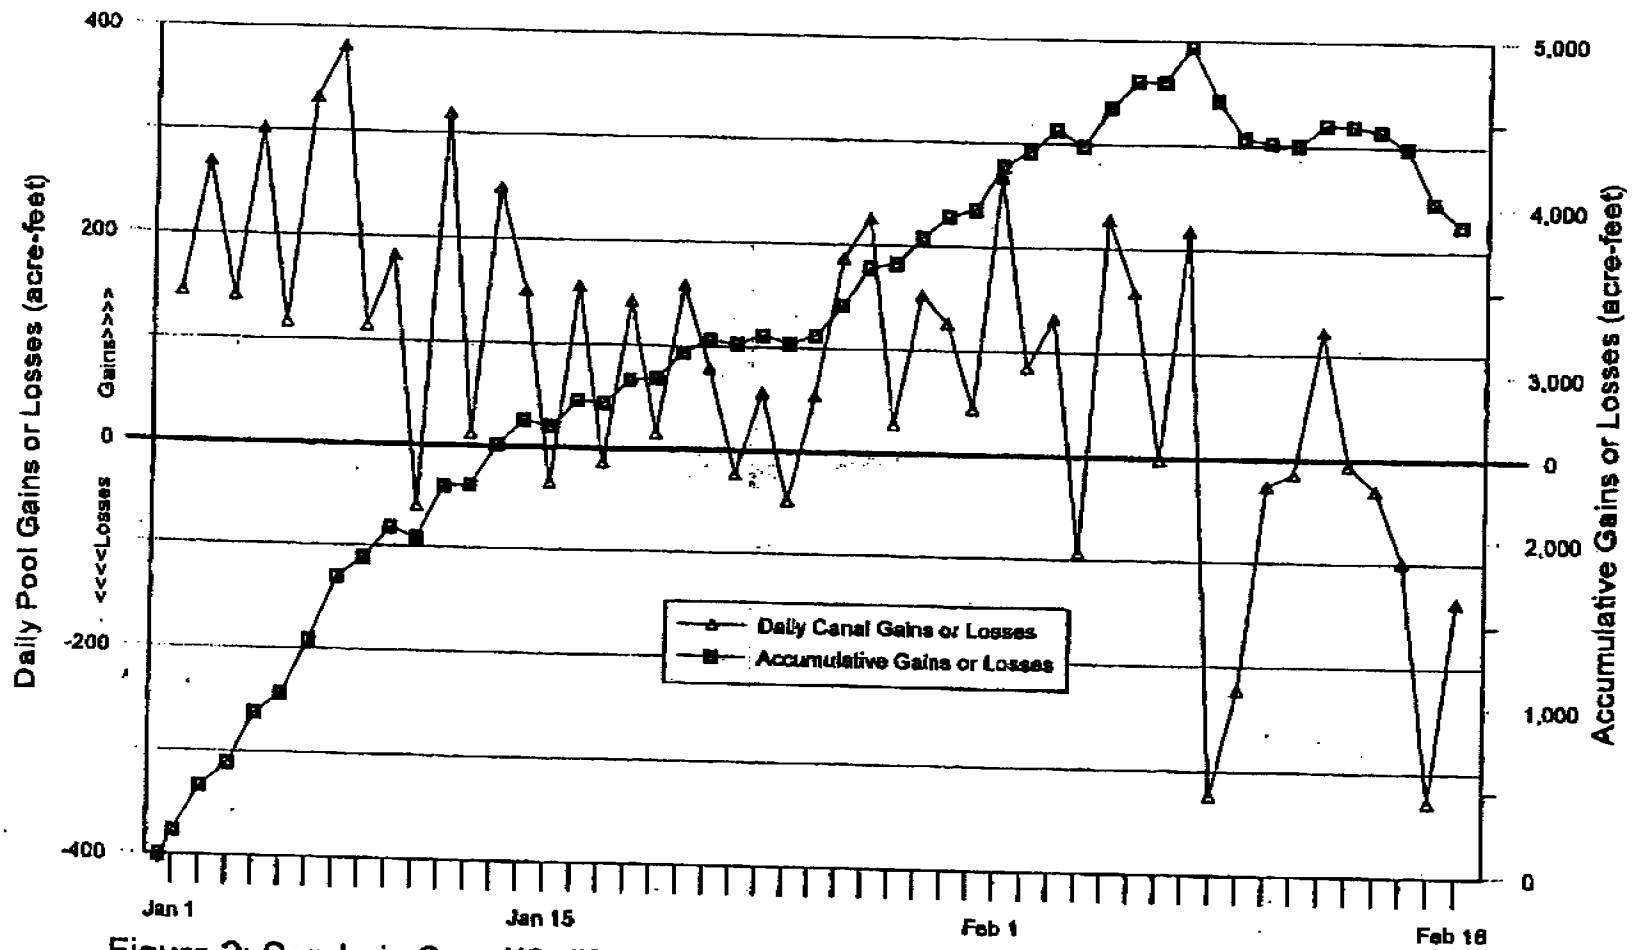
Figure 2: San Luis Canal/California Aqueduct - Pool 14 Test - January to February 2002

DWR conducted a ponding test of Pool 14 from January 1 to February 18, 2002. Some of the data are summarized in Table 1 and the total daily gain/loss for the pool is shown graphically in Figure 2. Pool 14 is approximately 10 miles long. The canal gained a total of 3,900 acre-feet of water during that period of time. DWR believes that questionable instrument accuracy may have contributed to the results noted in the test.

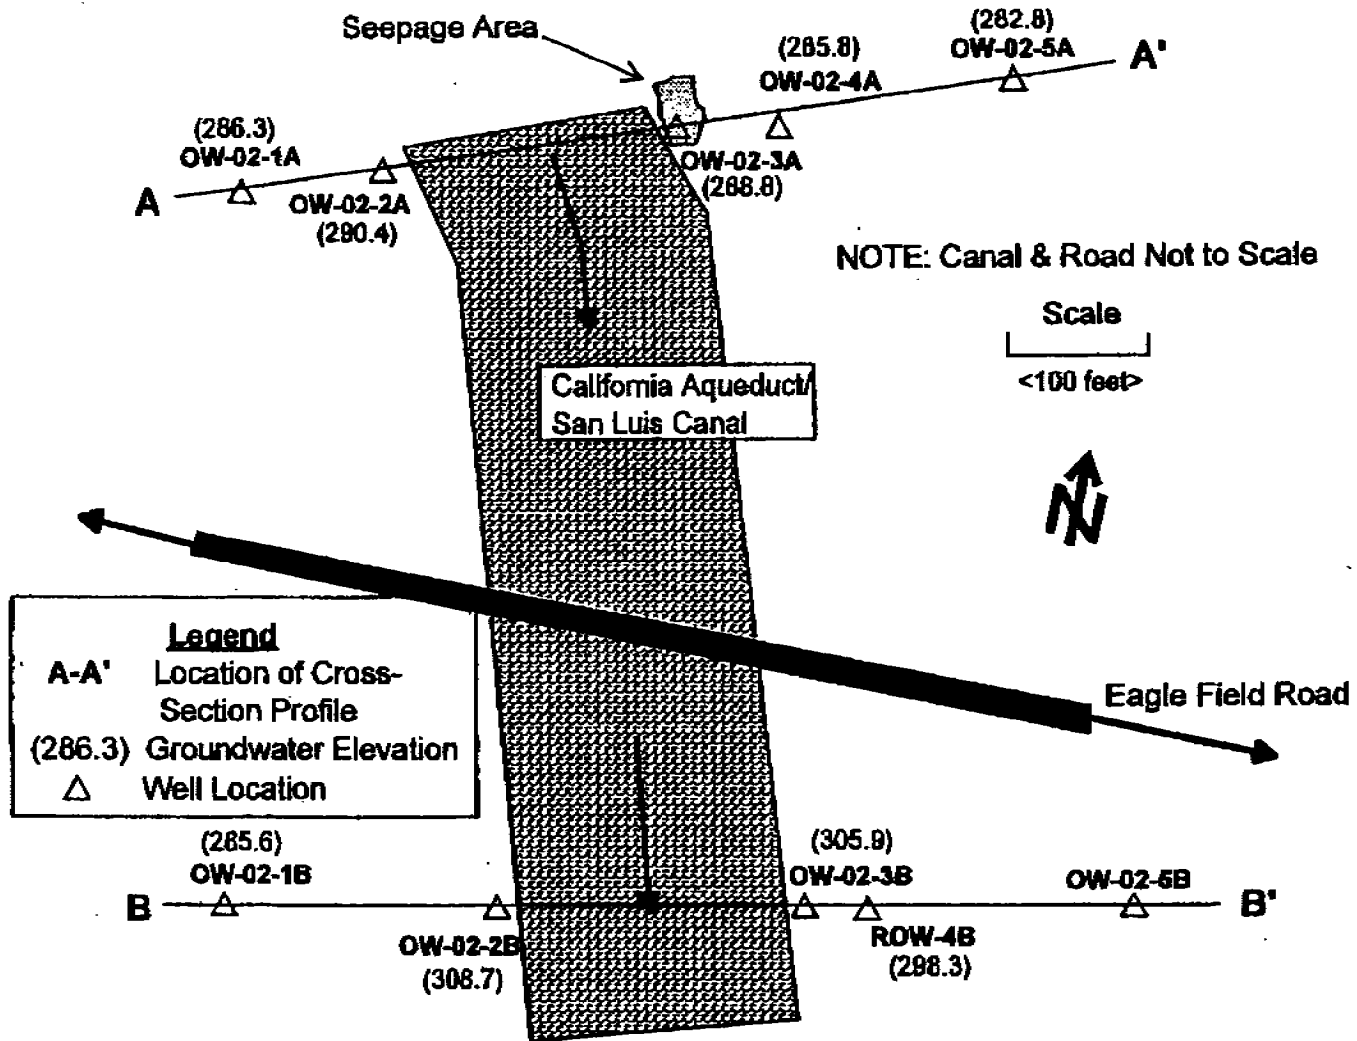
Figure 3: Eagle Field Road - Location of Wells and Groundwater Elevations

3. **Groundwater flow direction** - Each well was surveyed for elevation and location by MP-222 using a local coordinate system. These values are shown in Table 2. Groundwater level measurements are also shown in Table 2. Elevations show groundwater flow direction to be to the east, generally coinciding with the ground slope direction.

4. **Groundwater gradient** - By using the groundwater elevations for OW-02-1A, -1B, and -5A, the groundwater gradient across the study area calculates to be about 35 feet per mile to the east. This assumes that the wells farthest west and east reflect true groundwater

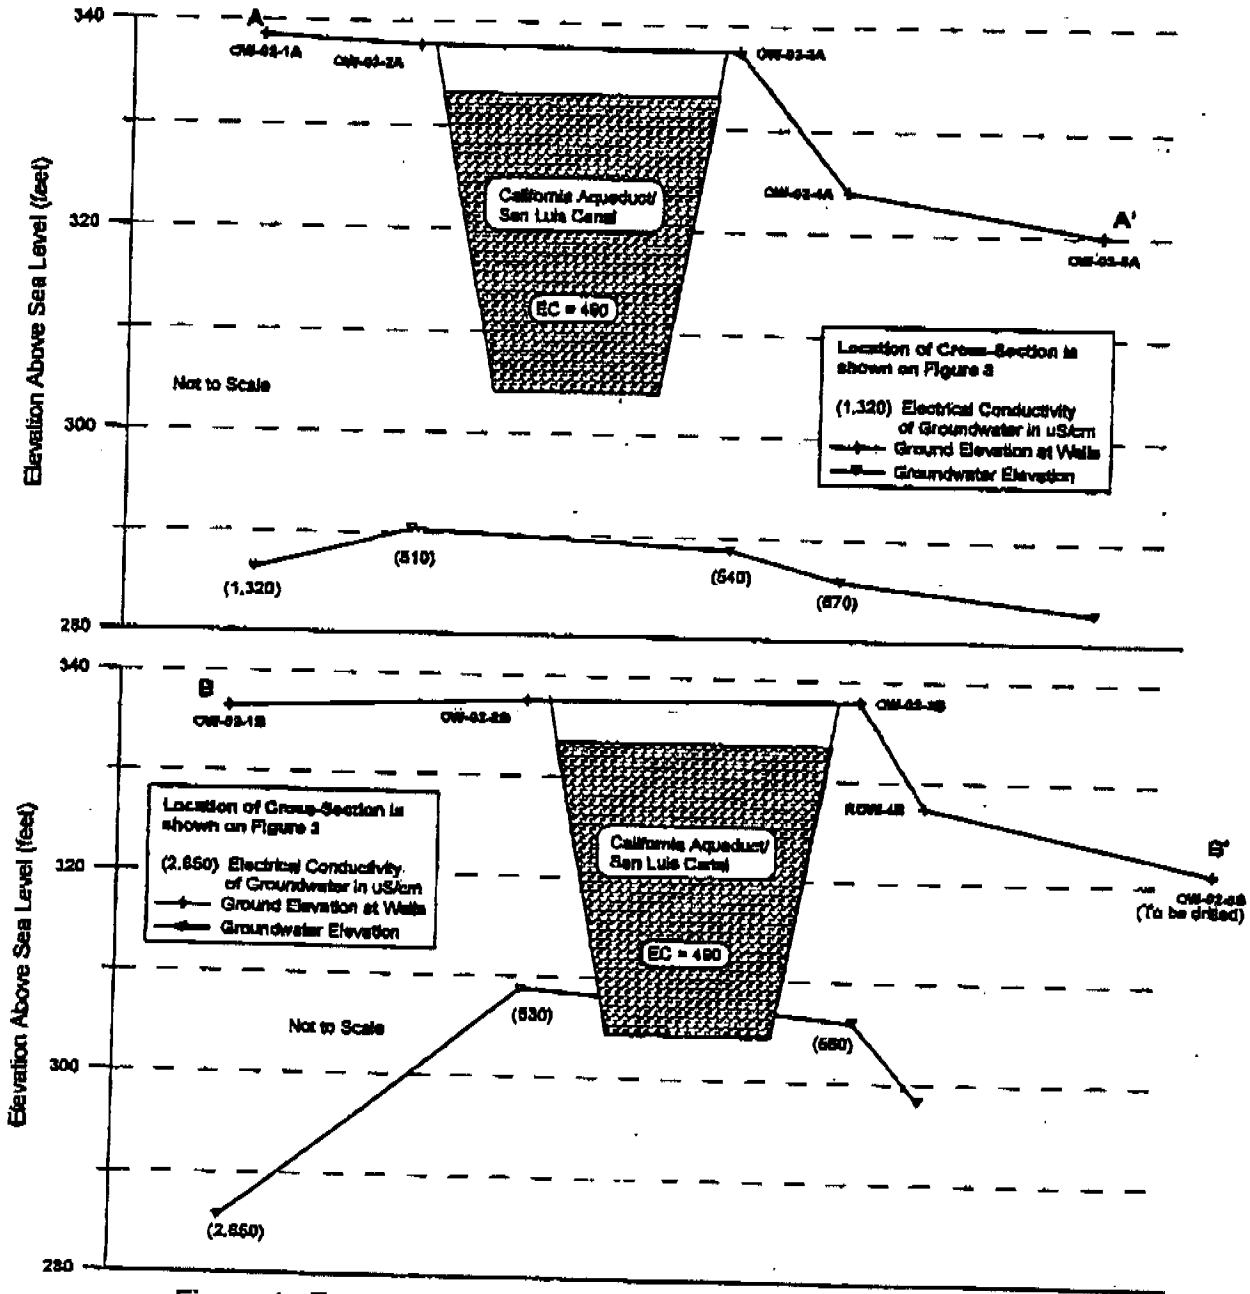
Figure 4: Eagle Field Road - Cross-Sections thru A-A' and B-B'

5. **Is there is a groundwater mound beneath the canal?** - Groundwater elevations show higher groundwater levels beneath the canal than east or west of the canal, indicating that a groundwater mound is present beneath the canal under both Profiles A and B (Figure 4). The mound is more pronounced beneath Profile B, where no visual seepage is indicated, than under Profile A, where there is a seepage area and water ponding east of the canal. This pronounced mound is most likely due to the low permeability soils at this location that retard horizontal and vertical migration of canal seepage water. The soils at Profile A have a higher permeability resulting in a less pronounced groundwater mound.
