August 30, 2016

SUBJECT: Field notes to Donovan and Peters Property, Mendocino County

On-stream Reservoir 2, 38°55'32.32"N, 123°17'25.98"W:

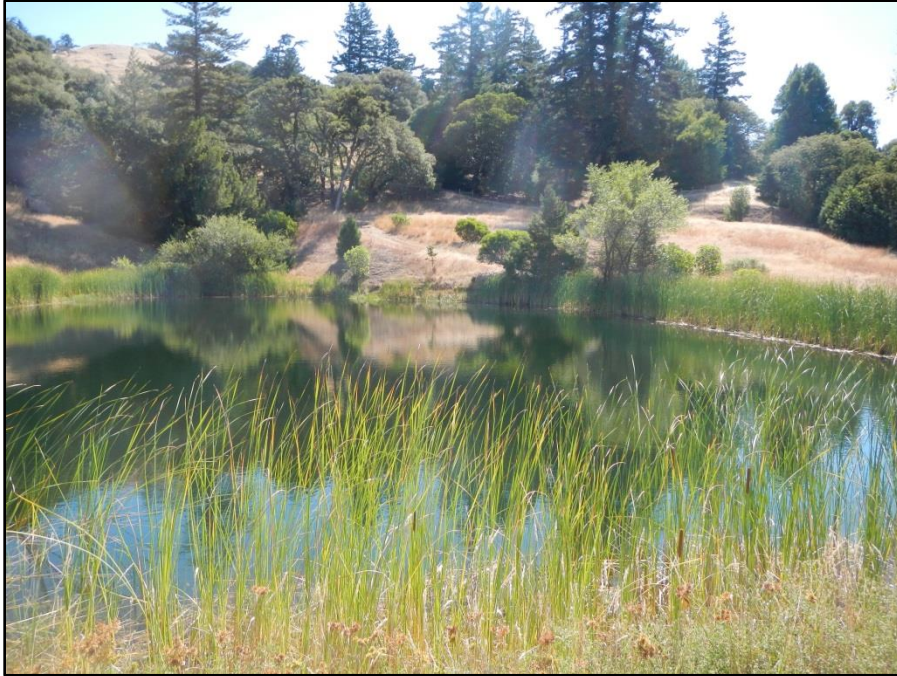
- The reservoir is created by construction of an earthen dam located on an unnamed tributary to Maple Creek and supplied by seasonal surface stream flow.

- Reservoir construction was completed in 1994 without engineering, geologic investigations or seismic considerations (Mr. Peters Personal communication). The reservoir is used as a water supply to produce alcohol crops.

- The reservoir operates via “fill and spill,” through a culvert spillway at the crest of the dam. Hydraulic capacity of the spillway is unknown. It appears if the reservoir were to over-top (i.e., if the culvert plugged) water would be directed over the face of the dam;

- The dam may be greater than 25 feet in height, and may be subject to the jurisdiction of the Division of Dam Safety;
- Drainage infrastructure (i.e., “tile drains”, or “French drains”) have been installed on adjacent hill-slopes, upstream the reservoir that can alter headwater stream network hydrology and reduce wetland vegetation;

Figure 2. Construction of Reservoir 2 has resulted in substantial changes to the bed, bank and channel of a stream, see FGC section 1602. The reservoir interrupts natural stream processes, including transport of sediment and benthic macro-Invertebrates downstream. The affected stream can be discerned in the background of the photo to the upper left.

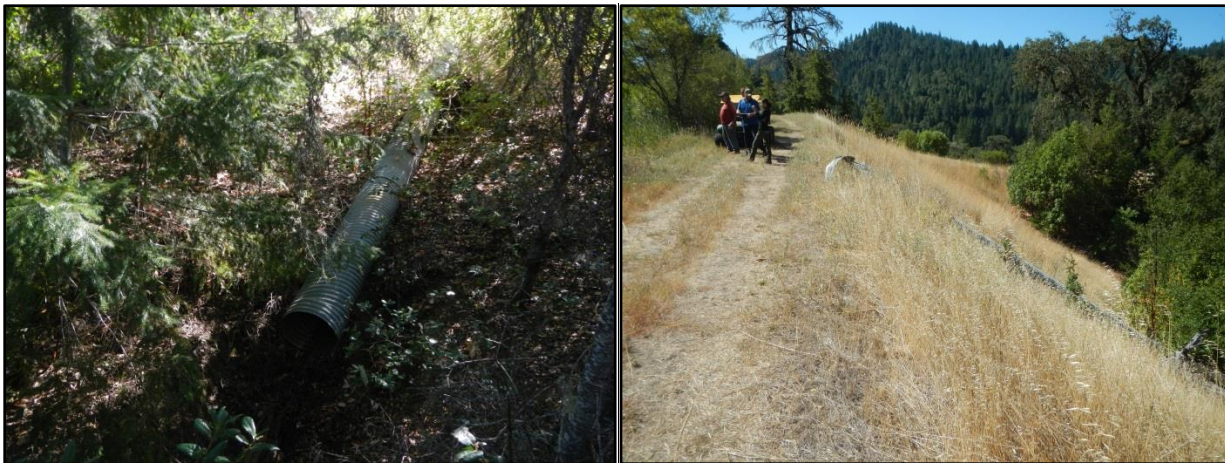
Figure 3. The dam obstructs the natural surface flow of a stream and only allows bypass flows at times when the reservoir spills, see FGC sections 1602 and 5937. Placement of earth materials into a stream channel from construction of the dam has resulted in placement of deleterious sediment where they can enter waters of the state, which does not comply with FGC section 5650.

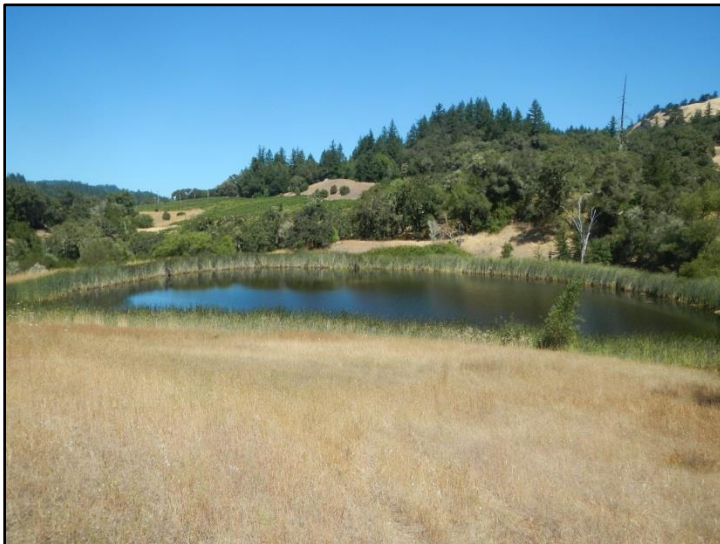
- The reservoir operates via “fill and spill,” through a culvert spillway at the crest of the dam. Large rock rip-rap has been placed within the stream channel beneath the dam;

Figure 4. Construction of Reservoir 1 has resulted in substantial changes to the bed, bank and channel of a stream, which does not comply with FGC section 1602. The reservoir can interrupt natural stream processes, including transport of sediment and benthic macro-invertebrates downstream. Placement of earth materials into a stream channel from construction of the dam has resulted in

placement of deleterious sediment where they can enter waters of the state, which does comply with FGC section 5650.

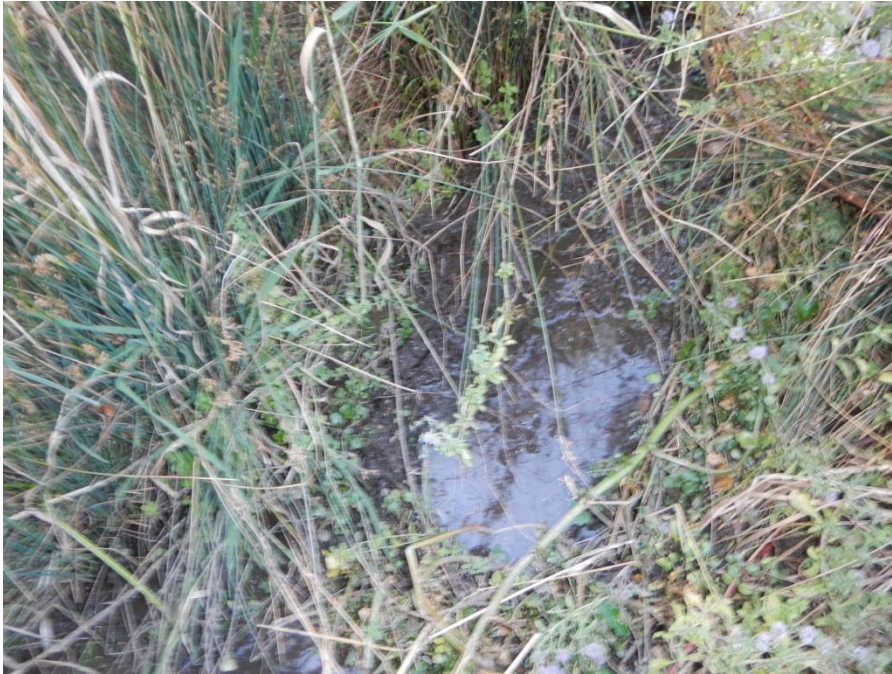
- Flowing surface water (estimated 5-10 gallons per minute) was present within a well-defined channel upstream the reservoir. Water flowing into the reservoir appeared cold and clean which is critically important to support downstream state and federally listed, cold water fish species during summer months. No water was observed within the stream channel directly beneath the dam.

- Abundant wetland vegetation (*Juncus spp.*) were present within and adjacent to the stream channel upstream the reservoir;
- The stream channel upstream the reservoir appeared channelized from heavy equipment use; and

Figure 5. View of the stream channel upstream Reservoir 1. Wetland indicators and surface stream flow are present to support non-fish aquatic life. The dam obstructs the natural surface flow of a stream and only allows bypass flows at times when the reservoir spills, which does comply with FGC sections 1602 and 5937.

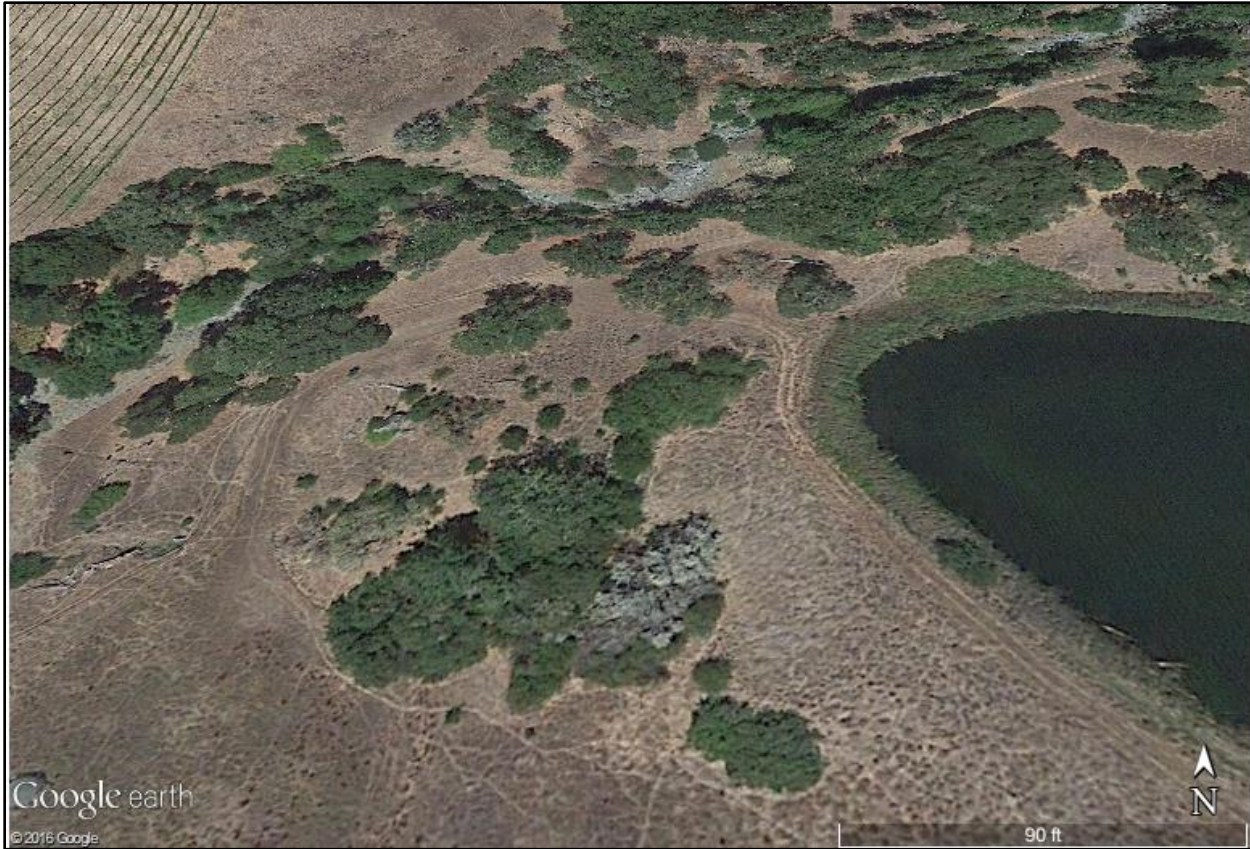
Figure 6. Google earth imagery shows the reach of the unnamed tributary to Maple creek directly beneath Reservoir 1 may have been buried, which does comply with FGC section 1602 and 5650. Maple Creek can be seen in the western portions of the figure.

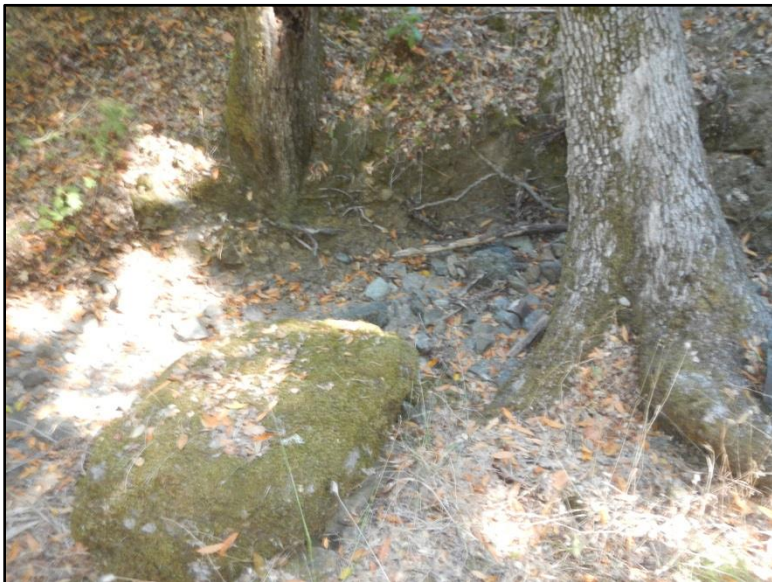
- Portions of an unnamed tributary to Maple Creek were observed up and downstream Reservoir 1 and immediately downstream of Reservoir 2.
- In between Reservoir 1 and 2 the stream channel was dry. However, habitat indicators were present to support non-fish aquatic life seasonally. Indicators include sufficient channel dimensions and slope, habitat complexity, well developed formations to allow pooling, root wads and logs, instream cover, large rocks and coarse sediment, mature riparian vegetation and canopy cover.
- The unnamed tributary to Maple Creek could not viewed beyond the immediate vicinity of Reservoir 1 for stream class indicators or fish passage barriers due to access and time constraints.

Figure 7. Photograph of the unnamed tributary to Maple Creek within the reach between Reservoir 1 and 2. The photograph demonstrates conditions of the unnamed tributary that appear relatively intact. Similar conditions could be expected to have extended downstream but have been eliminated by Reservoir 2. Further investigation is needed to determine if Reservoir 2 has eliminated any portions of stream channel that could support fish year round or seasonally, see FGC 5901.

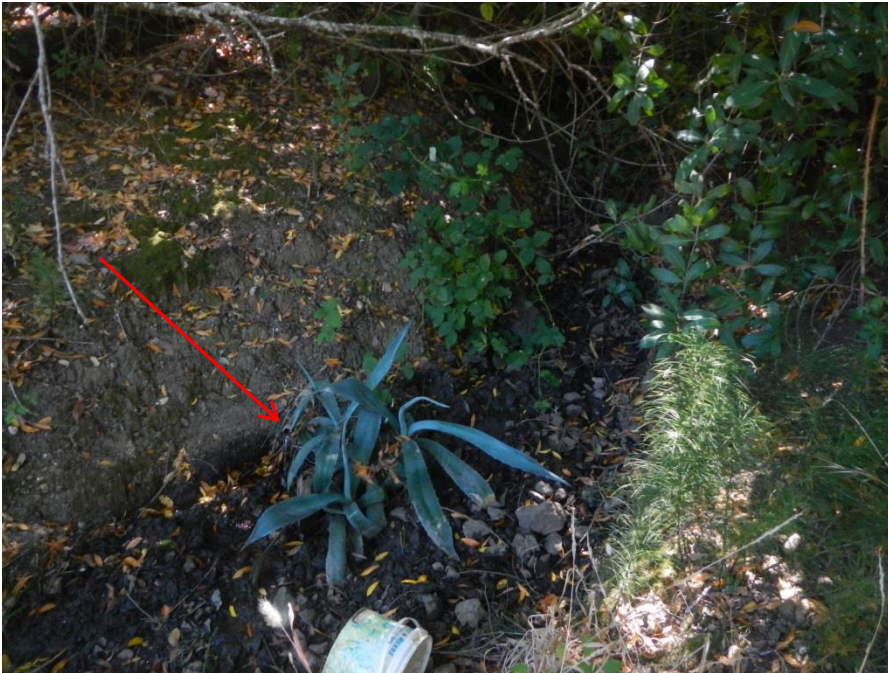
- Surface stream flow within the unnamed tributary to Maple Creek (upstream Reservoir 2) was followed to a small pipe and seepage around the pipe within the stream channel. Mr. Peters explained water coming from the pipe was from an improved spring that was developed during the “homestead era.” Flow from the pipe was not measured but visually estimated in the 5-10 gallon per minute range.
- Modifications to the spring included drilling a horizontal well beneath the spring and into the stream bank/riparian corridor adjacent to nearby vineyards.

Figure 8. A small pipe is shown by the red arrow that was described as being connected to a horizontal well. Seepage within the stream channel upstream the pipe indicates not all of the surface flow in the stream can be attributed to water from the pipe.

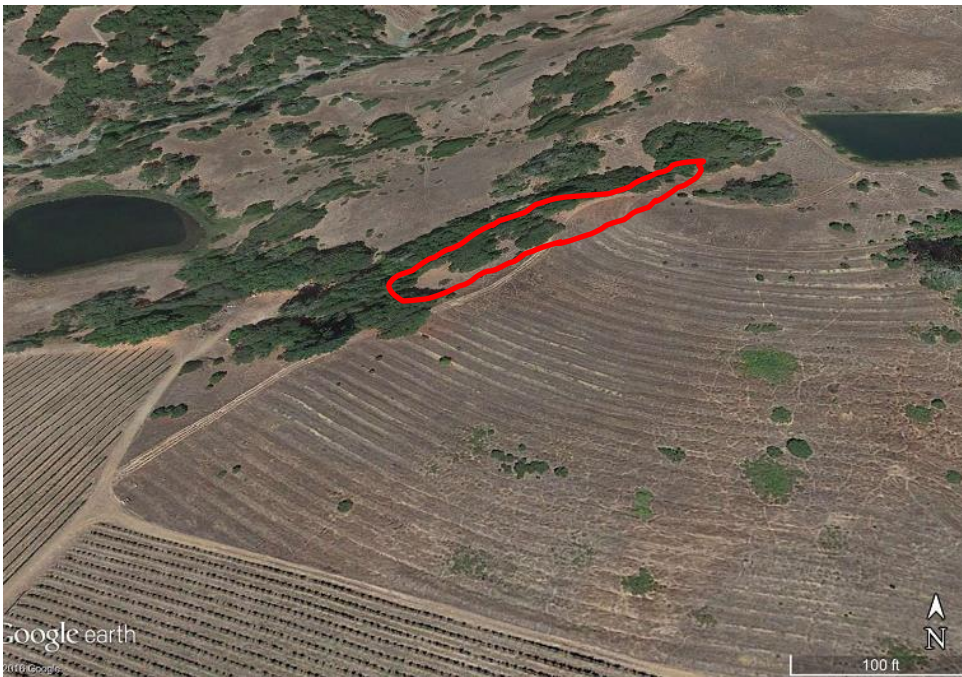
- Heavy equipment was used to push earth materials into portions of the stream channel downstream Reservoir 2, (Mr. Peters, Personal Communication);

- Fill materials were estimated to have been placed along an approximate 200 foot reach of the unnamed tributary to Maple Creek beneath Reservoir 2, (Mr. Peters, Personal Communication); and
- Fill materials were placed onto a streambank to an estimated elevation of 10 feet below the top-of stream bank, (Mr. Peters, Personal Communication).

Figure 9. The red polygon depicts where fill was placed into the unnamed tributary to Maple Creek. Placement of fill materials has substantially changed the bank of the stream, see FGC section 1602 and 5650. In addition, tile drains have been installed within the terraced hillside (every 5 terraces, Mr. Peters, Personal Communication) and directly concentrated run-off to the stream channel, see FGC section 1602.
