Mapping Versus Hydrologic Modeling of Episodic Channels on Alluvial Fans

Episodic Streams Workshop

Jeremy T. Lancaster

California Geological Survey

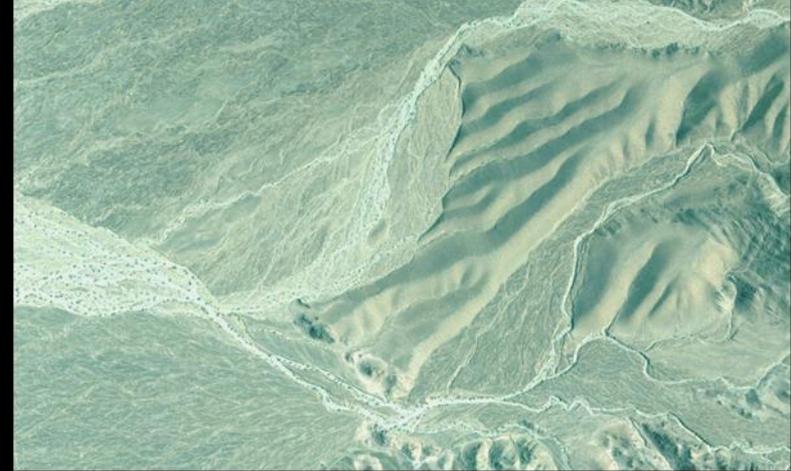
Topographic Pattern

Bar-and-channel morphology = Young
Ridge and ravine morphology = Old

Transverse and Longitudinal Profiles

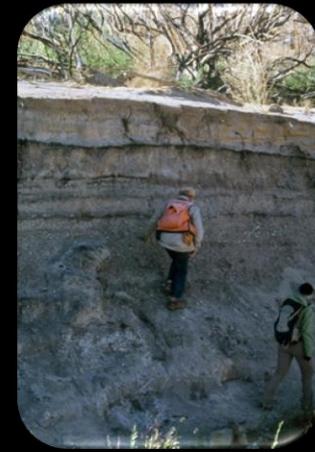
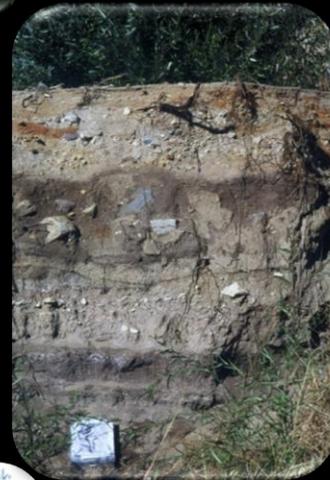
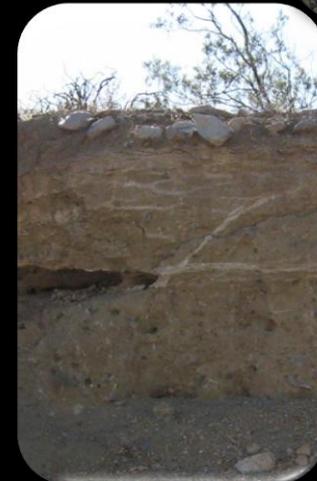
Age Indicators

- *B horizon development*
- *Rubification*
 - *Munsell - Hue and Chroma*
- *Carbonate Stage*
- *Fines Carbonate Morphology*
- *Gravel Carbonate Morphology*
- *Desert Pavement*
- *Parent material influences*
- *Cobble Weathering Stage*
- *Weathering Rind Thickness*
- *Desert Varnish*

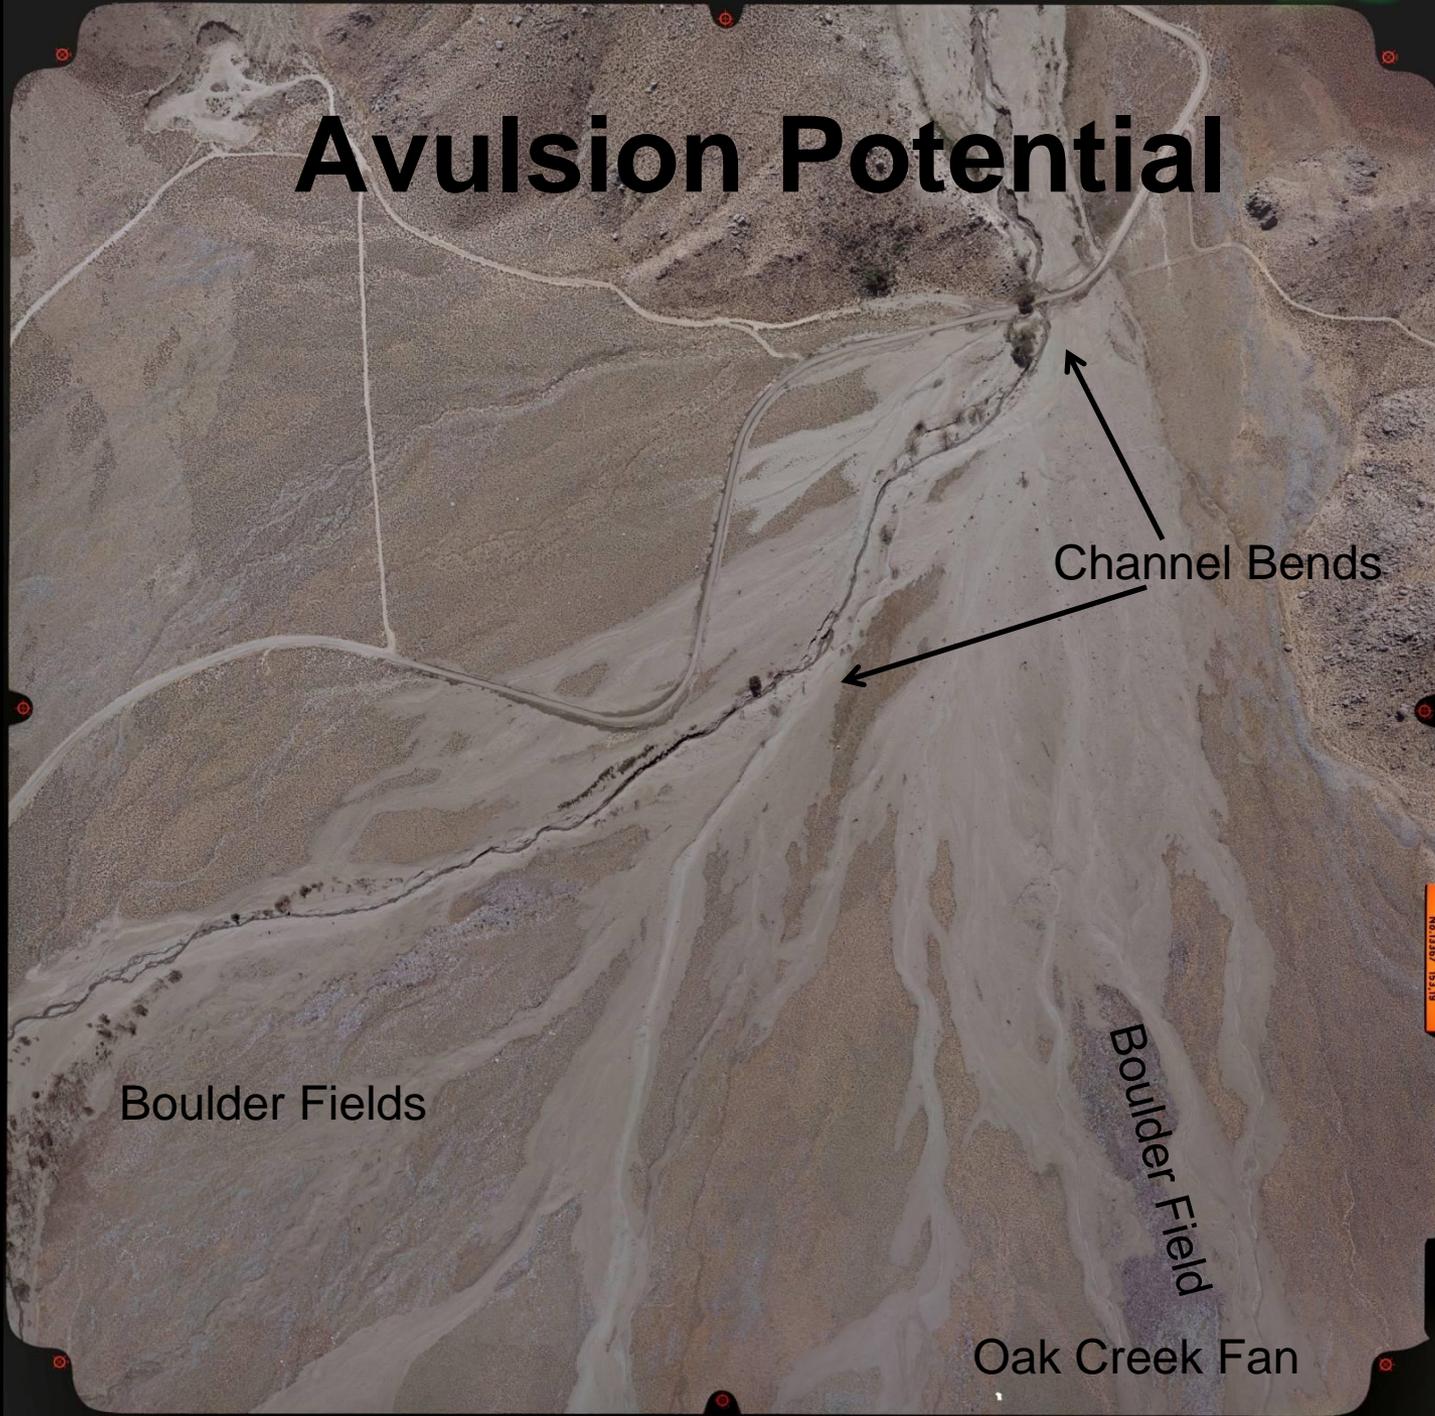
Avulsion Potential

Channel Bends

Boulder Fields

Boulder Field

Oak Creek Fan
