**THE DESTRUCTIVE FAILURE
OF CREEK RESTORATION
IN NIPOMO CREEK
NIPOMO, CALIFORNIA**

An Investigative Report

**The Devolution of Creek and Oak Habitat in
Southern San Luis County**

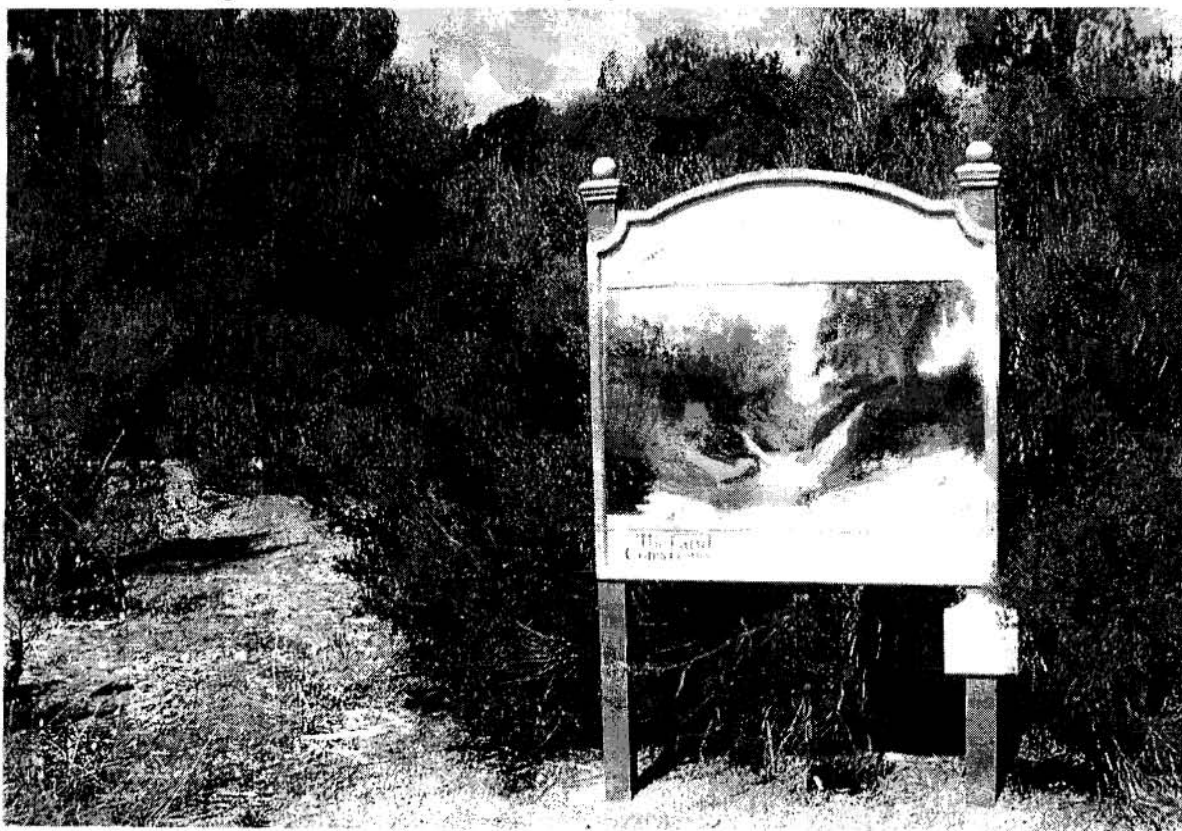
Figure 1. Entrance to Old Town Nipomo Creek Preserve

We will begin our "Creek Walk" as did Mr. Richard Chandler at the Land Conservancy Preserve Park. The painting at the entrance (Figure 1.) is a vision of soft colors melded together with the spirit of shadows that tends to draw the heart of the Nipomo's Old Town Community up a stream of the creators realm. The projected vision and reality are two different things. This was my perception on dedication day when I donated approximately 20 fairly mature oak trees to the Land Conservancy representatives in "charge" of the Nipomo Creek project.

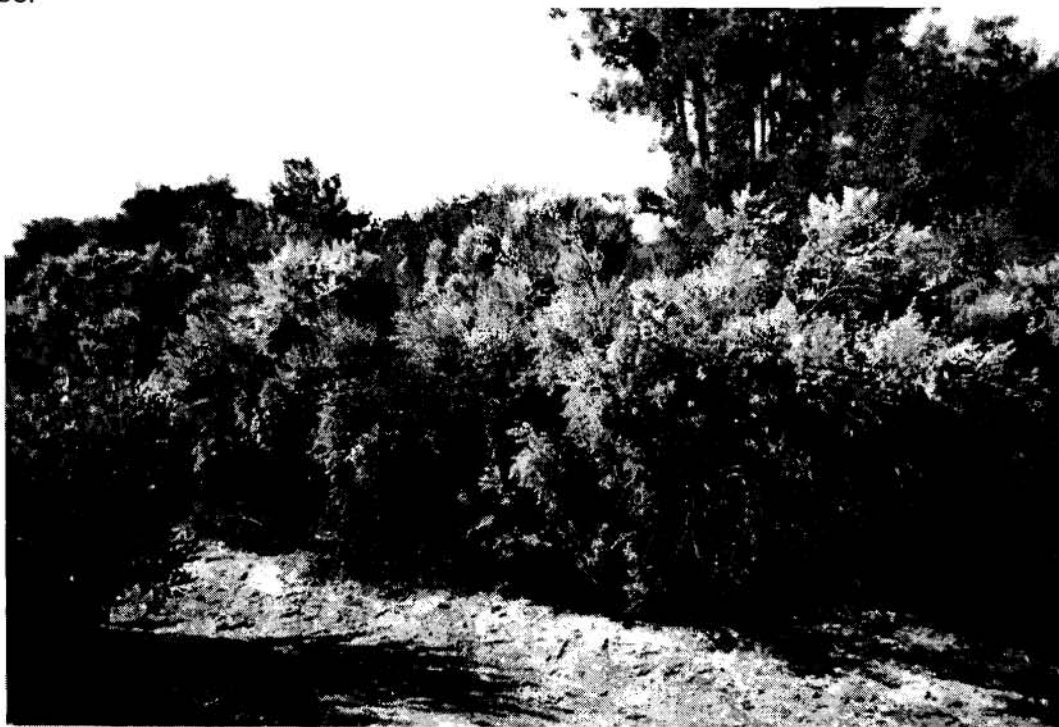
overgrown Coyote Brush obscures the view from the perimeter and makes safe use by the public untenable. With its paths and resting places being obscured by the overwhelming brush the lack of attention has created a haven for drug use. On a number of occasions I have found glass methamphetamine pipes, "bongs" created out of beer bottles and toilet paper rolls, tin foil paraphernalia, liquor bottles, cigarette butts and spent matches discarded along its maze of paths and resting places.

Figure 2. Overgrown Coyote Brush

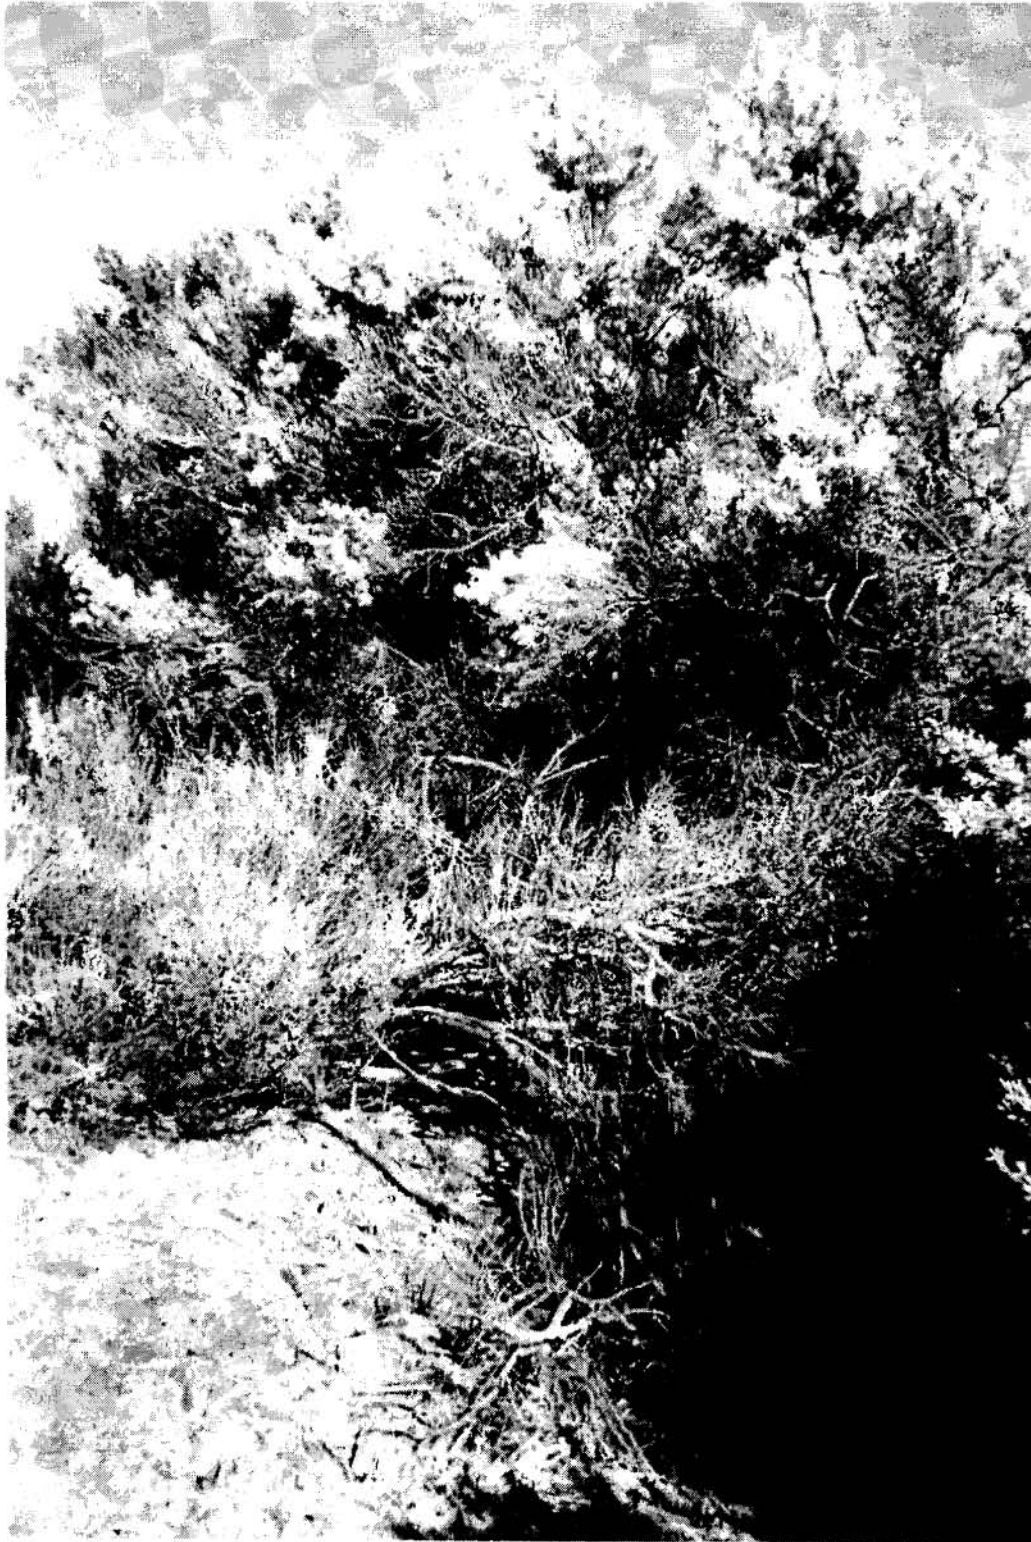
Figure 3. Mature Coyote Brush

At this stage of maturity Coyote Brush dies back setting the natural stage for fires.

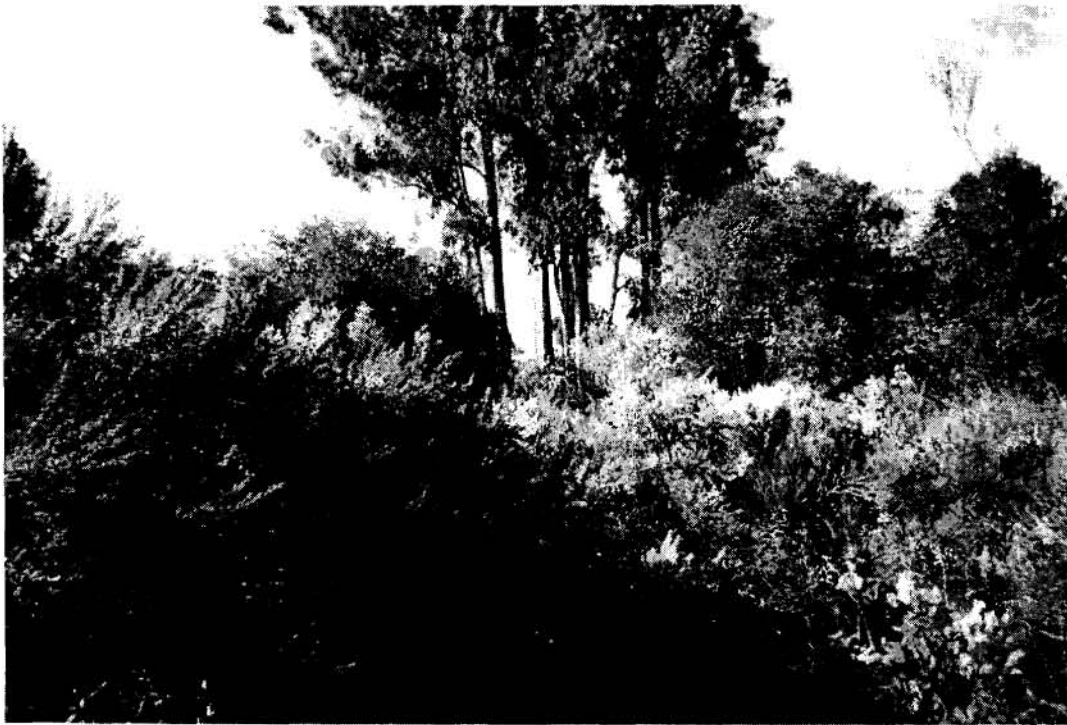
Figure 4. The massive fuel load of Coyote Brush dwarfs the man in the lower right.

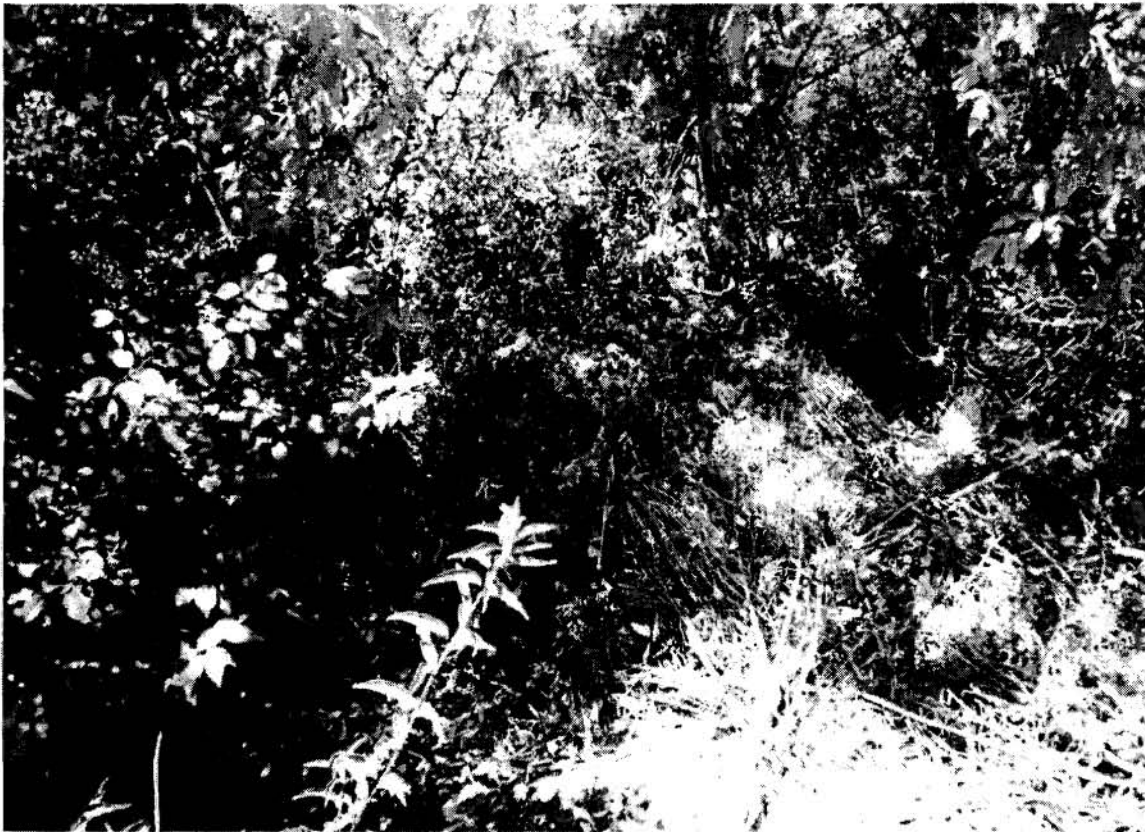
The path entrance to the creek has been purposely blocked with large piles of dried brush as can be seen in Figures 5 through 7. This questionable act adds an extreme fire hazard to an already tinder dry area covered by dry wood chips during a drought season already fraught with many fires. Fire officials have said that conditions this year "are the worst in memory". Coyote brush is an integral part of the chaparral, a fire oriented Biome. When this type of brush reaches a certain age of maturity it becomes woody and the undergrowth and upper stems die out (Figure 3.) creating tinder of extreme fuel load with a low flash point. This is the exact condition that exists in much of the Preserve Park. To ignore this reality leads me to believe that the "Professionals" and "Experts" are only connected by abstract academic theory with chaparral fires. All the book learning available does not hold a candle to experiencing the tornado like fire storms as I have seen dispersing embers for 50 yards in every direction. My hands-on education and therefore my concern have been seared into my being. This area is one careless cigarette or match from a stoned drug user away from a flameout that would incinerate all of the work done by the Responsible Agency and is only yards away from a set of commercial outlets (Figure 7.).

Figure 5. Dried Brush Blocking Paths to Nipomo Creek

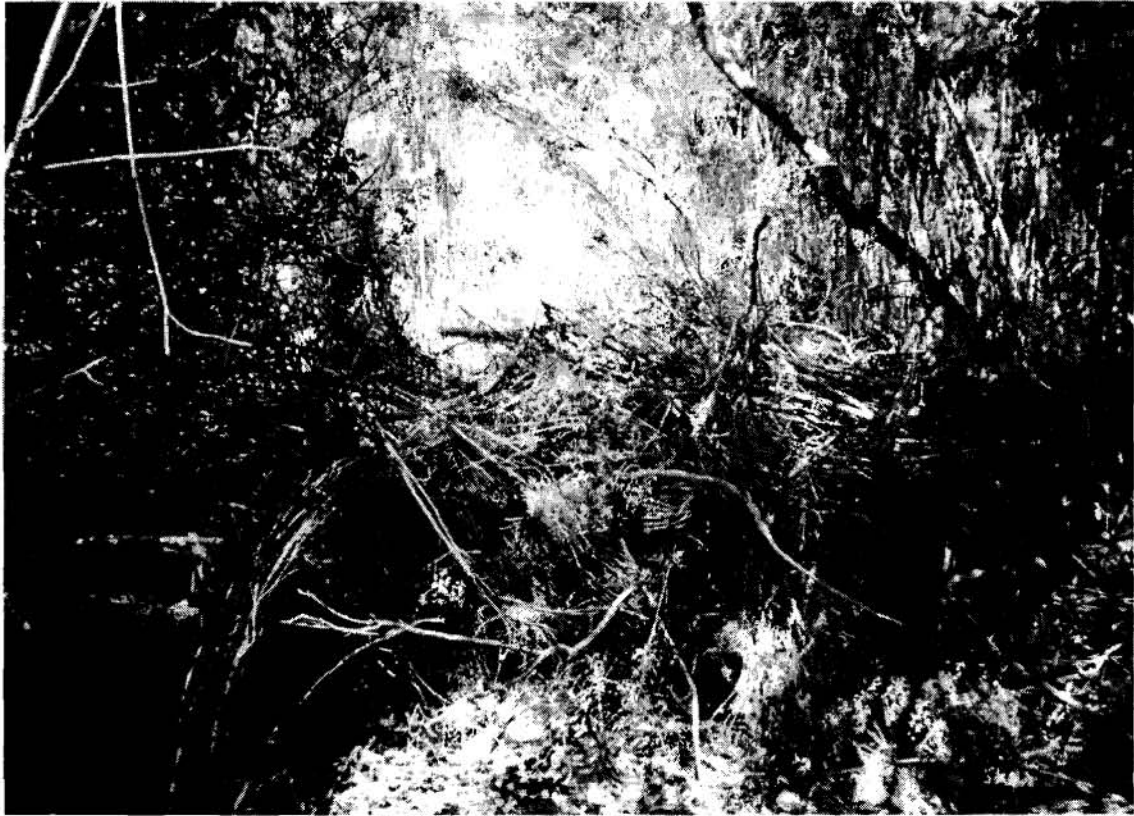
Figure 6. Dried Brush Pile Blocking Paths to Haystack Creek

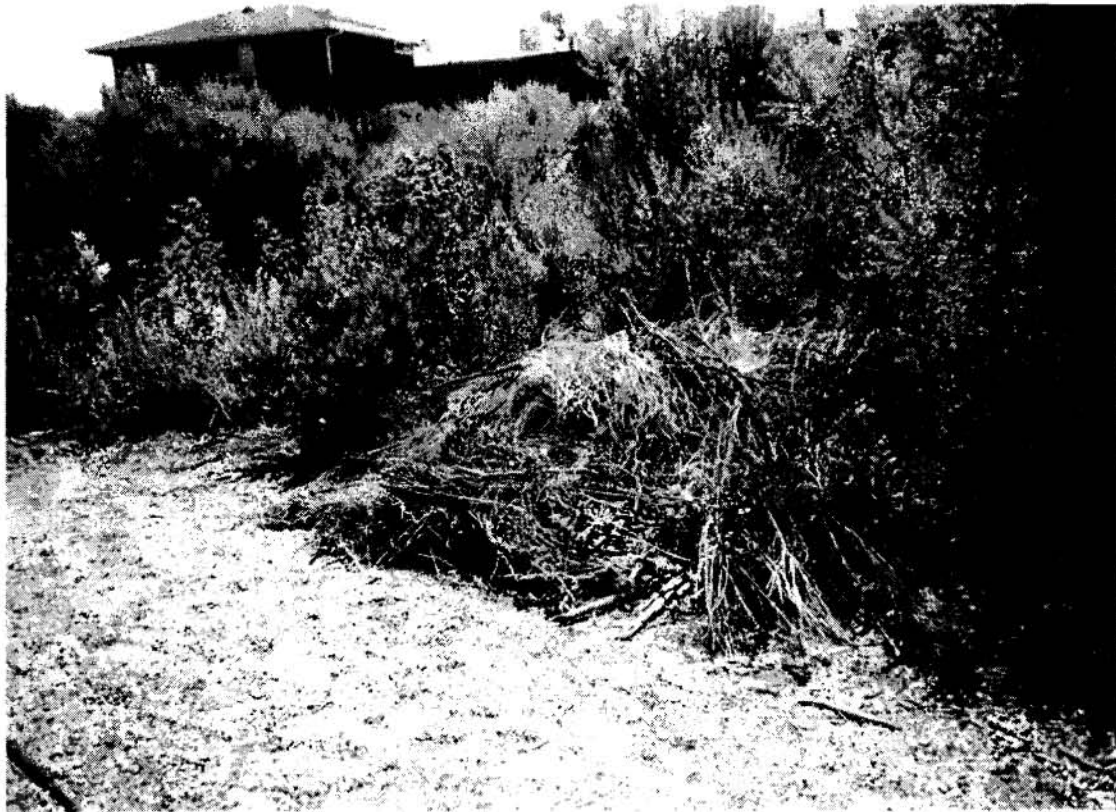
Figure 7. Fire Hazard in Volatile Area of the Preserve. (Note close proximity to commercial buildings)

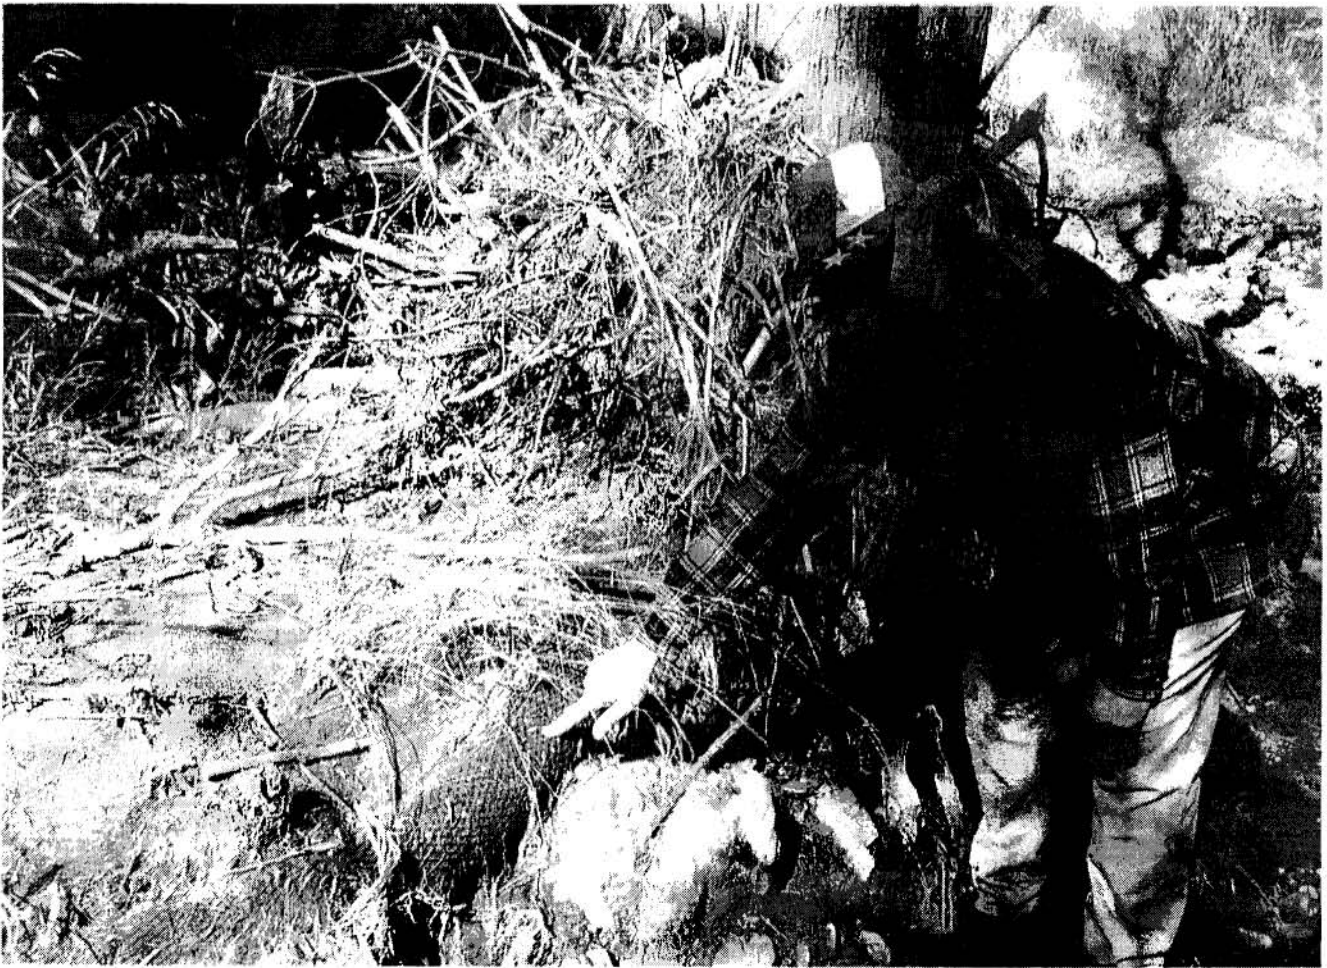
In the Figure 8, what you will see is a black plastic webbed "Biolog" in place on Haystack Creek (the only one of untold numbers that is left).

Figure 8. Black Plastic Webbed Biolog In place In Haystack Creek

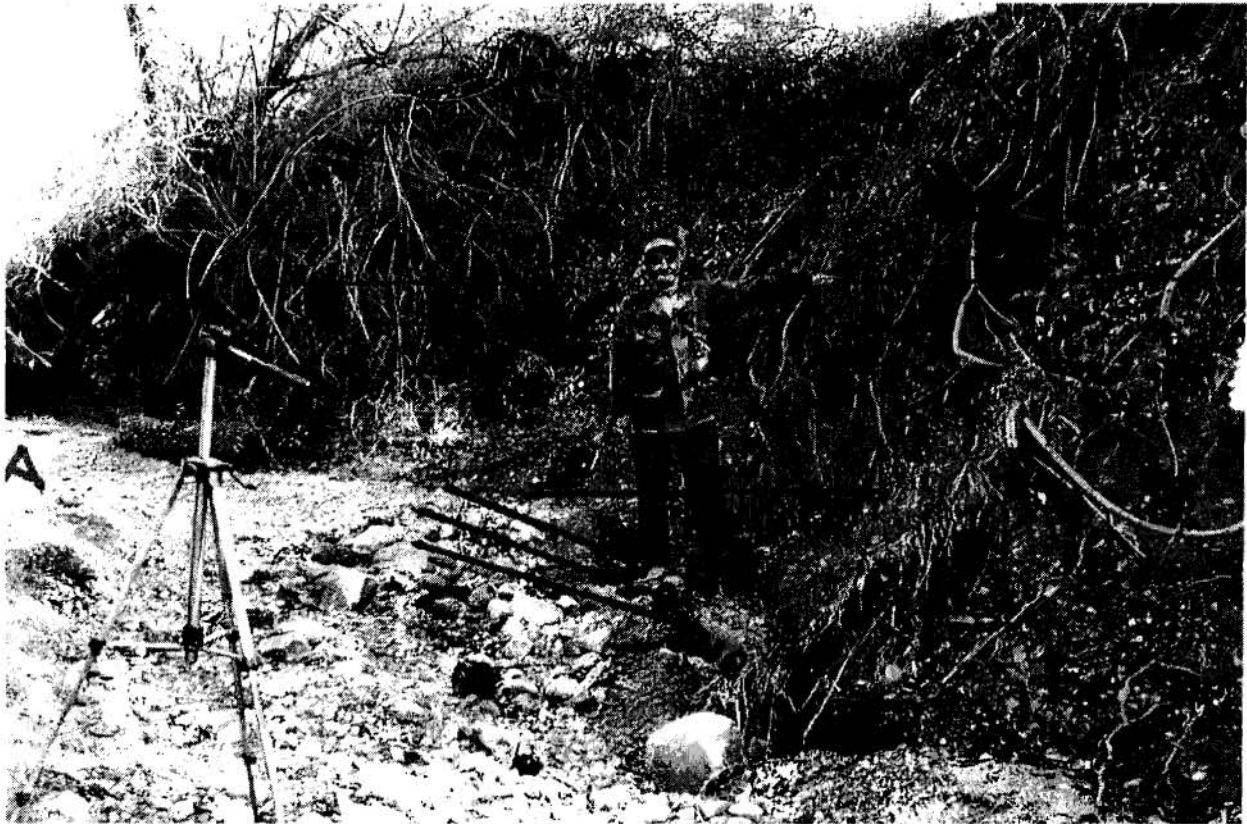
Figure 9 shows the remnants of 10" hemp "Biologs" that were placed the full length of lower Haystack Creek. These waddles are used for water flow control but become counter productive should that flow override their mass. When Mr. Chandler saw these and others in Nipomo Creek, he said, "What are these doing in a creek channel"? "Who put these here?" Where a channel flow overrides a solid object whether it is a large stationary rock or an elongated section of 10" waddles pinned to the creek basement, the downward "fall" accelerates erosion "scour" geometrically. The downward accelerated turbulence working off the solid stationary objects erodes the less stable sand gravel and soil at the base of the channel banks. The accelerated churning effect undercuts the consolidated channel bank formation held stable by plant roots. Once this penetration reaches a certain point there is a collapse and in short order because of the basal penetration, the banks integrity is lost and a major collapse ensues. This in turn affords lateral scour to affect bank degradation as well.

Figure 9. 10 Inch Hemp Waddle remnant in Haystack Creek

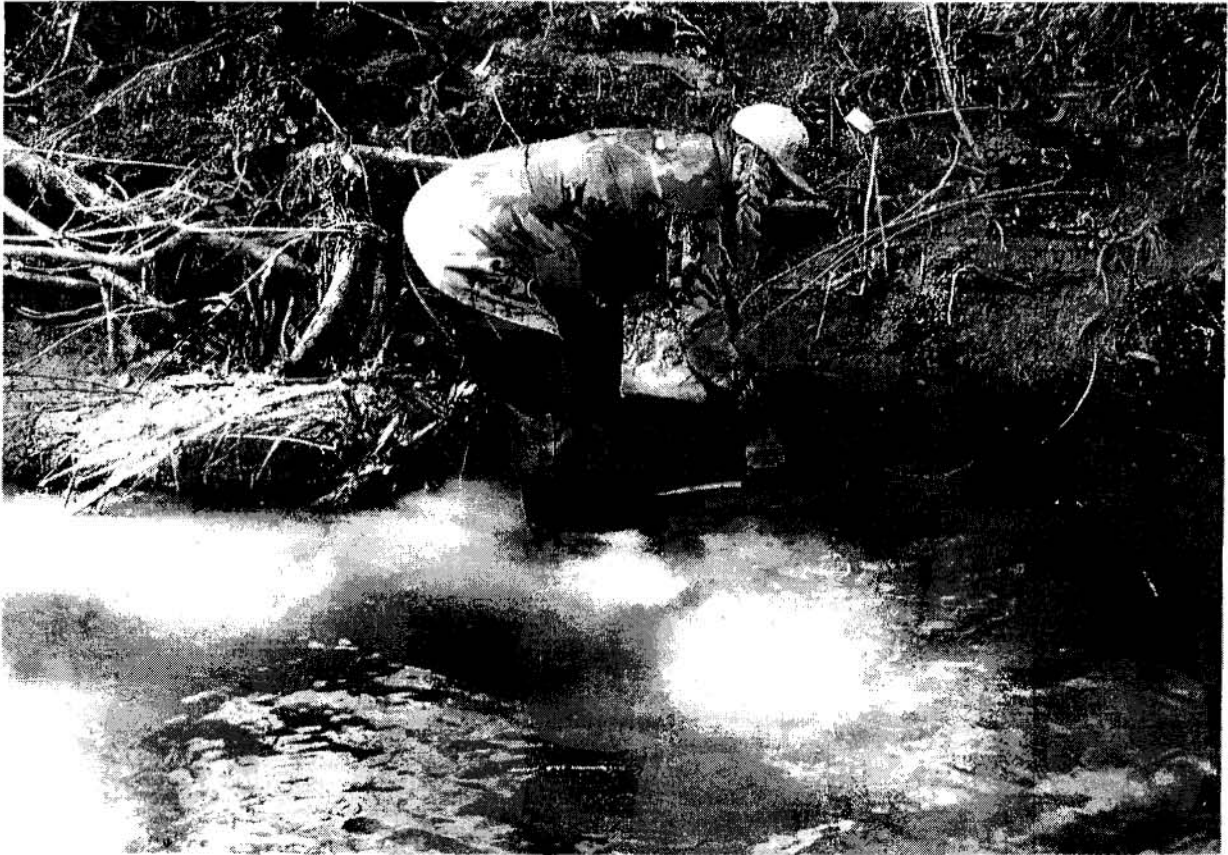
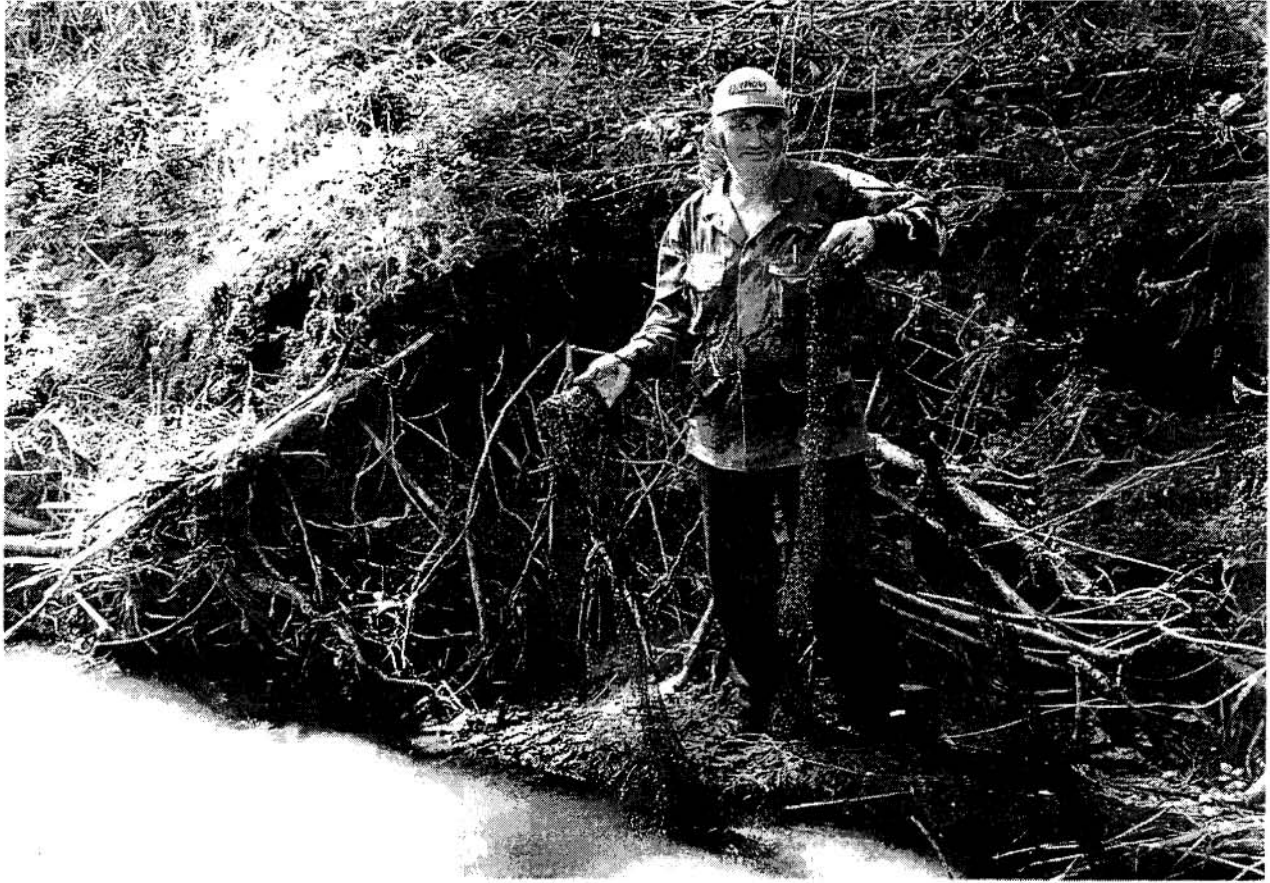
The next 2 creek images (Figures 10 & 11) show a "Creek Dog" pulling up the black plastic netting that once surrounded a "Biolog" as set in place by "creek restoration experts" in untold numbers in Haystack and Nipomo Creeks. When I first respectfully confronted the representatives from the Land Conservancy in charge of Nipomo Creek with this deplorable reality they vehemently claimed no responsibility. When asked if I could present my case to the Board of Trustees of their responsible agency one representative told me that he was absolutely sure the Board of Trustees had no interest in hearing anything I had to say or in viewing any of my photographic documentation. During that period of discussion the other representative sat mute not offering any input. Soon after this meeting I learned that the representative who sat mute was a member of the decision-making organ (Board of Trustees). I realized at this point the community of both man and of nature would not receive a "fair shake" as long as these representatives held sway in the matter of Nipomo Creek. Having my truthful concerns spurned in such a manner compelled me to initiate the production of "Destructive Failure". I believe this photo-documentation will speak louder than their words.

Figure 10. Creek Dog Lifting Black Plastic Webbed Biolog in Nipomo Creek

Figure 11. Creek Dog Holding Black Plastic Webbed Netting (Biolog)

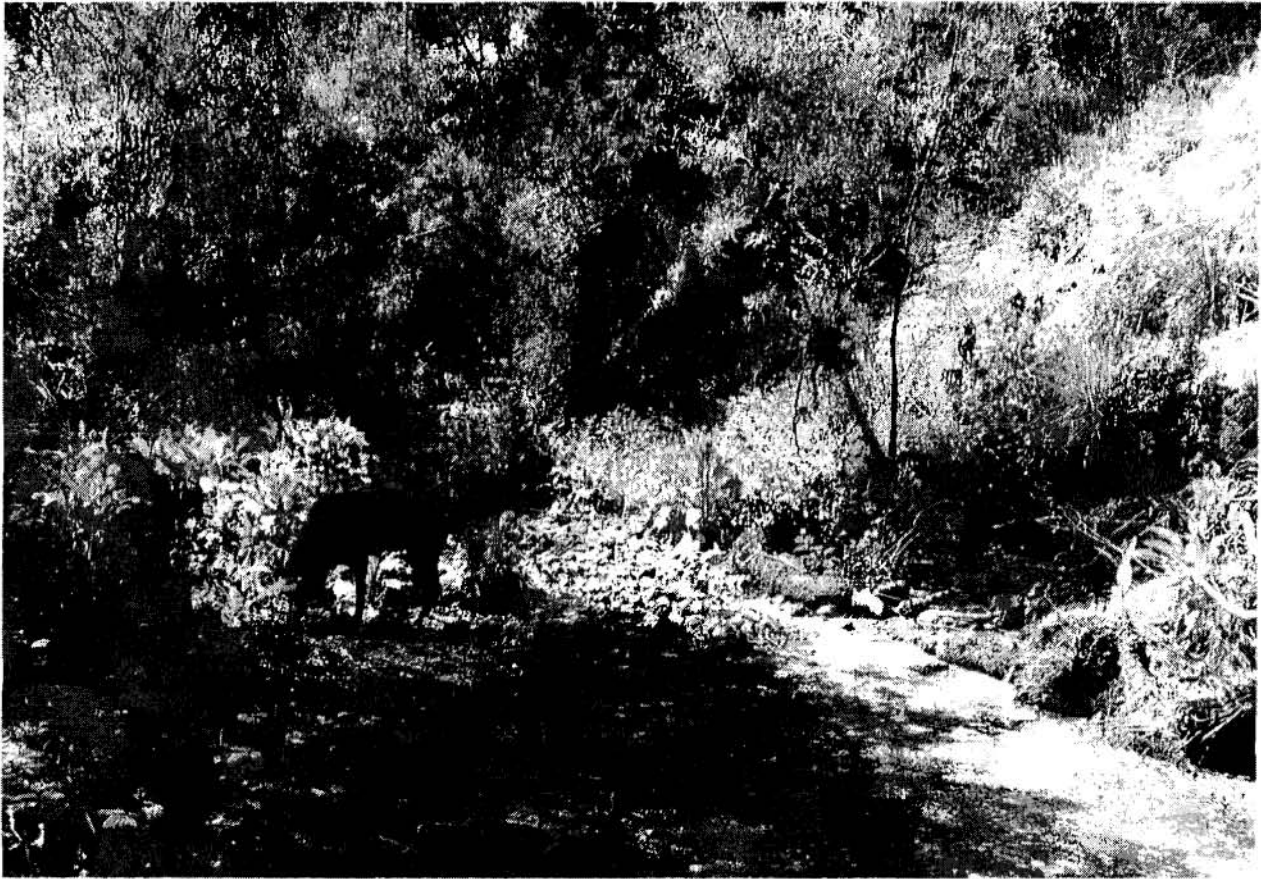
In the last of this set of images (Figure 12) you will see a view down Nipomo Creek with a four-legged "Creek Dog". From the lower right corner extending to a young "V" stemmed willow a remnant section of 10" hemp waddle can be seen. Here again a constant of nature prevailed in the face of agendized error and accelerated scour has caused creek bank degradation. Now channel flow has a 90-degree wall to churn against and it will erode under the consolidated formation's root bound zone and extend the cut bank down stream with every storm surge.

Figure 12. View Downstream Nipomo Creek Showing Bank Degradation

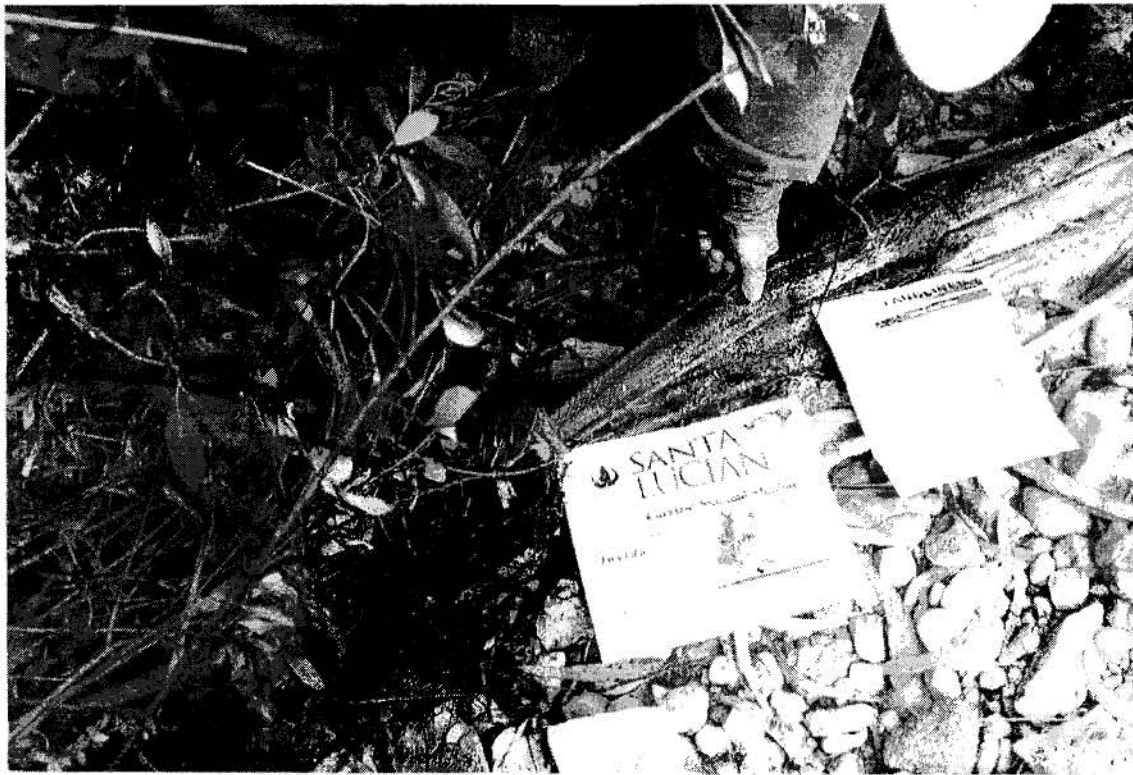
Although the damage in the preserve itself was noticeable it paled in comparison to that done downstream as a result of the emplacement of massive numbers of "Biologs" that hung up on every conceivable snag and created massive debris jams on properties below. We will visit only one. If I were to make a full documentation of the downstream impact this report would run well over 100 pages. Following Mr. Richard Chandler's footsteps, we have passed approximately 200 yards along the creek channel where numerous "isolate" Biologs and masses of black plastic tarp as shown in Figure 13 (also emplaced by "Creek Restoration Experts") are buried in the silted creek basement and tangled like fisherman's knots around exposed Oak roots and Willow trees that contributed to inordinate channel bank scour and undercutting the stability of "Mother Oaks". While the Land Conservancy rightfully revels in photo-ops in planting acorns and other Oak Tree mitigation projects, their noble efforts have been betrayed by the degradation and destruction of Oak habitat and mature "Mother" Oaks along Nipomo Creek. The damage will have long-term affects on Oak habitat.

Figure 13. Massive tarp tangled on foliage and buried in creek basement

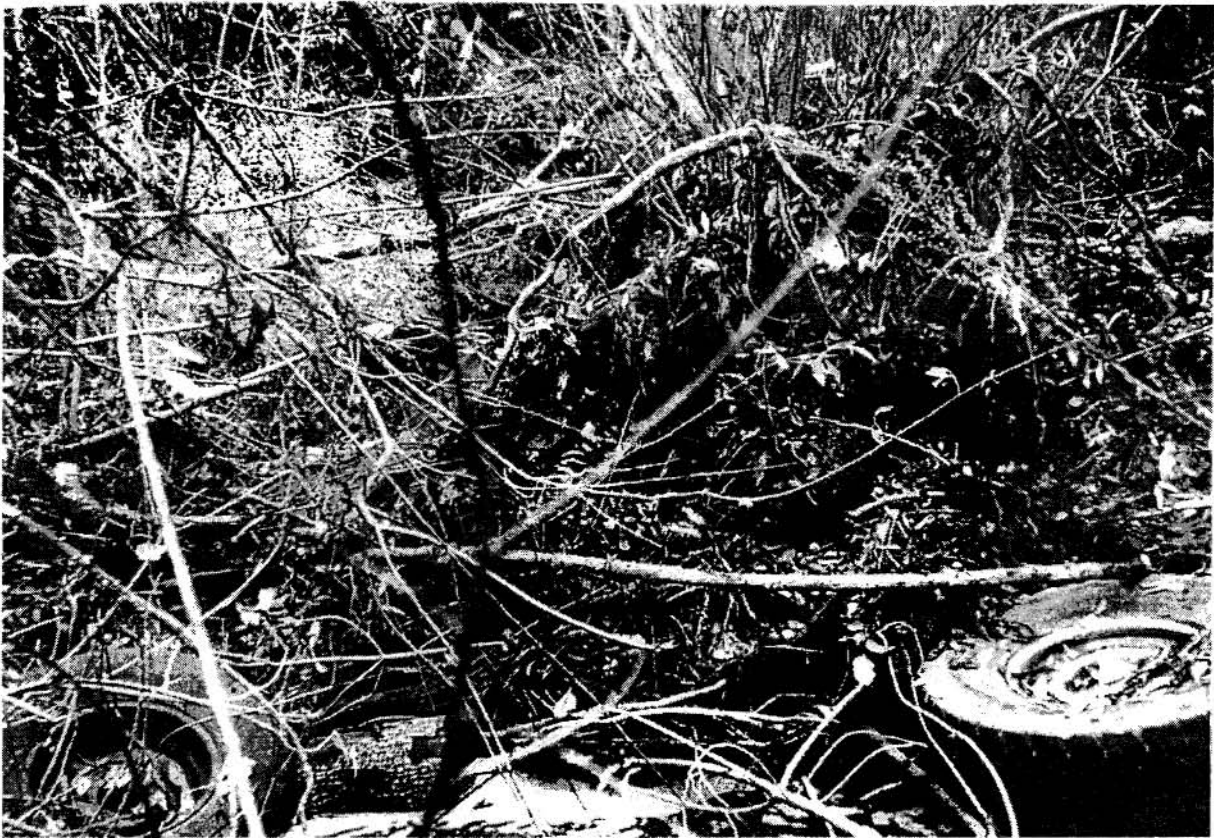
The next six images (Figures 14 through 19) will document the growth and maturity of only a single debris jam. In the first image you will see an embryonic debris jam. First a little brush wraps around a mid-stream Willow (Figure 14) followed by a few black plastic netted "Muerto logs" and or their empty netting and some black plastic agricultural drip tubing (a primary scourge in Nipomo Creek). The channel flow in front of the debris jam slows and heavier objects "drop" out. The debris jam grows and as it does channel flow is diverted laterally against what in this case was a set of channel banks 30 feet apart. In the next three images (Figures 15, 16, & 17) you can see how black plastic netted "Muerto-logs" integrate themselves into the debris jam that becomes consolidated and grows geometrically around constantly growing Willow uprights. Without the introduction of inorganic plastic, especially in massive amounts, organic materials being in a moist environment decompose quickly and erode incrementally causing little damage. I have watched this process many times in 50 years.

Figure 3. Embryonic Debris Jam in Nipomo Creek

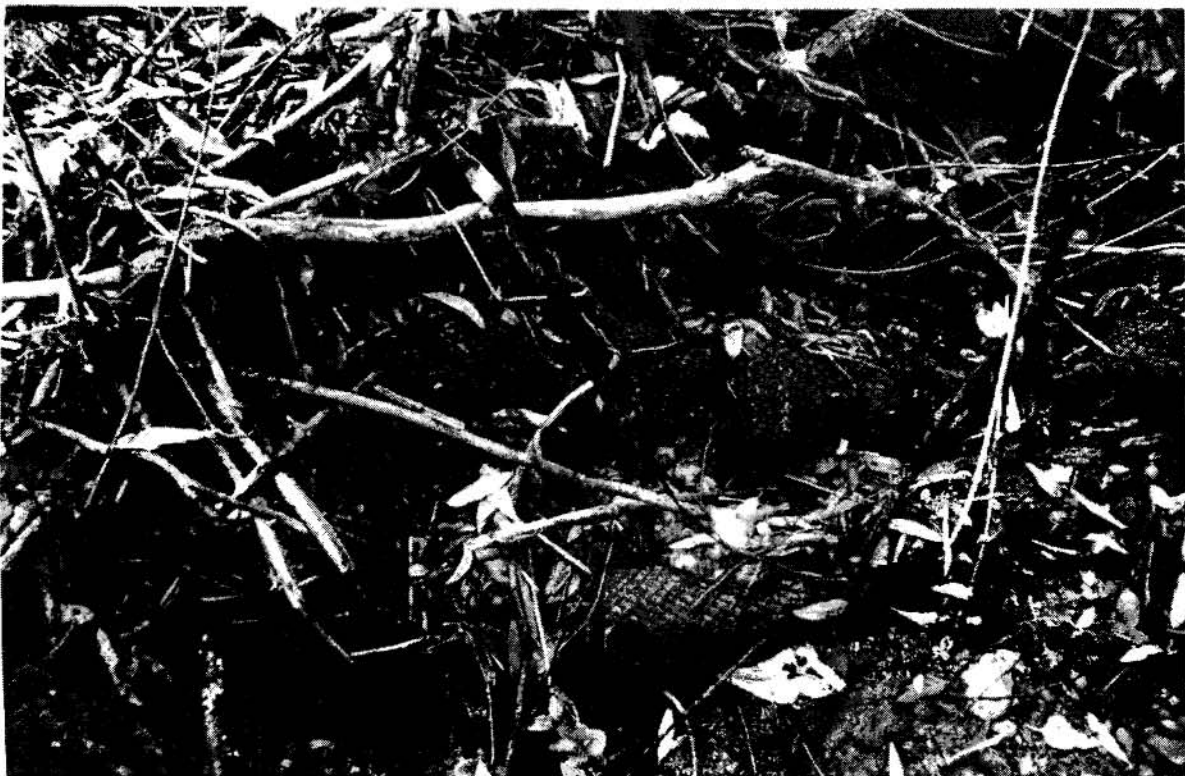
Figure 15. Biologs & Black Plastic Tubing integrated into Debris Jam

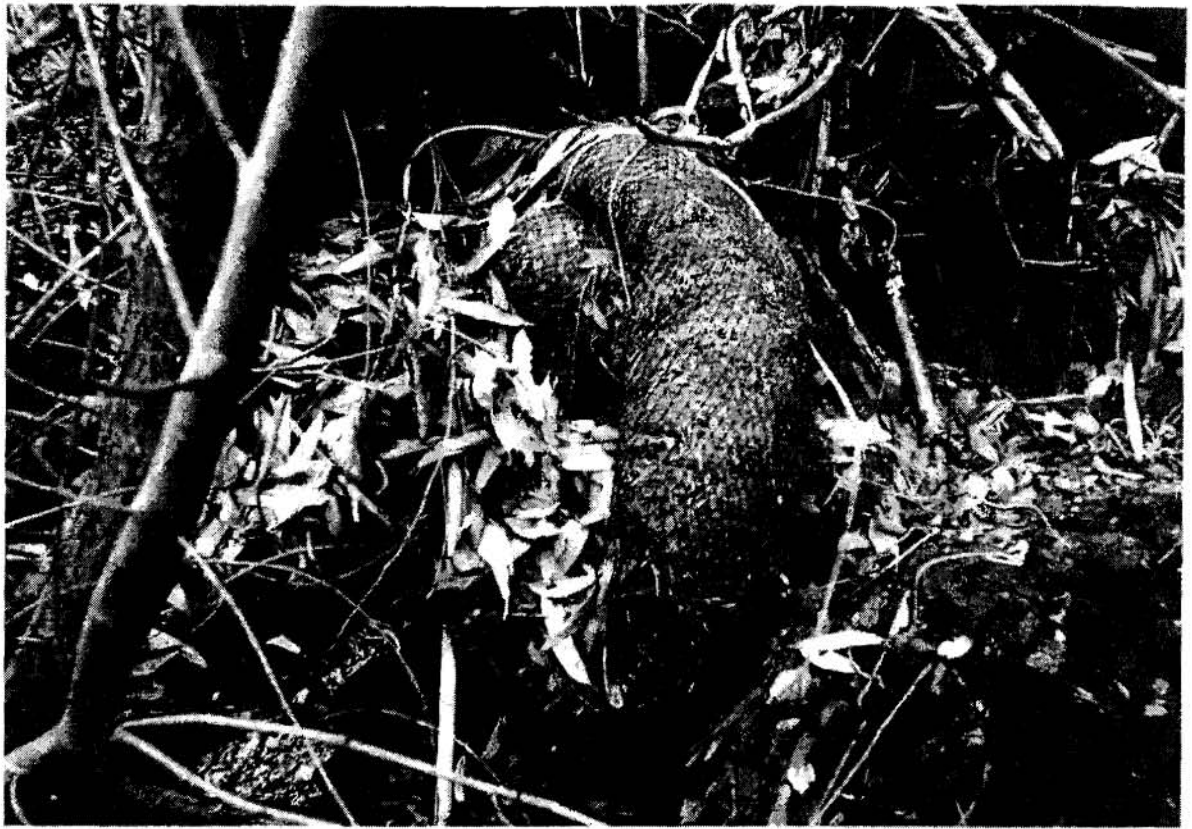
Figure 4. Biolog Binding Debris Jam

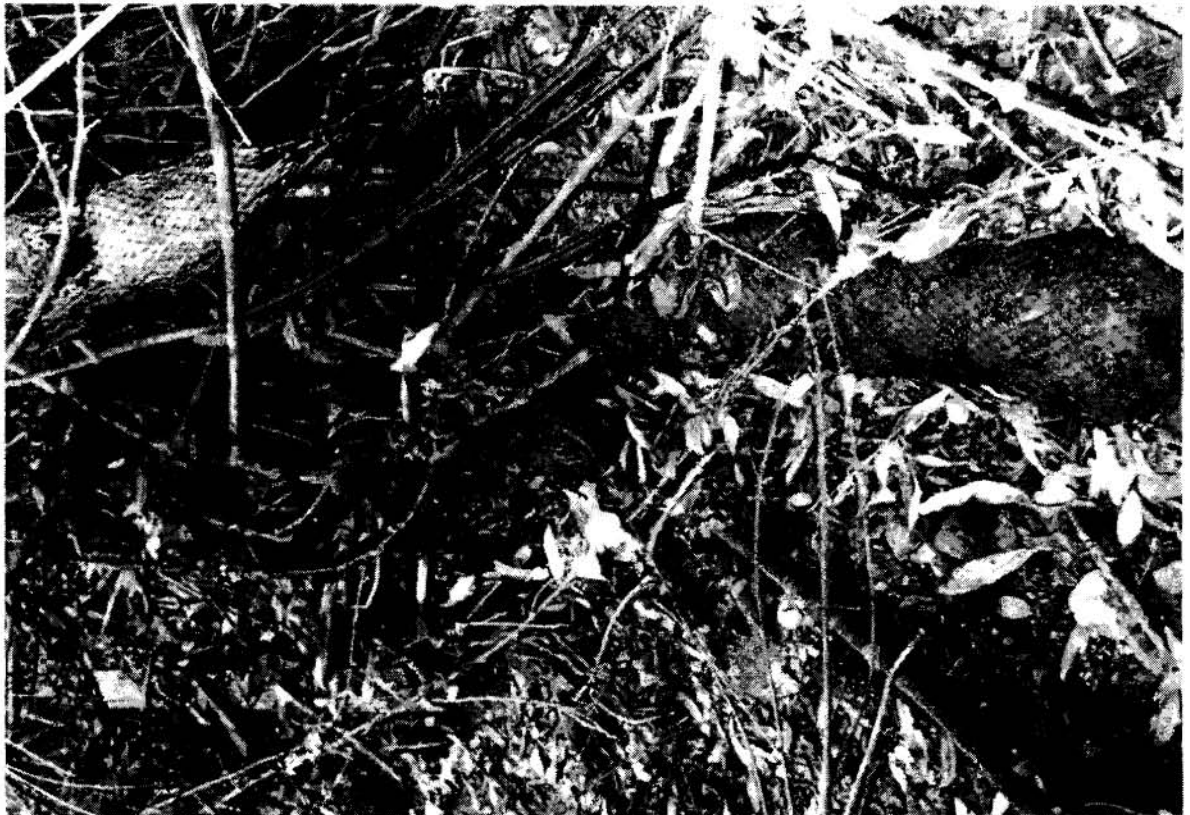
Figure 17. Plastic Bound Debris Jam at Basement Level of Creek

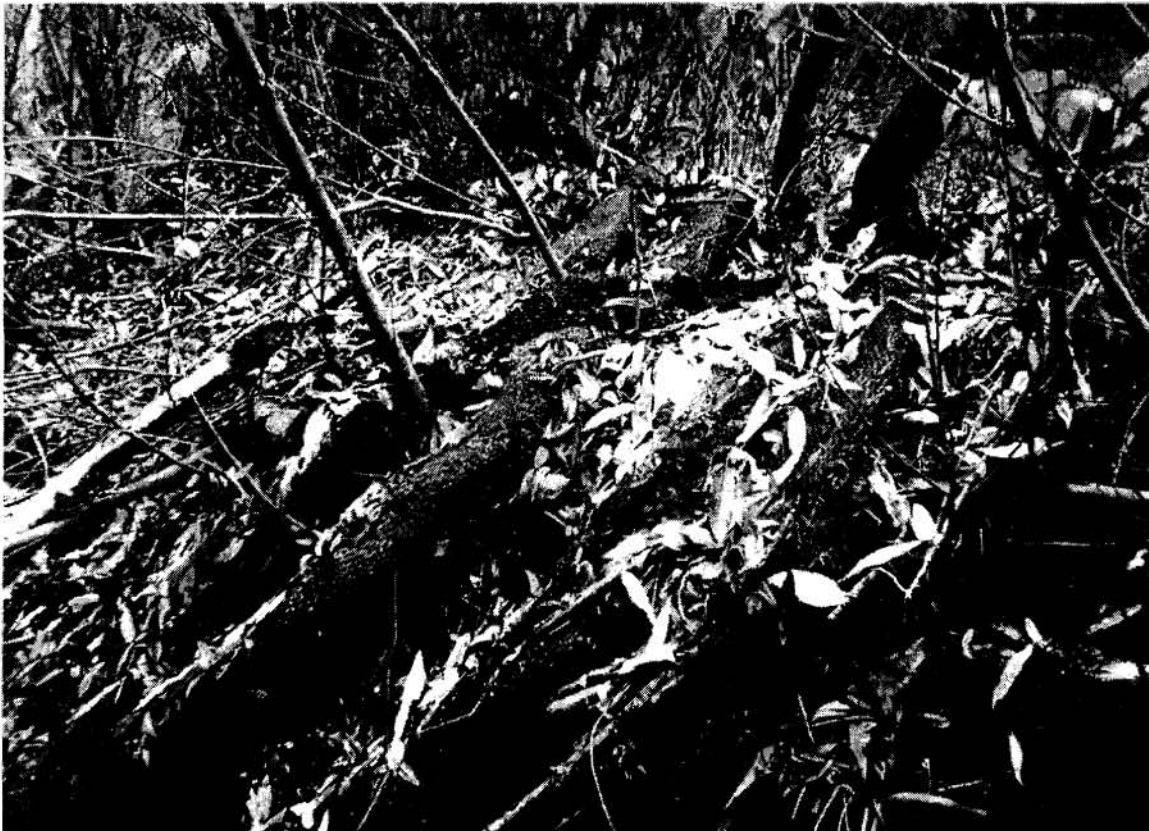
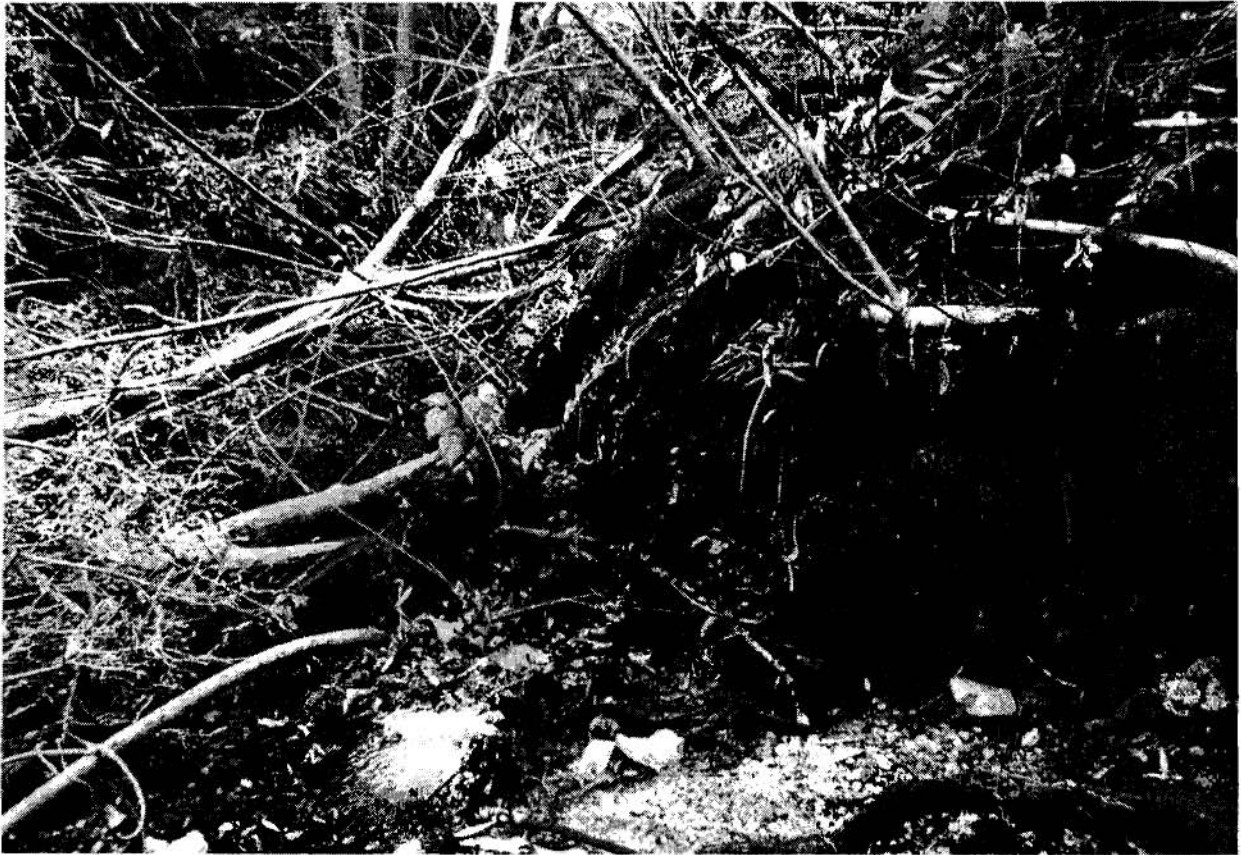
In Figures 18 & 19 you will see the leading point of a huge debris jam; I call this "Waddle Island". Its mass of organic material, silt and rocks consolidated by the unrelenting strength of plastics has created an island nearly as wide as the original creek channel. The channel flow now becomes diverted to either side of the ever-growing mass tied and bound by "Muerto-logs" and agricultural black drip tubing. The right side of the sixth image (Figure 18) shows a minor portion of Waddle Island wrapped from top to bottom by "Muerto-logs" and black drip agricultural tubing. During a moderate stream flows this past spring, (2008) the debris jam plugged the channel flow and the area on the left of this image, blew out undercutting the bank. The V shaped grey stem (Figure 19) and main stems in the foreground were part of an approximate 40' x 6' bank collapse that occurred just before this picture was taken. The next major storm surge will create a complete blockage of the stream channel to the top of the channel bank at approximately 12 feet and then "blow out" sending a wall of water down stream in a deluge. "Waddle Island" won't move leaving the oak studded banks to take the brunt of the erosion on either side of "Waddle Island" and the many properties below. You may think that I exaggerate but plastic tubing and a least one inflated waddle (since removed) hang from trees downstream approximately 12 ' above the stream channel basement.

Figure 18. Leading Edge of Waddle Island

Figure 19. Bank Collapse Due to Waddle Island
