**THE DESTRUCTIVE FAILURE
OF CREEK RESTORATION
IN NIPOMO CREEK
NIPOMO, CALIFORNIA**

An Investigative Report

**The Devolution of Creek and Oak Habitat in
Southern San Luis County**

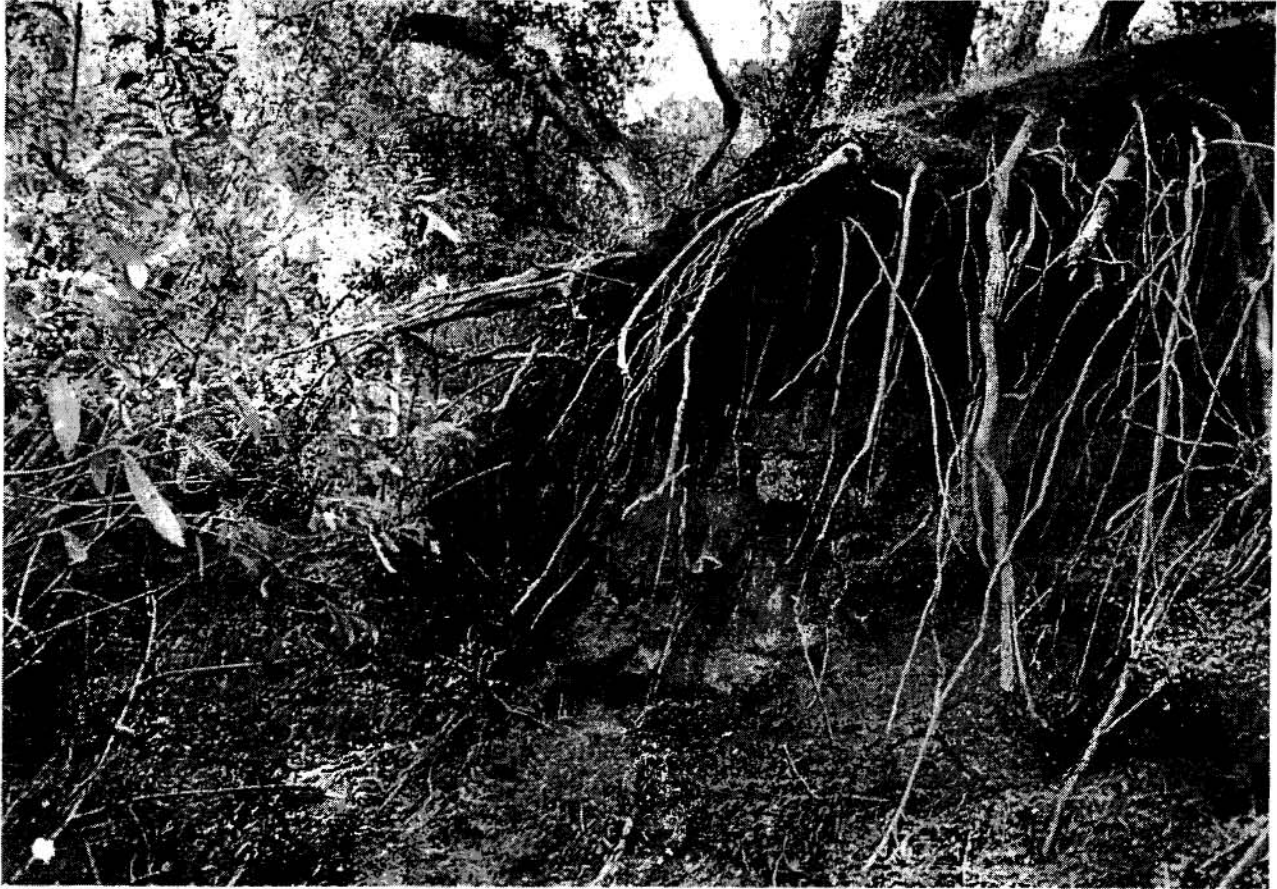
The first image (Figure 20) is of oak roots protruding from a fresh bank collapse on the west bank of "Waddle Island". The undercut and collapse of this bank has opened up a vertical wall for the next storm surge to churn a cutting spiral of water against. In my opinion at least four of the oaks seen in the upper pan of the image including the large "Mother Oak" are doomed to future high water.

Figure 20. Bank Collapse on West Bank of Waddle Island

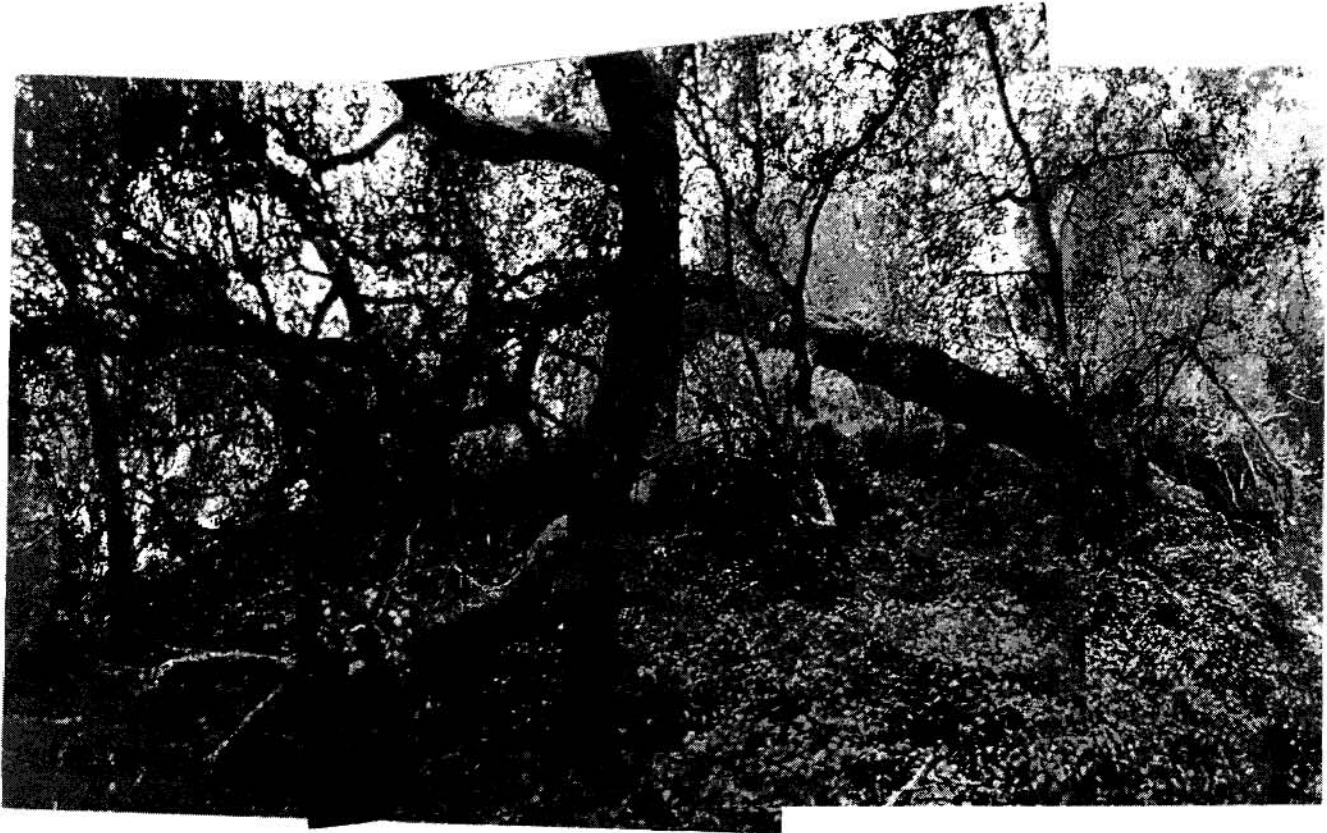
The third image (Figure 22) shows a large "Mother" Oak that has lost the vertical battle, its root wad hanging over the channel in the far right of the picture. This tree for decades was a daytime roost for generations of Great Horned Owls. Again, large amounts of black plastic were removed from this area of the creek channel and were wrapped around the Creekside root wad of this tree.

Figure 22. Large Oak that has lost the vertical battle

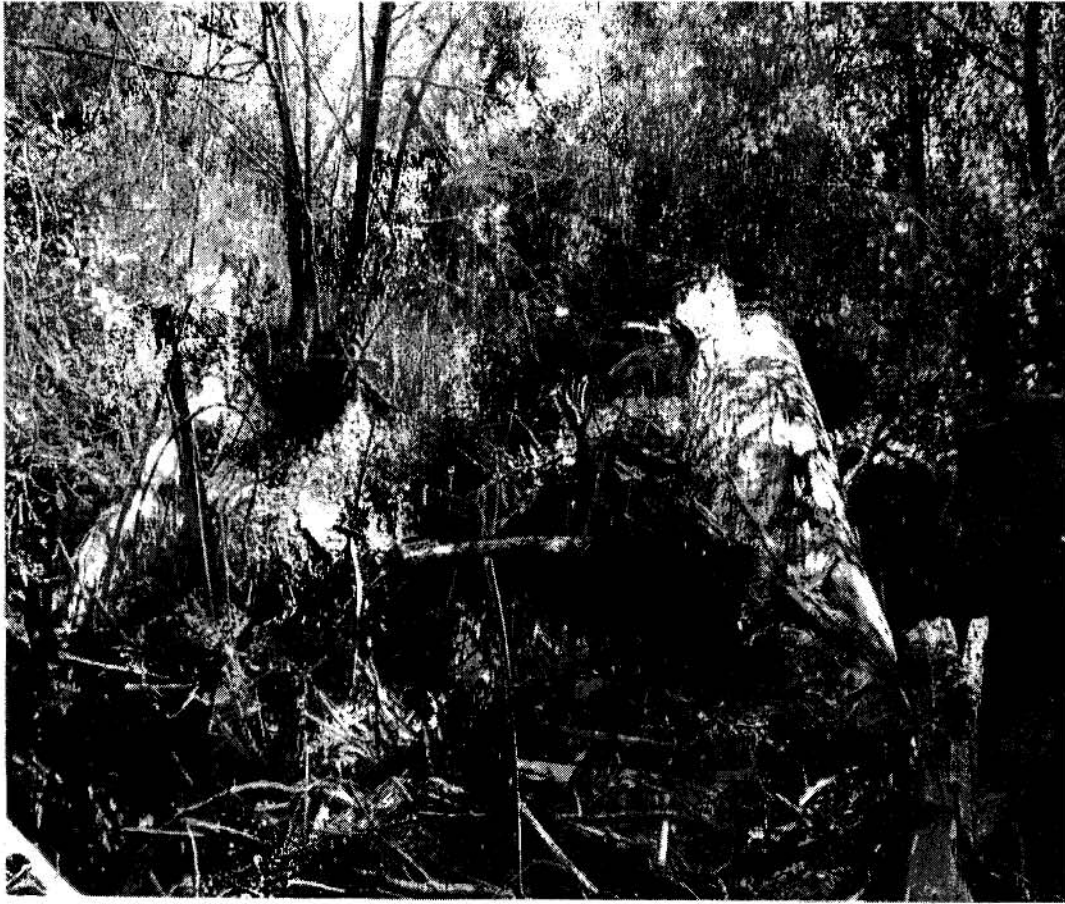
Figure 23. Main stem plugging creek channel

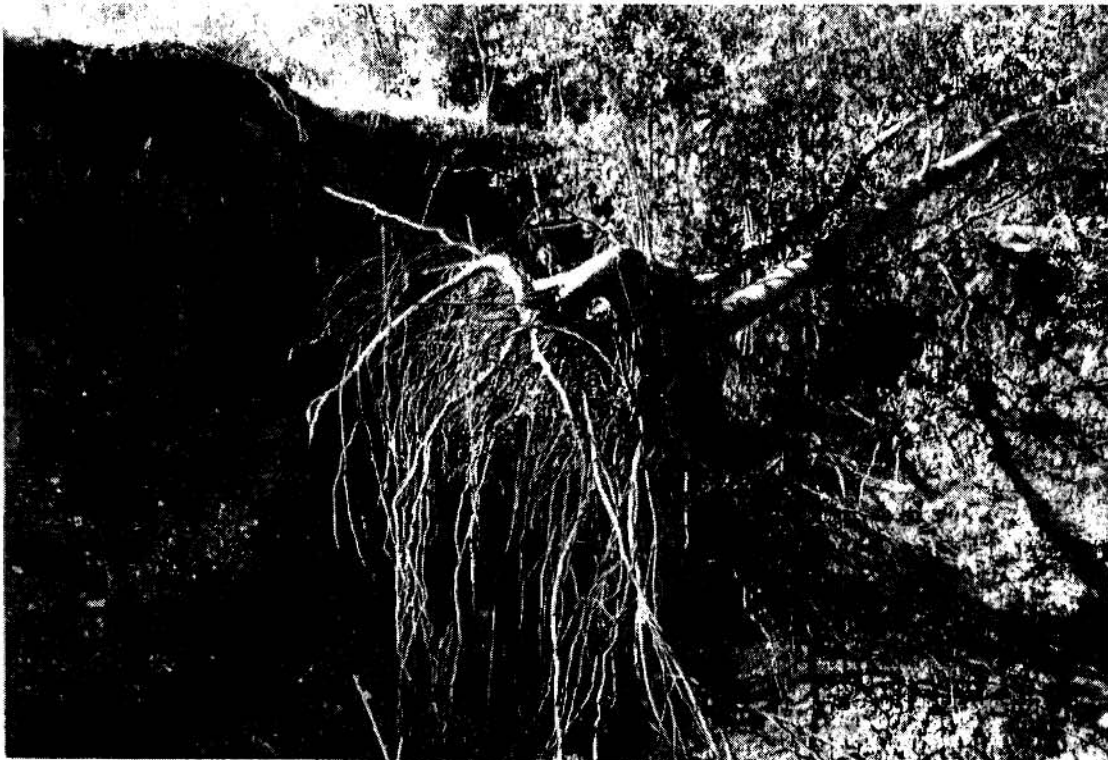
The destructive hydro modification of the Nipomo Creek channel below the restoration project has affected a significant length of its main stem and will continue to do so the likes of which I have not seen in ½ century. Blowouts have happened in the past but were the exception, not the rule. I have been told I do not understand the "Big Picture" and more recently that trees which have slumped into the stream channel "create habitat" In Figure 23 you will see a main stem plugging the creek channel. The next storm surge will cause extensive hydro modification. A garbage dump creates "habitat" for crows, rats, and seagulls. Using these excusatory buzzwords to obscure reality is another example of a constricted frame of impropriety. The broad horizon of Nipomo Creek's environmental future hangs by a root of hope (Figure 24.).

Figure 24. Creates habitat or destructive hydro modification?

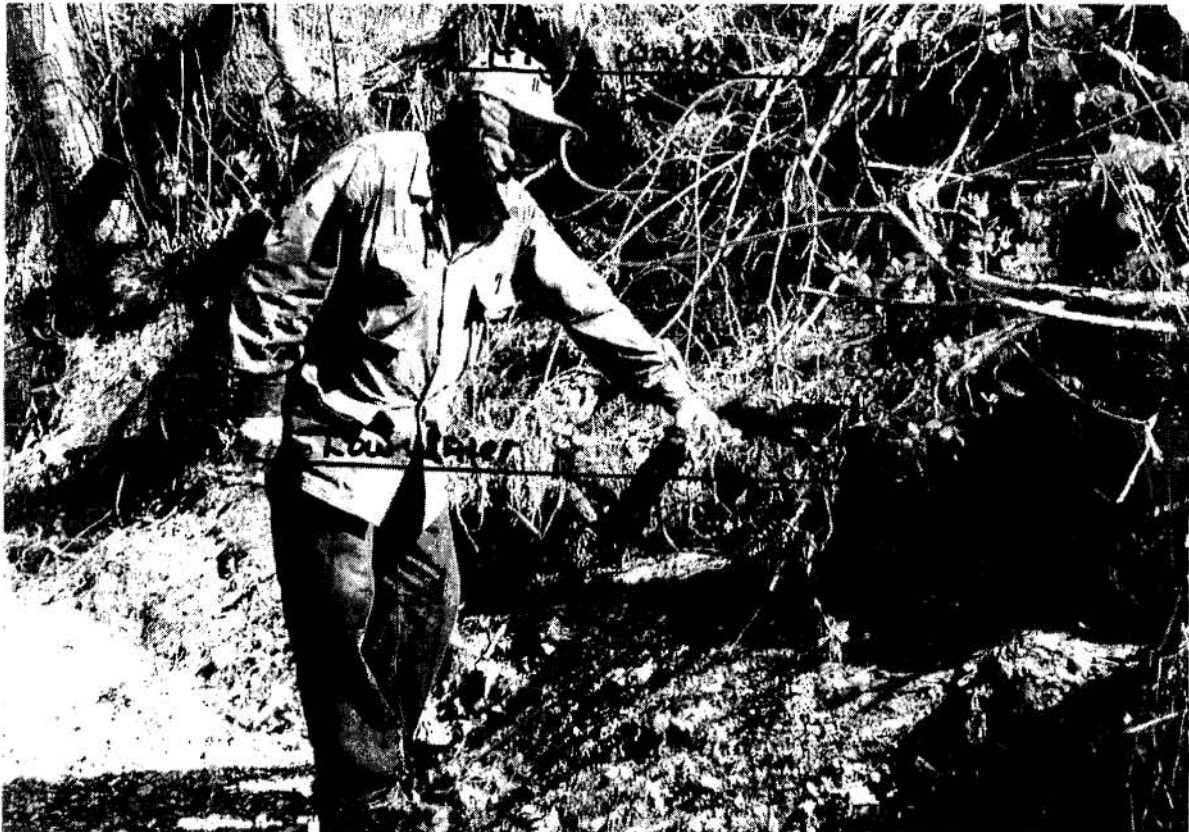
The first of three images (Figure 25) shows a "Creek Dog" holding up a previously storm flattened Red Oak. Please note I have included high and low mean watermarks. These estimates are drawn from 50 years of historical knowledge. Instead of using a hand auger to penetrate the consolidated root bound channel bank for the planting process, cut benches were hacked into the consolidated channel bank. This disruption of a consolidated root bound bank formation incurred inordinate scour of their vertical cuts. The cut benches in the following two images were carved out well below the mean low water zone and just above the basement of the creek channel. This exact zone is where the most substantial amount of erosion occurs in Nipomo Creek. In the second image (Figure 26) you will see a young California Rose and Redwood Tree at the same elevation. In the third image (Figure 27) you will see a Red Oak Tree (a grey flattened stem in lower right center) and a Redwood Tree. This is an example of widened erosion scour on an otherwise consolidated bank. These trees will never have a chance to mature. Without belaboring the point any further bank degradation is what we see here, not restoration. The way the "Big Picture" is framed in Nipomo Creek, life is again as expendable for the ink on the bottom line of control. In the case of Nipomo, public assets were totally wasted in the creek restoration efforts. Beyond that the damage done to the adjoining down stream properties and the environment increases the malfeasance geometrically.

Figure 25. Cut Benches Just Above Creek Basement

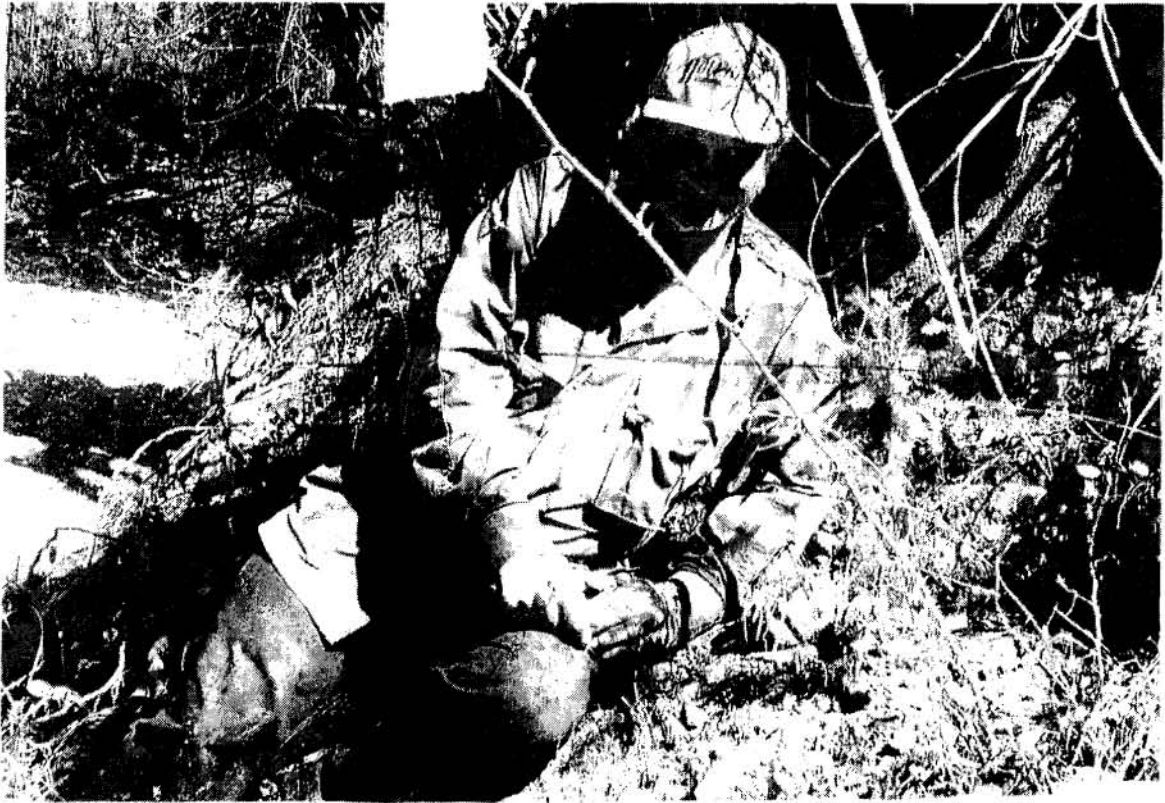
Figure 26. Doomed Redwood & Rose in Maximum Erosion Zone

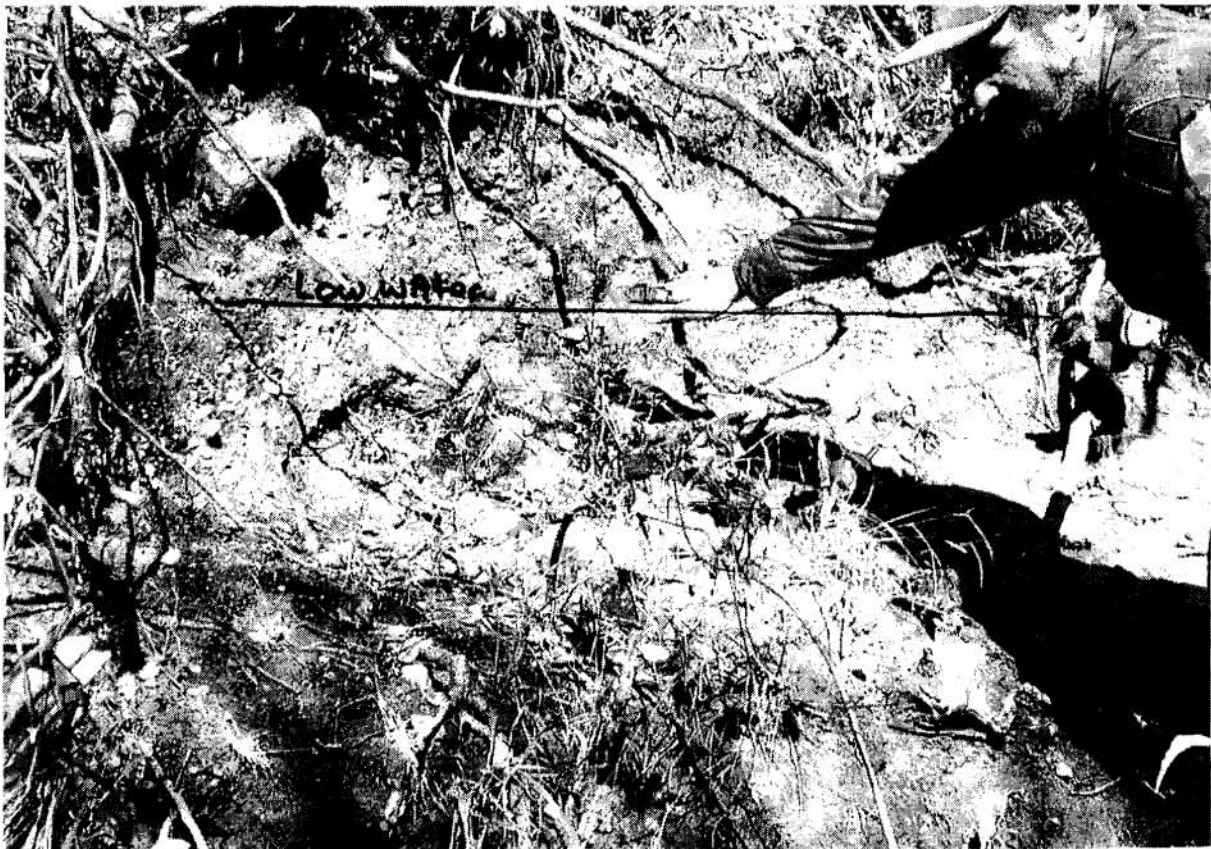
Figure 27. Accelerated Bank Degradation Due to Cut Bench in Previously Consolidated Bank Formation

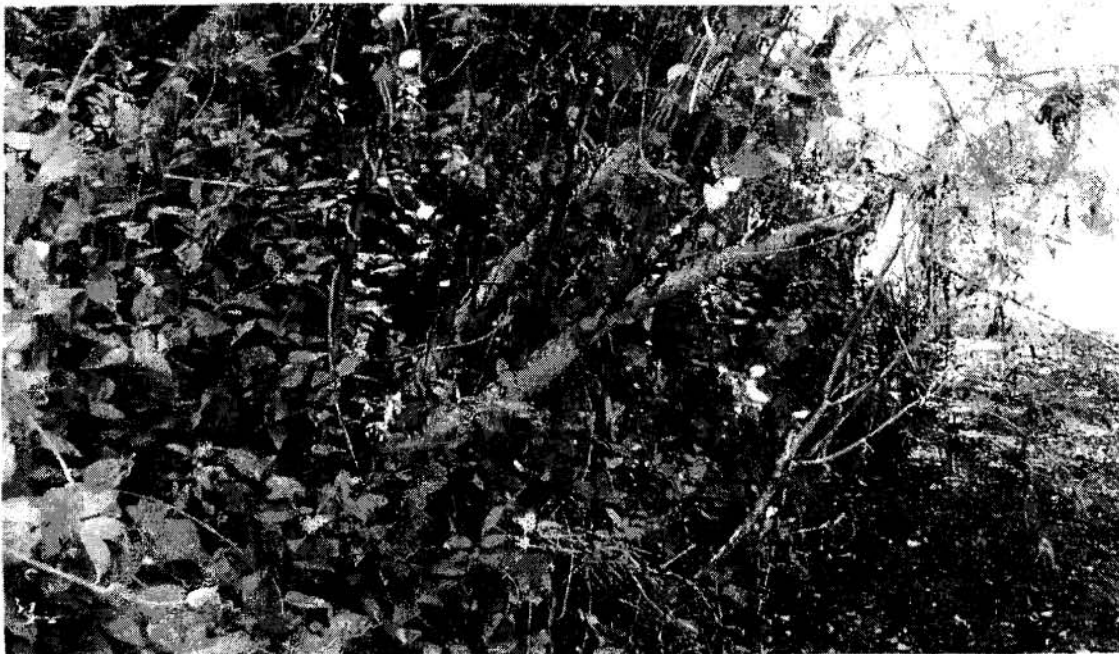
The second corollary issue that has to do with bank degradation is the static concept based agenda where the removal of all invasive species is involved. I am not adverse to this concept however without a component of flexibility and common sense on occasion more harm than good might be done. In the case of the Nipomo Creek the agenda to remove Periwinkle (an invasive species) as creek bank cover is remarkably short sighted. This plant has established itself to one degree or another over approximately one mile of the watershed. The community holds it in great esteem for its exceptional ability to retard erosion, which translates into the health and well being of the community. As to the probable failure of eradicating this plant, I will quote from page 50 of the Nipomo Watershed Management Plan: "The population of Periwinkle and Ivy were sprayed in 2004. At the time of winter of 2004 survey the majority of the plants were dead. In the spring of 2005 all populations of invasives were burgeoning. Weed removal efforts at this location will need to be continued frequently throughout many seasons and possibly many years". One must ask how many thousands of gallons of broad leaf herbicide over how many decades will be sprayed into this riparian environment? Will the herbicide also impact broad leaf native species? How long will it take to successfully re-establish native species and if the Periwinkle reappears in that zone will the reapplication of herbicides harm the new native growth? If a flood event occurs during the re-establishment period will the new growth be able to withstand the souring affects of storm surges? Was community safety taken into consideration? On page 67 of the same report, it is stated, "Large portions of the project site are a Periwinkle monoculture providing very little ecological benefit to the project." This is overtly misleading. There are Oaks, Willows, Box Elders, Poison Oak, Blackberries, and many other native plants that together form a symbiotic barrier to retard bank degradation. It seems to me this relationship and its ability to stop inordinate bank degradation would be one of the main pillars of ecological integrity in an active riparian ecotome. The first image (Figure 28) you will see is an unbeatable relationship of Willow and Periwinkle for bank stability. The "bank" Willow flattened against the bank channel by a previous storm surge has sprouted numerous vertical succors from its main stem. Its flexible comb-like structure tends to shed debris that would cause debris jams to a maximum extent. As an understudy of Willow, Periwinkle controls erosion with a blanket of foliage. Both have tenacious root systems and aggressive above ground growth. In the second image (Figure 29) you can see its ability to protect the bank. I applaud the concept of returning our natural areas to a Pre European contact environment, however in an urban/nature zone like Nipomo Creek the pros and cons of community safety should be weighed.

Figure 28. Symbiotic Relationships of Willow & Periwinkle

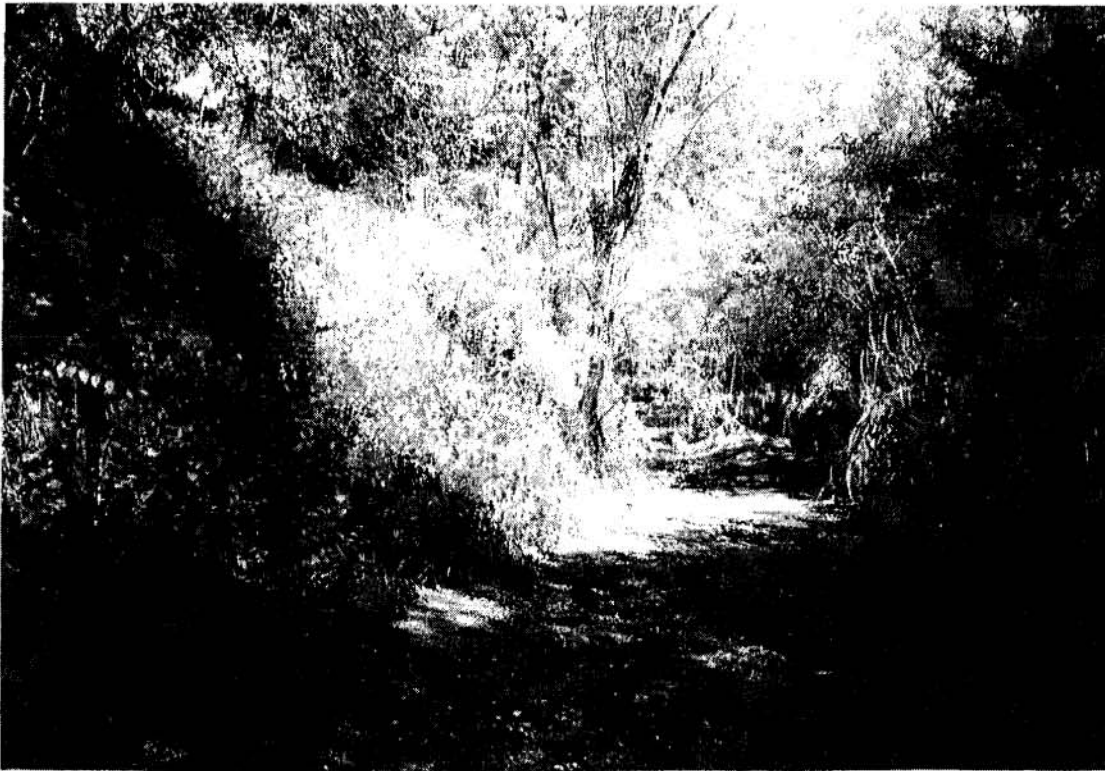
Figure 29. Periwinkle Bank Control Translates into Community Safety
