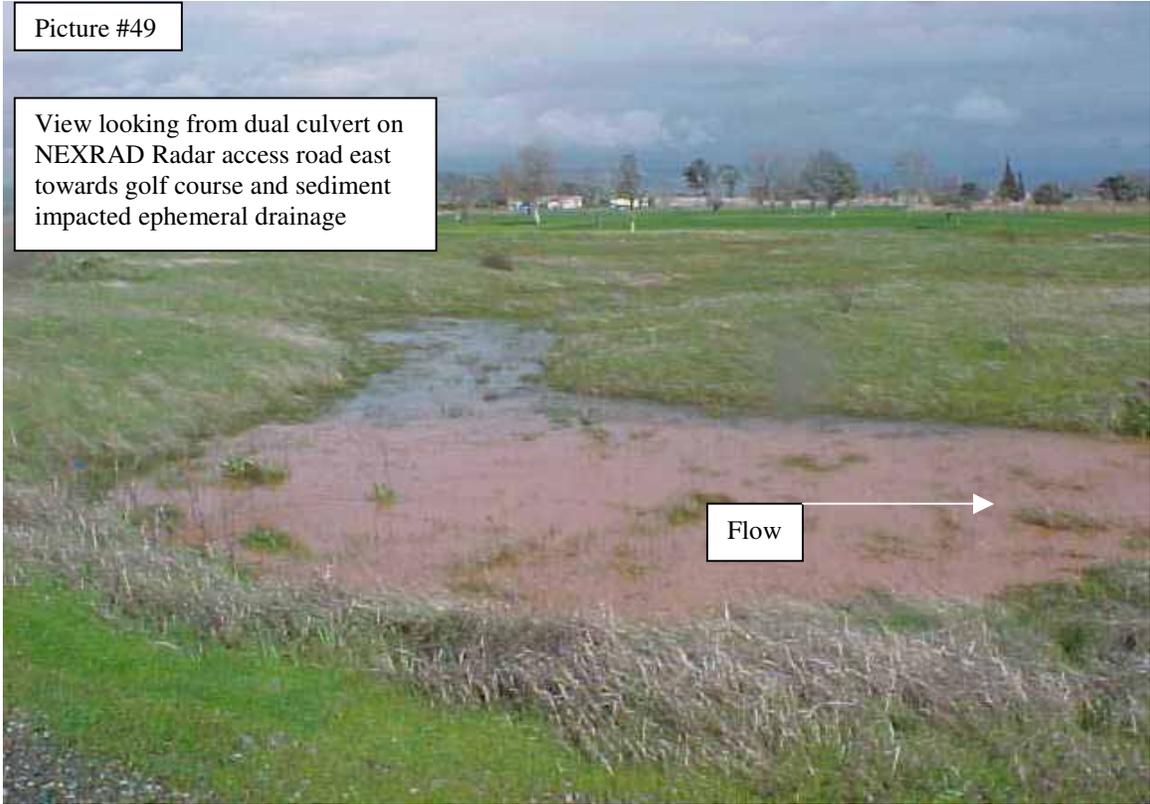
Picture #49

View looking from dual culvert on NEXRAD Radar access road east towards golf course and sediment impacted ephemeral drainage

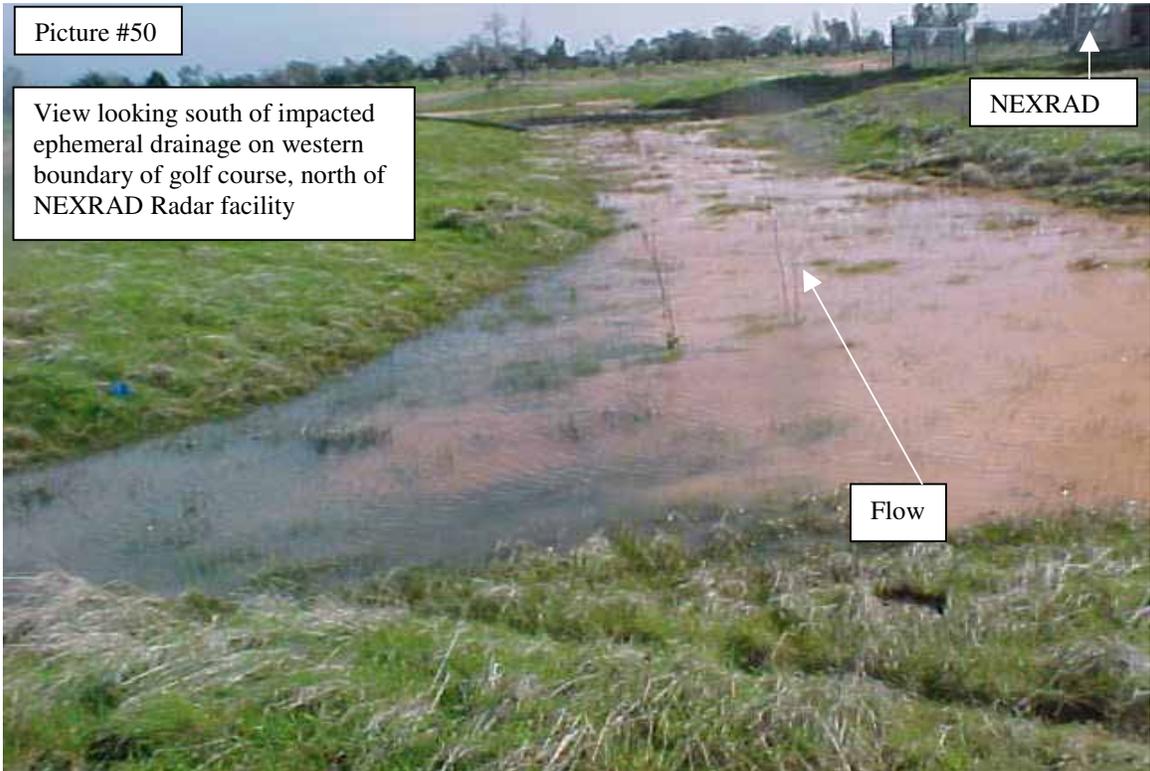
Picture #50

View looking south of impacted ephemeral drainage on western boundary of golf course, north of NEXRAD Radar facility

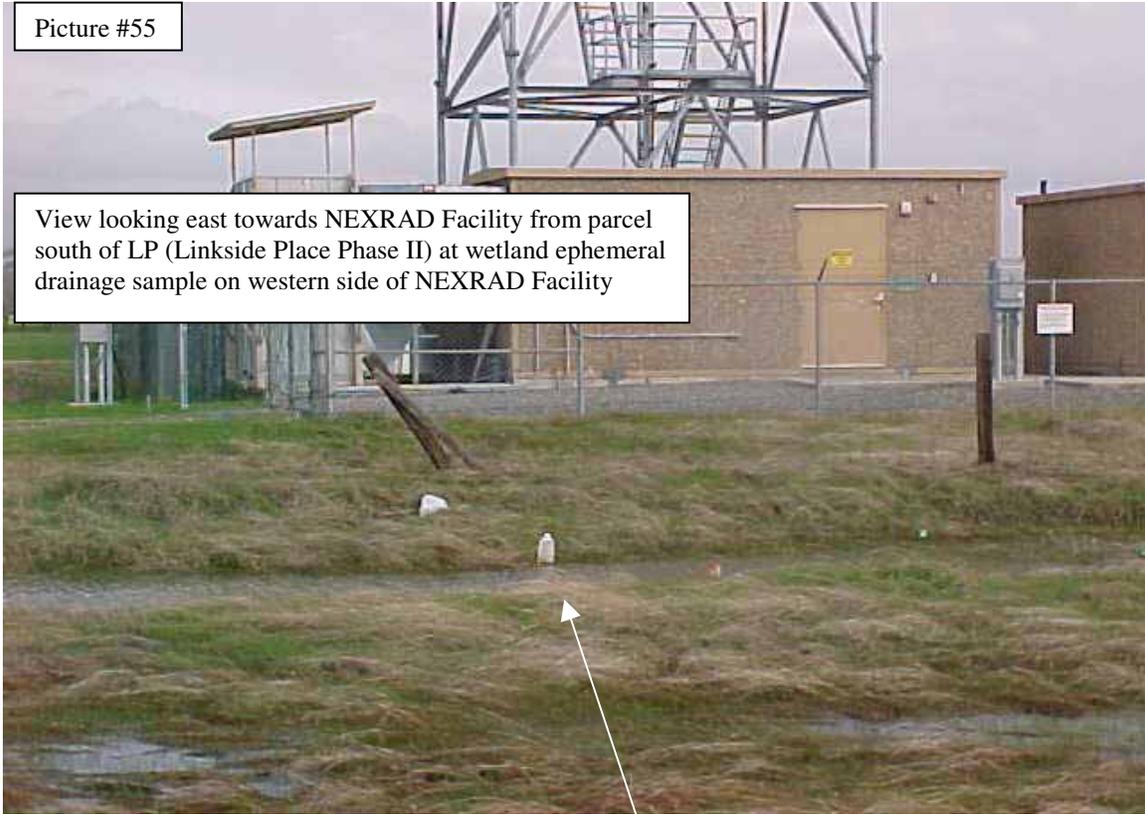
Picture #55

View looking east towards NEXRAD Facility from parcel south of LP (Linkside Place Phase II) at wetland ephemeral drainage sample on western side of NEXRAD Facility

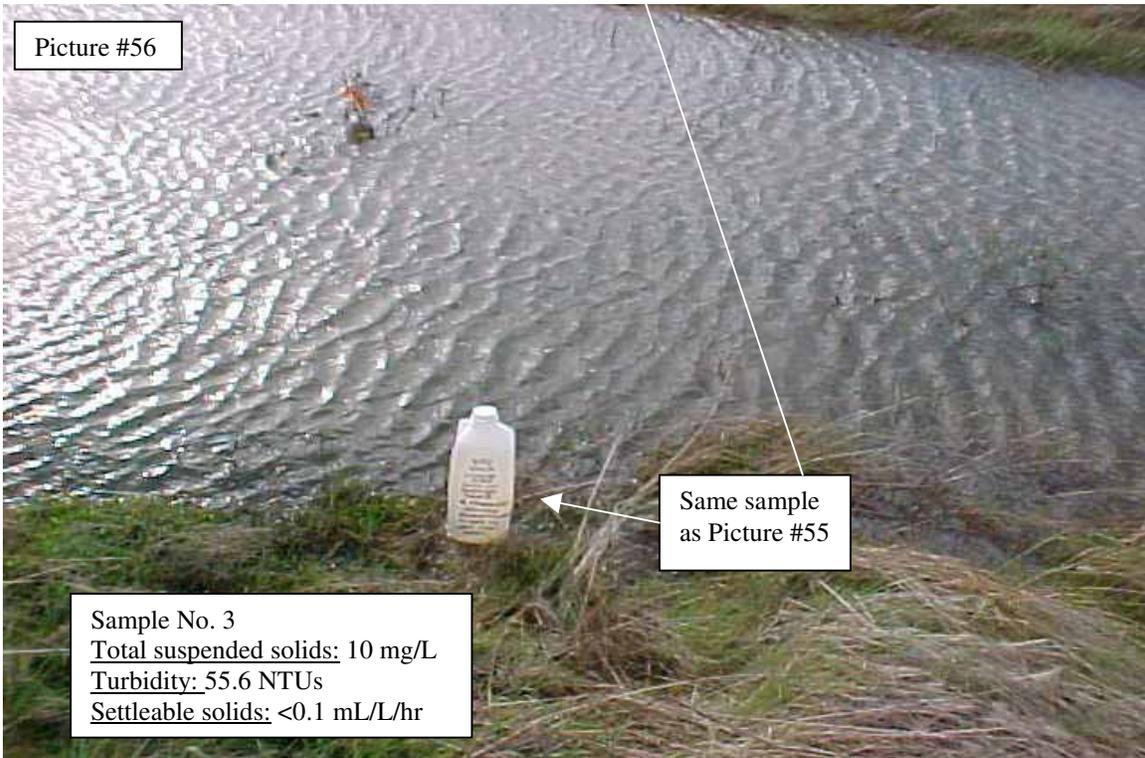
Picture #56

Same sample as Picture #55

Sample No. 3
Total suspended solids: 10 mg/L
Turbidity: 55.6 NTUs
Settleable solids: <0.1 mL/L/hr

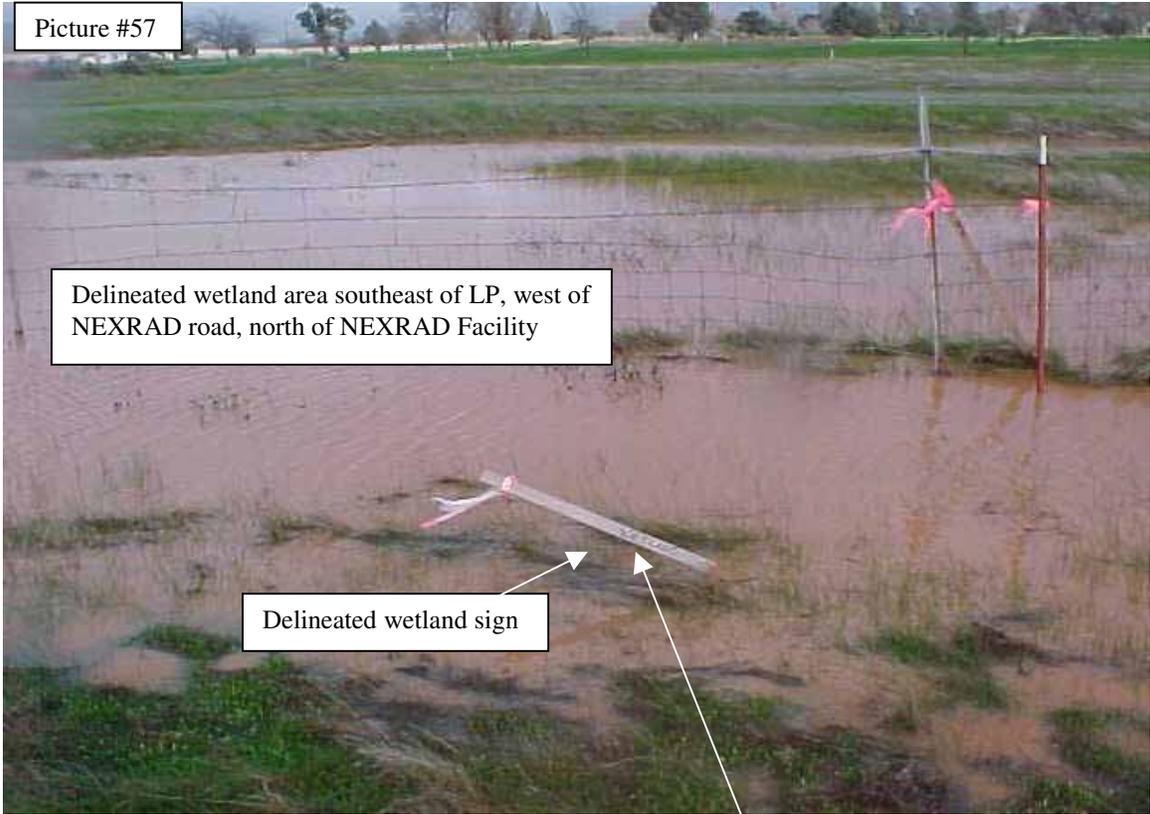
Picture #57

Delineated wetland area southeast of LP, west of NEXRAD road, north of NEXRAD Facility

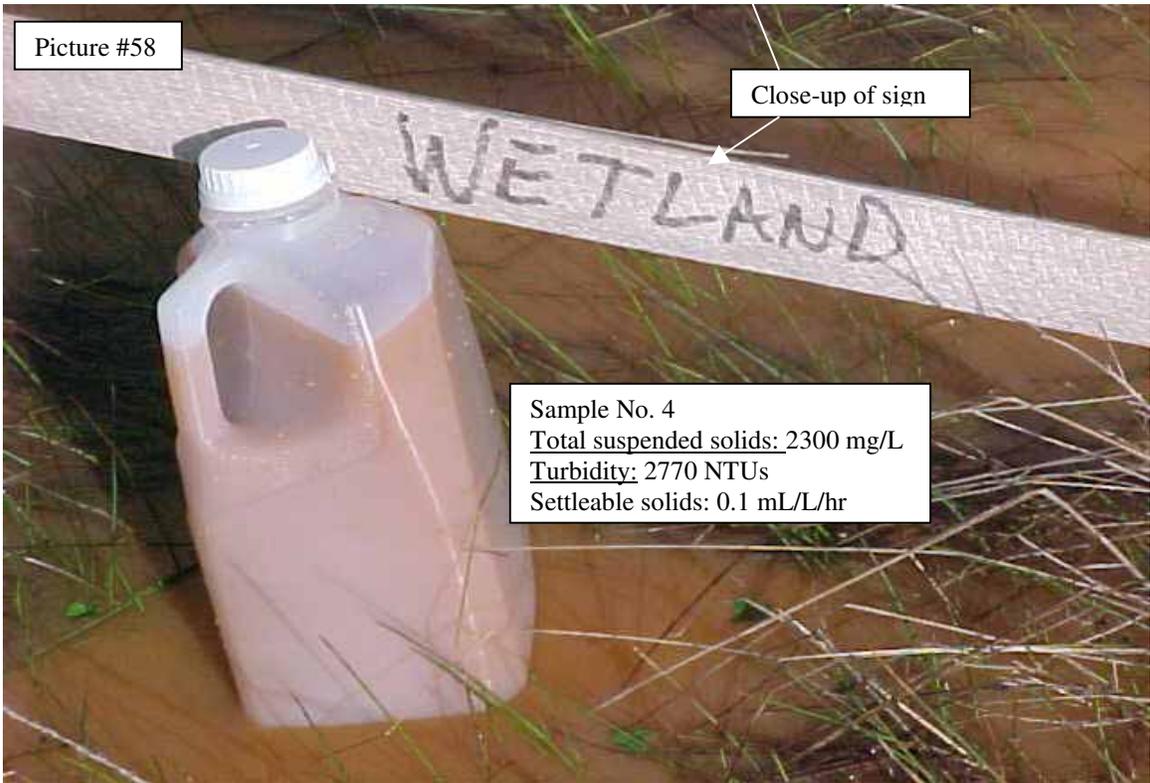
Picture #58

Delineated wetland sign

Close-up of sign
