13 CALIFORNIA REGIONAL WATER QUALITY CONTROL BOARD
14 CENTRAL VALLEY REGION

POINTS & AUTHORITIES
OPPOSING ADMINISTRATIVE
CIVIL LIABILITY COMPLAINT
R5-2006-0525

LINKSIDE PLACE SUBDIVISION CONSTRUCTION STORM WATER PERMIT VIOLATION, WDID NO. 5R04C324269, OROVILLE, BUTTE COUNTY

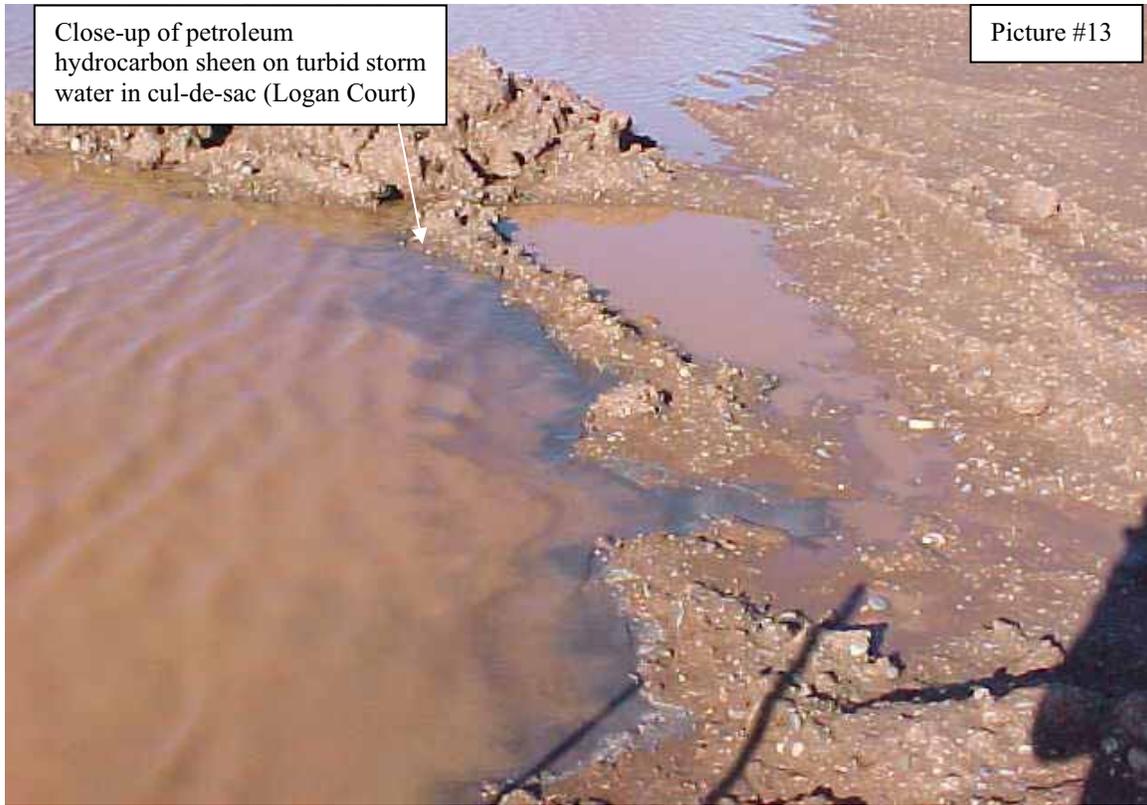
Picture #13

Close-up of petroleum hydrocarbon sheen on turbid storm water in cul-de-sac (Logan Court)

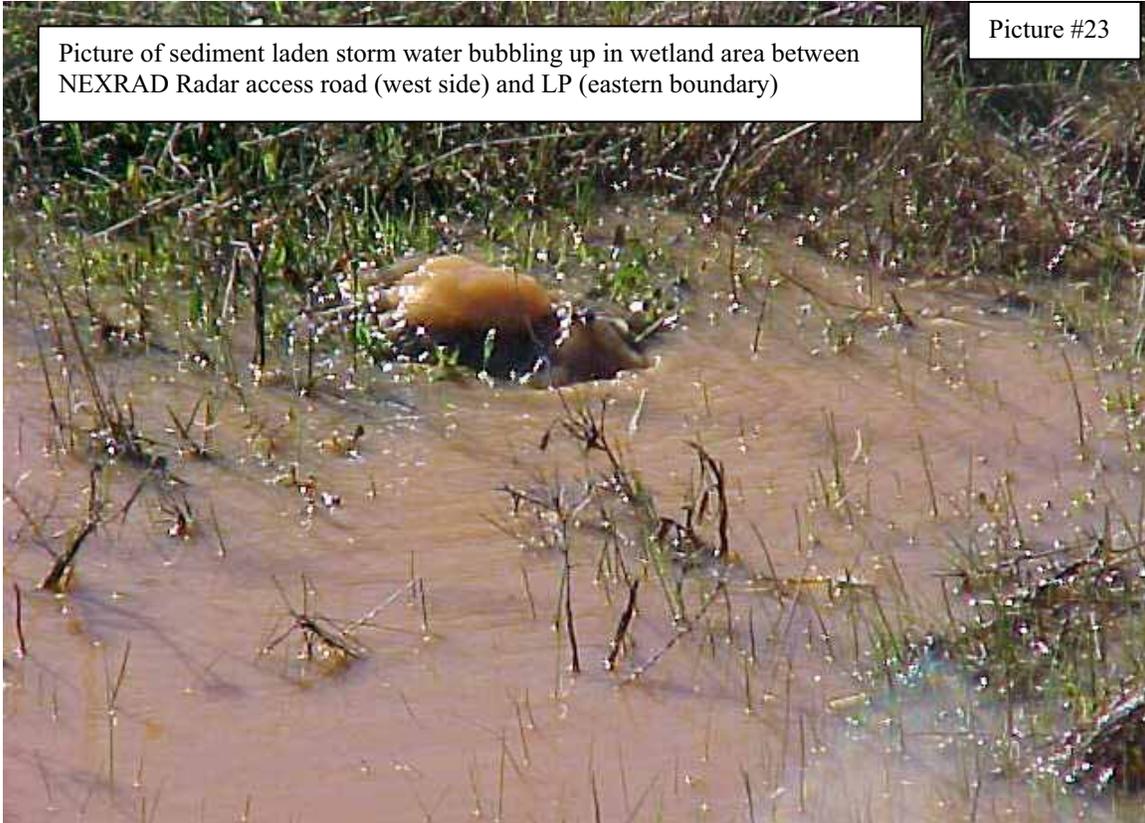
Picture #23

Picture of sediment laden storm water bubbling up in wetland area between NEXRAD Radar access road (west side) and LP (eastern boundary)

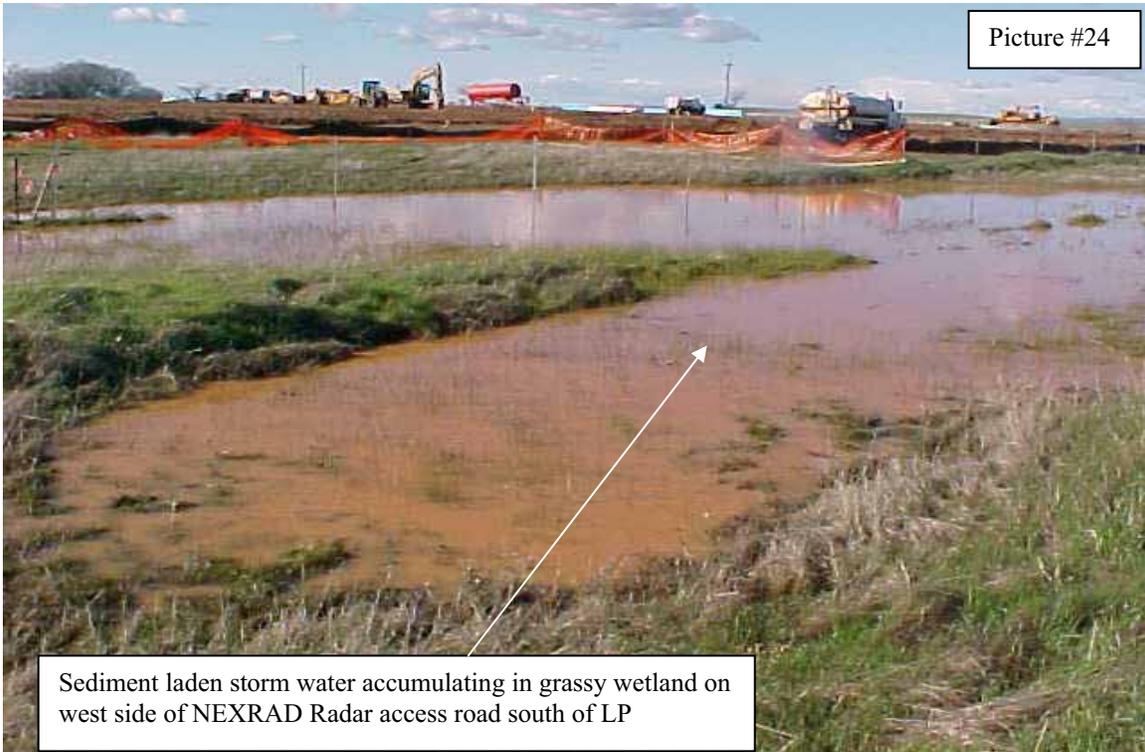
Picture #24

Sediment laden storm water accumulating in grassy wetland on west side of NEXRAD Radar access road south of LP

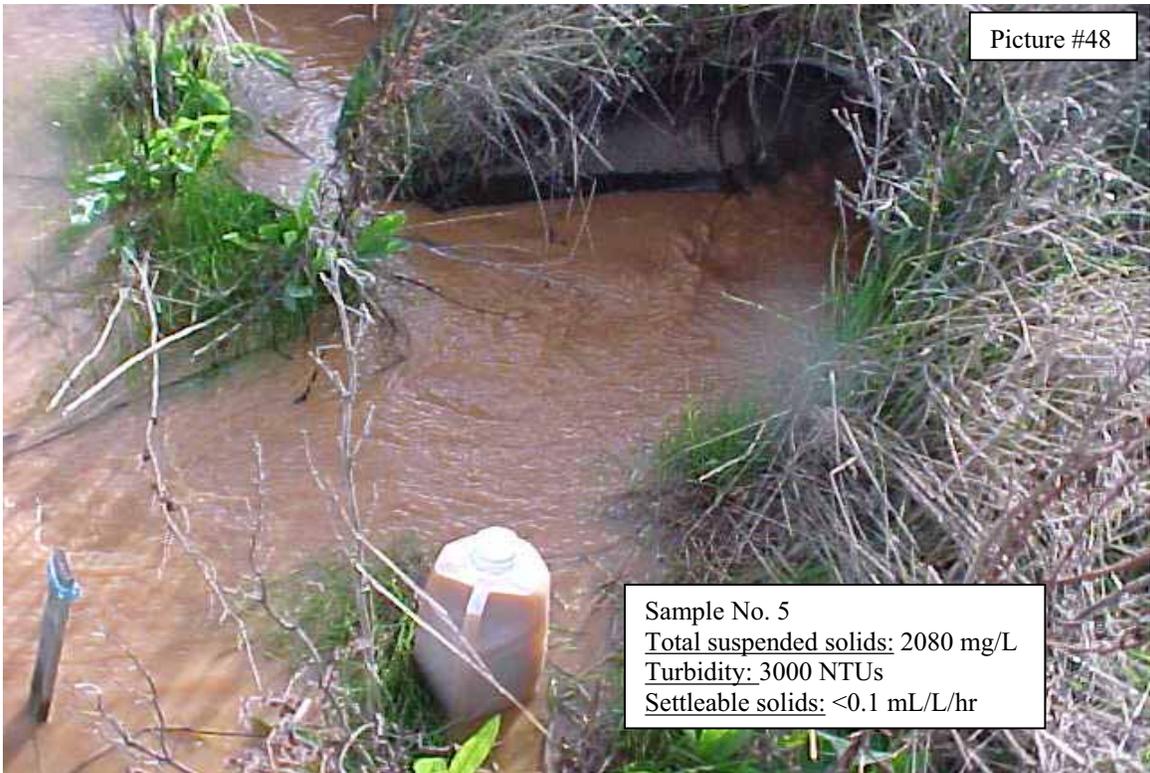
Picture #49

Pictures #49 and #50 show the sediment-laden discharge as it enters the ephemeral drainage on the western boundary of the golf course on the north side of the NEXRAD facility. Picture #51 shows the sediment-laden discharge on the south side of the NEXRAD facility receiving a non-sediment-laden discharge from the parcel to the immediate south of LP (Linkside Place Phase II). Picture #52 documents a water sample (Sample No. 6) that was taken from the ephemeral drainage immediately north of the NEXRAD facility. This was the same sample location used for background during the 18 February 2004 LP inspection. The sample results from the two inspections at this location document background water quality immediately north of the NEXRAD facility. Pictures #53 and #54 document the location of another background water quality sample location. This sample (Sample No. 7) location was immediately south of the NEXRAD facility in an ephemeral drainage that was not impacted by LP and feeds the impacted ephemeral drainage. Pictures #55 and #56 document the location of a third background water quality sample location. This sample (Sample No. 3) location was immediately to the west of the NEXRAD facility, on the parcel immediately south of LP (Linkside Place Phase II), approximately 200 feet southeast from the southeast corner of LP, in a wetland ephemeral drainage. Pictures #57 and #58

View looking from dual culvert on
NEXRAD Radar access road east
towards golf course and sediment
impacted ephemeral drainage

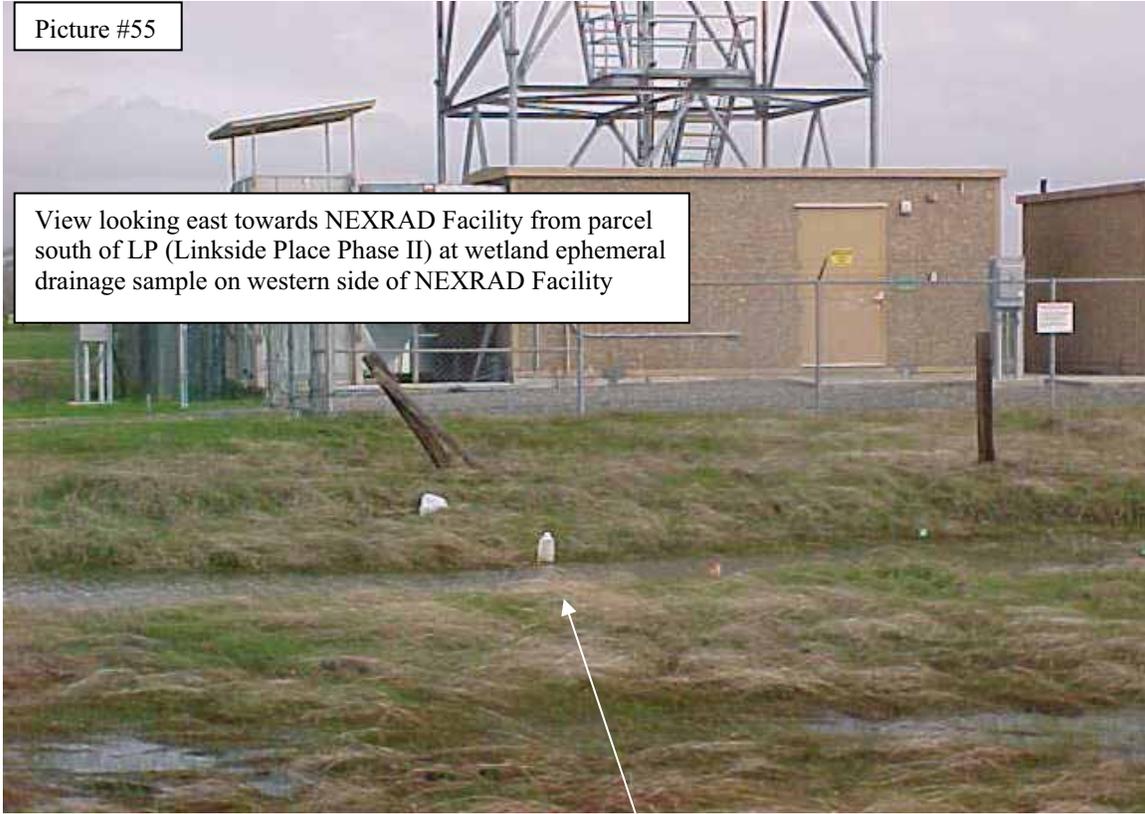
Picture #56

Same sample as Picture #55

Sample No. 3
Total suspended solids: 10 mg/L
Turbidity: 55.6 NTUs
Settleable solids: <0.1 mL/L/hr

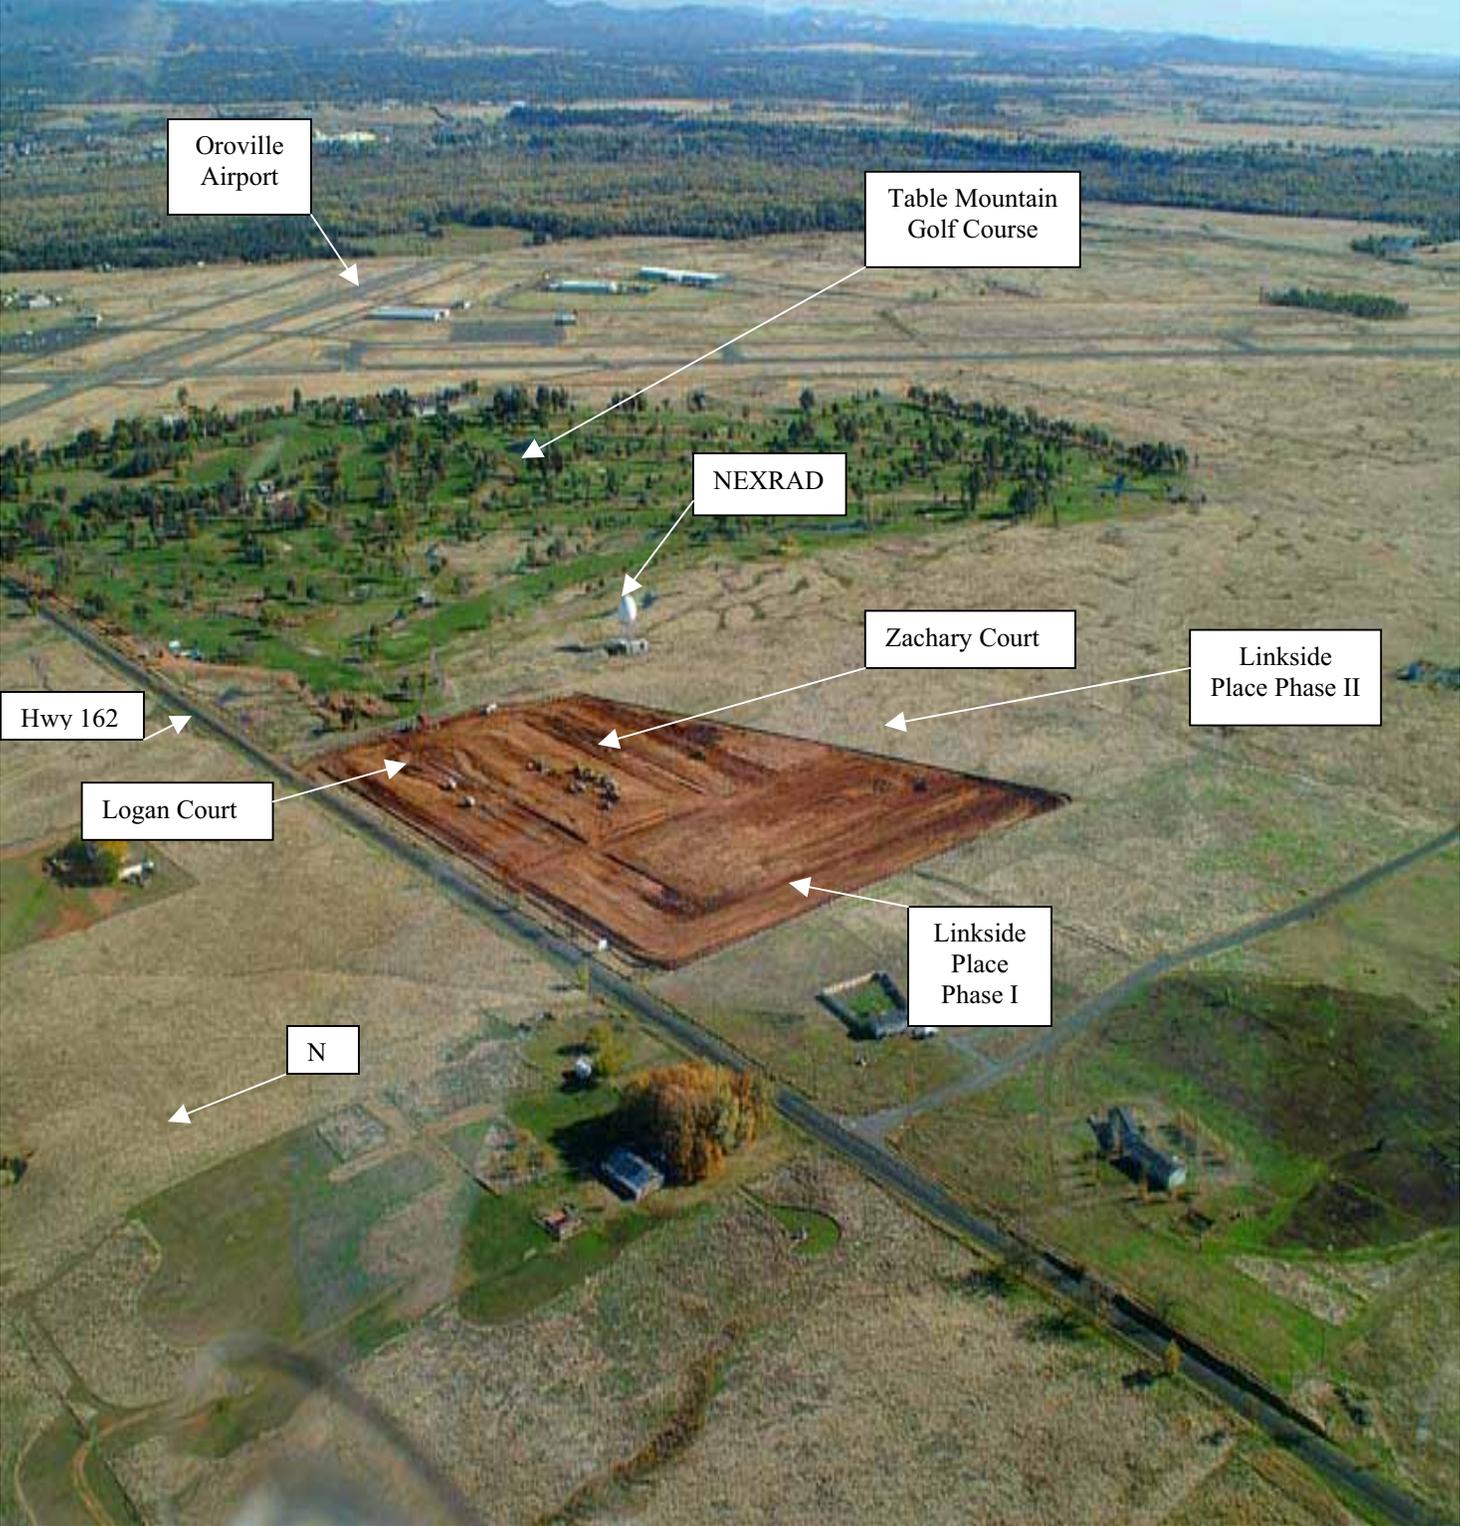
FIGURE 3

In late Fall 2003, the site was cleared of vegetation and extensive grading and earthwork activities were conducted throughout the site. Water Board Redding Office staff obtained an aerial photograph of Linkside Place taken on 21 November 2003 (see Figure 3). The aerial photograph shows that no erosion control Best Management Practices (BMPs) were deployed on the site and only a silt fence was deployed around the perimeter. During the winter of 2003-2004 construction activities started and two shallow cul-de-sacs were constructed on the eastern side (Logan and Zachary Courts) to provide storm water detention or treatment. These shallow cul-de-sacs were greatly undersized and therefore inadequate to prevent the discharge of highly turbid water and sediment into nearby wetlands and ephemeral drainages.

Linkside Place Subdivision aerial taken 21 November 2003 by Loafer Creek LLC.

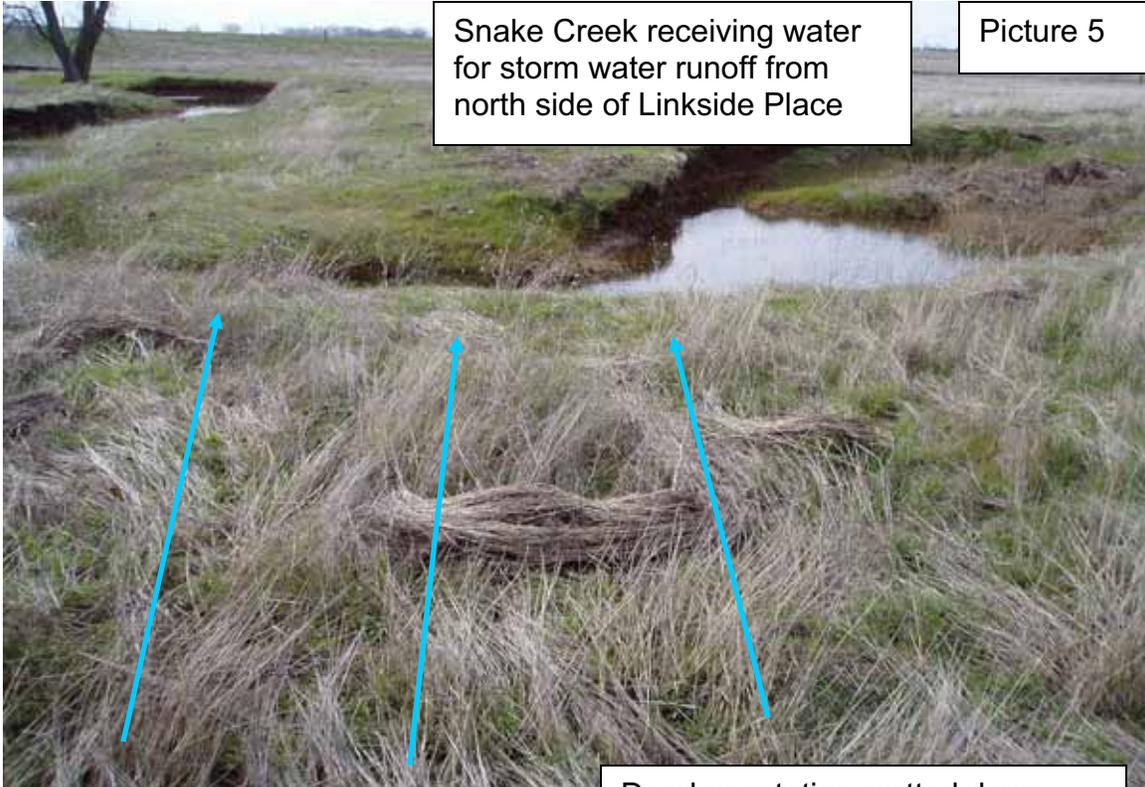
Picture 5

Snake Creek receiving water for storm water runoff from north side of Linkside Place

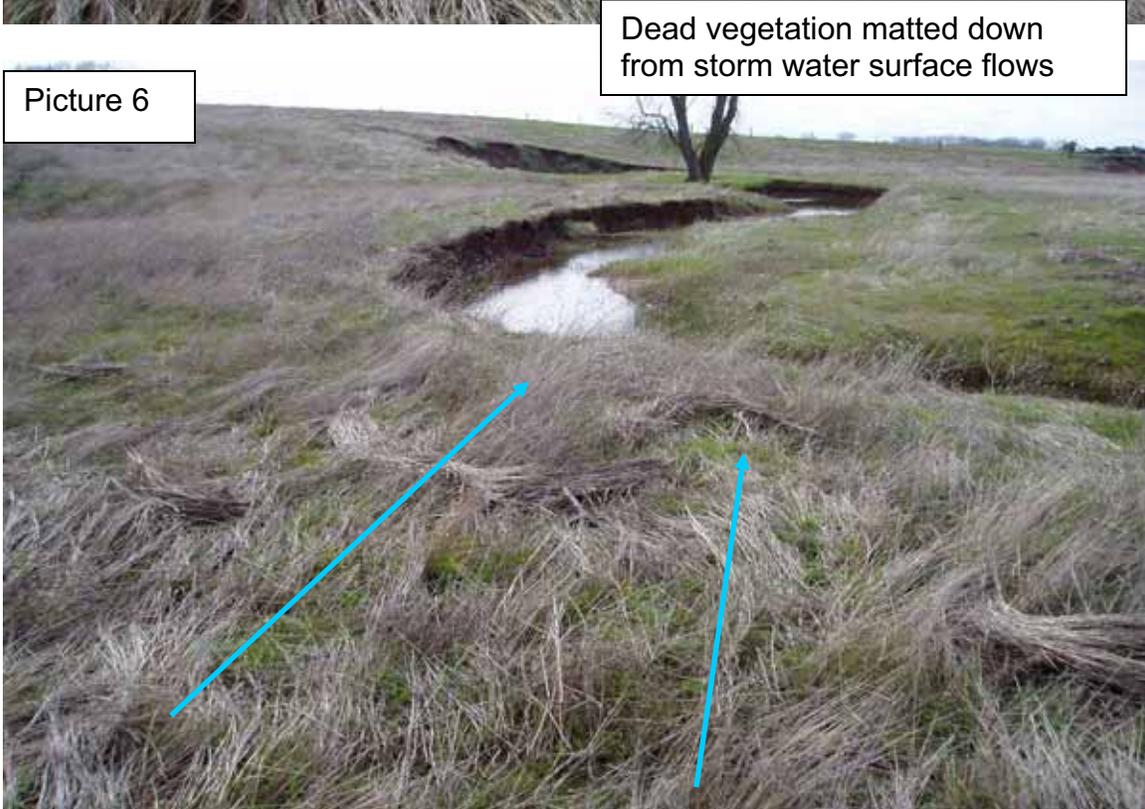
Picture 6

Dead vegetation matted down from storm water surface flows

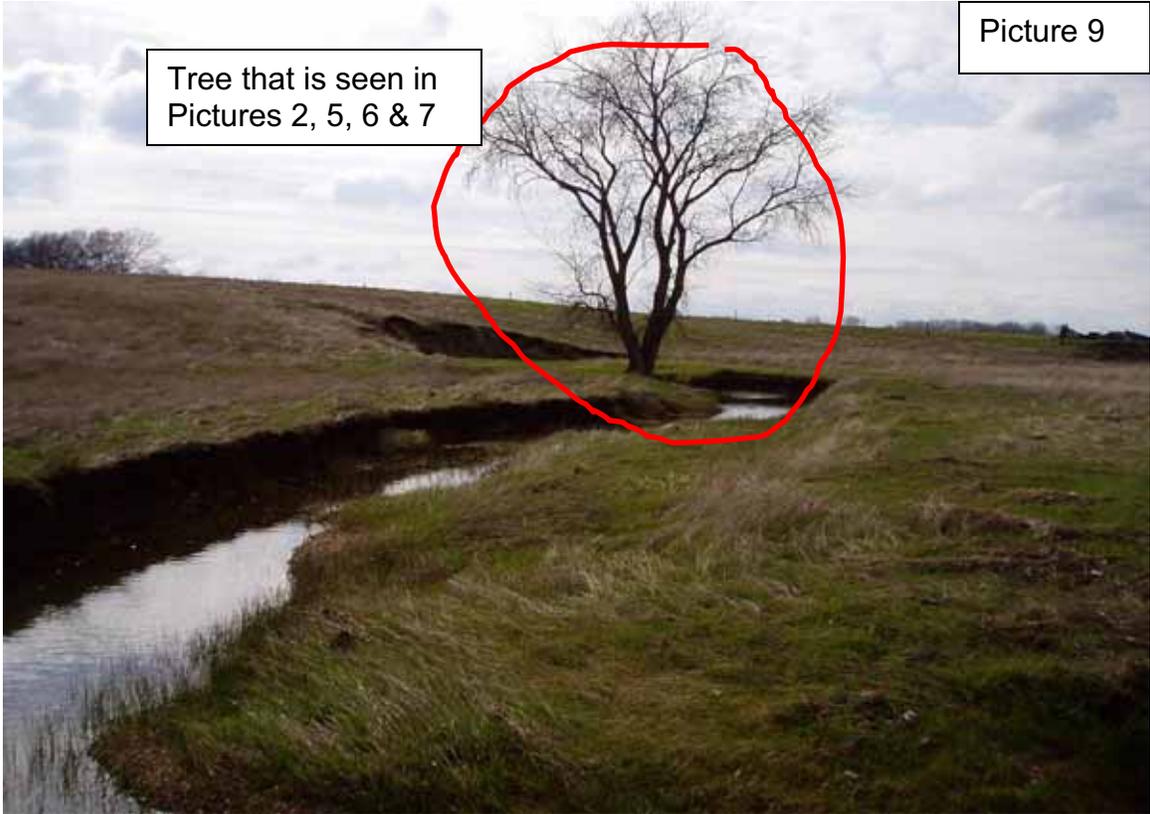
Picture 9

Tree that is seen in Pictures 2, 5, 6 & 7

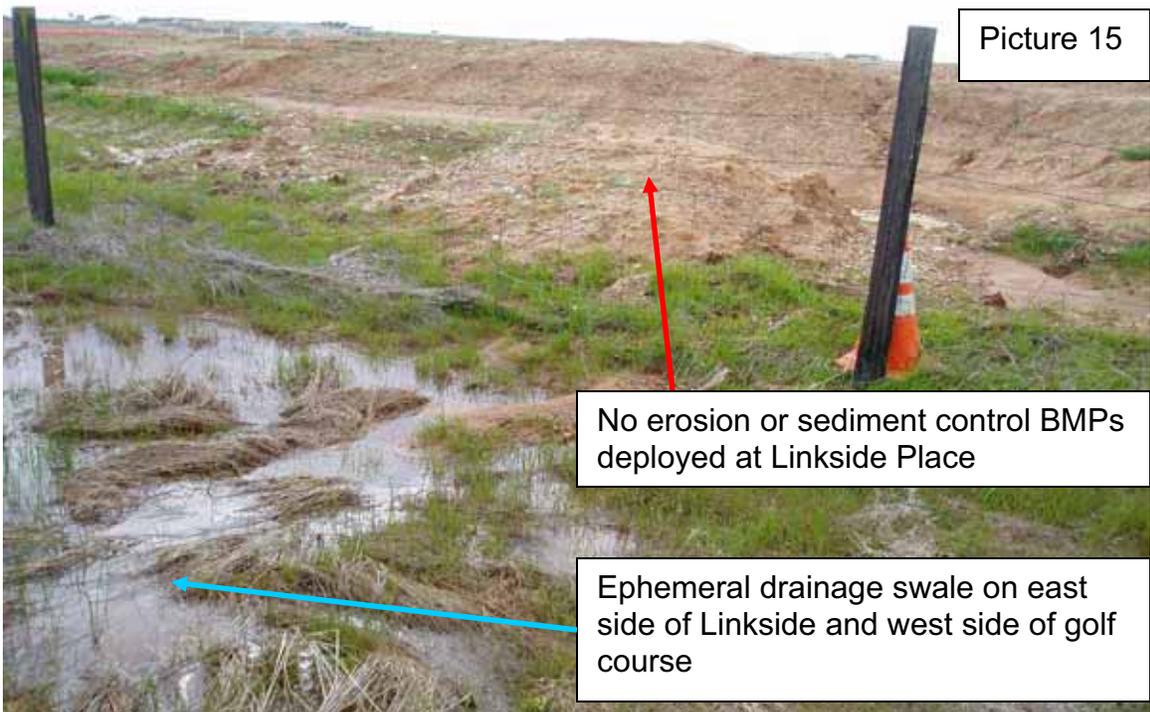
Picture 15

No erosion or sediment control BMPs
deployed at Linkside Place

Ephemeral drainage swale on east
side of Linkside and west side of golf
course
