Attachment C

Attachment C – Aerial Photo 1971 and 2 June 2009 Photos

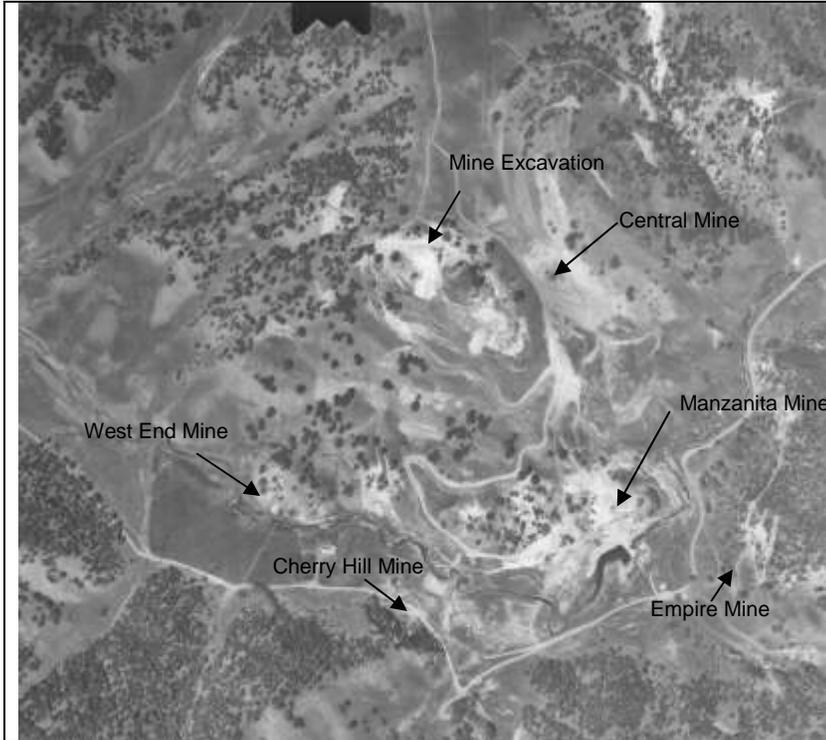
<p>This is an aerial photograph from 1971 showing a landscape with several mine sites. Labels with arrows point to: Mine Excavation (top center), Central Mine (top right), West End Mine (left), Manzanita Mine (right), Cherry Hill Mine (bottom center), and Empire Mine (bottom right). A winding creek, Sulphur Creek, flows through the area.</p>	<p><b>Photo 1</b> This is aerial photo taken in April 1971 and was obtain from the County of Colusa. This photo shows earth moving or excavation at Manzanita and Central Mines, and excavation directly west of Central Mine. Also note directly south of Manzanita Mine, Sulphur Creek has at least been partially dammed. Several roads cross Sulphur Creek.</p>

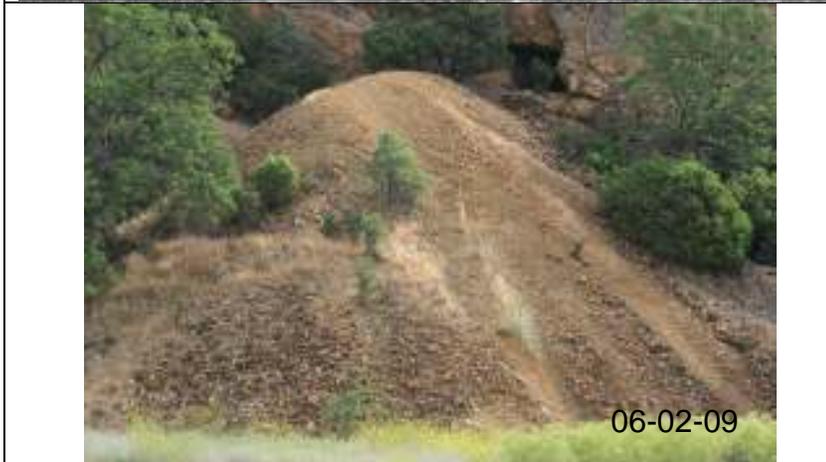
<p>A photograph showing a large, conical pile of brown, loose mining waste rock on a hillside. A dirt path or road leads up the slope. The date '06-02-09' is printed in the bottom right corner.</p>	<p>This picture shows a mining waste rock pile and one of the portals at the West End Mine. The waste rock pile is very loose material and is susceptible to slope sliding and erosion. Sulphur Creek is between the photographer and the waste pile. Photo was taken by Victor Izzo.</p>

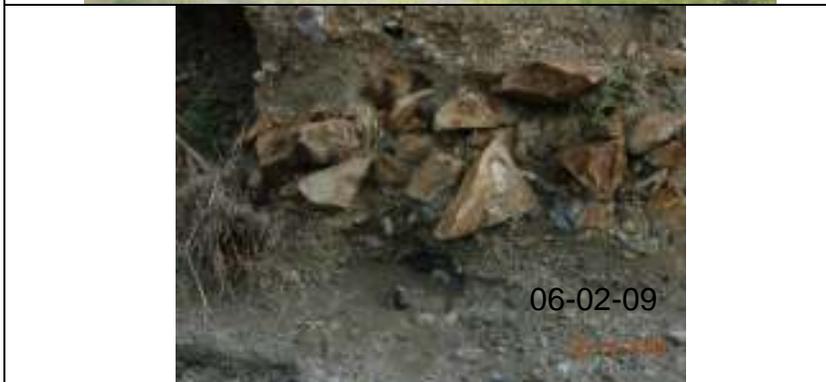
<p>A close-up photograph of angular, reddish-brown rock fragments on a creek bank. The date '06-02-09' is printed in the bottom right corner.</p>	<p>This is a picture of angular rock in the bank of Sulphur Creek. This appears to be mining waste rock because it is not typical stream flood plain deposit. This picture was taken directly south of Manzanita Mine. Photo was taken by Jeff Huggins</p>
