**SUBJECT: Rebuttal of Comments on Cease and Desist Order NO. R5-2011-xxxx Requiring the City of Colfax Wastewater Treatment Plant Placer County to Cease and Desist from Discharging Contrary to Requirements.**

**V. The CDO Recognizes the Capacity of the WWTP is dependent on Controlling the Seepage into the Pond and Influent Flow Reductions from Infiltration and Inflow Work.**

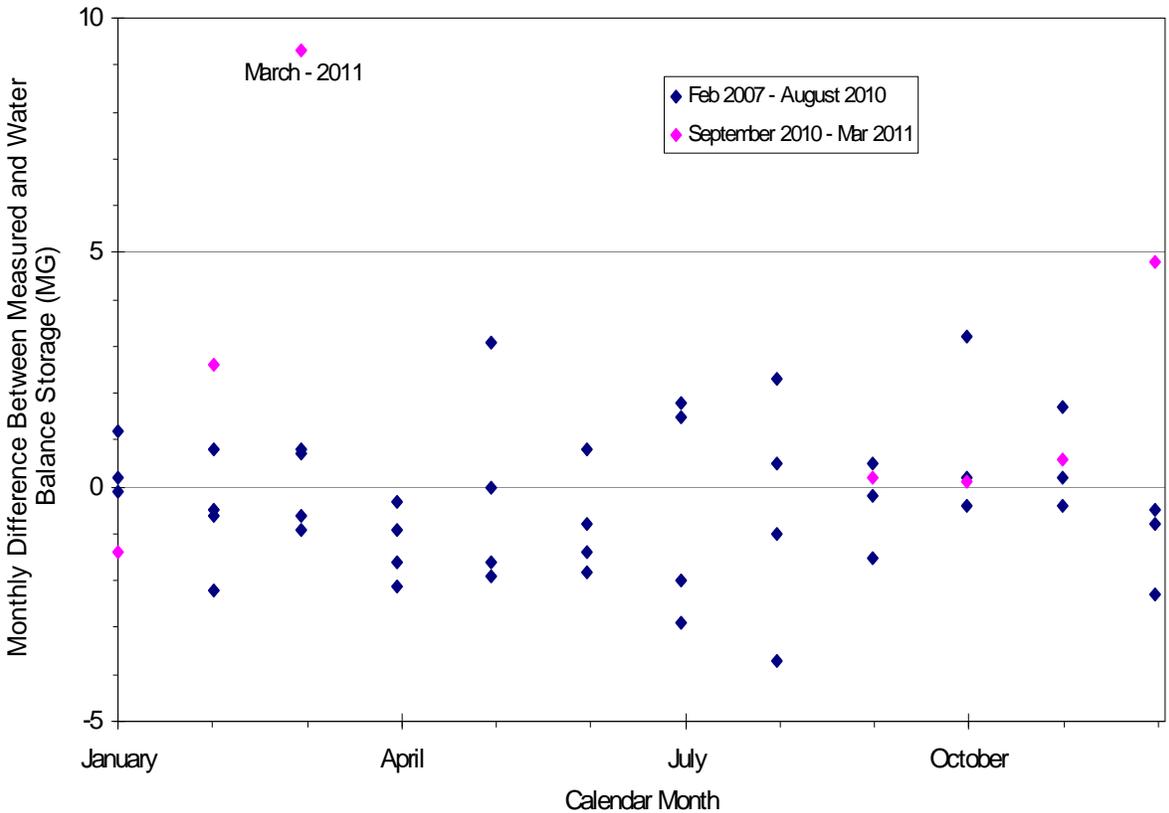
**Figure 1: Difference Between Measured and Calculated Change in Storage per Calendar Month.**

The City is lining Pond 3 as a means to comply with Permit Discharge Prohibition III.A and prevent any leakage that is not currently captured. In the process of developing the August 2011 water balance, the calculated change in pond volume was compared to the measured change in pond volume. A plot of the difference between the measured monthly change in pond volume compared to the water balance calculated change in the monthly pond volume is presented as Figure 1 (Figure 13 in the August 2011 water balance report). As stated in the water balance report, there is an average of 0.25 MG per month (less than 0.01 MGD) loss from the reservoirs. Additionally, there is generally a  $\pm 3$  MG difference between measured and calculated monthly change in storage volume, corresponding to  $\pm 4\%$  of the available storage volume. Additionally, there are no apparent substantial systematic errors, especially in the July through September time period where conditions are driest. If there were significant levels of water seeping out of the ponds the pattern would be evident on Figure 1.

The Edwards Family Farm contends that the seepage into the pond is more significant than thought by the City because of the postulated high levels of seepage from the pond. However, the City intends to line the pond, blocking seepage from entering the pond; the channel parallel to Pond 3 has been relined and geologic investigations are planned to determine if there is seepage under the channel into the pond. The Edwards contend there may be an additional 3 MG per year of water to treat, but that would equate to an additional 0.008 MGD, which is within the error of the analysis. The Edwards point out that for June and July 2008 the water balance is “short” approximately 1.5 MG per month, however the June and July 2009 are calculated to have an extra 0.8 and 1.8 MG, respectively. The differences in monthly totals are within the error of the model.

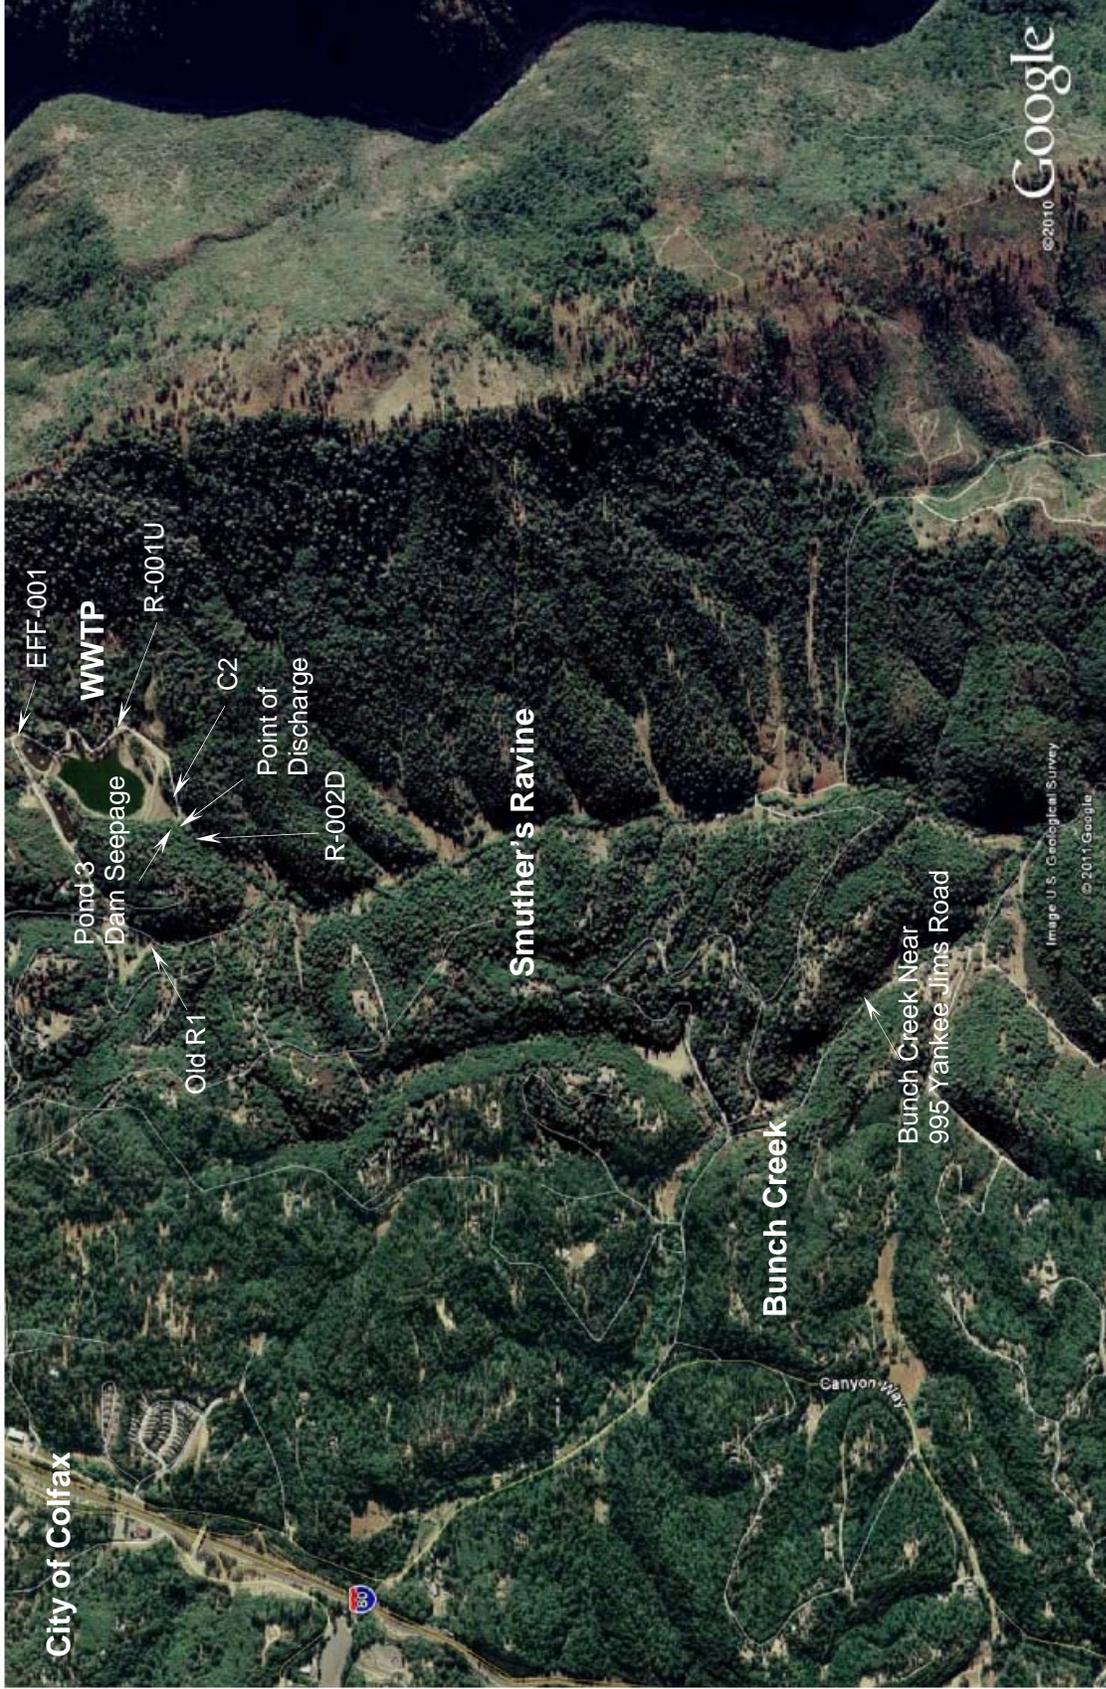
**Figure 2: Bacteria Sample Location Schematic.**

The WWTP discharge to the receiving water is of high quality. When the turbidity of the effluent increases toward the daily average value of 2 NTU, the effluent is diverted. Since WPCS modified to the operation of the plant by adding alkalinity to the influent, ammonia levels in the discharged effluent are typically below 0.5 mg/L as N. Operators at the plant consistently report no odors in the effluent. On October 24, 2011, the City conducted sampling for bacteria levels at several sites. Figure 2 is a schematic of the area around the City of Colfax WWTP, including the locations sampled on October 24, 2011. The samples included the WWTP effluent, dam seepage, Smuther's Ravine Creek above the WWTP confluence, and Bunch Creek upstream from the confluence with Smuther's Ravine Creek. The analytical results of the sampling are listed in Table 1. The two samples with the highest levels of bacteria are the Old R1 site on Smuther's Ravine Creek upstream of the WWTP effluent influence and Bunch Creek upstream from the Smuther's Ravine Creek confluence. The Smuther's Ravine Creek watershed contains more inputs than solely the WWTP discharge. During the October 24, 2011 sampling, there was no recent precipitation, conditions are thought to be reflective of dry conditions.

**Table 1: Bacterial Levels Measured October 24, 2011. Sample Locations Displayed on Figure 2.**

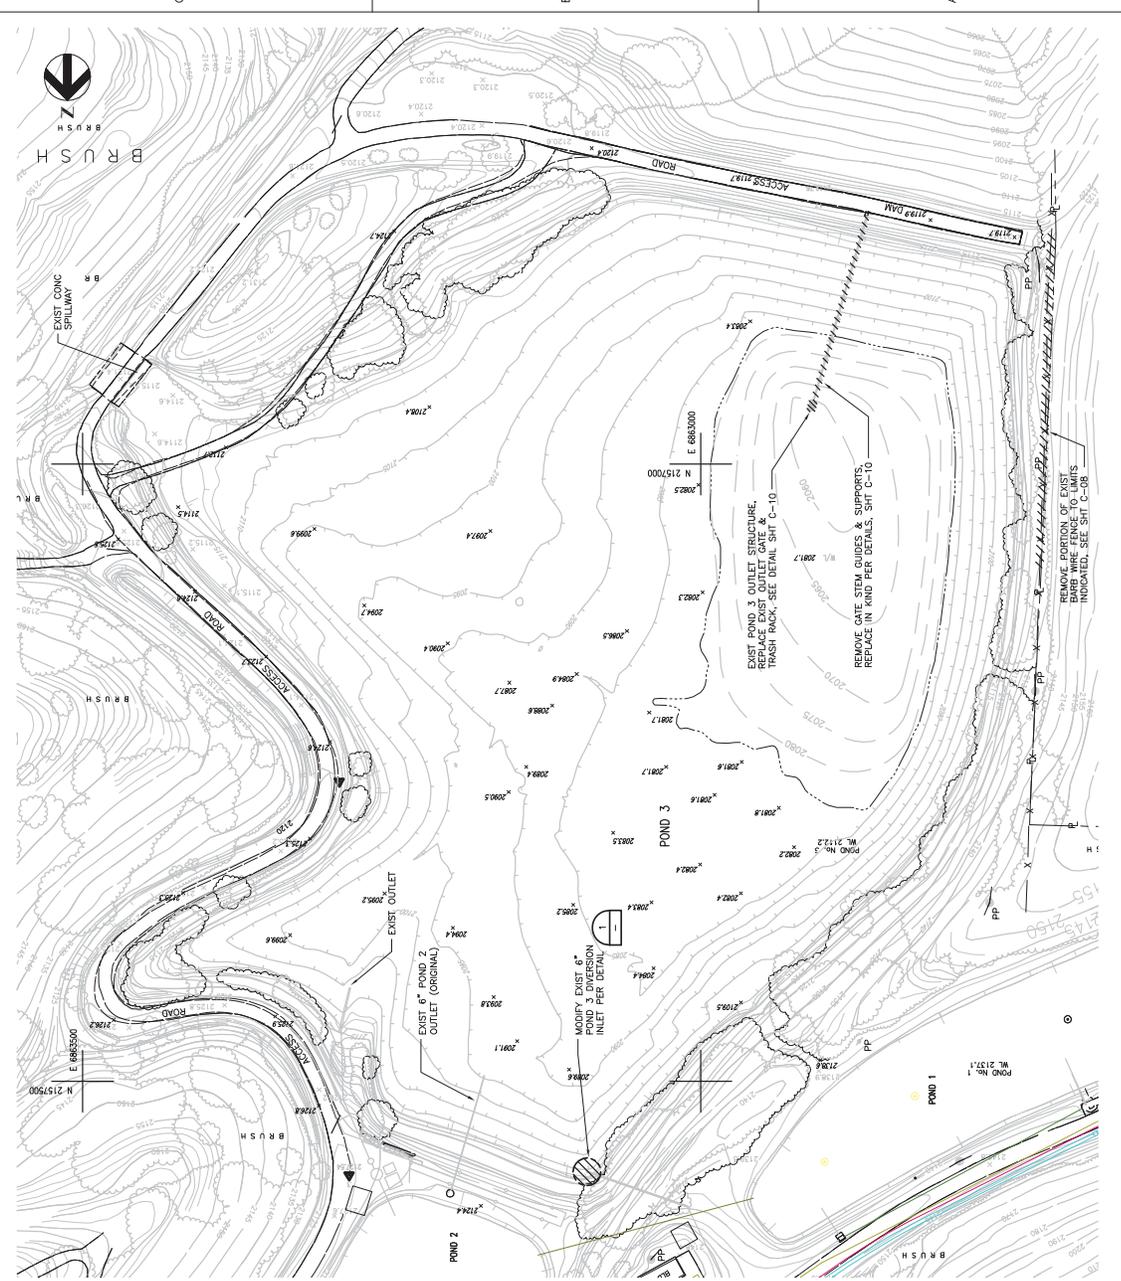
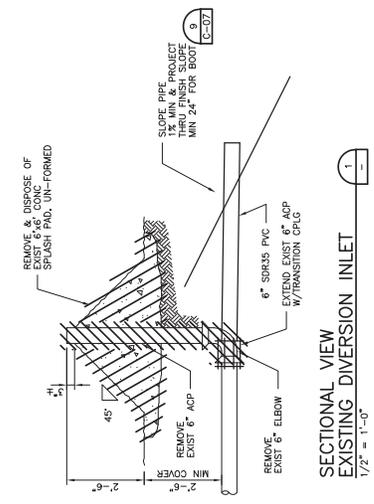
**DEMOLITION PLAN**

SECTIONAL VIEW  
EXISTING DIVERSION INLET  
1/2" = 1'-0"

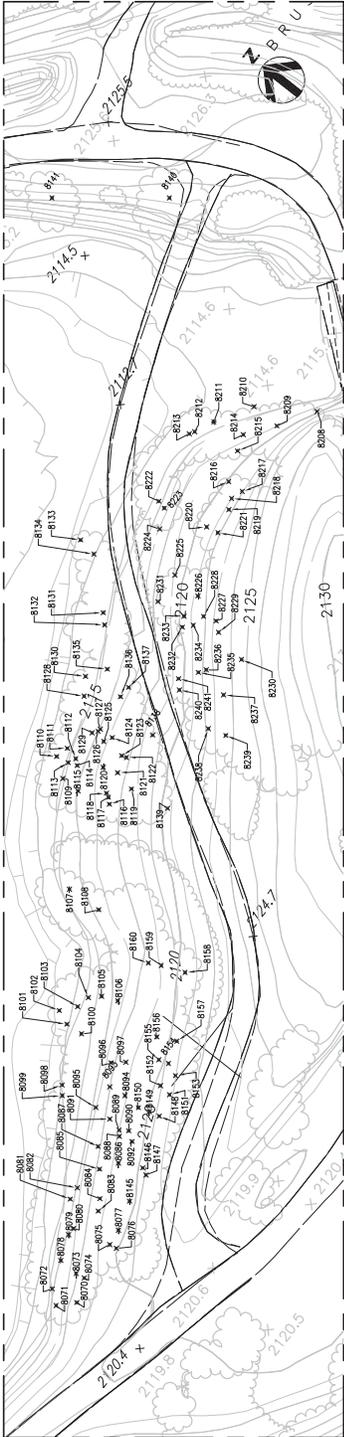
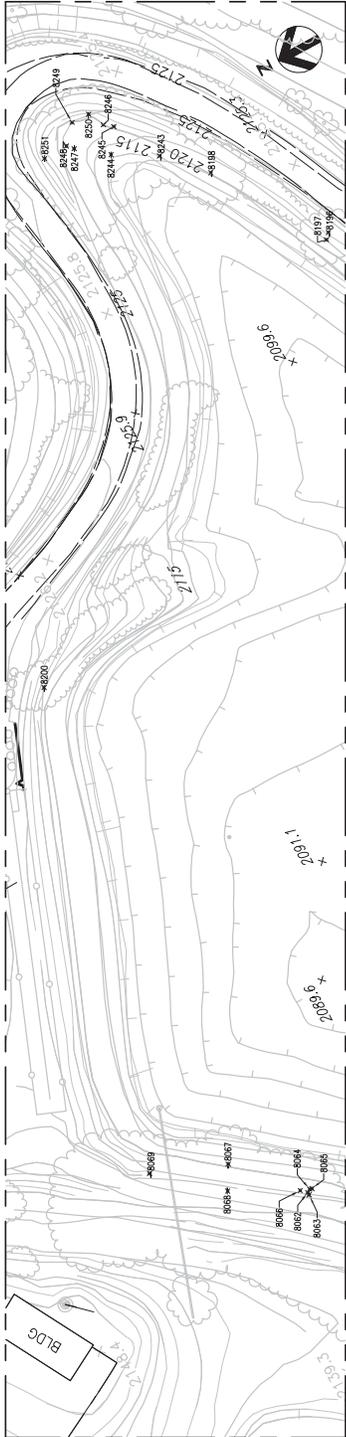
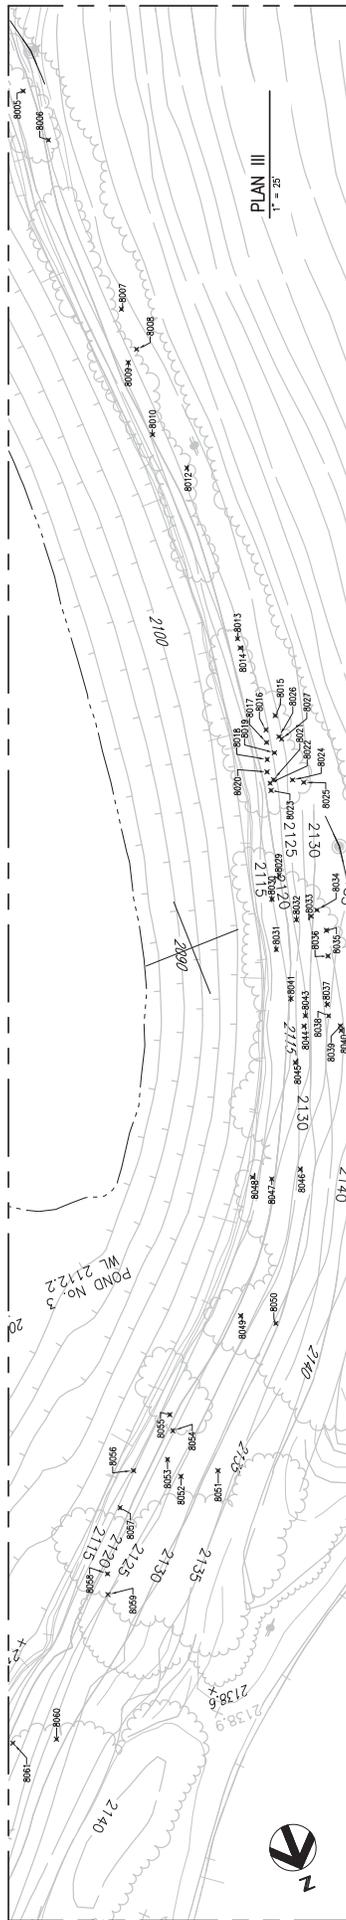
FILENAME 74238\_C-04.dwg  
 SCALE AS NOTED  
 SHEET C-04

PLAN I  
1" = 25'

PLAN II  
1" = 25'

PLAN III  
1" = 25'

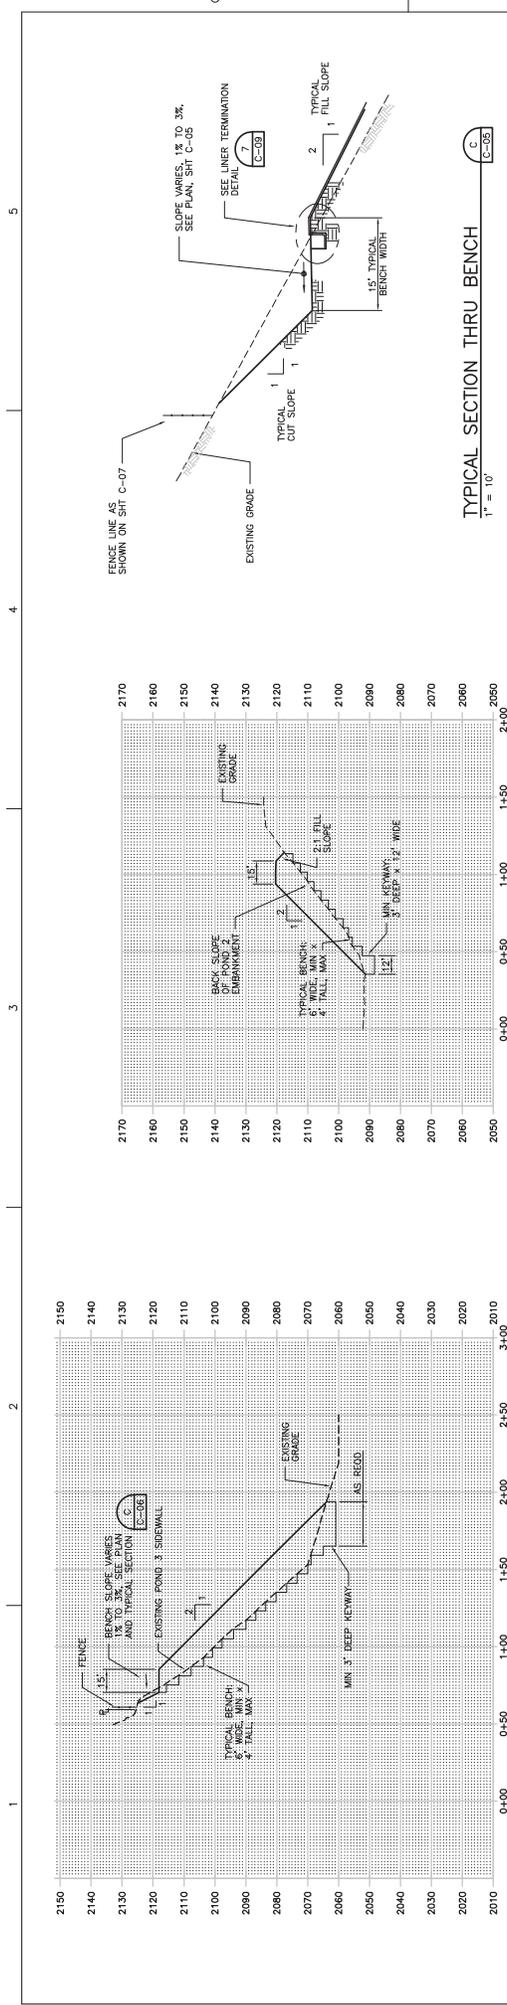
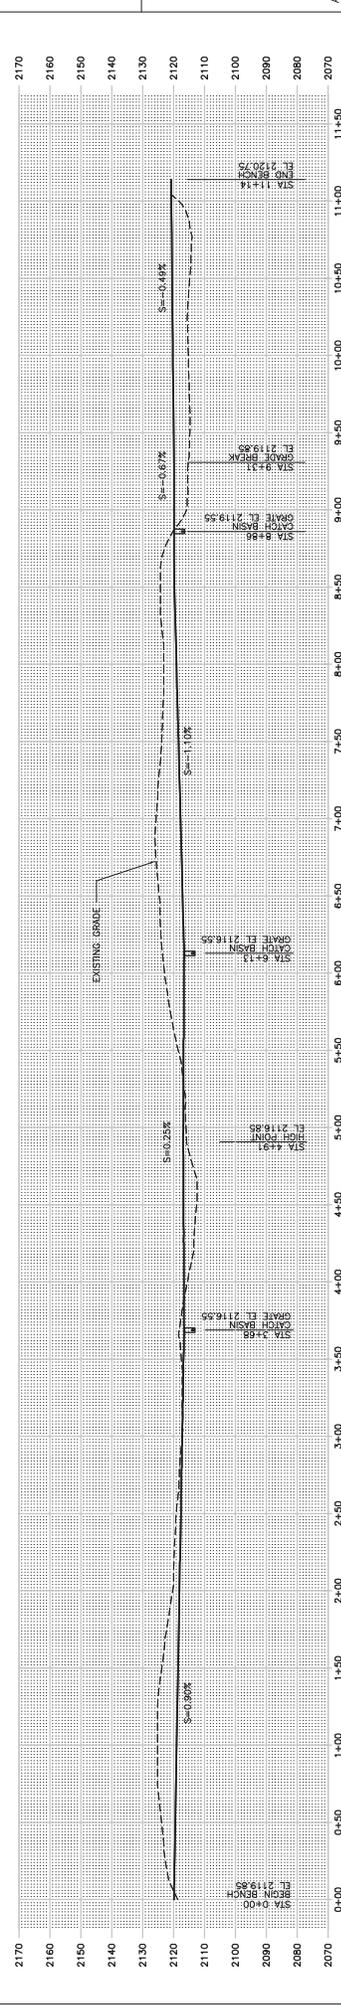
FILENAME 74238\_C-06.dwg  
 SCALE AS NOTED  
 SHEET C-06

**SECTION A**  
 HORIZONTAL: 1" = 40'  
 VERTICAL: 1" = 20'

**SECTION B**  
 HORIZONTAL: 1" = 40'  
 VERTICAL: 1" = 20'

**TYPICAL SECTION THRU BENCH**  
 1" = 10'

**PROFILE -- BACK OF BENCH**  
 HORIZONTAL: 1" = 40'  
 VERTICAL: 1" = 20'

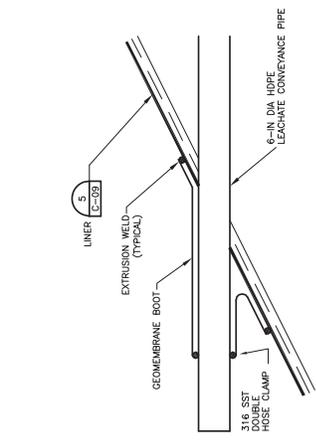
**MISCELLANEOUS PIPE OUTLET DETAIL**  
NO SCALE

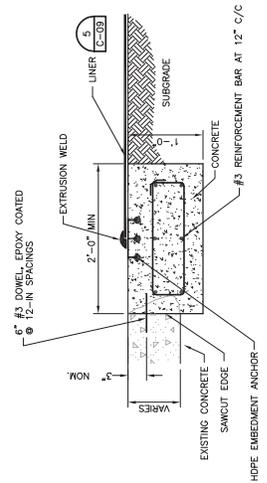
**TYPICAL HDPE EMBEDMENT ANCHOR STRIP DETAIL**  
NO SCALE

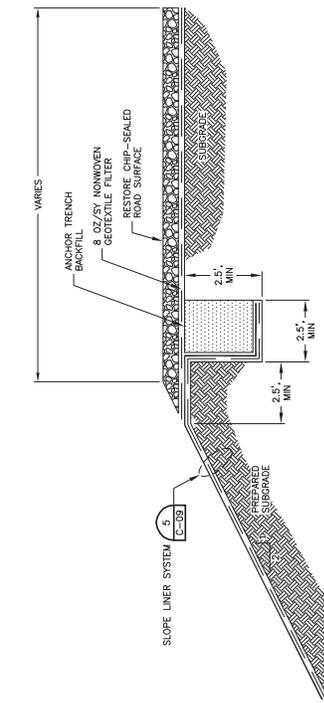
**LINER TERMINATION DETAIL AT ROAD DETAIL**  
NO SCALE

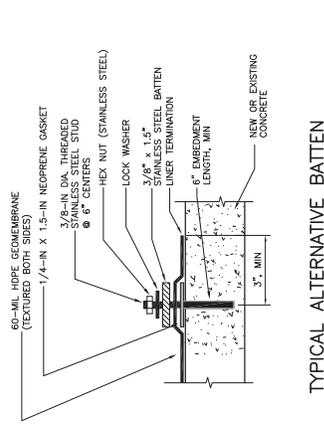
**TYPICAL ALTERNATIVE BATTEN STRIP ANCHOR DETAIL**  
NO SCALE

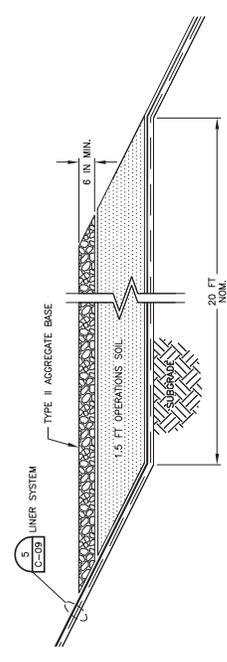
**ACCESS RAMP DETAIL**  
NO SCALE

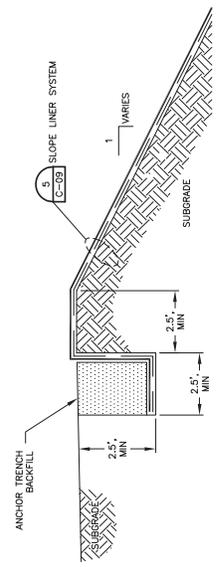
**LINER TERMINATION DETAIL**  
NO SCALE

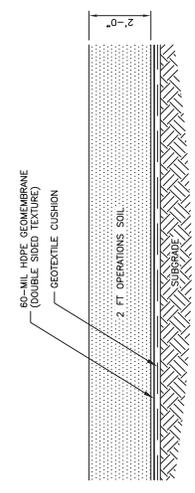
**BALLAST OPERATIONS LAYER DETAIL**  
NO SCALE

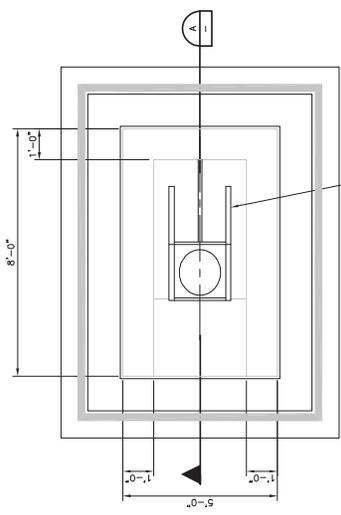
**PLAN VIEW  
EXISTING INTAKE STRUCTURE**  
1/2" = 1'-0"

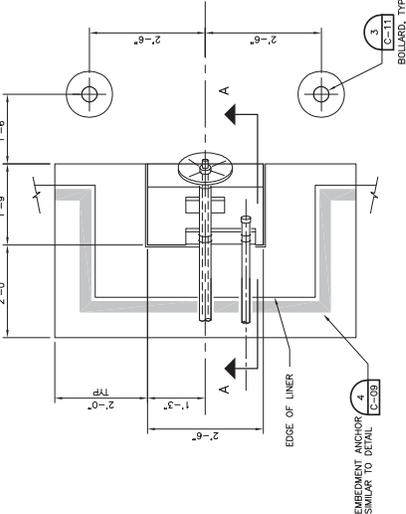
**PLAN VIEW**  
3/4" = 1'-0"

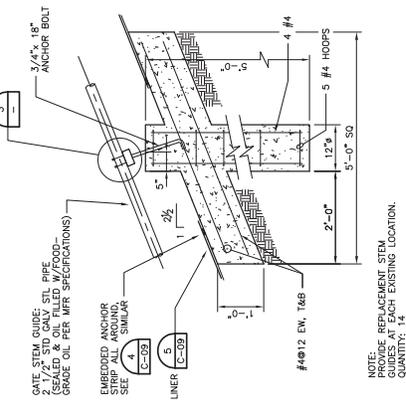
**GATE STEM GUIDE DETAIL**  
3/4" = 1'-0"

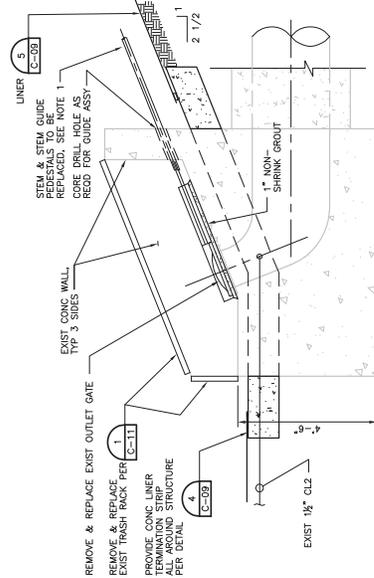
**SECTION A-A**  
1/2" = 1'-0"

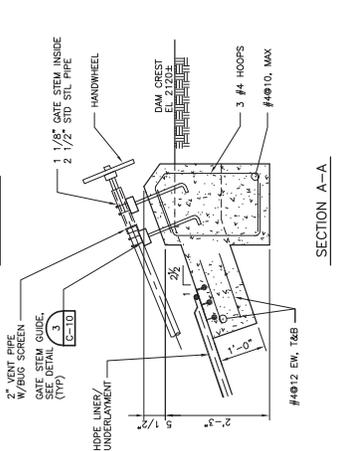
**SECTION A-A**  
3/4" = 1'-0"

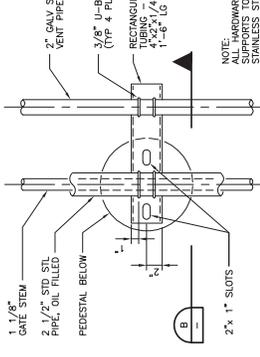
**STEM GUIDE DETAIL**  
1 1/2" = 1'-0"

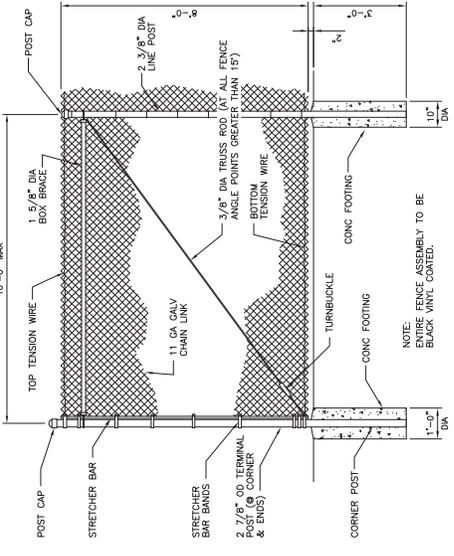
CHAIN LINK FENCE DETAIL  
1/2" = 1'-0"

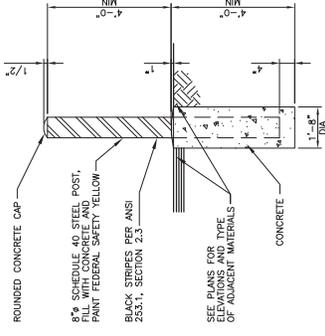
FIXED BOLLARD DETAIL  
NO SCALE

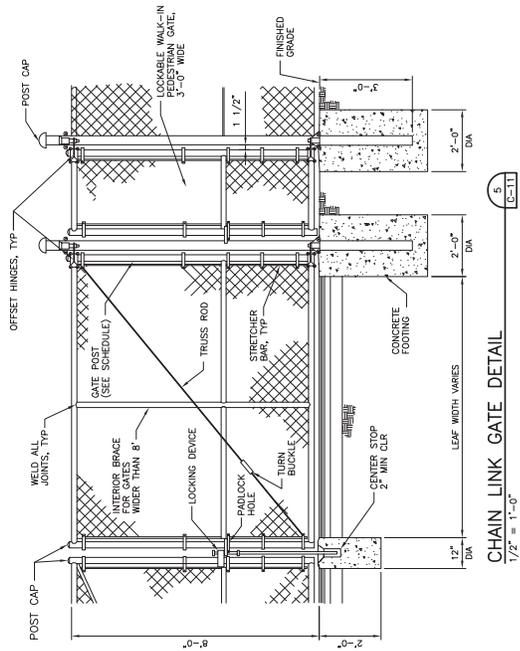
CHAIN LINK GATE DETAIL  
1/2" = 1'-0"

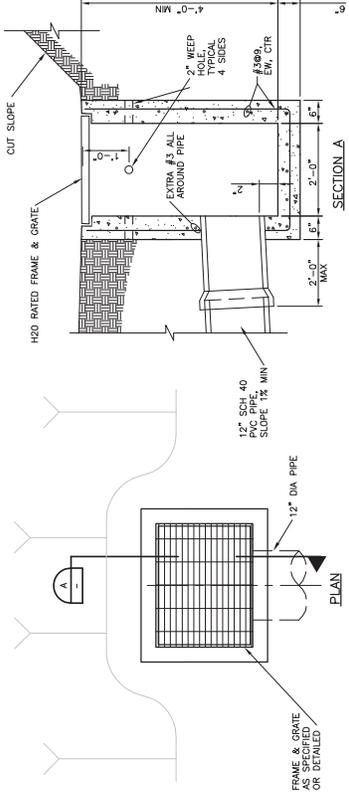
NOTE: CONTRACTOR MAY SUBMIT PRECAST CONCRETE CATCH BASIN PROVIDING IT MEETS MINIMUM REQUIREMENTS SHOWN IN THIS DETAIL.

CATCH BASIN DETAIL  
NO SCALE

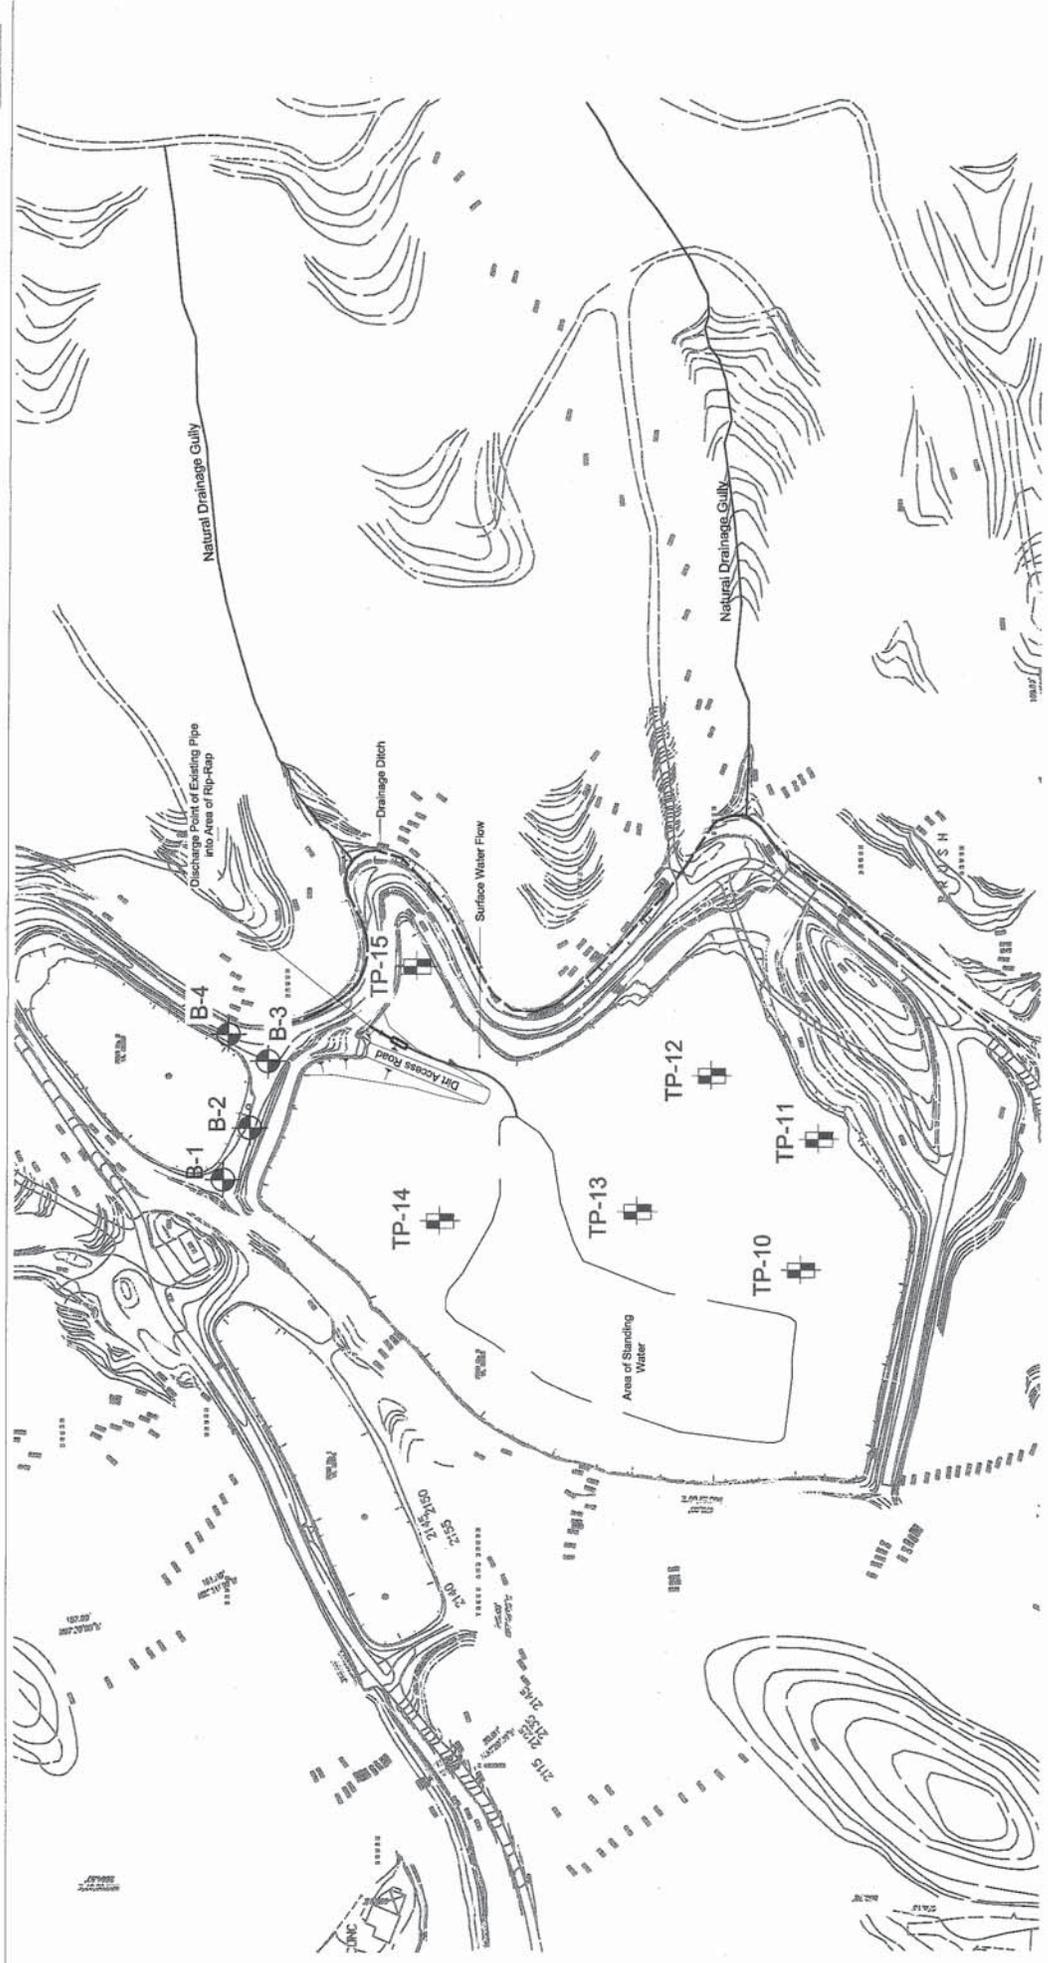
**SITE MAP AND TEST PIT LOCATION PLAN**  
Colfax WWTP Upgrade Project  
Colfax, California

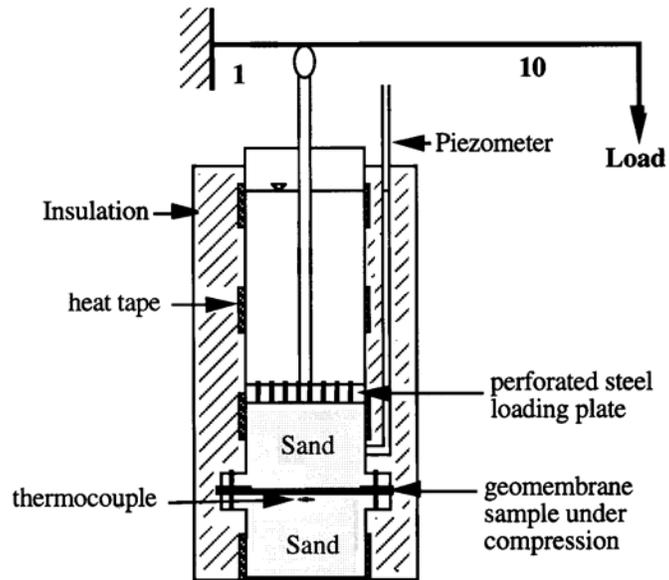
Figure 1. Incubation schematic and photograph of multiple cells maintained at various constant temperatures.

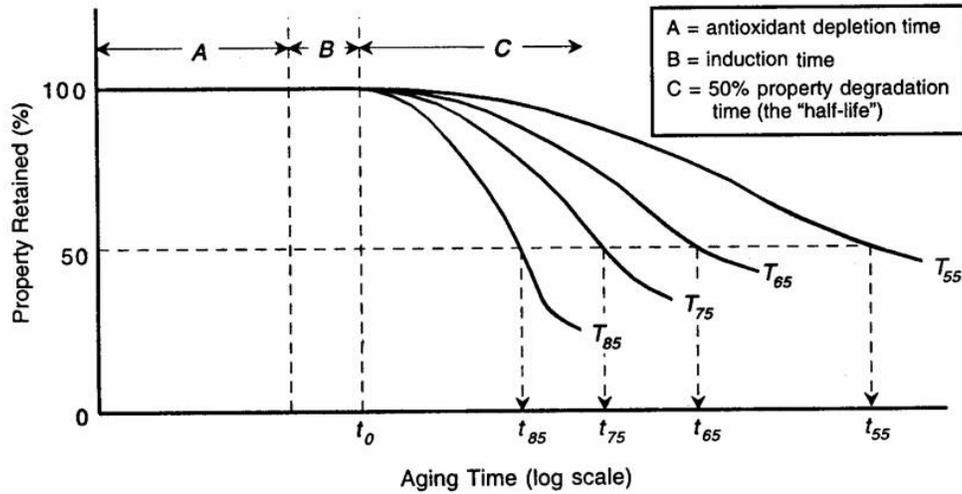
Figure 2. Three individual stages in the aging of most geomembranes.

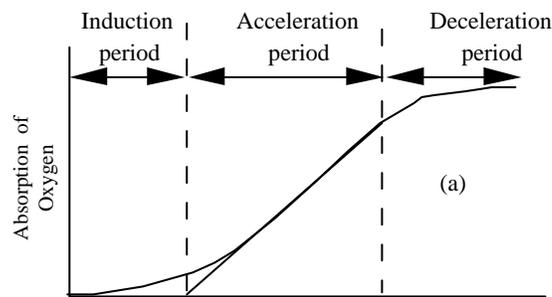
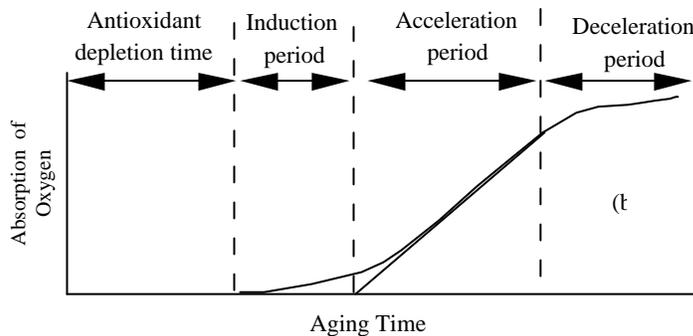
(a) Pure unstabilized polyethylene

(b) Stabilized polyethylene

Figure 3. Curves illustrating various stages of oxidation.

This progression is illustrated by the S-shaped curve of Figure 3(a). The initial portion of the curve (before measurable degradation takes place) is called the induction period (or induction time) of the polymer. In the induction period, the polymer reacts with oxygen forming hydroperoxide (ROOH), as indicated in Equations (1)-(3). However, the amount of ROOH in this stage is very small and the hydroperoxide does not further decompose into other free radicals which inhibits the onset of the acceleration stage.

In a stabilized polymer such as one with antioxidants, the accelerated oxidation stage takes an even longer time to be reached. The antioxidants create an additional depletion time stage prior to the onset of the induction time, as shown in Figure 3(b).

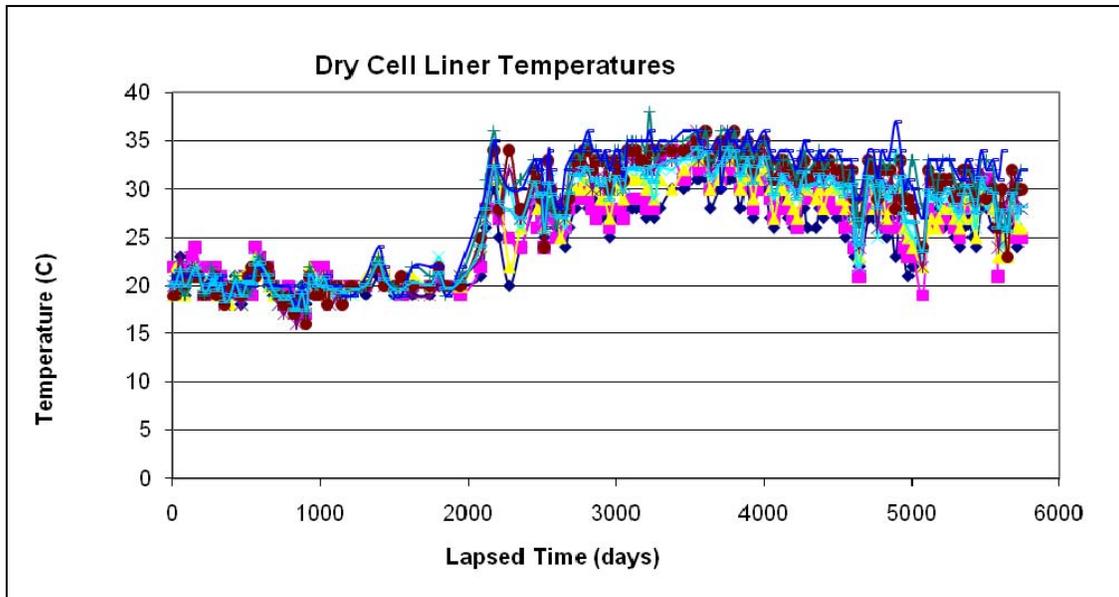
Figure 4. Long-term monitoring of an HDPE liner beneath a municipal solid waste landfill in Pennsylvania.

Summarizing Stages A, B, and C, it is seen in Table 2 that the half-life of covered HDPE geomembranes (formulated according to the current GRI-GM13 Specification) is estimated to be 449-years at 20°C. This, of course, brings into question the actual temperature for a covered geomembrane such as beneath a solid waste landfill. Figure 4 presents multiple thermocouple monitoring data of a municipal waste landfill liner in Pennsylvania for over 10-years, Koerner and Koerner (2005). Note that for 6-years the temperature was approximately 20°C. At that time and for the subsequent 4-years the temperature increased to approximately 30°C. Thus, the half-life of this geomembrane is predicted to be from 166 to 446 years within this temperature range. The site is still being monitored, see Koerner and Koerner (2005).

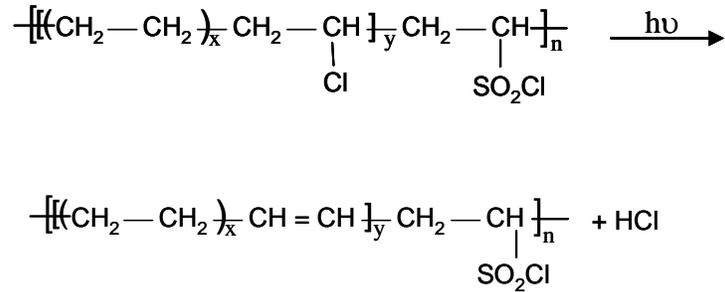
Figure 6. Dechlorination degradation of crosslinked CSPE geomembranes (Chailan, et al., 1995).

For CSPE geomembranes, the degradation mechanism is dehydrochlorination by losing chlorine and generating carbon-carbon double bonds in the main polymer chain, as shown in Figure 6.

The carbon-carbon double bonds become the preferred sites for further thermodegradation or cross-linking in the polymer, leading to eventual brittleness of the geomembrane.

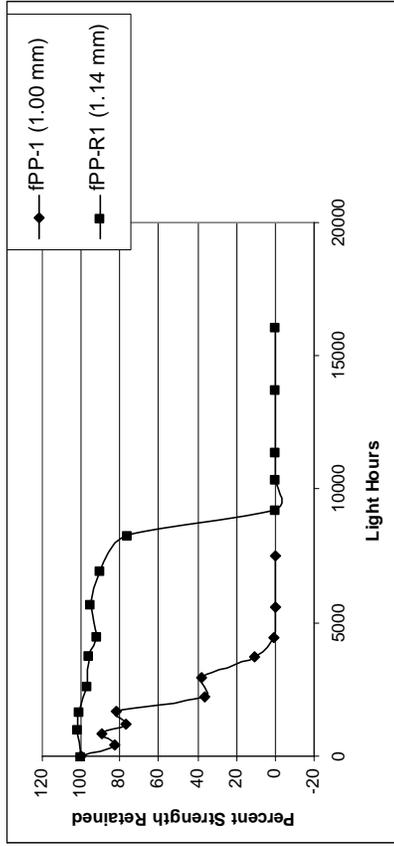
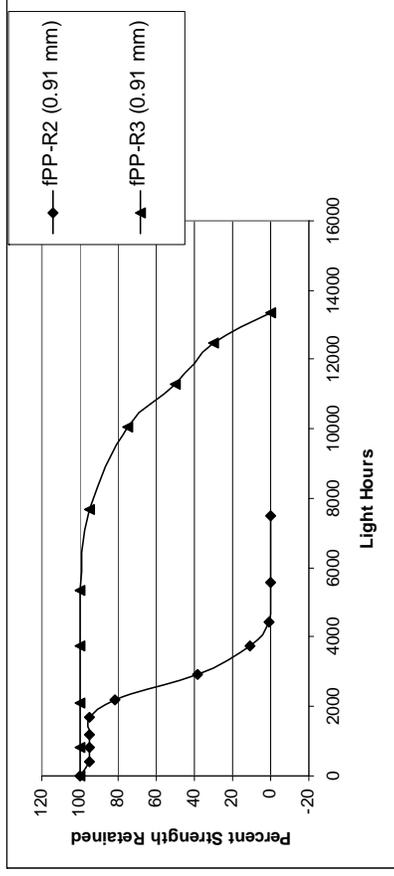
(a) Two Sites in West Texas

(b) Two Sites in So. Calif.

Lab-to-Field Correlation Factors  
(ASTM D7238 @ 70°C)

There are presently (2011) four field failures of flexible polypropylene geomembranes and using unexposed archived samples from these sites their responses in laboratory UV Fluorescent devices per ASTM D7328 at 70°C are shown in Figure 5. From this information we deduce that the average correlation factor is approximately *1200 light hours*  $\simeq$  *one-year in a hot climate*. This value will be used accordingly for other geomembranes.

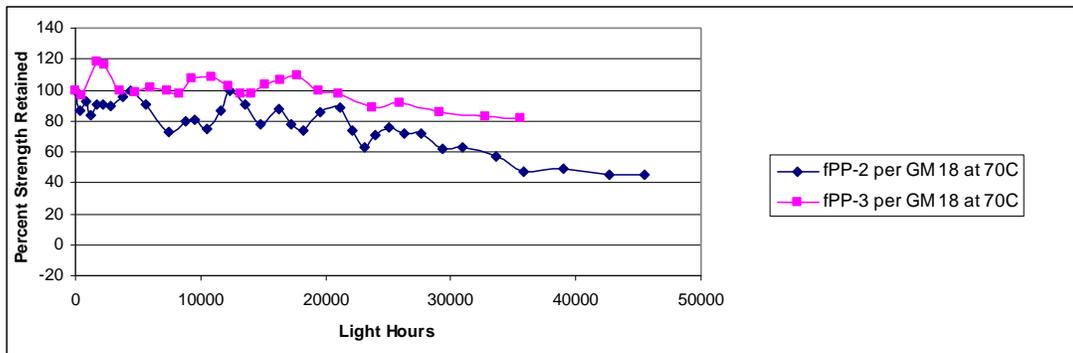
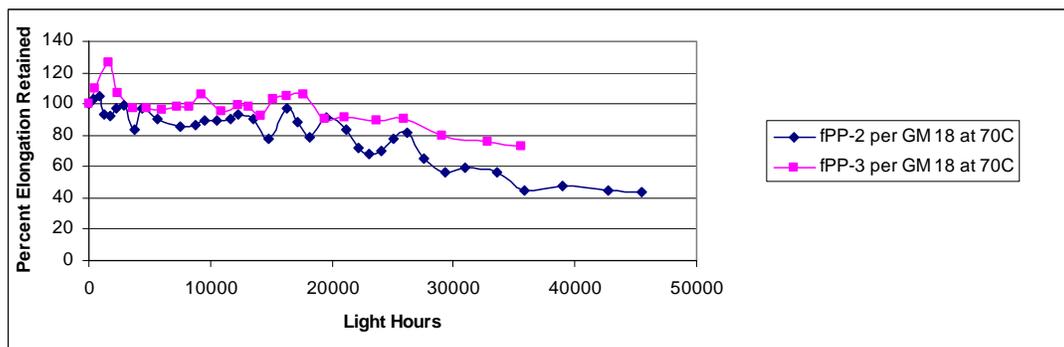
Figure 6a. Flexible polyethylene (fPP) geomembrane behavior.

- Two black 1.0 mm (4.0 mil) unreinforced flexible polypropylene geomembranes formulated per GRI-GM18 Specification; see Figure 6a.
- Two black unreinforced polyethylene geomembranes, one 1.5 mm (60 mil) high density per GRI-GM13 Specification and the other 1.0 mm (40 mil) linear low density per GRI-GM17 Specification; see Figure 6b.
- One 1.0 (40 mil) black ethylene polypropylene diene terpolymer geomembrane per GRI-GM21 Specification; see Figure 6c.
- Two polyvinyl chloride geomembranes, one black 1.0 mm (40 mil) formulated in North America and the other grey 1.5 mm (60 mil) formulated in Europe; see Figure 6d.

From the response curves of the various geomembranes shown in Figure 6a-d, the 50% reduction value in strength or elongation (usually elongation) was taken as being the “half-life”. This value is customarily used by the polymer industry as being the materials lifetime prediction value. We have done likewise to develop Table 6 which is our predicted values for the designated exposed geomembrane lifetimes to date.

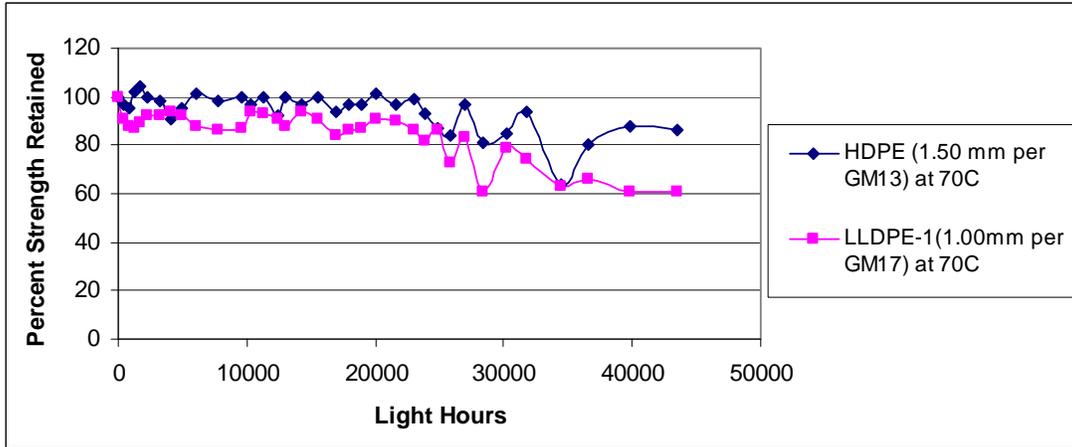
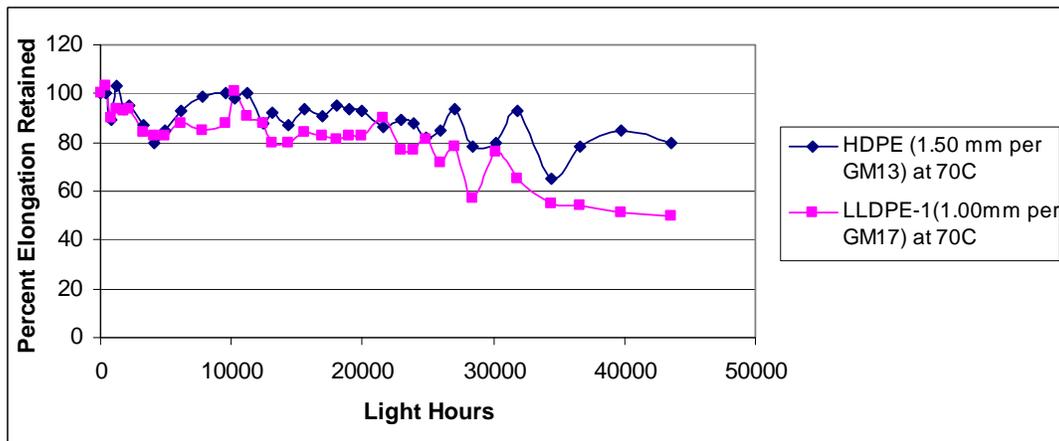
Figure 6b. Polyethylene (HDPE and LLDPE) geomembrane behavior.

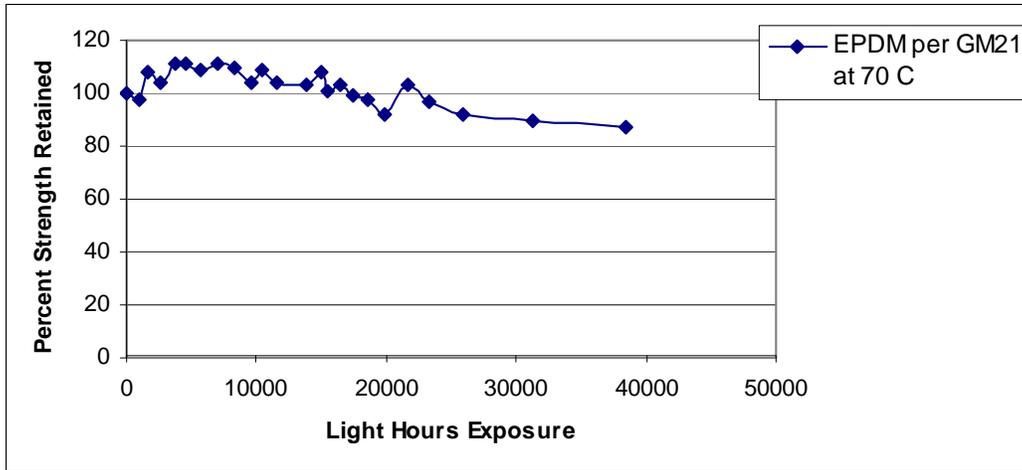
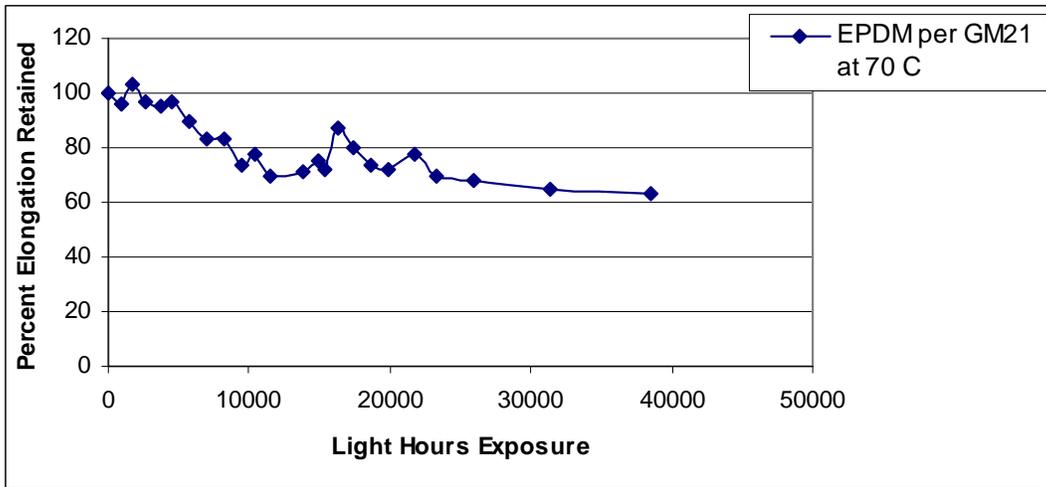
Figure 6c. Ethylene polypropylene diene terpolymer (EPDM) geomembrane.

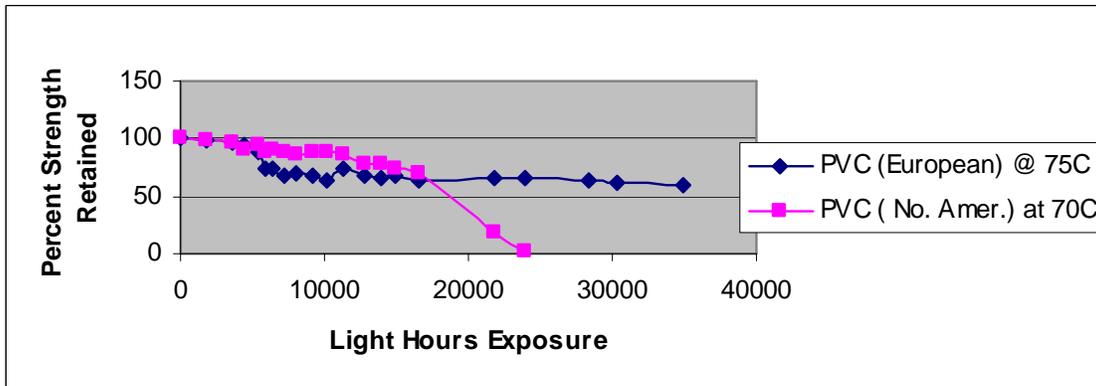
Figure 6d. Polyvinyl chloride (PVC) geomembranes.

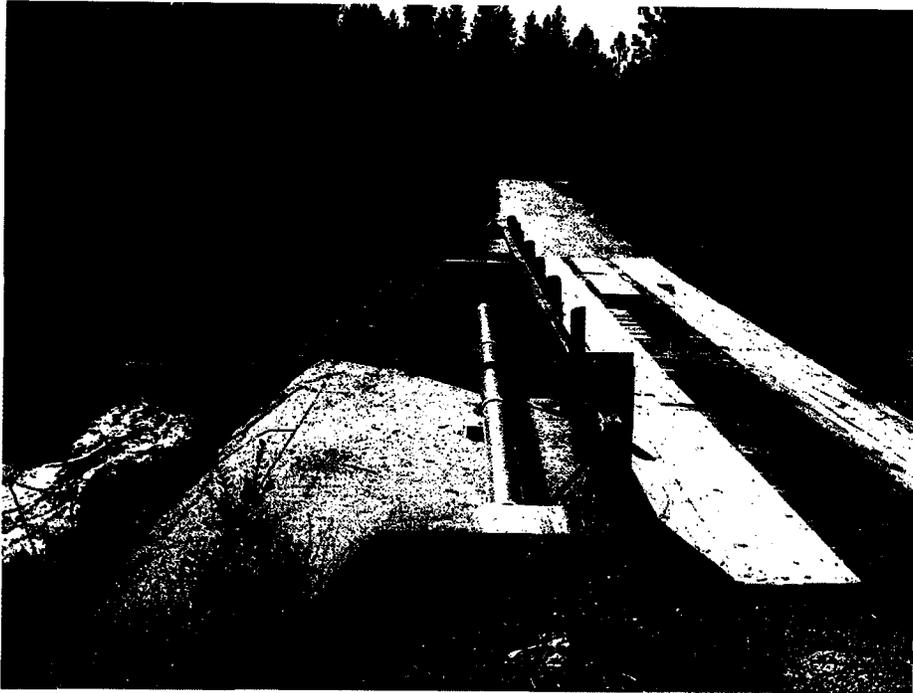
Spillway Control and Downstream Channel
