Henry Tosta Dairy  
20662 S. San Jose Road  
Tracy, San Joaquin County  
28 March 2002

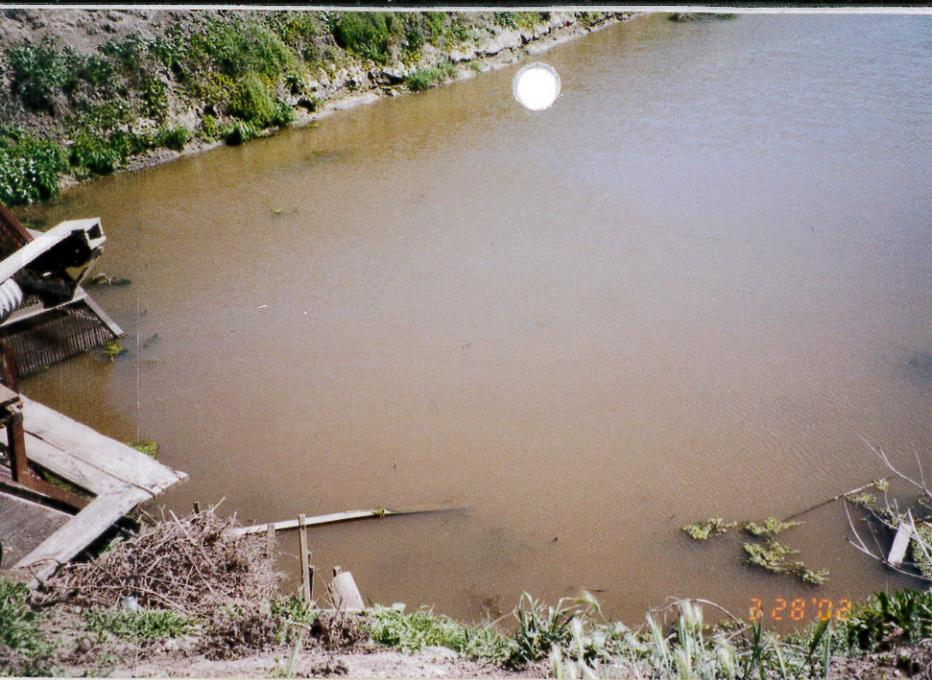
Photo 1: Looking SE at the Naglee-Burke sump at Bethany Road. The pump is at far left. EC 5000  $\mu$ hmos, NH<sub>3</sub> 1.40 mg/L

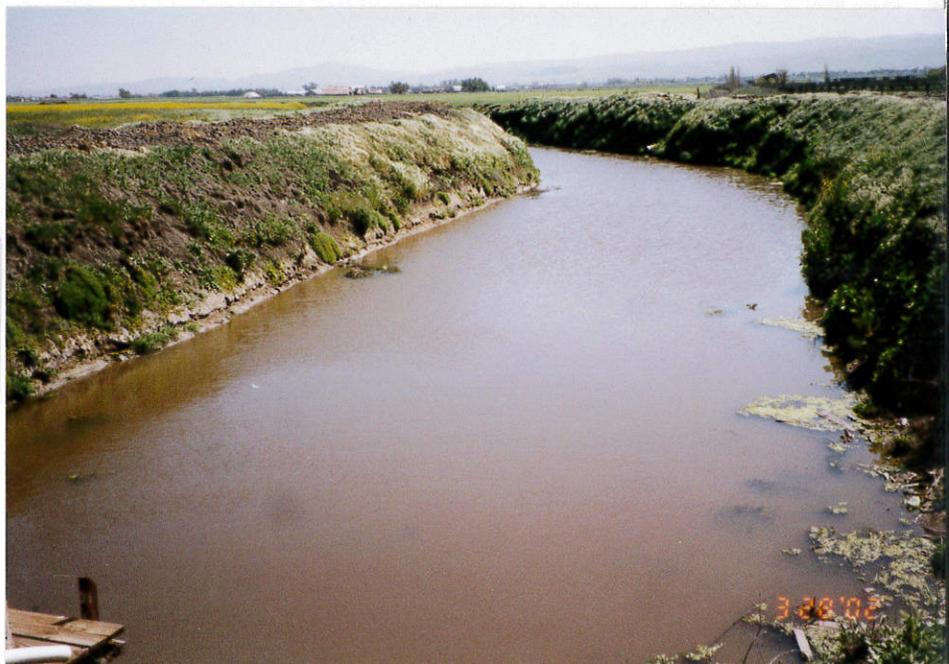
Photo 2: Looking SE at the Naglee-Burke sump at Bethany Road. The pump is at far left. EC 5000  $\mu$ hmos

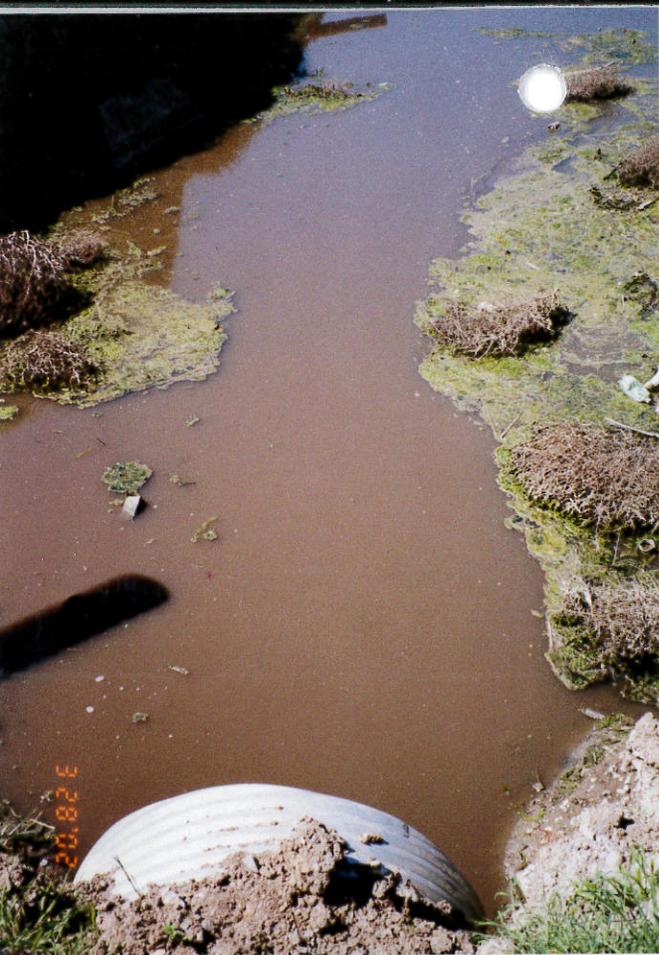
Photo 3: Naglee-Burke Drain at  
Reeve Road. EC 4700  $\mu$ hmos. NH<sub>3</sub>  
6.33 mg/L

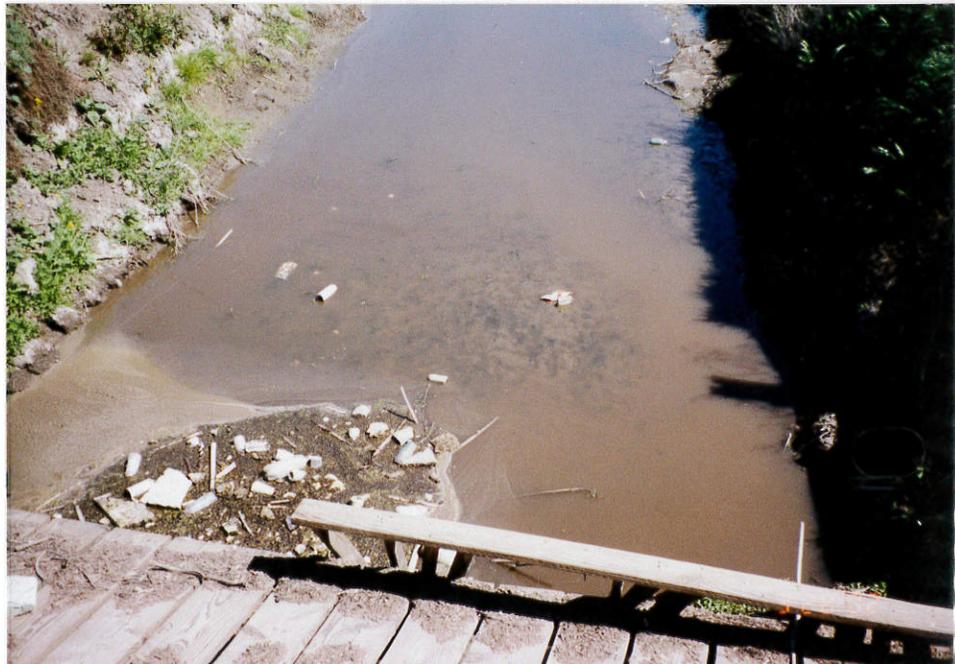
Photo 4: Looking East up Naglee-  
Burke Drain at San Jose Road. EC  
4800  $\mu$ hmos, NH<sub>3</sub> 5.35 mg/L

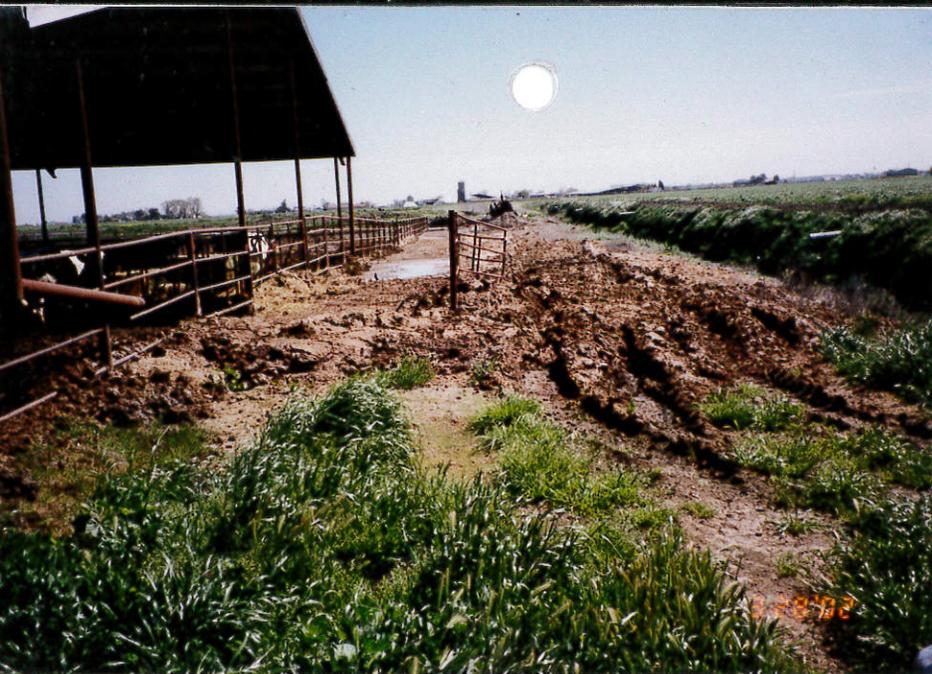
Photo 5: Looking East along Naglee-Burke Drain, East of San Jose Road. Note manure solids scraped from barn into the drain.

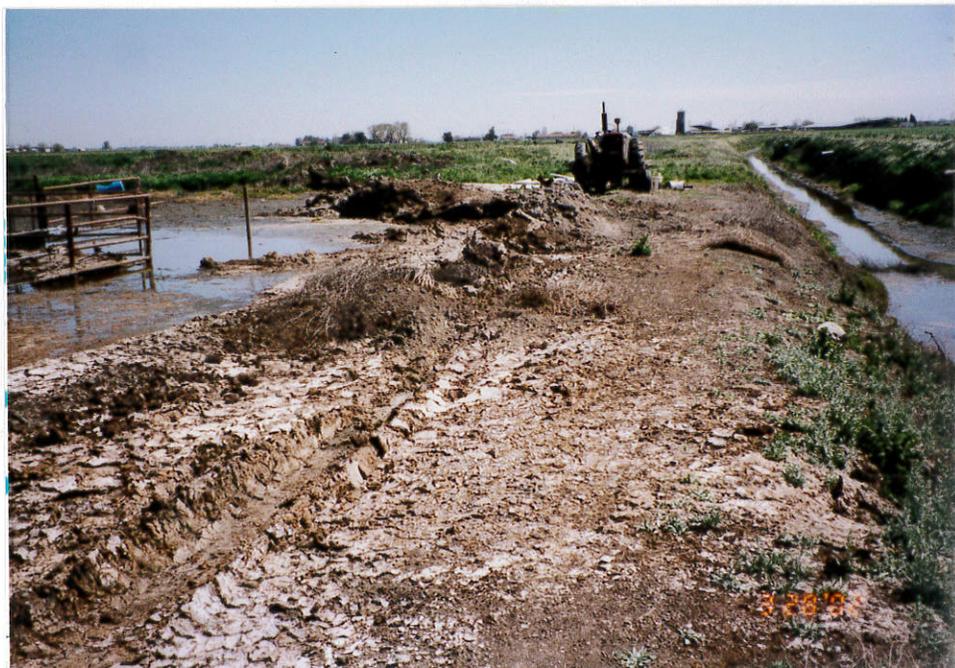
Photo 6: Looking East along Naglee-Burke Drain further East. Note manure solids along bank where discharges have occurred in past.

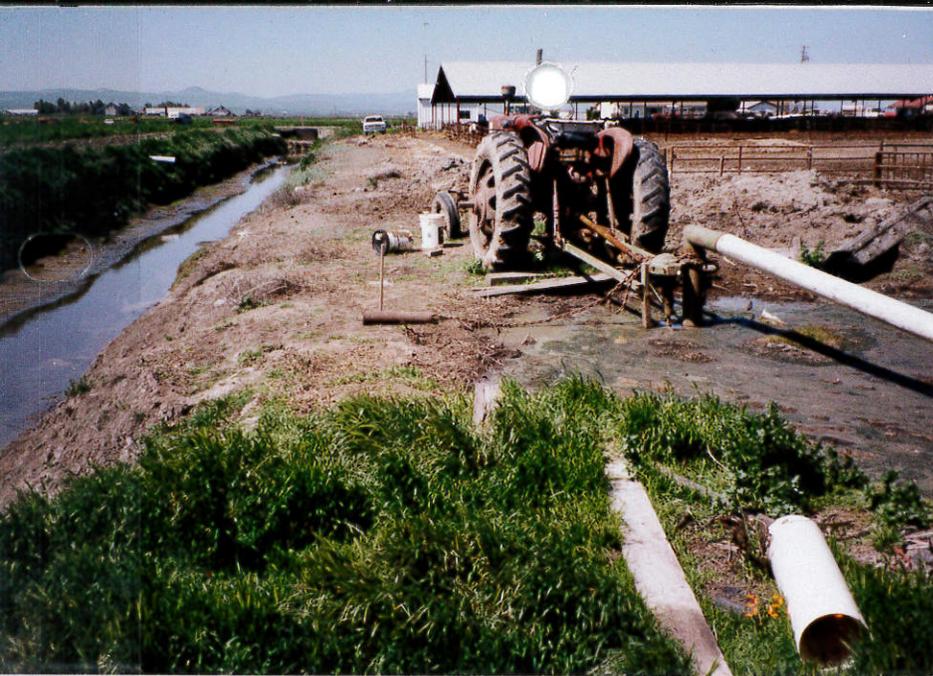
Photo 7: Looking West along Naglee-Burke Drain. Note lack of freeboard on sump at right.

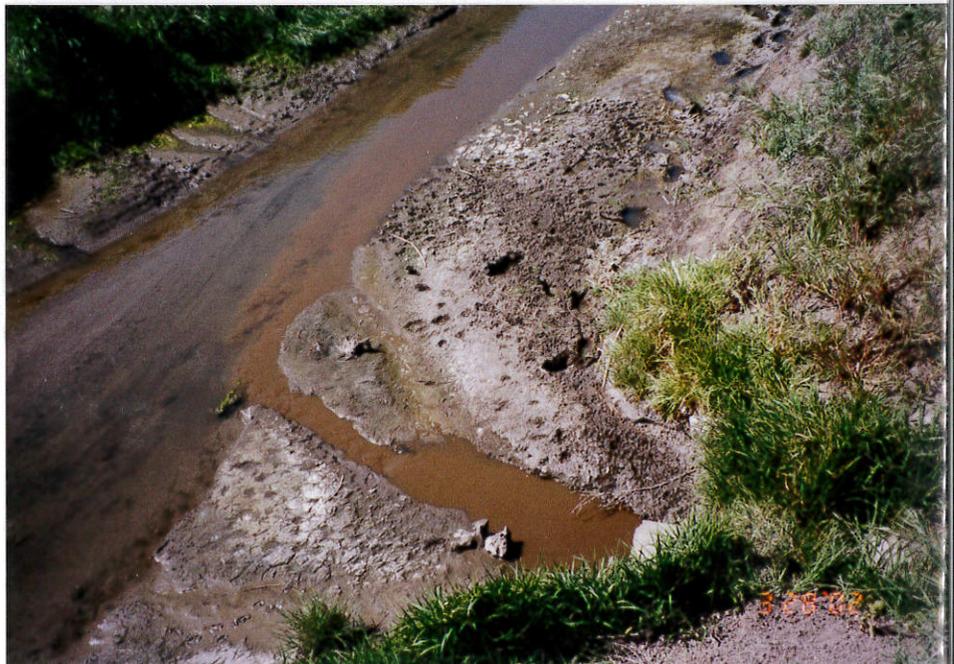
Photo 8: Looking SW at the flow of wastewater from the North lateral into the main drain. EC of discharge 4500  $\mu$ hmos. EC in drain above 3900  $\mu$ hmos. NH<sub>3</sub> upstream 0.523 mg/l. NH<sub>3</sub> in discharge 24.9 mg/L.

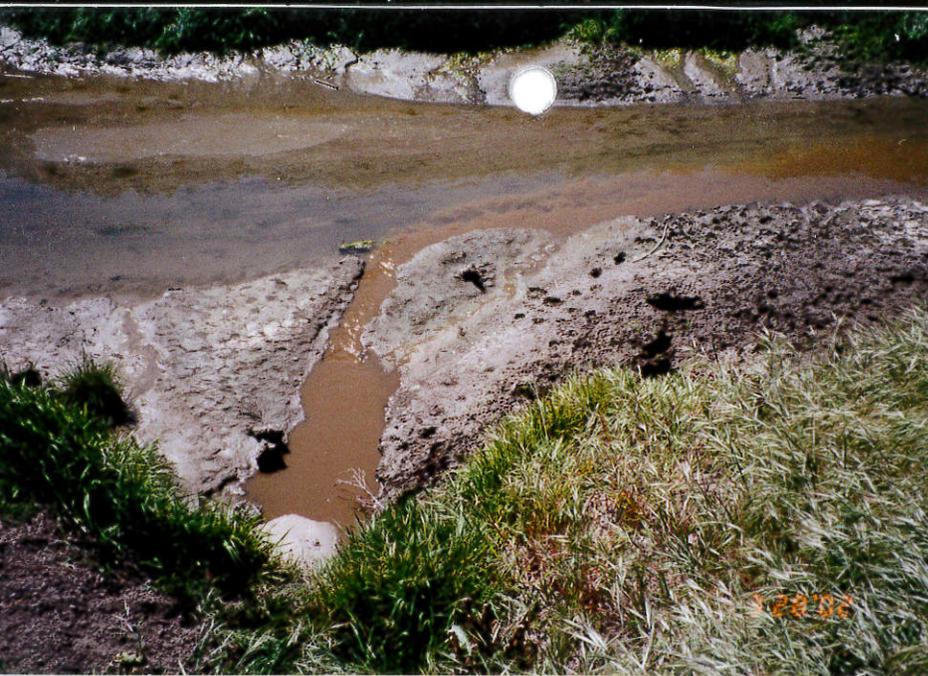
Photo 9: Looking South at the flow of wastewater from the North lateral into the main drain. EC of discharge 4500  $\mu$ hmos. EC in drain above 3900  $\mu$ hmos.

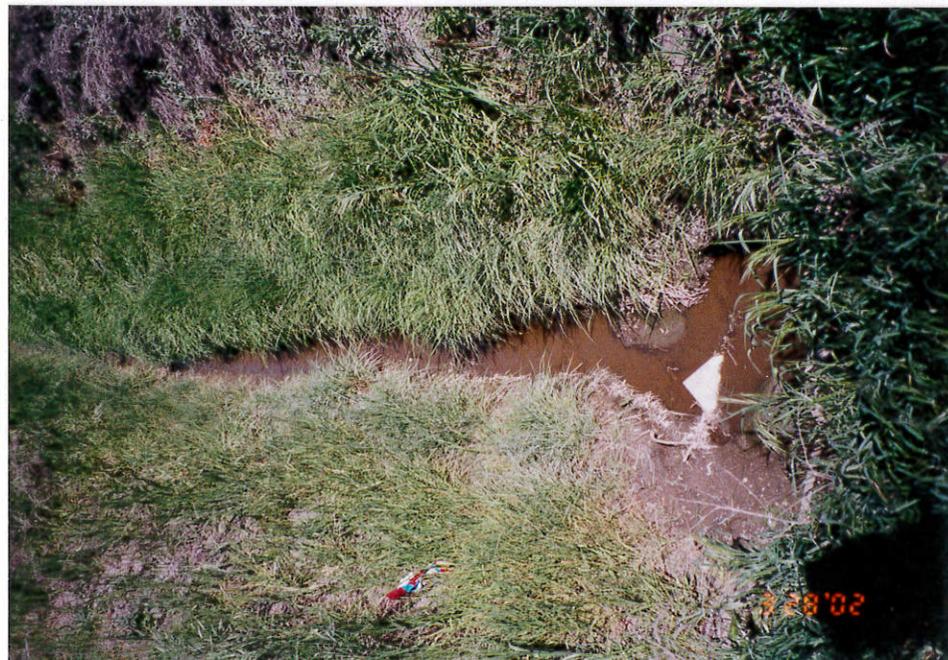
Photo 10: Looking North up the North lateral

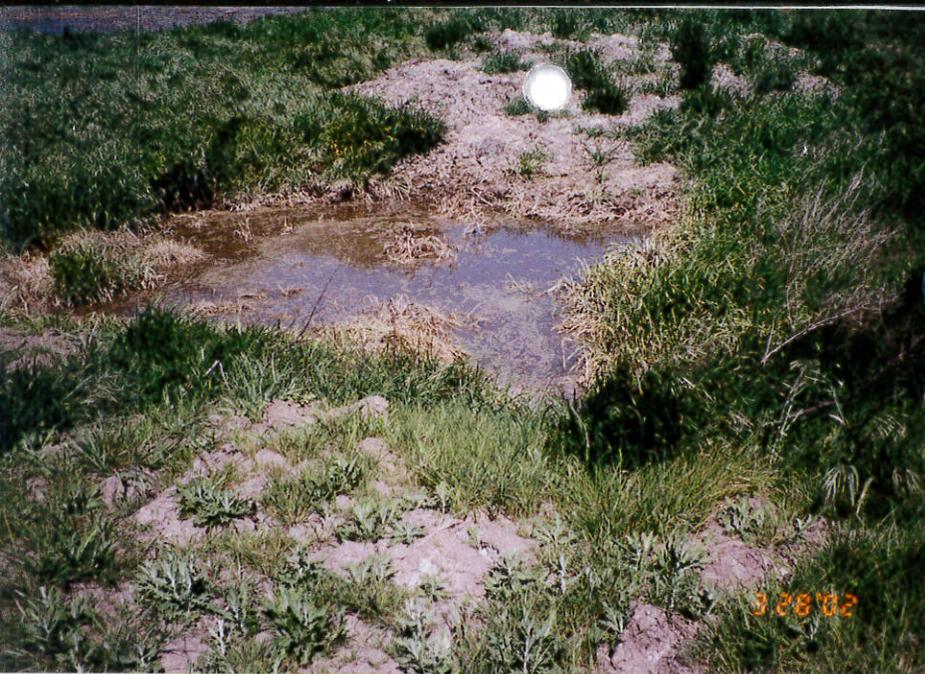
Photo 11: Looking North at a pond of wastewater near the SE corner of the waste pond. Wastewater was flowing into the drain.

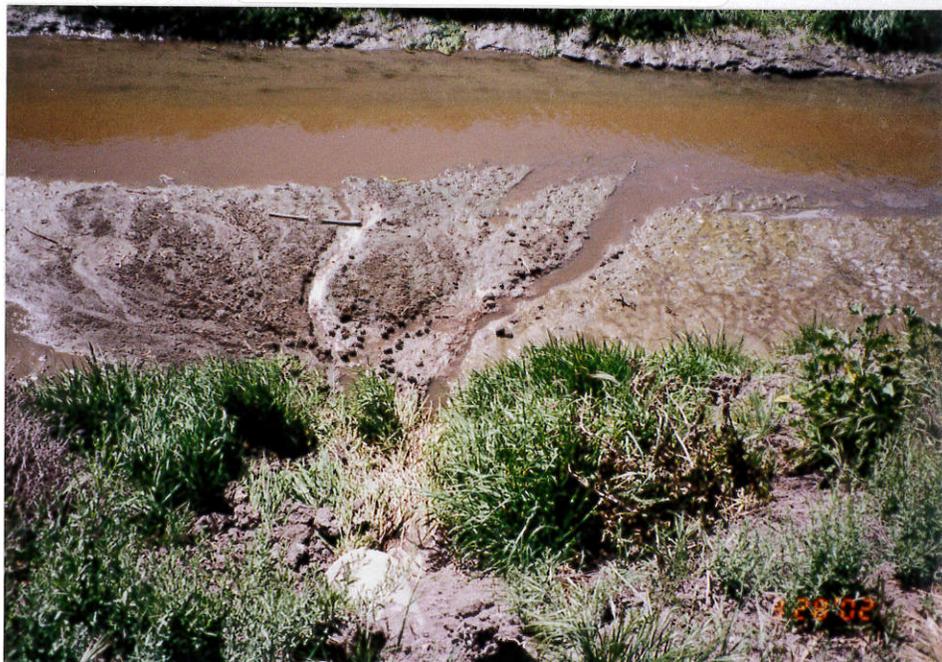
Photo 12: Looking East at one of several discharges of wastewater from the field into the North lateral. EC 4600  $\mu$ hmos. NH<sub>3</sub> 64.0 mg/L

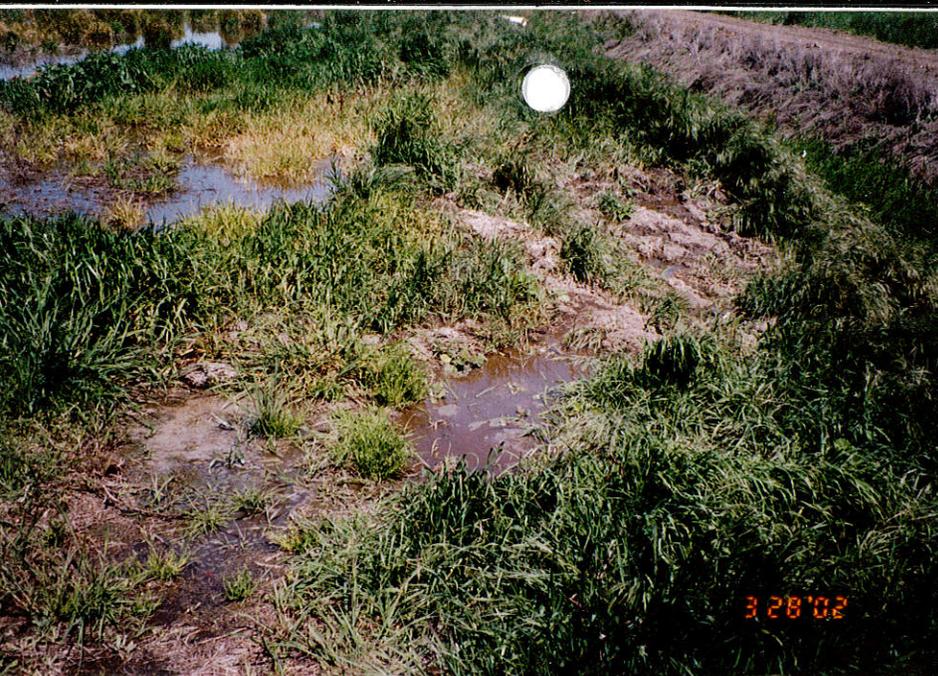
Photo 13: Looking North along the area between the field and the North lateral (upper right). Note discharge at right. EC 4400  $\mu$ hmos,  $\text{NH}_3$  50.3 mg/L

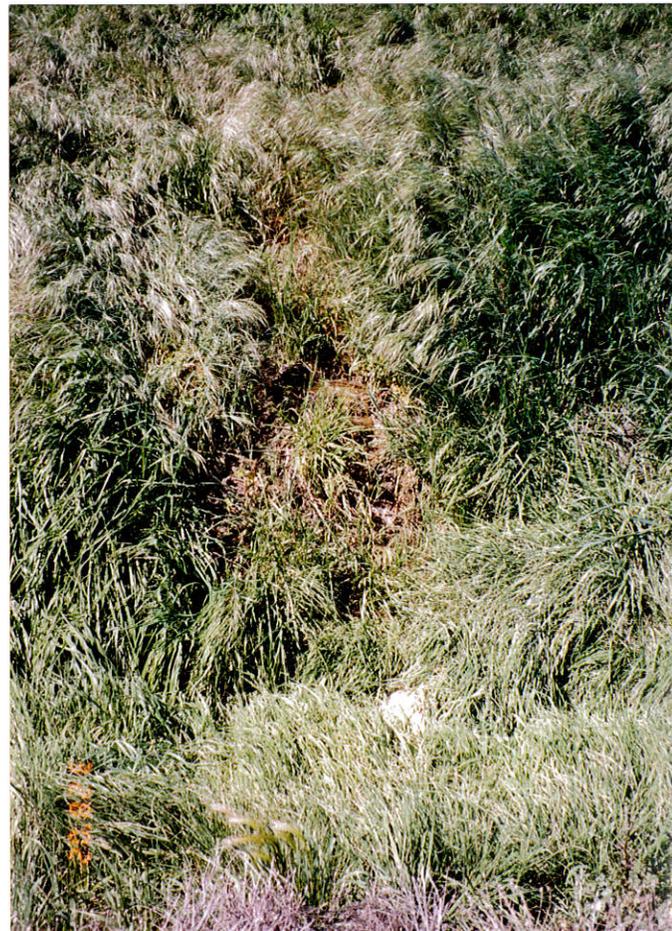
Photo 14: Looking West at one of several discharges from the field into the North lateral.

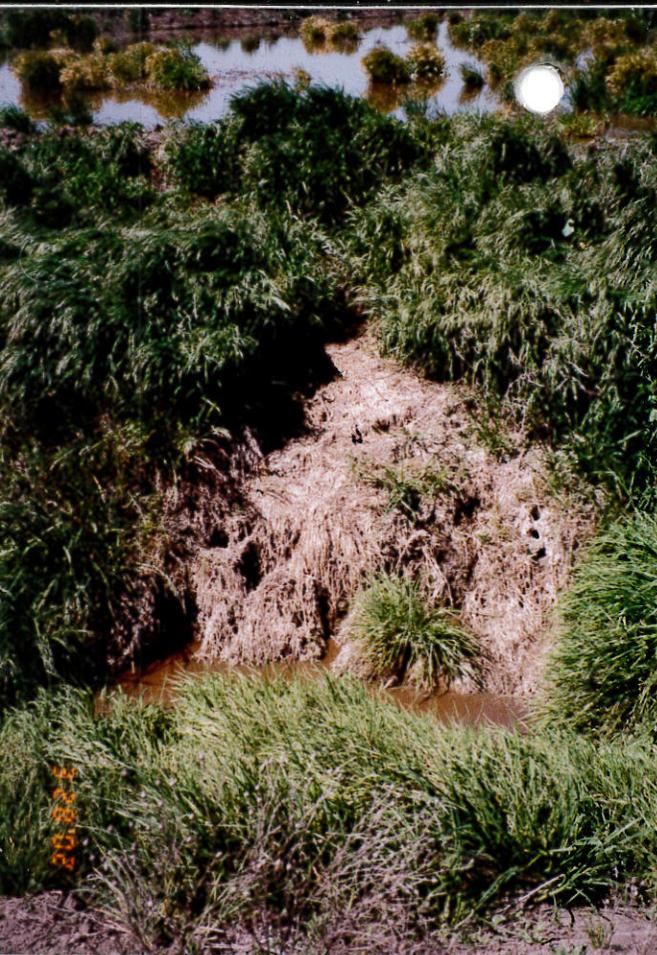
Photo 15: Looking West at one of several discharges from the field into the North lateral. Note wastewater in field at top.

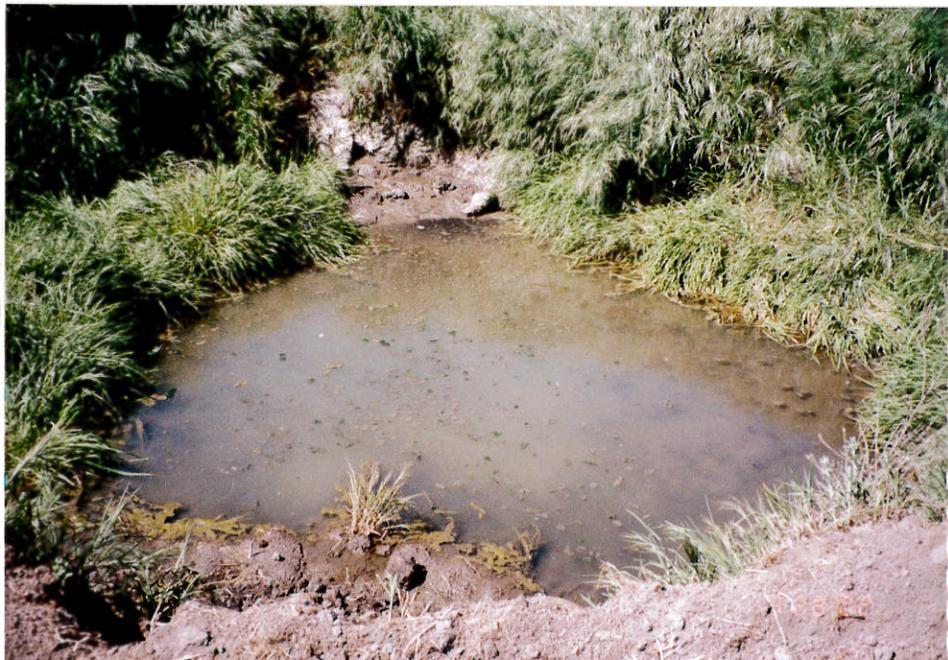
Photo 16: Water ponded in North lateral above the discharges. EC 4800  $\mu$ hmos,  $\text{NH}_3$  0.0119 mg/L

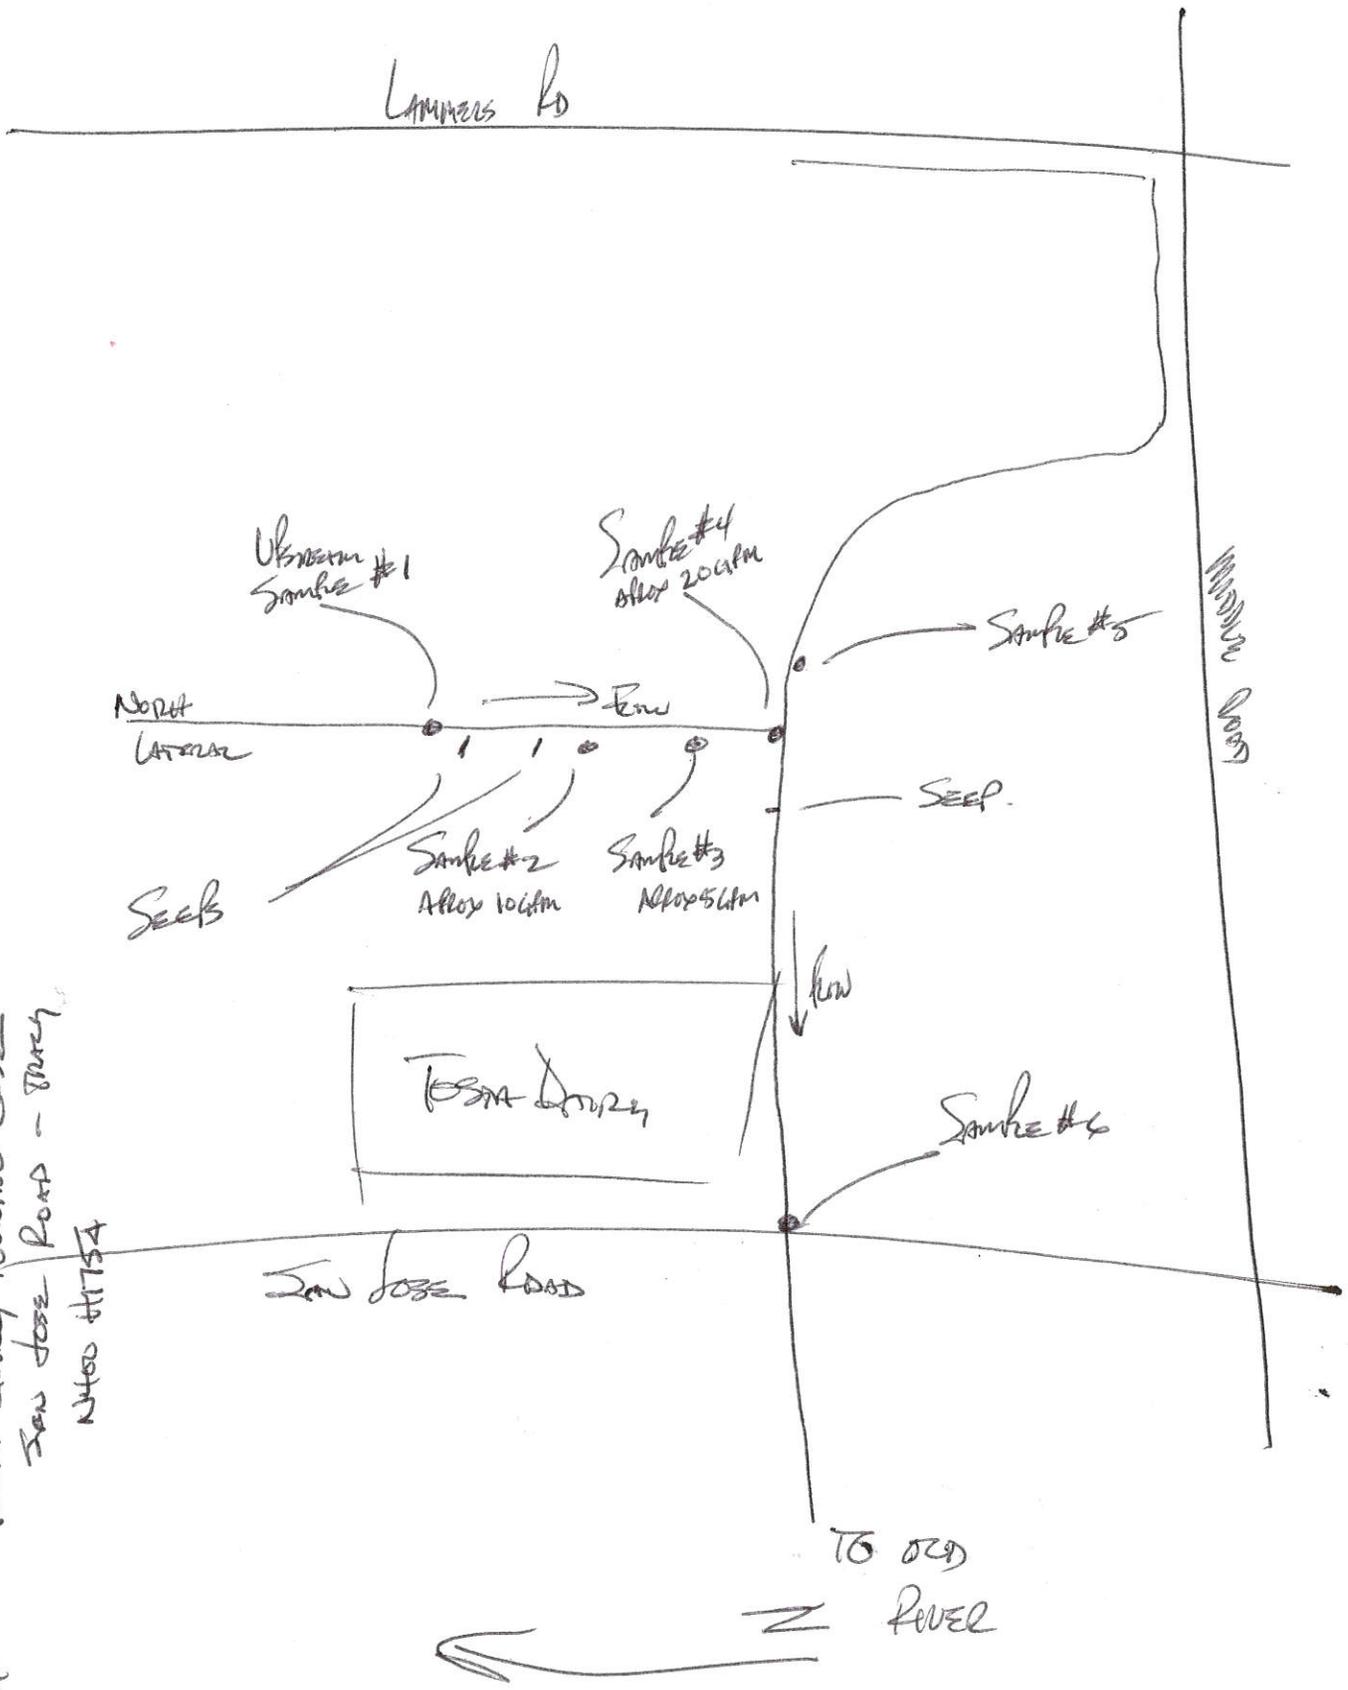
Figure 2  
Henry Tosta Dairy  
20662 S. San Jose Road  
Tracy, San Joaquin County

EC 3500

Waste  
Water  
Ponded

EC 5800

EC 4800

Manure from alley
