# CENTRAL VALLEY REGIONAL WATER QUALITY CONTROL BOARD

## INSPECTION REPORT

**LOCATION & COUNTY:** Henry Tosta Dairy  
20662 San Jose Road, Tracy  
San Joaquin County

**INSPECTION DATE:** 26 June 2013

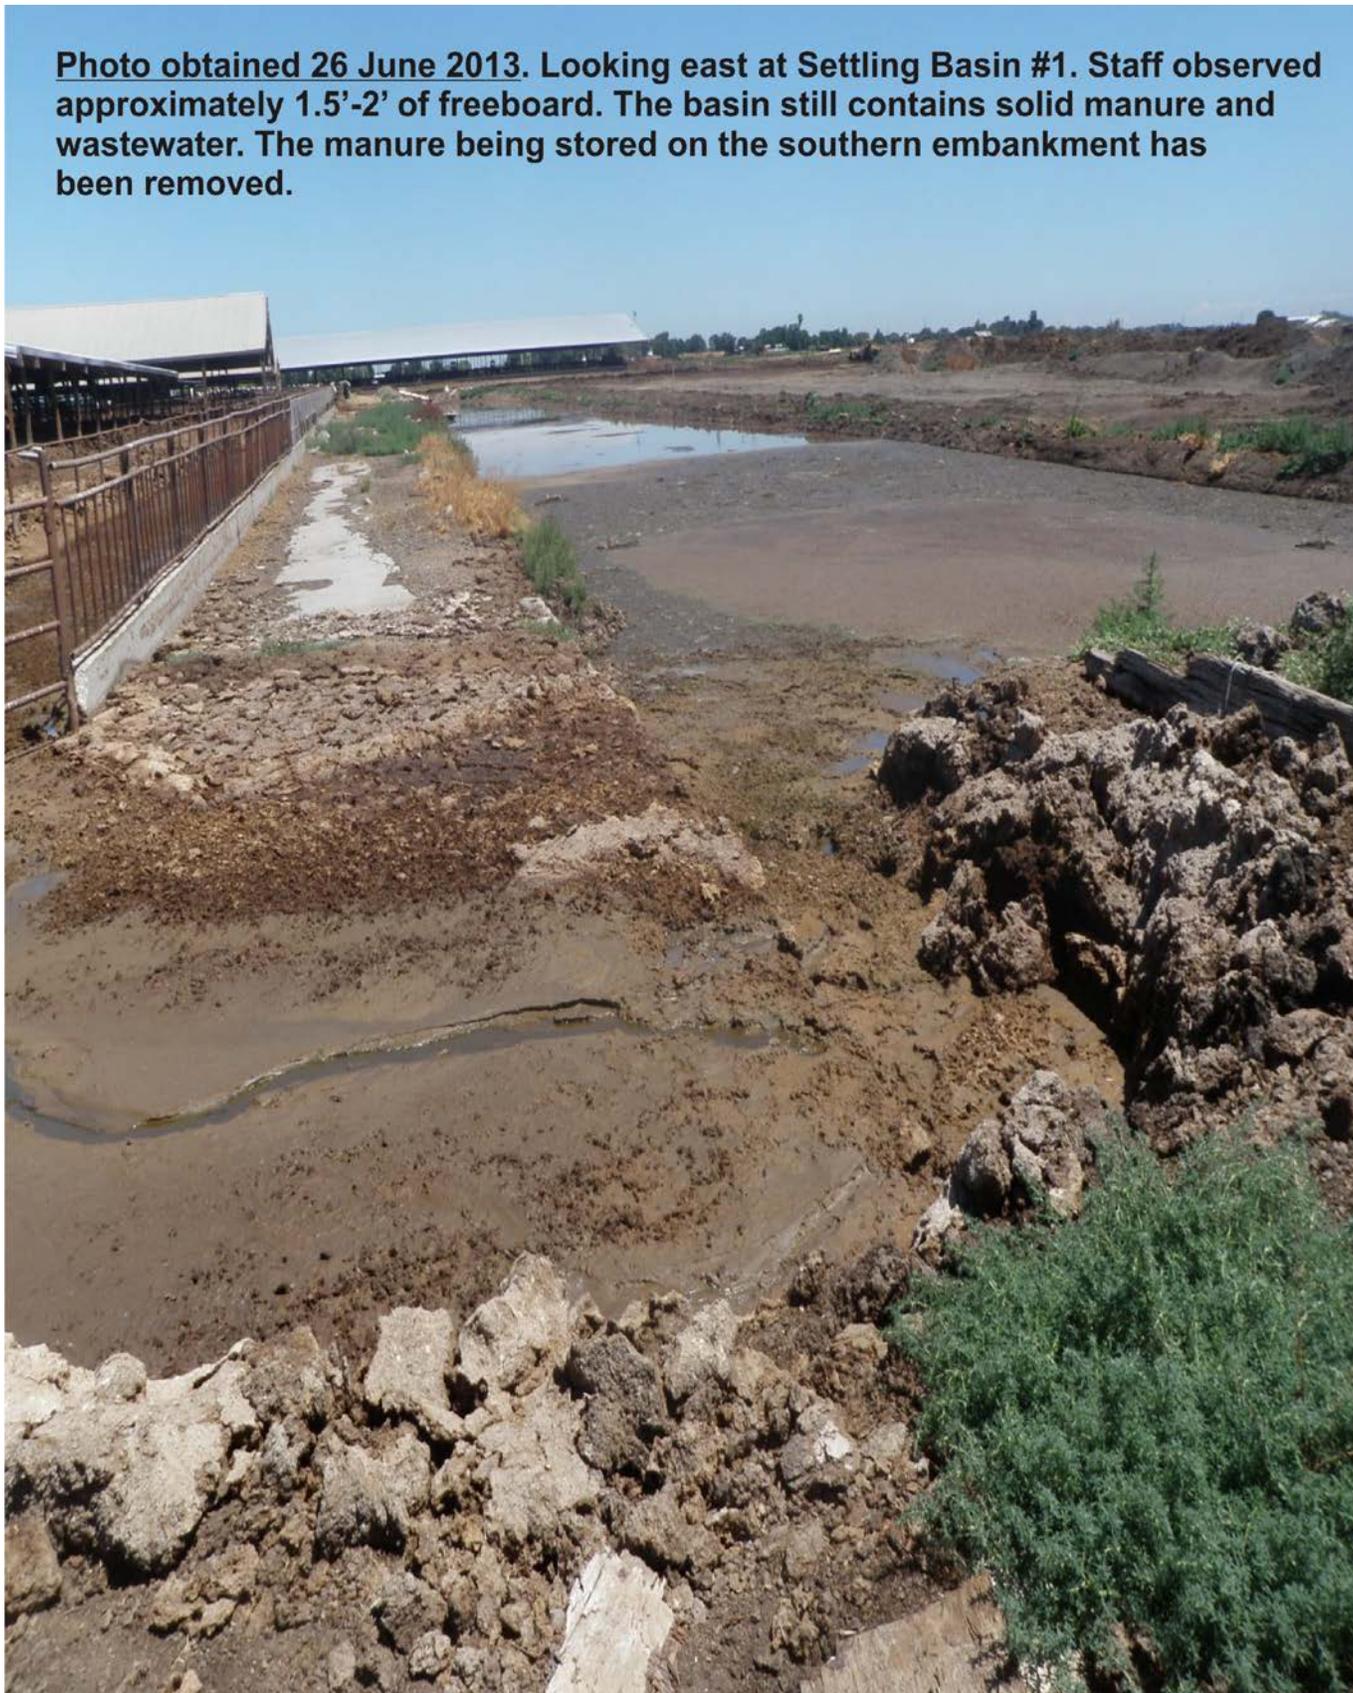
**Photo 1**

At the time of the inspection Settling Basin #1 had approximately 1.5'-2' freeboard. The basin still contains solid manure and wastewater. The manure being stored on the southern embankment has been removed. See Photo 1.

**Photo obtained 26 June 2013. Looking east at Settling Basin #1. Staff observed approximately 1.5'-2' of freeboard. The basin still contains solid manure and wastewater. The manure being stored on the southern embankment has been removed.**

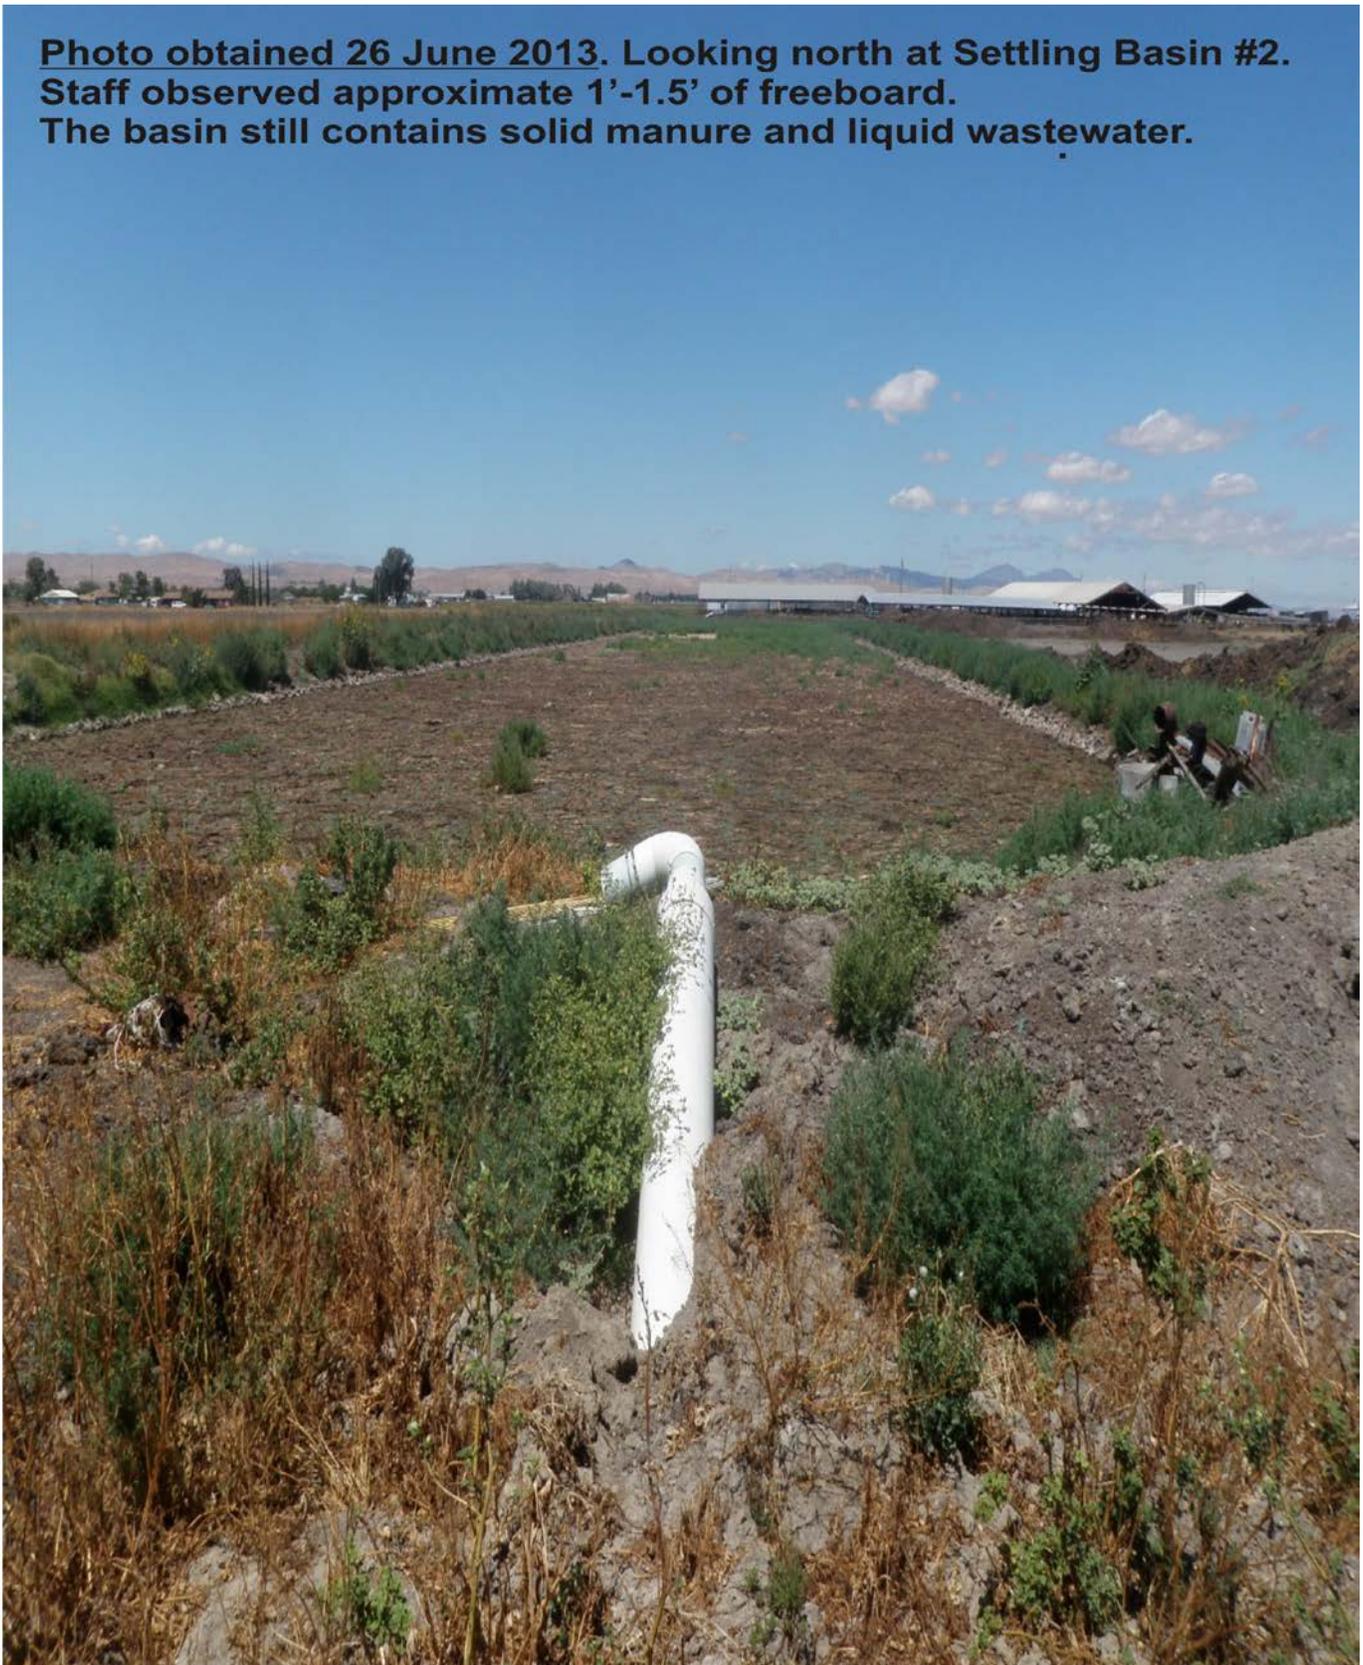
**Photo 2**

At the time of the inspection Settling Basin #2 had approximately 1.5'-2' freeboard. The basin still contains solid manure and wastewater. See Photo 2.

**Photo obtained 26 June 2013. Looking north at Settling Basin #2. Staff observed approximate 1'-1.5' of freeboard. The basin still contains solid manure and liquid wastewater.**

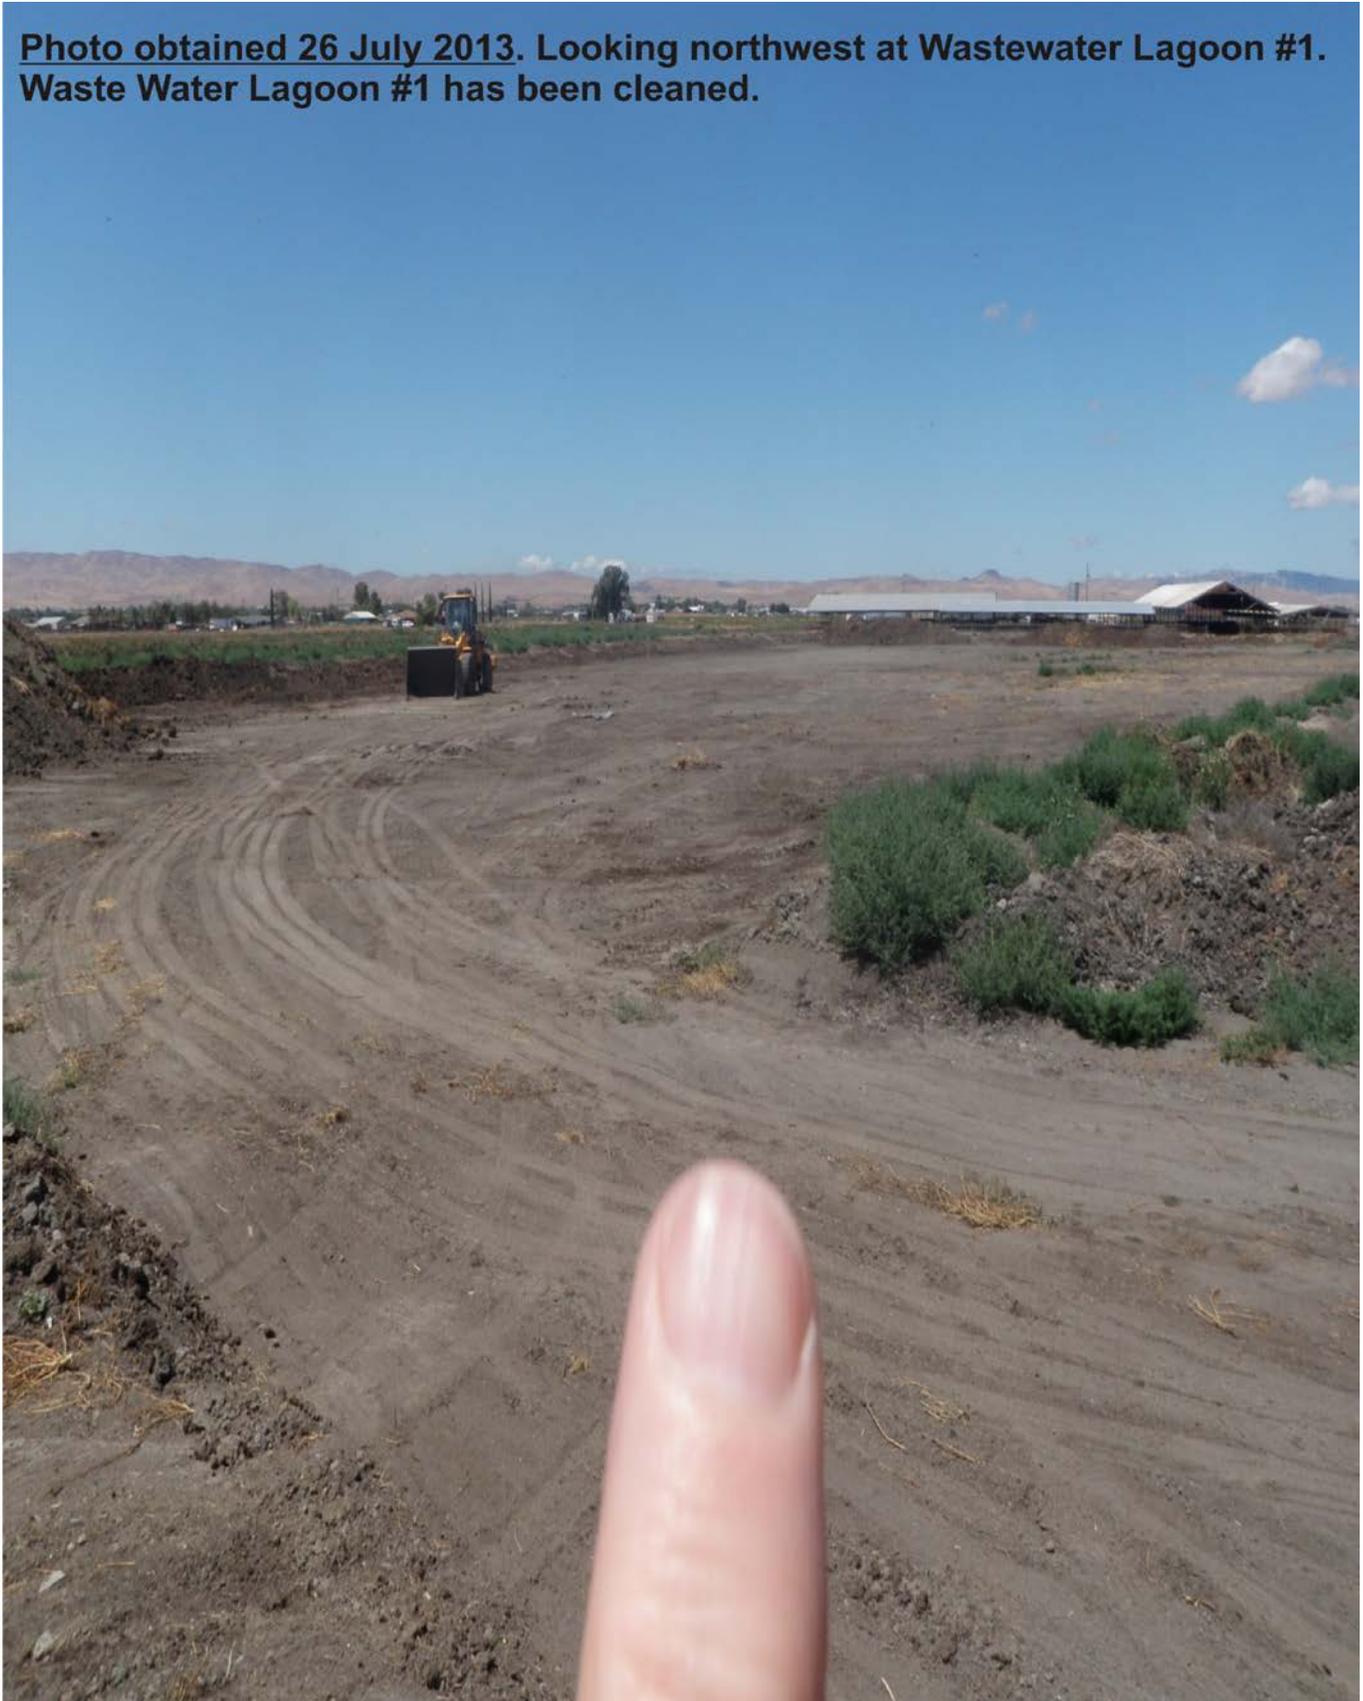
**Photo 3**

Wastewater Storage Lagoon #1 has been cleaned. See Photo 3.

**Photo obtained 26 July 2013. Looking northwest at Wastewater Lagoon #1. Waste Water Lagoon #1 has been cleaned.**

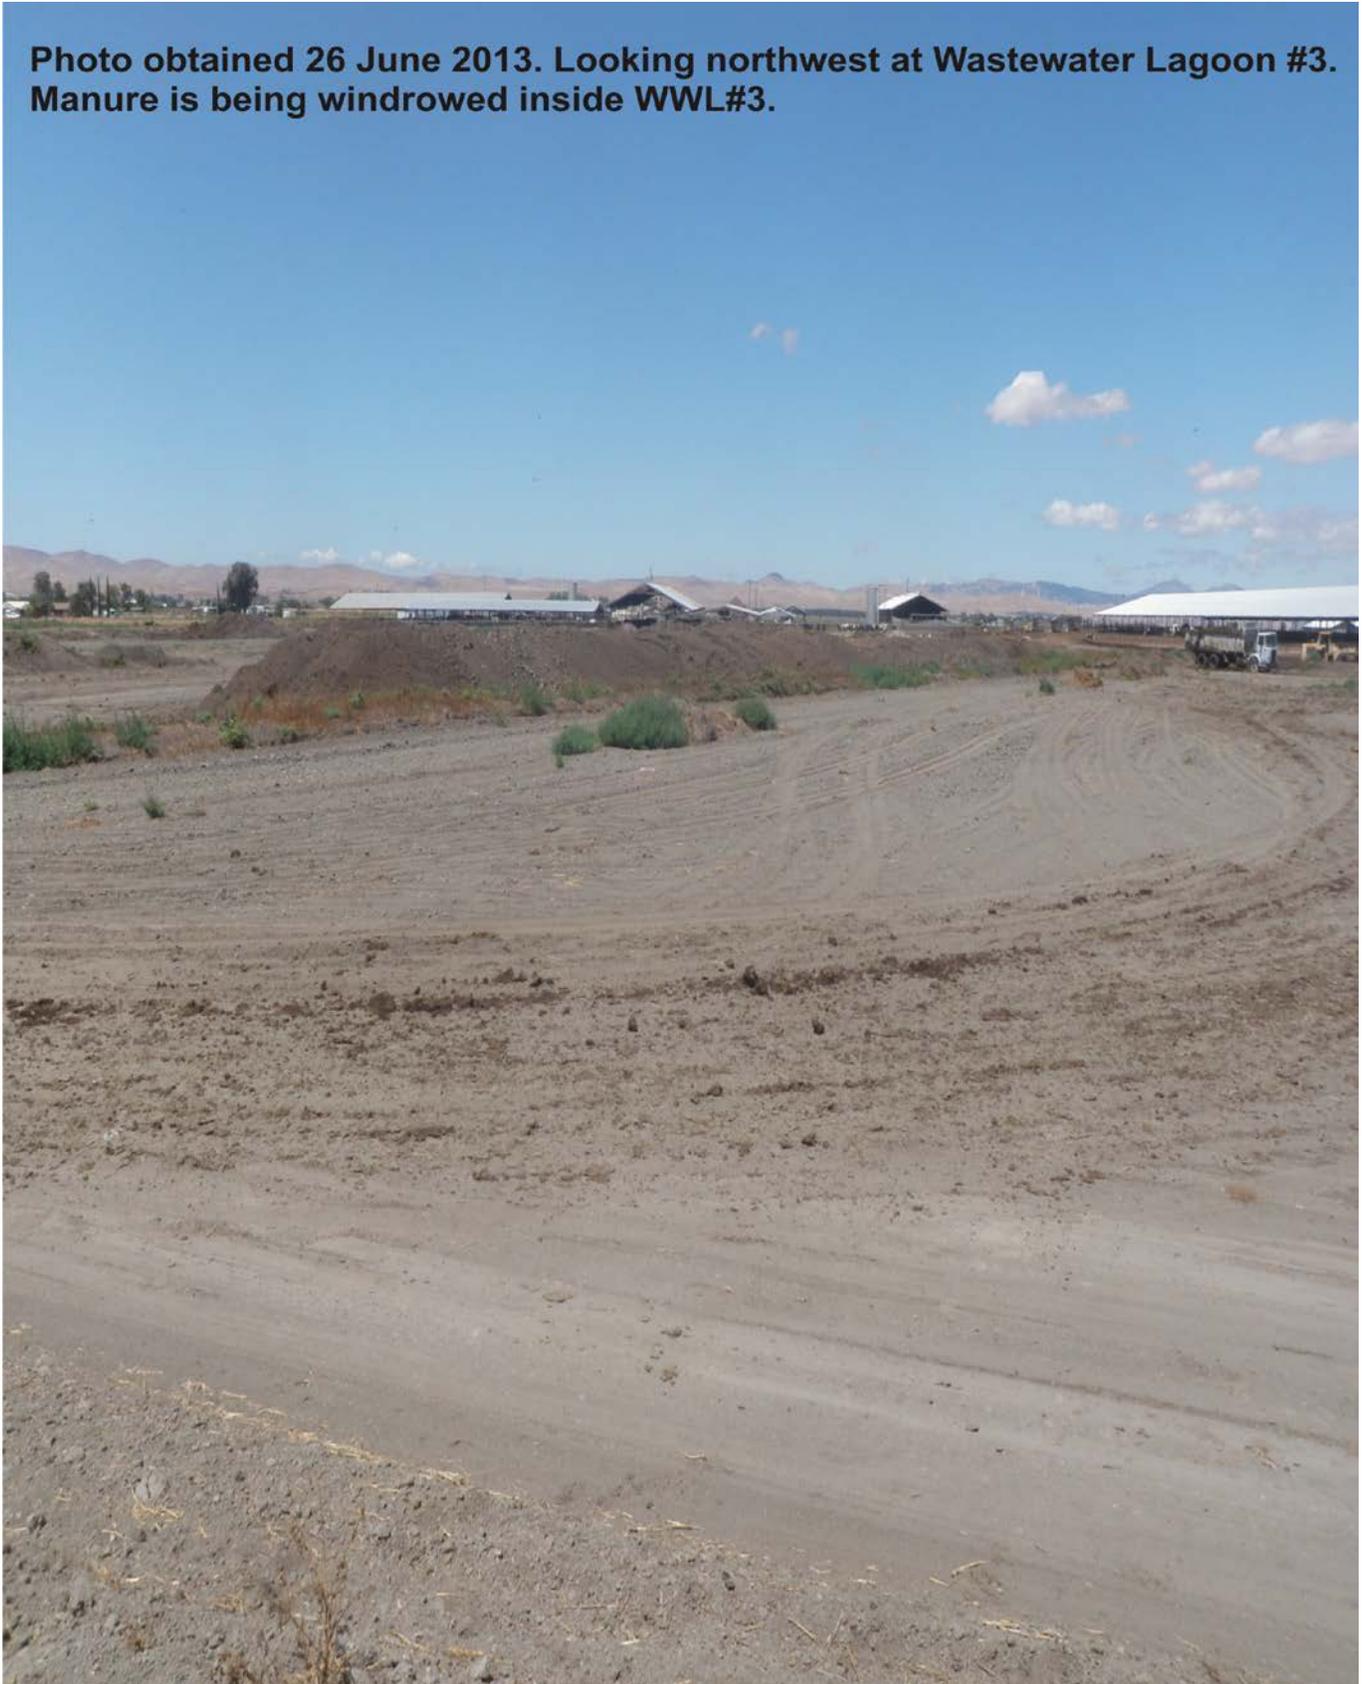
**Photo 4**

Wastewater Storage Lagoon #3 is being used to windrow (dry) manure. See Photo 4.

**Photo obtained 26 June 2013. Looking northwest at Wastewater Lagoon #3. Manure is being windrowed inside WWL#3.**

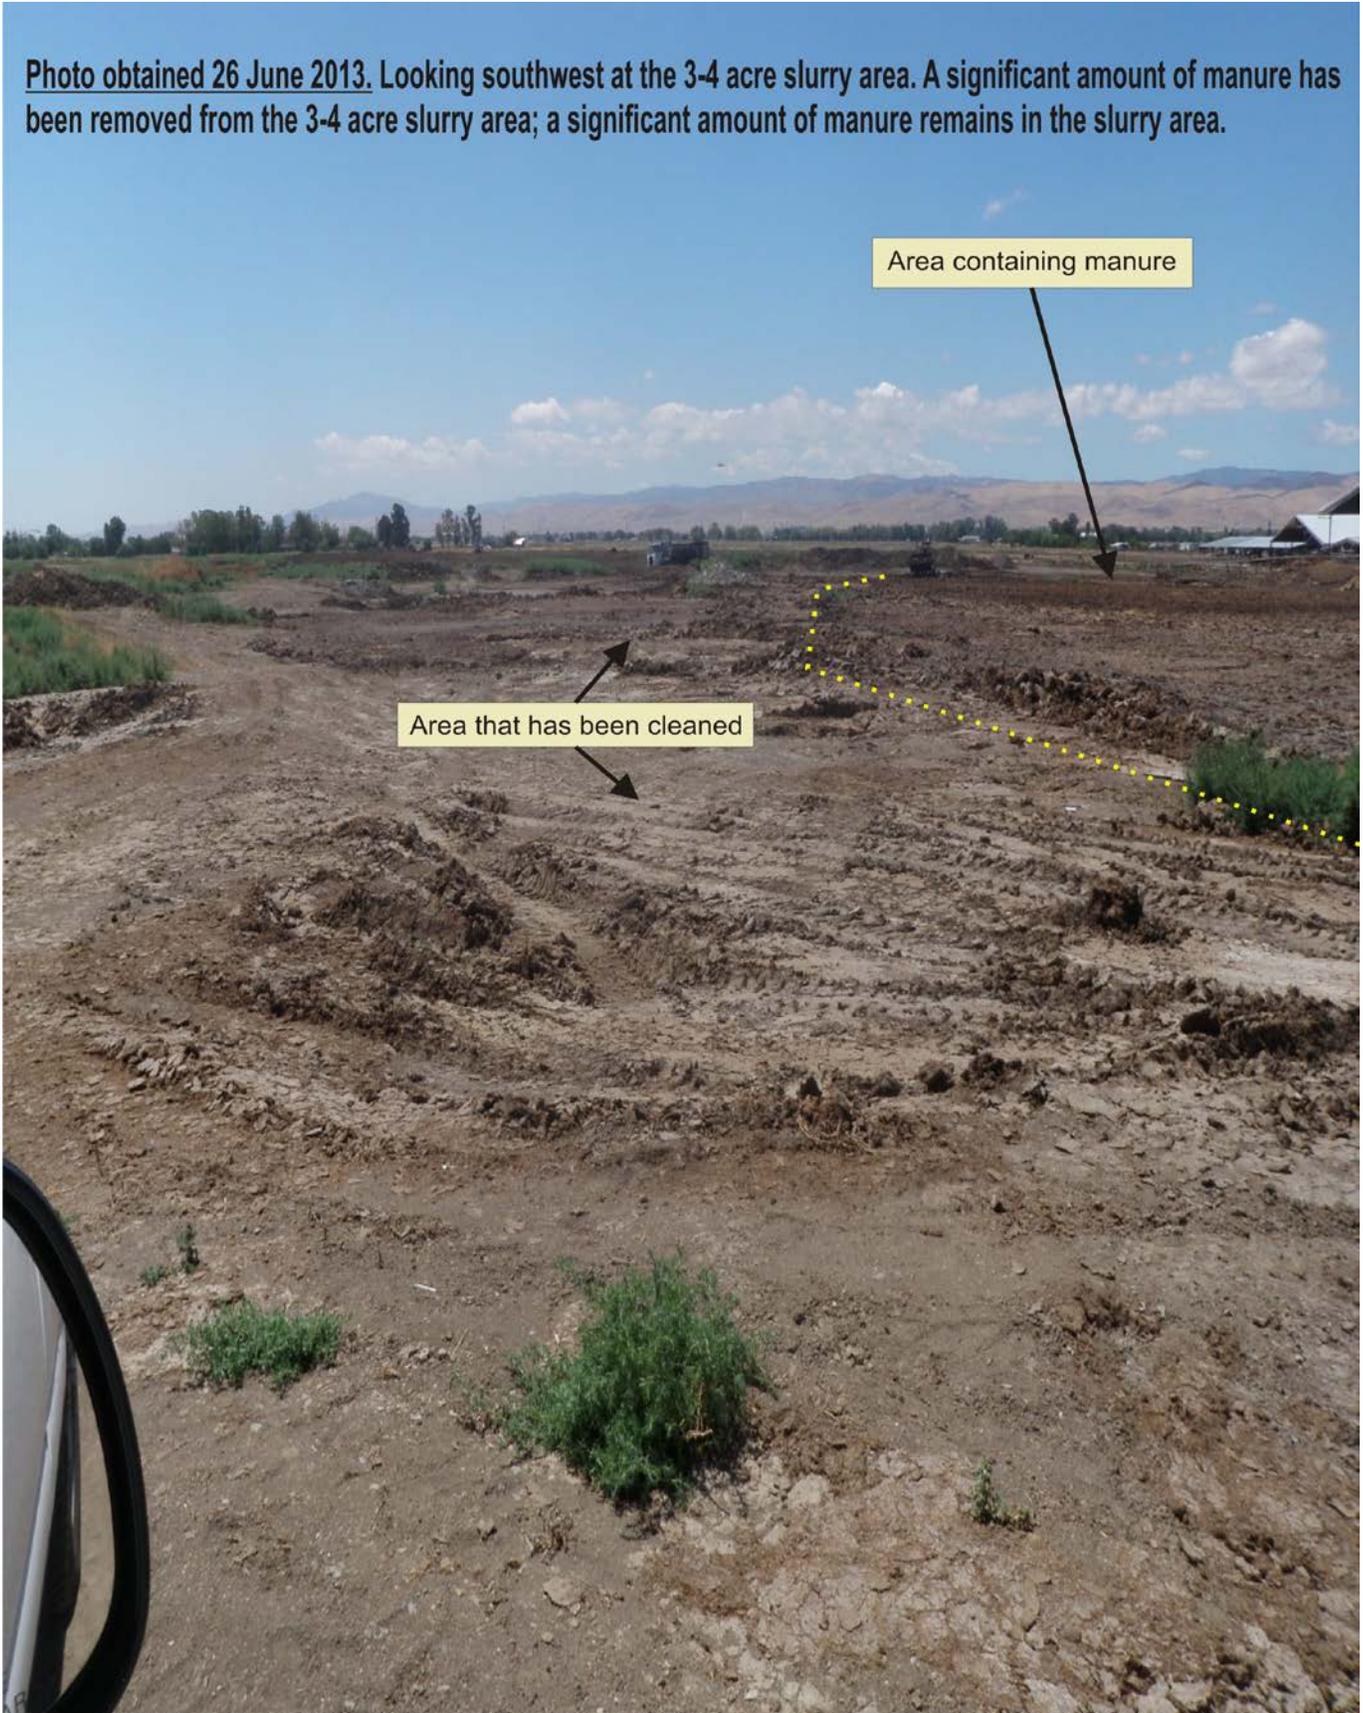
**Photo 5**

A significant amount of manure has been removed from the 3-4 acre slurry area; a significant amount of manure remains in the 3-4 acre slurry area. See Photo 5 and 6.

**Photo obtained 26 June 2013. Looking southwest at the 3-4 acre slurry area. A significant amount of manure has been removed from the 3-4 acre slurry area; a significant amount of manure remains in the slurry area.**

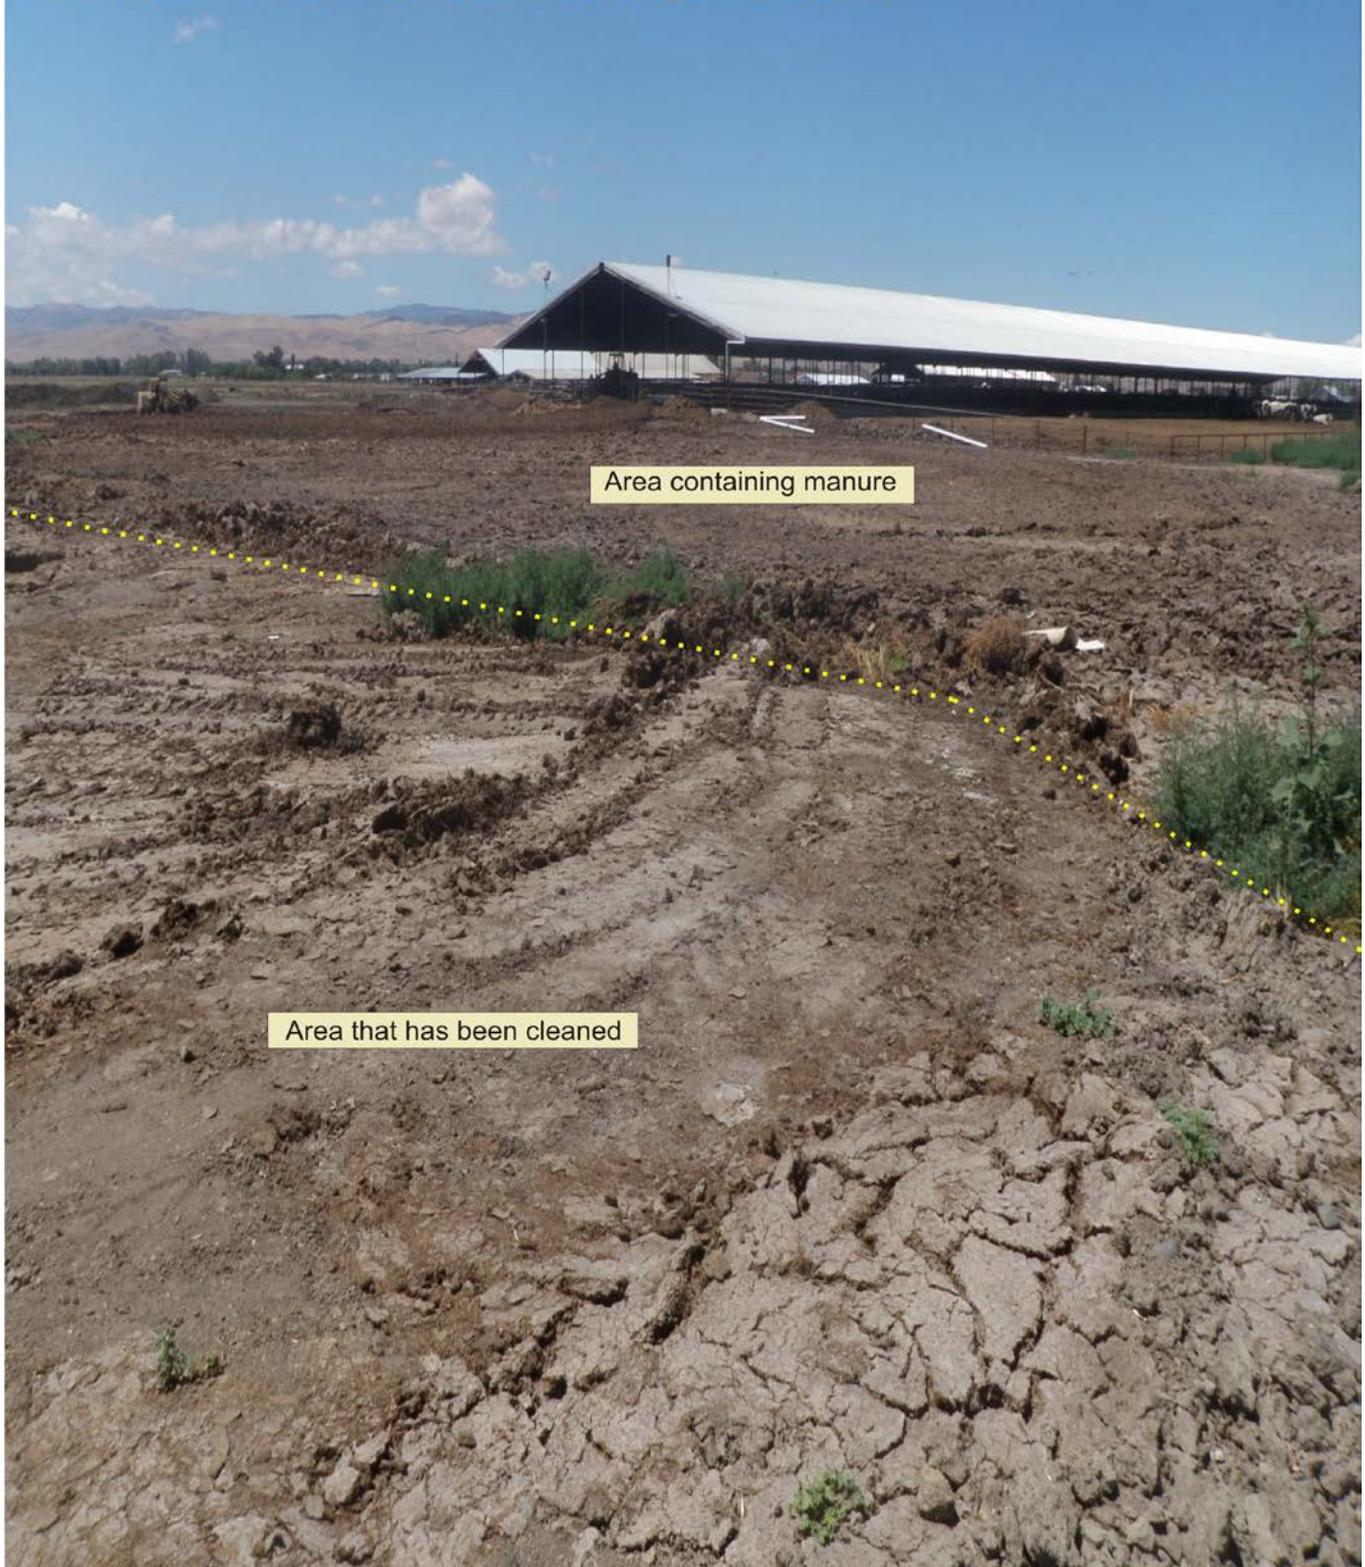
**Photo 6**

**Photo obtained 26 June 2013. Looking west at the 3-4 acre slurry area.  
Manure remains in the 3-4 acre area of native soil**

Area containing manure

Area that has been cleaned
