Central Valley Regional Water Quality Control Board

DATE: 4 November 2015

SUBJECT: Settling Pond Expansion, Morningstar Tomato Packing Plant,
Waste Discharge Requirements R5-2013-0144, Colusa County

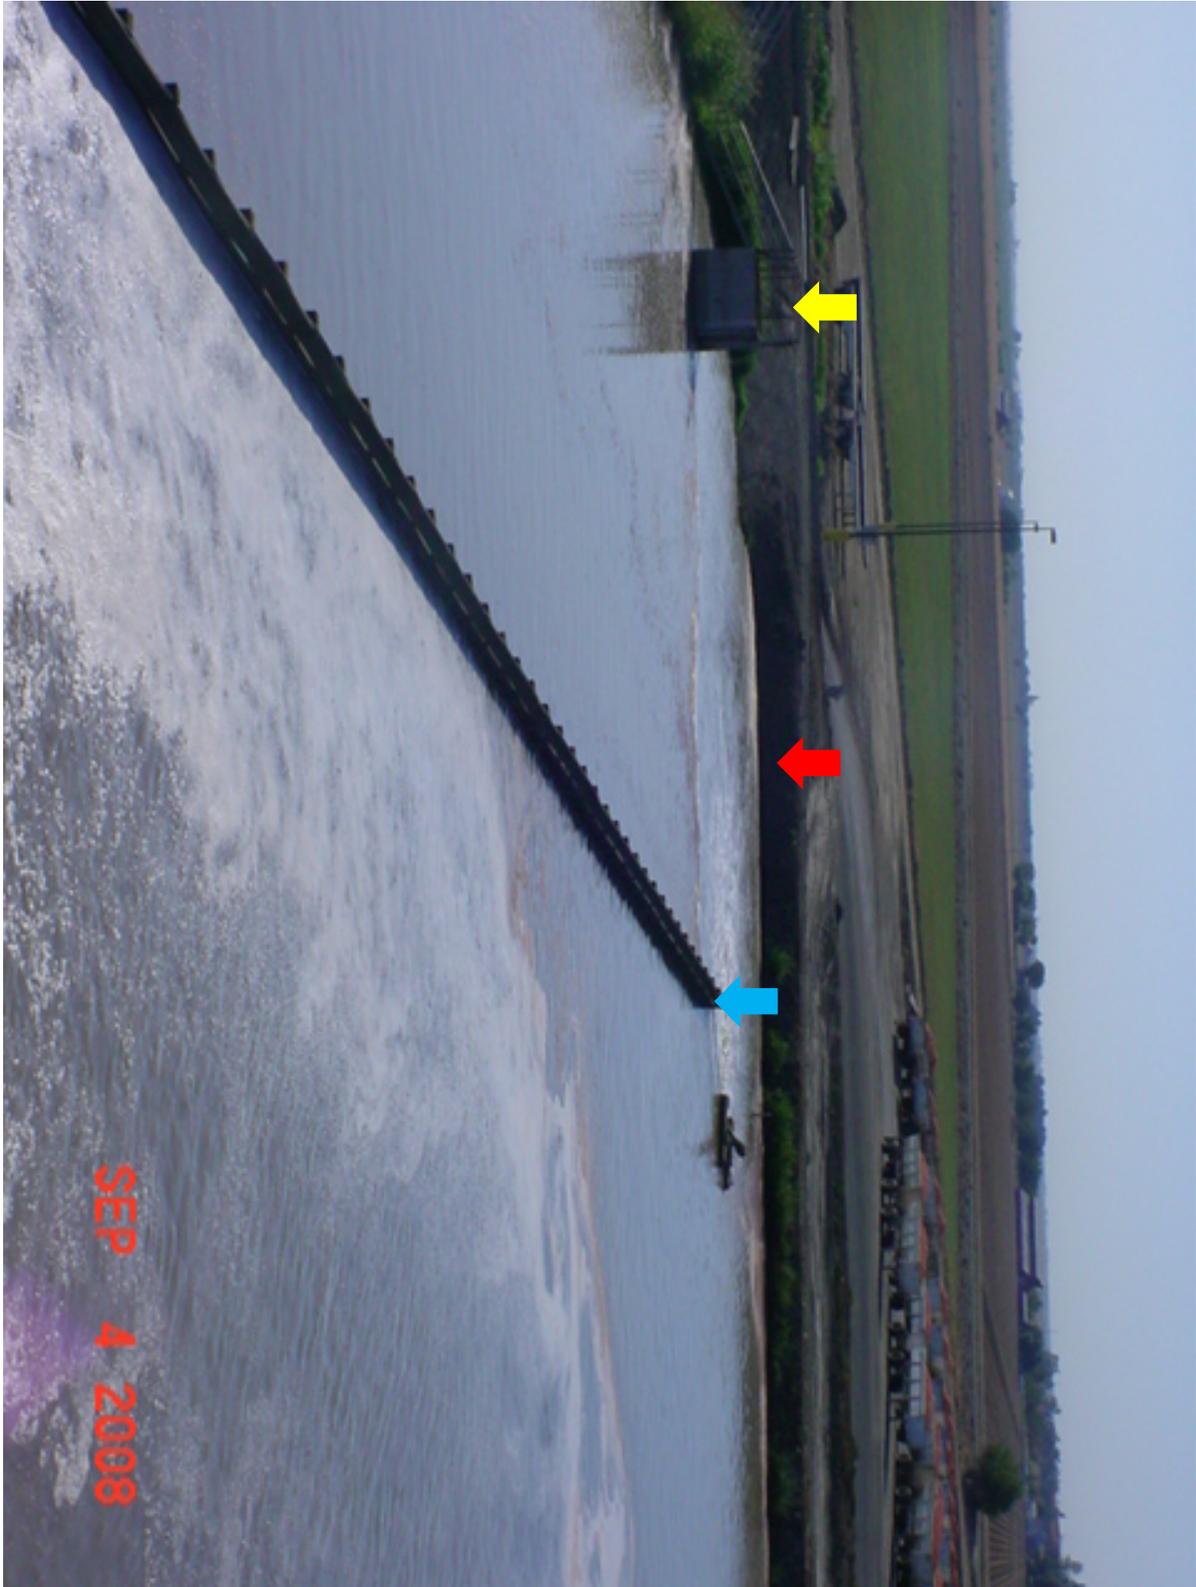
Photograph 1, 4 September 2008

Photograph 1

Staff's 4 September 2008 facility inspection⁴ photograph shows the Morningstar Tomato Packing Plant Settling Pond. This photograph clearly illustrates the relational distance between the terminus berm, the wastewater discharge point and how the pond's center divider essentially ends across from the discharge point.

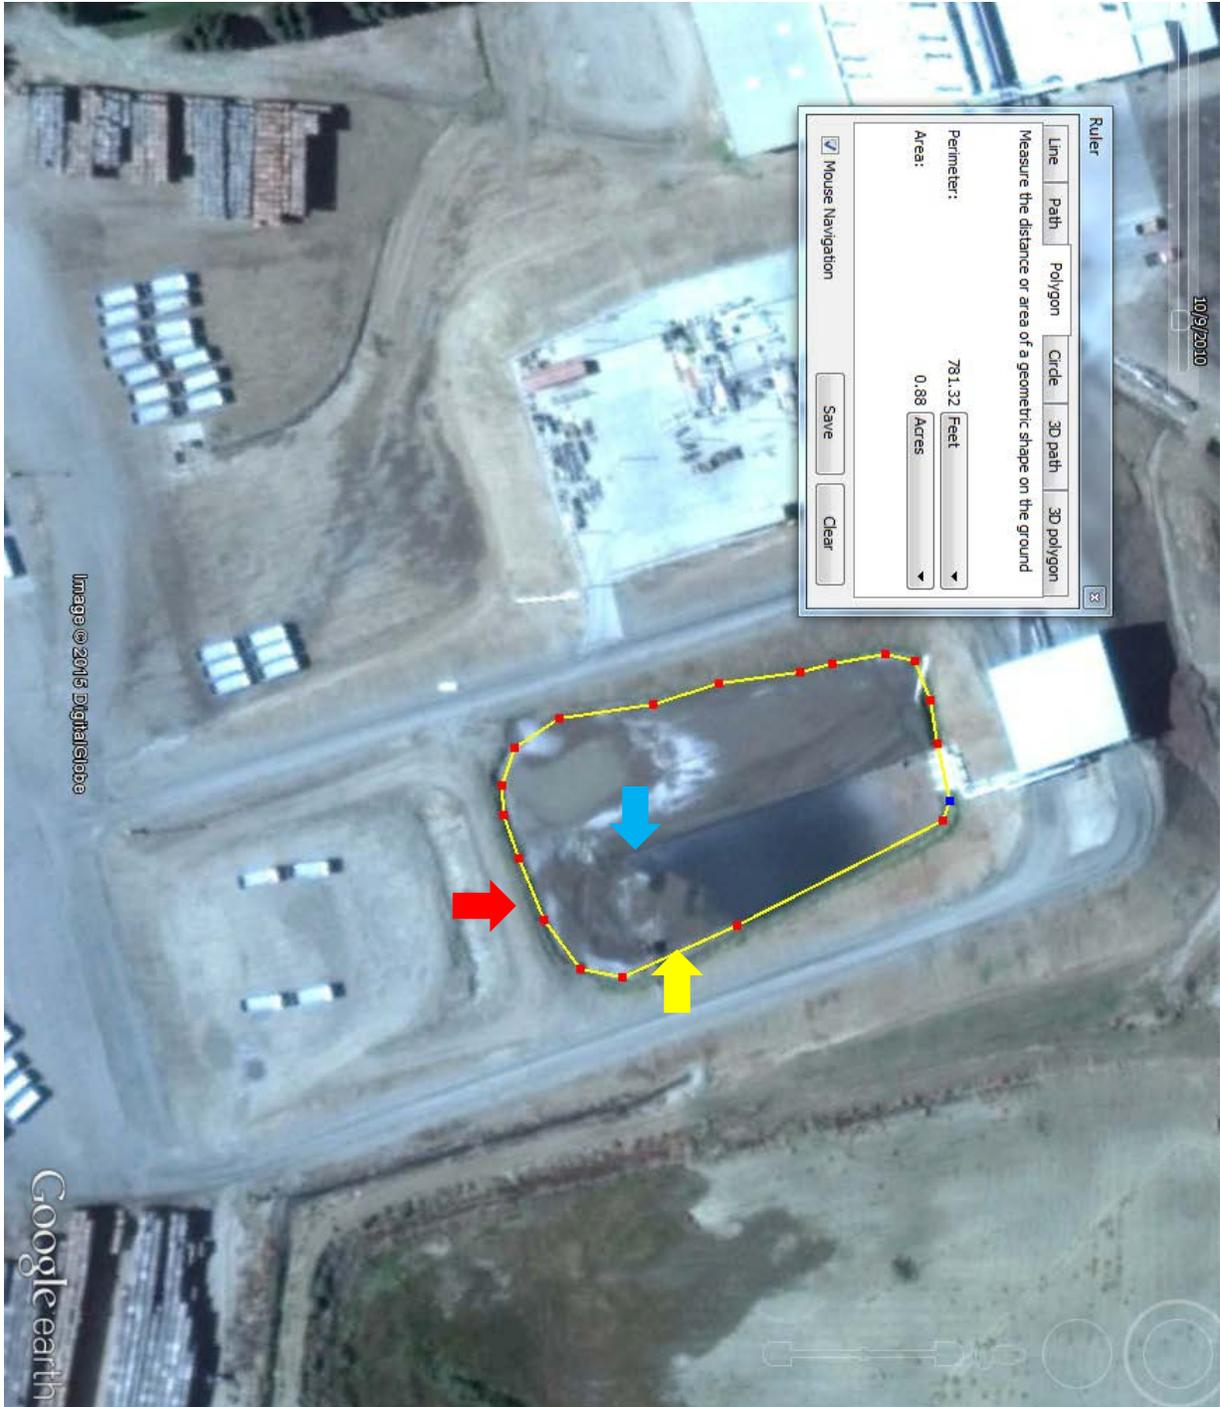
Photograph 2, 9 October 2009

Photograph 2

Google Earth is an electronic resource that Regional Board staff use to evaluate compliance with regulatory requirements. Specifically, it can provide a chronology of site activities, as well as calculate the area of a selected item. On 9 October 2009, a "satellite" photograph was taken of the Morningstar Tomato Packing Plant. As shown in the Google Earth photograph⁵, the settling pond appears to be consistent in size to the 40,000 square foot (approximately 1 acre) described in Morningstar's, 1995 Report of Waste Discharge.⁶ The text box in the photograph presents the approximate area of the pond on that day, which was 0.88 acre. North is at the top of the photograph. Note the large parking area beyond the pond's southern berm terminus.

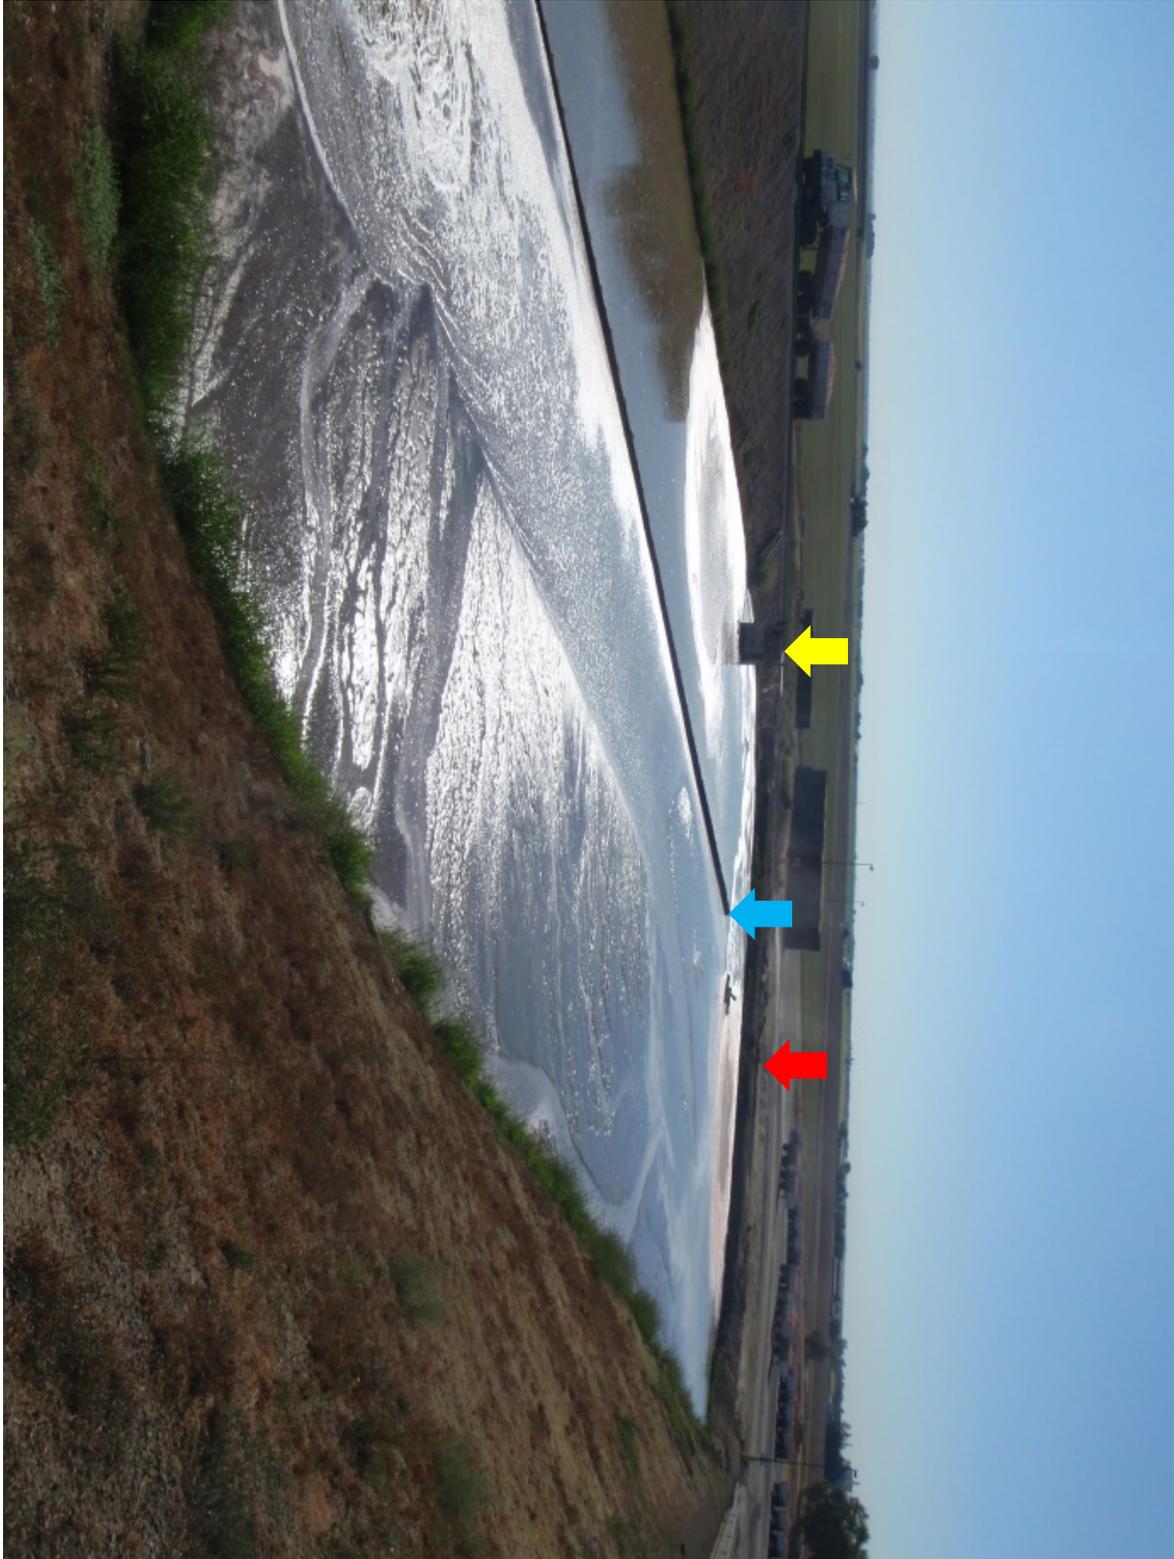
Photograph 3, 20 September 2011

Photograph 3

On 20 September 2011, staff conducted a site inspection and took this photograph looking south across the Settling Pond⁷. For consistency, it appears to be taken from a similar location as Photograph 1. There appears to be no change in the Settling Pond's geometry since the previous the 2008 inspection.

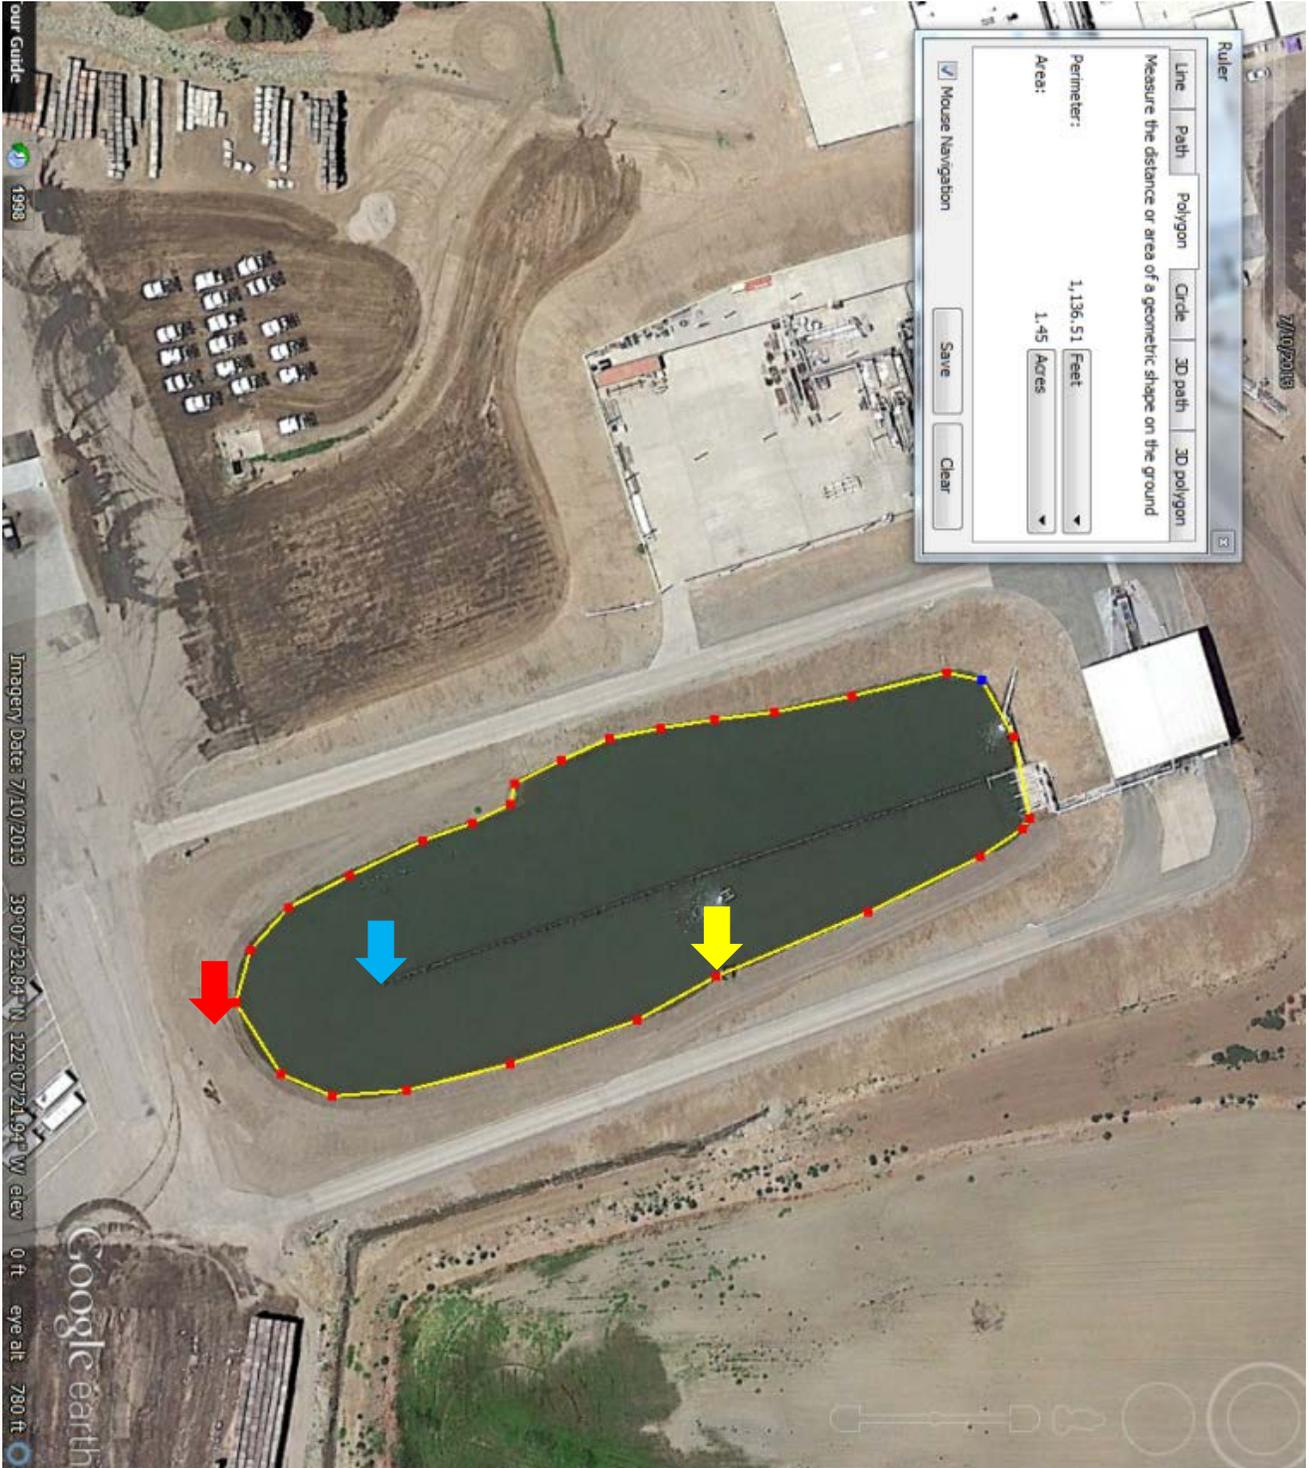
Photograph 4, 10 July 2013

Photograph 4

On 10 July 2013, approximately six-months prior to adoption of the current WDRs, Google Earth took another "satellite" picture of the settling pond at the Morningstar Tomato Packing Plant⁸. The pond in this photograph is much larger than previously shown in Google Earth's 2009 "satellite" picture and field verified by Regional Board staff on previous inspections. The parking area, which was evident in the 9 October 2009 Google Photograph, is no longer present. The pond here is estimated at 1.48 acres. For comparison with the 9 October 2009 picture, note the increase in distance between the end of the pond's central divider (the blue arrow), as well as the pond terminus (the red arrow).

The WDRs were issued with specific site conditions that must be maintained. Findings 12 and 13 of the WDRs no longer describe accurately the site conditions. Therefore, a 13267 Order should be issued to retain information to accurately verify the current dimensions and capacity of the pond, for compliance verification with the 2013 WDRs.

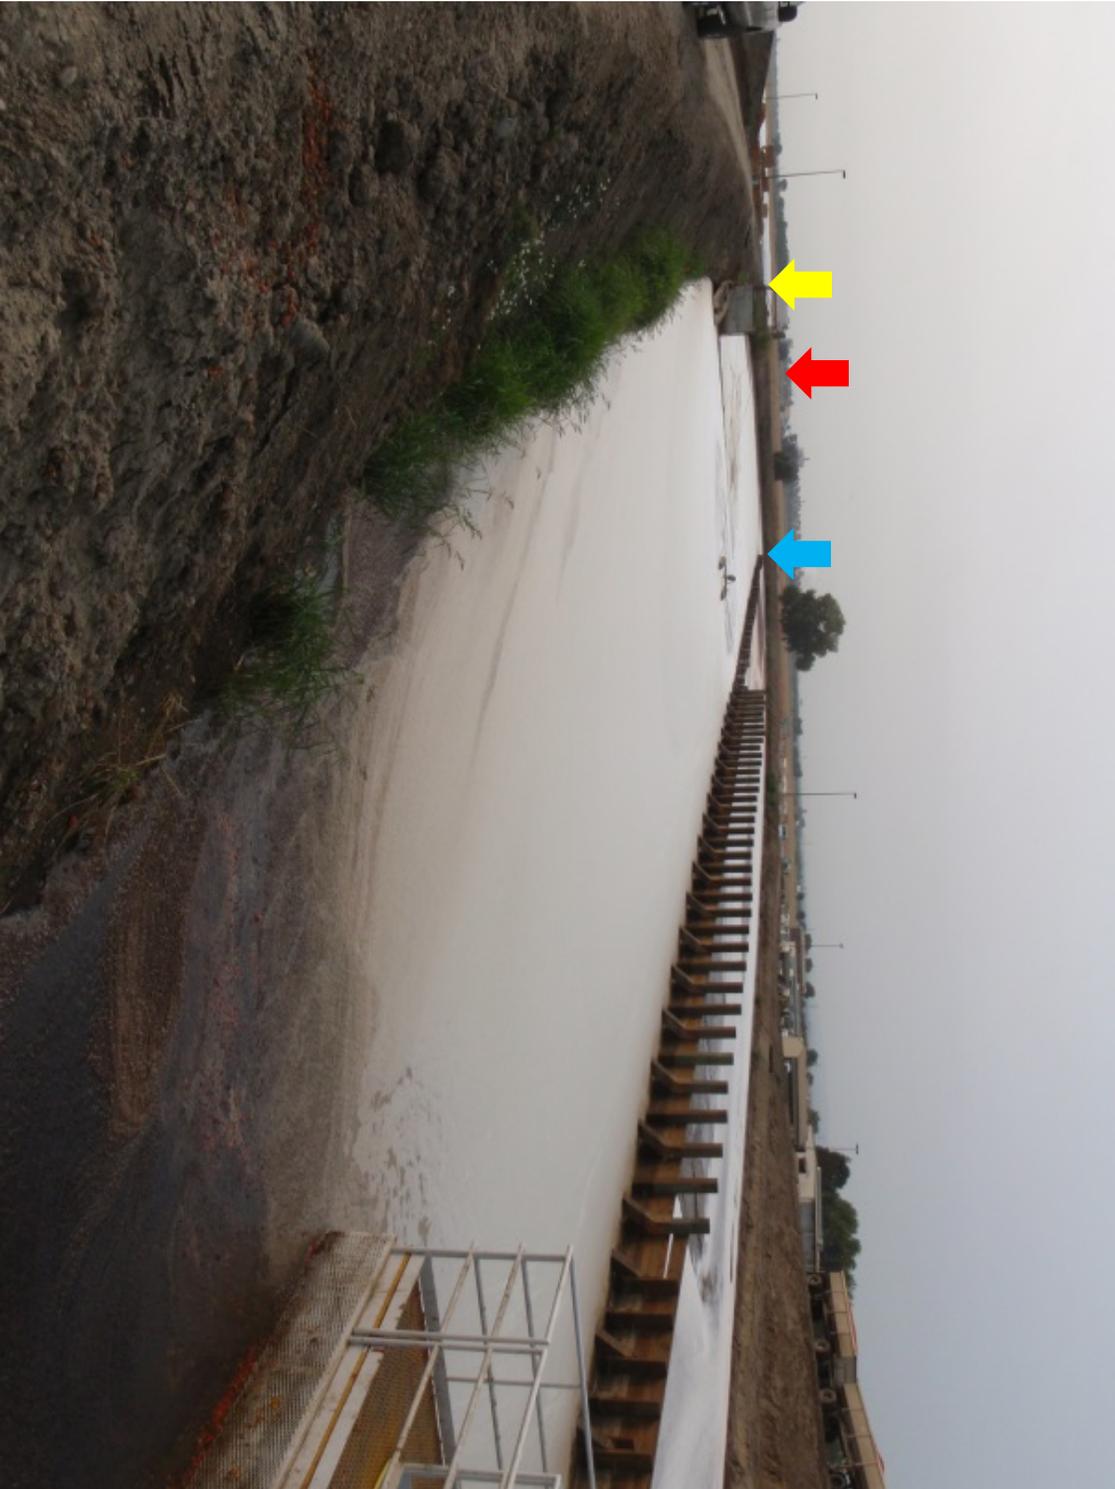
Photograph 4, 20 August 2015

Photograph 5

On 20 August 2015⁹, staff conducted another site inspection of the facility. The photograph was taken from the opposite side of the pond from where Photographs 1 and 3 were taken. This photograph provides field confirmation that the pond dimensions have enlarged.
