Re: ESJWQC removal of rotating Assessment Monitoring location in Zone 4

DATE: October 16, 2013
TO: Jelena Hartman
FROM: Michael Johnson
SUBJECT: Follow up to ESJWQC Jones/Silva Drain Request Letter
ATTACHMENTS: None

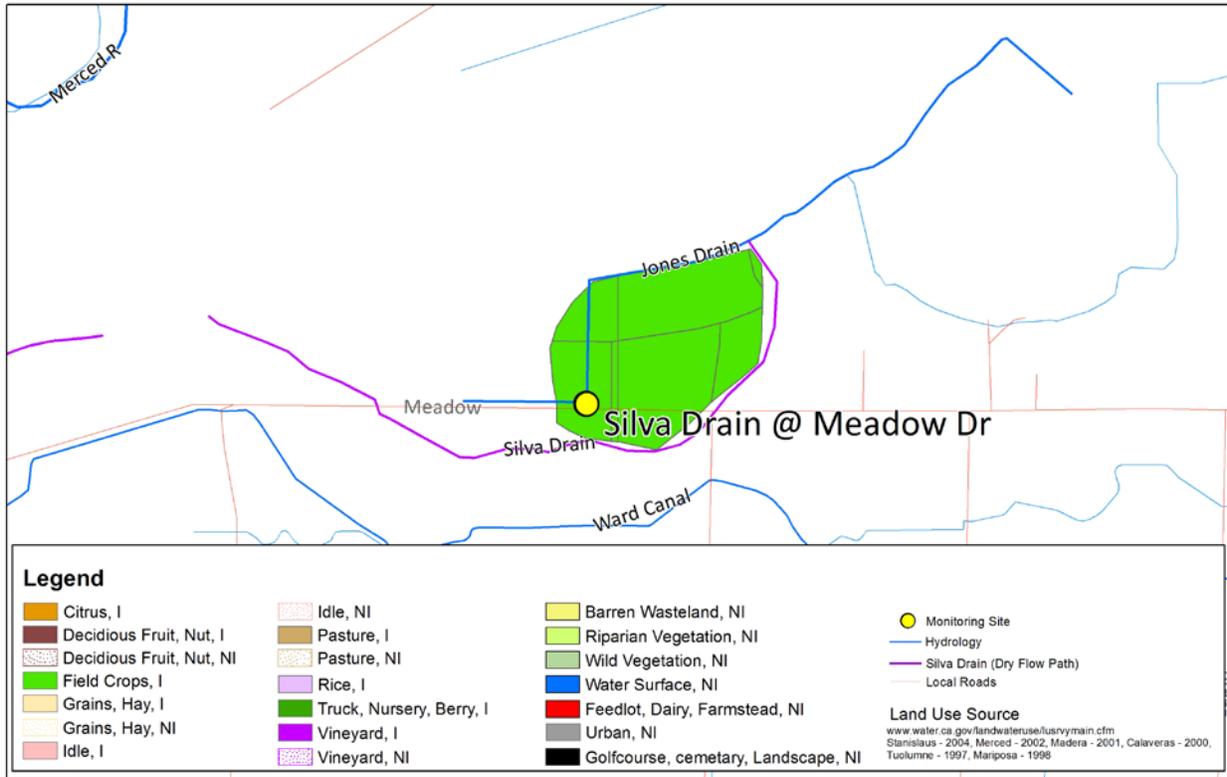
Figure 1. Site subwatershed map of land use for Silva Drain @ Meadow Dr.

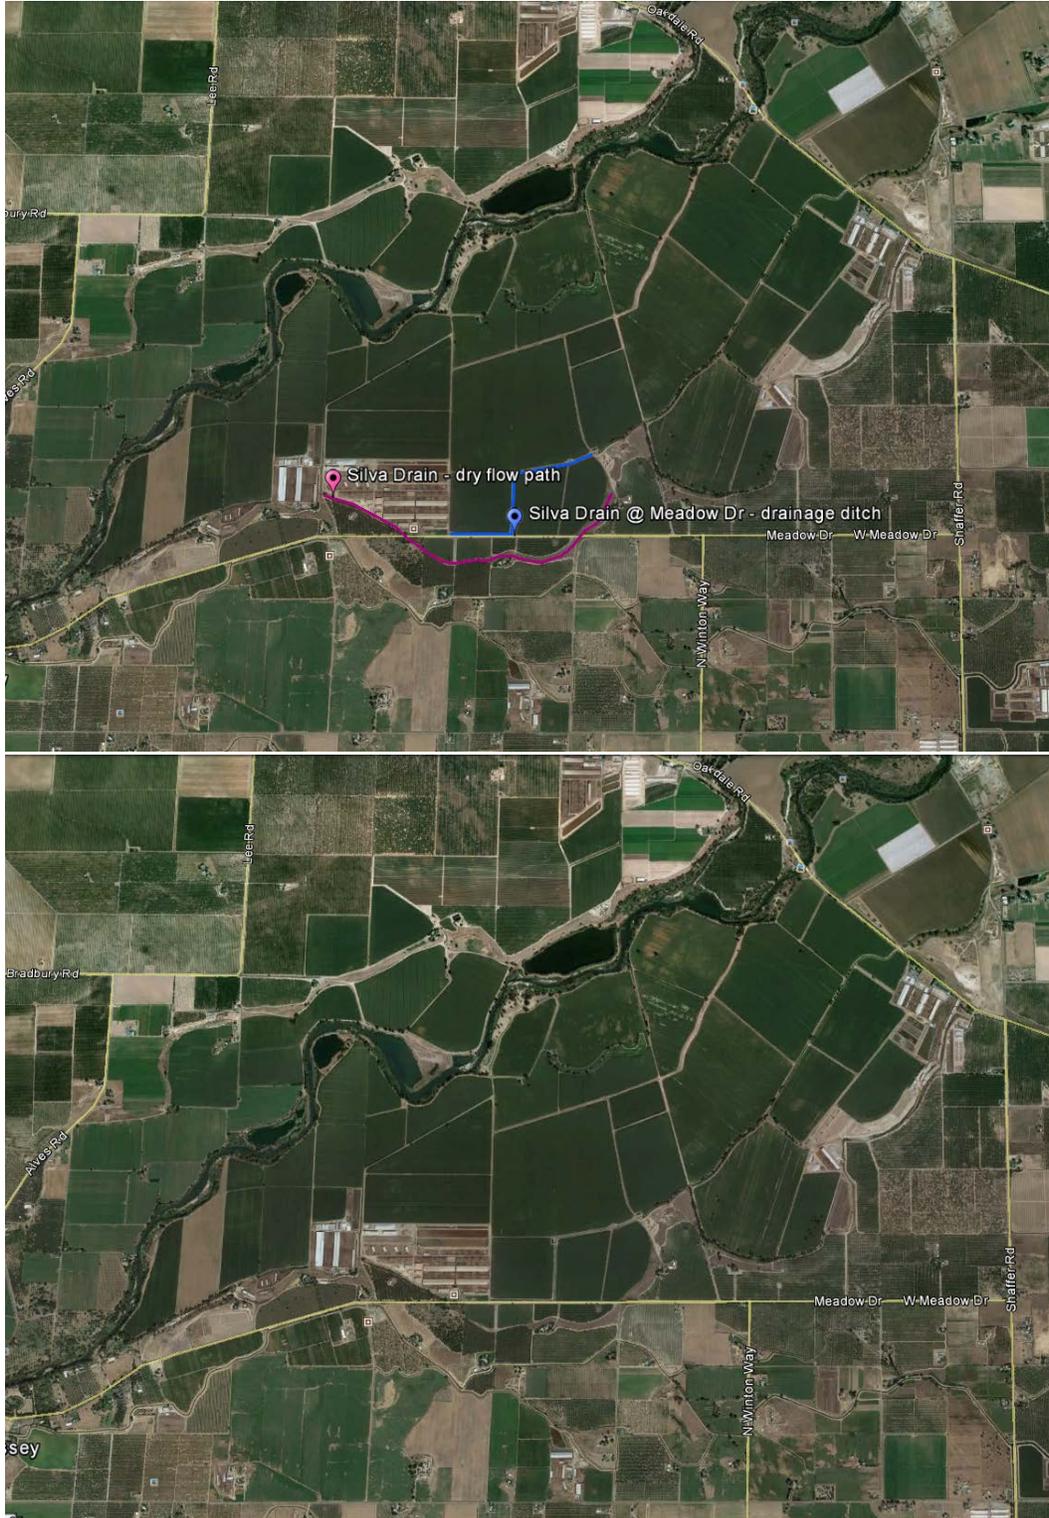
Figure 2. Satellite view of monitoring area with and without highlighted flow paths of the drainage ditch and dry Silva Drain.

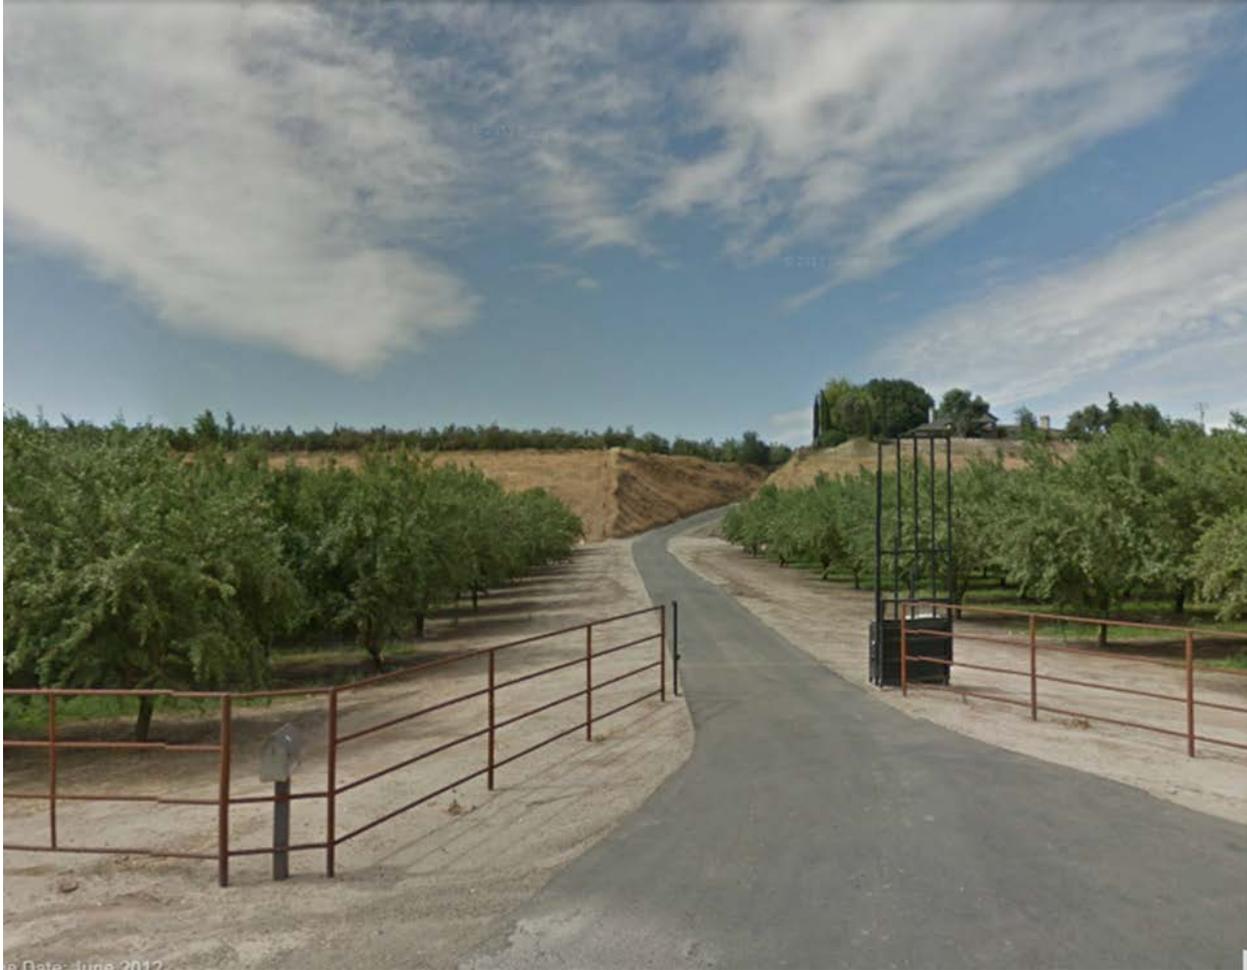
road and aerial maps indicate there is no waterbody present for monitoring in that area (Figure 3). Reviewing aerial photographs indicates that Silva Drain has been eliminated entirely and is now farmed land.

Figure 3. Large embankment/hillside where Silva Drain is indicated in the GIS map.

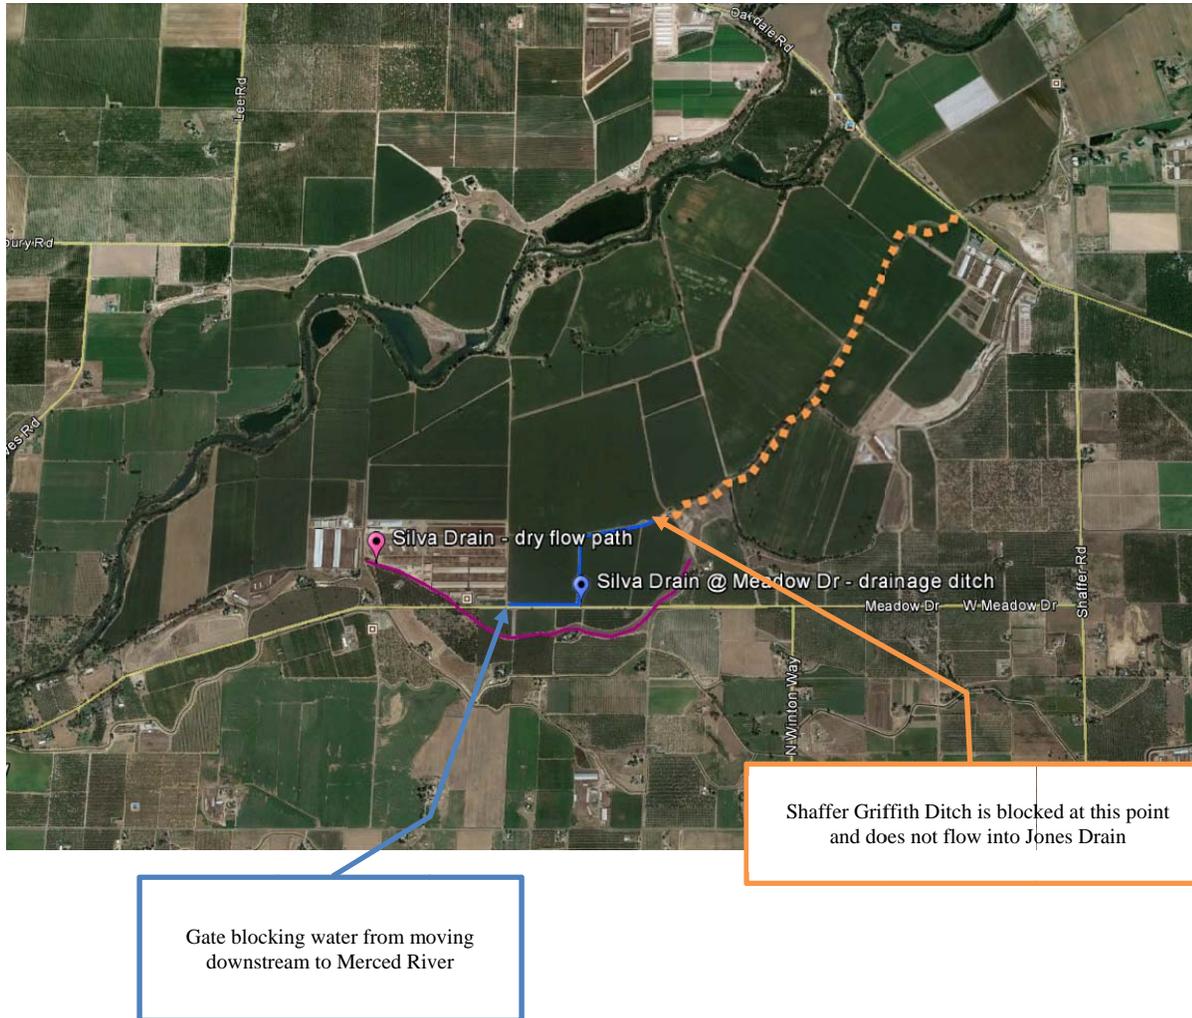
Figure 1. The below image is from the letter to the Regional Board on June 4, 2013 and indicates the flow path of the water body sampled by the Coalition and mislabeled as Silva Drain @ Meadow Rd (blue line). Silva Drain (pink line) no longer exists.

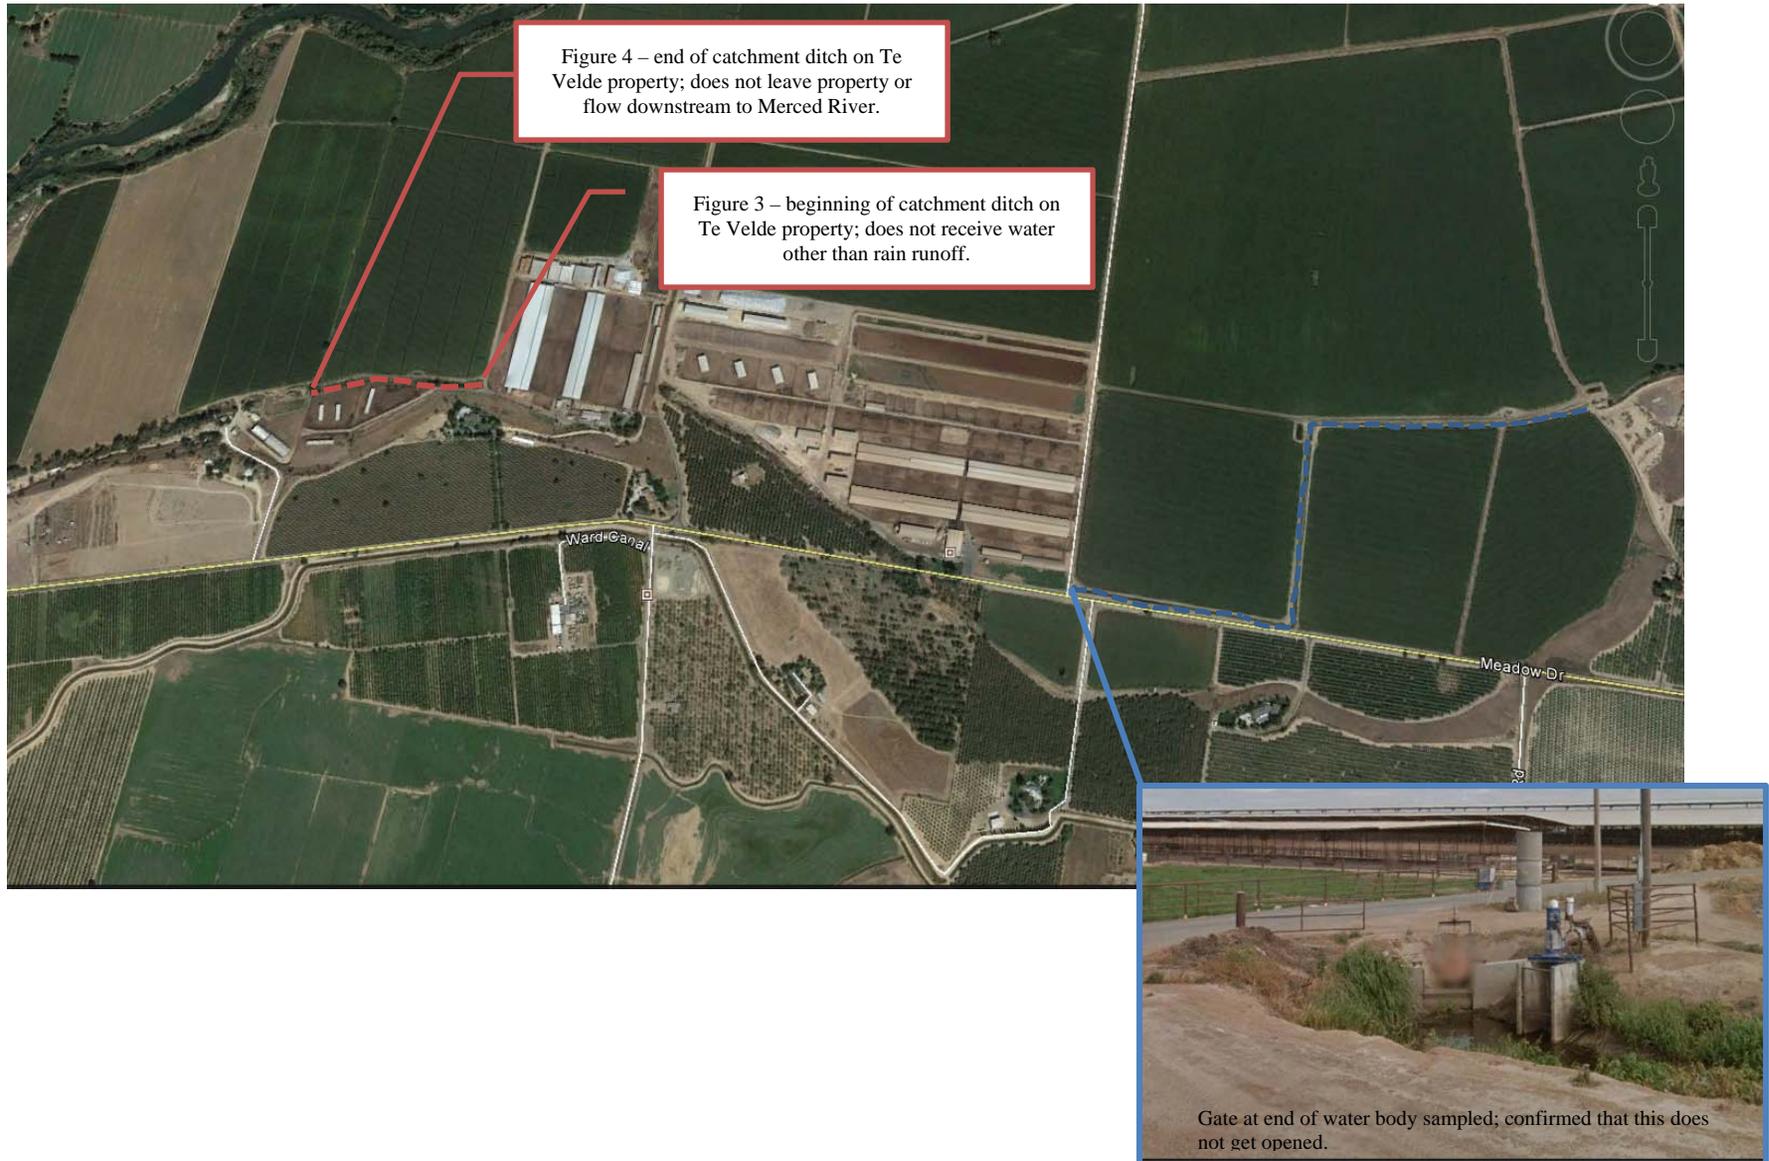
Figure 2. Close up of area toured with two ESJWQC members.

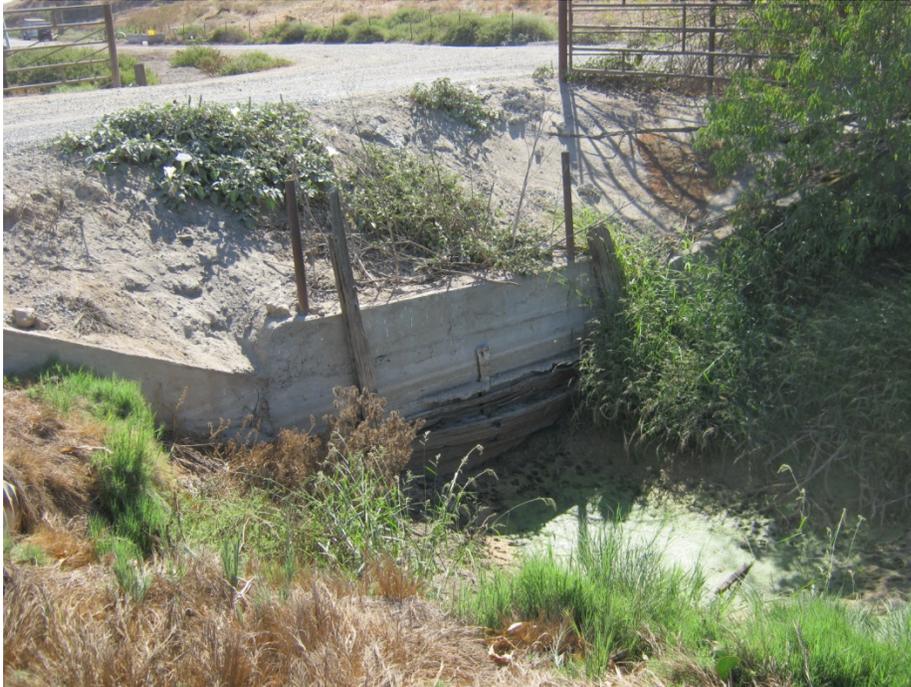
Figure 3. Eastern end of Te Velde catchment area. Catchment area only receives runoff water during rain events.

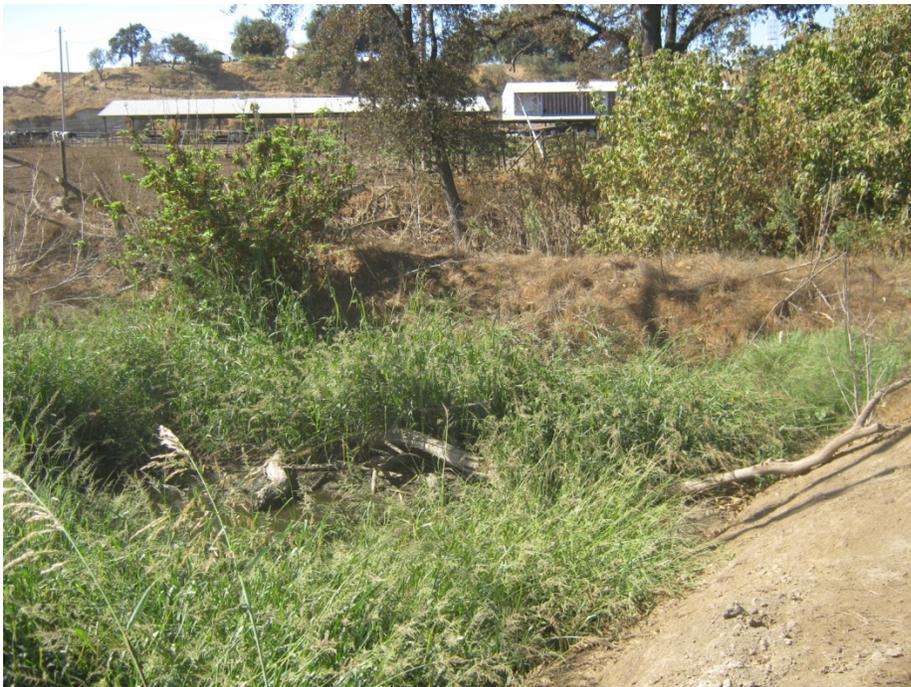
Figure 4. Photo facing west; depicts end of catchment area of Te Velde dairy. Water in catchment does not leave the property or flow into the Merced River.

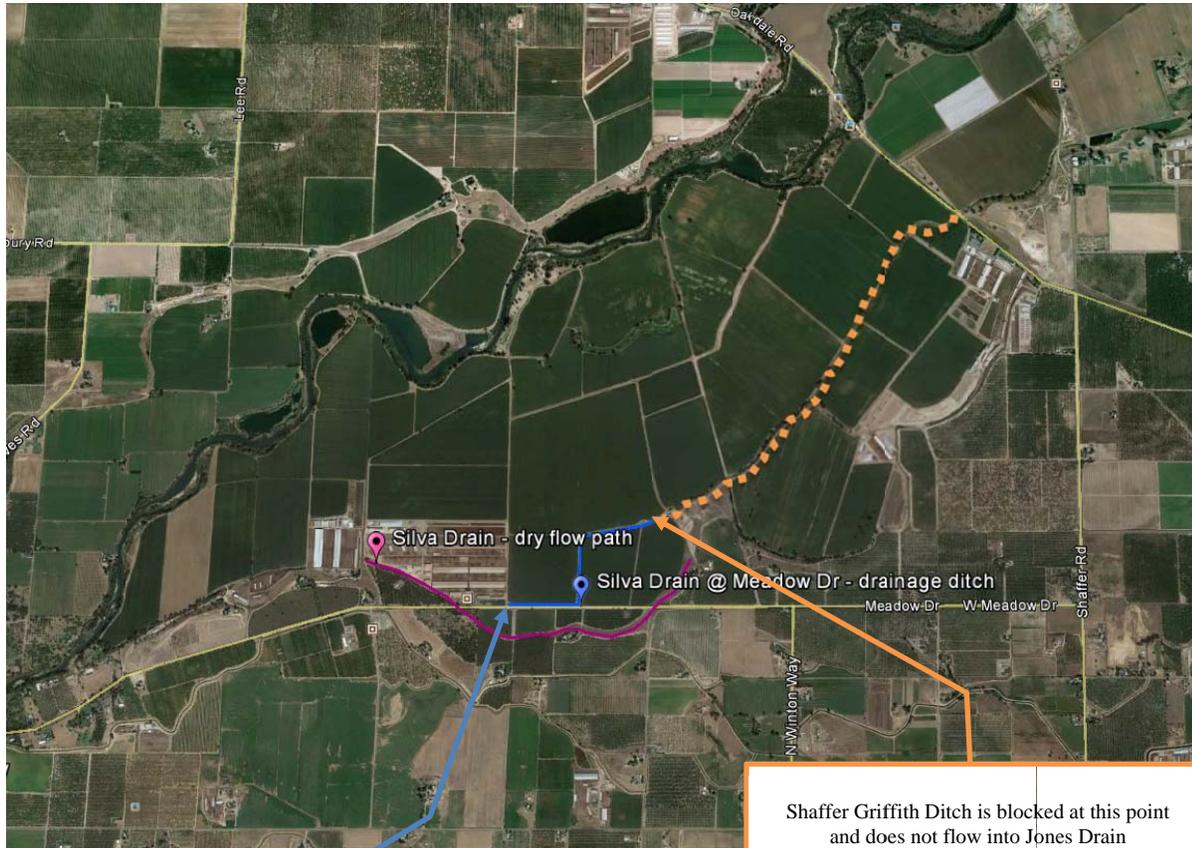
Figure 1. The below image is from the letter to the Regional Board on June 4, 2013 and indicates the flow path of the water body sampled by the Coalition and mislabeled as Silva Drain @ Meadow Rd (blue line). Silva Drain (pink line) no longer exists.

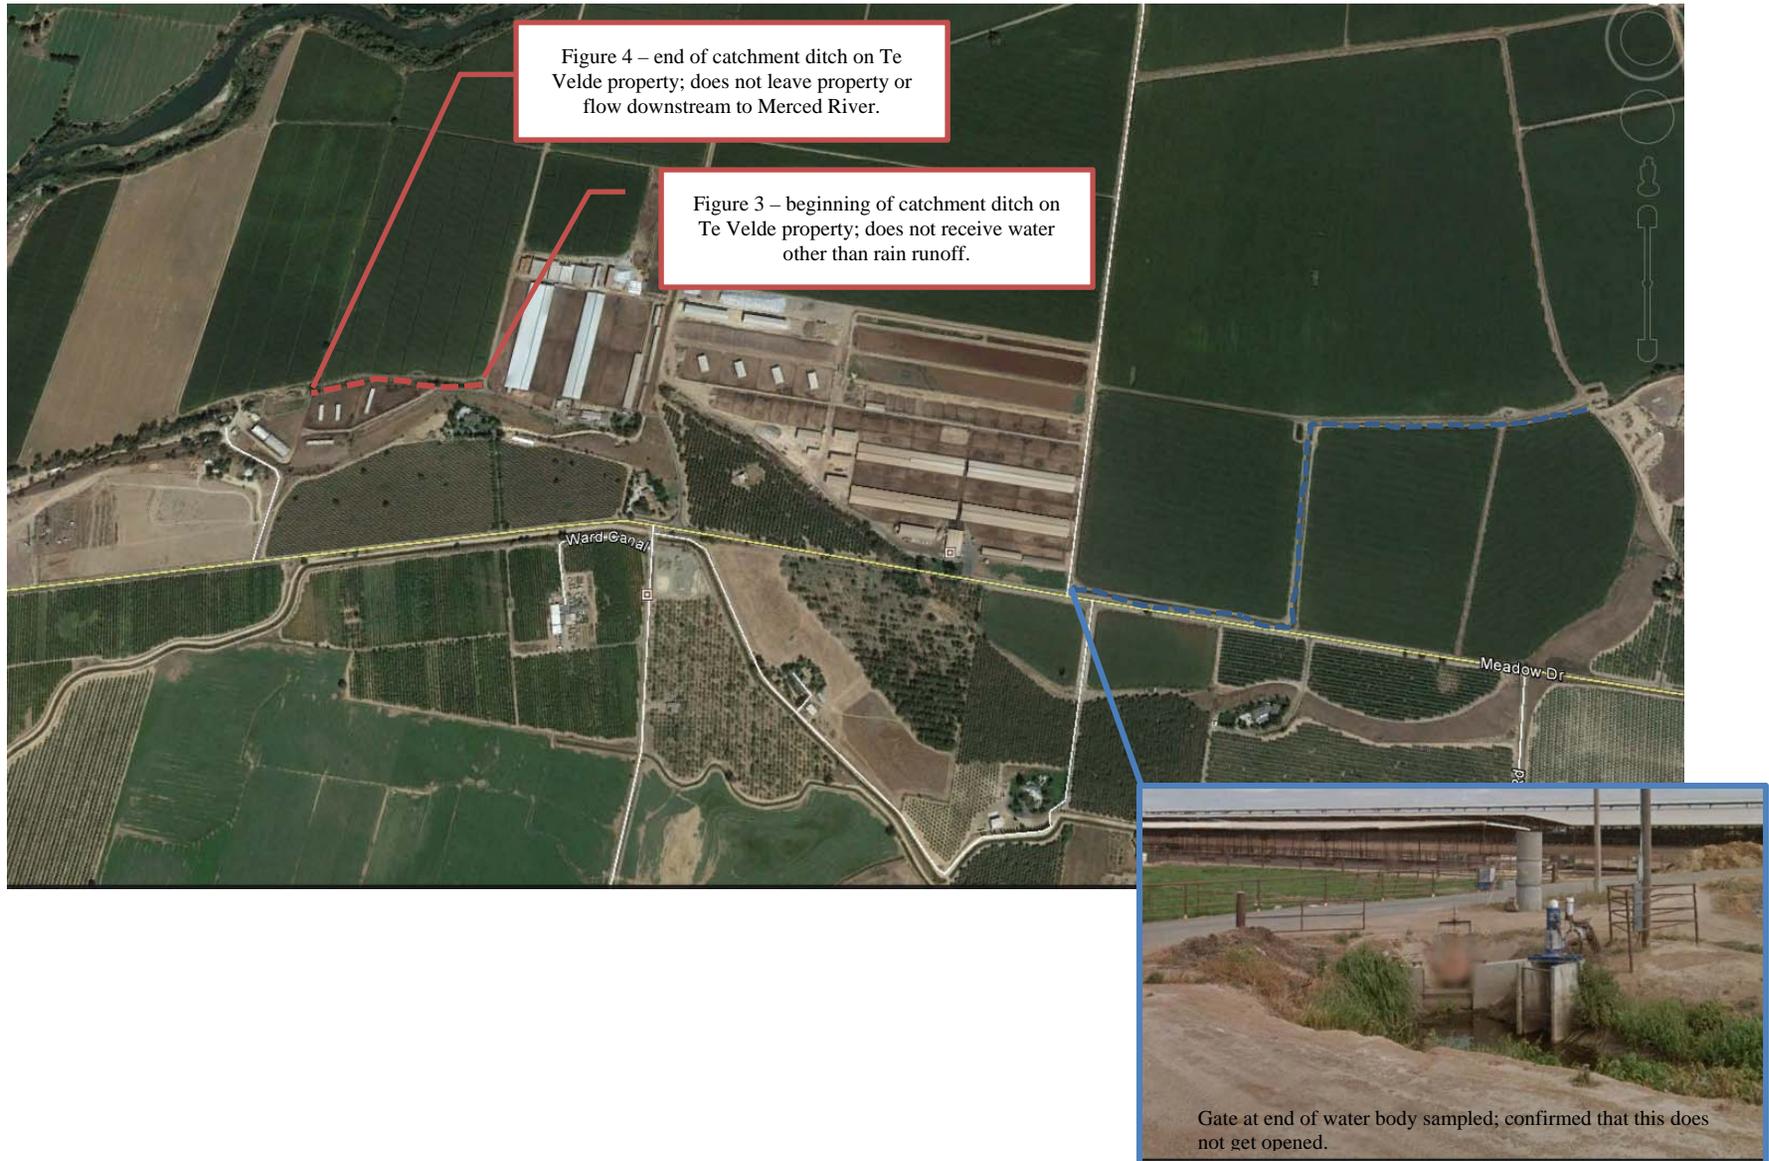
Gate blocking water from moving downstream to Merced River

Shaffer Griffith Ditch is blocked at this point and does not flow into Jones Drain

Figure 2. Close up of area toured with two ESJWQC members.

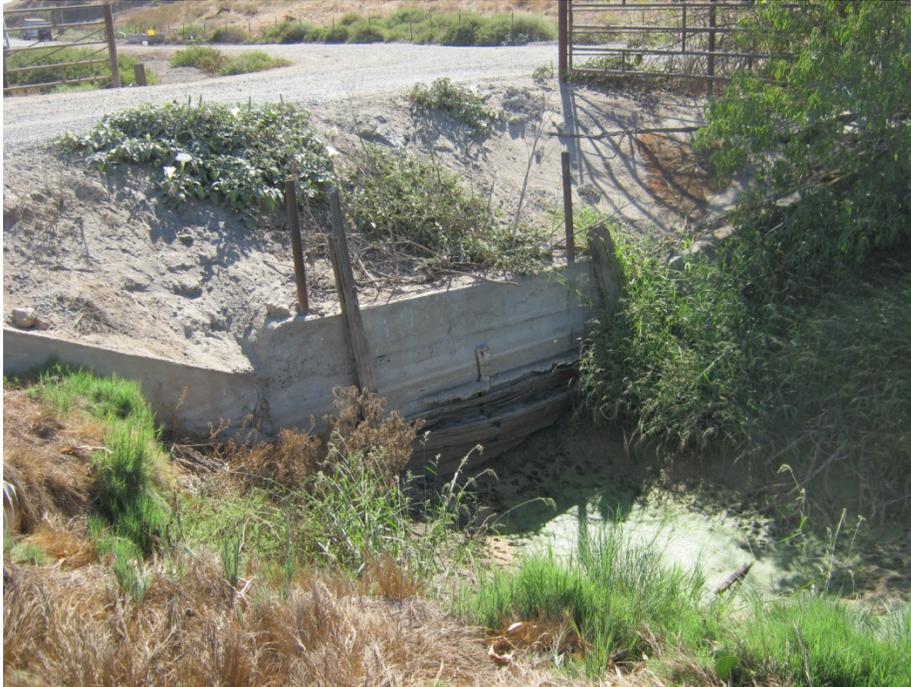
Figure 3. Eastern end of Te Velde catchment area. Catchment area only receives runoff water during rain events.

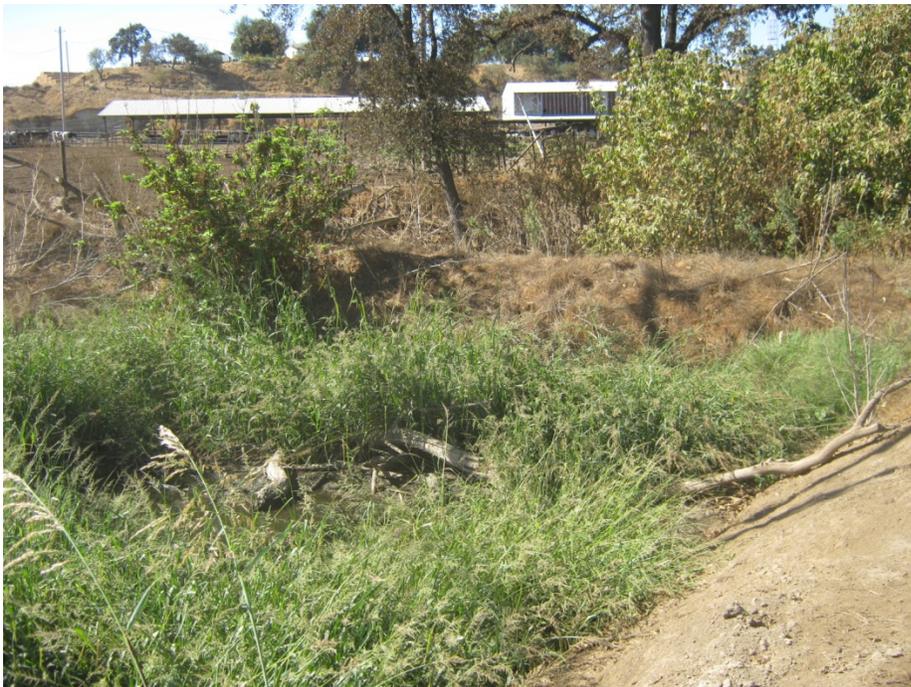
Figure 4. Photo facing west; depicts end of catchment area of Te Velde dairy. Water in catchment does not leave the property or flow into the Merced River.
