Case 2: Post-Fire Putah Creek WQ Monitoring

Alex Rabidoux, PE
Solano County Water Agency

Post-Fire WQ Monitoring

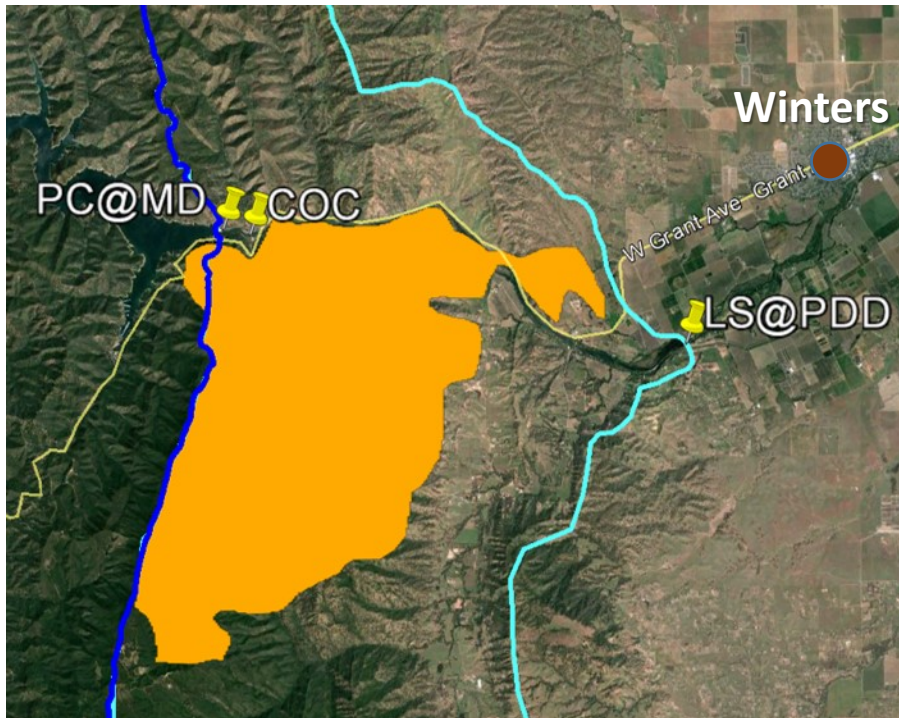
Sample Locations

Name	Description
PC@MD	Putah Ck (Lower D/S L. Berryessa)
COC	Cold Canyon Ck (U/S of Putah Ck)
LS@PDD	Lake Solano @ Div Dam (Intake)

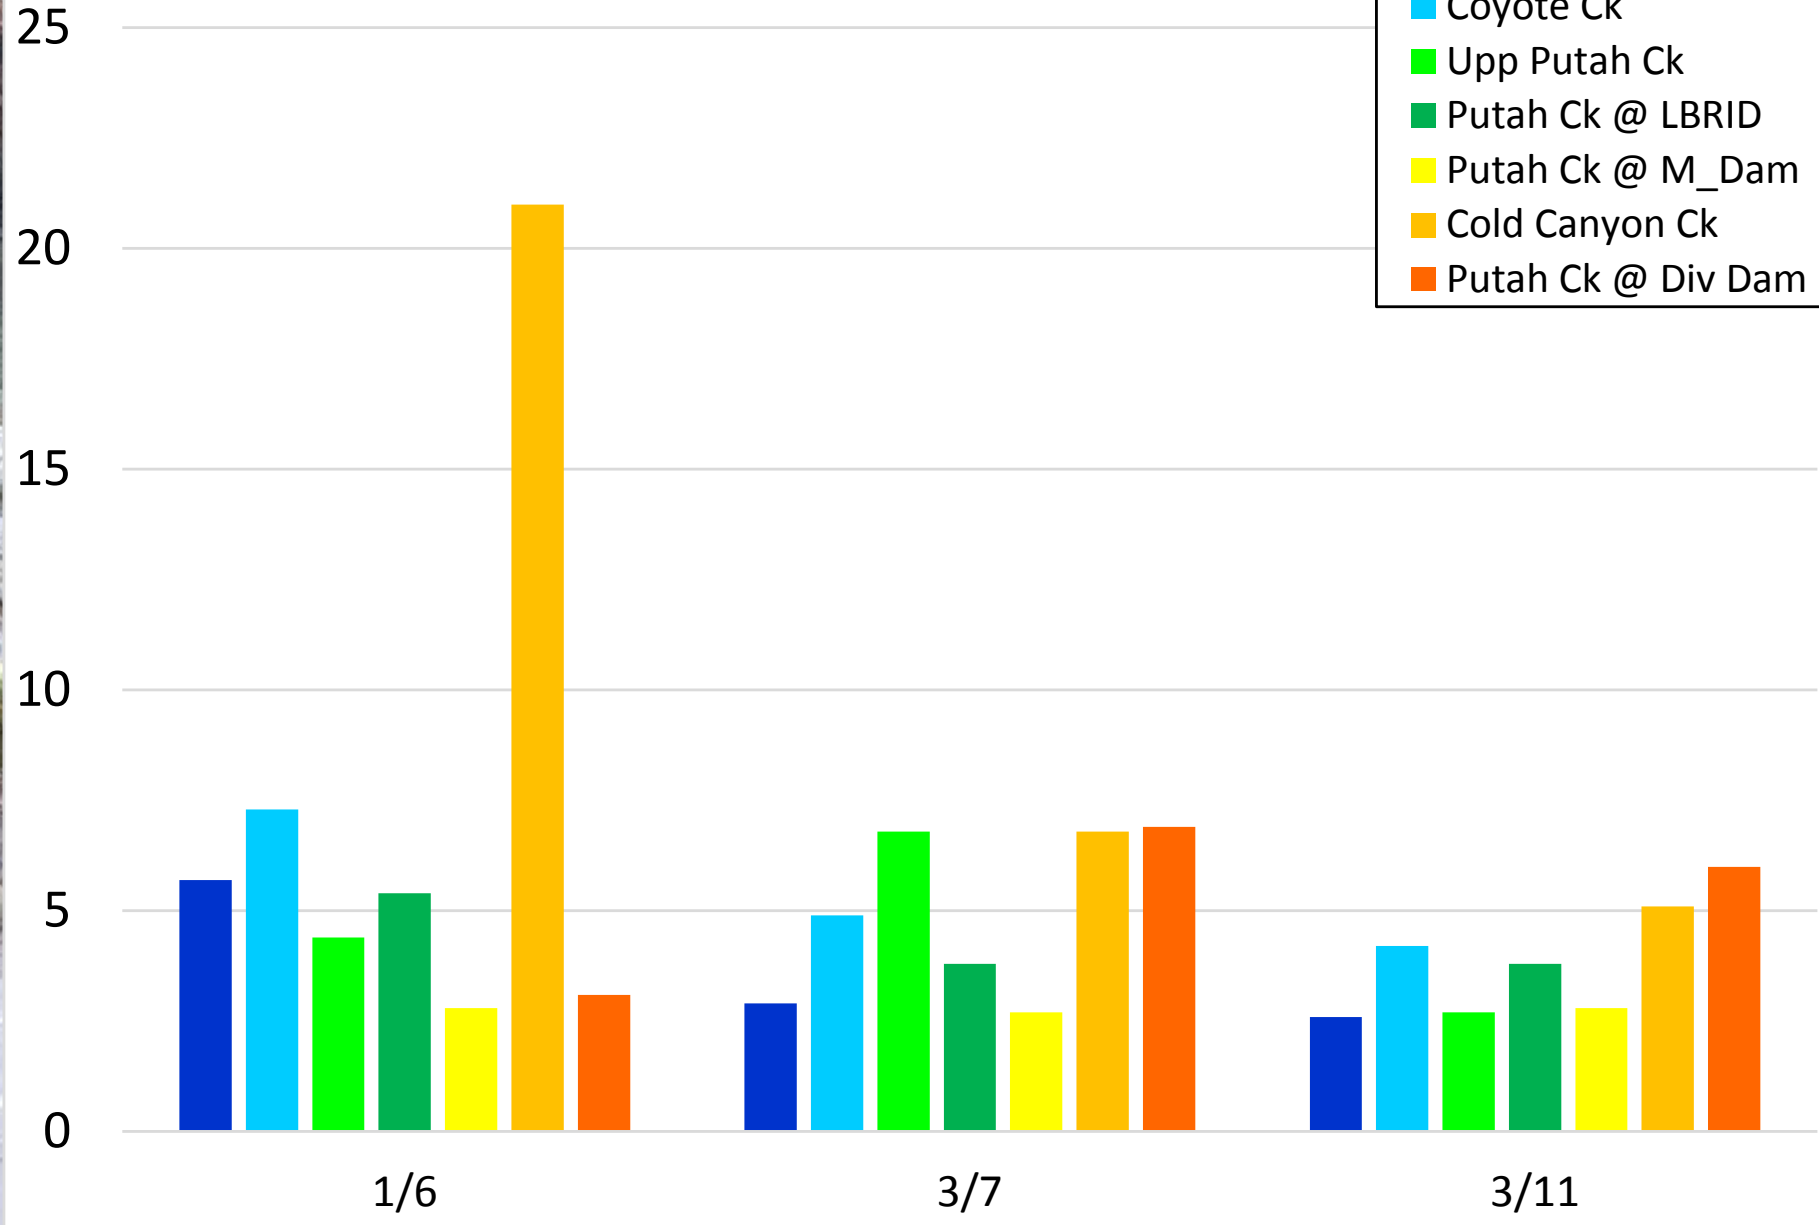
Total Organic Carbon (mg/L)

- St Helena Ck
- Coyote Ck
- Upp Putah Ck
- Putah Ck @ LBRID
- Putah Ck @ M_Dam
- Cold Canyon Ck
- Putah Ck @ Div Dam

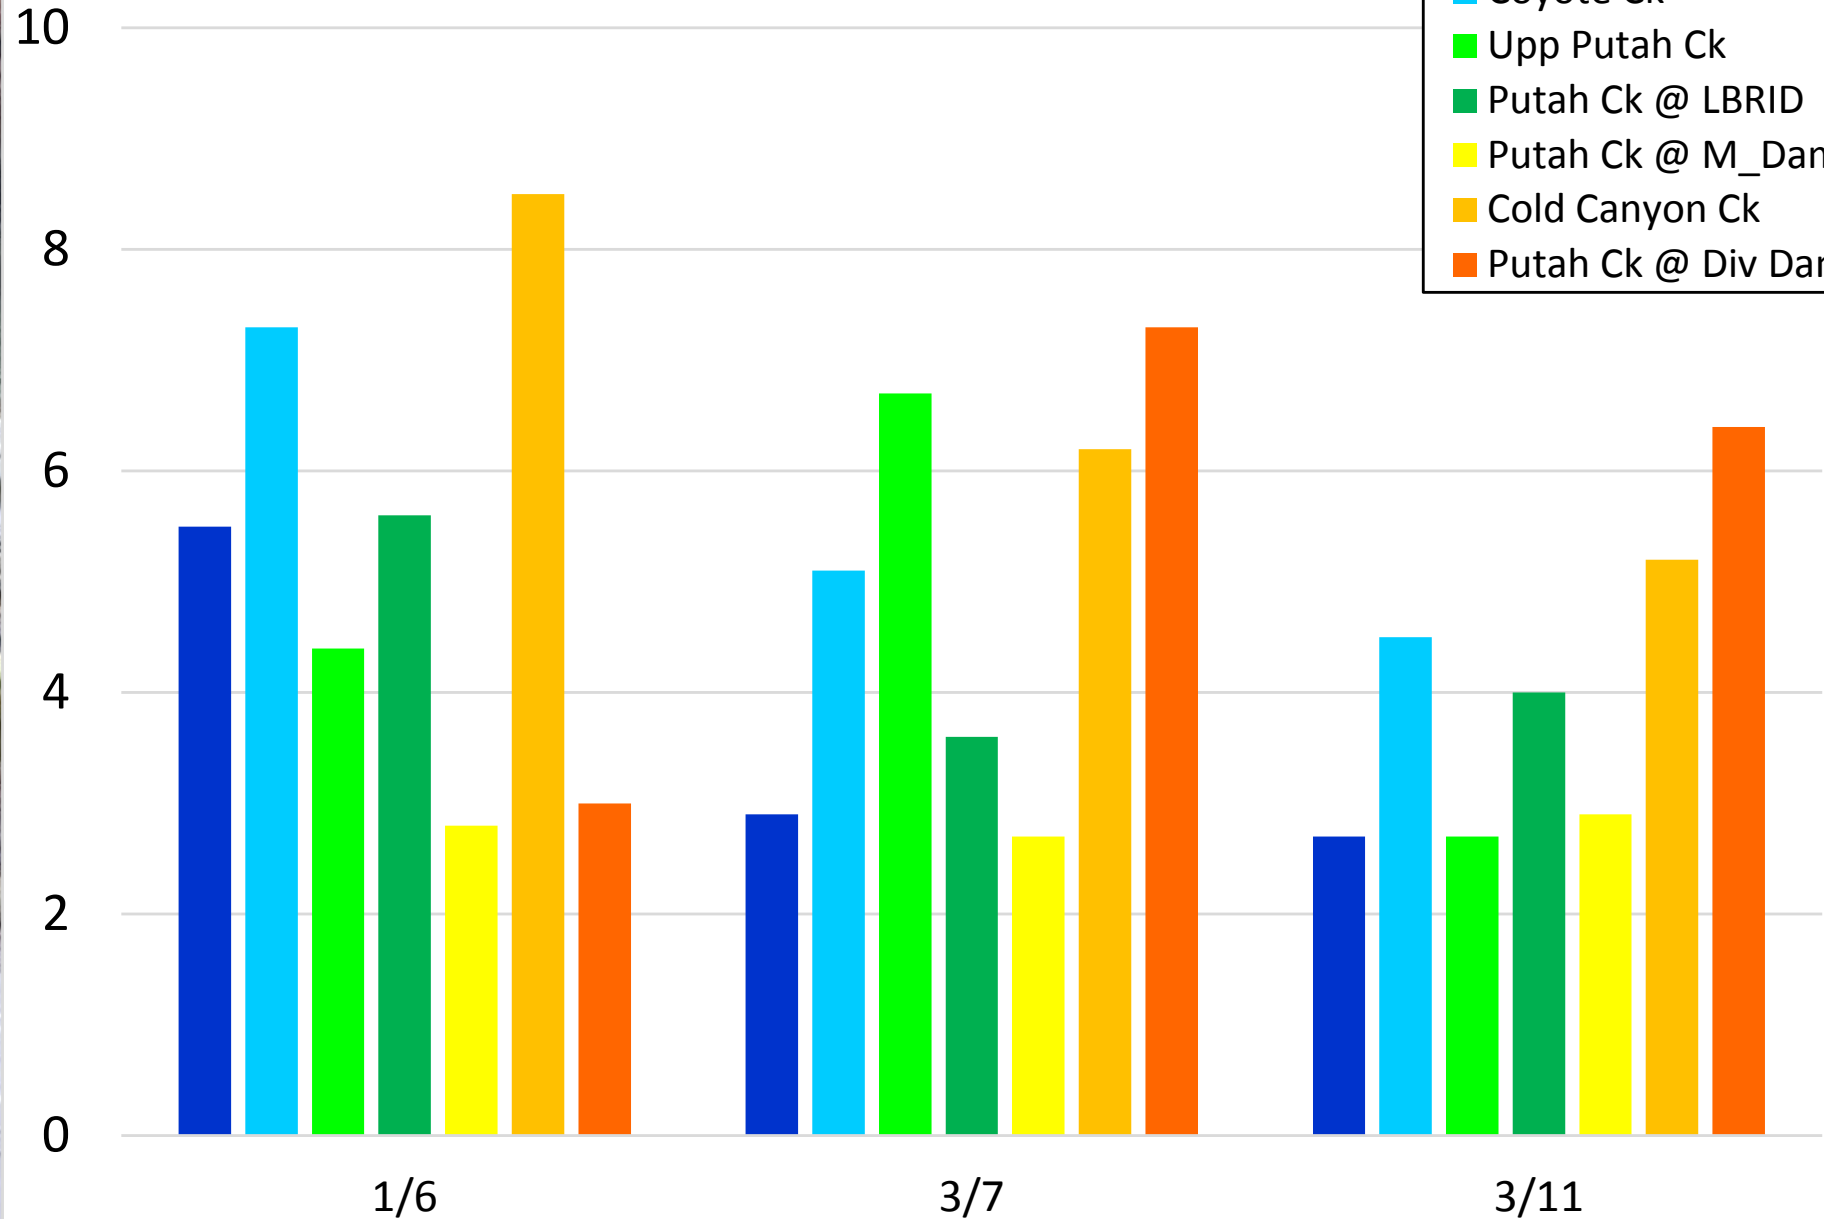
Dissolved Organic Carbon (mg/L)

- St Helena Ck
- Coyote Ck
- Upp Putah Ck
- Putah Ck @ LBRID
- Putah Ck @ M_Dam
- Cold Canyon Ck
- Putah Ck @ Div Dam

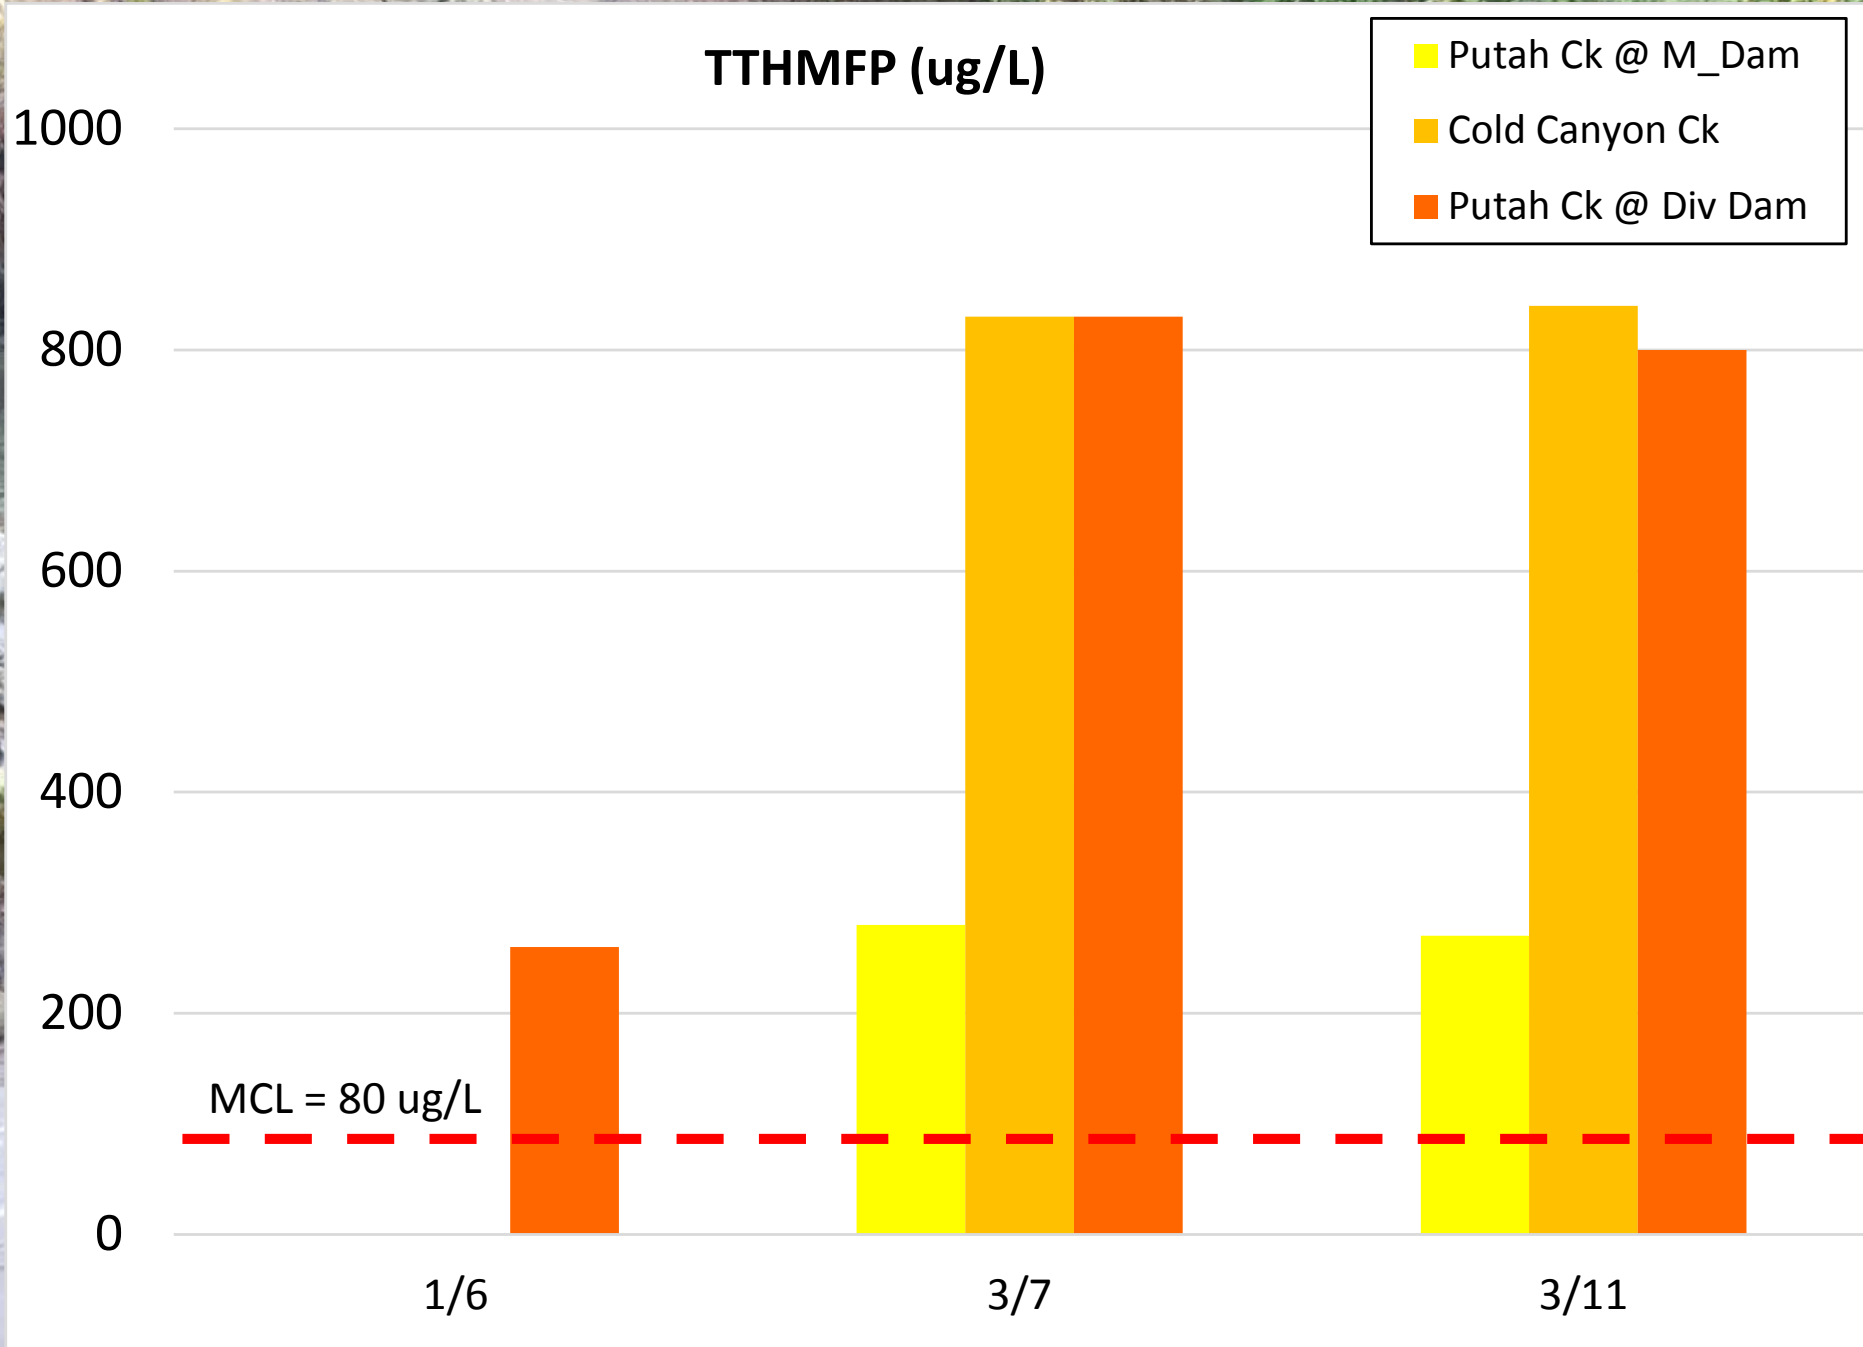
TTHMFP (ug/L)

- Putah Ck @ M_Dam
- Cold Canyon Ck
- Putah Ck @ Div Dam

MCL = 80 ug/L

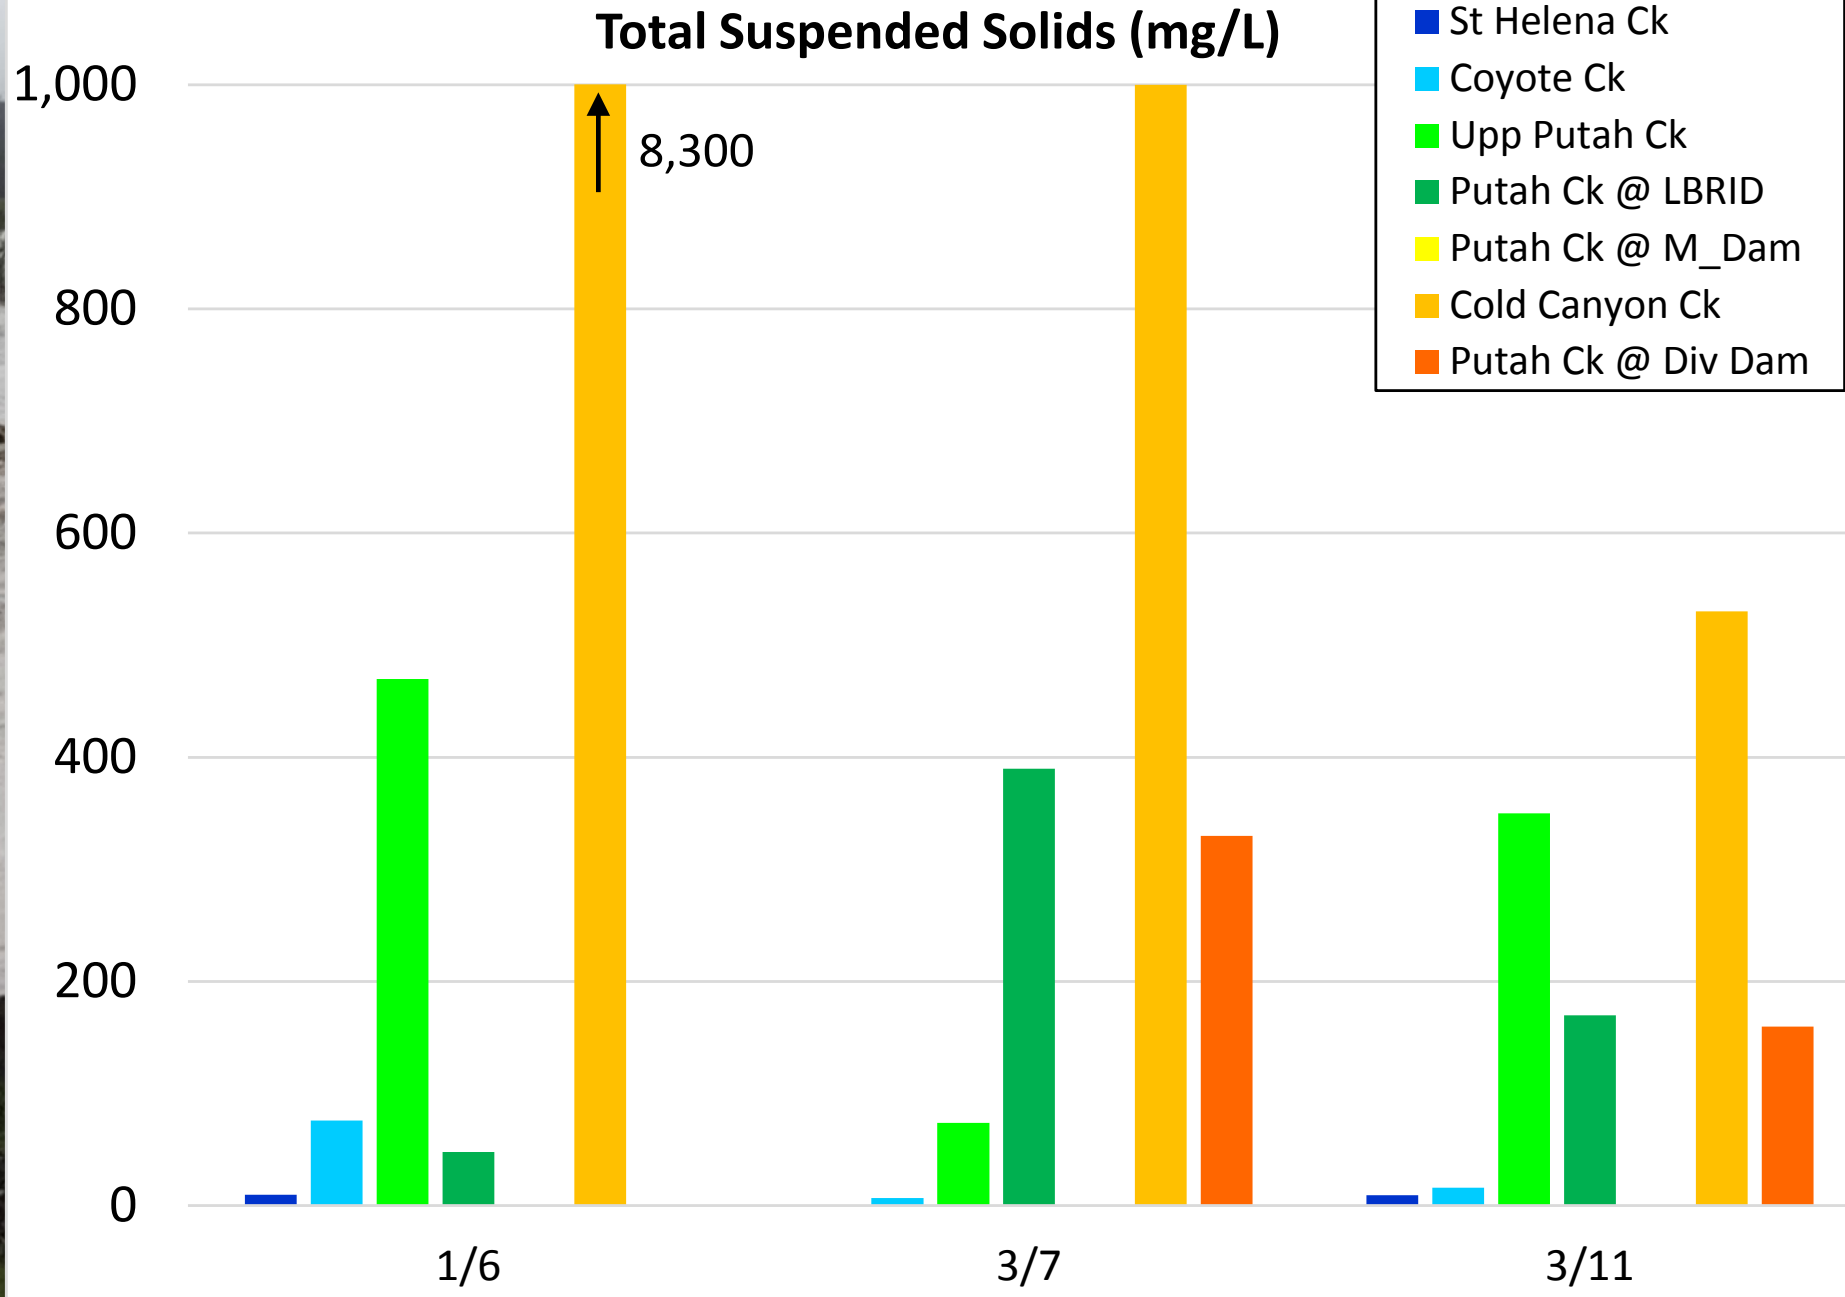
Total Dissolved Solids (mg/L)

- St Helena Ck
- Coyote Ck
- Upp Putah Ck
- Putah Ck @ LBRID
- Putah Ck @ M_Dam
- Cold Canyon Ck
- Putah Ck @ Div Dam

- Cold Canyon Creek (Interdam Reach) had the worst WQ
- Primarily in suspended sediment [TSS = 8,300 mg/L; TDS = 270 mg/L]
- No significant WQ degradation in Upper Putah Creek
- Upper Putah Creek has excellent WQ!

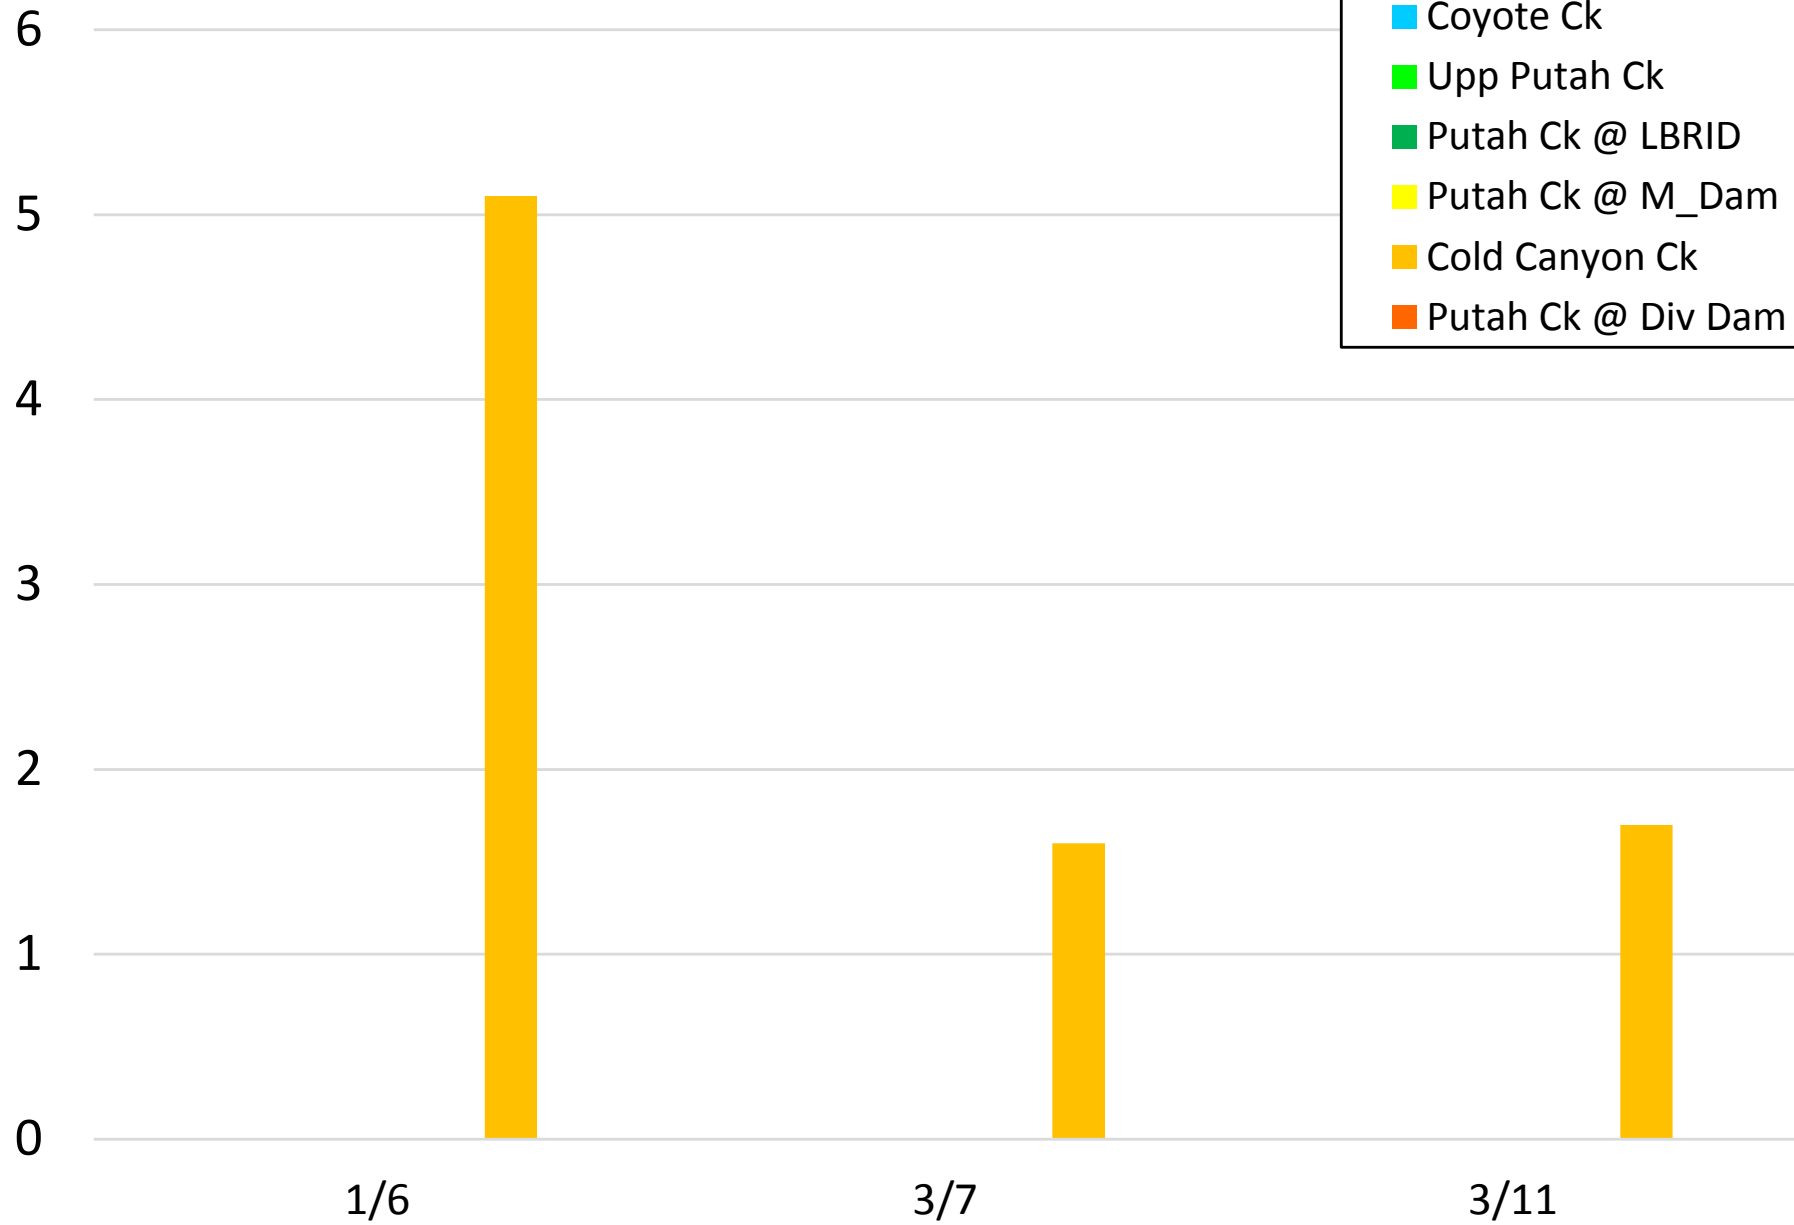
Total Nitrogen (mg/L)

- St Helena Ck
- Coyote Ck
- Upp Putah Ck
- Putah Ck @ LBRID
- Putah Ck @ M_Dam
- Cold Canyon Ck
- Putah Ck @ Div Dam

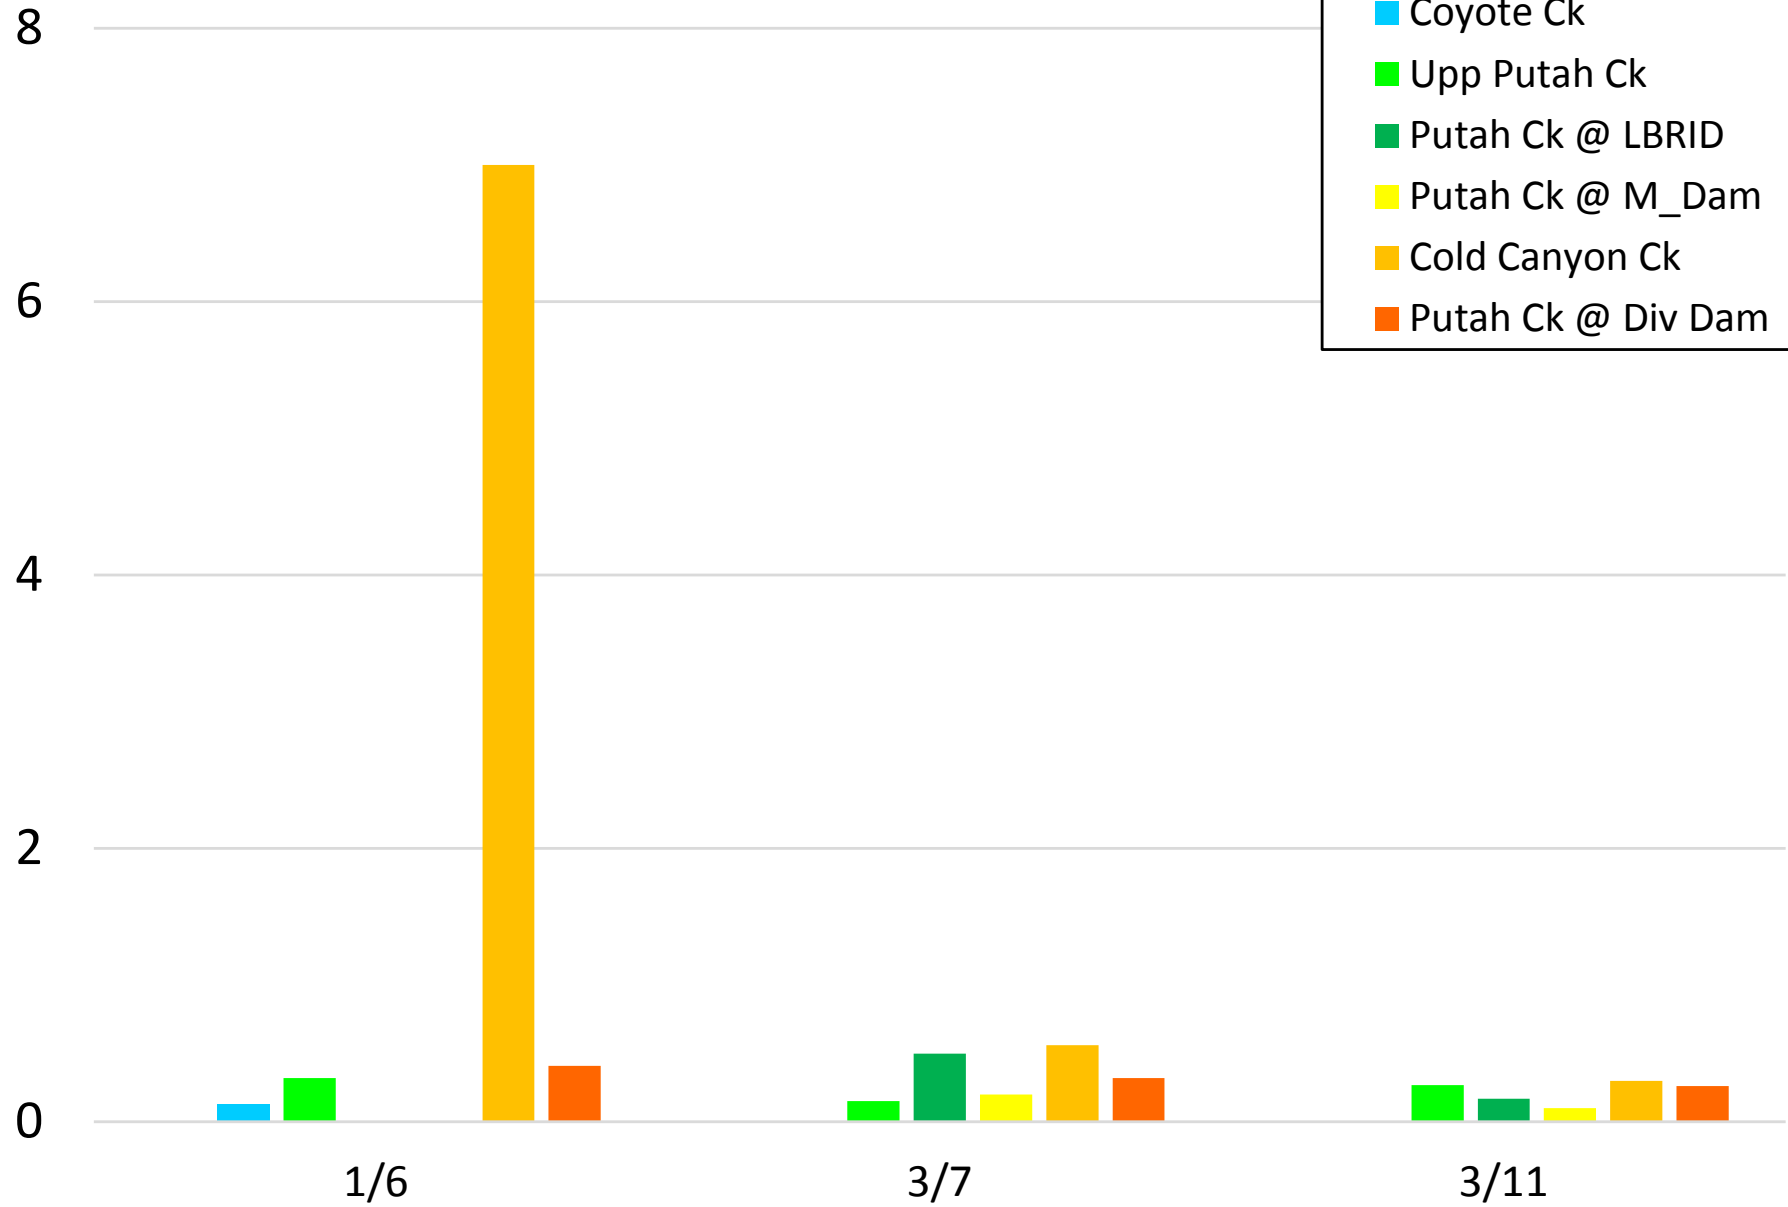
Phosphorus (mg/L)

- St Helena Ck
- Coyote Ck
- Upp Putah Ck
- Putah Ck @ LBRID
- Putah Ck @ M_Dam
- Cold Canyon Ck
- Putah Ck @ Div Dam

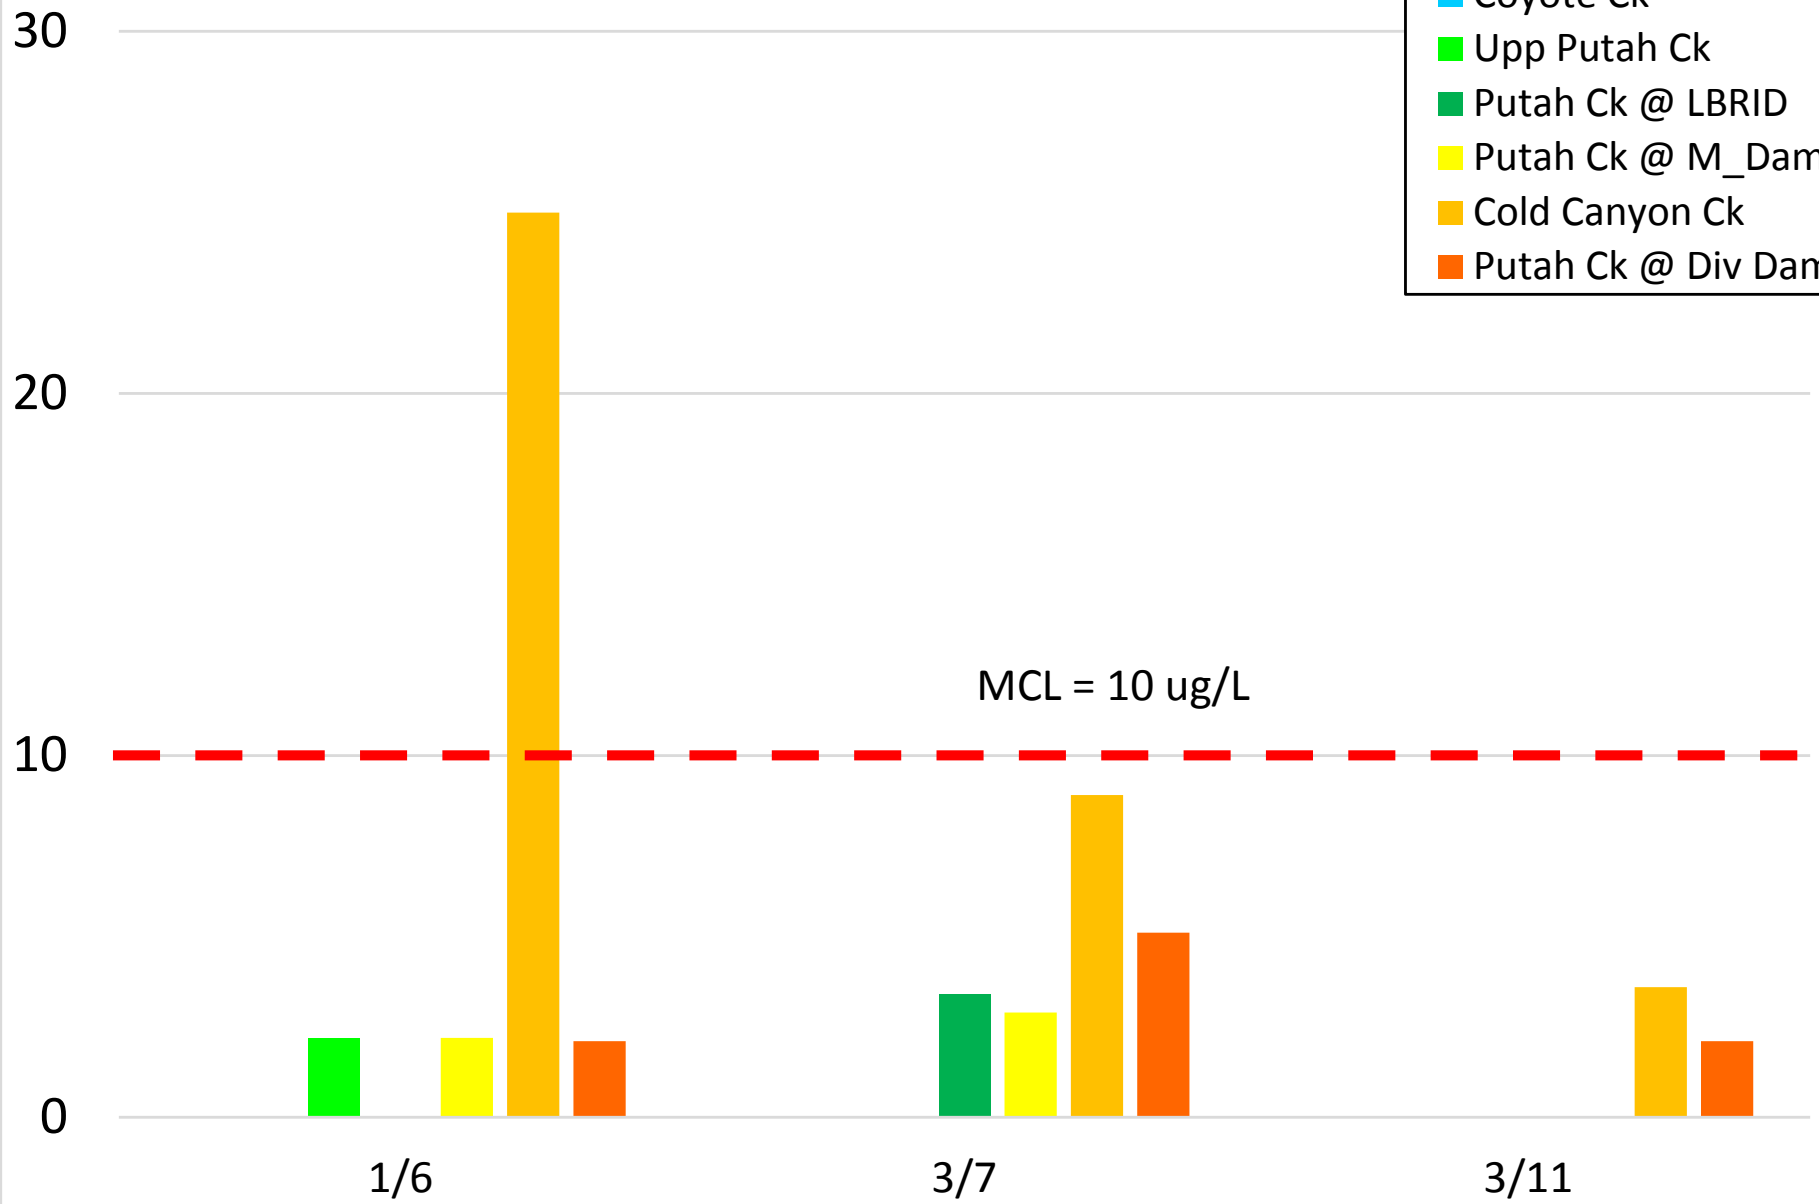
Arsenic (ug/L)

- St Helena Ck
- Coyote Ck
- Upp Putah Ck
- Putah Ck @ LBRID
- Putah Ck @ M_Dam
- Cold Canyon Ck
- Putah Ck @ Div Dam

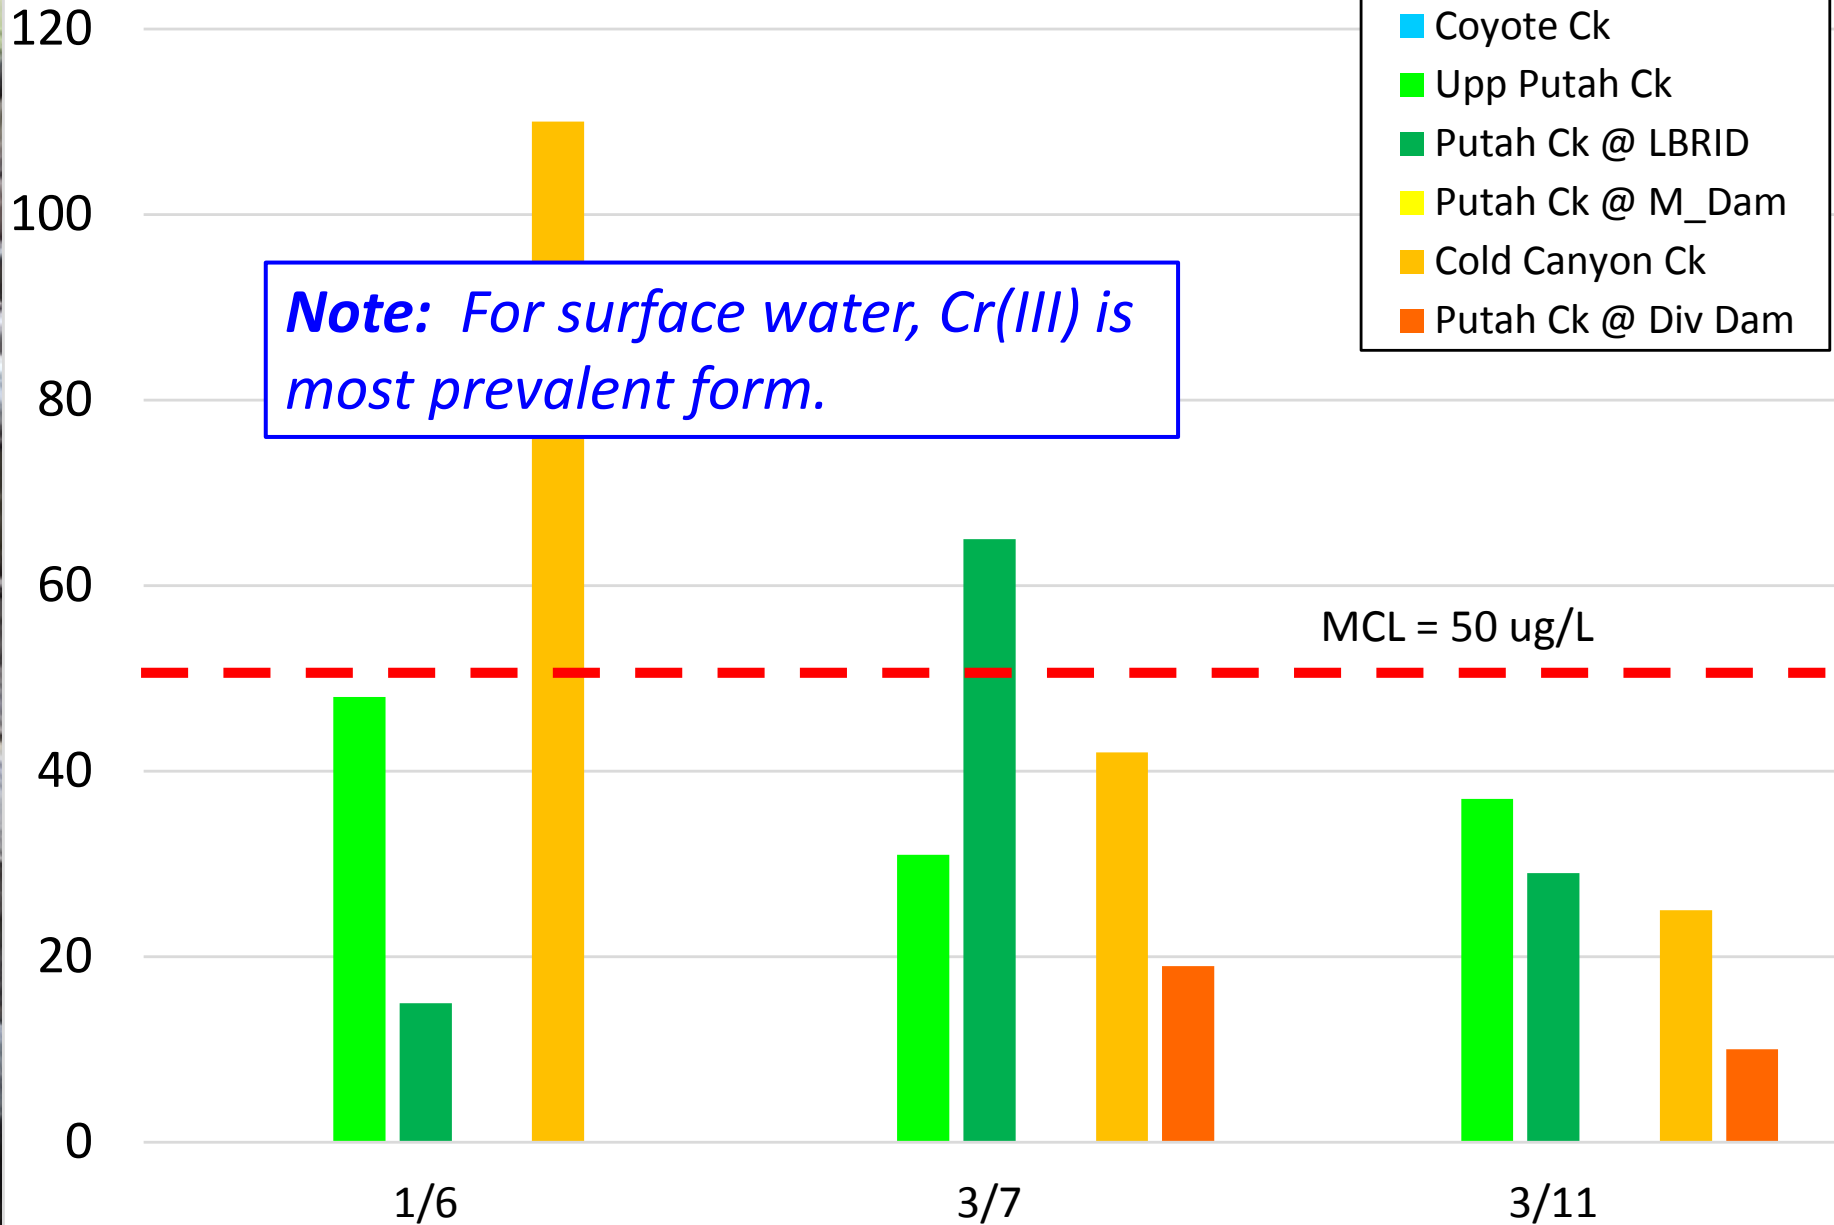
Total Chromium (ug/L)

- St Helena Ck
- Coyote Ck
- Upp Putah Ck
- Putah Ck @ LBRID
- Putah Ck @ M_Dam
- Cold Canyon Ck
- Putah Ck @ Div Dam

Note: For surface water, Cr(III) is most prevalent form.

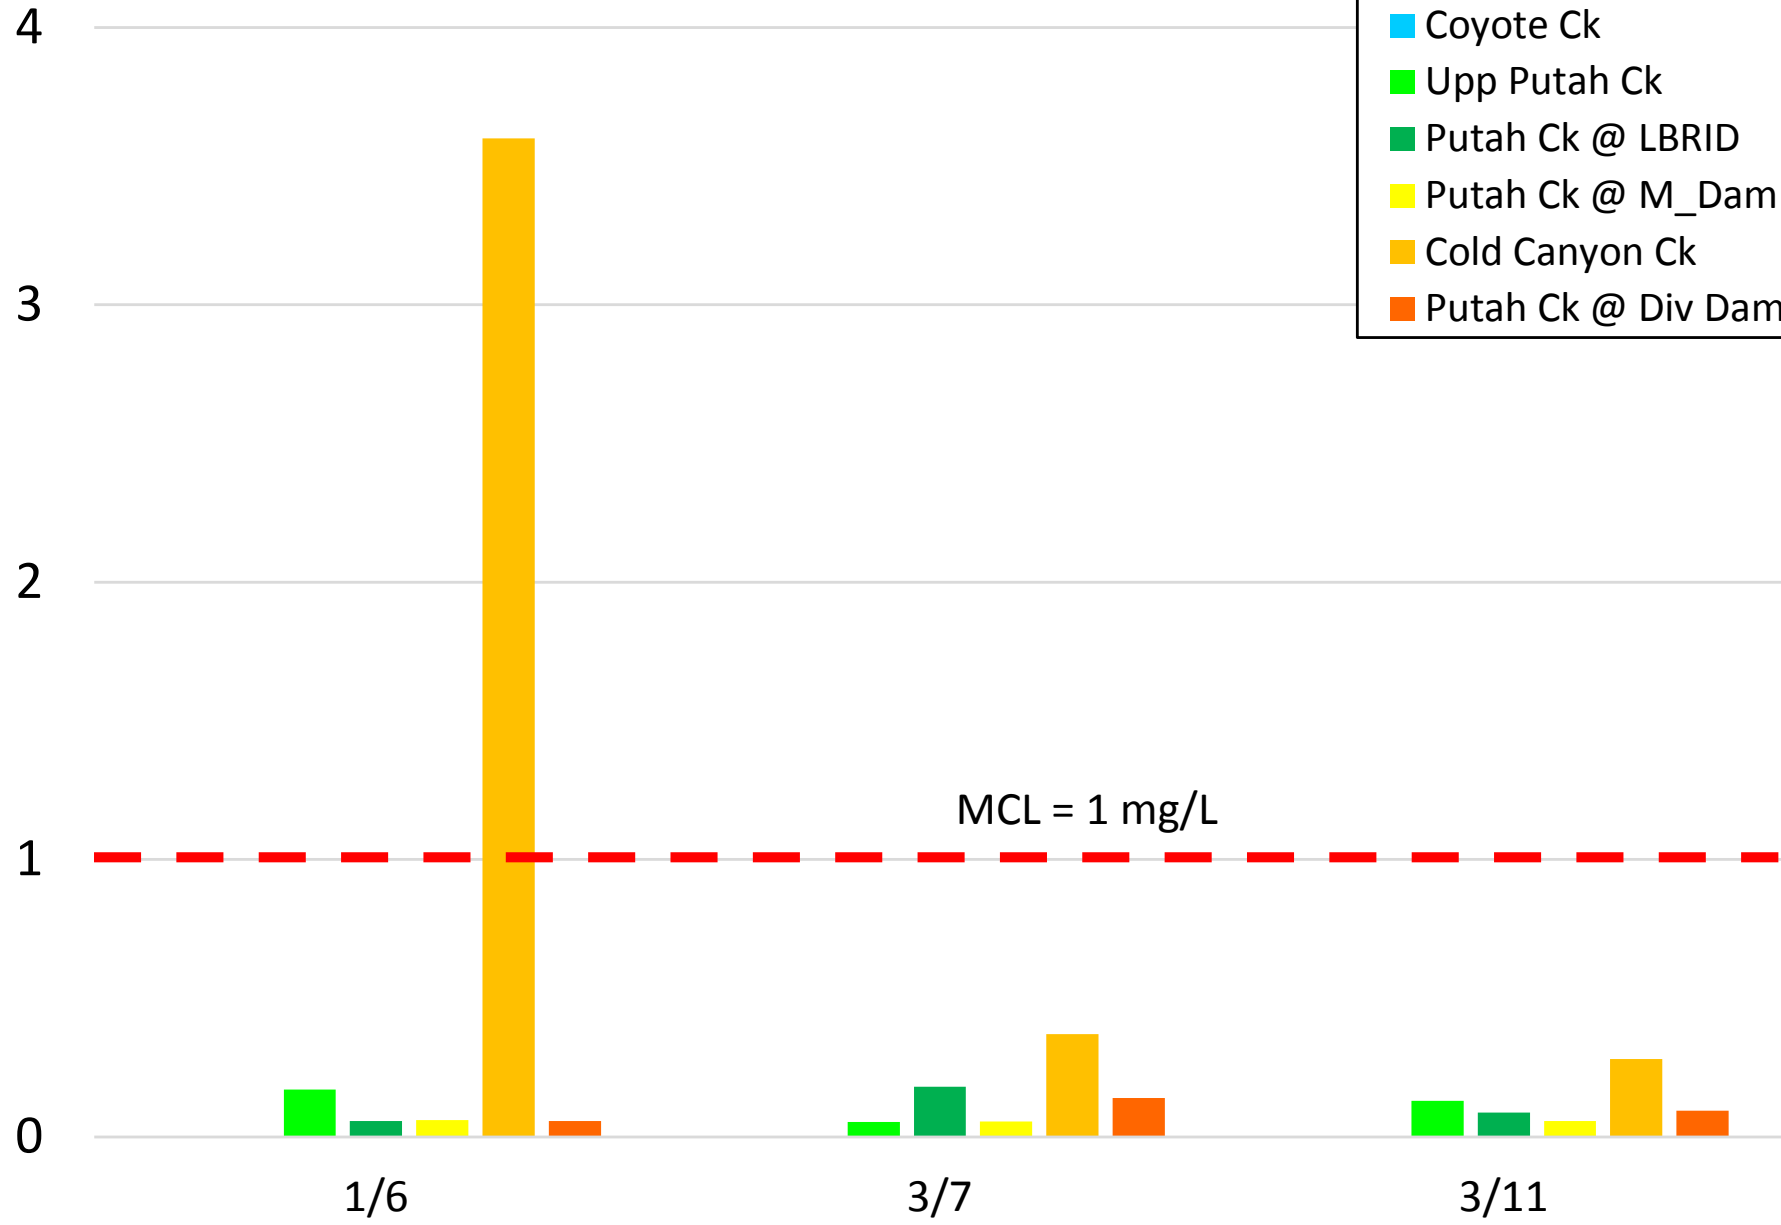
Barium (mg/L)

- St Helena Ck
- Coyote Ck
- Upp Putah Ck
- Putah Ck @ LBRID
- Putah Ck @ M_Dam
- Cold Canyon Ck
- Putah Ck @ Div Dam
