Case 2: Post-Fire Putah Creek WQ Monitoring

Alex Rabidoux, PE
Solano County Water Agency

Post-Fire WQ Monitoring

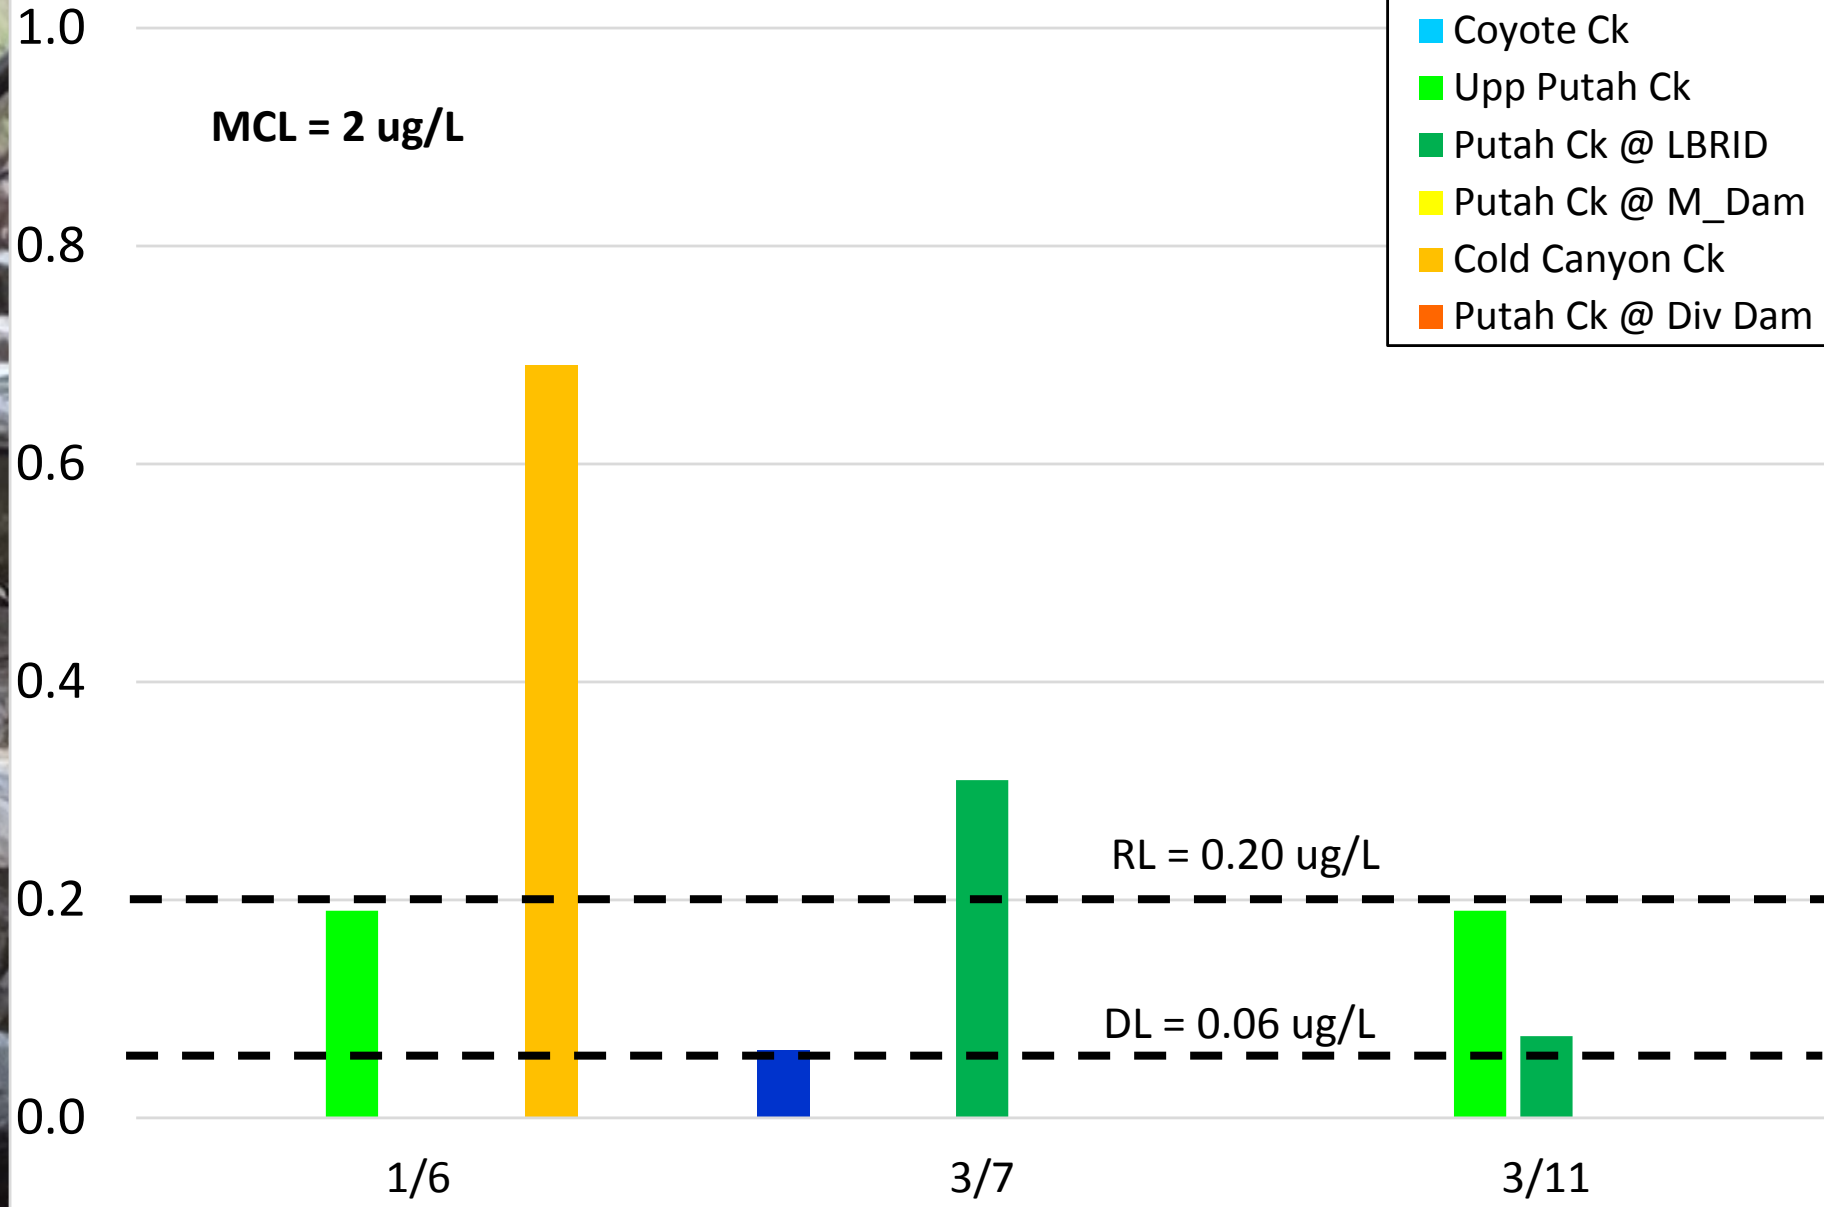
Mercury (ug/L)

- St Helena Ck
- Coyote Ck
- Upp Putah Ck
- Putah Ck @ LBRID
- Putah Ck @ M_Dam
- Cold Canyon Ck
- Putah Ck @ Div Dam

MCL = 2 ug/L

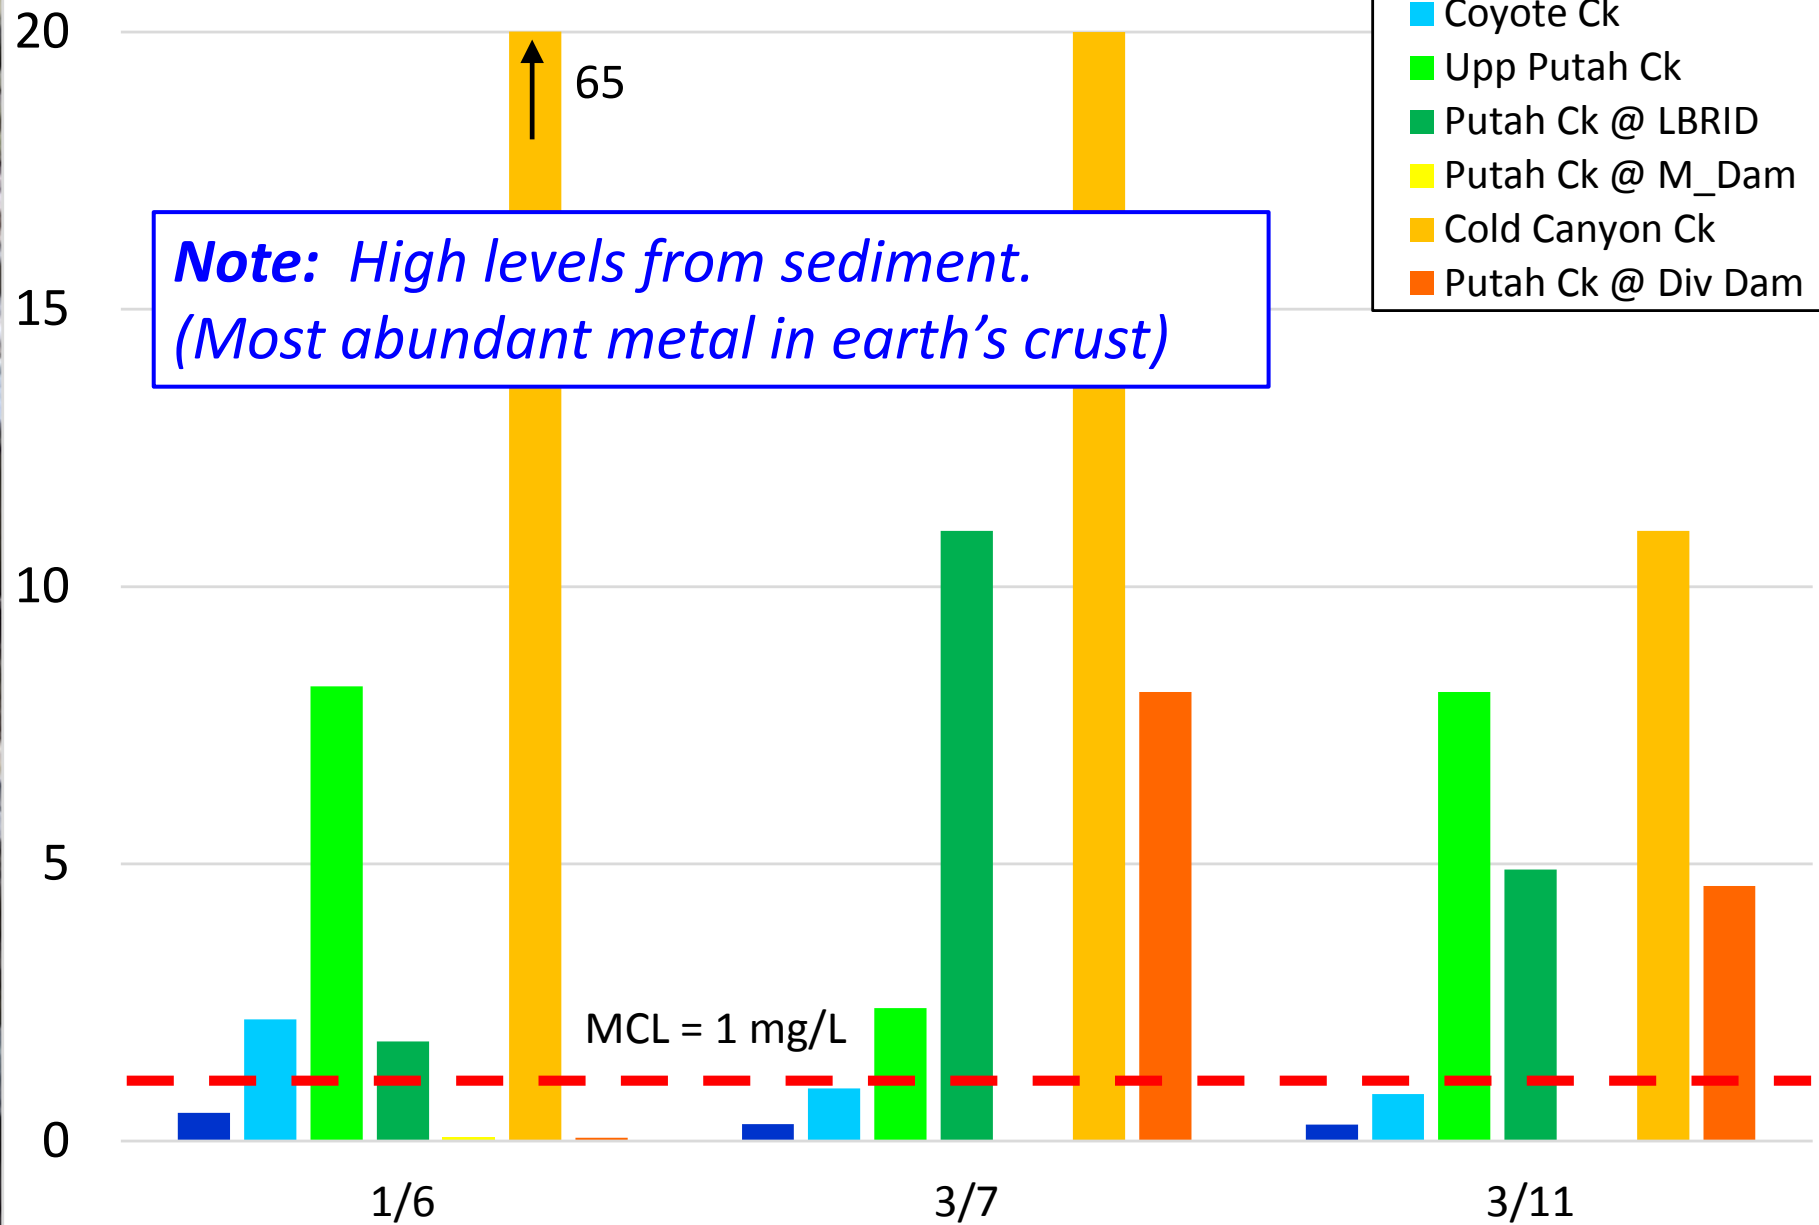
Aluminum (mg/L)

- St Helena Ck
- Coyote Ck
- Upp Putah Ck
- Putah Ck @ LBRID
- Putah Ck @ M_Dam
- Cold Canyon Ck
- Putah Ck @ Div Dam

*Note: High levels from sediment.
(Most abundant metal in earth's crust)*

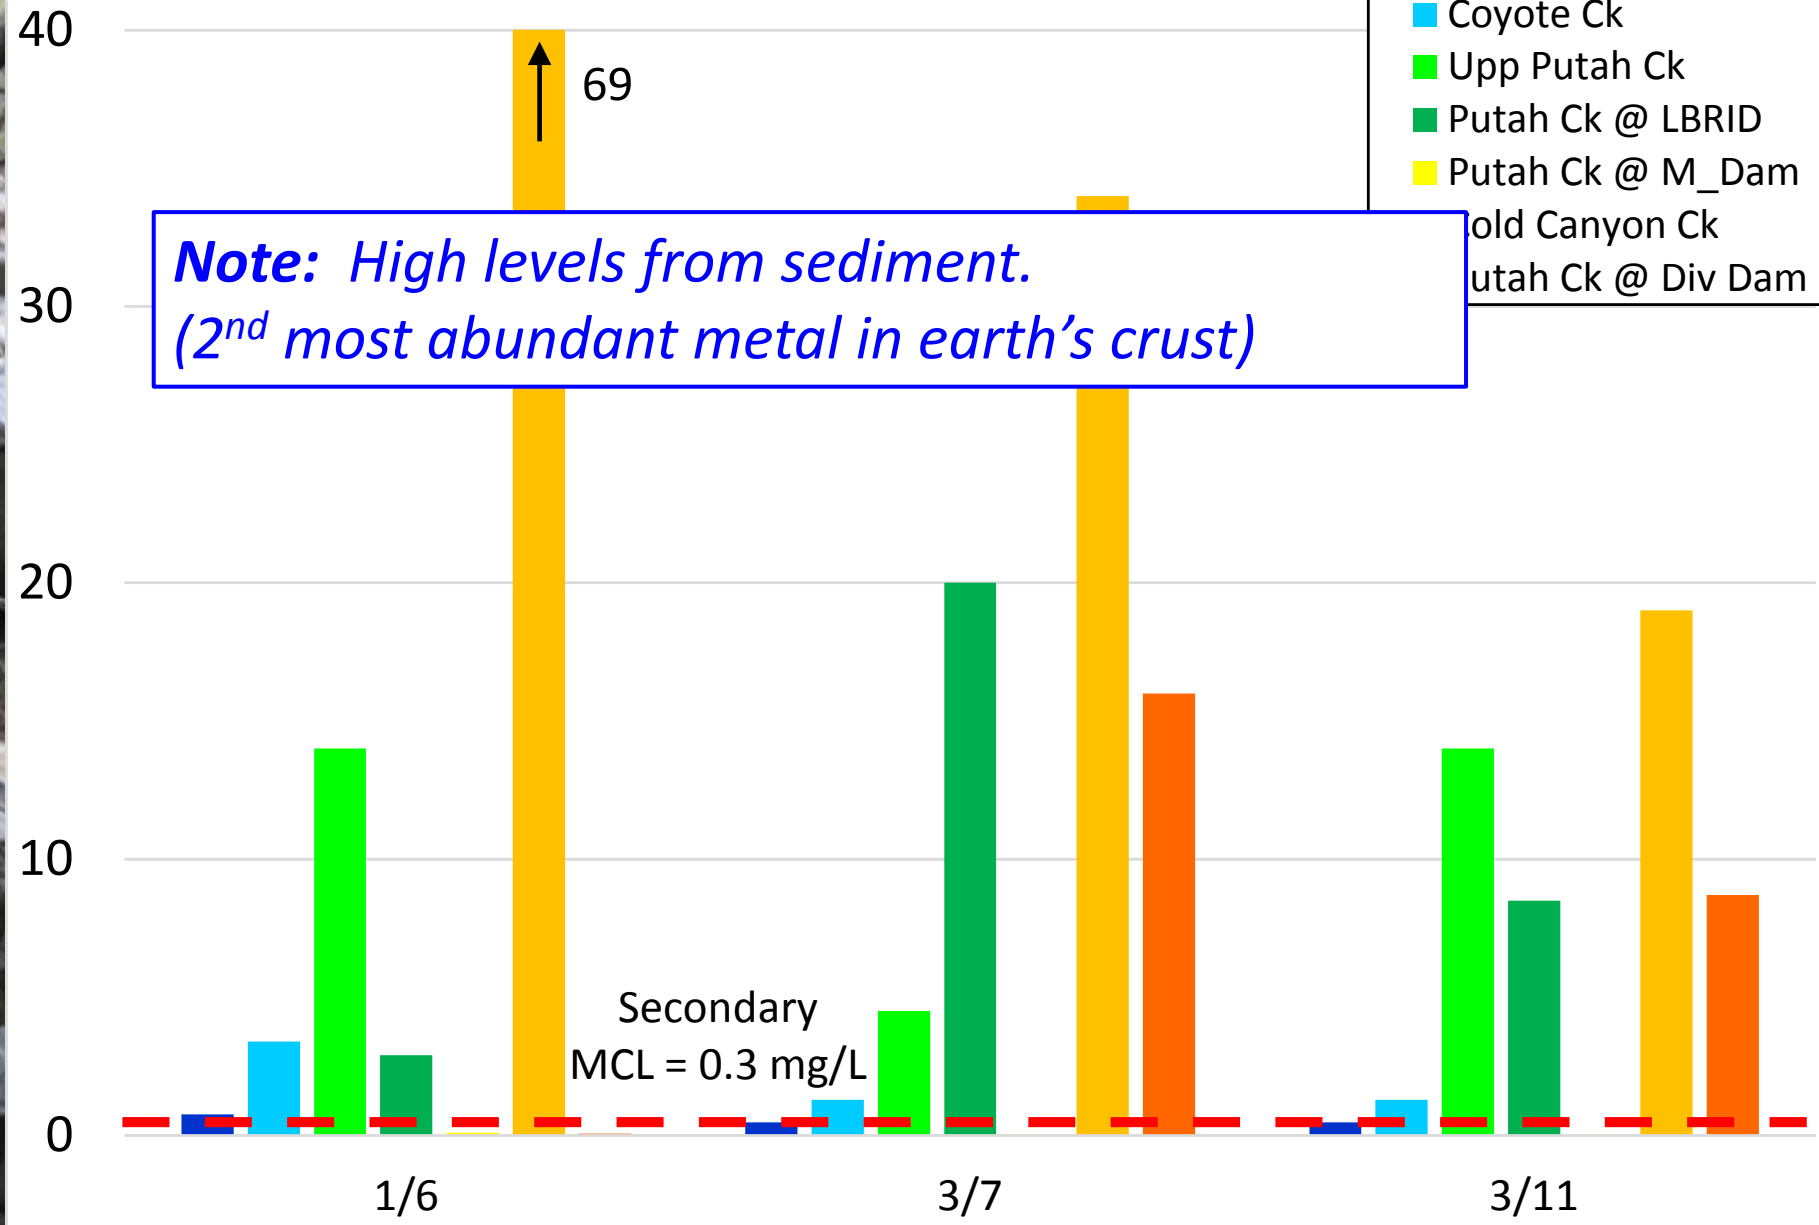
Iron (mg/L)

- St Helena Ck
- Coyote Ck
- Upp Putah Ck
- Putah Ck @ LBRID
- Putah Ck @ M_Dam
- Old Canyon Ck
- Putah Ck @ Div Dam

*Note: High levels from sediment.
(2nd most abundant metal in earth's crust)*

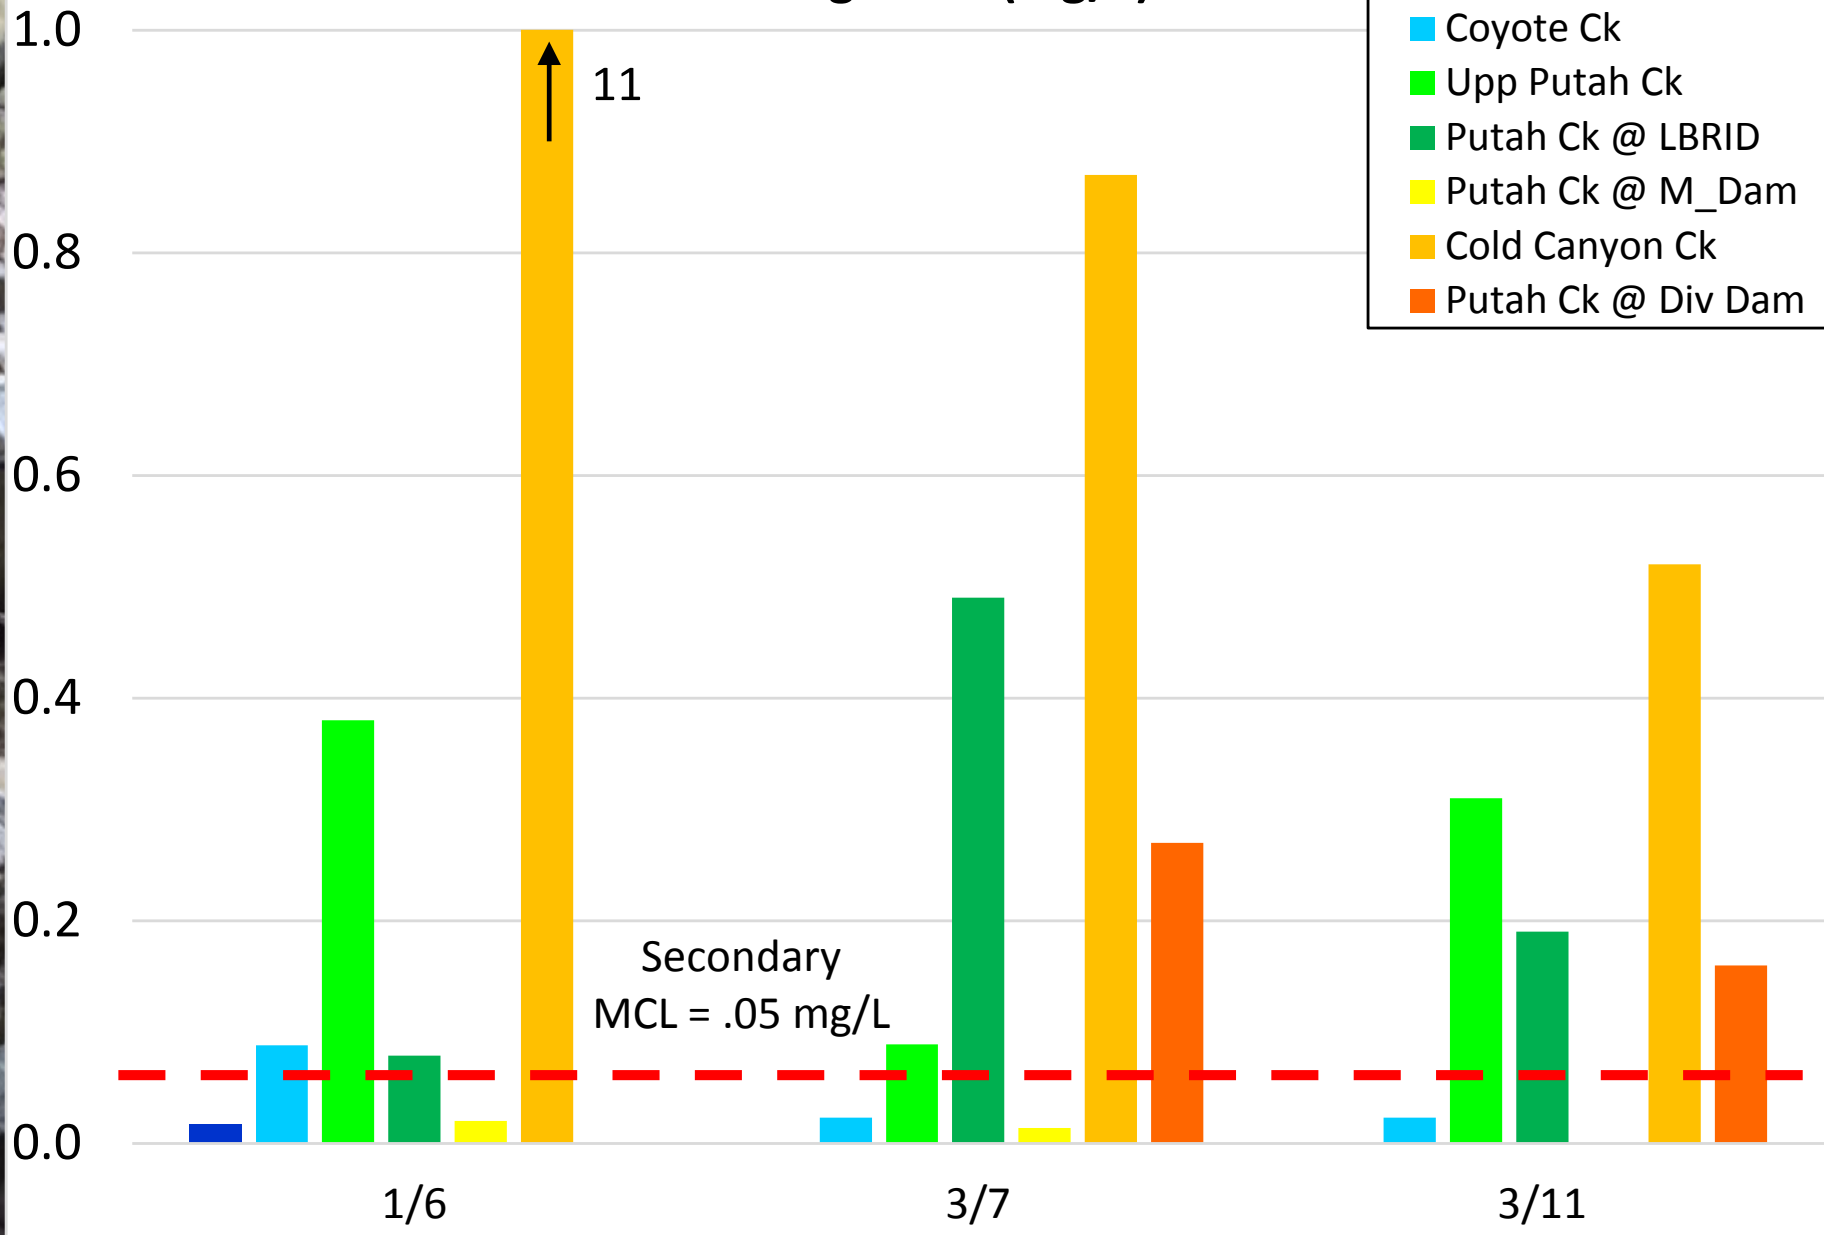
Manganese (mg/L)

- St Helena Ck
- Coyote Ck
- Upp Putah Ck
- Putah Ck @ LBRID
- Putah Ck @ M_Dam
- Cold Canyon Ck
- Putah Ck @ Div Dam
