**CALIFORNIA REGIONAL WATER QUALITY CONTROL BOARD
LAHONTAN REGION**

CLEANUP AND ABATEMENT ORDER NO. R6T-2013-0076

**REQUIRING MICHAEL LOCKE TO CLEAN UP AND ABATE THE DISCHARGE AND
THREATENED DISCHARGE OF WASTE EARTHEN MATERIALS TO WETLANDS
TRIBUTARY TO HOT CREEK IN THE WEST WALKER RIVER WATERSHED**

Delineation of Jurisdictional Waters of the U.S.

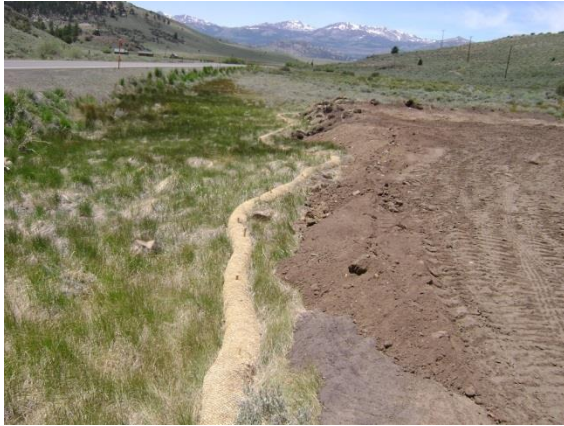
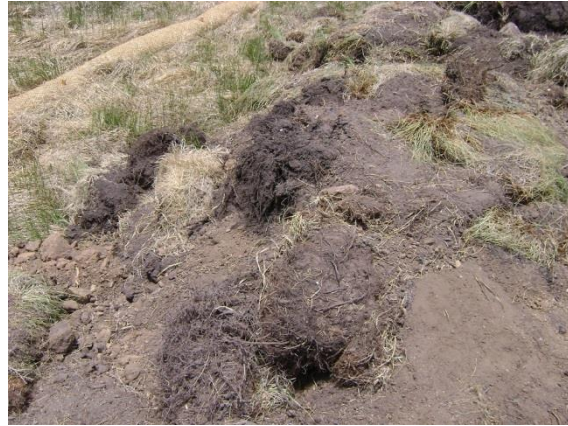
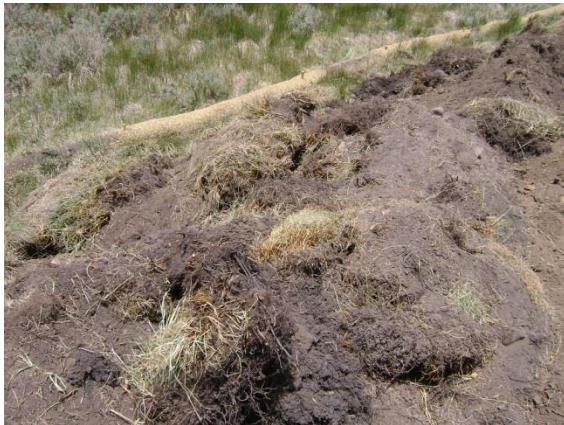
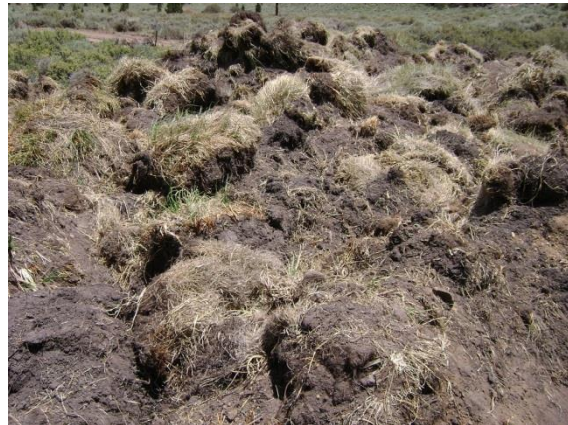
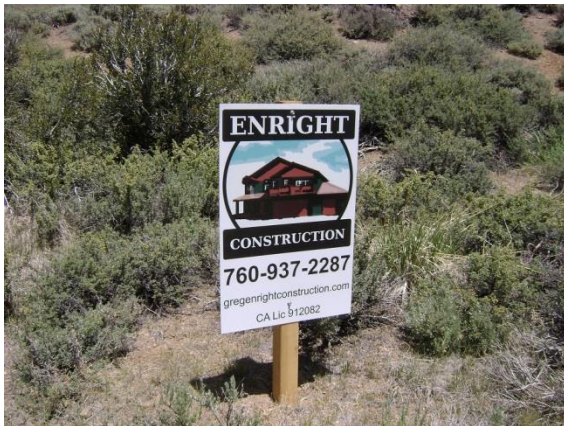
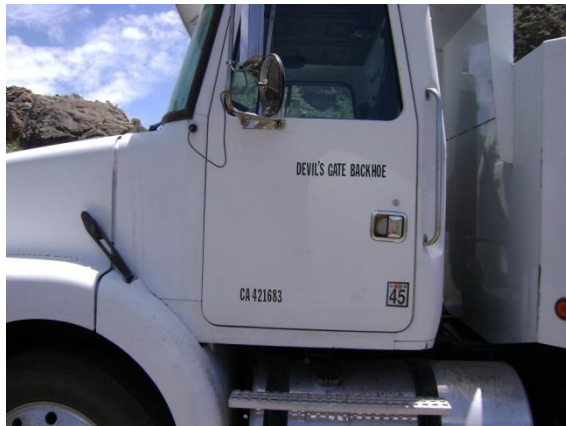
REGIONAL BOARD STAFF PHOTOS
JUNE 19, 2013

3. On June 19, 2013, Water Board staff observed recent soil disturbance (grading and filling) at the Site adjacent to the highway. Staff also observed wetland vegetation that had been cleared and stockpiled against the nearby uphill slope. Attachment A, referenced and incorporated herein, contains photos of the Site from that day.

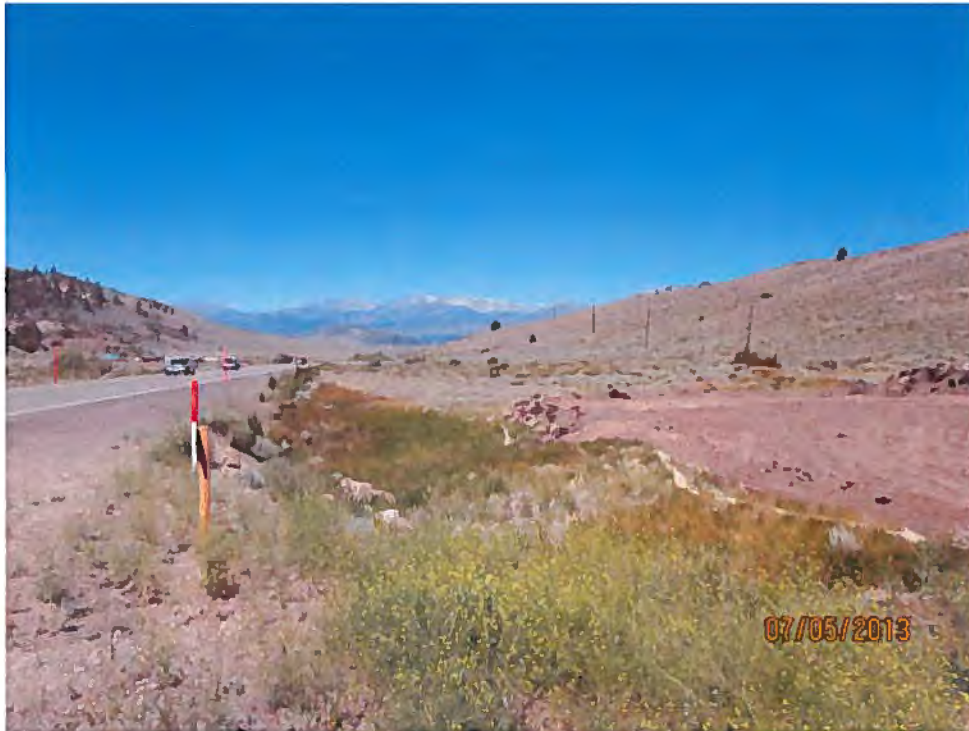
Photo 1. View to the west along Hwy 395. Remaining wetland is located within Caltrans right-of-way and the fill area on the right.

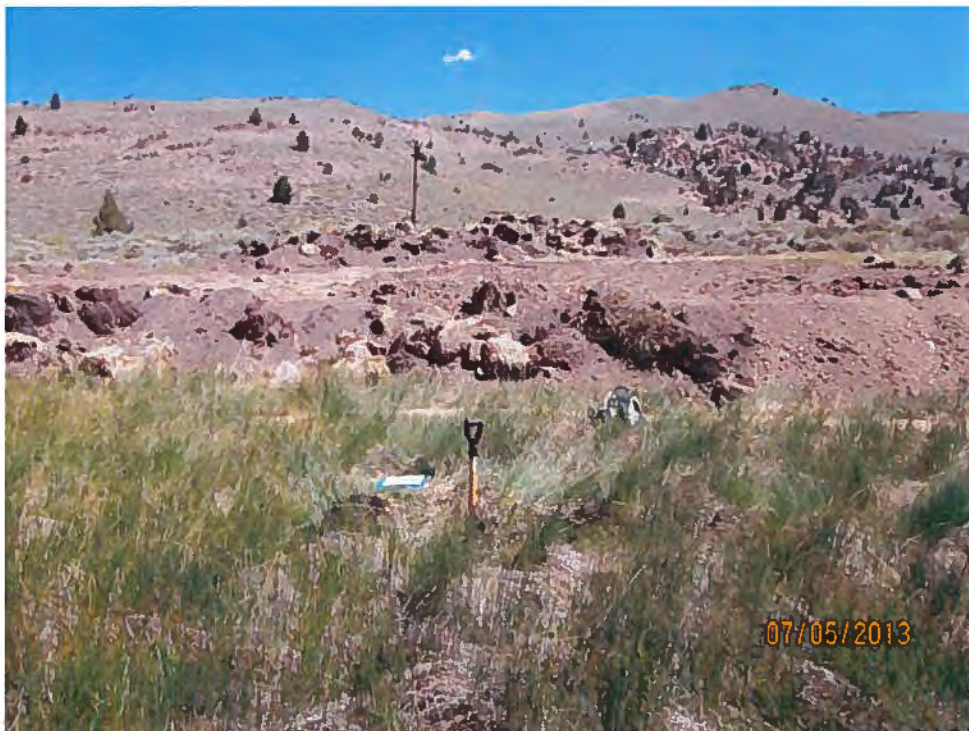
Photo 2. View to the north of DP 1 characterizing emergent wetland dominated by *Carex* sp. and *Juncus mexicanus* (FACW).

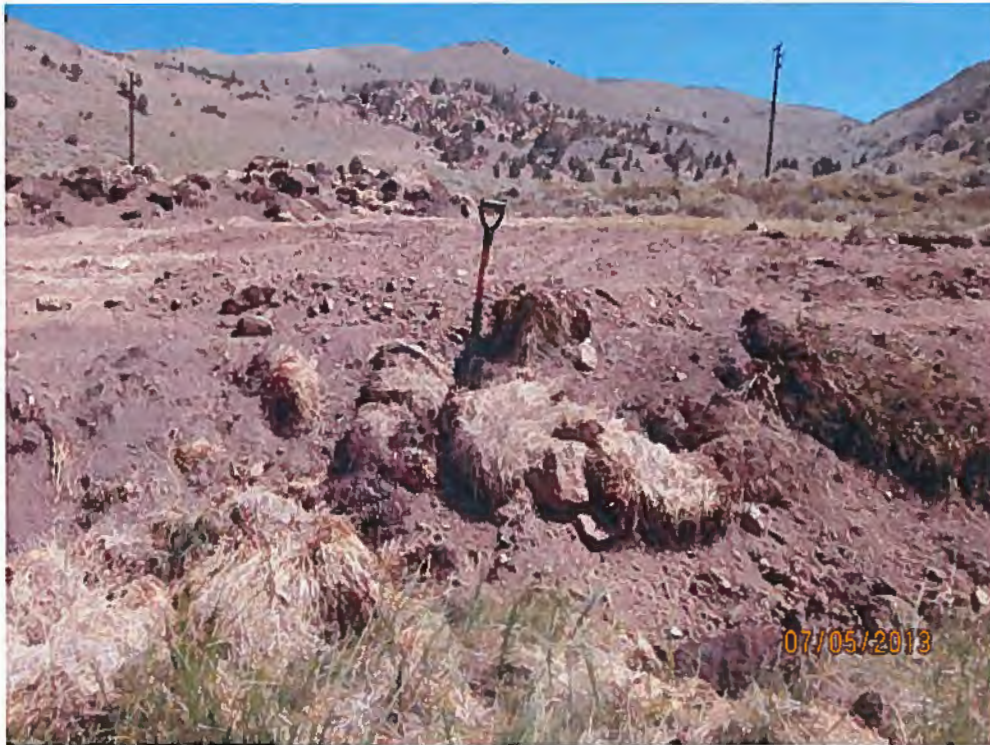
Photo 3. View to the north of DP2 describing fill material. Note darker colors of original soils and presence of *Juncus mexicanus* (FACW) in clumps of remaining original soil on edge of fill.

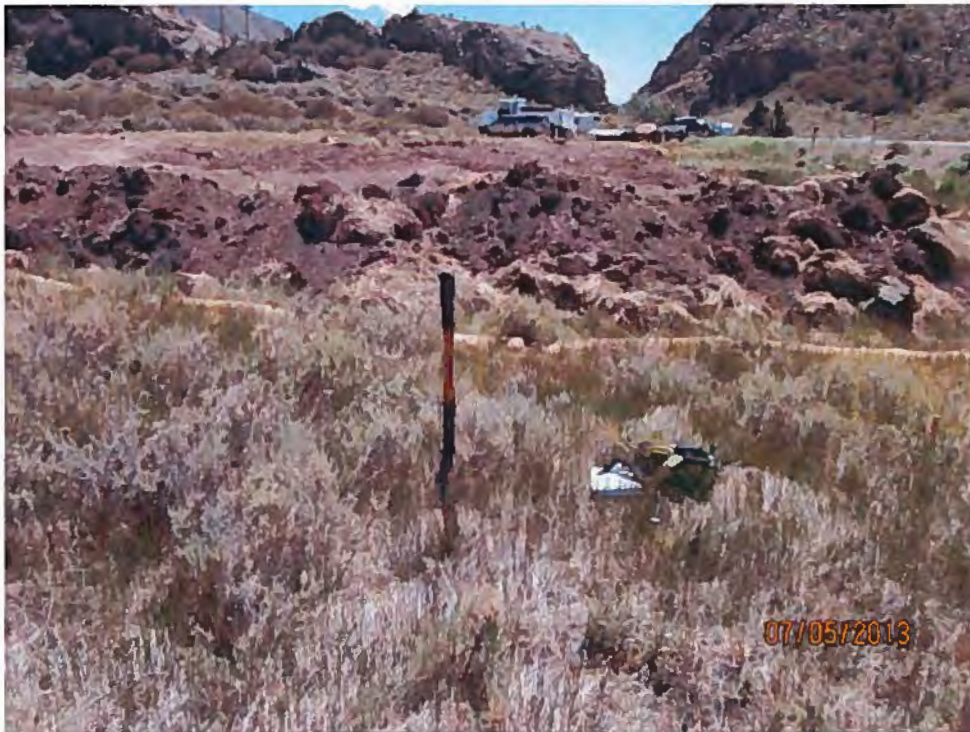
Photo 4. View to the east of DP 3 describing Silver Sage vegetation community.

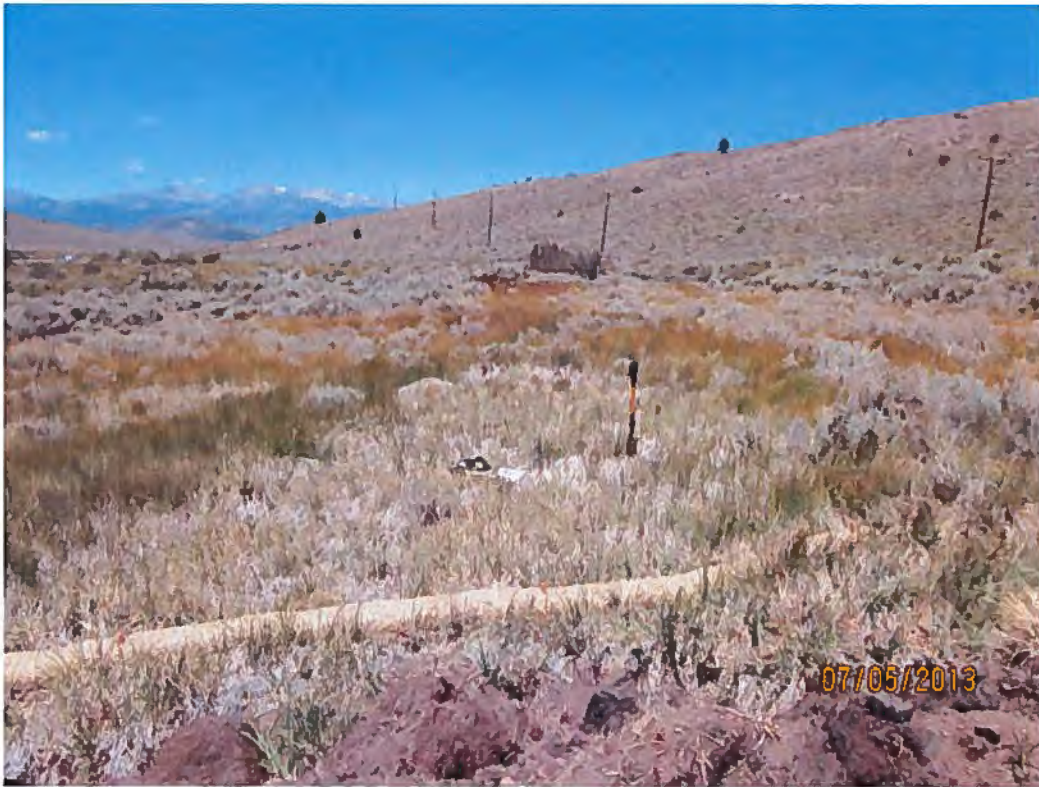
Photo 5. View to the west of DP4 describing emergent wetland adjacent to west side of fill area.

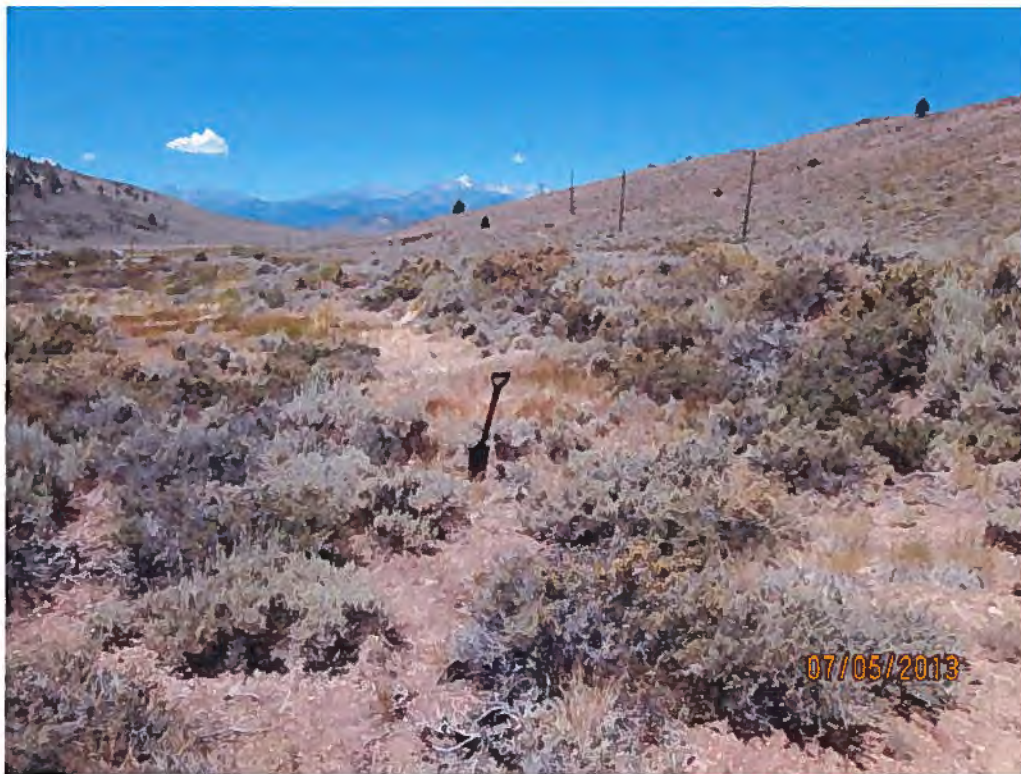
Photo 6. View to the west describing DP 6 taken within old roadbed. Vegetation dominated by upland shrubs. Fill will be removed from emergent wetland and placed within footprint of old road bed and adjacent uplands.

1. The fill material will be removed, and the wetland area will be restored to original grade and slope.
2. The fill material will be relocated to an upland area located along the old road through the site as indicated on Figure 4 and described by DP5 of the delineation report. The designated fill location is characterized by upland vegetation and soils are disturbed and compacted by the presence of the old road.
3. The top 12 inches of topsoil, which is currently stock piled on site, will be replaced and compacted.

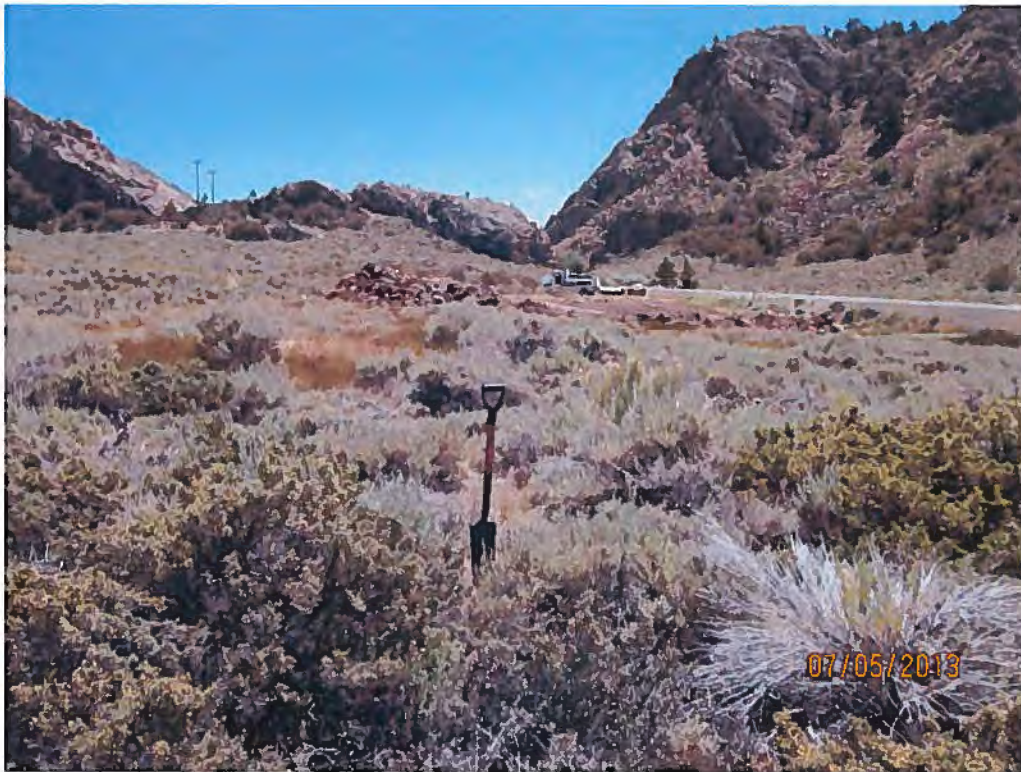
Photo 7. View to the east of DP 6 characterizing upland scrub-shrub typical of site. Dominant vegetation consists of antelope bitterbrush and big sage.

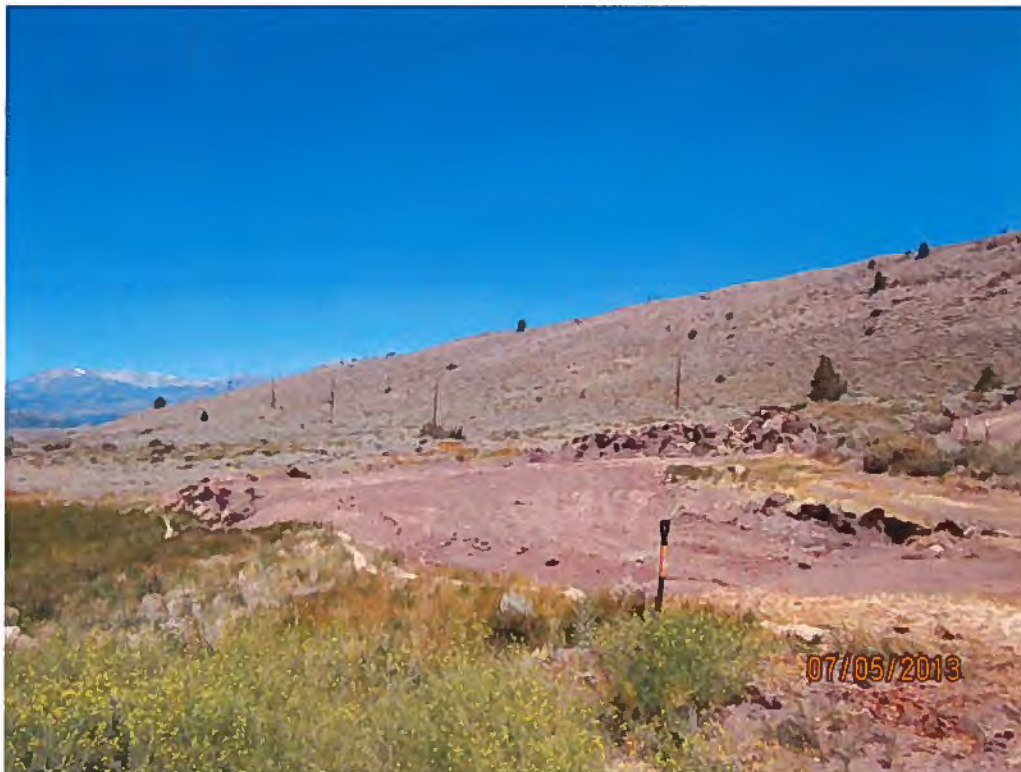
Photo 8. Overview of fill area.

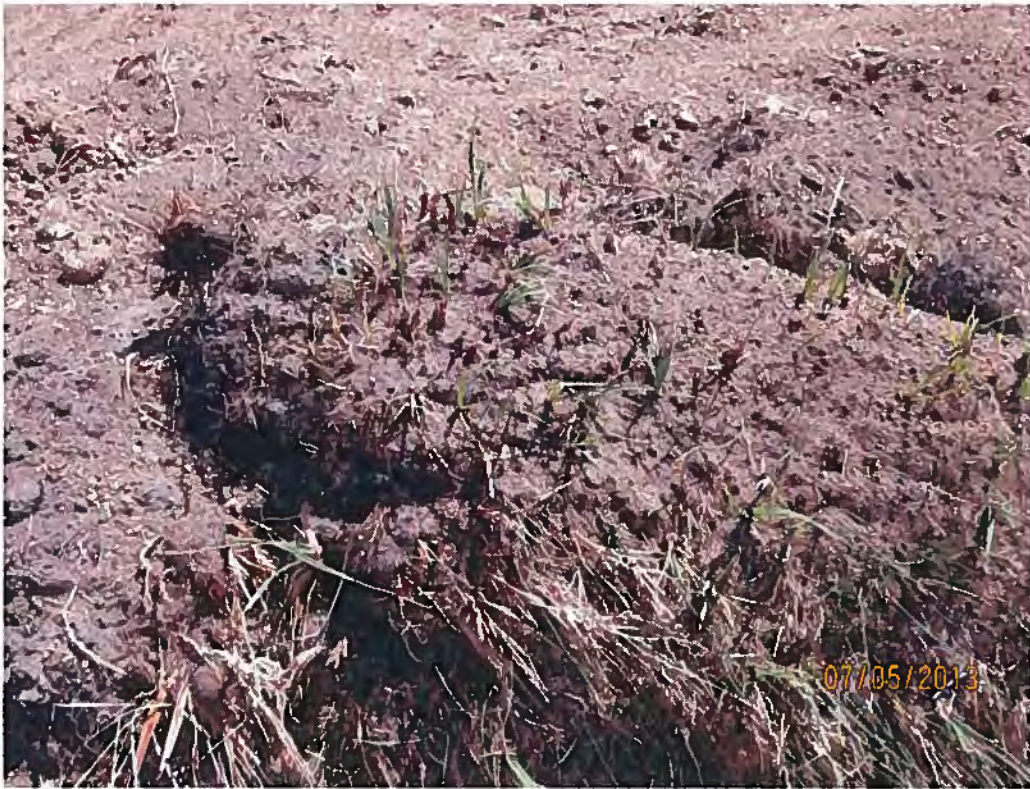
Photo 9. Example of native soils and plants spoiled
