Lahontan Regional Water Quality Control Board

SECOND NOTICE OF VIOLATION OF NPDES MARINA GENERAL PERMIT REQUIREMENTS AND INVESTIGATIVE ORDER NO. R6T-2014-0068 FOR THE TAHOE KEYS MARINA, EL DORADO COUNTY, WDID NO. 6A091807005

COMPLIANCE INSPECTION REPORT

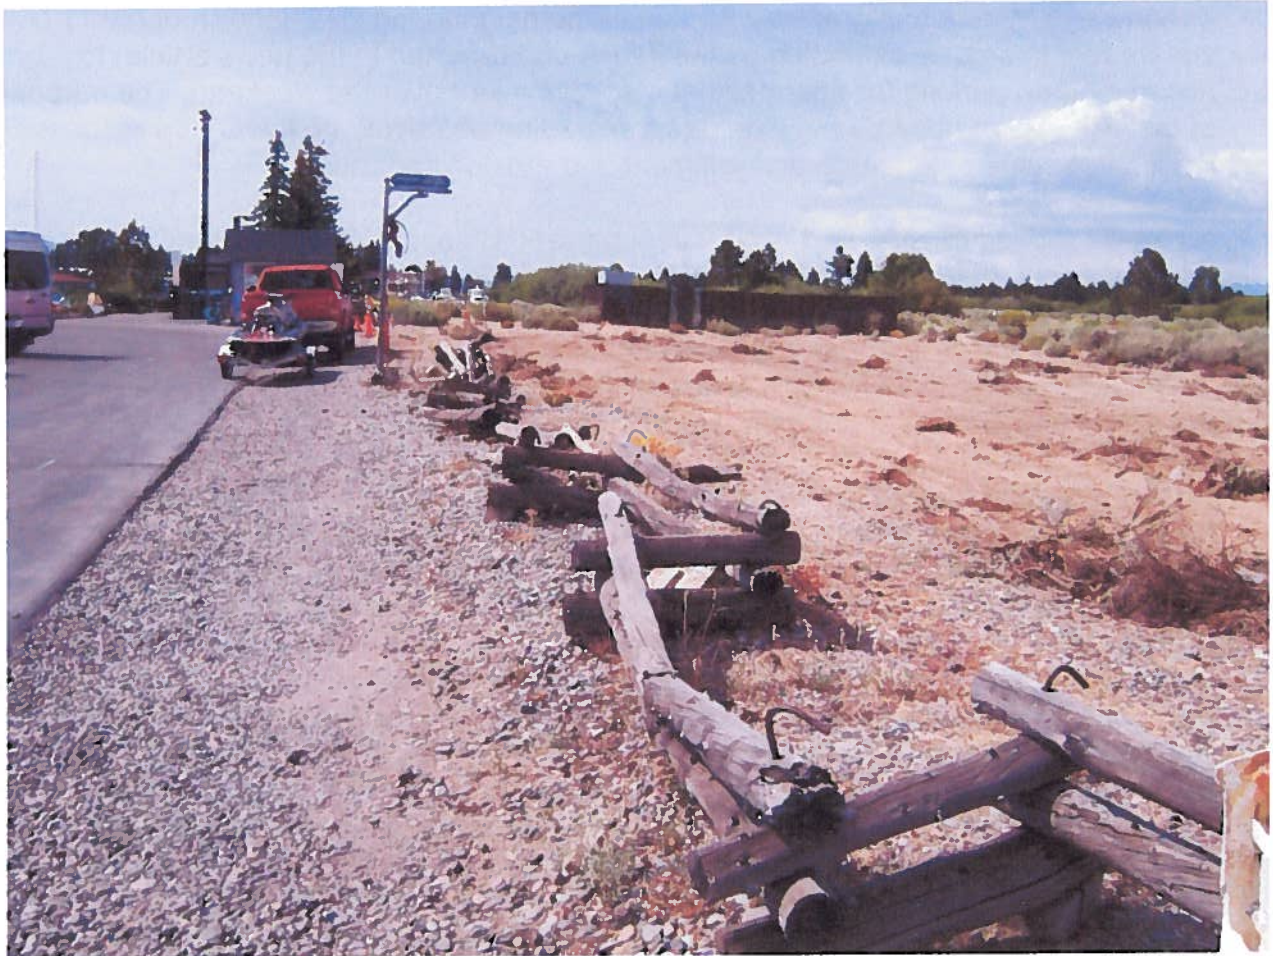
Photo No. 1. Looking northeast at graded area. Marina parking and boat ramp is on left. Existing graveled area abuts border between fenced area and parking lot.

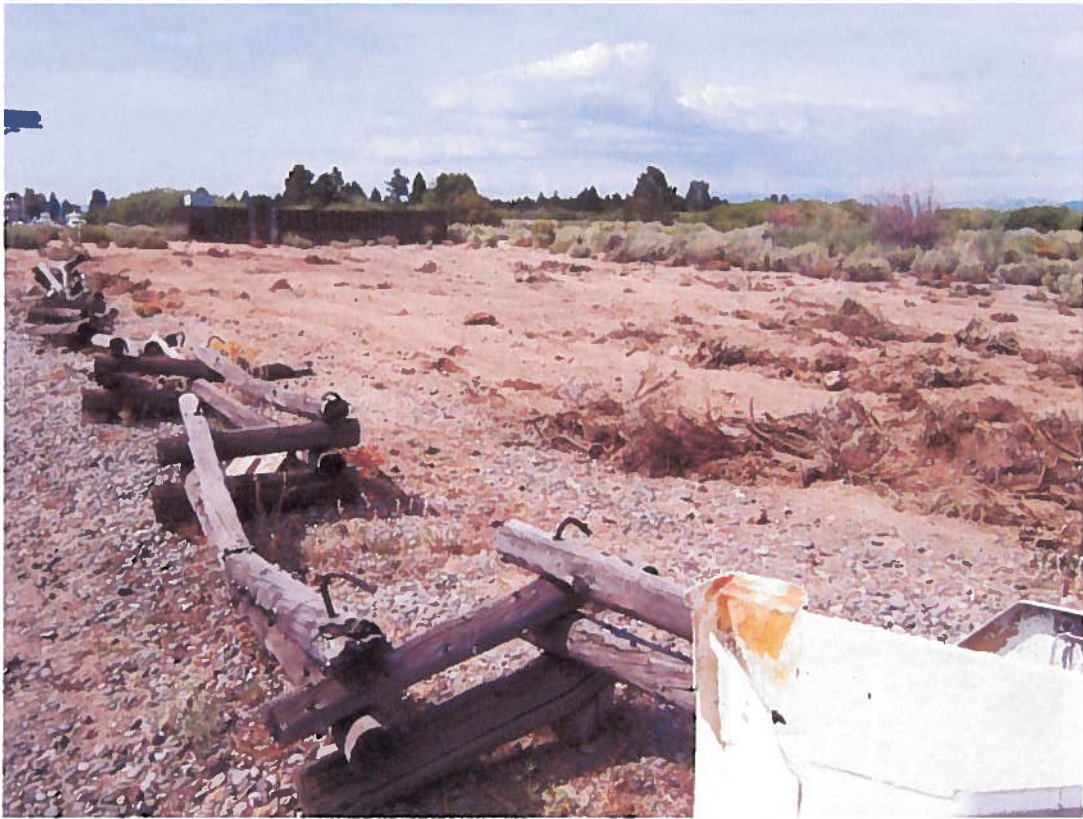
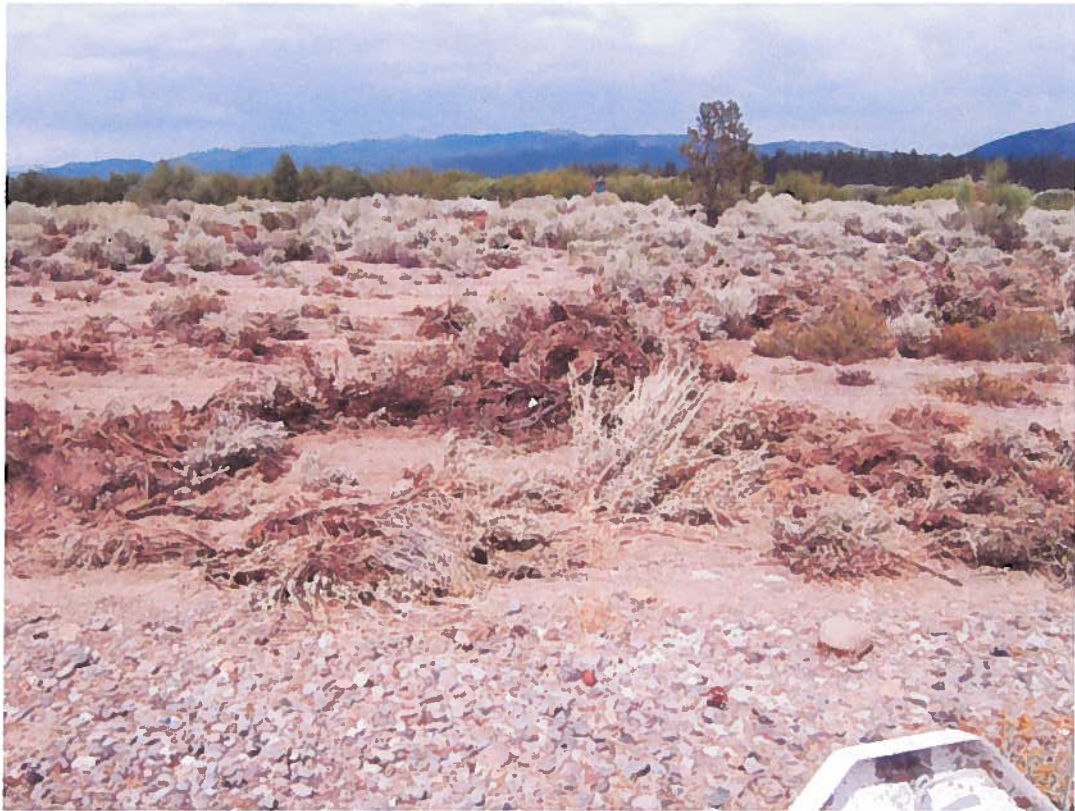
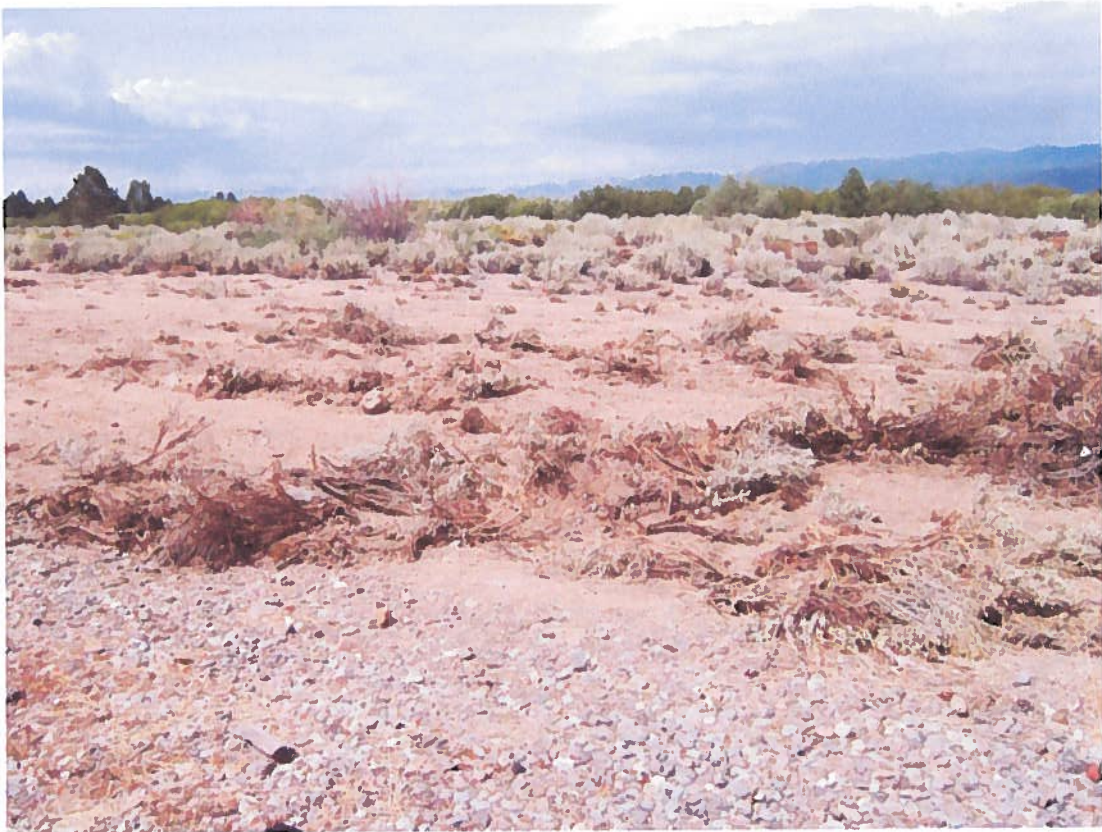
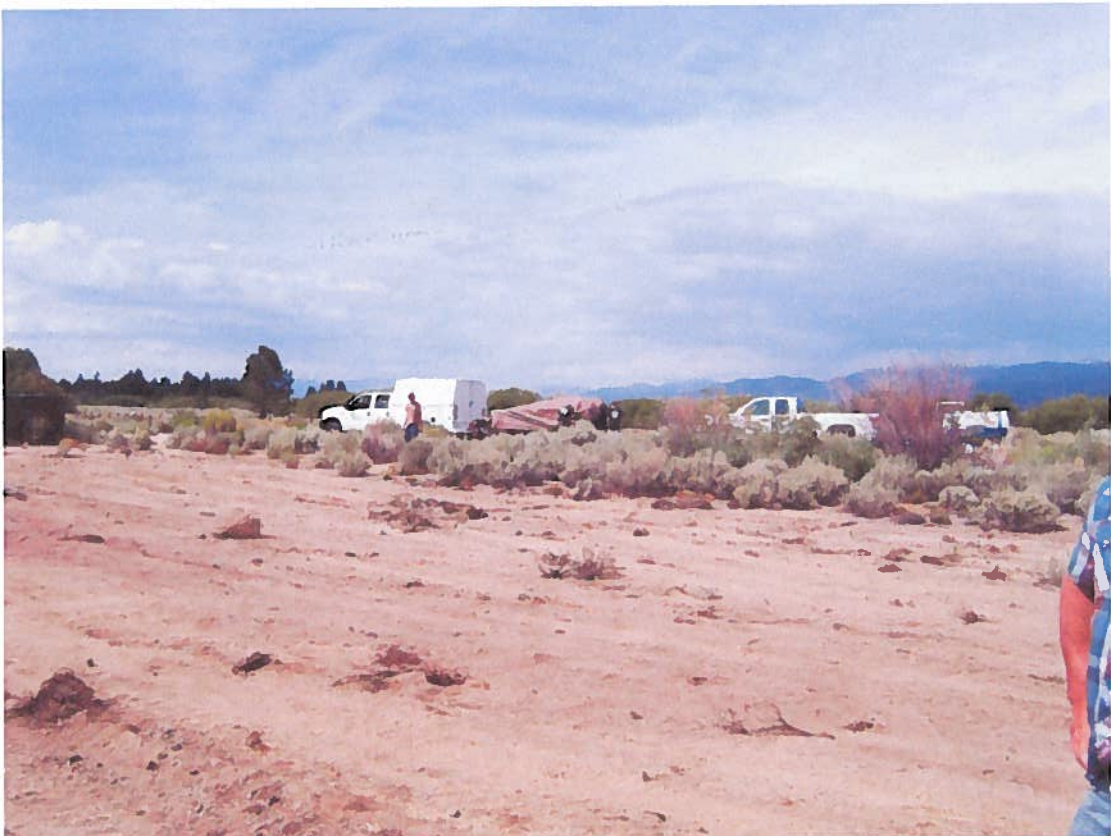
Photo No. 2. Looking east northeast at graded area.

Photo No. 3. Looking east at graded area.

Photo No. 4. Looking east northeast at graded area.

Photo No. 5. Looking east northeast at graded area, CTC crews arriving to install BMPs.

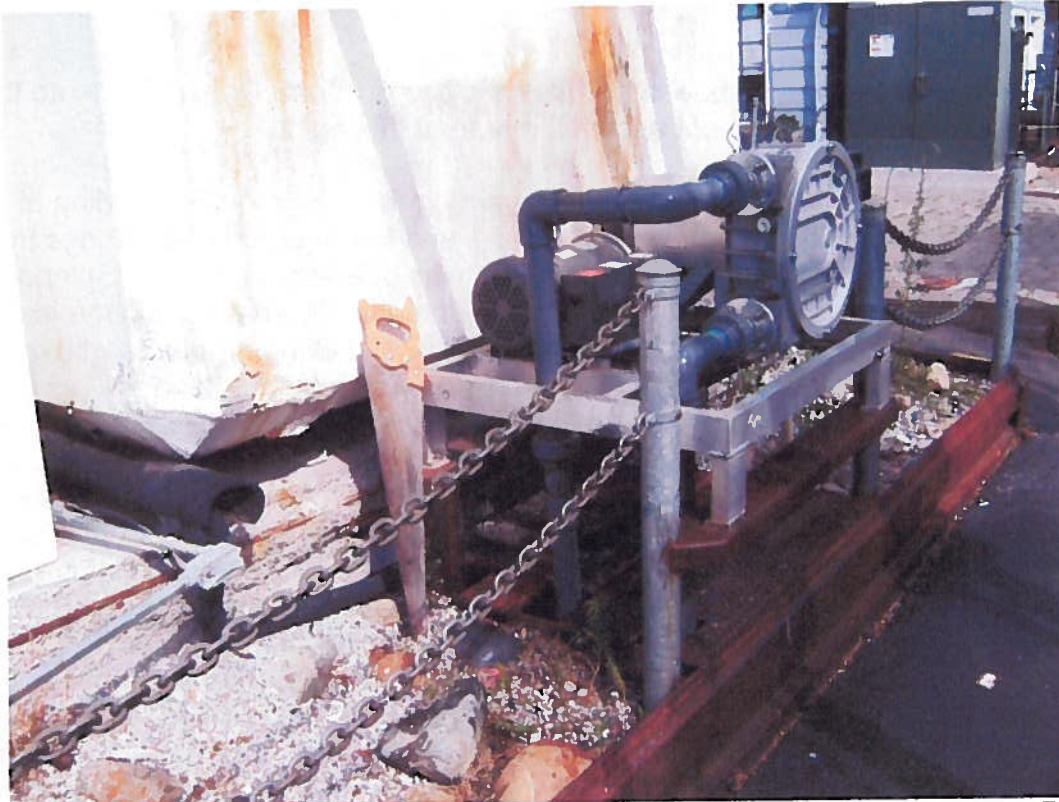
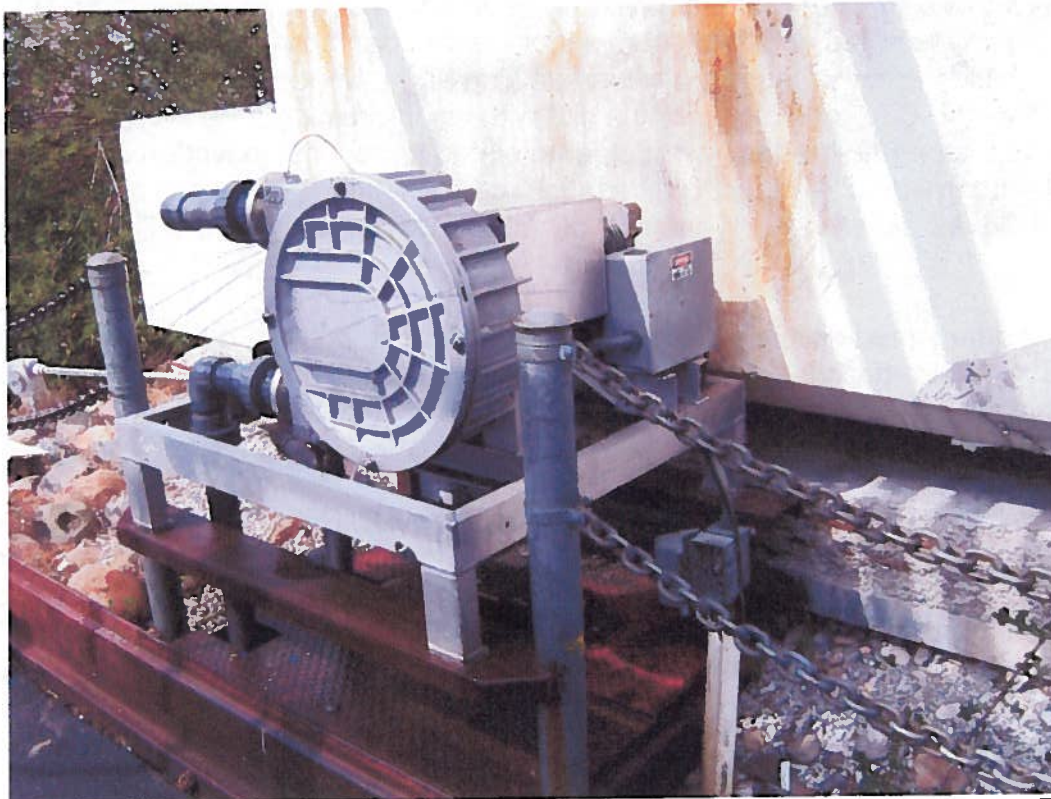
We walked out to the sewage pump-out station and Mr. Spinnato showed me the work that was underway to repair it (See Photo Nos. 6 and 7). Mr. Spinnato went to meet the folks delivering gravel (he was taking the additional step to lay additional gravel on the edge of the marina paved area along the site that was graded without authorization). I walked to the area where I observed the antifreeze spill last week during my July 22nd inspection. The gravel area was still stained (See Photos Nos. 8 and 9). I found Mr. Spinnato and brought this to his attention. Mr. Spinnato deployed two individuals to dig out the gravel while I was there (he instructed them to put the gravel in a bucket to be disposed of separately). I observed the crew digging out the gravel when I left the site at 4:10 p.m.

Photo No. 6. Sewage Pump-Out, located on northwest side of Fresh Ketch restaurant. Repairs had been made to facility earlier in the day, per Robert Spinnato.

Photo No. 7. Sewage Pump-Out, located on northwest side of Fresh Ketch restaurant. Repairs had been made to facility earlier in the day, per Robert Spinnato.

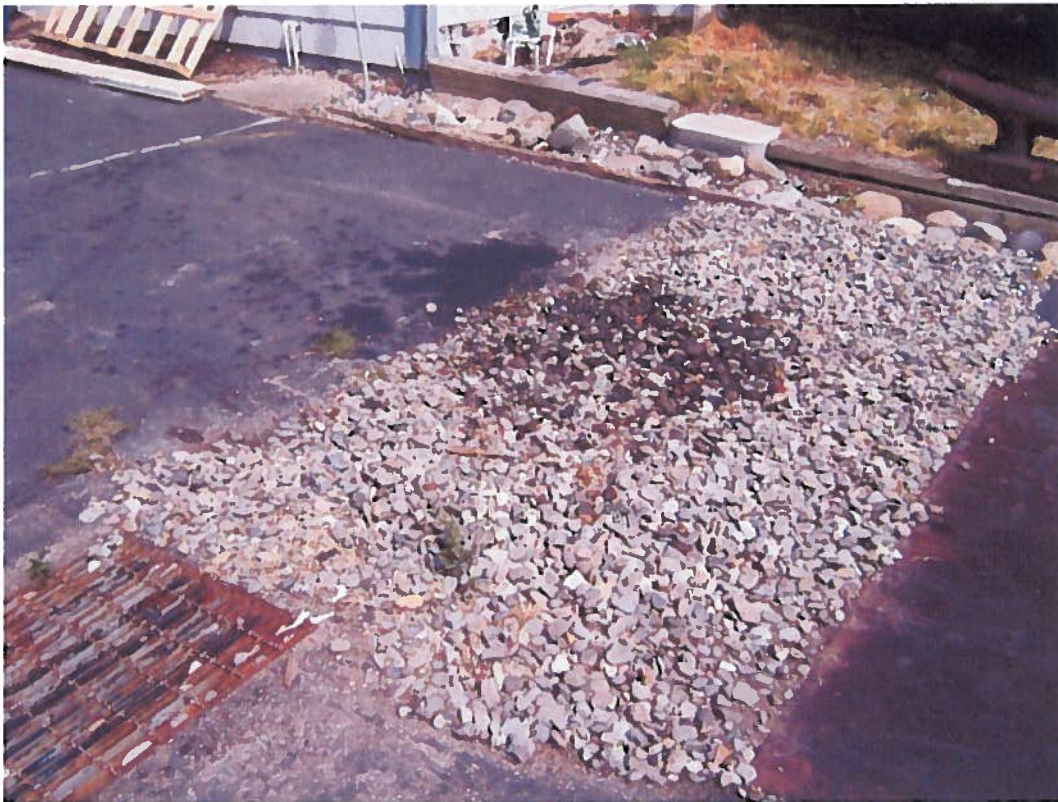
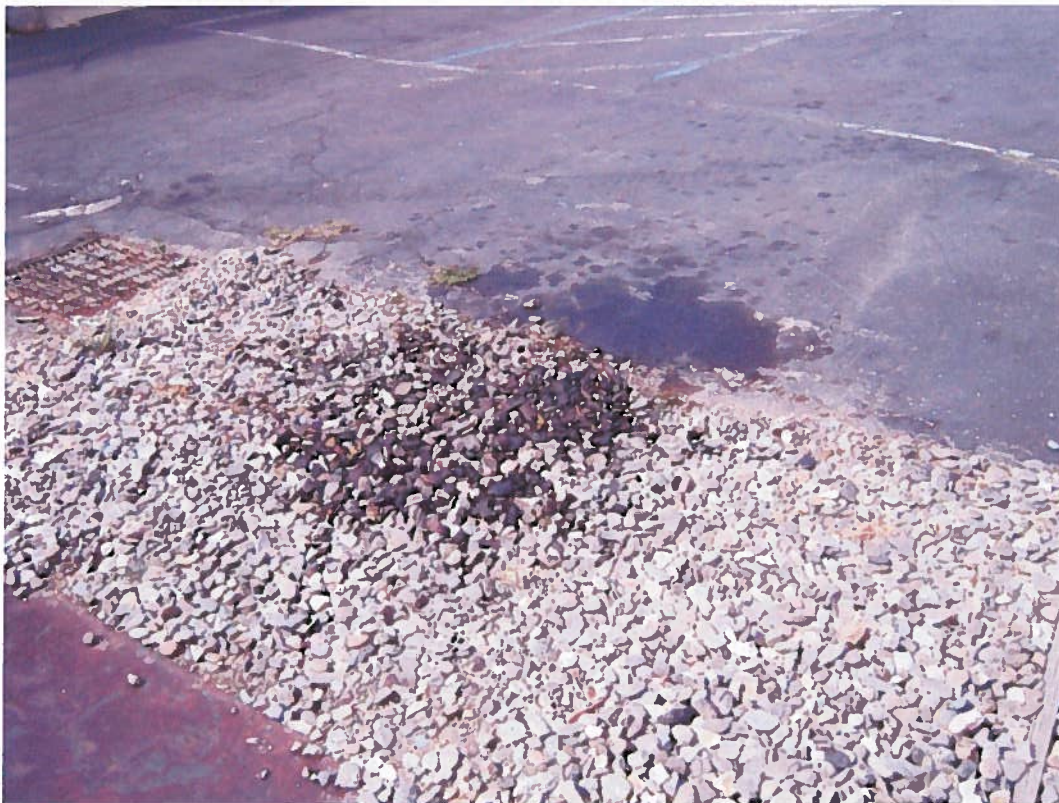
Photo No. 8. Antifreeze-stained gravel in drain rock on northwest corner of maintenance building. Looking southeast, marina bulkhead is immediately to the right of photo

Photo No. 9. Antifreeze-stained gravel in drain rock on northwest corner of maintenance building. Looking east northeast, marina bulkhead is immediately behind me.

2. Continued failure of the Tahoe Keys Marina to clean up anti-freeze spill in an area close to marina waters. Section III.D.4.c of Attachment G of the Permit requires Tahoe Keys Marina to implement, "Procedures for expeditiously stopping, containing, and cleaning up leaks, spills, and other releases." (Attachment G to the Marina General Permit is incorporated by section VII.A.11 of the Marina General Permit.) The Marina's Storm Water Pollution Prevention Plan (SWPPP) notes that non-stormwater releases may be associated with drips from parked vehicles, and the response to spills or releases includes, "...excavate all soils found to be contaminated, store material on thick plastic sheeting surrounded by straw bales, disposal to be provided by EPA authorized hauler." [Appendix B, Item C.3 of the SWPPP]

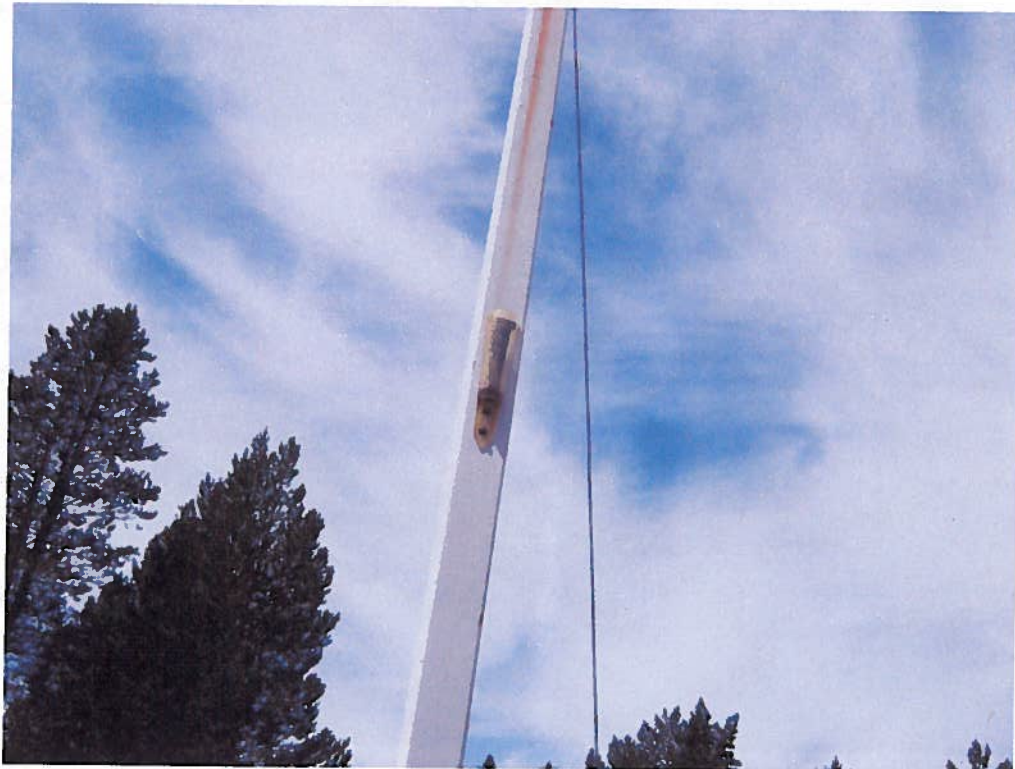
We began the tour of the facility by heading northwest from the marina office to the harbor, along the northwest side of the Fresh Ketch restaurant. The fueling pumps, sewage pump out, and rain gage are all located within this area. We immediately observed the rain gage, and noted that after all the rain that had occurred over the weekend, it was empty. Mr. Spinnato noted that because of its position on the post (see Photo No. 1), it doesn't collect rain very well.

Photo 1. Rain gage located west of Fresh Ketch near Fuel Pump, looking West

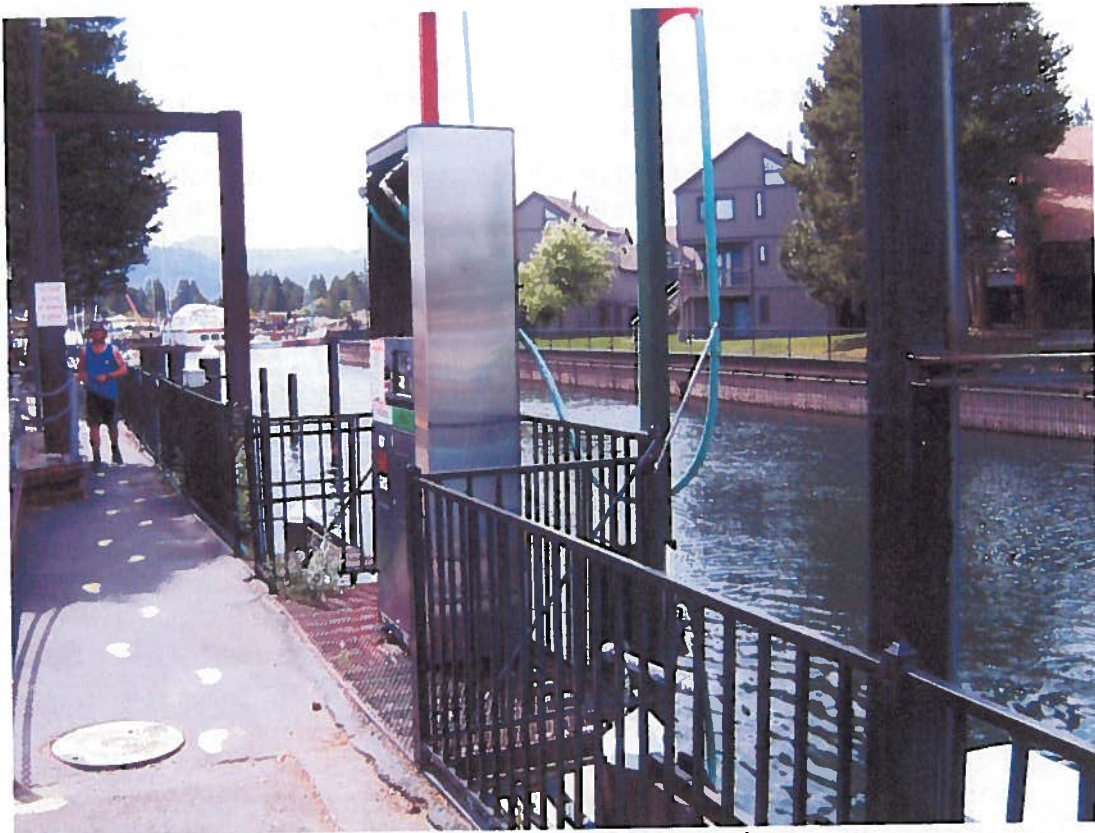
Photo 2. Diesel Pump, looking southwest.

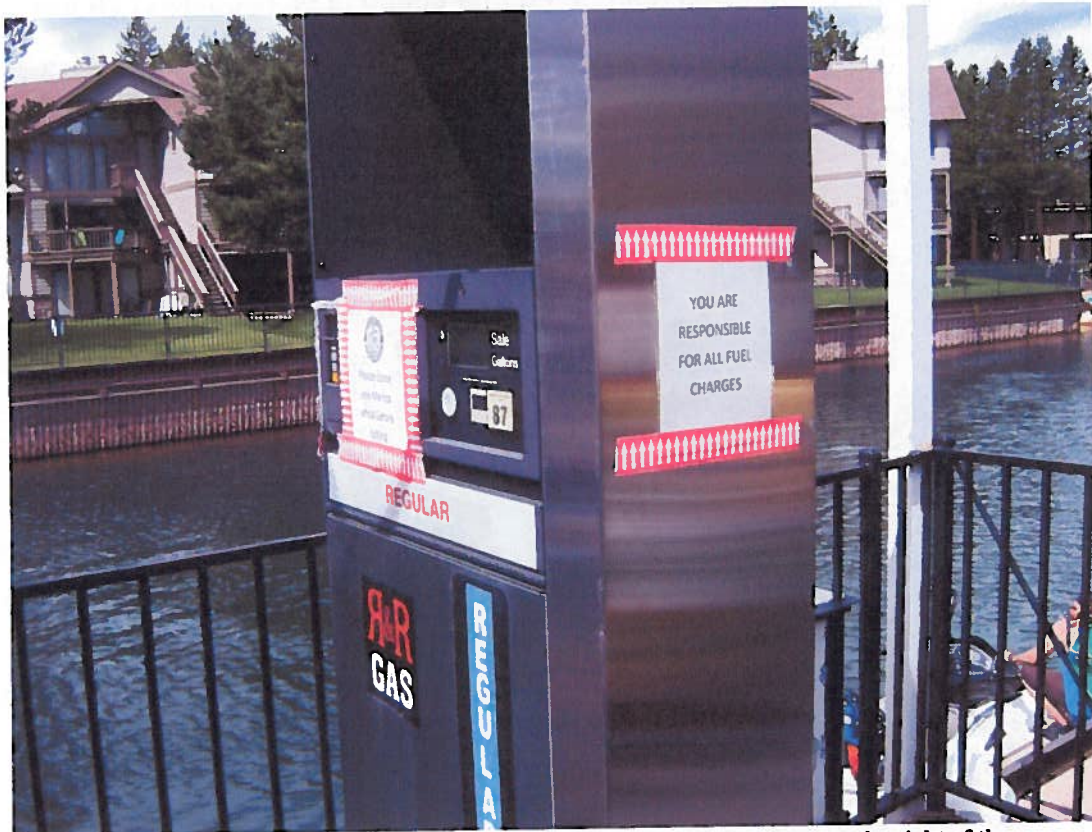
Photo 3. Gas pump, looking north west. Rain gage is on the white post to the right of the pump.

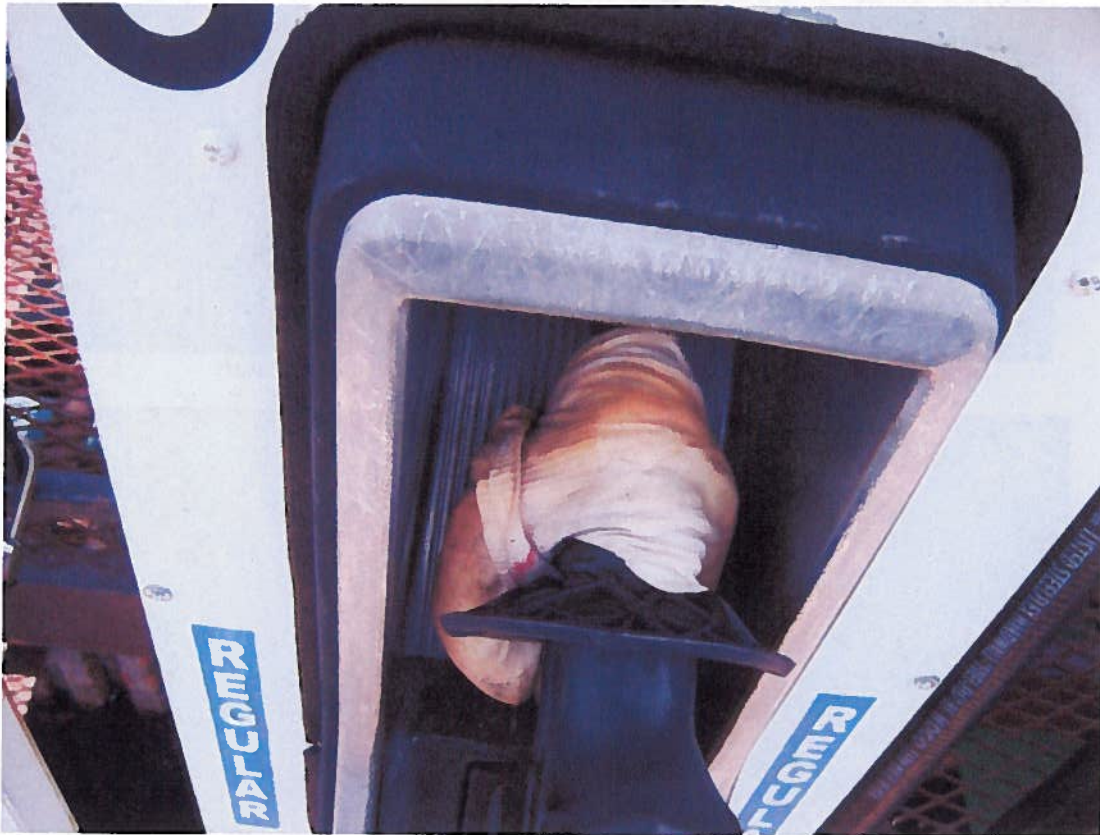
We then turned our attention to the fueling pumps. The gasoline nozzle had an oil-rag wrapped around it to collect incidental drips. However, the rag appeared to be completely saturated and of no use. Mr. Spinnato said that they were out of oil-absorbent pads, and that new materials were on order. (At the end of the inspection, he provided us with Invoice No. 12081 from Hytec Environmental showing that additional materials had been ordered. The Form is Attached, but it shows that the order was placed on July 22, 2014 – the date of the inspection, and that materials would not be delivered until July 25, 2014. Mr. Spinnato stated that the order was placed the day prior, July 21, but that it has the July 22nd date on it because that is when they called to get a copy of the invoice.) However, some oil boom materials were in stock in other areas of the marina, but no absorbent pads. More booms and pads were on order.

Photo 4. Gasoline-soaked absorbent material around pump dispenser.

8. Failure to properly dispose soiled absorbent pads (see Photo No. 4) pursuant to section I.A.13.e of the Marina Pollution Prevention Plan (Attachment H to the Marina General Permit, incorporated under section VII.A.11 of the permit).

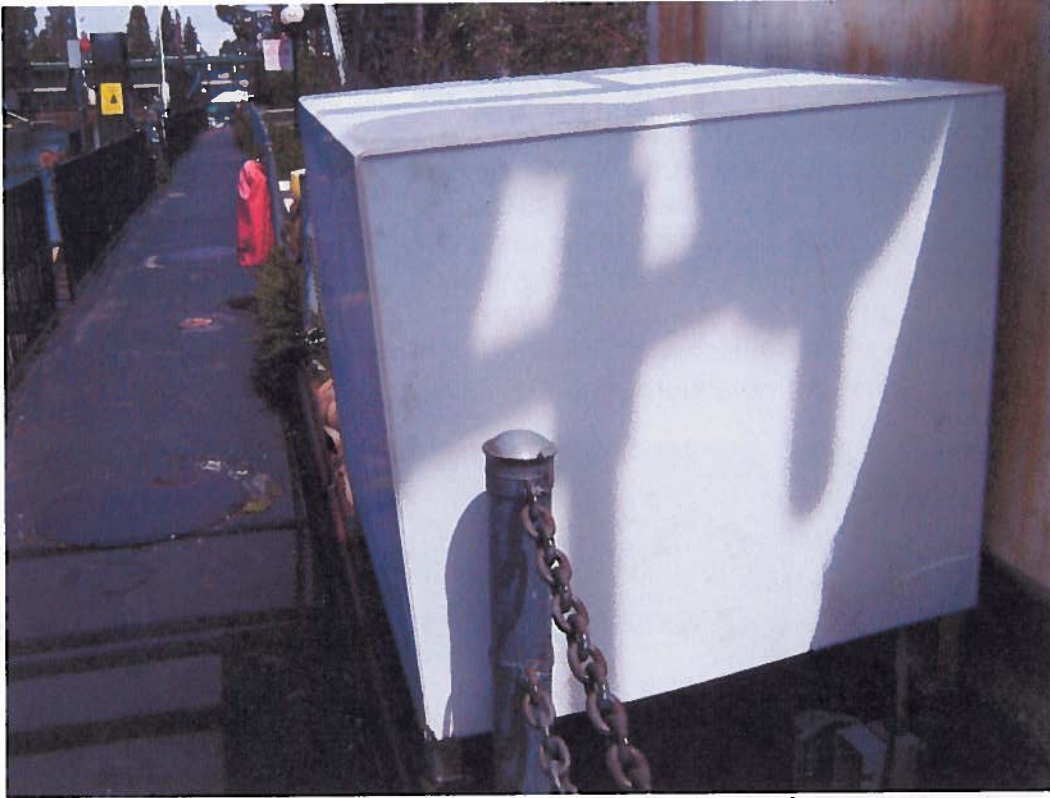
We next inspected the sewage pump out facility, which is located across the walkway and southeast of the fuel pumps. Mr. Spinnato stated that the pump-out has been non-operational sporadically for approximately a month (he was able to get it to work for about two weeks during this non-operational period). Mr. Spinnato indicated that he hopes to get it operational by the following day - July 23, 2014. At the end of the inspection, Mr. Spinnato discussed the difficulties he has had over the past month to secure supplies and replacement parts, noting that they have to be special ordered, and that when he gets an order that is incorrect the process slows even further. He stated he will provide documentation of what has been ordered.

Photo 5. Sewage Pump Out facility, looking northeast.

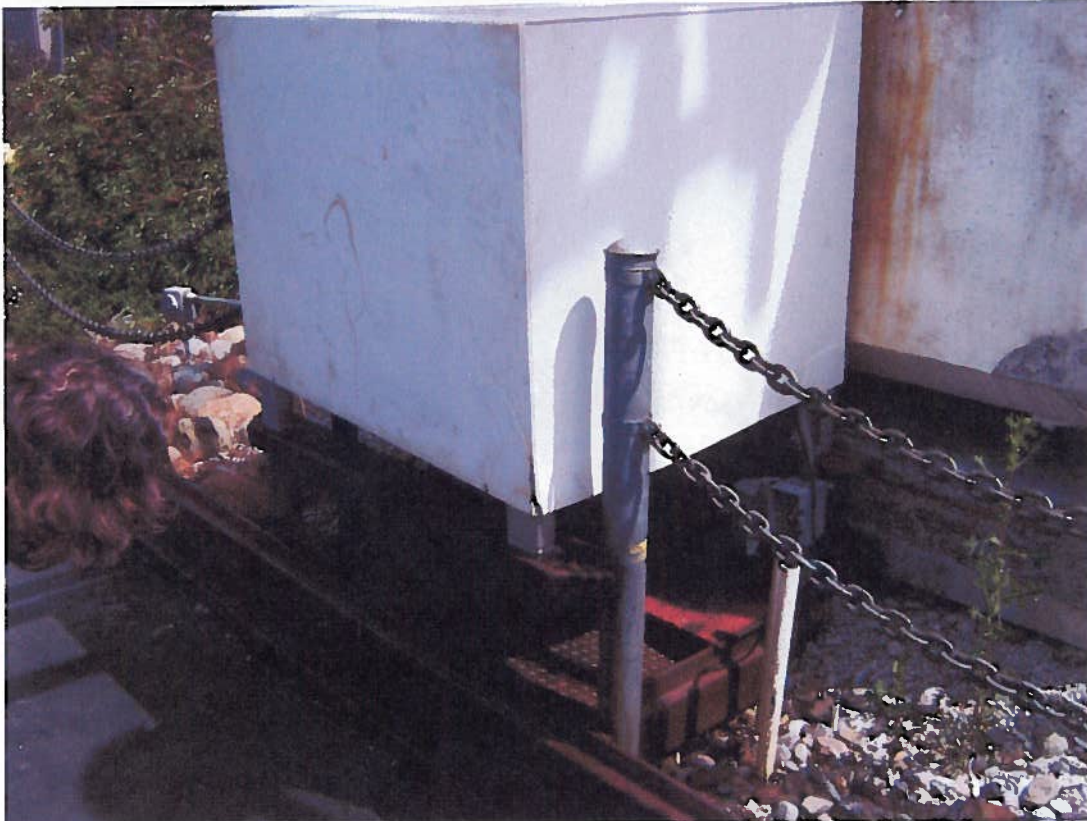
Photo 6. Sewage Pump Out facility, looking northeast. Silicon lubricant has spilled on rocks/rack below from ongoing maintenance activities to get it operational again.

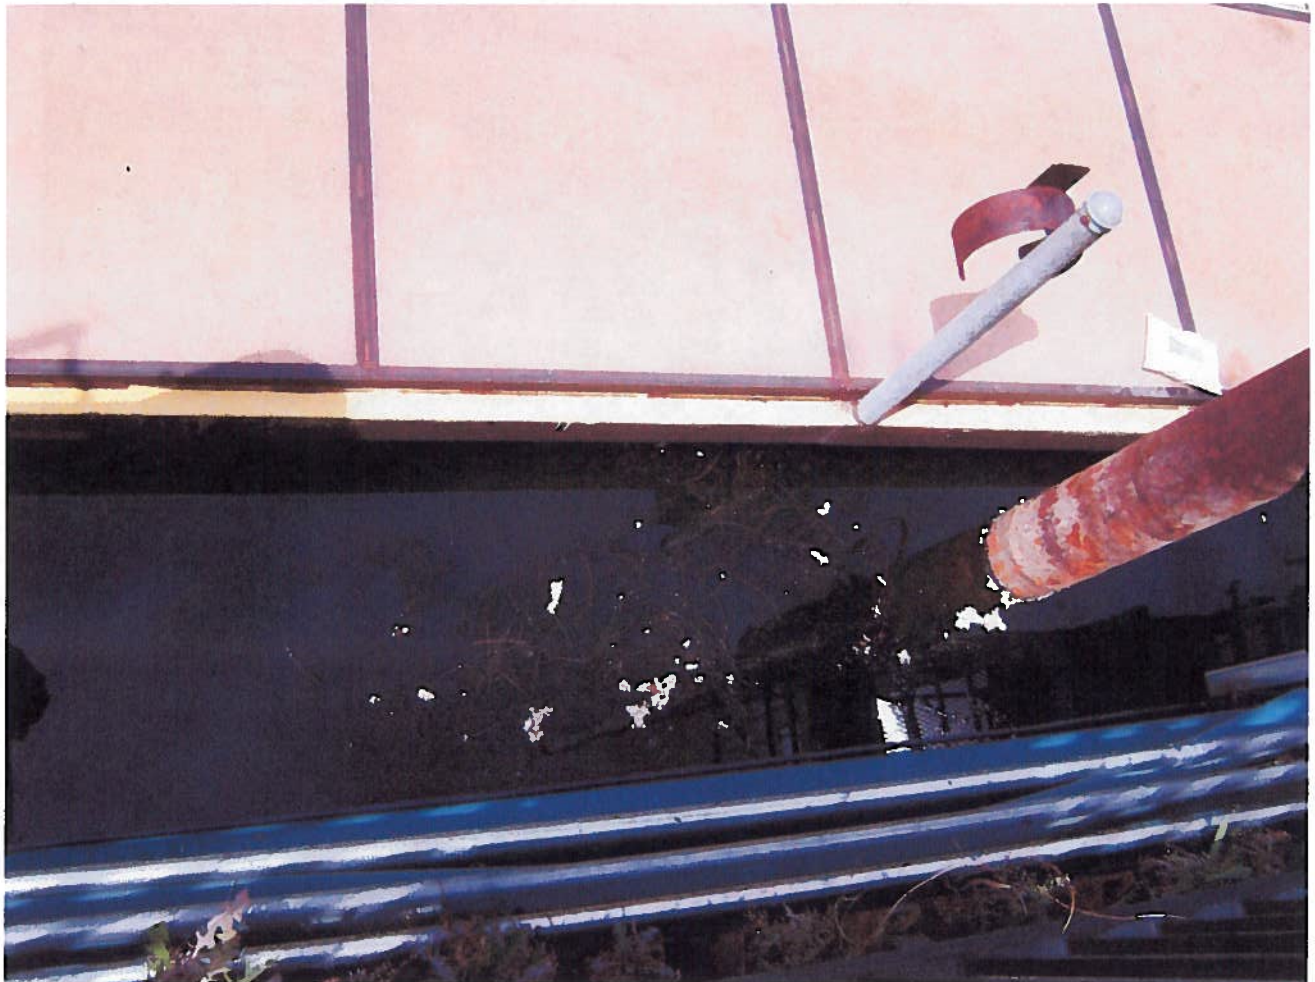
We observed pieces of Styrofoam still in the water, which was the subject of a complaint from last spring. Mr. Spinnato stated that crews are out every morning to collect all floating materials (Styrofoam, garbage, aquatic plant materials, etc.) around the docks. He stated that this is a constant activity as material is continually blown into the harbor areas.

Photo 7. Extraneous styrofoam in harbor, between bulkhead and dock on the northwest side of the Fresh Ketch restaurant, near the area of the fuel pumps.

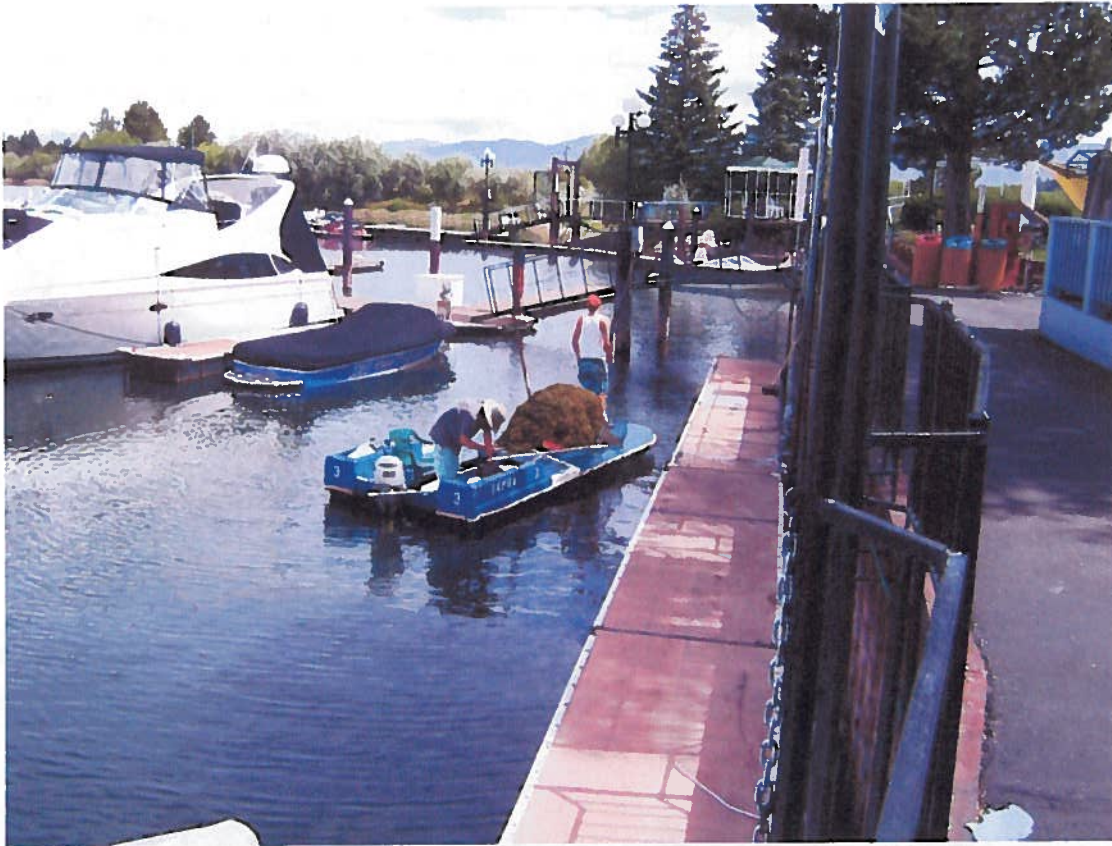
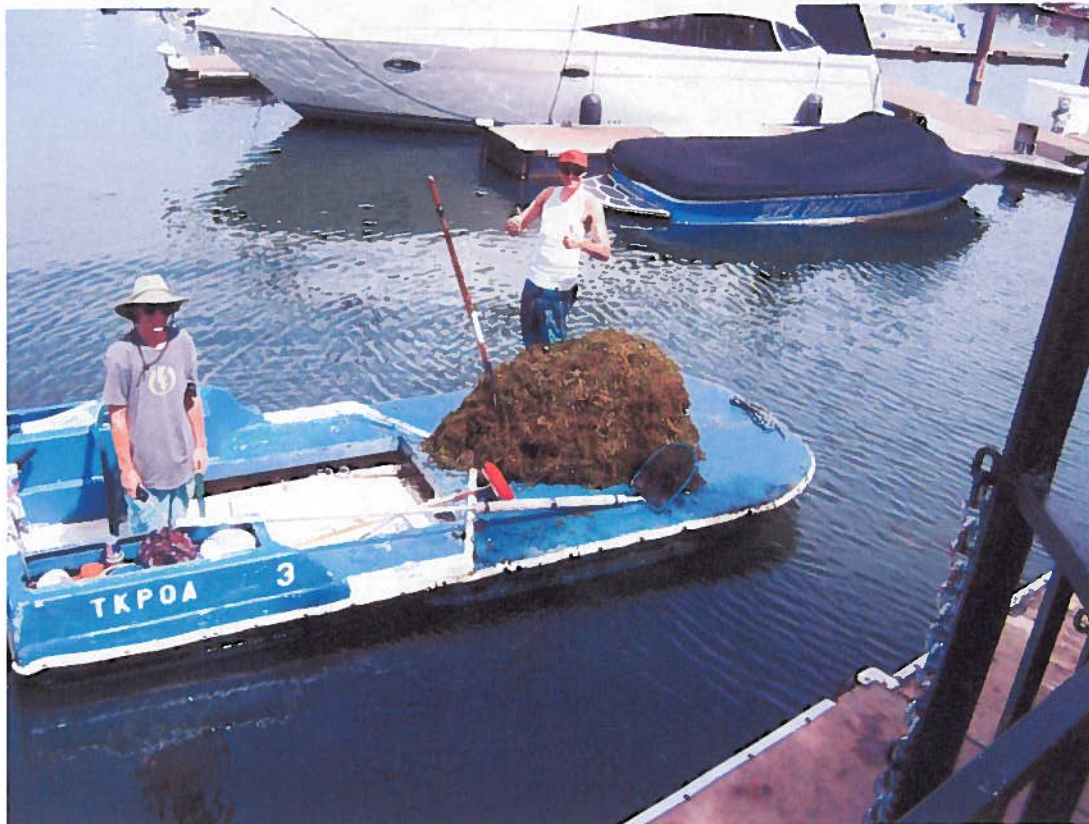
Photo 8. Crew harvesting floating materials (mostly vegetative), located on the northeast side of the Fresh Ketch restaurant, looking toward boat launch area.

Photo 9. Crew harvesting floating materials (mostly vegetative), located on the northeast side of the Fresh Ketch restaurant.

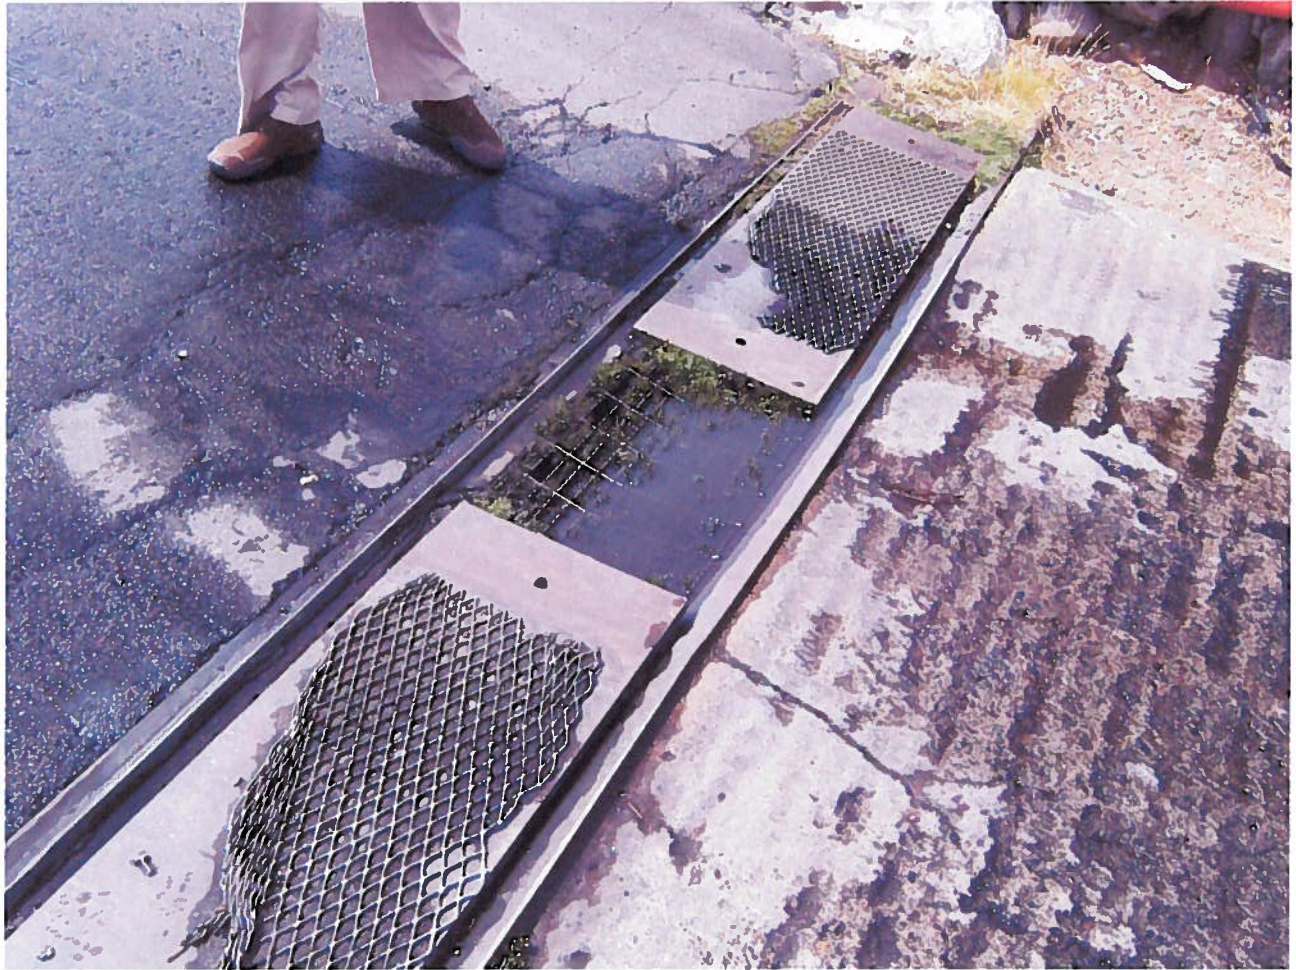
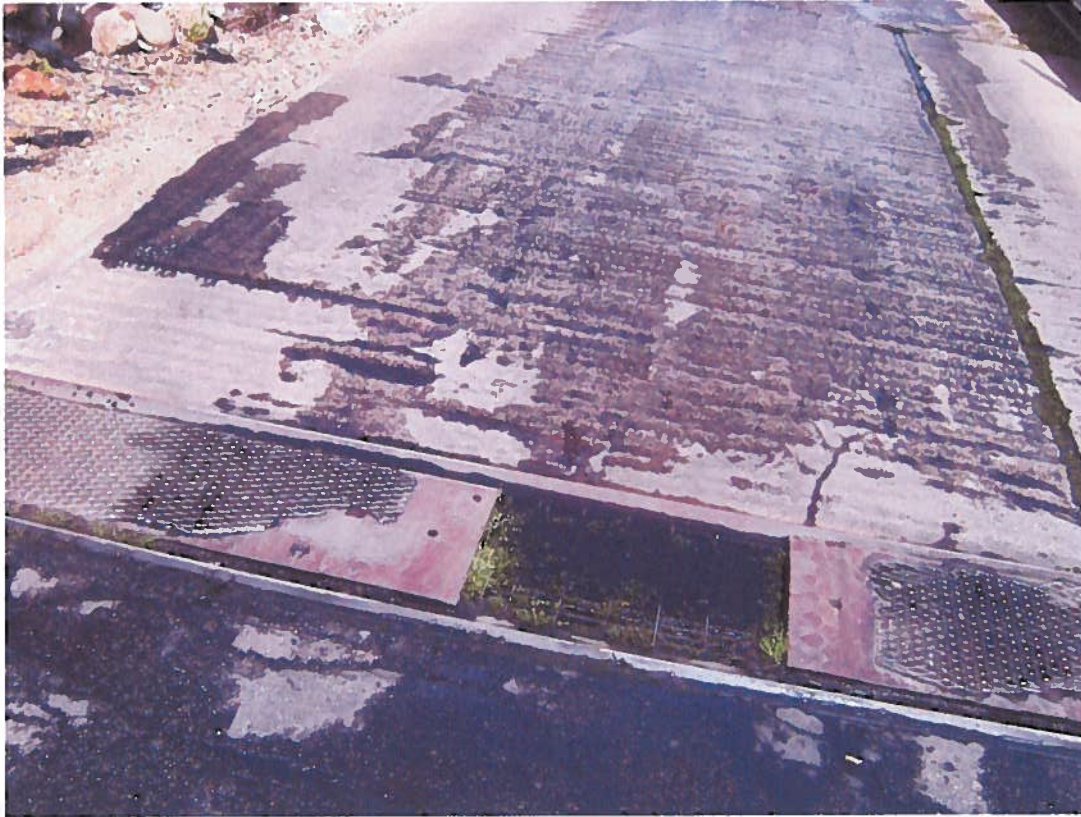
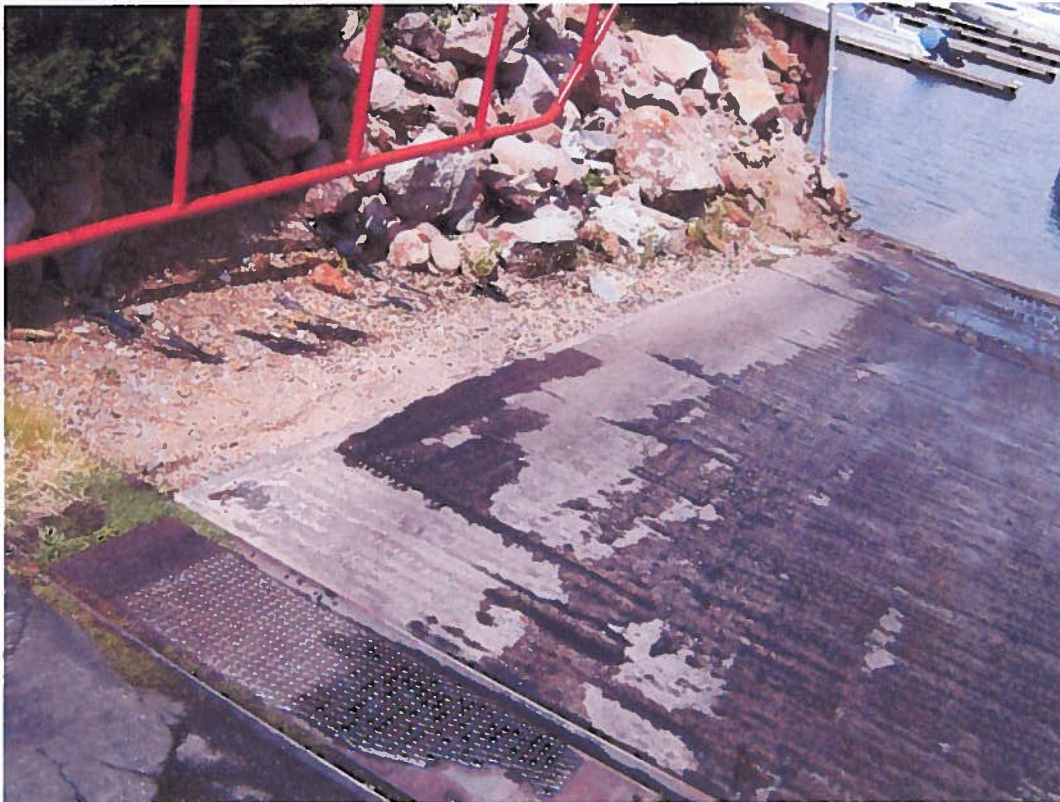
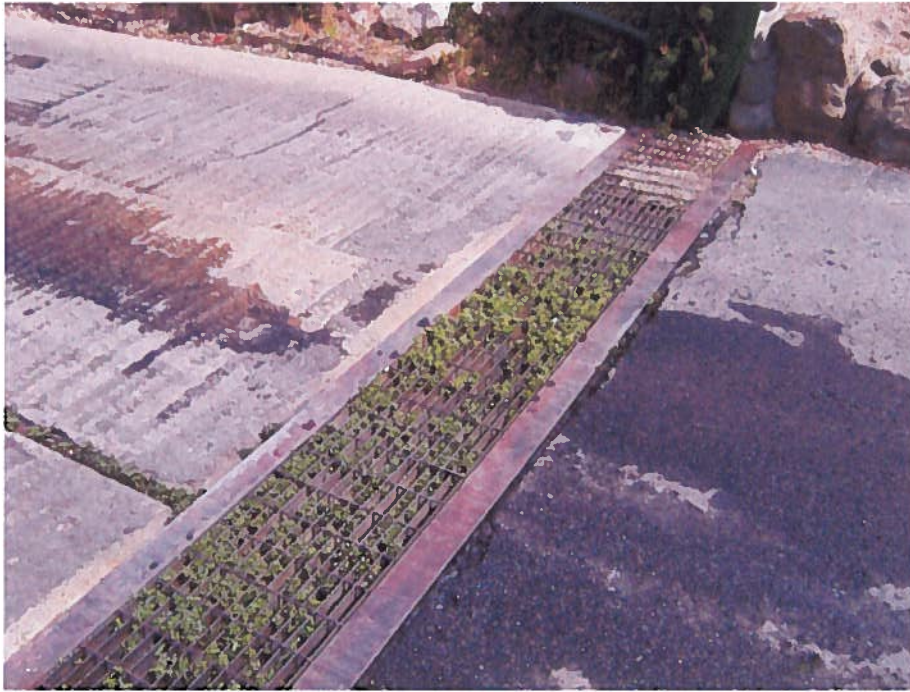
We walked over to the boat launch area. The slotted drain was clogged, full of water, and full of sediment. Vegetation was growing out of it. Mr. Spinnato stated that the drain is not cleaned out very often because it is welded down. He also stated that this, along with the rest of the parking lot, will be reconstructed in the future, and all BMPs will be retrofitted at that time. Mr. Spinnato stated that he has a meeting with the California Tahoe Conservancy on Thursday, July 24th, to discuss retrofit plans and the incorporation of some of the existing and adjacent Conservancy land in the project. He also noted that the Tahoe Regional Planning Agency (TRPA) is requiring the retrofit to be completed in 2015 as a condition of their existing marina permit from the TRPA.

Photo 10. Clogged slotted drain along boat ramp, located on northeast side of the marina, looking toward the west side of the ramp.

Photo 11. Clogged slotted drain along boat ramp, located on northeast side of the marina, along the west side of the ramp facing the Lake.

Photo 12. Clogged slotted drain along boat ramp, located on northeast side of the marina, along the west side of the ramp.

Photo 13. Clogged slotted drain along boat ramp, located on northeast side of the marina. Looking toward the east side of the ramp.

10. Failure to maintain on site storm water runoff BMPs, as required by Section VII.C.3.b.i. of the Marina General Permit. The boat ramp drain was clogged (Photos Nos. 10-13).

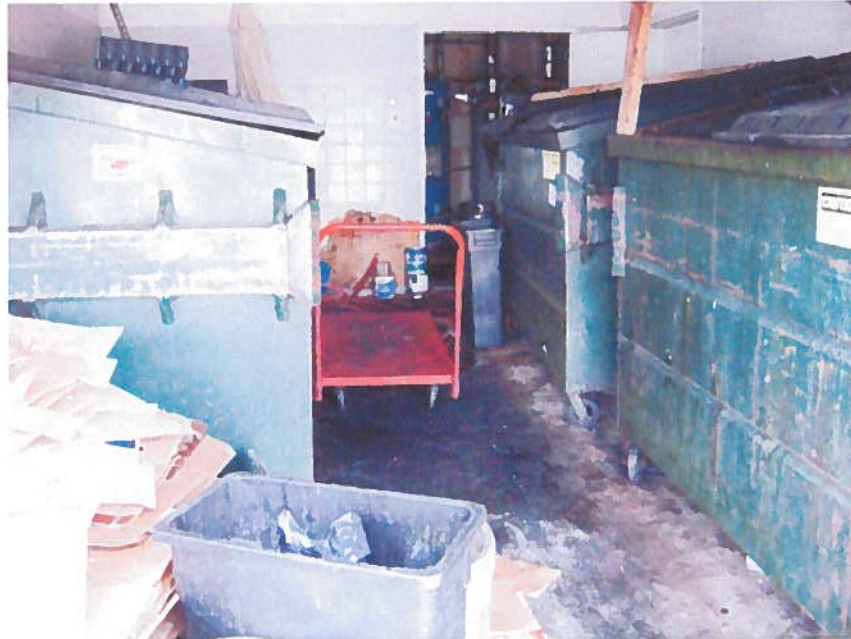
has a floor drain which is plumbed directly to the local sewer system. We commented that there wasn't a lot of room for washing mats in this area and Mr. Spinnato agreed with us, noting the presence of boxes and other items.

Photo 14. Restaurant maintenance/storage area.
