Lahontan Regional Water Quality Control Board

SECOND NOTICE OF VIOLATION OF NPDES MARINA GENERAL PERMIT REQUIREMENTS AND INVESTIGATIVE ORDER NO. R6T-2014-0068 FOR THE TAHOE KEYS MARINA, EL DORADO COUNTY, WDID NO. 6A091807005

COMPLIANCE INSPECTION REPORT

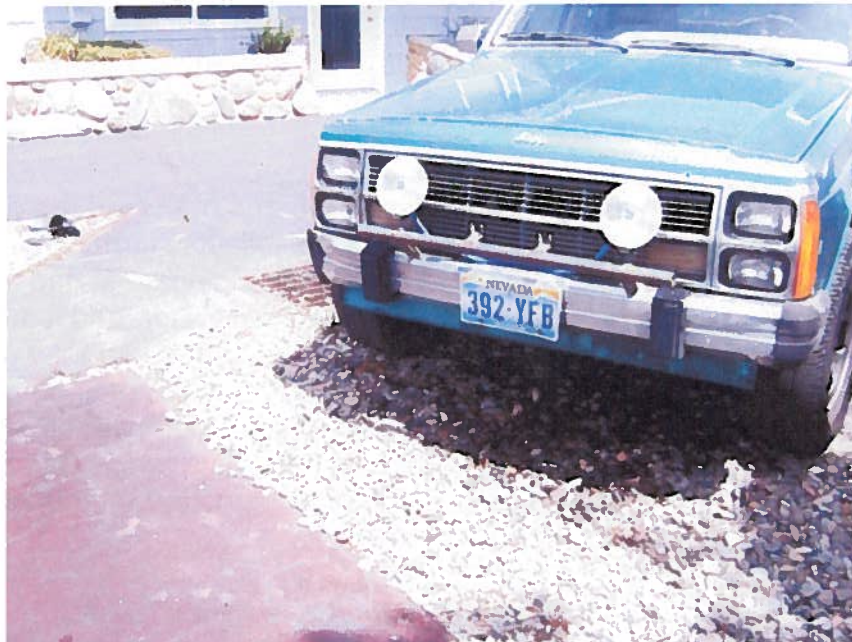
We observed the drop inlet located by the laundry facility, located on the southwest side of the marina office building. Mr. Spinnato stated that this drain does not have an oil/water separator. From here we walked to the Maintenance Barn, which is located southwest of the office building. Parked between the office and maintenance buildings was a truck dripping antifreeze onto a rock-lined area that discharges into a storm drain. See Photo No. 15. Mr. Spinnato stated that he would get this immediately cleaned up.

Photo 15. Truck dripping antifreeze onto drain rock along bulkhead, between maintenance and office buildings.

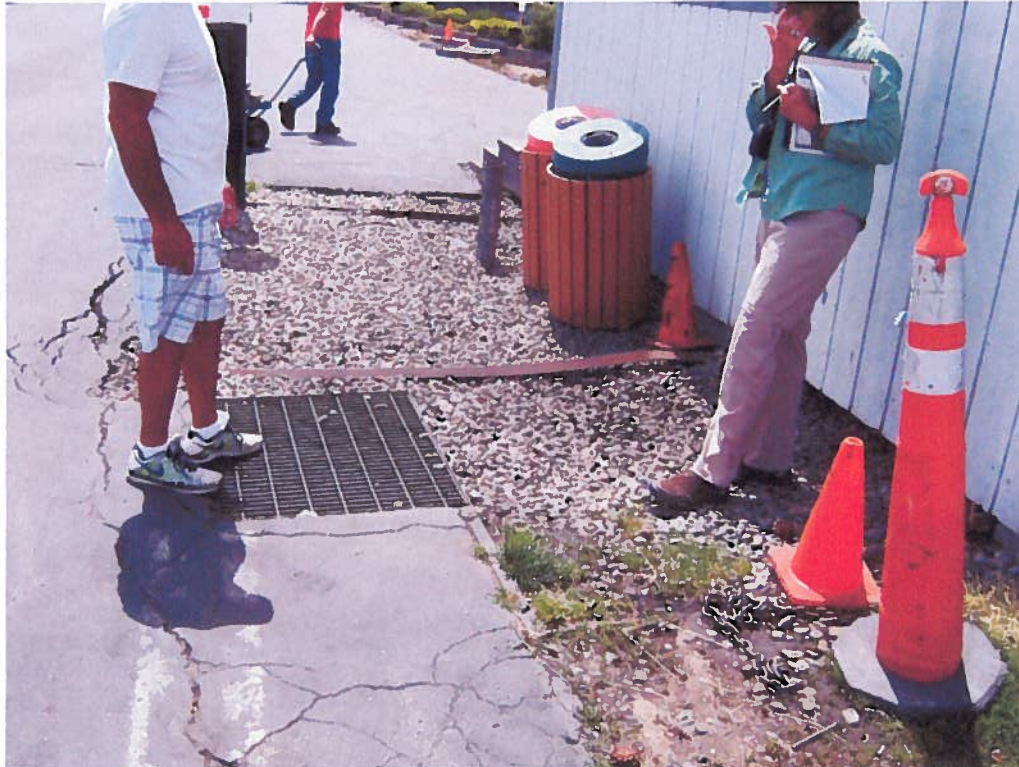
A fishing charter business is located on the southeast corner of the maintenance building. A drain to collect parking lot runoff is located just outside this facility. During the May, 2014, inspection, the drain had been dug up to determine why it continued to back up. The drain inlet had been replaced, and Mr. Spinnato told us that they discovered that the drain had been constructed many years ago with no outlet. He indicated that this is another item that will be addressed when the parking lot will be improved. He also indicated that the maintenance building will be moved to the far southwest side of the marina (where the dredge pond is currently located) in 12 to 24 months, and they are currently evaluating potential uses for the existing maintenance building space.

Photo 16. Drain area on southeast side of Maintenance Building, facing in a southwest direction. Mr. Spinnato is on the left, Tobi Tyler is on the right. New drain rock had been installed where the area had previously been excavated to determine why this area had been clogging.

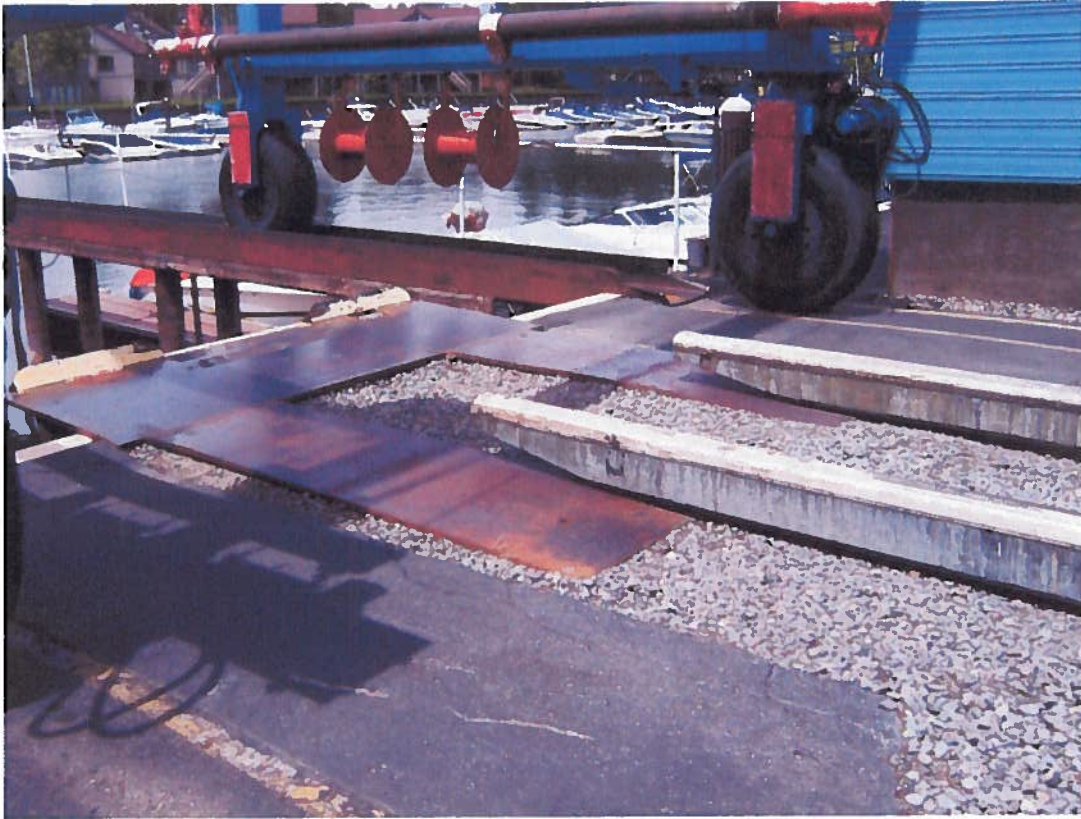
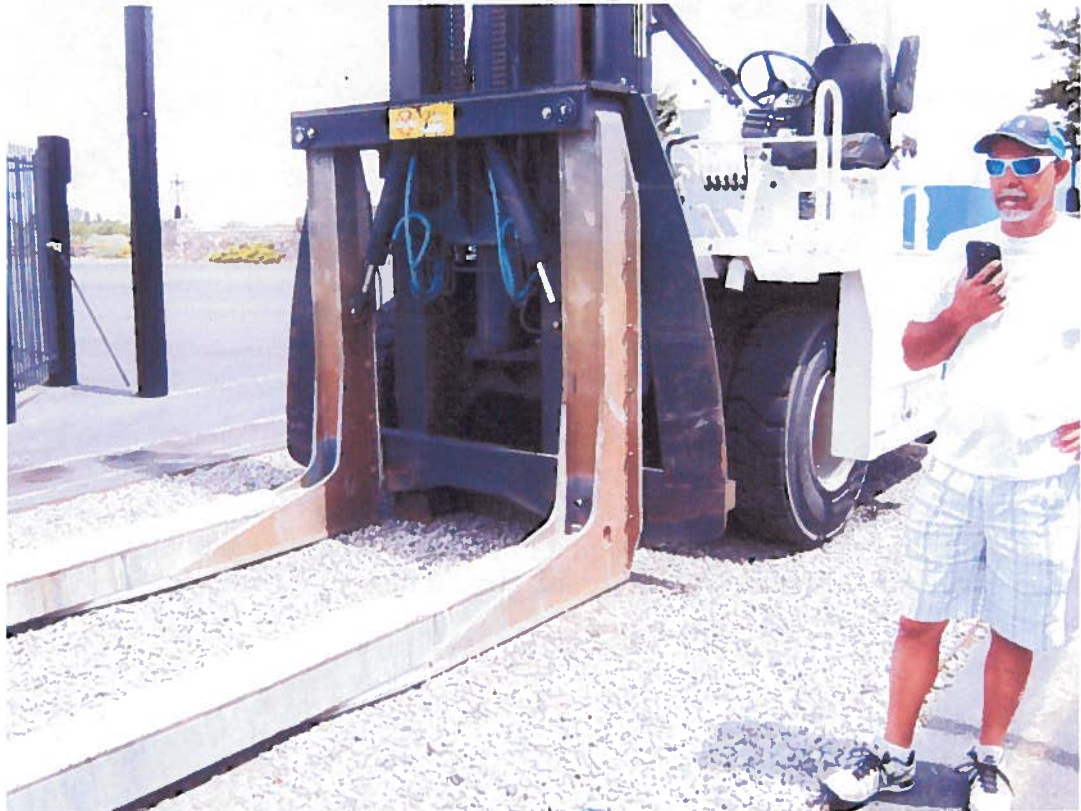
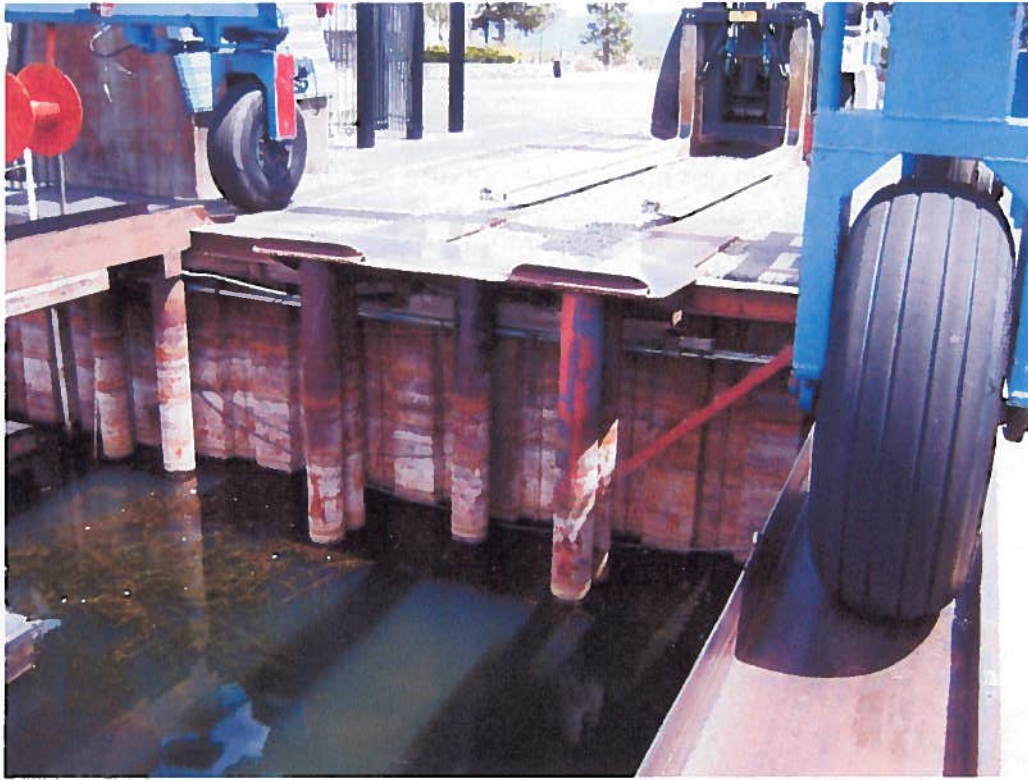
We continued walking in a southwest direction toward the boat lift unit. The boat lift is located in the southeast corner of the marina area. The area appeared to be clean and free from any evidence of spills. Drain rock is placed under the lift facility, behind the bulk head wall of the marina. This area had previously been designated for boat washing activities. However, Mr. Spinnato commented that boats are no longer washed in this area.

Photo 17. Drain rock behind bulk head at the boat lift unit. Facing northwest.

Photo 18. Drain rock behind bulk head at the boat lift unit. Facing northeast. Robert Spinnato is pictured on the right.

Photo 19. Bulk head of boat lift, facing east.

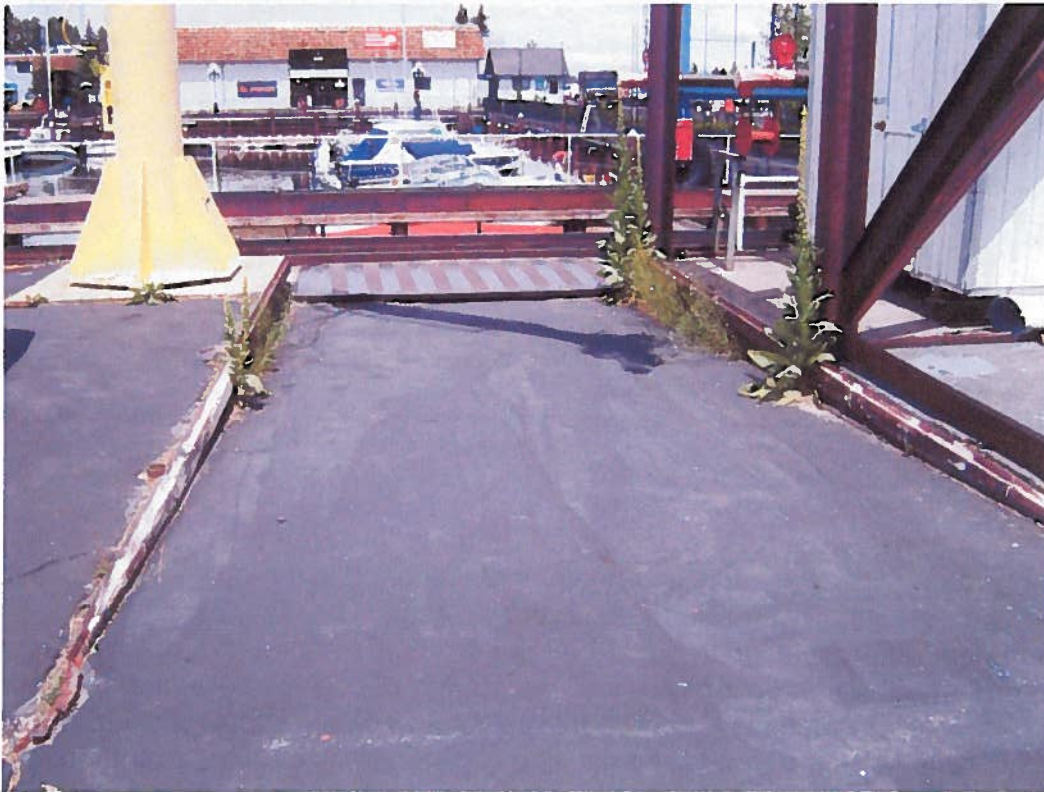
Photo 20. Ramp area on southwest side of boat lift, facing northeast toward maintenance building. (Fishing Charter business is in the small building to the right of the maintenance building, and the drain from Photo No. 16 is to the right of the small building)

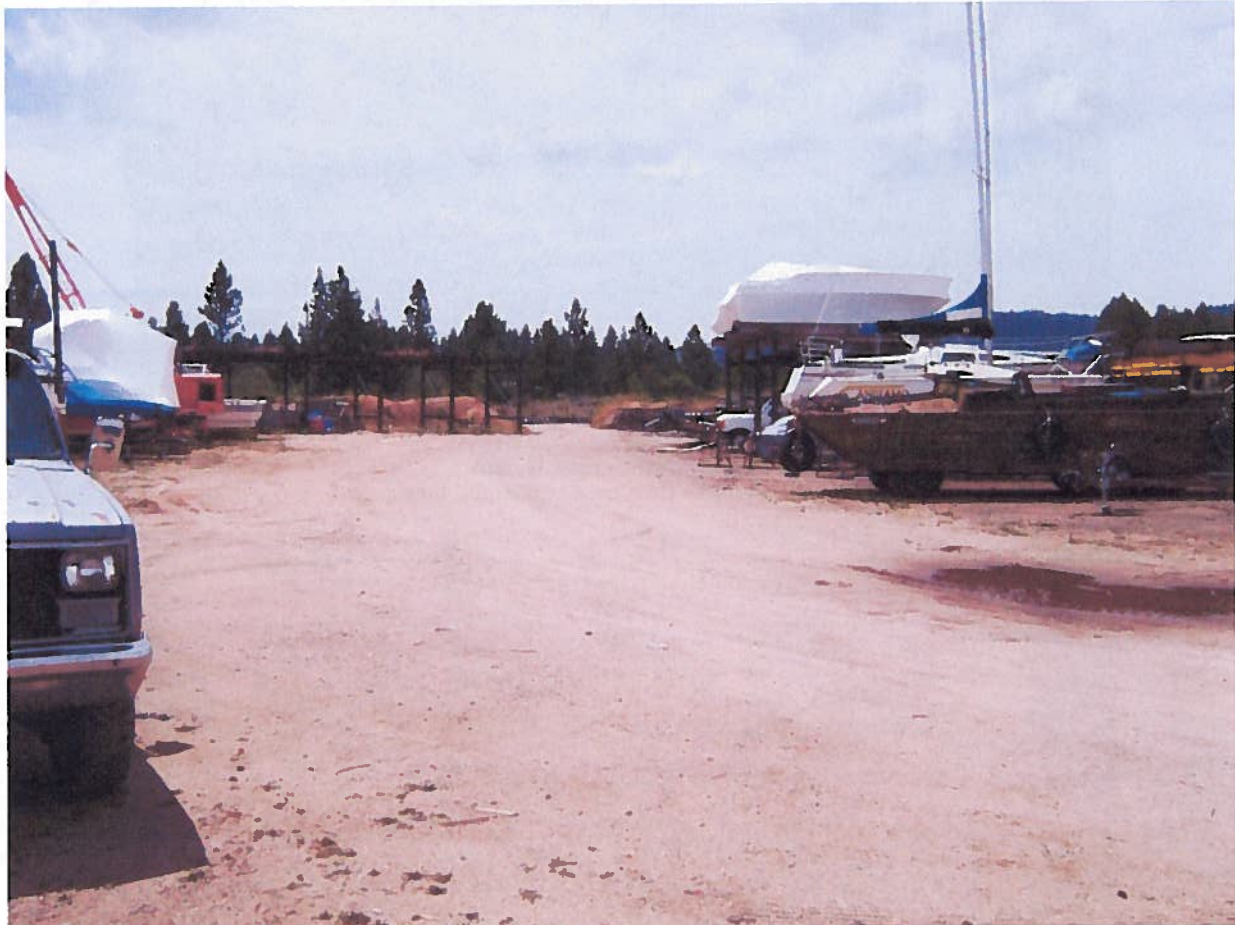
From the boat lift area, we walked west along the southern portion of the marina property. This is the area where boats are stored during the winter season. The area had piles of pallets, plywood, trex deck material (re-purposed from the Tahoe Keys Homeowners Association's docks to resurface the docks within the Tahoe Keys Marina), scrap metal, dried barrel containers of asphalt (from when the parking lot was resurfaced last fall, according to Mr. Spinnato), and other materials. No spills were observed, but the area was generally unkempt and had the appearance of a scrap yard. Mr. Spinnato stated that metal recyclers are scheduled to come out later this summer to remove scrap metal material that is of no further use.

Photo 21. Southern area of marina where boats are stored, facing west. The entrance to the existing dredge pond area is in the center of the photograph.

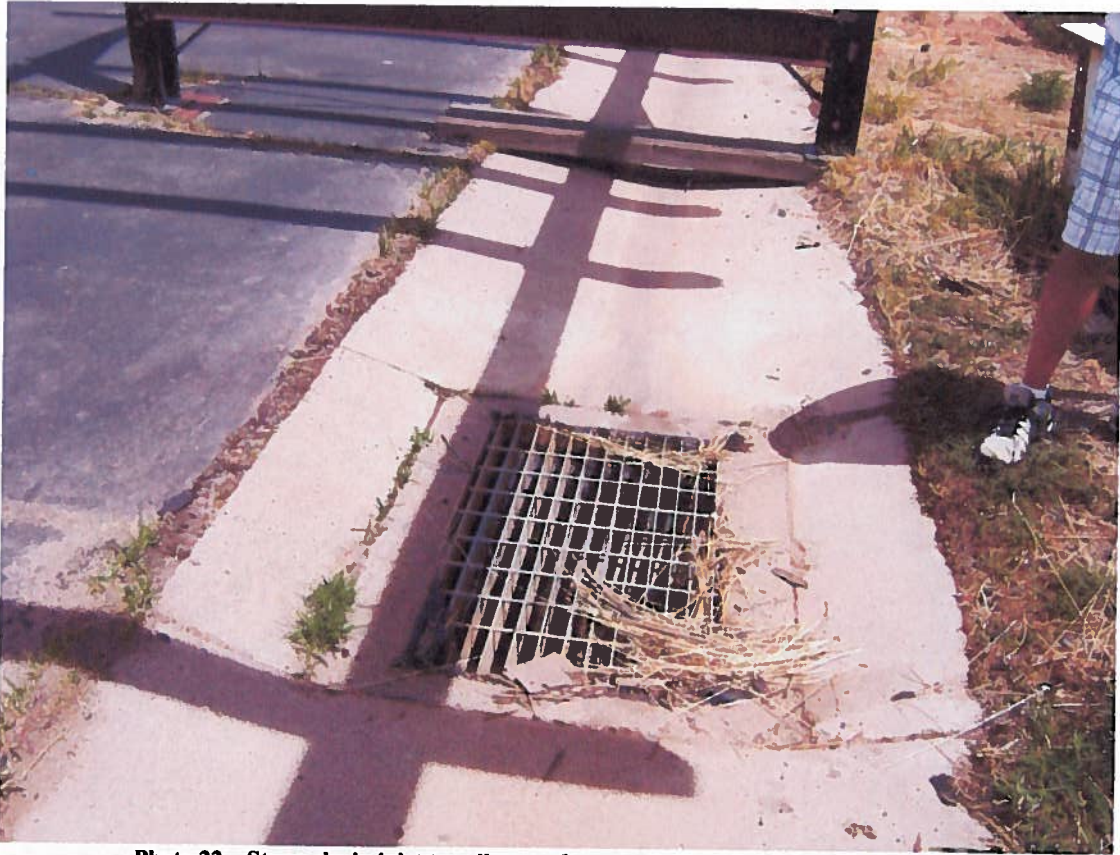
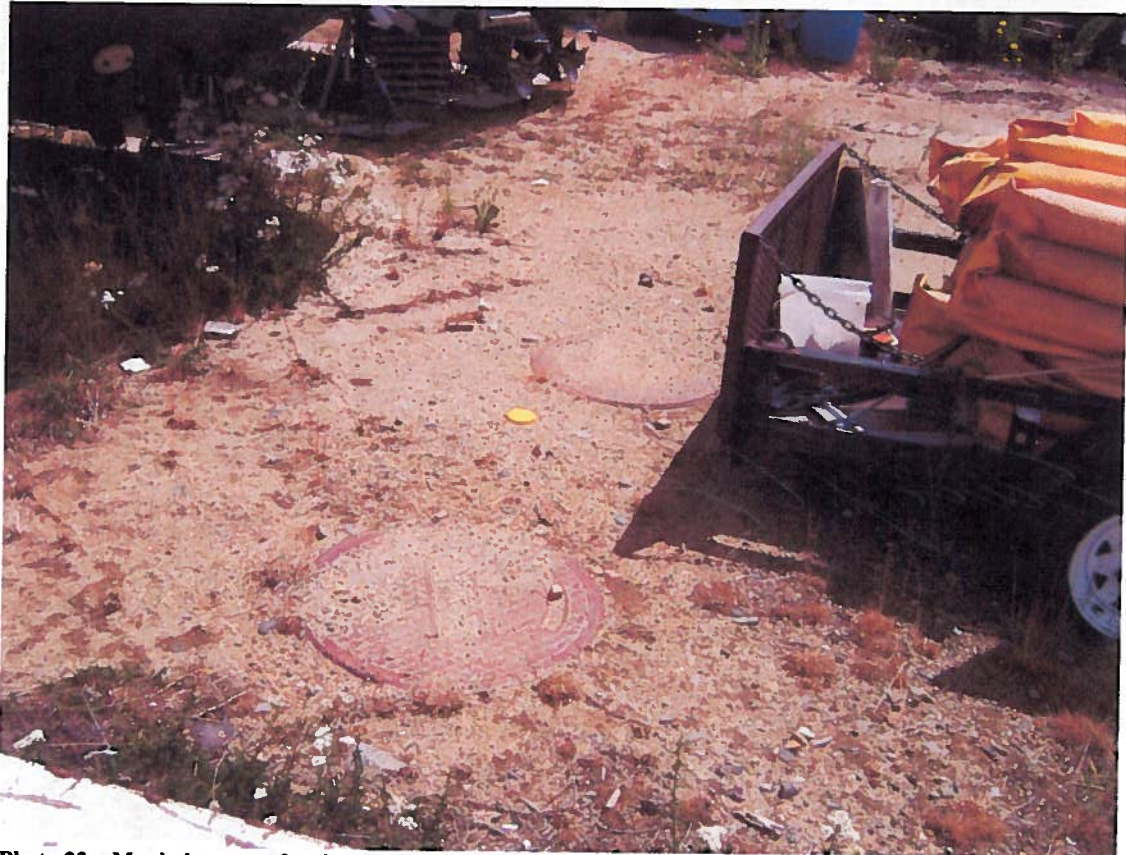
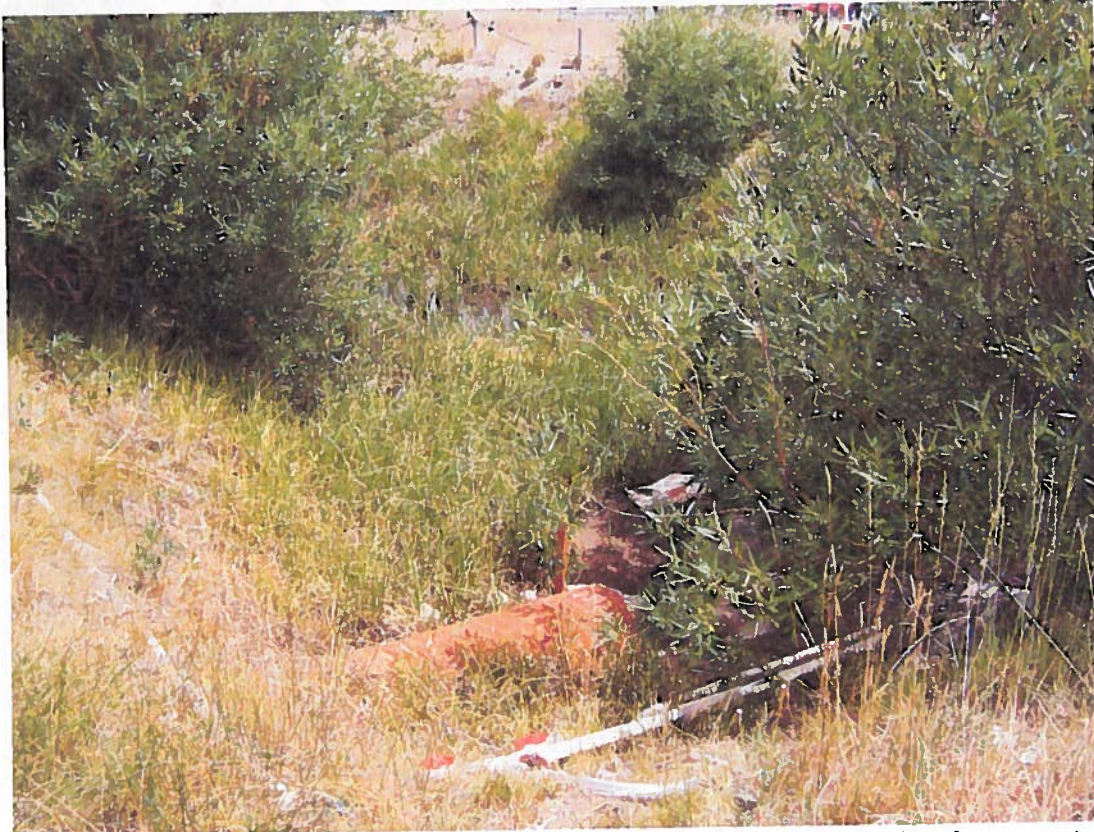
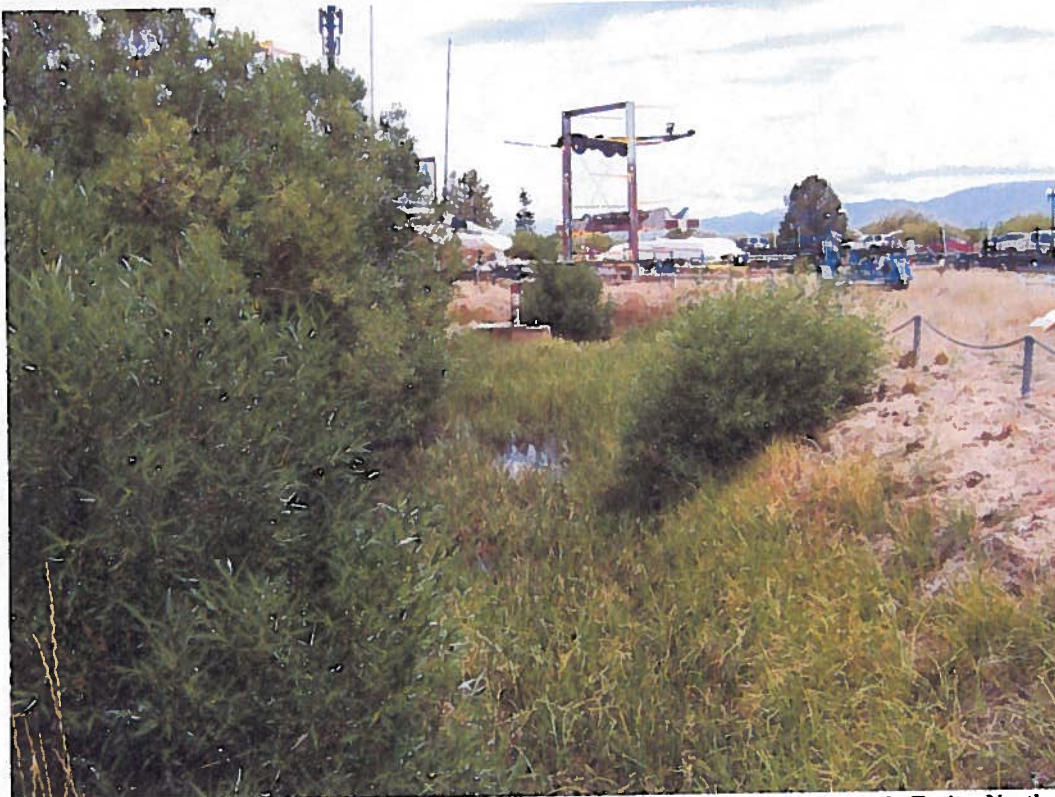
The storm drain system for the parking lot runoff in this area was observed. Mr. Spinnato stated that since this is a newer installation, it is the only storm collection system that has an oil/water/sand separator system. The discharge from the system is to a surface pond that is located south of the storm drain inlet. The pond was nicely vegetated, and the pond overflows into the marina during extreme high flow events or when excess snow melt is pumped out from the existing dredge pond area. Mr. Spinnato stated that the pond (and existing vegetation) is cleaned out approximately every five years to maintain the pond's capacity. The area appeared functional, and no problems were observed.

Photo 22. Storm drain inlet to collect surface runoff from boat storage area. Facing east.

Photo 23. Manhole covers for the stormwater treatment system vault, located south to the drain inlet. Facing south.

Photo 24. Discharge pipe (rust colored pipe in foreground) from stormwater treatment vault into the stormwater pond. Facing southeast.

Photo 25. Stormwater pond. Overflow stand pipd is located at the end of the pond. Facing Northeast.
