**CLEANUP AND ABATEMENT ORDER
NO. R6V-2016-PROP**

**REQUIRING THE CALIFORNIA DEPARTMENT OF TRANSPORTATION DISTRICT 8
TO CLEAN UP AND ABATE THE EFFECTS OF THE DISCHARGE OF DREDGE AND
FILL MATERIAL TO WATERS OF THE STATE AT THE CALIFORNIA HIGHWAY 138
WIDENING PROJECT AT SHEEP CREEK**

**California Department of Transportation State Route 138 Widening Project –
Phase 1, San Bernardino, California (Project) (WDID SB13004IN)**

Project Inspection: September 29, 2015

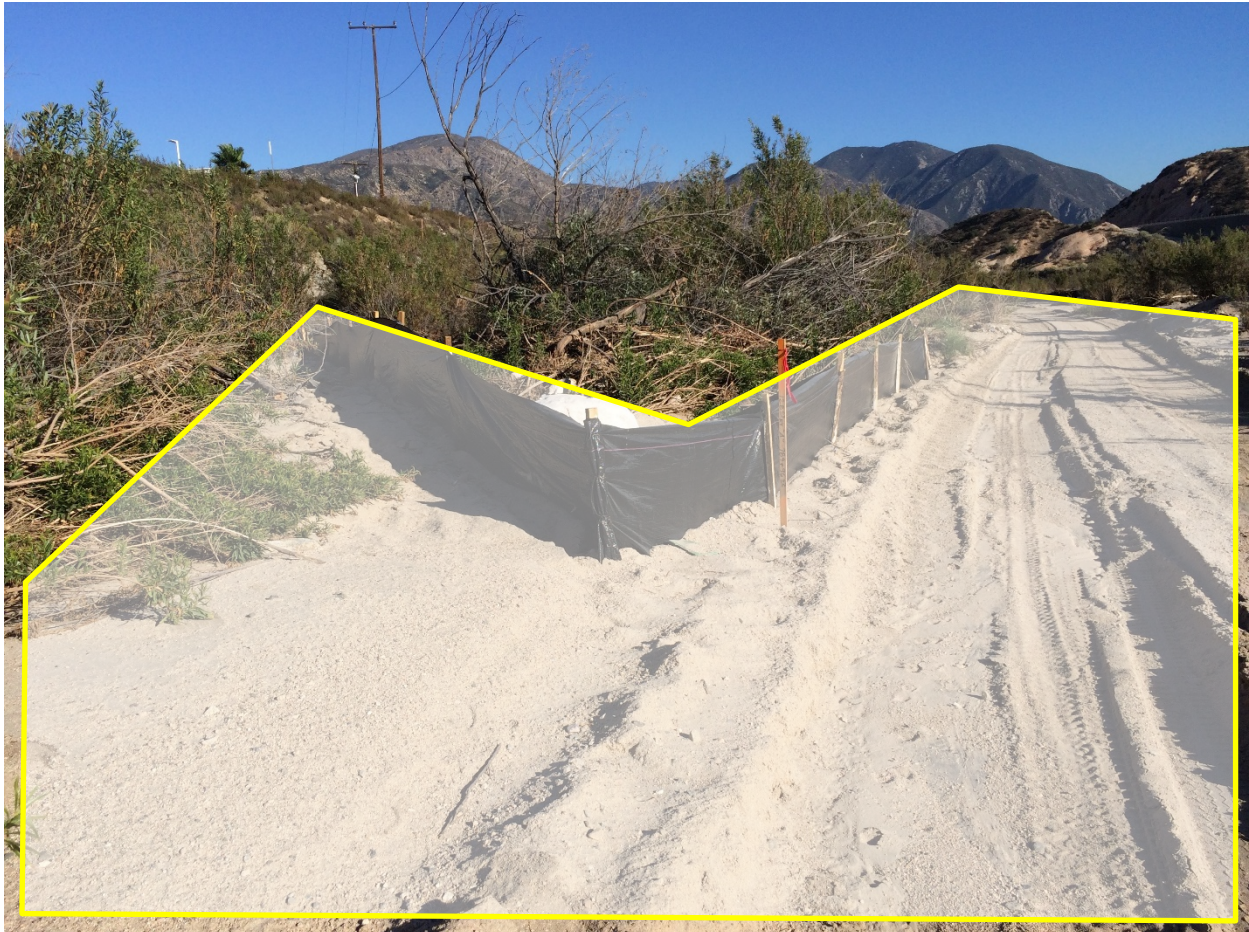
Picture 1: Unauthorized temporary impact in Cajon Creek (rough outline of area in yellow)

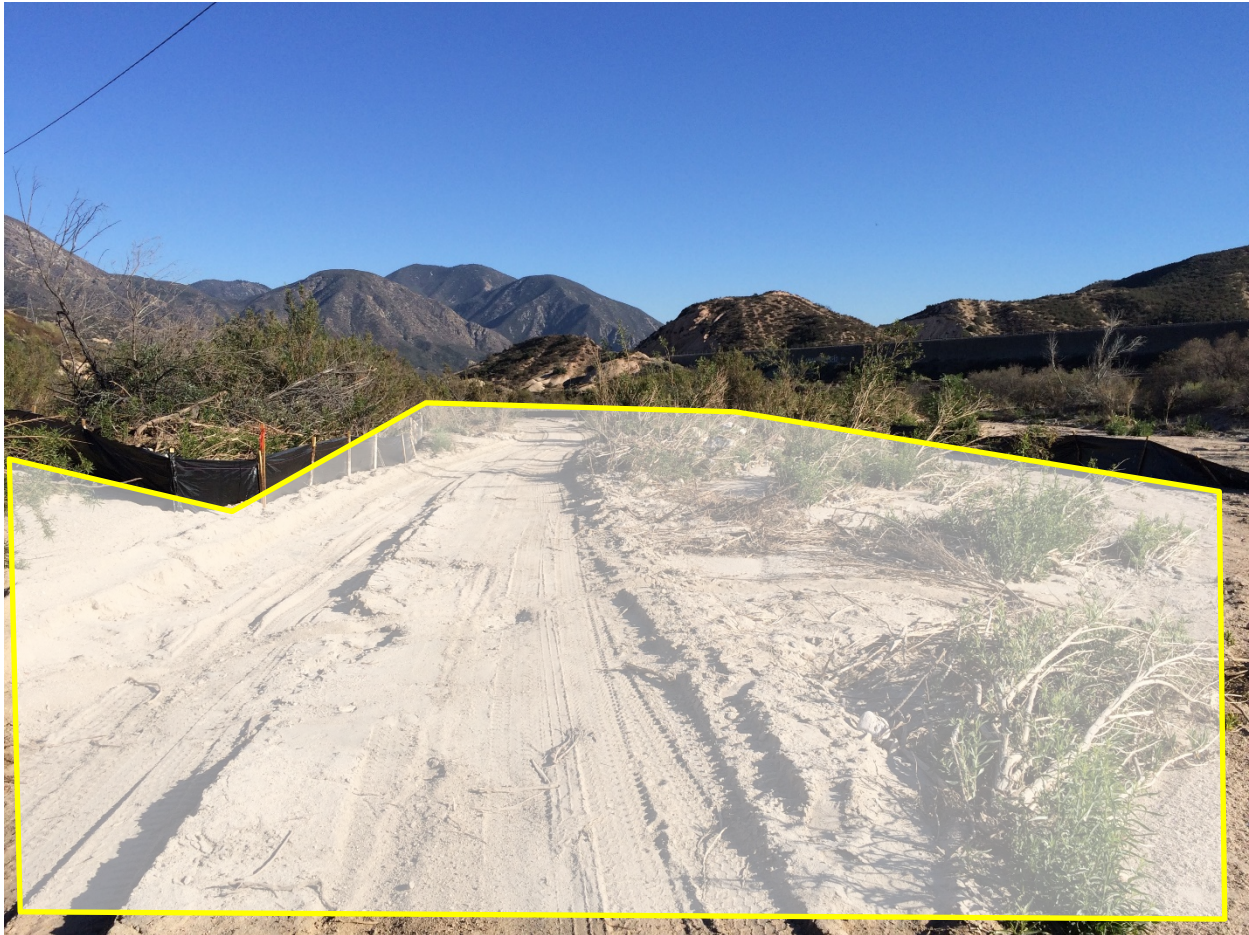
Picture 2: Unauthorized temporary impact in Cajon Creek (rough outline of area in yellow)

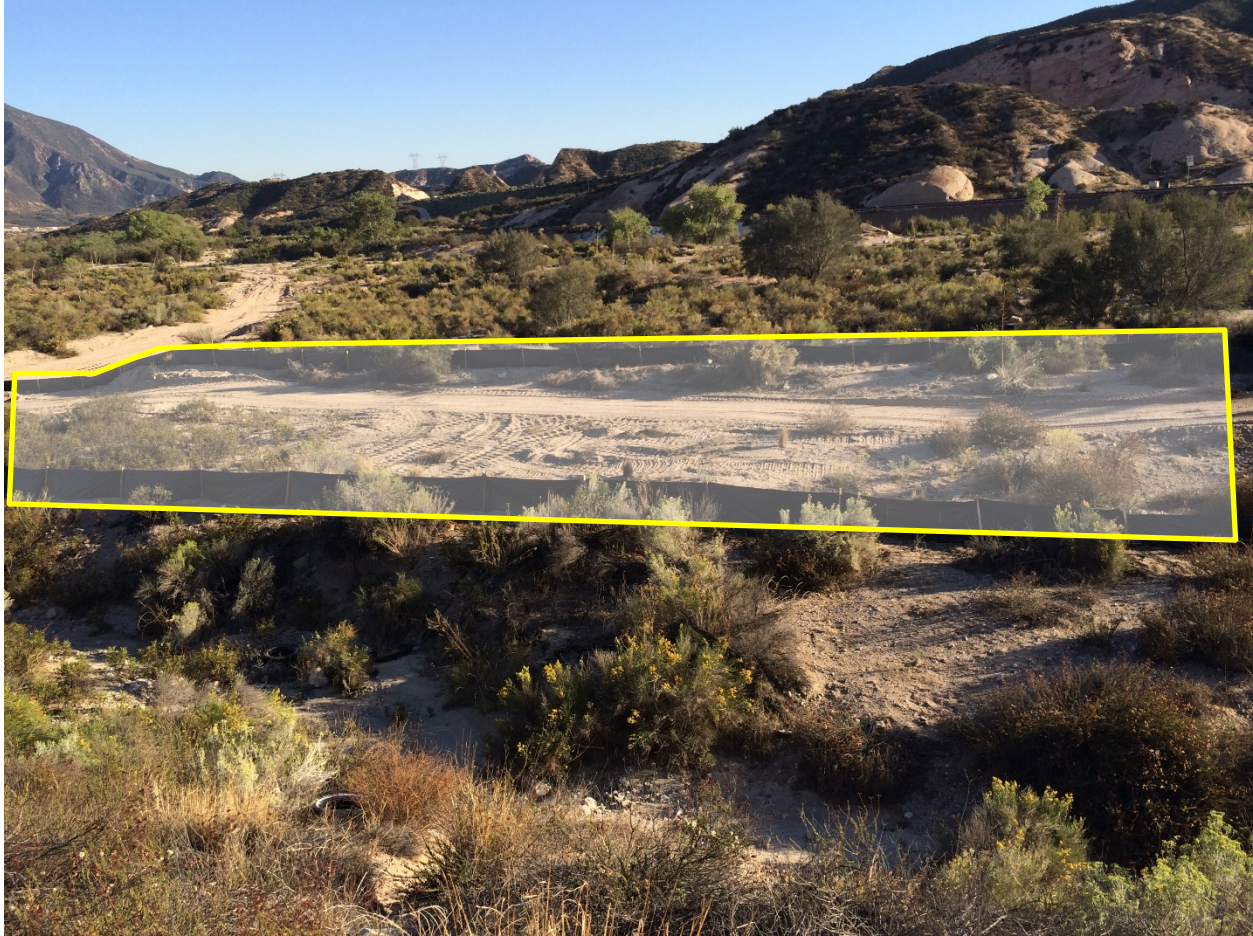
Picture 3: Unauthorized temporary impact in Cajon Creek (rough outline of area in yellow)

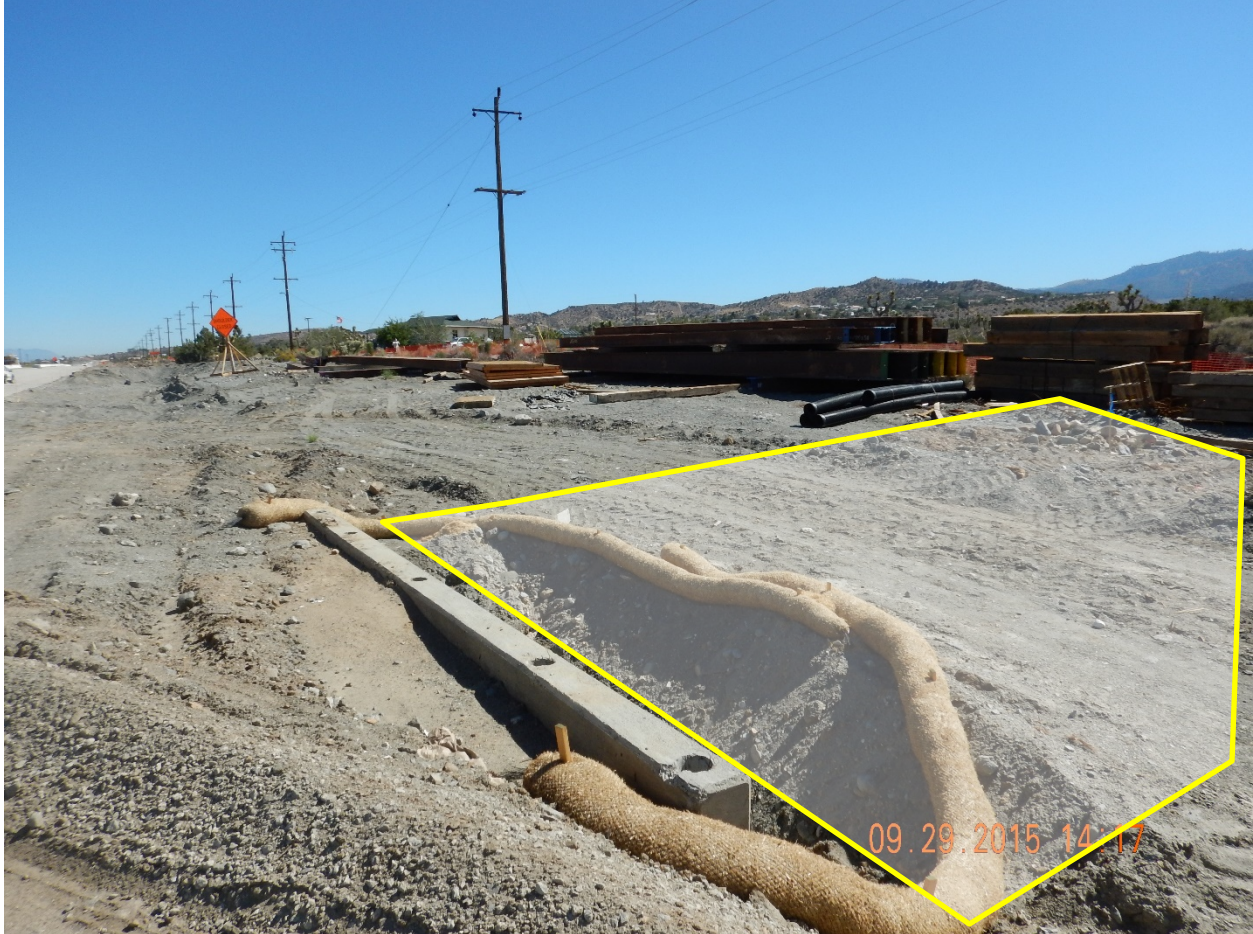
Construction materials and soil, silt, and sand observed placed in washes. (See pictures 4, 5, 6, 7, 8, 9, and 11 below.)

Picture 4: View South East of unpermitted temporary impact at Drainage ID 54. Note fill from access road in the stream channel (rough outline of area in yellow).

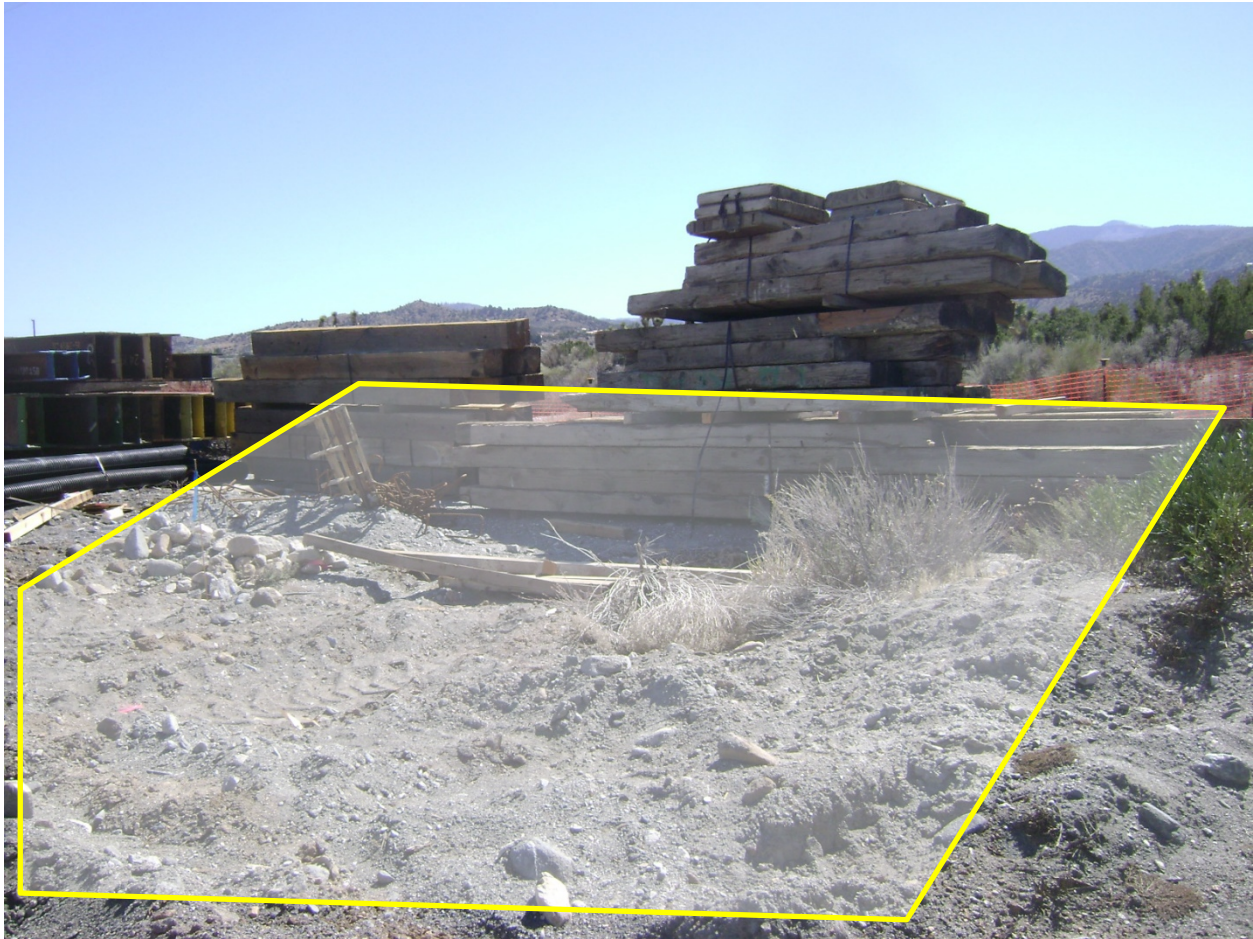
**Picture 5: View South of timber mats stockpiled within the channel of Drainage I.D. 54
(rough outline of area in yellow).**

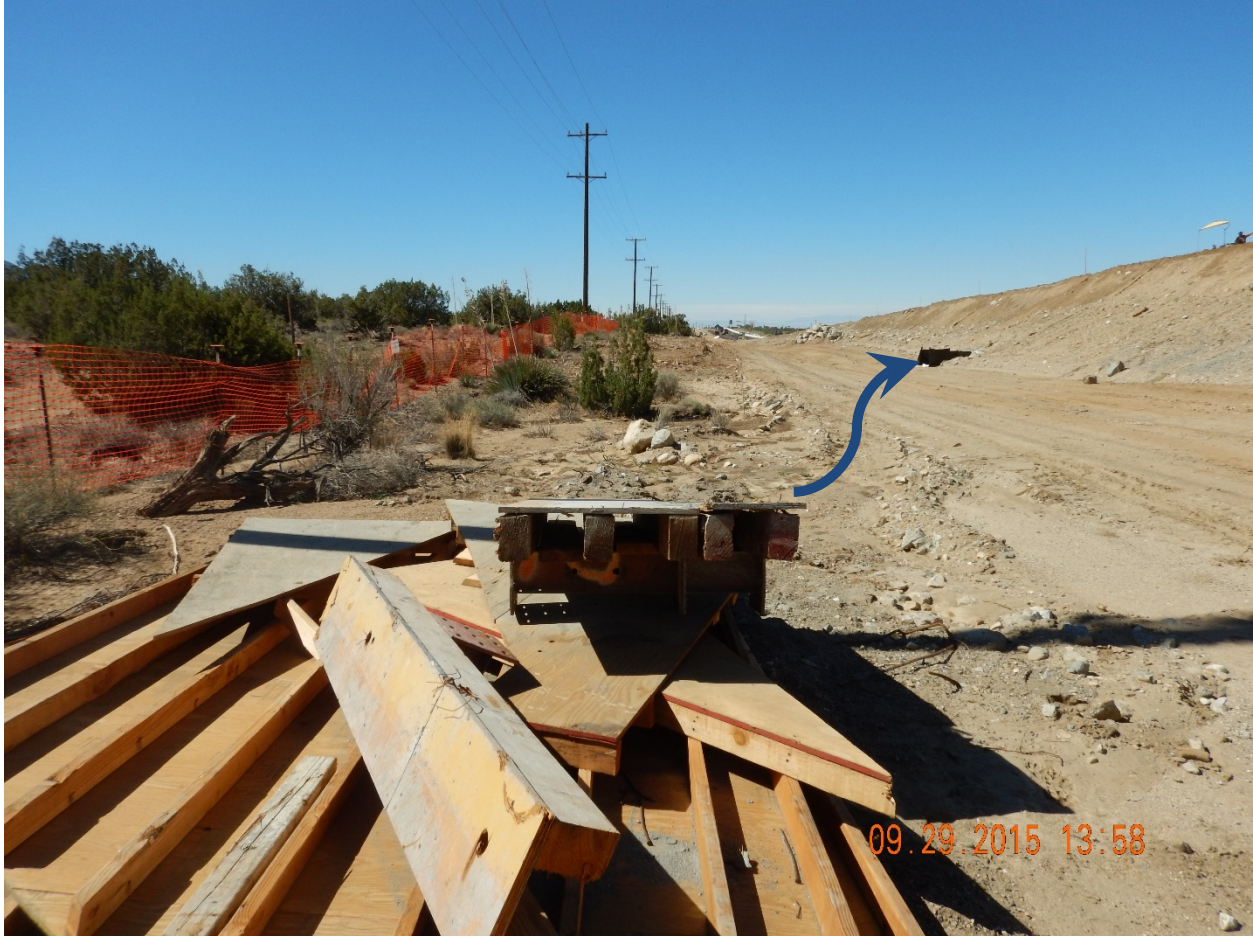
Picture 6: View West of unpermitted temporary impact at Drainage ID 55. Note the access road parallel to road construction and fill within the stream channel. Flow path and direction shown with arrow.

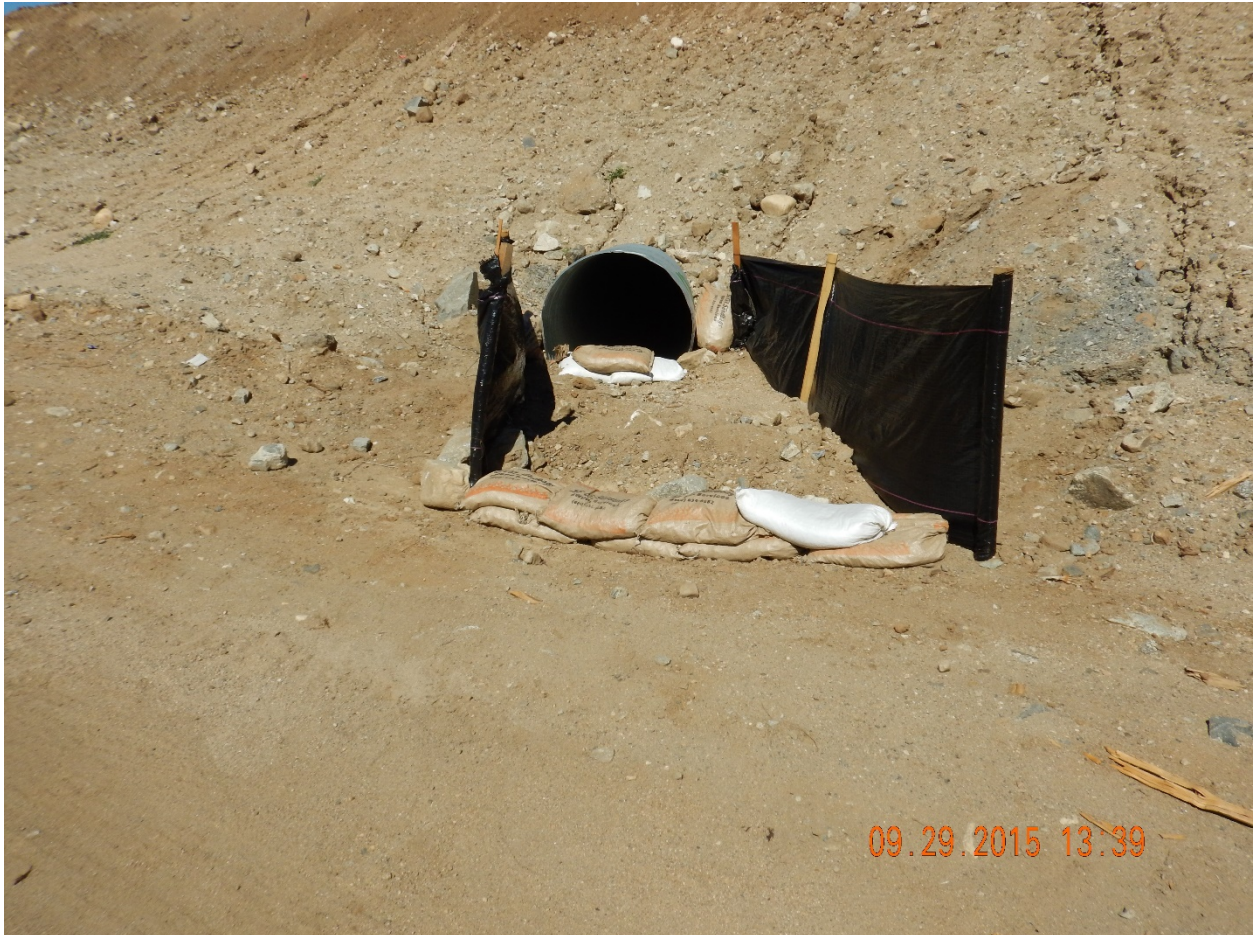
- a. Inadequate BMPs observed throughout the Project. (See picture 7 below.)
- b. Majority of Drainage IDs did not have any BMPs installed to minimize sediment disturbance and prevent sediment from areas disturbed during construction from entering a Water of the U.S. (See pictures 8, 9, and 10 below.)
- c. A single wattle was observed at Drainage I.D. 1b which provided insufficient coverage. (See picture 11 below.)

- a. Inadequate erosion control BMPs to protect waters of the U.S. were observed throughout the many Project areas. (See pictures 7, 8, 9, 10, and 11 below.)

Picture 7: View North of Drainage ID 55. Note the inadequate BMPs and unconsolidated sediment and sandbags in the stream channel.

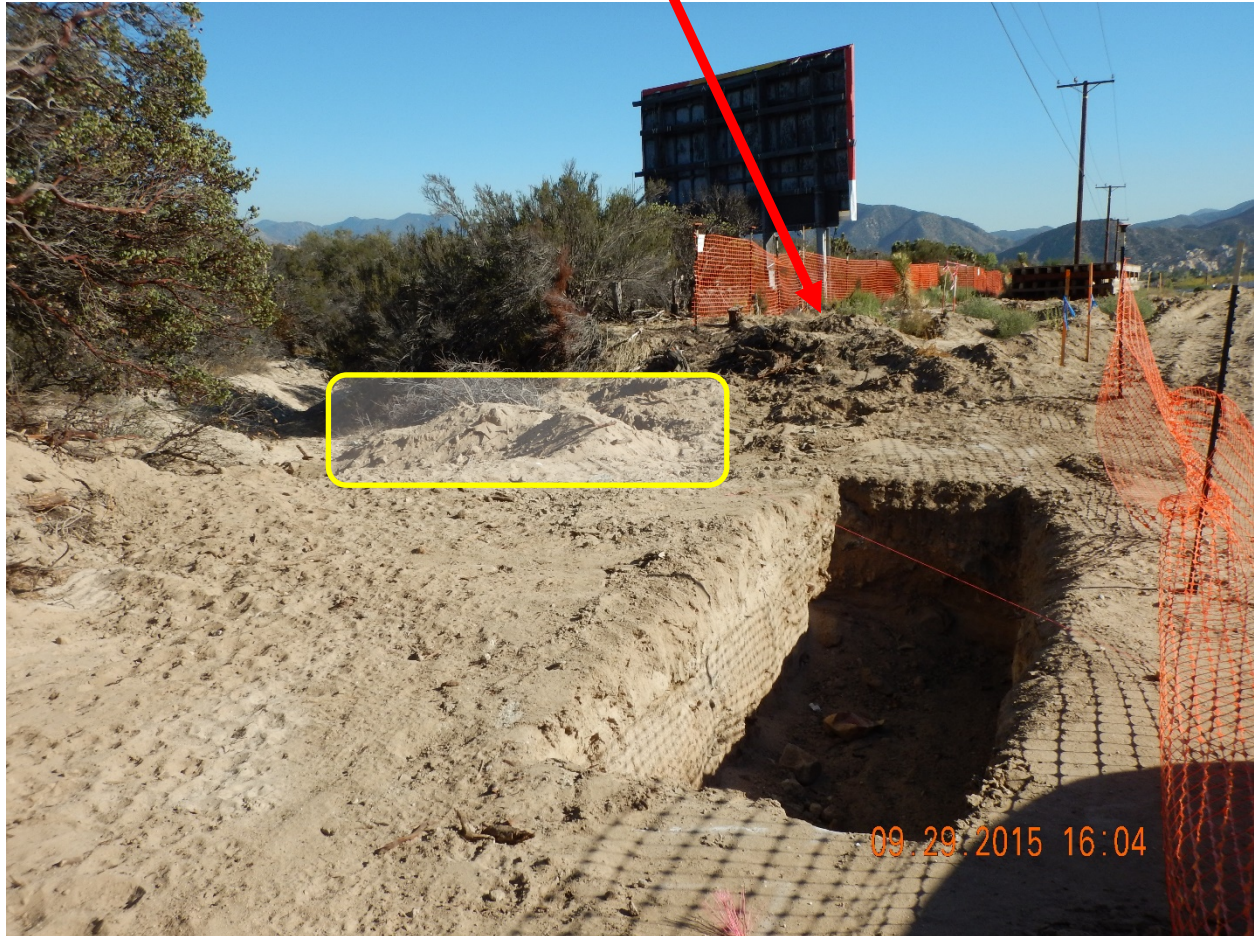
Picture 8: View South East of Drainage ID 69. Note excavation in channel, spoils from excavation stockpiled adjacent to excavation and in channel (shown in yellow rectangle), and no erosion and sediment controls installed.

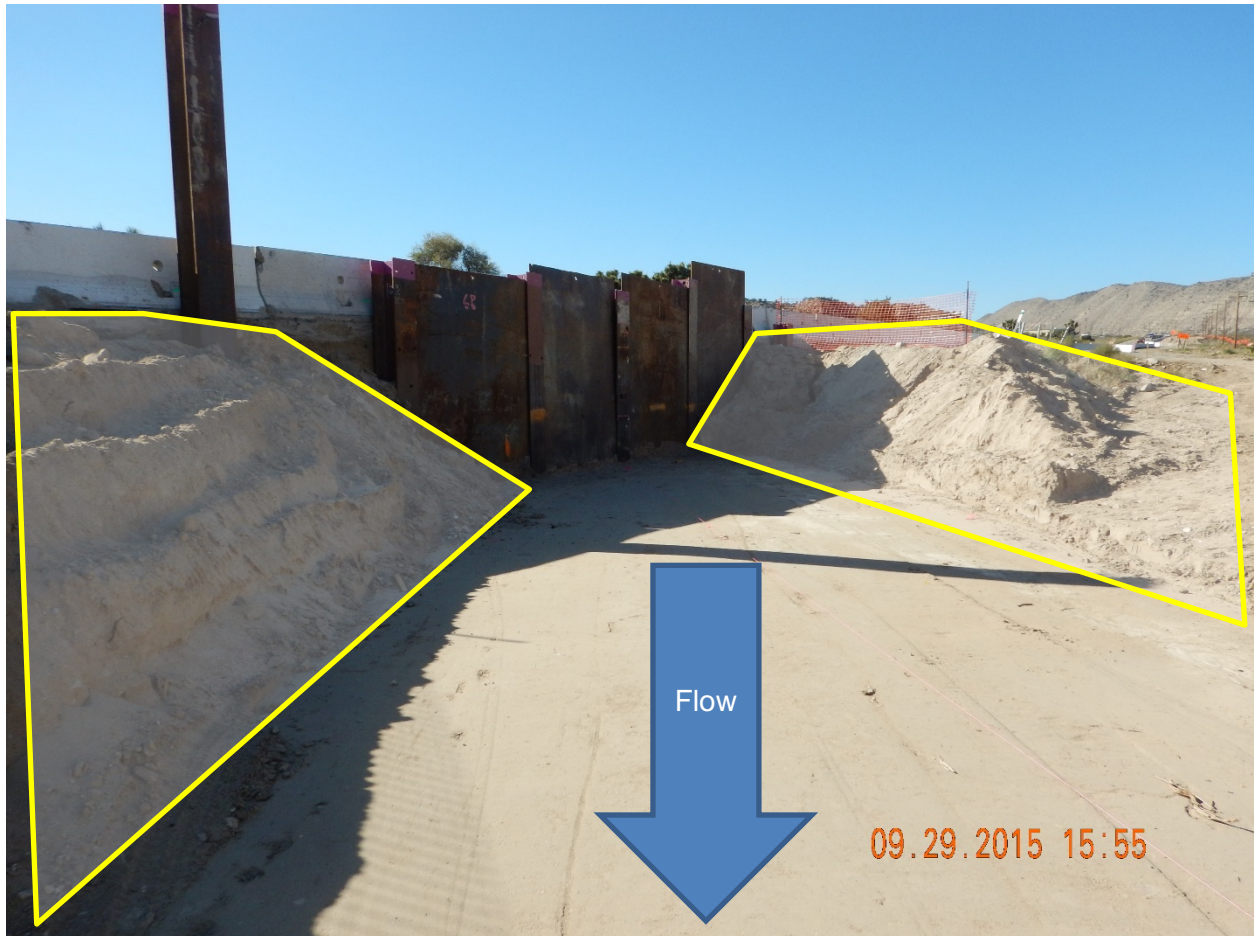
Picture 9: View West at Drainage ID 16. Note the un-stabilized stream banks and absence of erosion and sediment controls (approximate areas in yellow boxes). Additionally the stream has been completely disconnected from upstream flow with metal sheet pilings.

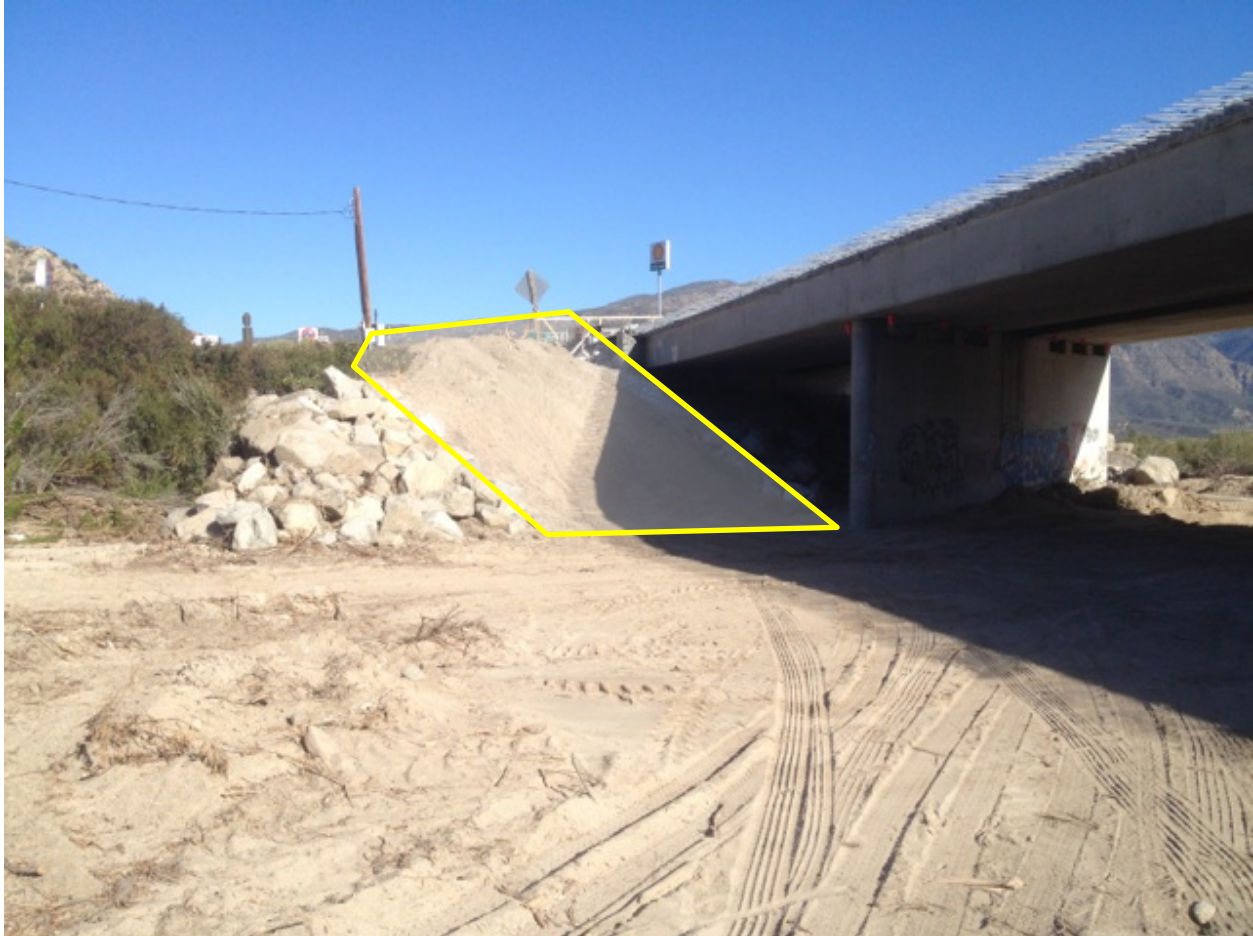
Picture 10: View East of Cajon Creek North East bank. Note the absence of erosion and sediment controls on the exposed bank (rough outline of area in yellow).

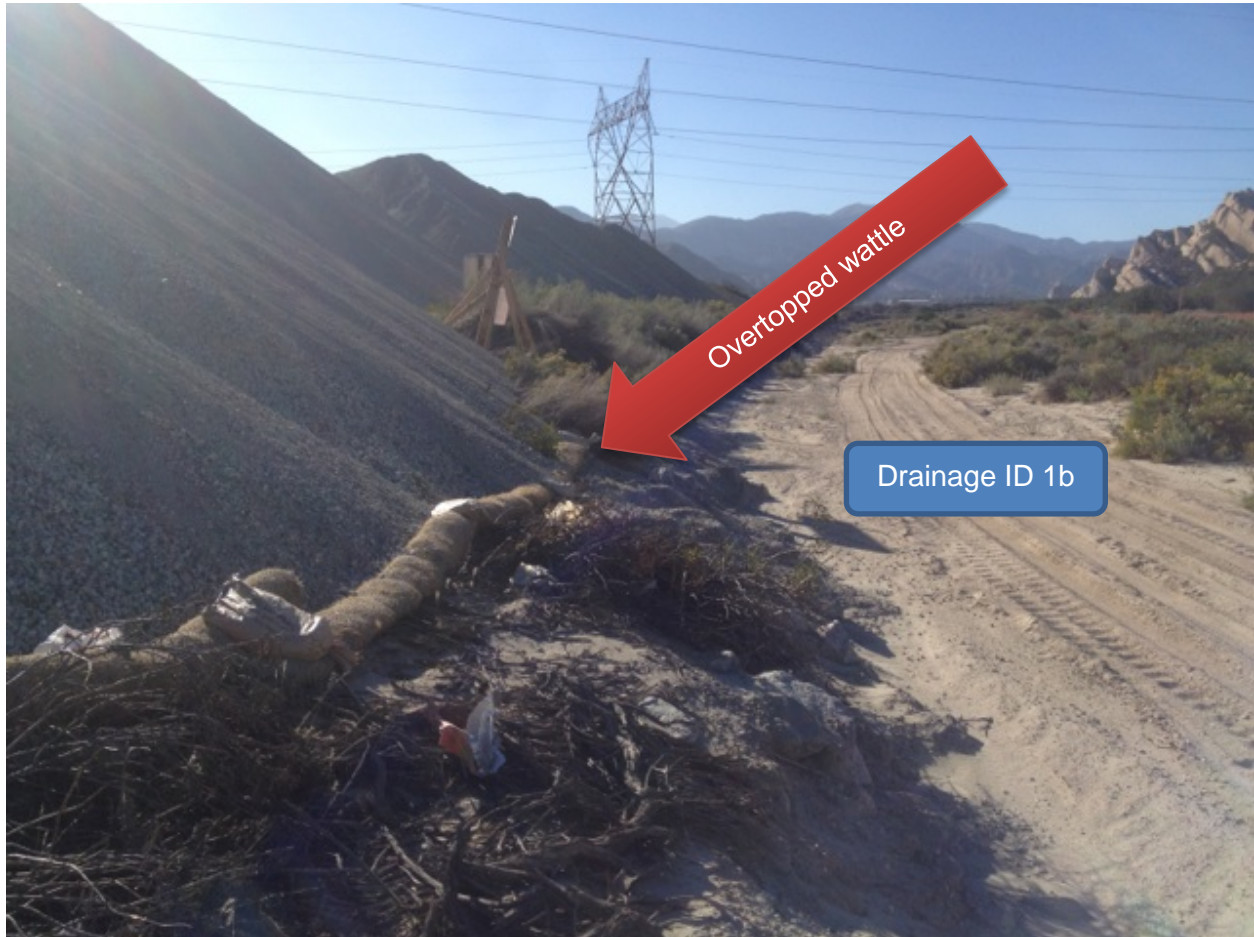
Picture 11: View North West of Drainage ID 1b. Note the large stockpile of gravel adjacent to water body and overtopped wattle with gravel in streambed.

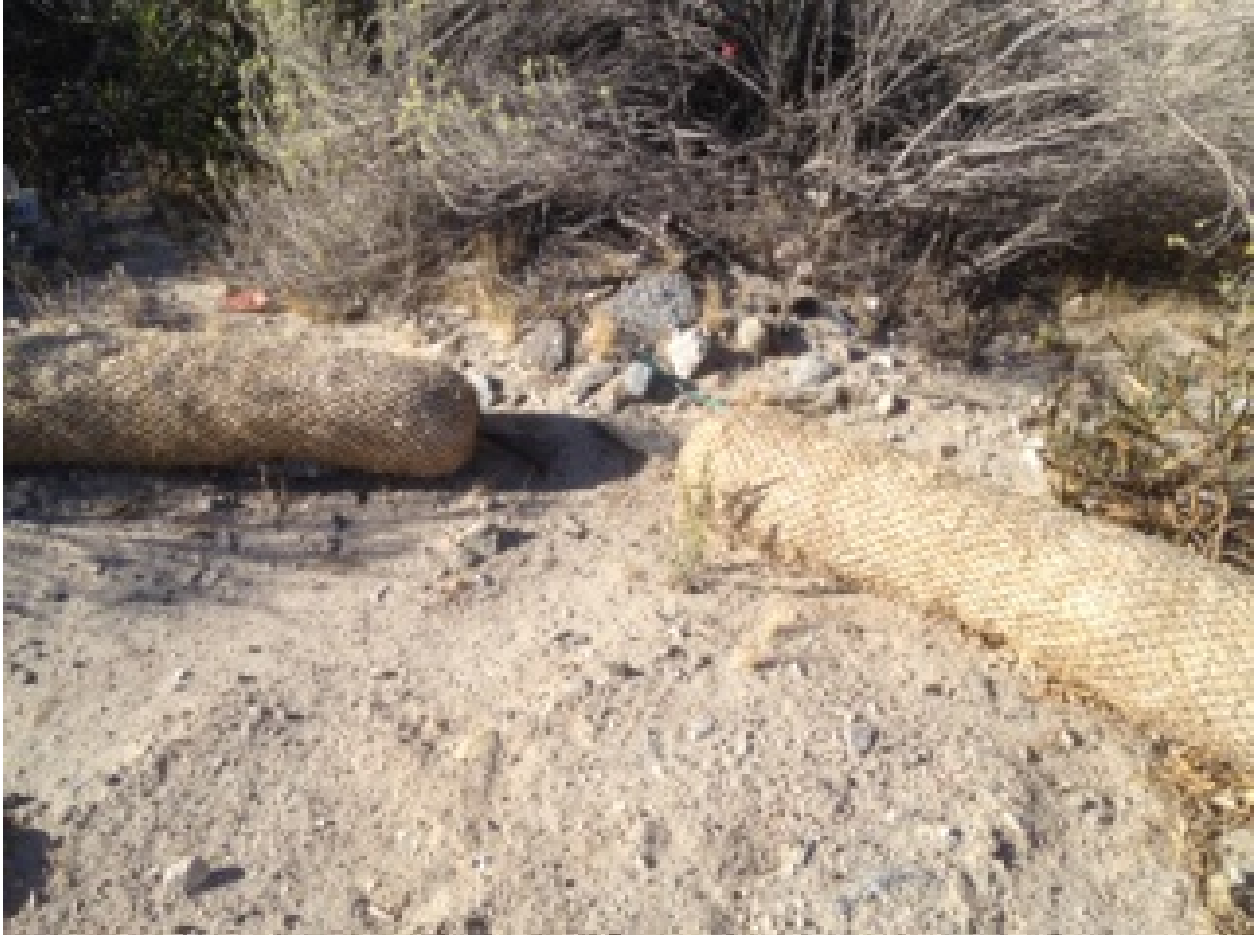
- a. BMPs were observed installed not per specifications governing their proper design, installation, and operation. (See pictures 12,13, and 14 below.)
- b. Silt fence observed installed perpendicular to the flow of Cajon Creek which would wash down the creek following a rain event. Caltrans staff stated that silt fence was installed for exclusion fencing as requested by California Department of Fish and Wildlife. (See pictures 13 and 14 below.)

Picture 12: View of gap in wattles adjacent to Drainage ID 1b.

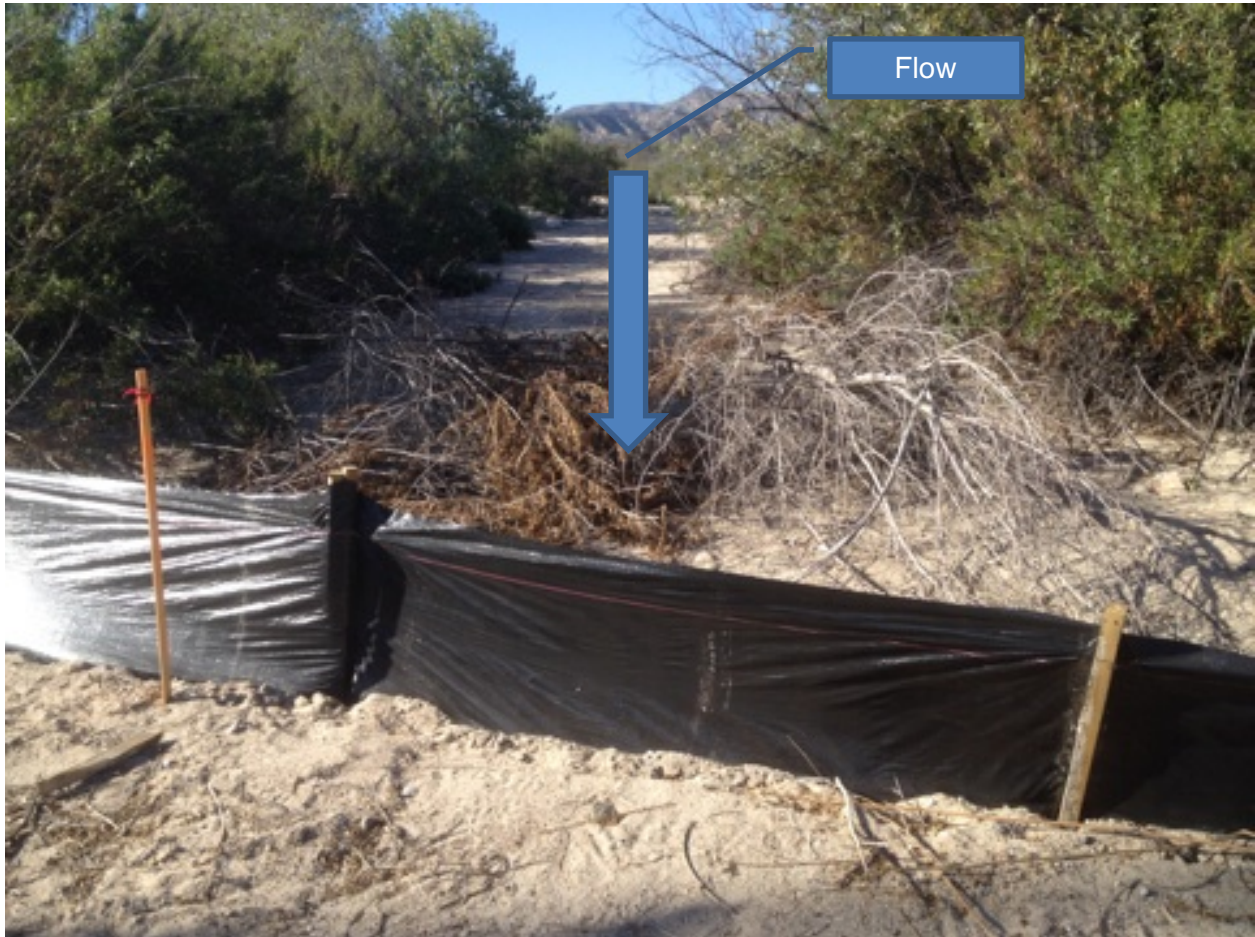
Picture 13: View North of silt fence installed across Cajon Creek Channel.

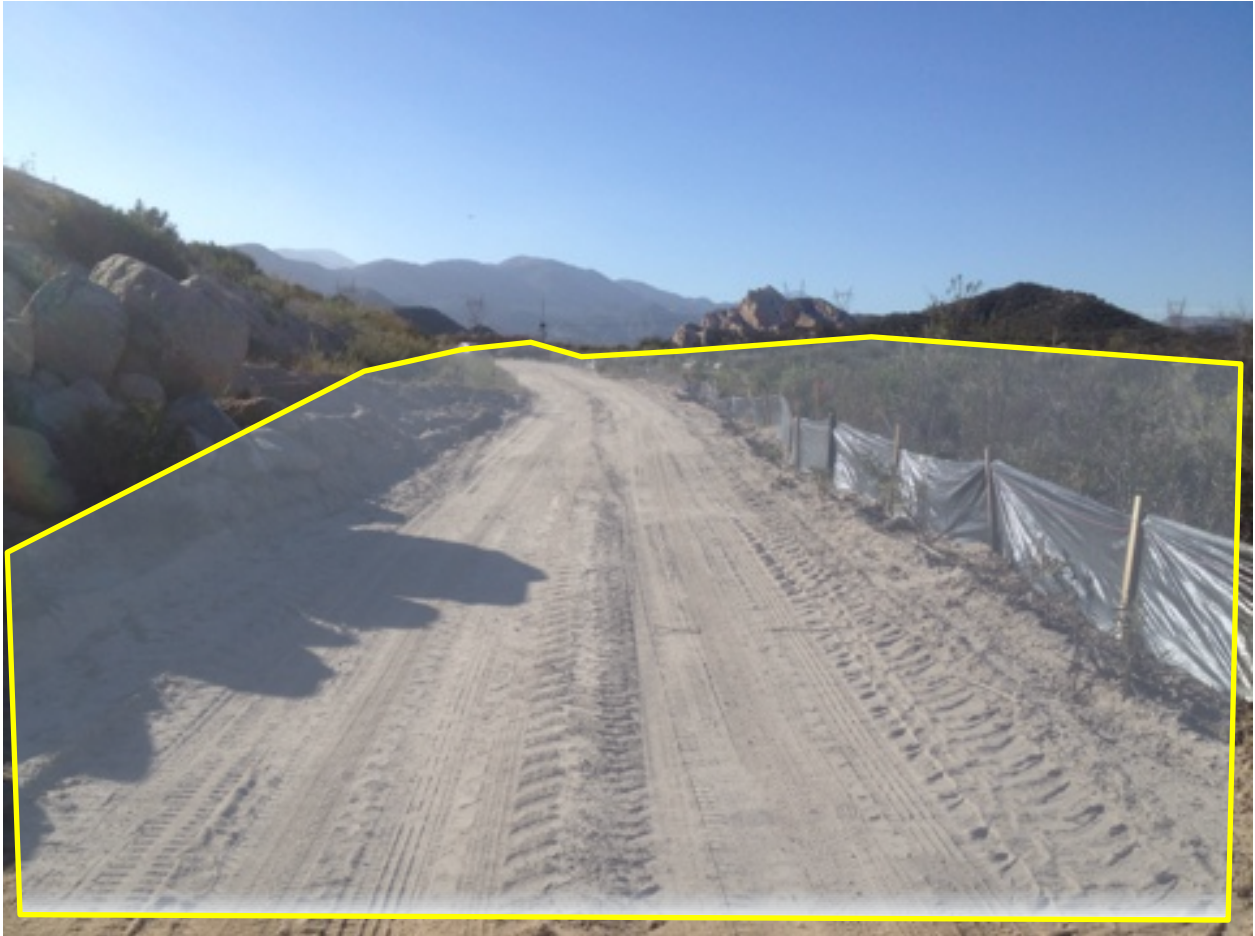
Picture 14: View West of silt fence installed as wildlife exclusion fencing in the Cajon Creek stream channel. Note the road in the channel and rock rip rap along the southern banks of the channel (rough outline of channel area in yellow).

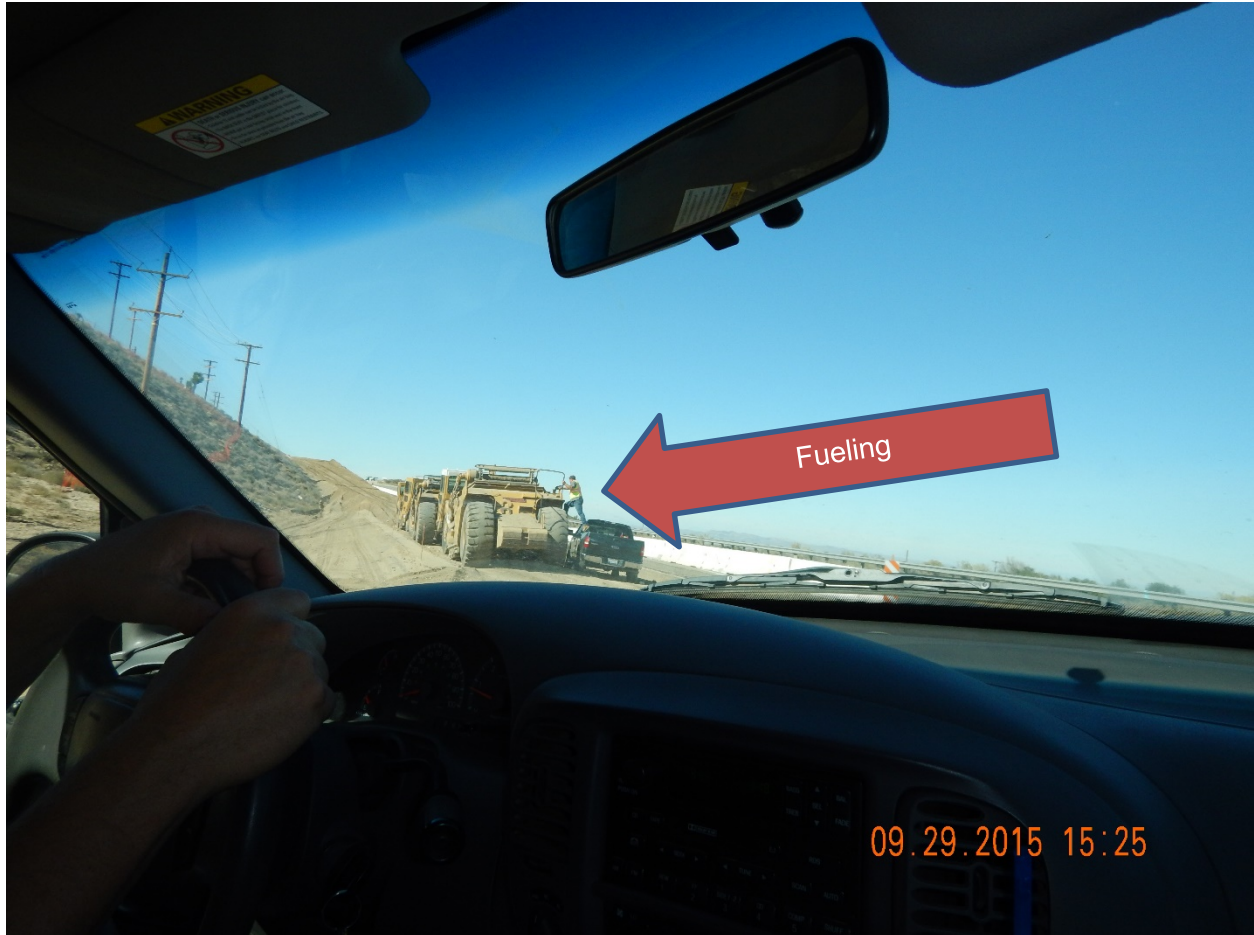
- a. Equipment fueling observed in Drainage I.D. 41b. (See picture 15 below.)
- b. Fuel stains on ground observed in Drainage I.D. 41b. (See picture 16 below.)

Picture 15: View North of fueling in Drainage I.D. 41b.

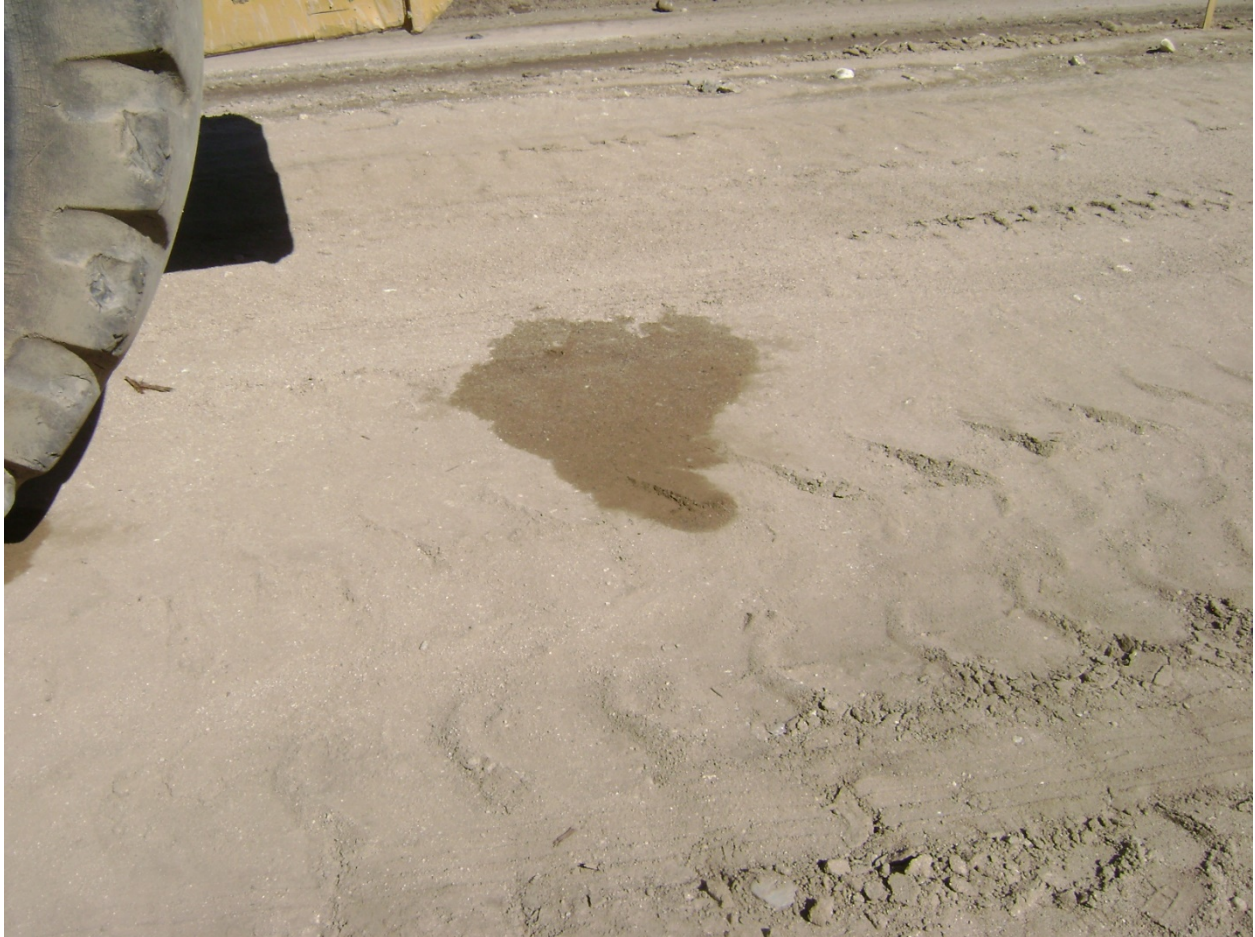
Picture 16: View of petroleum stained ground within Drainage I.D. 41b.

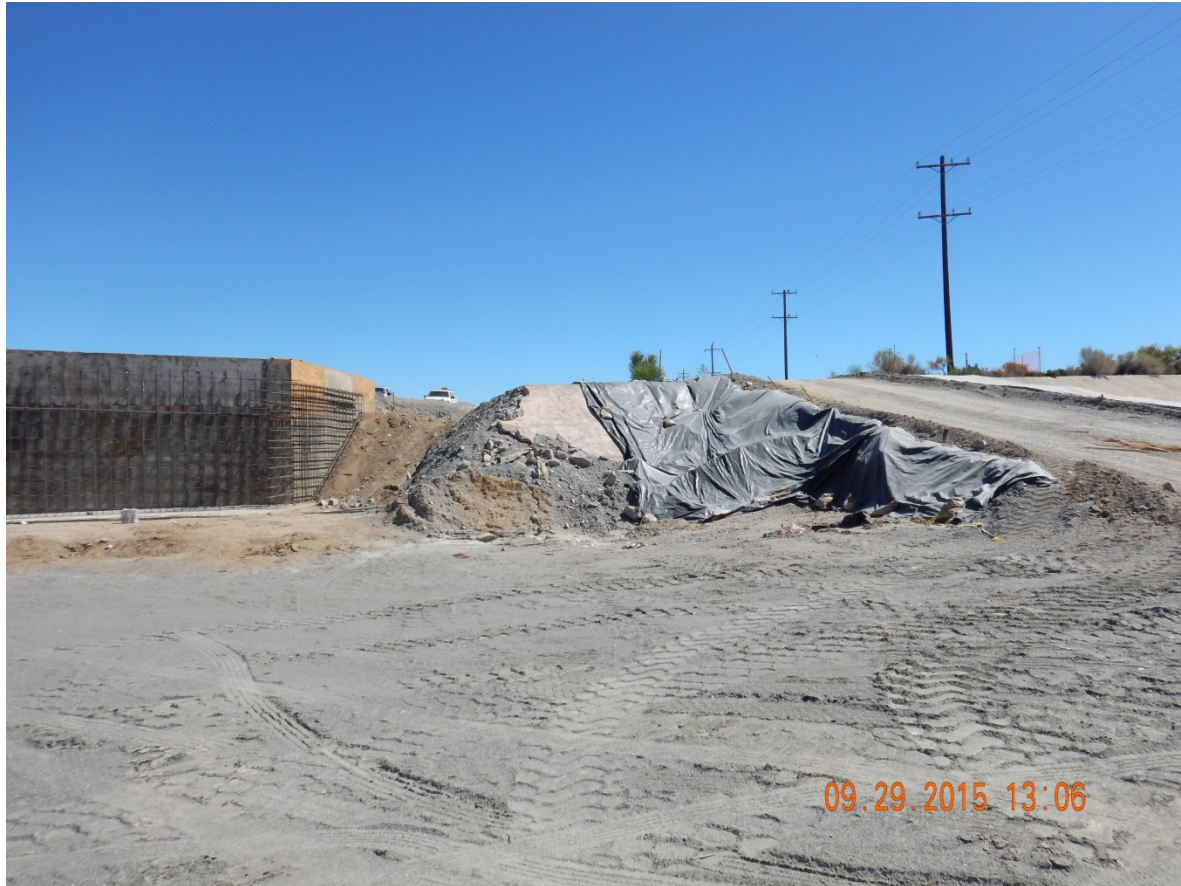
Picture 17: View to the East, From Within Sheep Creek. Note the lack of BMPs and failing BMPs.

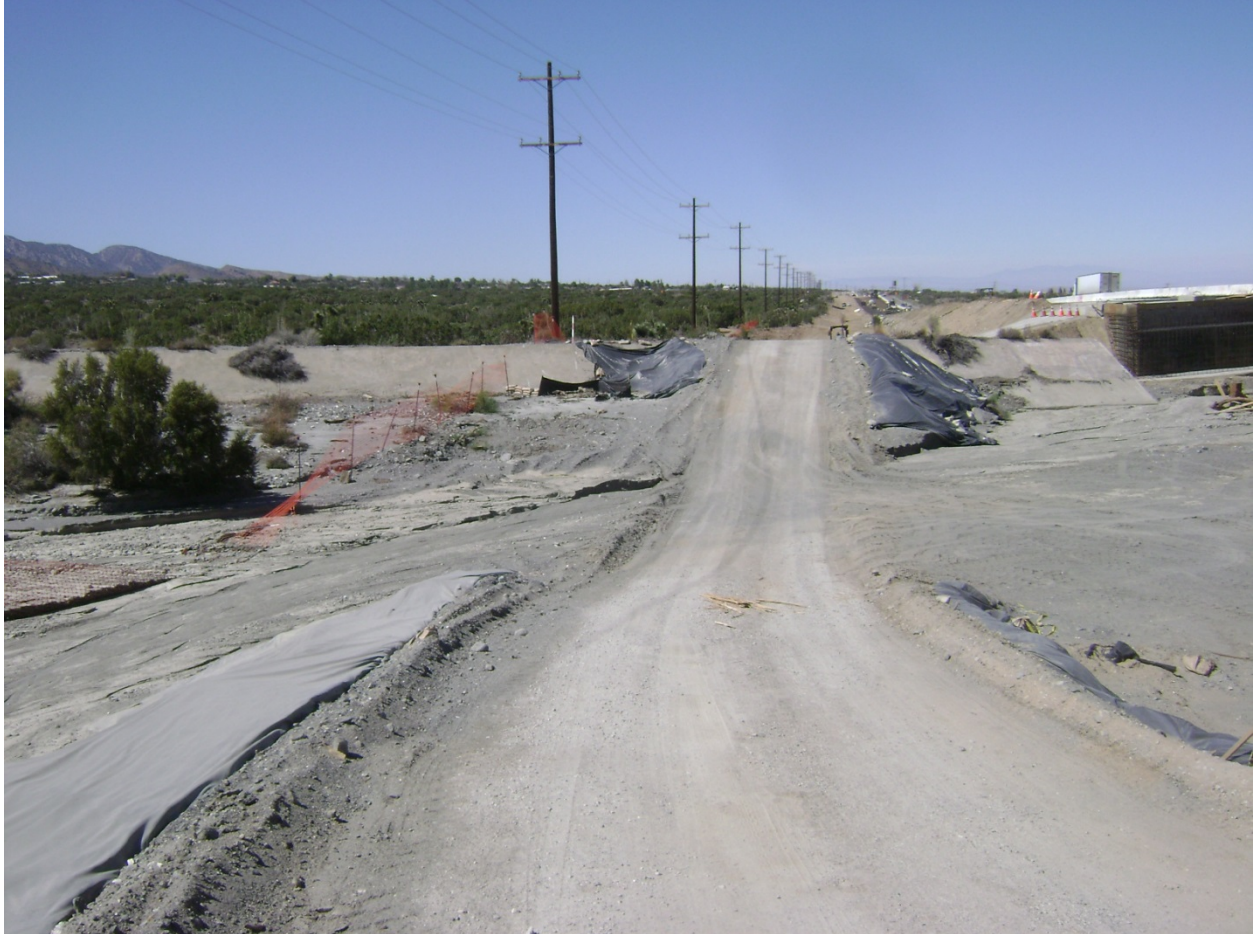
Picture 18: View to the West, From East Bank of Sheep Creek. Note Construction Access Road Crossing Through Creek With Inadequate BMPs.

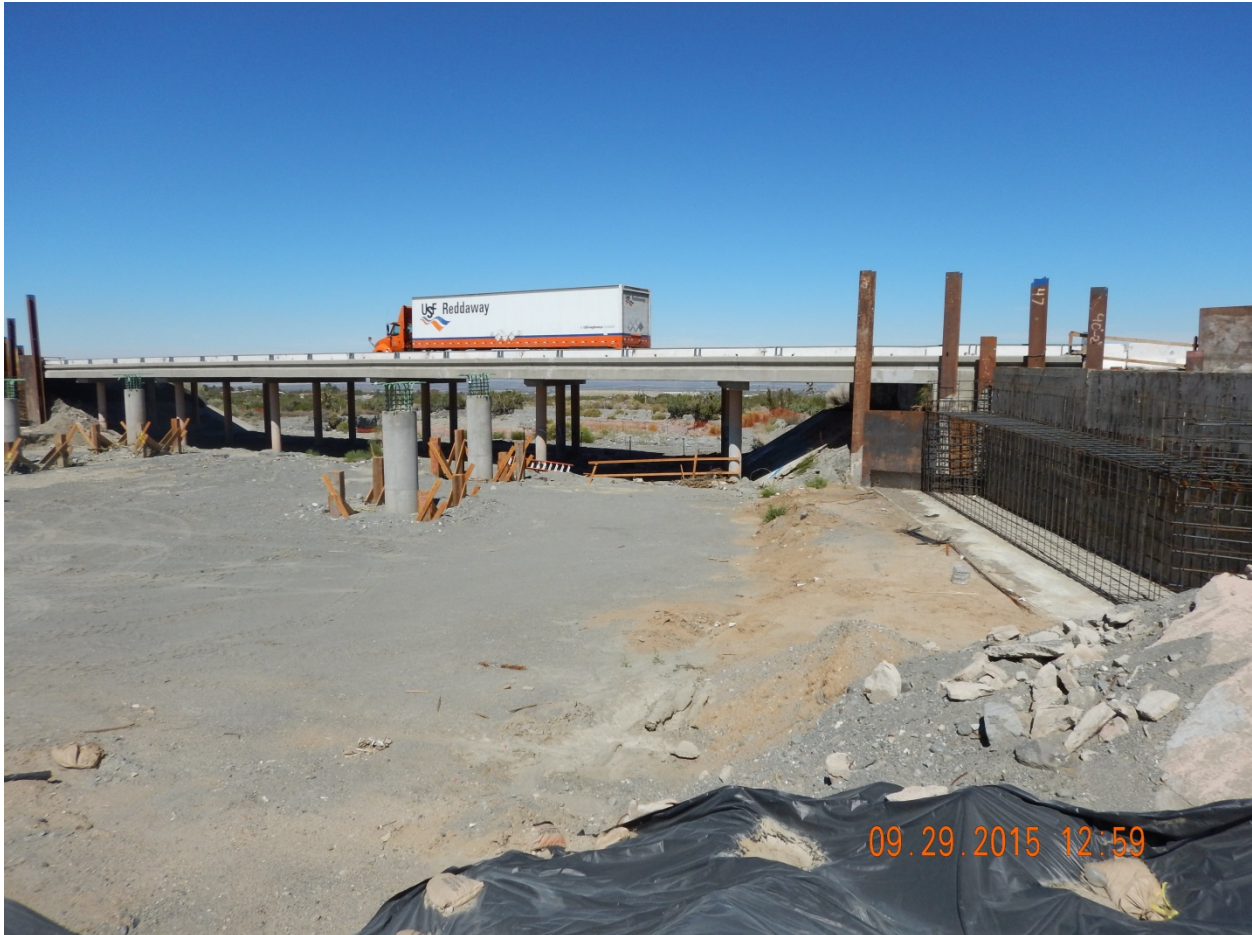
Picture 19: View North Within Sheep Creek. Note Extensive in-channel work and inadequate BMPs.
