**CLEANUP AND ABATEMENT ORDER
NO. R6V-2016-PROP**

**REQUIRING THE CALIFORNIA DEPARTMENT OF TRANSPORTATION DISTRICT 8
TO CLEAN UP AND ABATE THE EFFECTS OF THE DISCHARGE OF DREDGE AND
FILL MATERIAL TO WATERS OF THE STATE AT THE CALIFORNIA HIGHWAY 138
WIDENING PROJECT AT SHEEP CREEK**

**California Department of Transportation State Route 138 Widening Project –
Phase 1, San Bernardino, California (Project) (WDID SB13004IN)**

Project Inspection: September 29, 2015

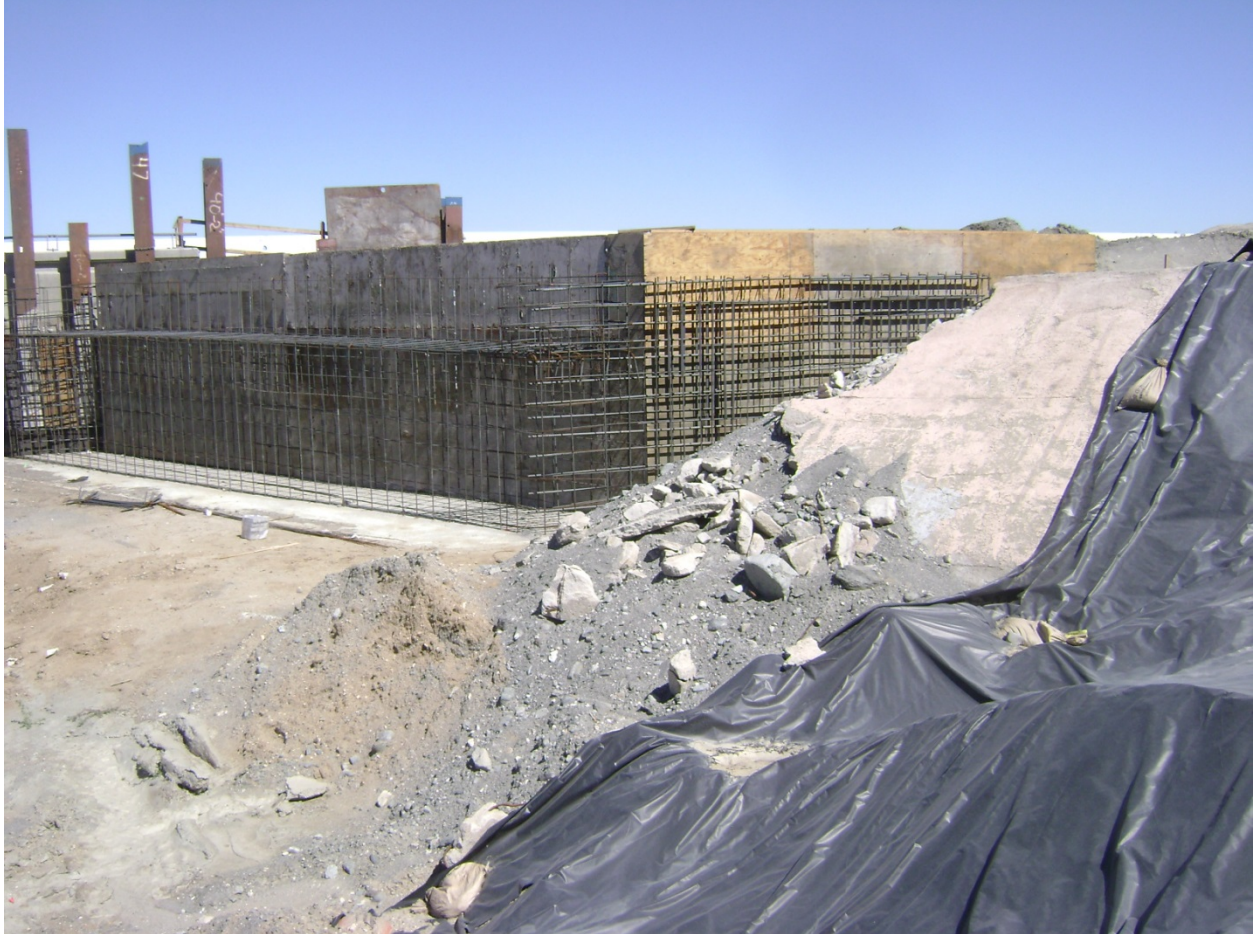
Picture 20: View North Within Sheep Creek. Note Inadequate BMPs.

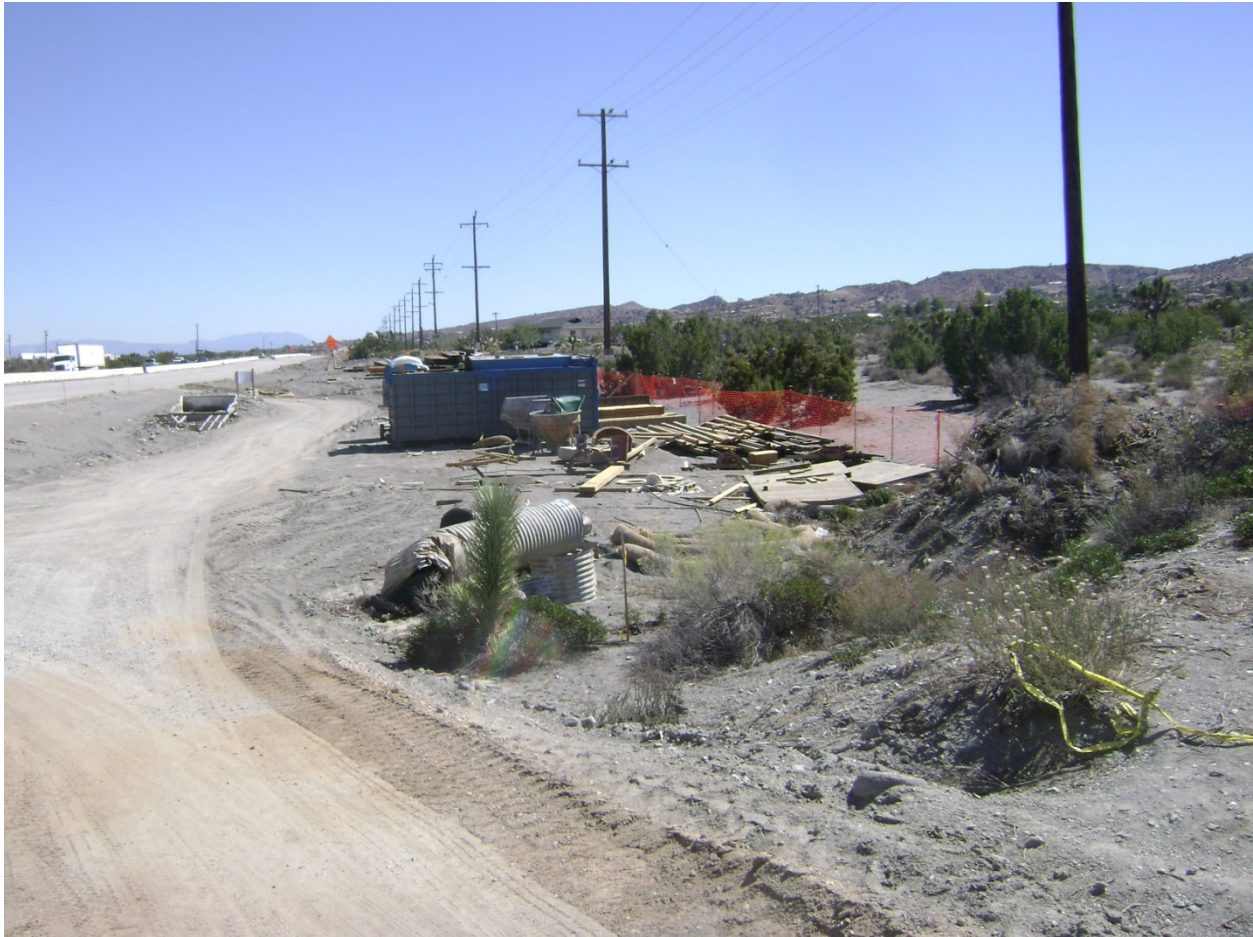
Picture 21: Facing East from Bank of Sheep Creek. Note construction debris and trash.

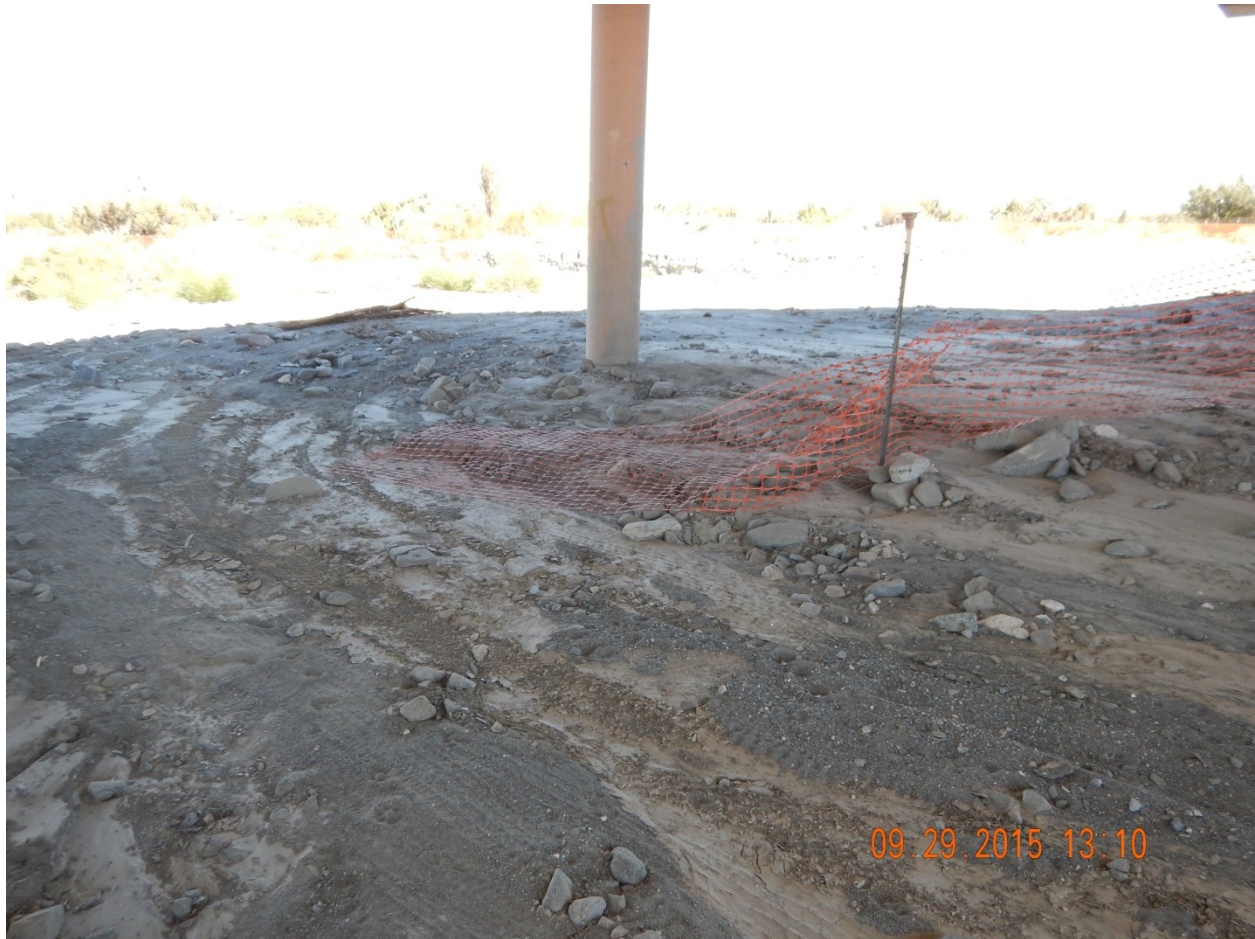
Picture 22: Beneath the Sheep Creek Bridge. Note damaged construction fencing left in the creek.

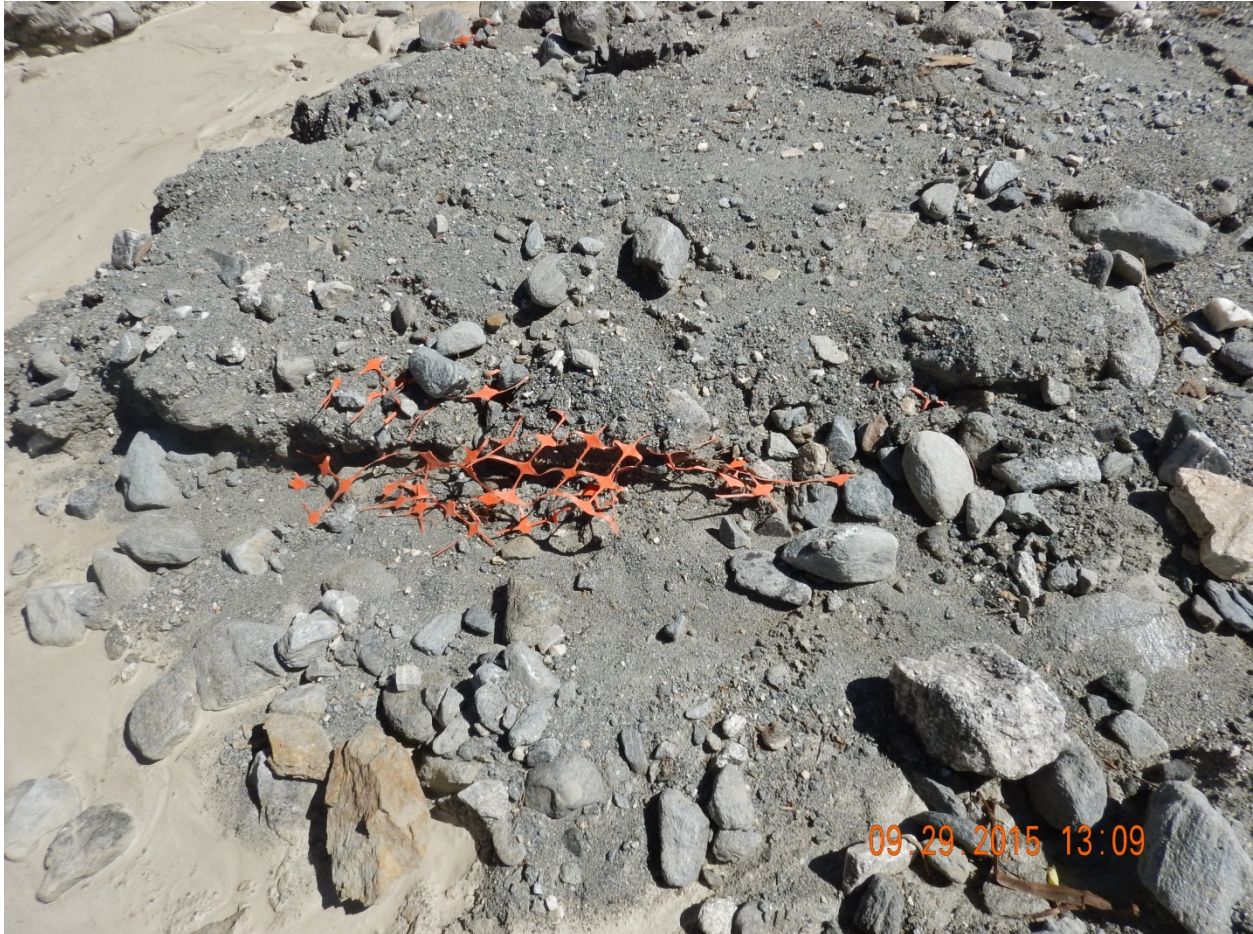
Picture 23: Construction fencing debris within Sheep Creek. Note that it is covered with sediment.

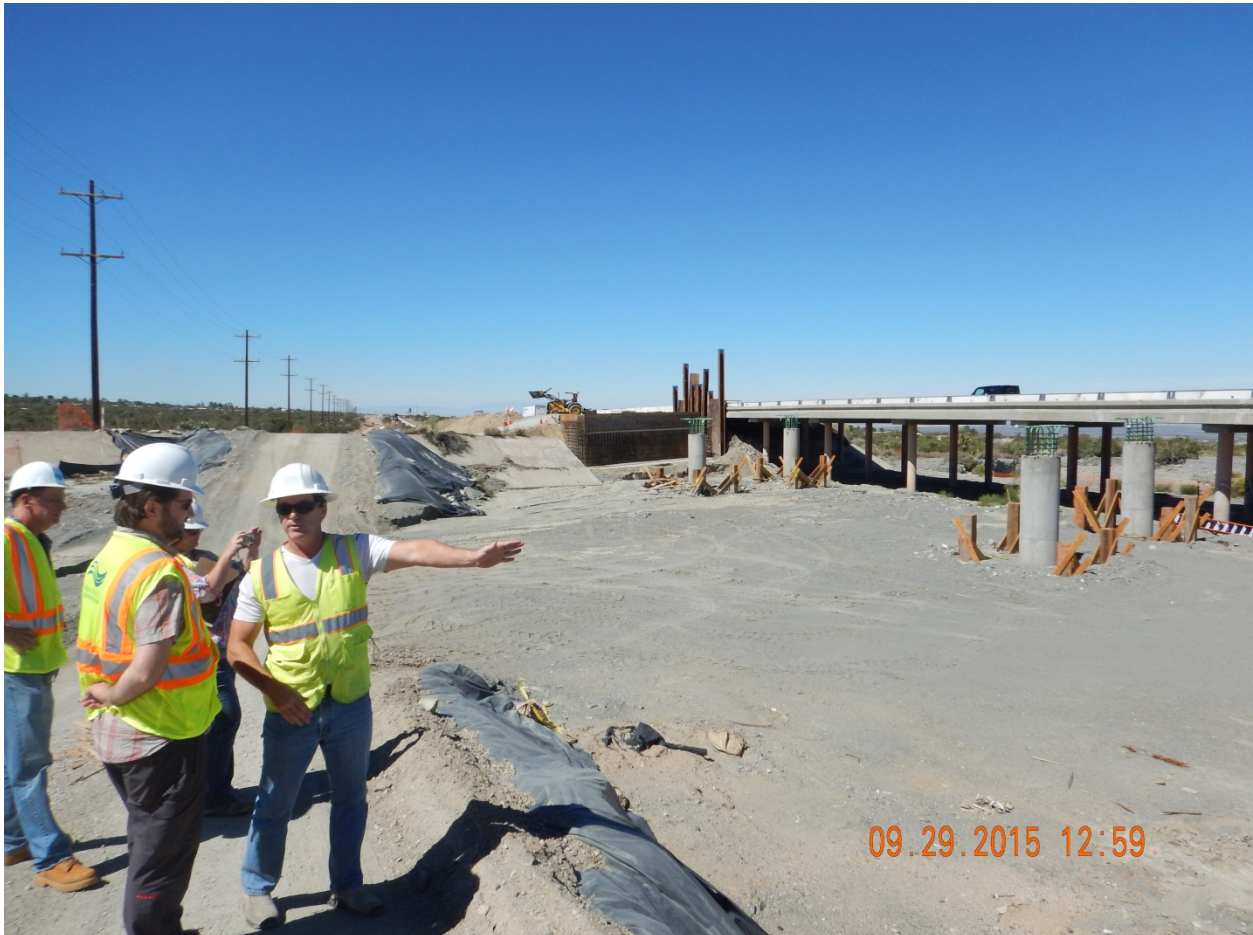
Picture 24: View North West from eastern bank of Sheep Creek. Note Construction Access Road through the Creek with inadequate BMPs.

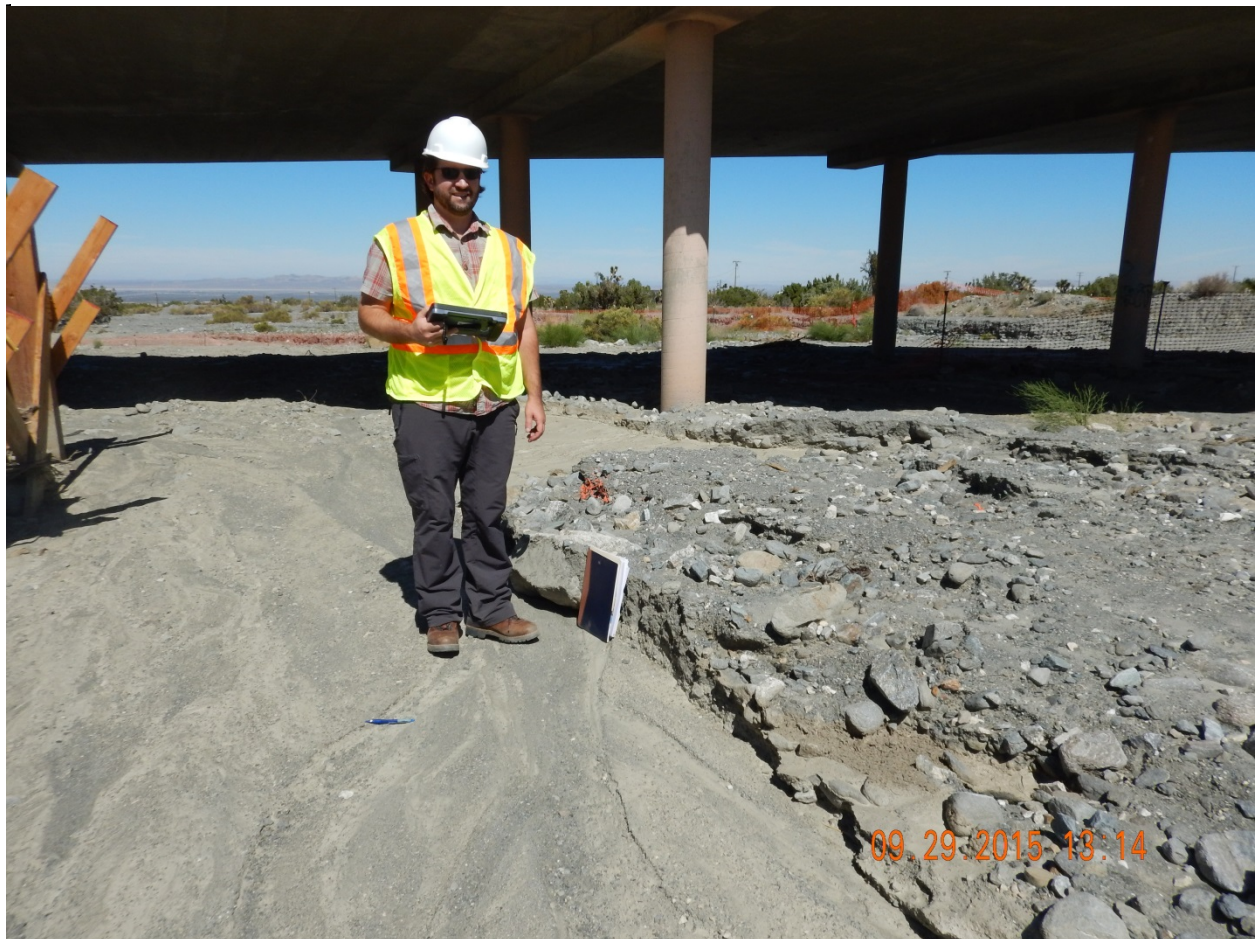
Picture 25: View North within Sheep Creek. Note approximately 10 inches of unconsolidated sediment washed out from this location during last storm event.

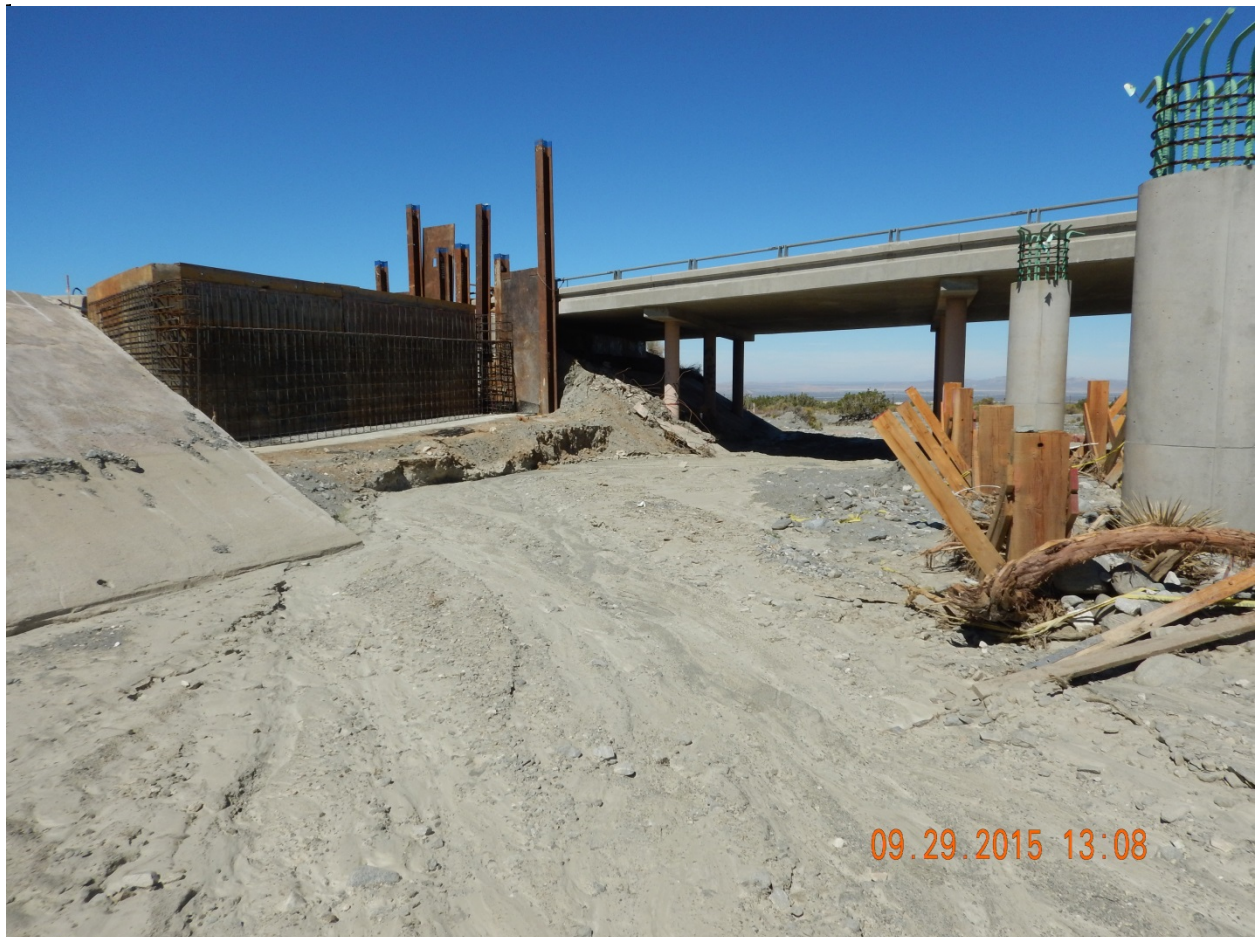
Picture 26: View North within Sheep Creek. Note lack of BMPs on creek banks and debris accumulation upstream of footings from last storm event.

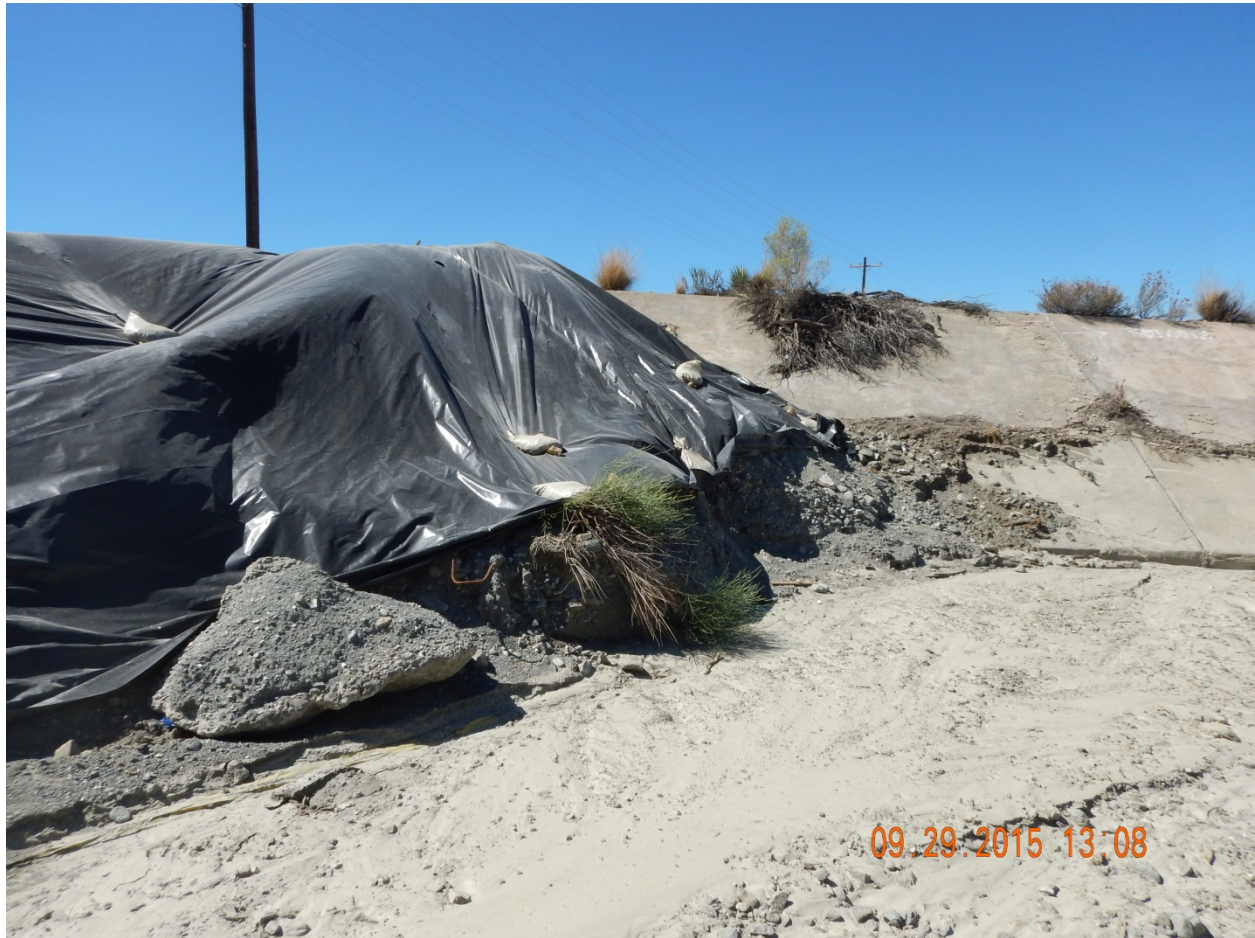
Picture 27: View West from within Sheep Creek. Note inadequate BMPs.

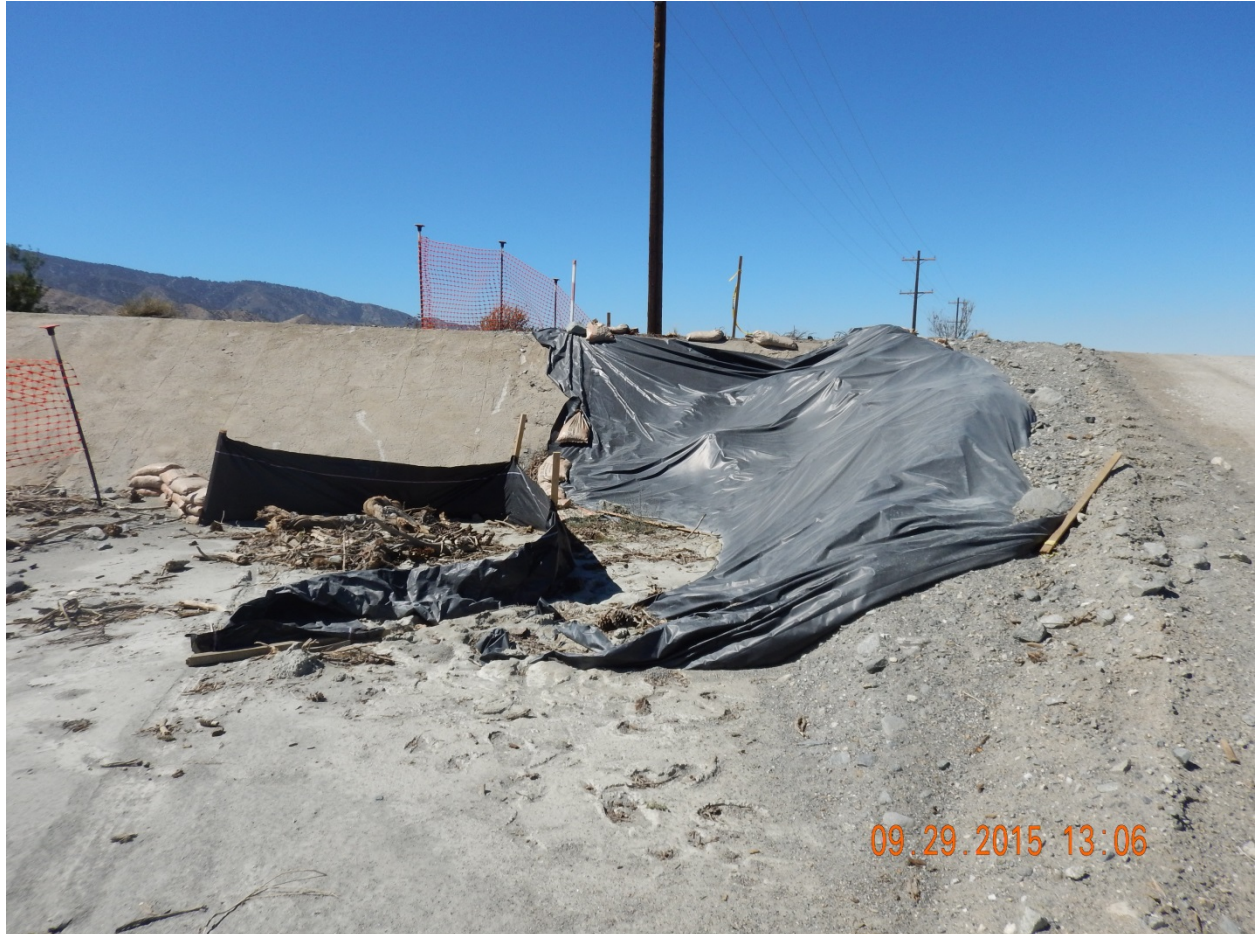
Picture 28: View West from within Sheep Creek. Note inadequate BMPs and failing improperly installed silt fencing.

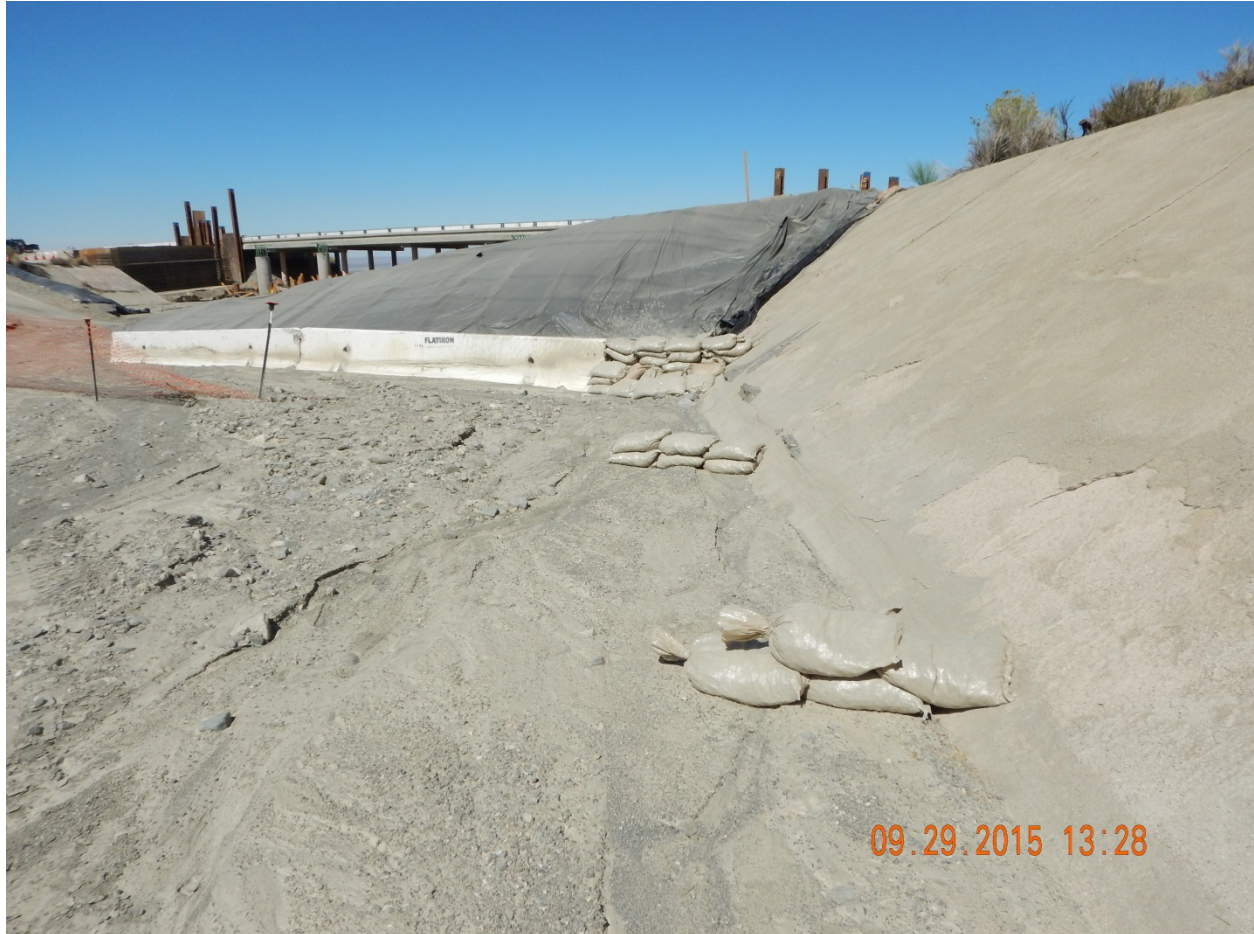
Picture 29: View North from within Sheep Creek. Note that the k-rail does not extend far enough to the west to protect the toe of the access road.

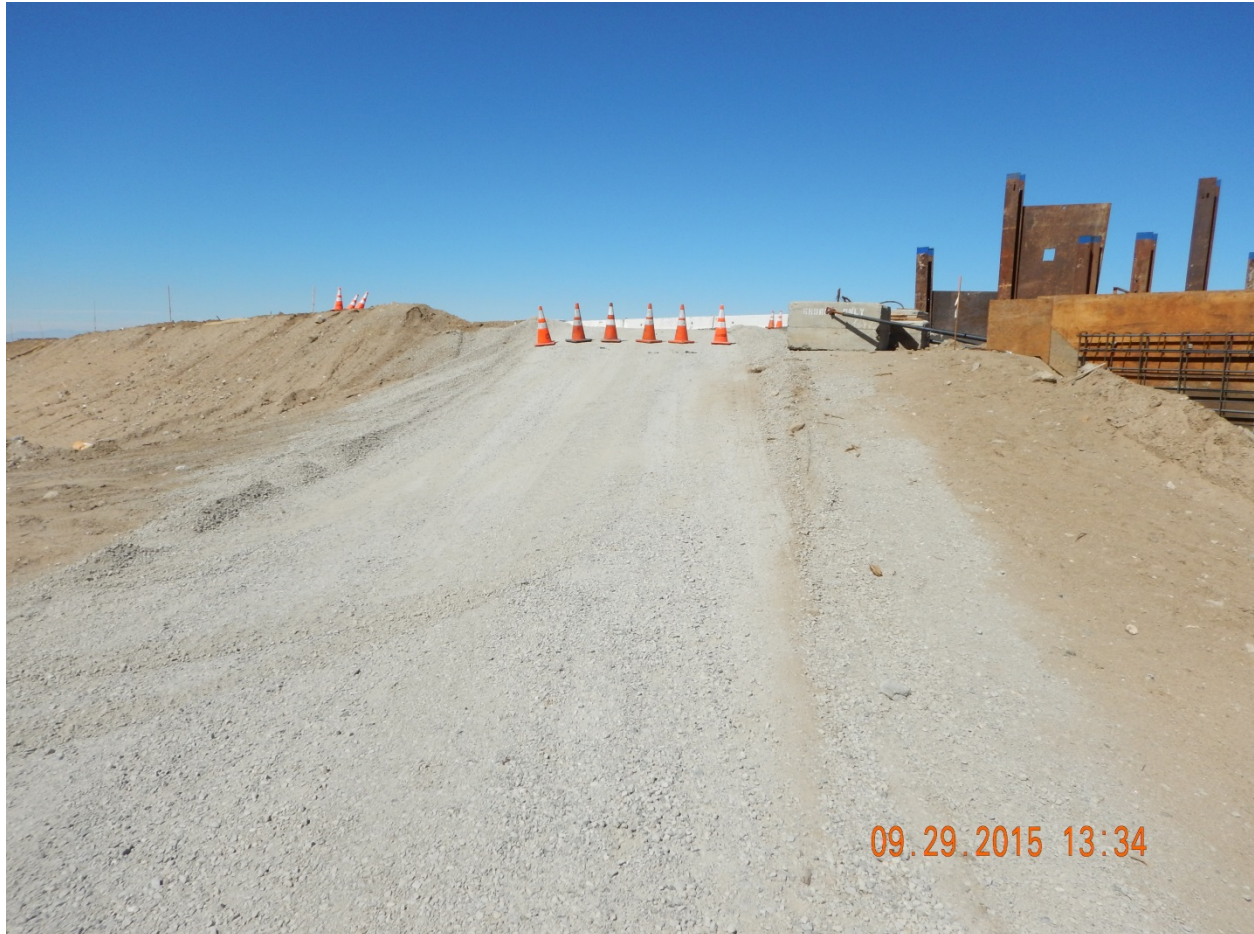
Picture 31: View facing north along construction access road (west of Sheep Creek) to active paving activity along the SR 138 alignment.
