**YEAR-END REPORT**  
**FOR THE 2021 FIELD SEASON**  
**AT LEVIATHAN MINE**

**Alpine County, California**

**March 2022**

**California Regional Water Quality Control Board, Lahontan Region  
2501 Lake Tahoe Boulevard  
South Lake Tahoe, CA 96150**

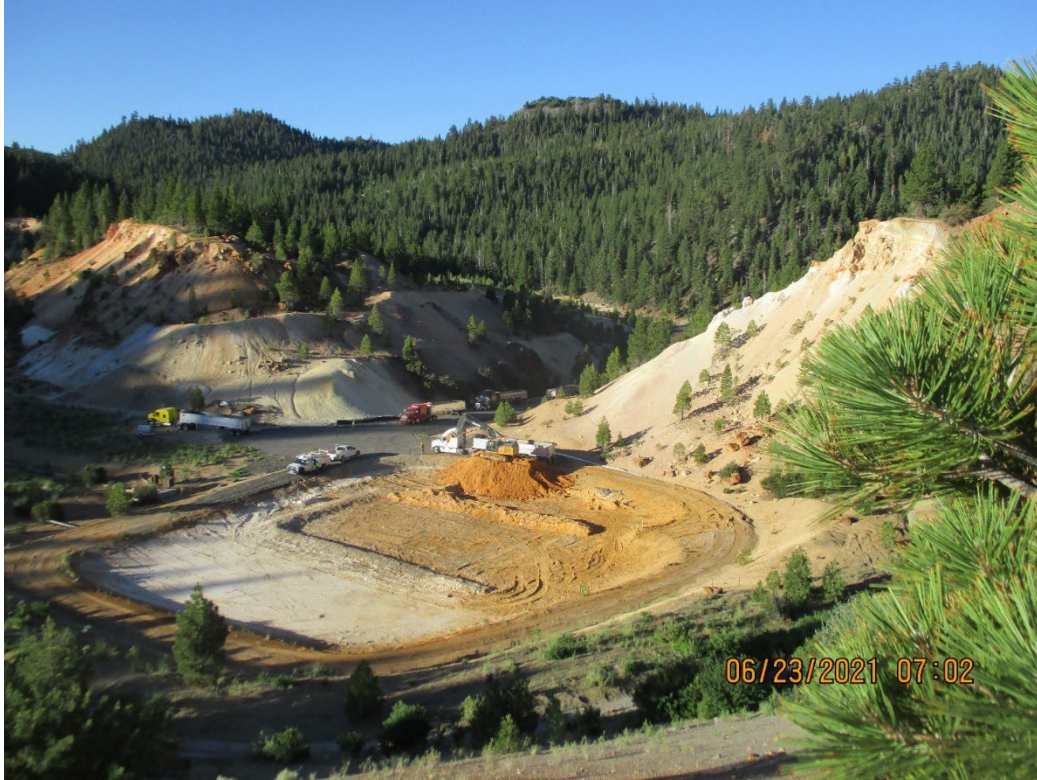
Photo 1 – June 23, 2021, Sludge stockpile and disposal activities at the pit clarifier

Approximately 336 tons of sludge generated during operations of the pond water treatment plant (Plant) in 2020 were removed from the Pit Clarifier by the Water Board's contractor AECOM Technical Services (AECOM), in late-June 2021. The sludge was sampled, analyzed, and characterized in the fall of 2020; the results from the fall 2020 sampling were reported in the Water Board's 2020 Year-End Report. The sludge was hauled to a Class I hazardous waste landfill in Beatty, Nevada for disposal. Hazardous waste manifests are available for review at the Water Board's office in South Lake Tahoe. The sand drainage layer in the bottom of the Pit Clarifier was evaluated; the sand layer was within the specified thickness, and replenishment was not necessary. Sludge removal and disposal activities are shown in Photo 1.

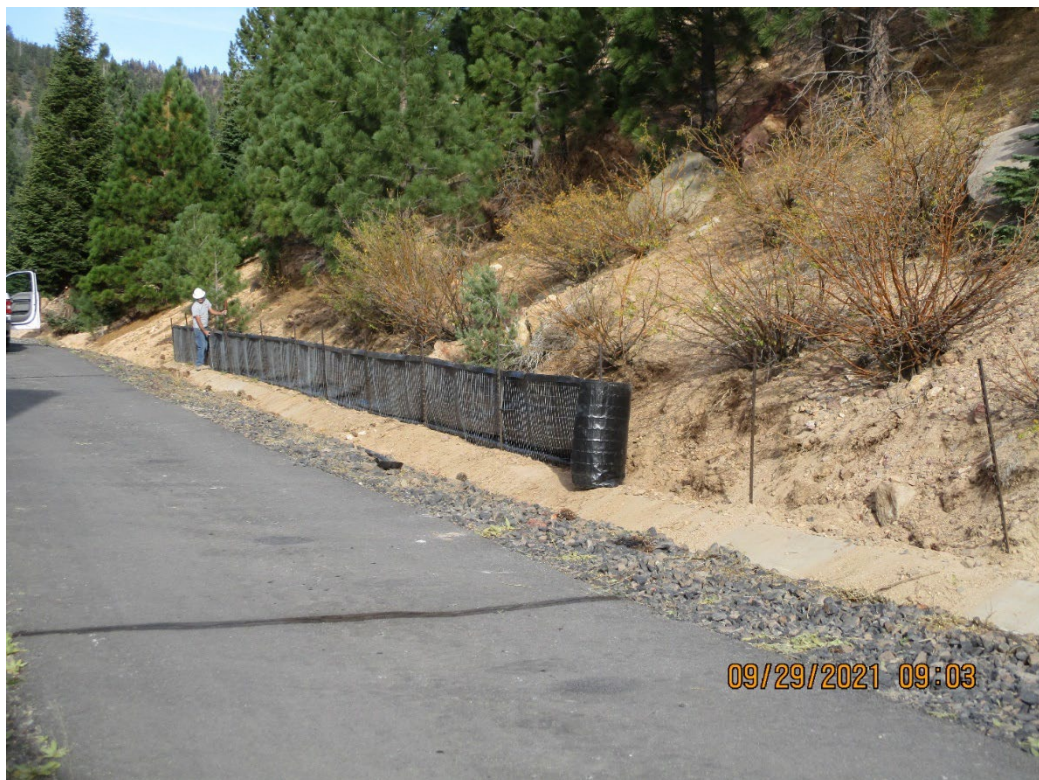
Photo 4 – September 29, 2021, Installation of new reinforced silt fence near Pond 1

Water Board staff noted that the BMP's along the Pit access road and in the Pond 1 area needed to be replaced. Water Board staff directed AECOM to remove the existing silt fence, remove sediment loading, and install new reinforced silt fence. AECOM replaced the silt fence in September 2021. Water Board staff also directed AECOM to remove existing fiber rolls near the confluence of Leviathan Creek and the Lower Tributary, remove sediment loading, and install new fiber rolls. AECOM replaced the fiber rolls in September 2021. Installation of new reinforced silt fence can be seen in Photo 4.

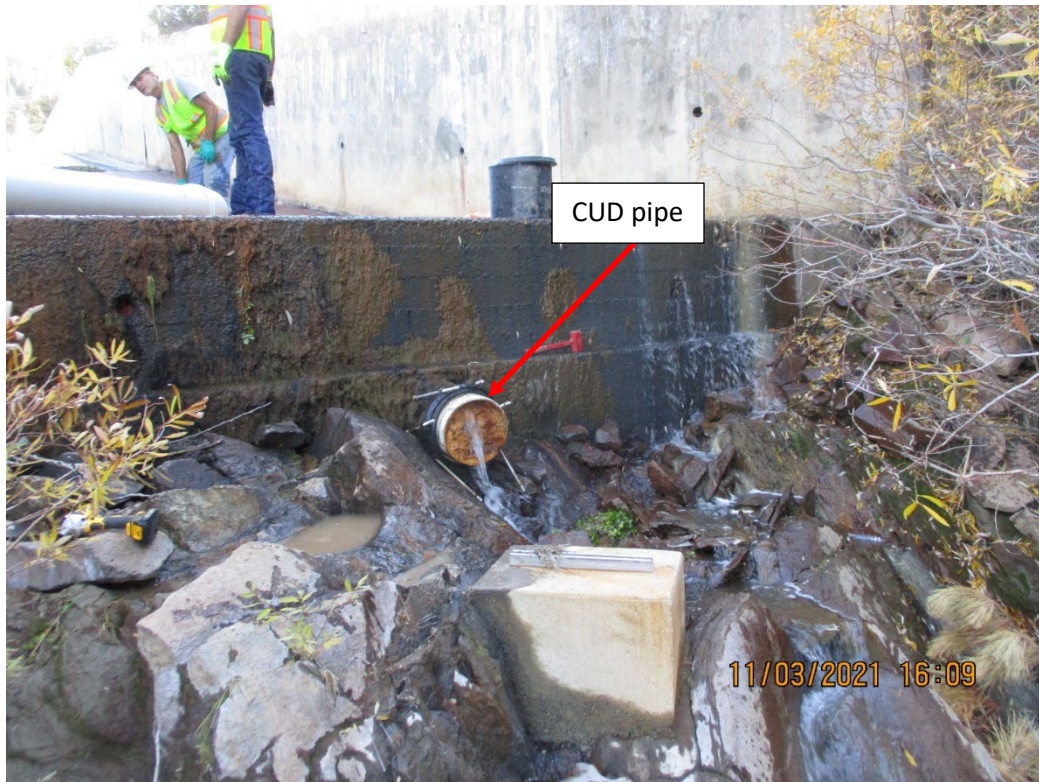
Photo 7 – November 3, 2021, Metal precipitates at the downstream end of the CUD pipe

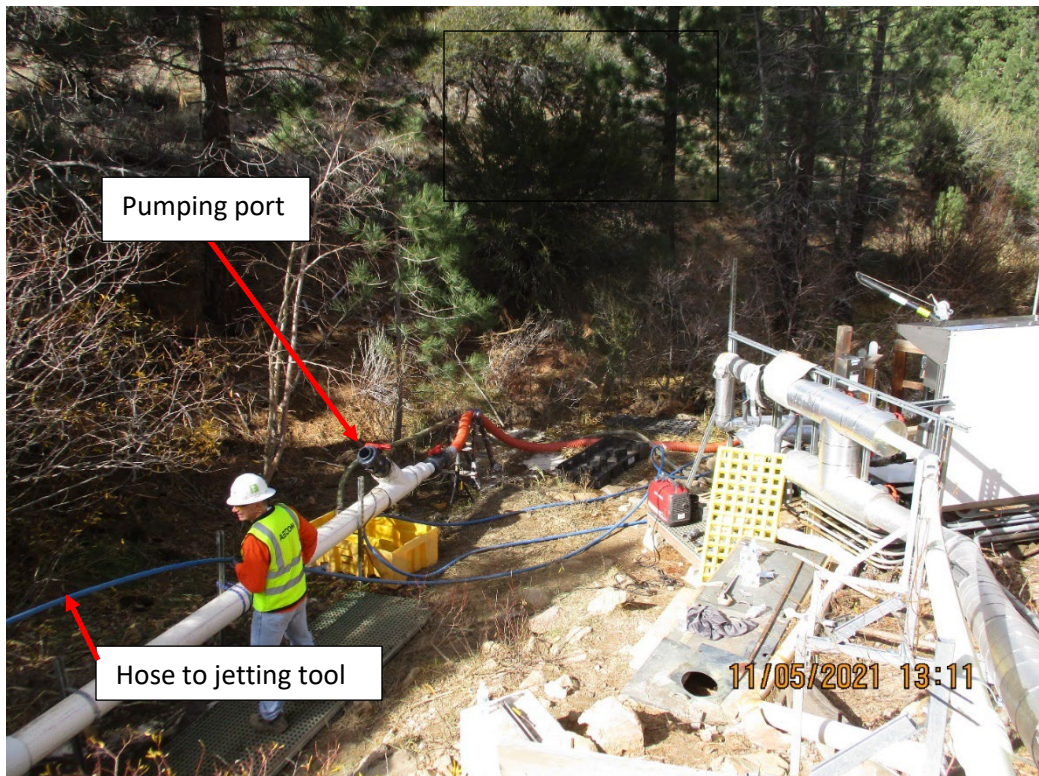
Photo 10 – November 5, 2021, Jetting and pumping activities at the CUD

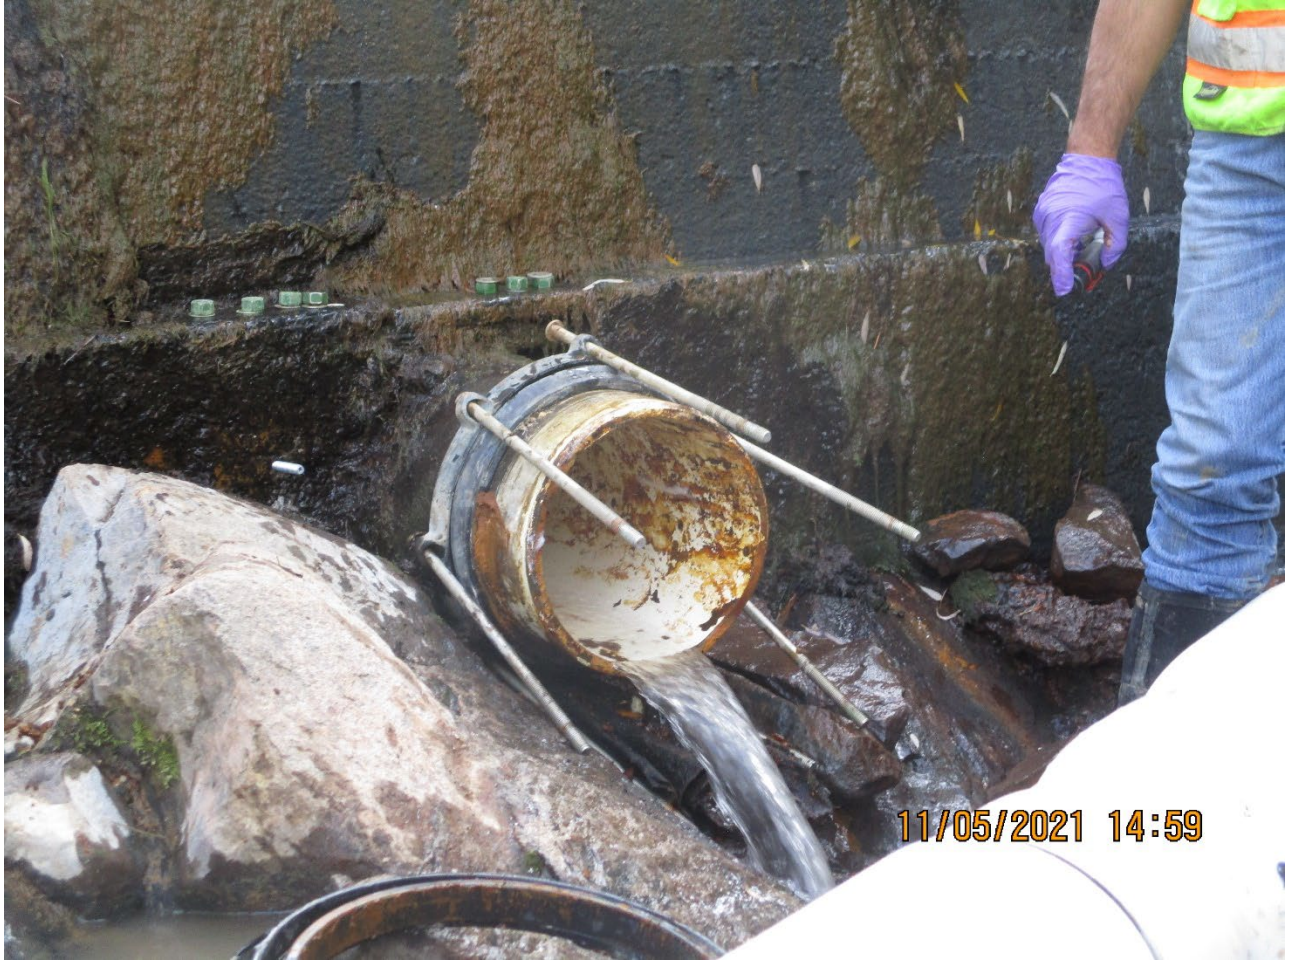
Photo 11 – November 5, 2021, CUD pipe after removal of metal precipitates (prior to reinstallation of the outlet pipe to weir box)

Water Board staff intended to perform a video inspection of the CUD pipe following cleanout activities. Due to the cleanout being completed very late in the field season, and the onset of winter weather, staff were unable to locate a contractor with availability to perform a video inspection. Provided field conditions allow, Water Board staff intend to have a video inspection of the CUD pipe performed during the 2022 field season, if CUD and stream flow conditions permit.
