California Regional Water Quality Control Board
North Coast Region

Cleanup and Abatement Order No. R1-2004-0076

Brookfield Investors, LLC

Regarding
10100 Brooks Road, Windsor

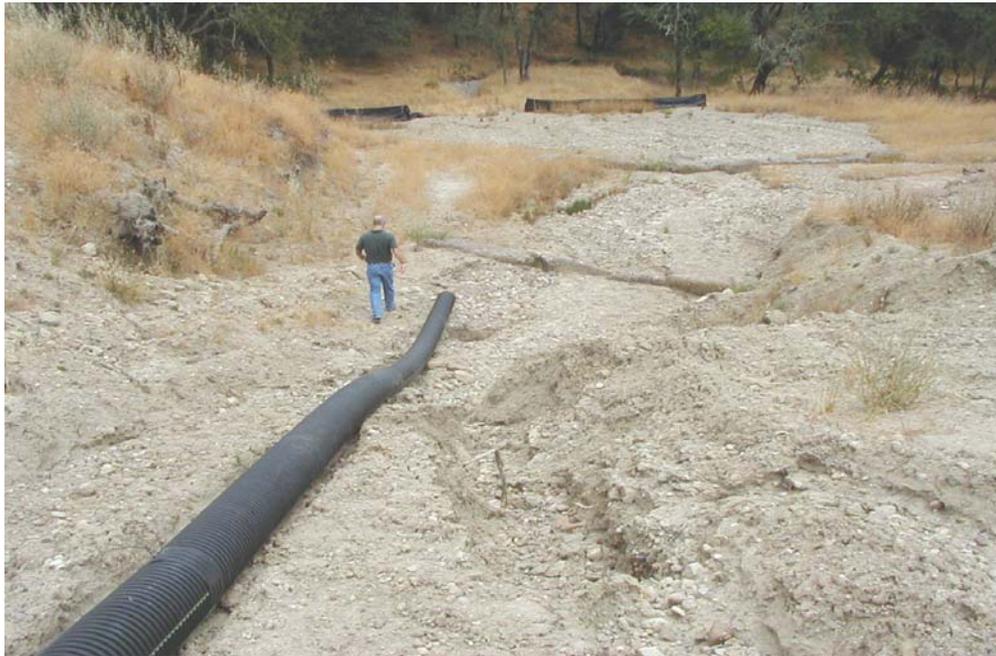
Photo 1. View of Land Slide #1 (LS#1) and newly placed pipe, facing down towards the intermittent stream that was inundated with sediment. 6/29/04.

East of the main entrance road, we stopped and looked at an area that has significant landslides and erosion that has discharged a significant amount of sediment into a small intermittent stream. The landslides and erosion appear to have been caused by the grading of the area, which destabilized the slopes. At the toe of the slope, between the slide and the intermittent stream, there is some old degraded silt fencing, and upon a closer look, there was another section of silt fencing that had been completely overwhelmed by a sediment flow, and was knocked down and buried. The newer silt fence has also been knocked down in sections due to significant sediment discharges of off the slope. As a side note, the new silt fence was not properly installed, as the bottom was not buried below grade. The stream above the sediment discharge point is cobble dominated and below the discharge point the entire channel is filled with silt/sand for approximately 450 lineal feet downstream.

3. Submit a plan to stabilize the landslide areas and associated erosion identified in Finding #4 above, and to remove accumulated sediment from the intermittent stream that has been impacted by severe sediment discharges associated with the landslides by **September 24, 2004**. The plan shall be implemented prior to October 15, 2004, upon concurrence from the Regional Water Board.

- Removal of the accumulated sediment shall not result in any further impacts to the riparian habitat along the intermittent stream, and therefore shall be conducted by hand, or other means not damaging to the stream habitat.

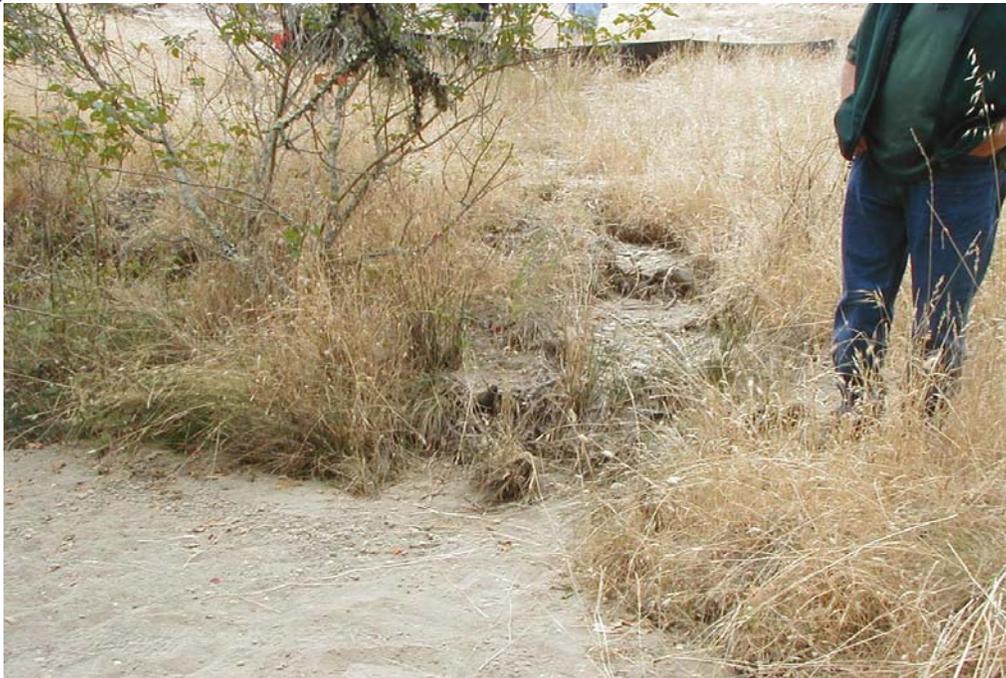
Photo 2. Land Slide #1 discharge point into an intermittent stream that flows through the site, with large accumulation of fines and sand within the stream channel. 6/29/04.

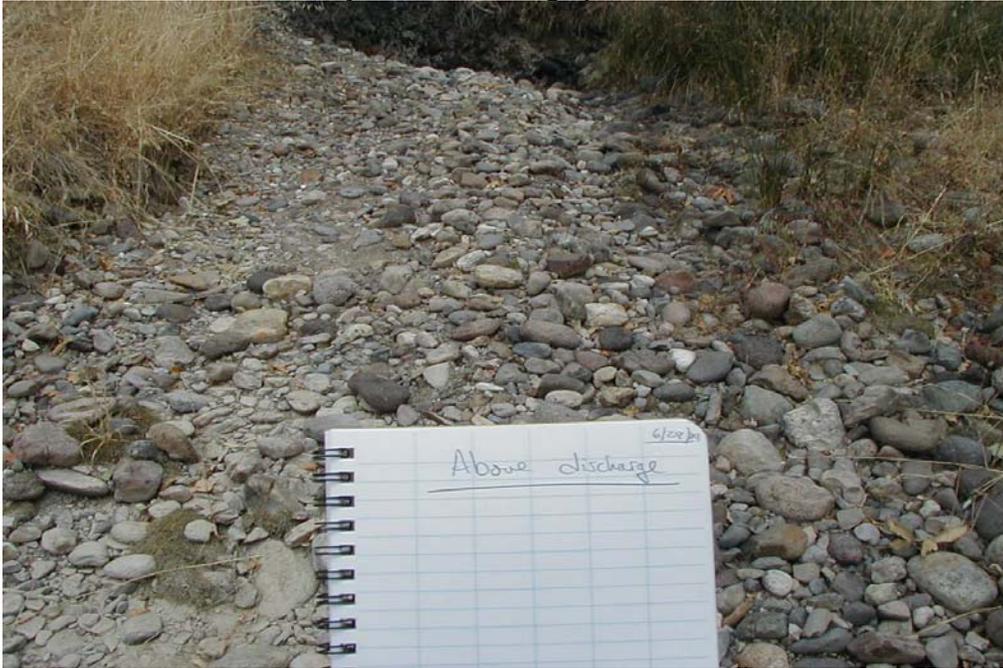
Photo 3. Intermittent stream directly above discharge point of LS#1. 6/29/04.

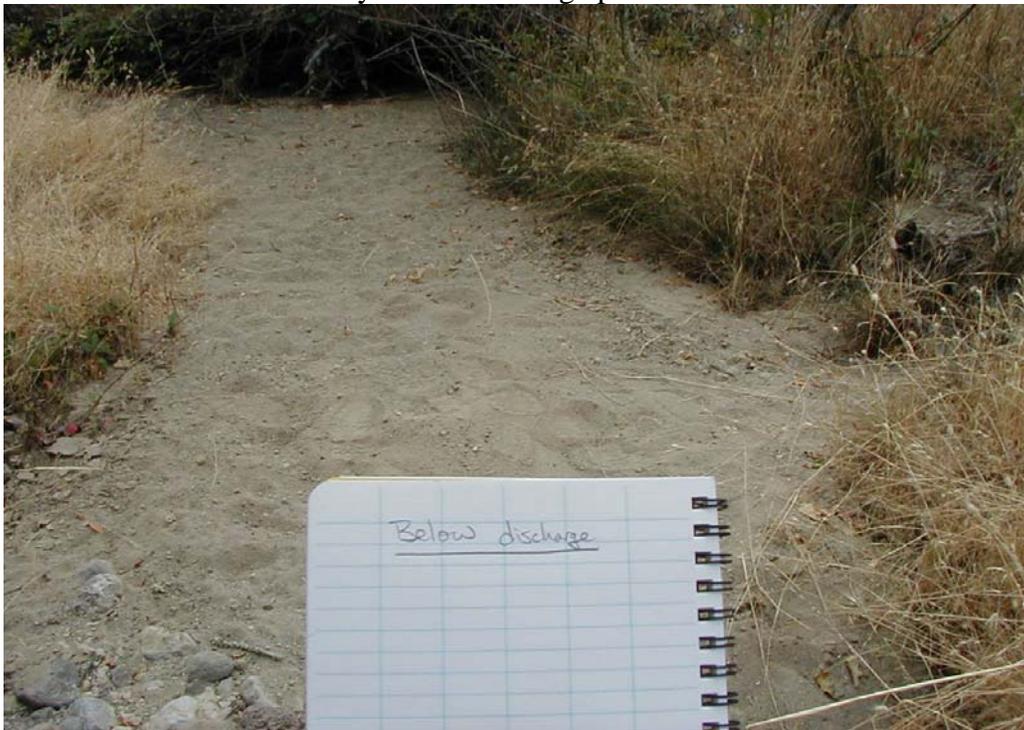
Photo 4. Intermittent stream directly below discharge point of LS#1. 6/29/04.

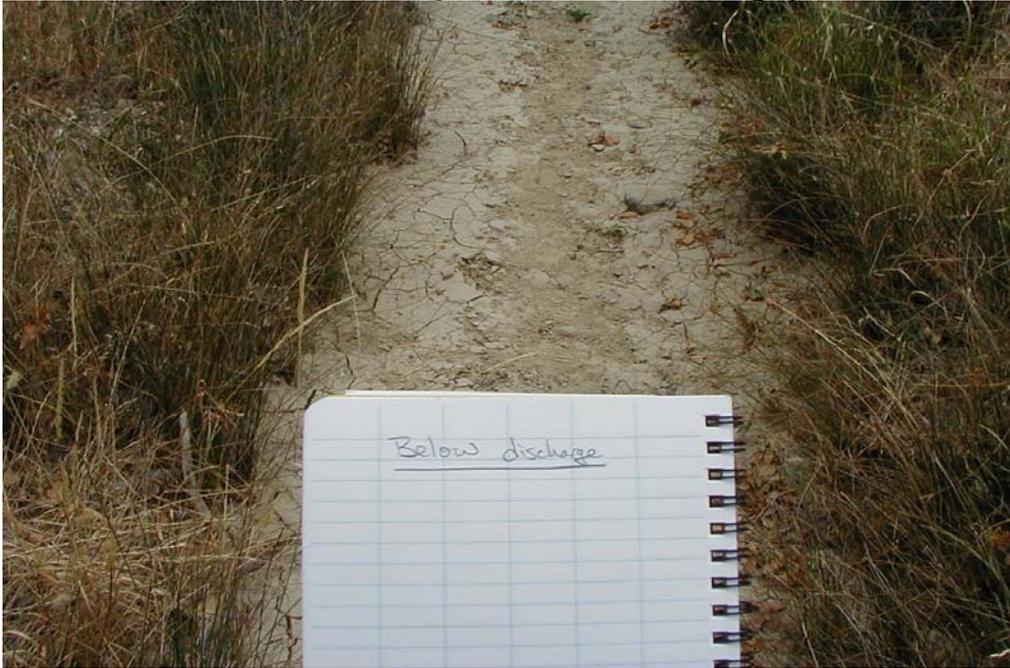
Photo 5. Intermittent stream approximately 150-feet below discharge point of LS#1. 6/29/04

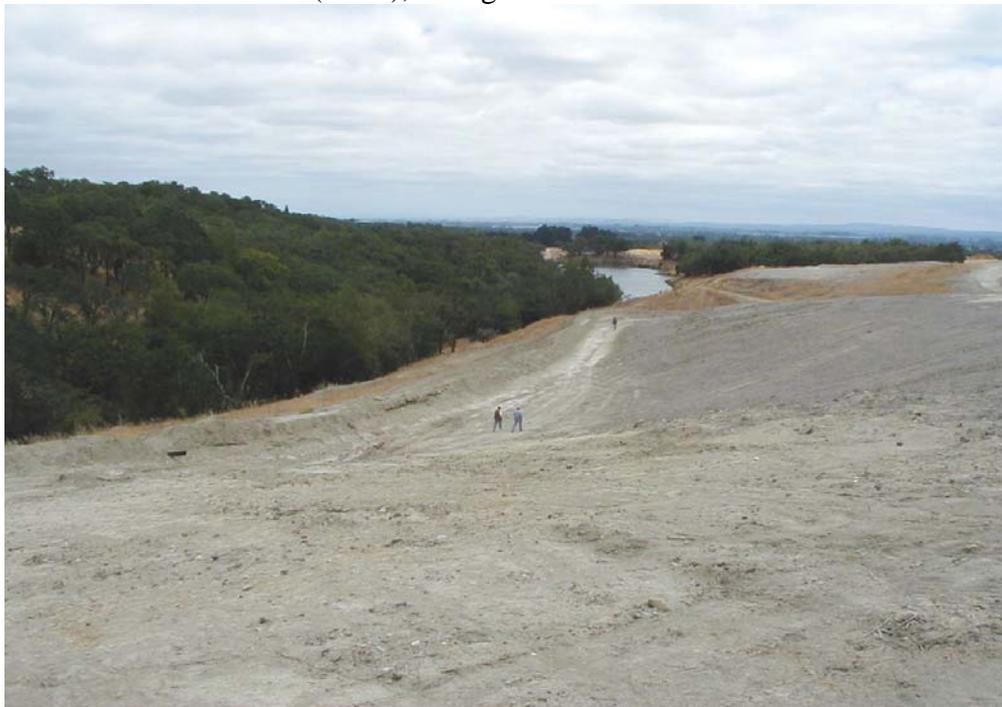
Photo 6. View of Land Slide #2 (LS#2), facing down towards the intermittent stream. 6/29/04.

Slightly upstream of LS #1, there is another significant landslide and erosion area referred to as LS #2 in my notes. This area has a small detention basin at the top of the slope that appears to have a new culvert that had been installed during a time when conditions were wet. There was a significant amount of sediment discharged into the intermittent stream. The stream flows into an instream impoundment, which then continues to Starr Creek.

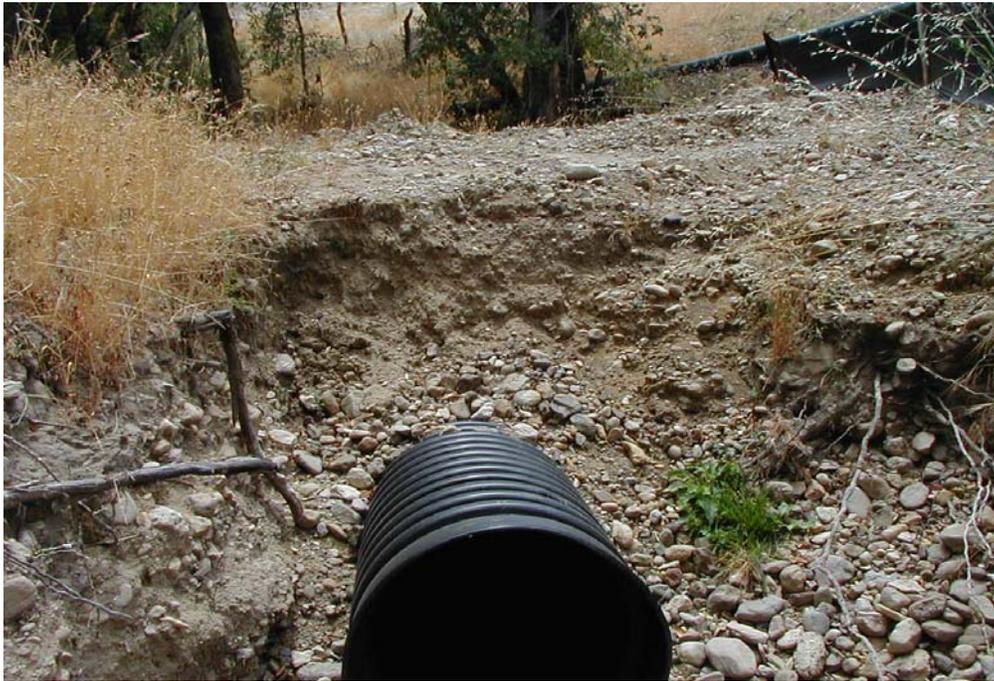
Photo 7. View of the unauthorized stream crossing, placed in the intermittent stream upstream of LS #1&2. 6/29/04

Just below LS #2, there was a crossing installed in the stream, which consisted of a new plastic corrugated pipe and unconsolidated gravel fill material. The culvert was placed in the stream without any permits from the various resource agencies.

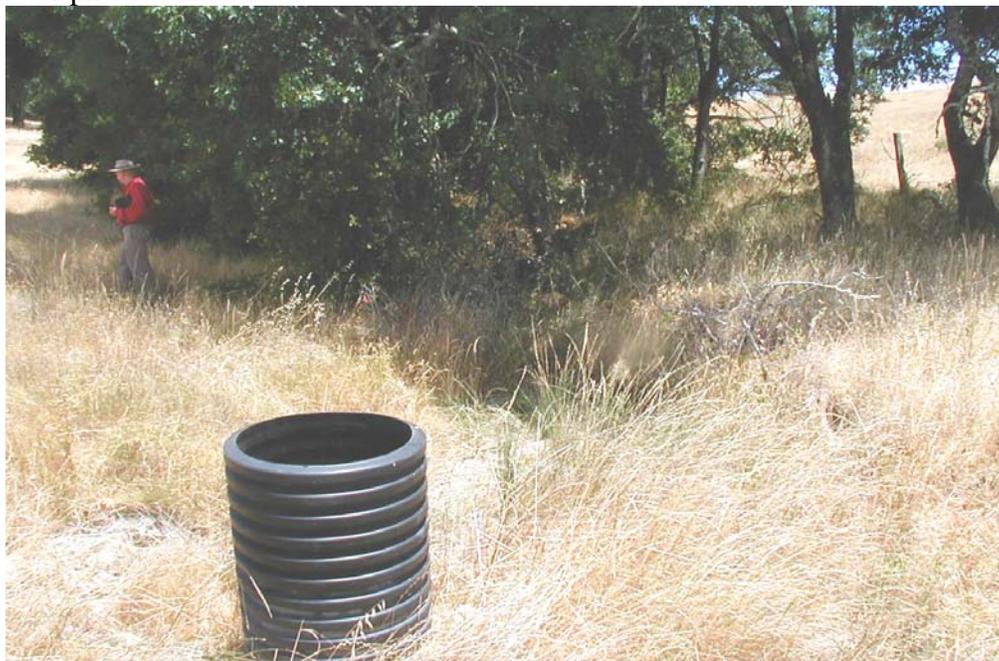
Photo 8. Intermittent stream that has been culverted and filled. Drop inlet structure shown in foreground of photo. 6/14/04

At the northeastern section of the property, an intermittent stream had been culverted and filled. There was a drop inlet structure that leads into a pipe that then flows through the site to the eventual day lighted culvert into Starr Creek. It will be necessary to review aerial photographs, additional pre- and post- project photos, and grading plans, in order to determine the length of filling that occurred.

- a. A Workplan for removing the linear culverts and fill material from all intermittent tributaries that have been filled on the Site. The Workplan shall include information regarding the location and suitability of a chosen disposal site for the excavated fill material;

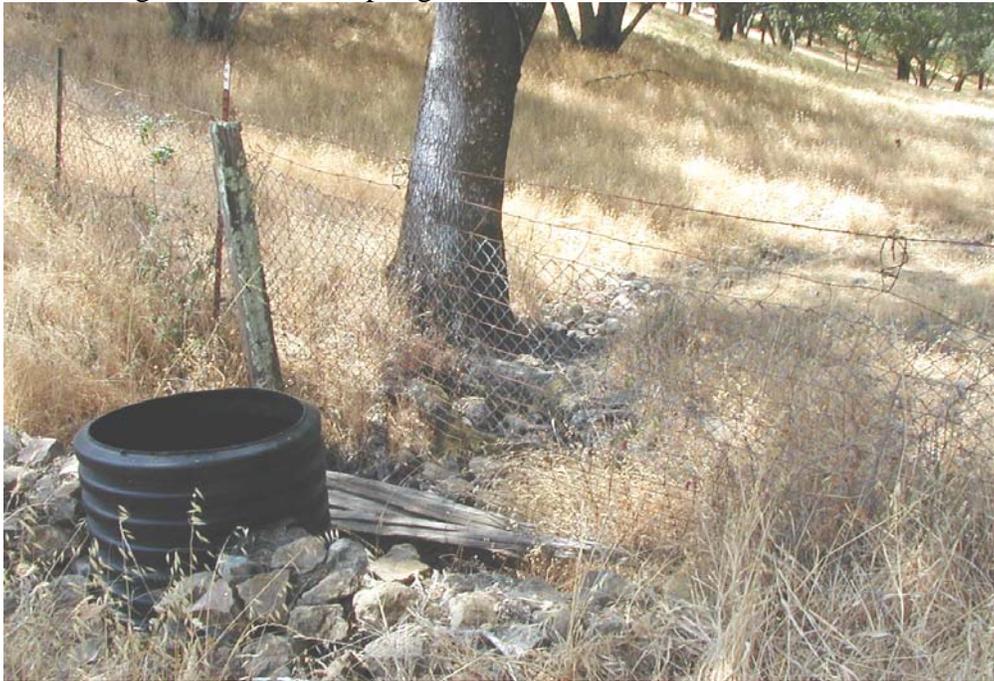
Photo 9. Intermittent stream that is culverted and filled from the northern property boundary at the fence line, through the Diamond Springs site. 6/29/04

Another section of intermittent stream is intercepted at the northern property boundary (fence line) with a drop inlet into a subsurface culvert. The area has been completely filled and piped.

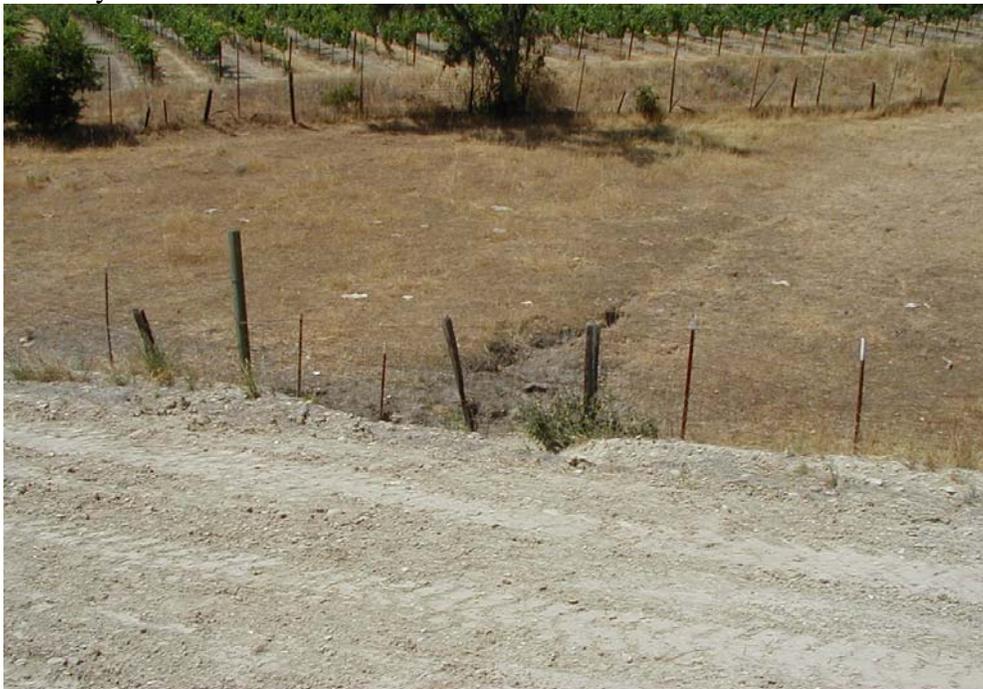
Photo 10. Small headwater of an intermittent drainage that has been filled along the northern property boundary. 6/29/04

At the northern property boundary, a small headwaters section of stream terminates into a fill prism. There is evidence of flow and since the site has been graded, there is no longer an outlet for any flow within this section of headwaters stream.

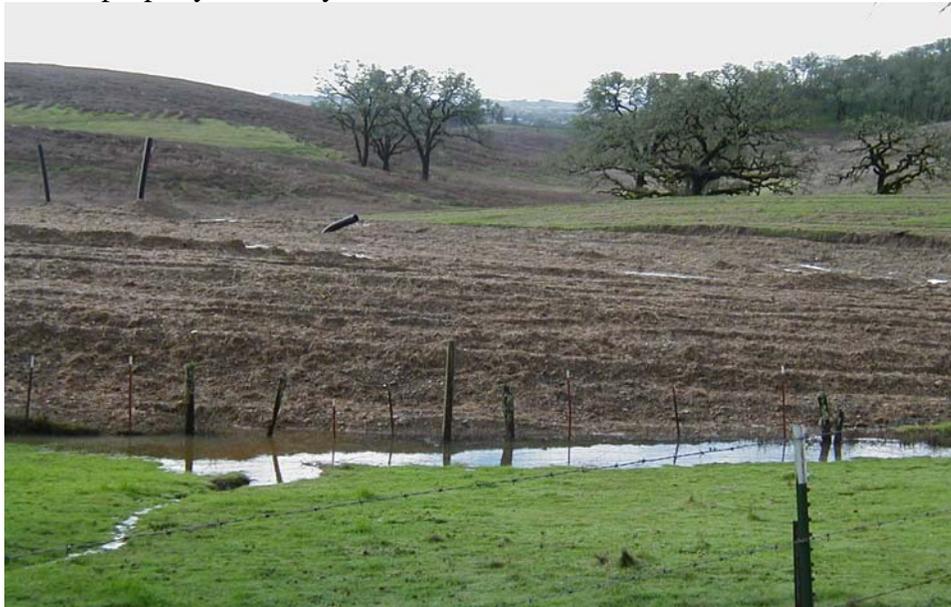
Photo 11. Another view of the small headwater of an intermittent drainage that has been filled along the northern property boundary. 2/18/04

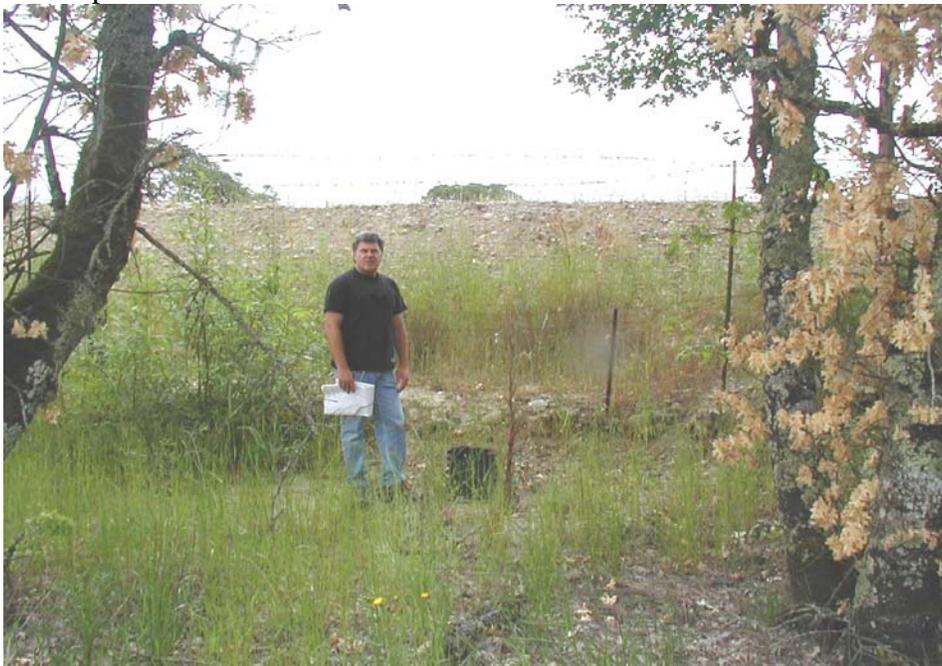
Photo 12. View of a culverted intermittent drainage and filling of wetland habitat, taken from adjacent property. Drop inlet structure and new culvert shown at the fence line. Mr. Andrew Baker is shown in photo for scale. 5/21/04

Along the western boundary along the fence line the owner has installed a culvert that extends through the adjacent property, Windsor Oaks Vineyards, and ties into an existing culvert outfall. The installation of the new culvert impacted habitat determined to be wetland by the ACOE during an earlier site visit (June 14, 2004) on the Windsor Oaks Vineyards Property. In addition, two large mature oaks trees that were within the bottom of a swale area, were killed due to the trenching, and subsequent root damage, associated with the culvert placement. The wetland area ends at a new fill prism on the Diamond Springs Property, which appears to have reduced the overall footprint of the wetland feature.

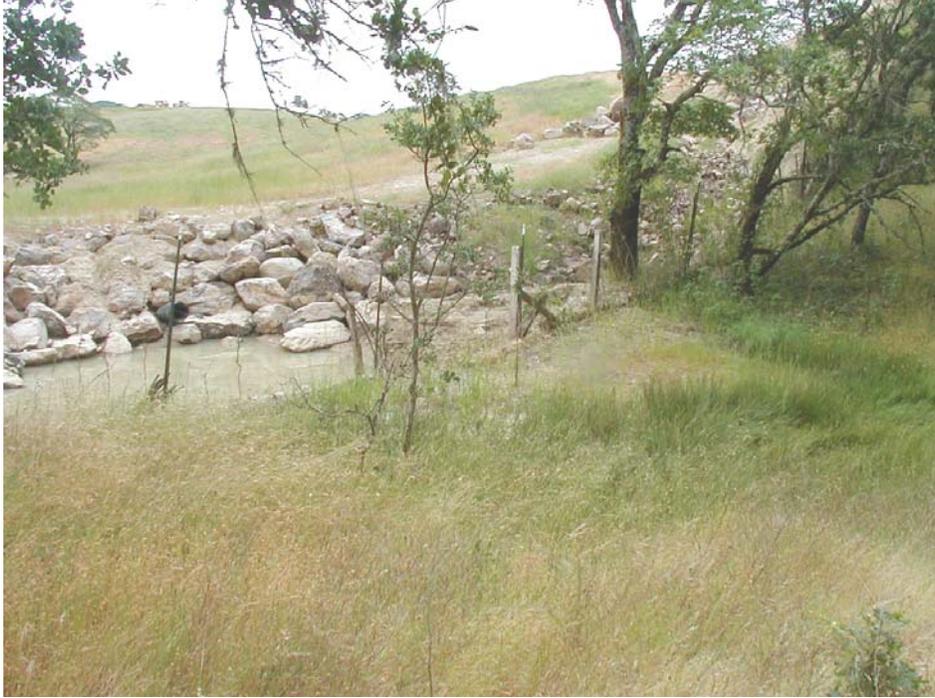
Photo 13. Culverted and filled wetland swale feature, that flows from Windsor Oaks Vineyards property onto the Diamond Springs Property, where it has been filled and culverted at the fence line. 5/21/04

Similar to CS#4 and WI#1 described above, there was a wetland swale feature that flows down slope from Windsor Oaks Vineyards to the Diamond Springs Property, where it currently terminates into a fill prism created during the mass grading and filling of the site.

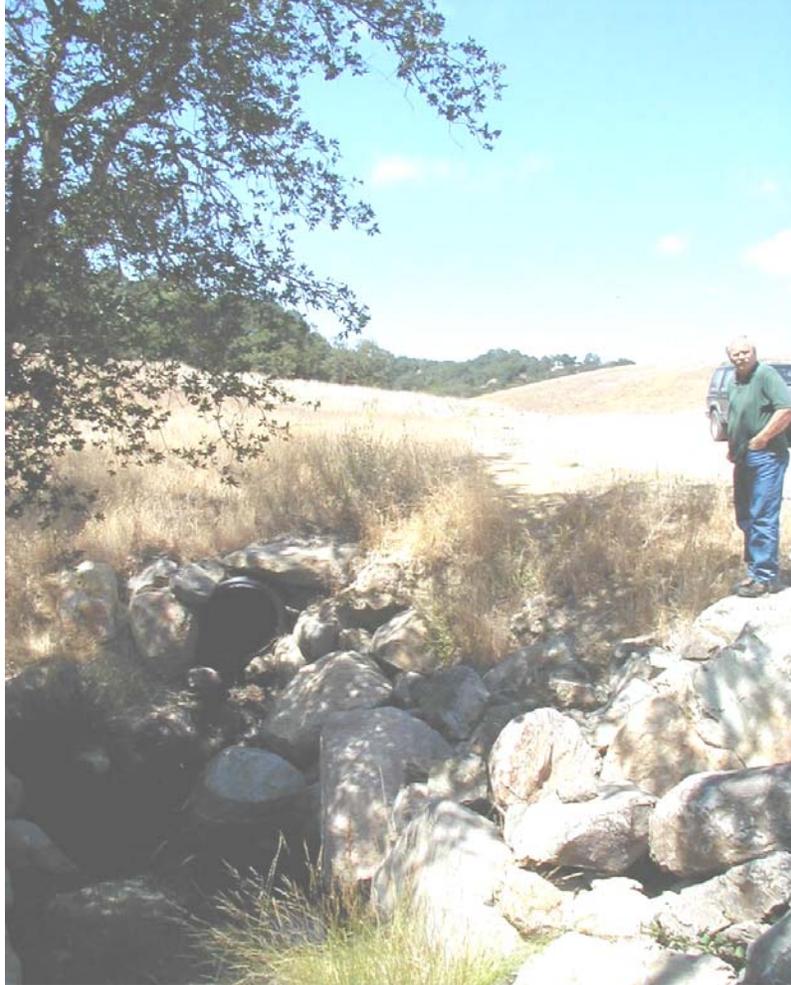
Photo 14. Outfall structure where all piped drainages discharge as a single source back into a remnant section of Starr Creek Tributary #3, which was not filled. Active flow coming out of pipe at time of photo. 6/29/04

The outfall structure is the culvert outfall where all the piped drainages discharge as a single source, a 36-inch plastic culvert outfall, into the remnant section of Starr Creek Tributary #3, that was not filled during mass grading of the site. The outfall structure had a continuous small flow exiting the pipe during the time of the inspection. The stream section below the outfall structure was flowing during the inspection (Photo 14), and there were numerous tadpoles and abundant aquatic macro invertebrates present. Representatives from NOAA Fisheries determined that the stream may provide spawning and rearing habitat for steelhead trout (*Oncorhynchus mykiss*), barring any downstream passage impediments.

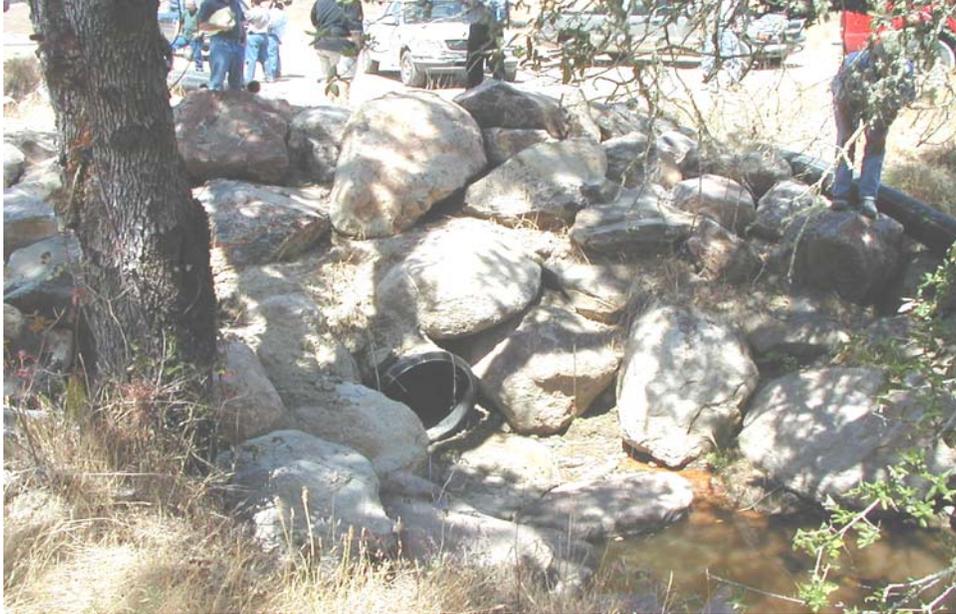
Photo 15. View of a second unauthorized stream crossing, placed into Starr Creek Tributary #3, just below of the outfall structure. The crossing was replaced in approximately 2001, without any permits from the resource agencies. 6/29/04

There is a stream crossing that was replaced during the mass grading of the site in approximately 2001, which crosses Starr Creek Tributary #3, just below of the OS#1, described above.

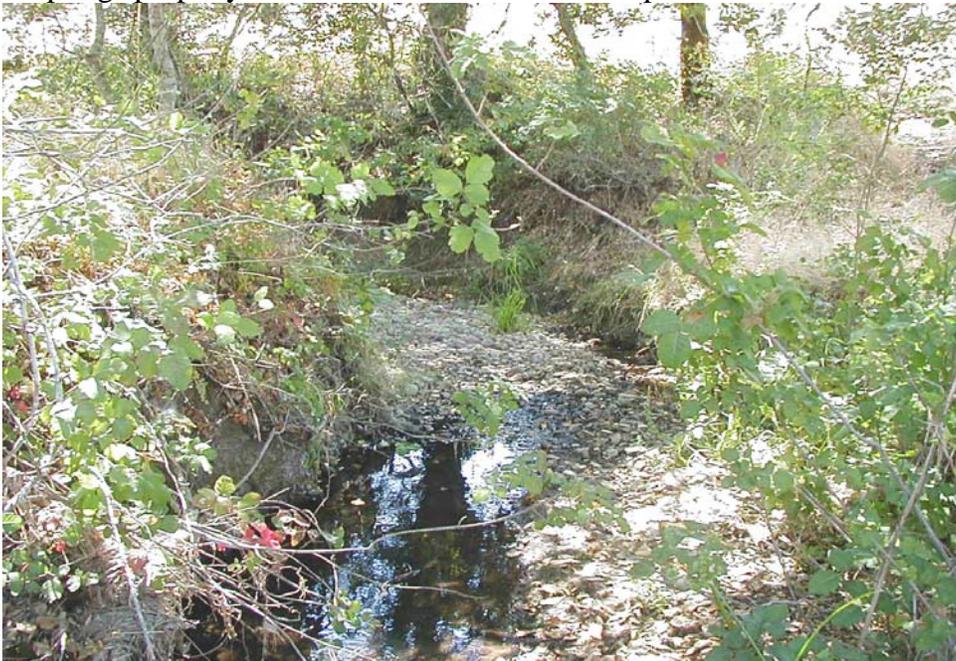
Photo 16. View of Starr Creek Tributary #3 directly downstream of culverted and filled sections on Diamond Springs property. Stream had flow at time of inspection. 6/29/04
