California Regional Water Quality Control Board  
North Coast Region

Cleanup and Abatement Order  
No. R1-2009-0039

Mr. Nolan Phillips and Mr. Patrick Shannon  
APN # 522-174-09, 522-174-05, 522-175-03, 522-175-07  
Willow Creek Area

Humboldt County

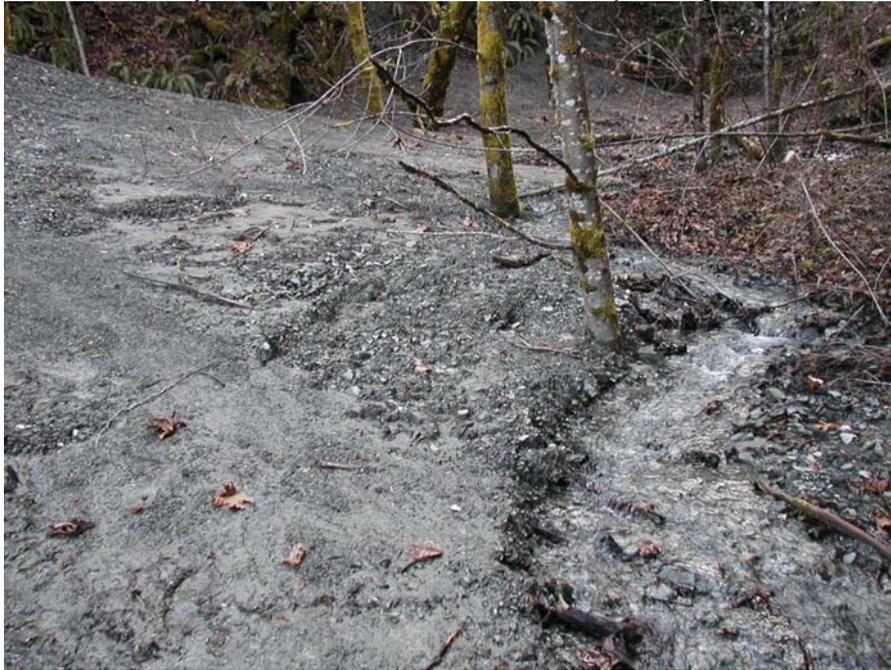
- a) Evidence of a recent debris flow that had inundated several hundred linear feet of Katherine Creek with sediment. Sediment depths across this linear debris flow ranged from several inches to up to one foot deep at the wetted perimeter of Katherine Creek, to approximately 4-6 feet deep at a point approximately 50-foot horizontal distance from the creek. (Photo 1)
- b) Hay bales check dams that Caltrans had reportedly recently installed within Katherine Creek, just upgradient of a Caltrans 48" culvert that carries the creek under Highway 299. The hay bales check dams were necessary in order to protect the culvert from being plugged by the

5. Department of Fish and Game reported significant deposition of sediment on rocks within Willow Creek at a distance of approximately one mile downstream from its confluence with Katherine Creek. The deposition of this sediment constitutes an apparent violation of Fish & Game Code Section 5650 (water pollution). In addition, the substantial alteration of the bed, bank or channel as evidenced along Katherine Creek constitutes an apparent violation of Fish & Game Code Section 1602. (Photos 1, 11 and 12)

Photo 1: February 19, 2009 Sediment mass impacting Katherine Creek

1. Cease the discharge of earthen materials, soil, and sediment to waters of the State, including Katherine and Willow Creeks, and clean up and abate, in accordance with requirement numbers 2 and 3 below, the earthen materials, soil, and sediment placed adjacent to Katherine Creek.

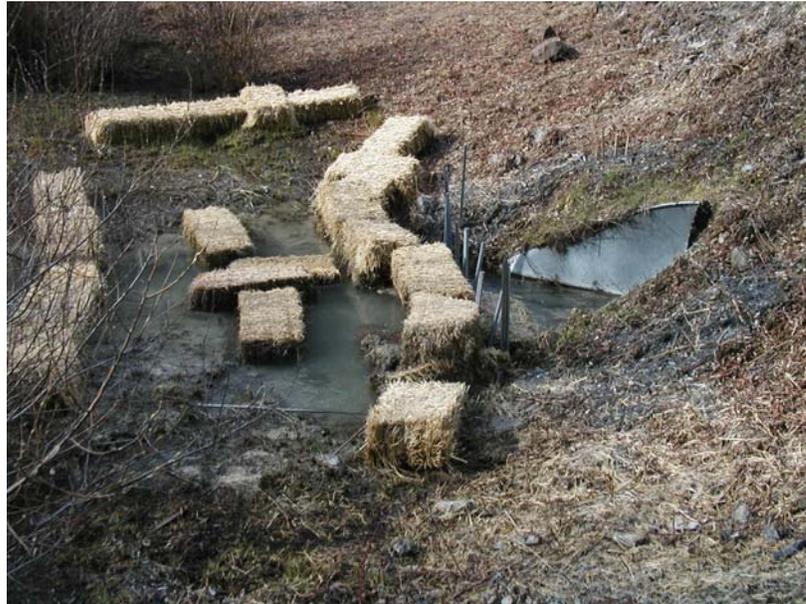
sediment and downed trees that might potentially be delivered from the Site. (Photo 2)

Photo 2: February 19, 2009 Caltrans culvert crossing under Highway 299 –Hay bale check dams installed in effort to trap sediments

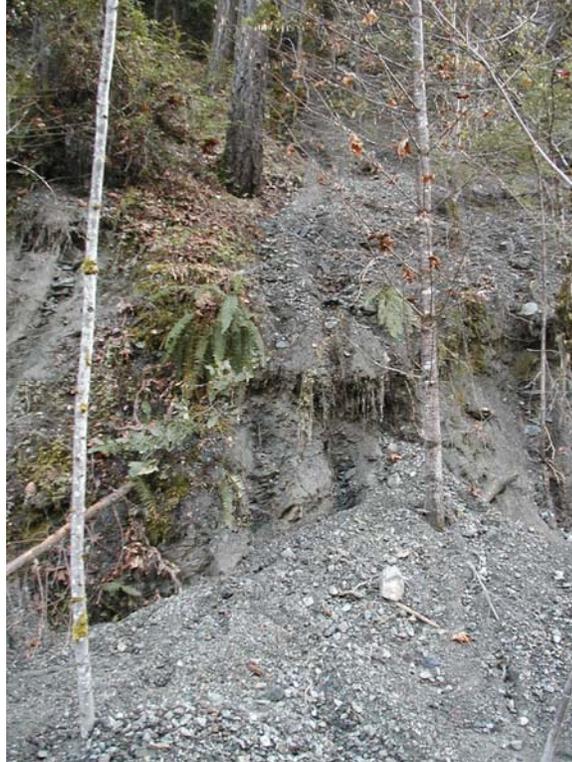
- c) A series of debris flows, static at the time of inspection, had occurred along slopes as steep as 80%. Staff observed scores of uprooted trees stuck within the static sediment plumes, poised to continue their downward trek with the next significant rain event. (Photo 3)

Photo 3 February 19, 2009 Evidence of debris flows - looking up towards sediment sources

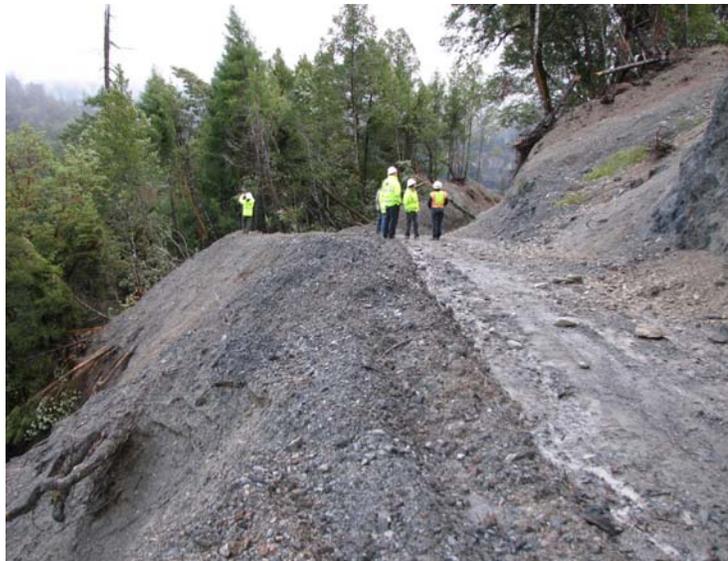
- d) Evidence of recent roadwork activities, including deep cuts into the hillside and scores of uprooted, side cast mature trees.
  - e) Thousands of yards of cut soil side cast over steep slopes. Recent heavy rains mobilized this soil, delivering a portion into Katherine Creek; the remaining soil, hung up on long steep hill slopes, is susceptible to delivery during future rainfall events. Staff noted numerous trees that had been carried downgradient within these sediment flows. (Photo 4)

Photo 4: February 19, 2009 Side casting of cut slope materials

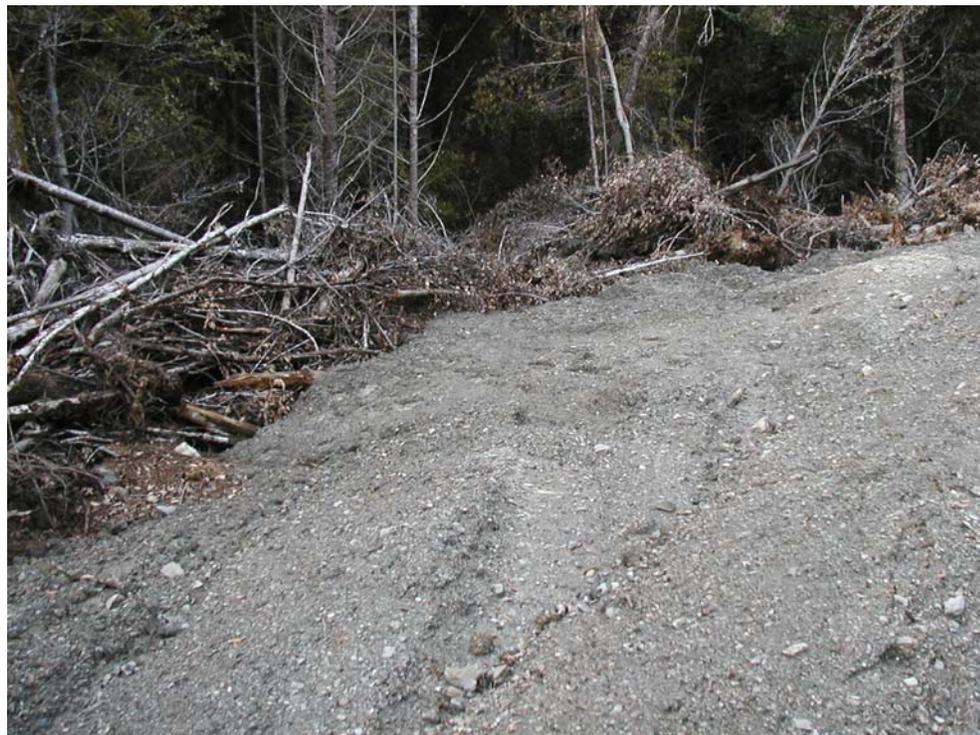
- f) Side cast soils on steep slopes wedged up against crib walls built of root wads, whole trees and slash, braced by standing trees located further down slope. (Photo 5)

Photo 5: February 19, 2009 Soils pushed up against root wads and uprooted trees

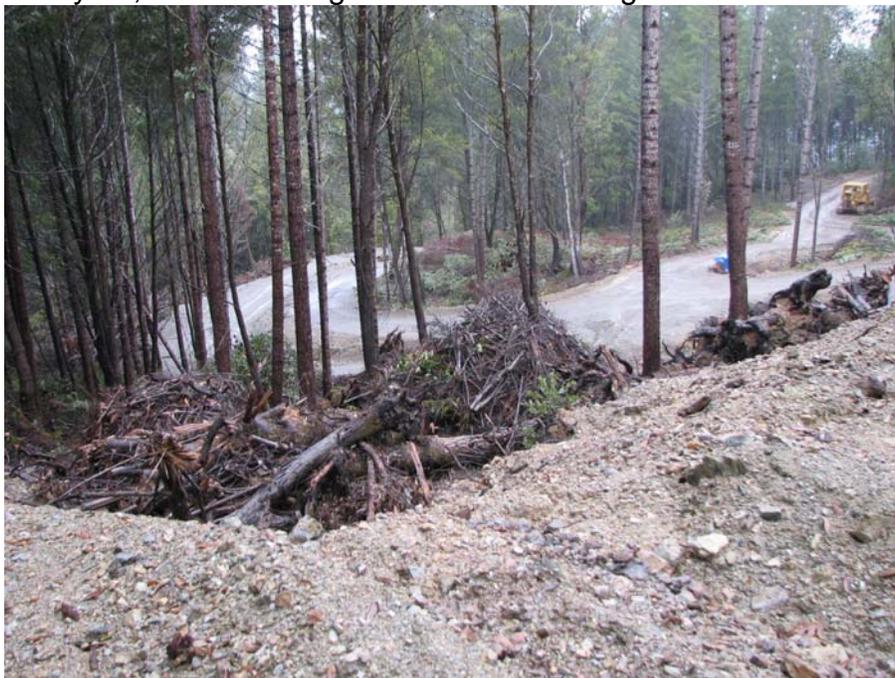
- g) An approximately 2-acre area had been recently cleared and graded. Soils had been pushed downhill by heavy equipment creating a flattened area with outsloped fill prisms of unconsolidated soil (upwards of 30 feet thick at toe). Staff observed root wads and large branches mixed in with the graded soils. (Photo 6)

Photo 6: February 19, 2009 2 acre graded area revealing unconsolidated soil

3. Submit a long-term workplan to the Regional Water Board, for Executive Officer concurrence, on or before May 30, 2009, that includes the following:
  - a. A restoration plan that describes and shows in detail how the Discharger proposes to restore all graded areas at the Site. The plan shall contain an engineering and biological design for any hydrological restoration components, a time schedule for restoration activities, criteria to judge the success of the restoration project, and a monitoring proposal to evaluate whether the restoration is successful. The restoration plan must be prepared by a professional experienced in rural road restoration and erosion/sediment control and must be approved by the Executive Officer.

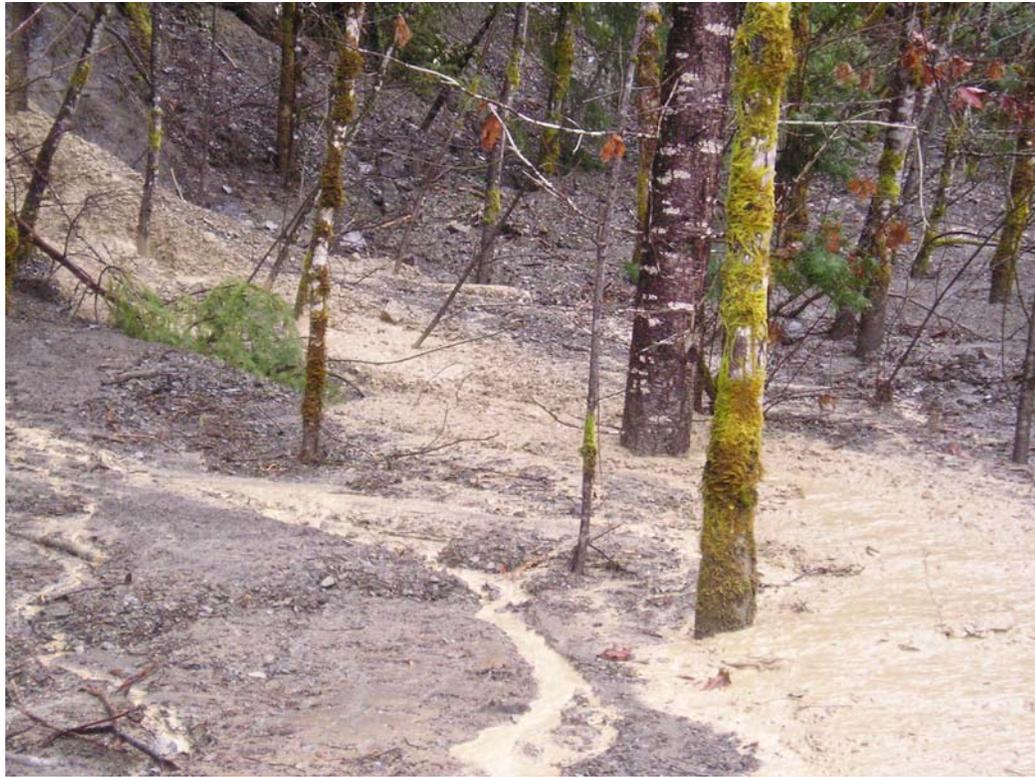
4. Discharges of sediment during February 11 and 13 rain events caused sediment plumes to enter Katherine Creek and Willow Creek (Photos 7 and 8). These plumes were significant enough to be seen at the confluence of Willow Creek and the Trinity River, approximately 2 miles downstream from the source of the sediment discharges (Photos 9 and 10).

Photo 7: February 11, 2009 Sediment laden runoff entering Katherine Creek

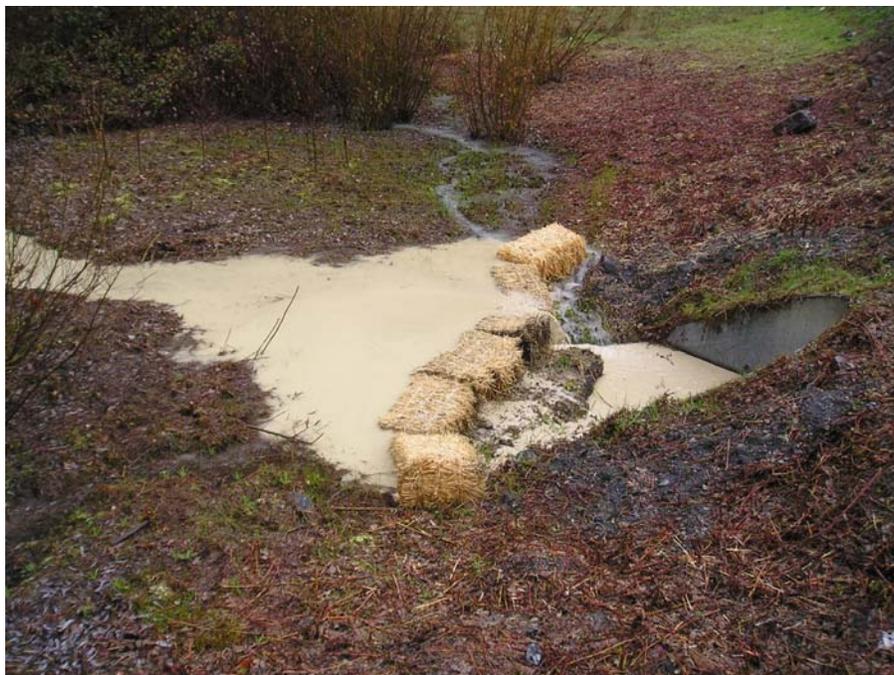
Photo 8: February 11, 2009 Katherine Creek

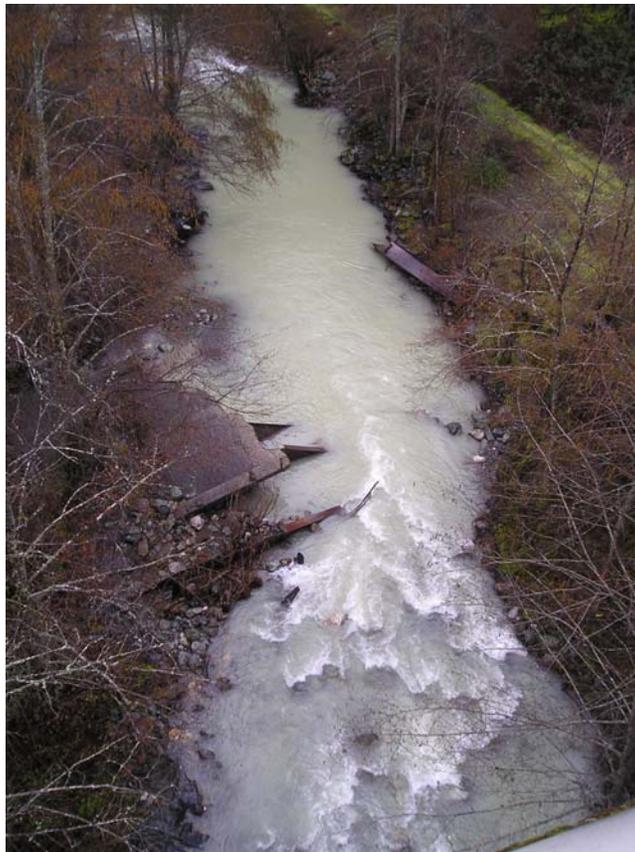
Photo 9 February 11, 2009  
Willow Creek downstream from Katherine Creek confluence

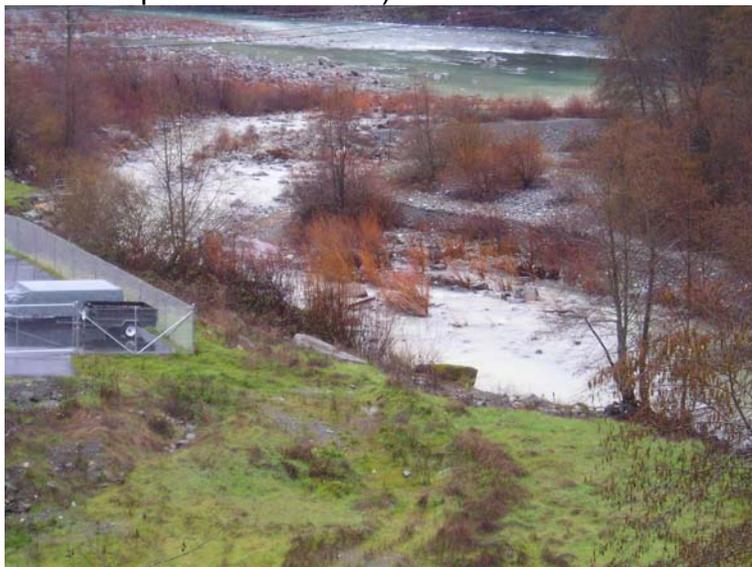
Photo 10 February 11, 2009 Willow Creek confluence with Trinity River (Willow Creek water treatment plant at lower left)

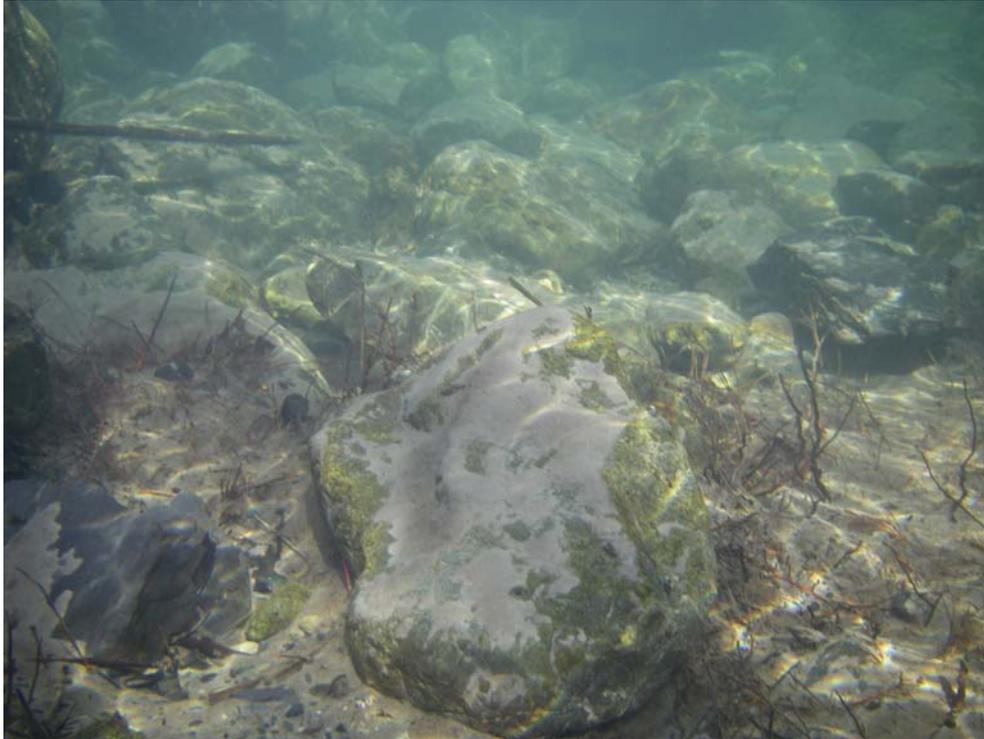
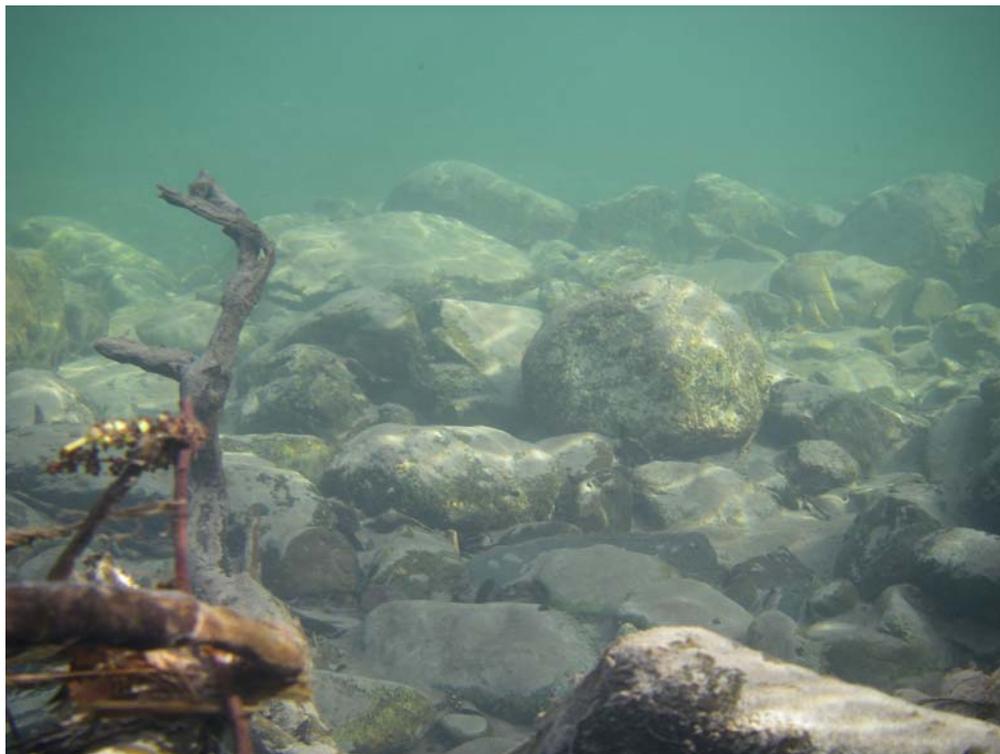
Photo 11 and 12, February 17, 2009, Sediment deposition onto rocks within bed of Willow Creek
