North Coast Regional Water Quality Control Board

Subject: **NOTICE OF VIOLATION:** Unauthorized activities involving the placement of fill (soil, sandbags, concrete, and fence posts) and fence construction in vernal pools and draining vernal pools in violation of the Federal Clean Water Act and California Water Code.

Files: 4032 Madera Avenue, Santa Rosa, Sonoma County

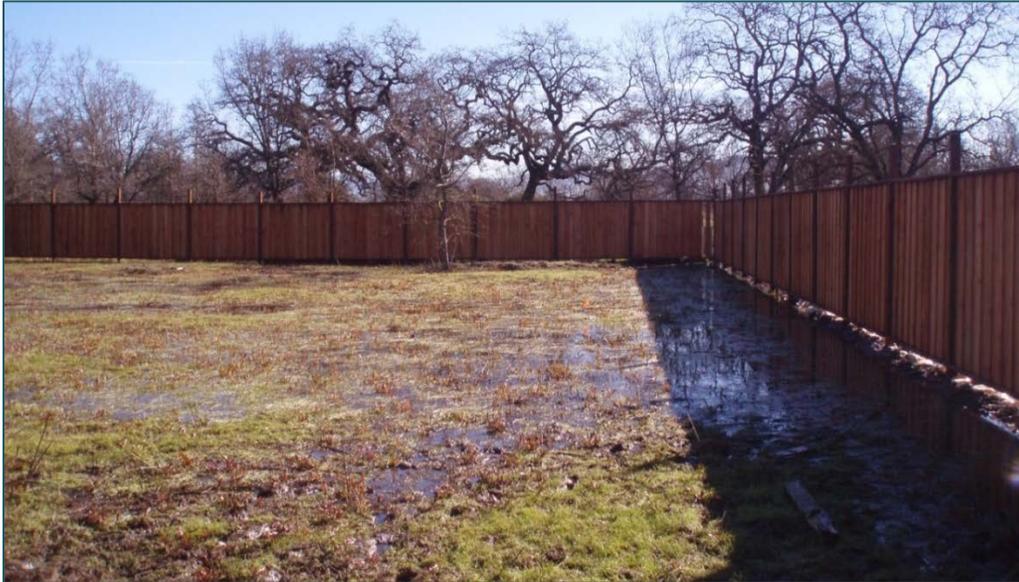
Photograph 1. Photograph was taken February 22, 2014, by Scott Gergus and looking east. The photograph was taken at the rear of the property and shows a portion of the vernal pool complex on 4032 Madera Avenue, APN 035-182-002, in southwest Santa Rosa.

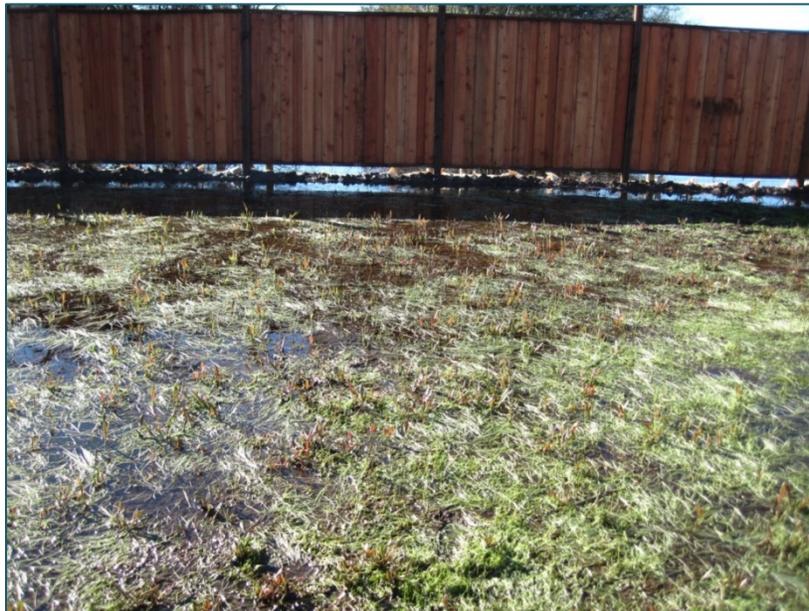
Photograph 2. This photograph was taken on February 22, 2014, by Stephanie Buss with the California Department of Fish and Wildlife. The photograph was taken looking south towards the rear of the property and shows a portion of the vernal pool complex and the wetland plant California semaphore grass, perimeter fence, and sandbags and earthen berm along the fence line. The vernal pool complex extends to the south, east, and west onto neighboring properties.

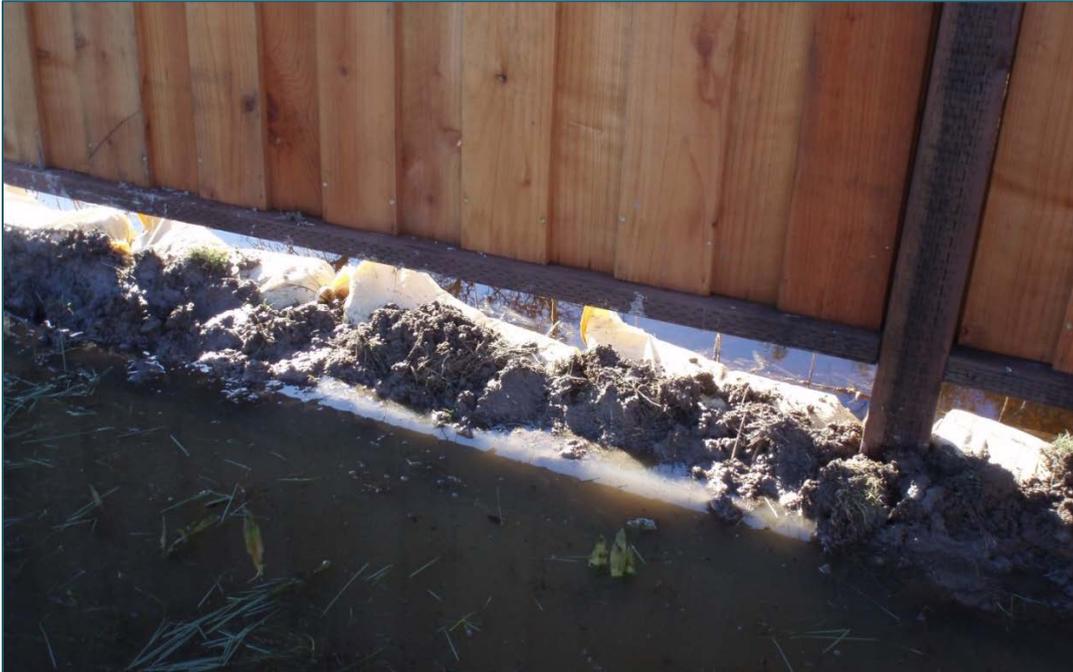
Photograph 3. Photograph was taken February 22, 2014, by Scott Gergus. Close-up photograph showing the earthen fill and sand bags placed in the vernal pool along the southern property line for the purpose of isolating onsite vernal pools and to prevent vernal pool complexes located on neighboring properties from flowing and filling the onsite vernal pool complex with water.

- a) Refill ditch that was excavated to drain vernal pool/wetlands with material that was removed; elevation shall be the same as prior. If it is not possible to fill the ditch due to water being present, then the ditch shall be blocked at the end to prevent further drainage from the vernal pool/wetland.
- b) Remove sump-pump and stop draining the vernal pool/wetlands.
- c) Remove wooden board fence and fence posts within vernal pool and other wetland areas. Areas of the fence that may shade the vernal pool/wetland area shall also be removed so that vernal pools receive natural sunshine and are not shaded.

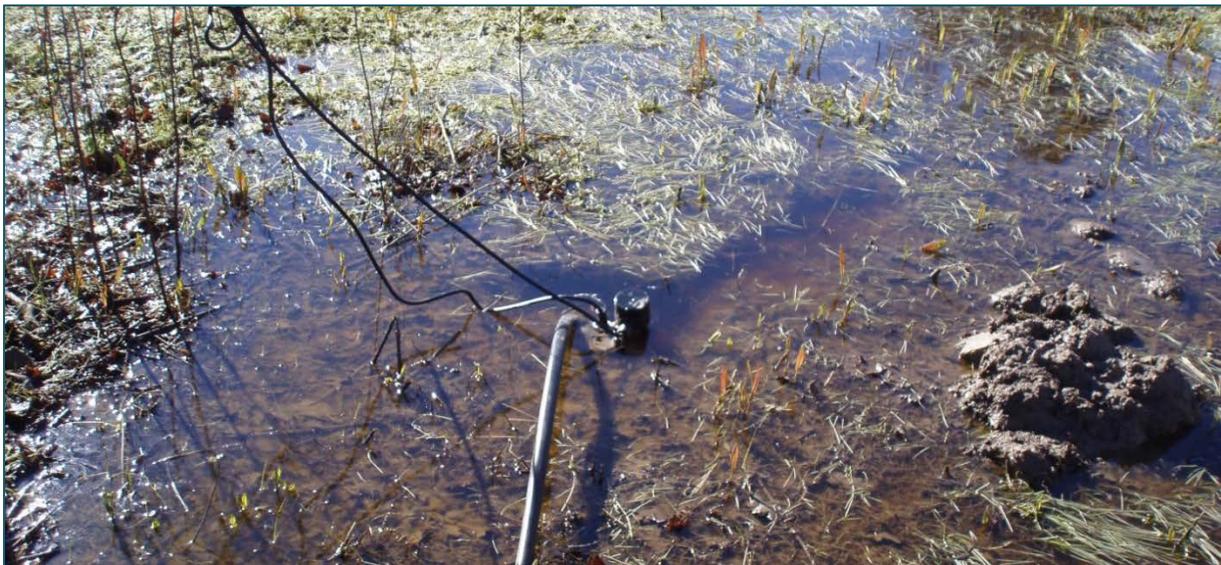
Photograph 4. This photograph was taken on February 22, 2014, by Scott Gergus. An electrically powered sump pump had been placed in an excavated hole in the vernal pool complex to drain it. A soil pile from the excavation can be seen to the right. A rope and electric cord can be seen tied to an overhead tree branch. A $\frac{3}{4}$ -inch black plastic discharge hose is attached to the sump pump and extends an estimated 175 feet to the Madera Avenue roadside ditch.

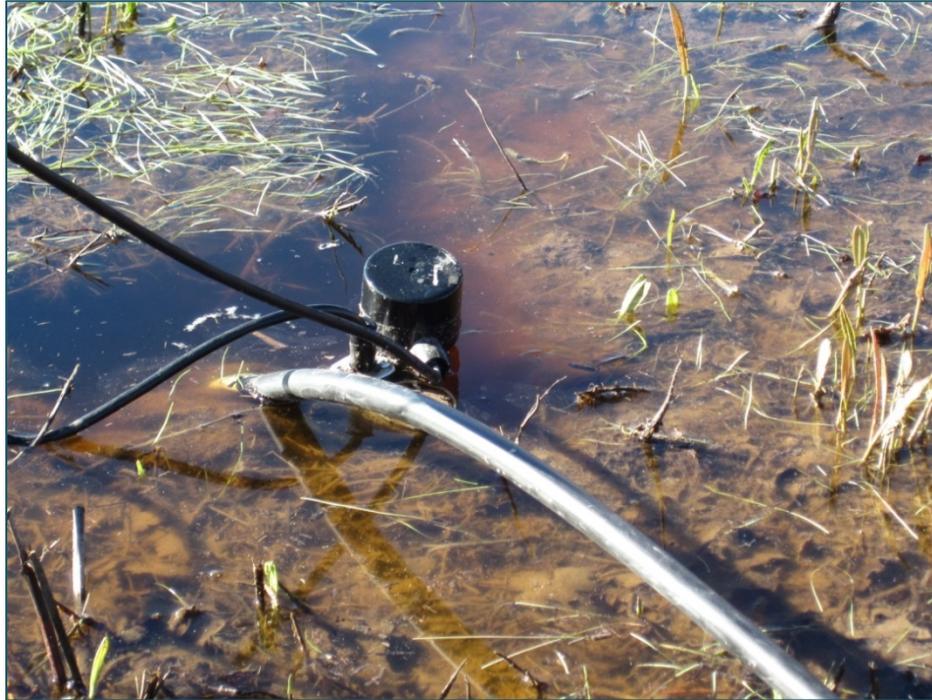
Photograph 5. This photograph was taken on February 22, 2014, by Stephanie Buss with the California Department of Fish and Wildlife. Close-up of the sump pump in the vernal pool. The black plastic hose leads to the Madera Avenue roadside ditch.

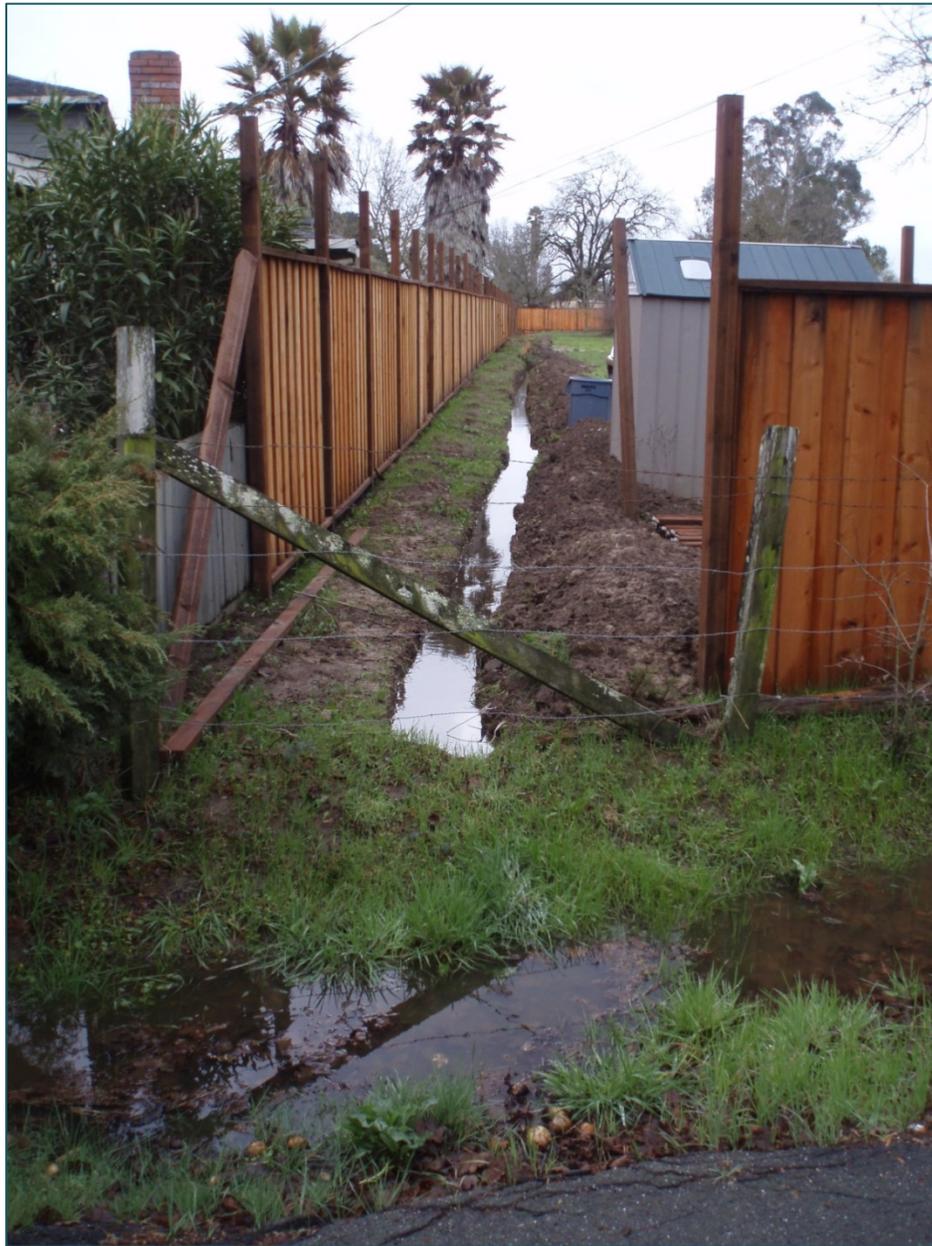
Photograph 6. This photograph was taken on February 27, 2014, by Scott Gergus. This photograph shows the excavated ditch along the eastern fence line. The ditch extends from the rear of the property to the top of the roadside ditch along Madera Avenue through the vernal pool complex. The ditch sidecast materials have been placed beside the ditch and into the vernal pool complex. The entire ditch had standing water in it and appeared to be close to discharging into the Madera Avenue roadside ditch.

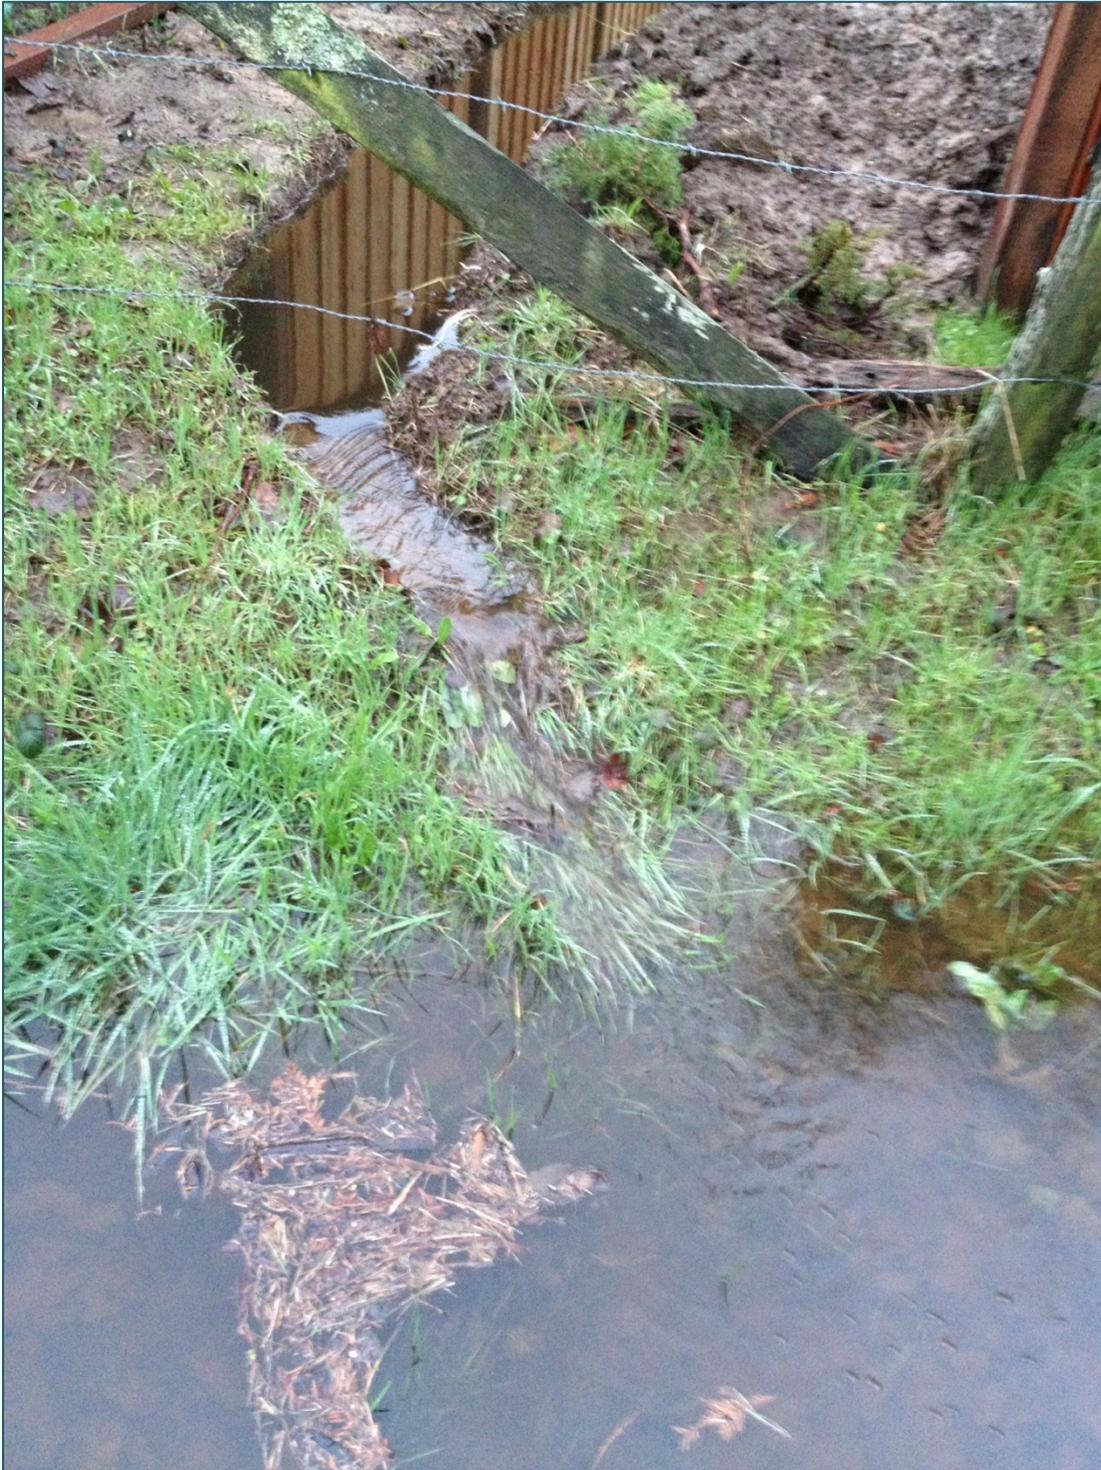
Photograph 7. This photograph was taken on February 28, 2014, and submitted by Warden Demitri Esquivel. The photograph shows the ditch discharging (draining) water from the vernal pool complex on 4032 Madera Avenue to the roadside ditch along Madera Avenue.
