North Coast Regional Water Quality Control Board

Subject: Notice of Violation of Order No. R1-2013-0005, General Waste Discharge Requirements for Discharges for Timber Operations on Non-Industrial Timber Management Plans (NTMPs) in the North Coast Region

File: Nonindustrial Timber Management Plan 1-97NTMP-010 HUM,
"Swains Flatt NTMP"

September 23 and November 4, 2015 Site Inspection Compliance Issues

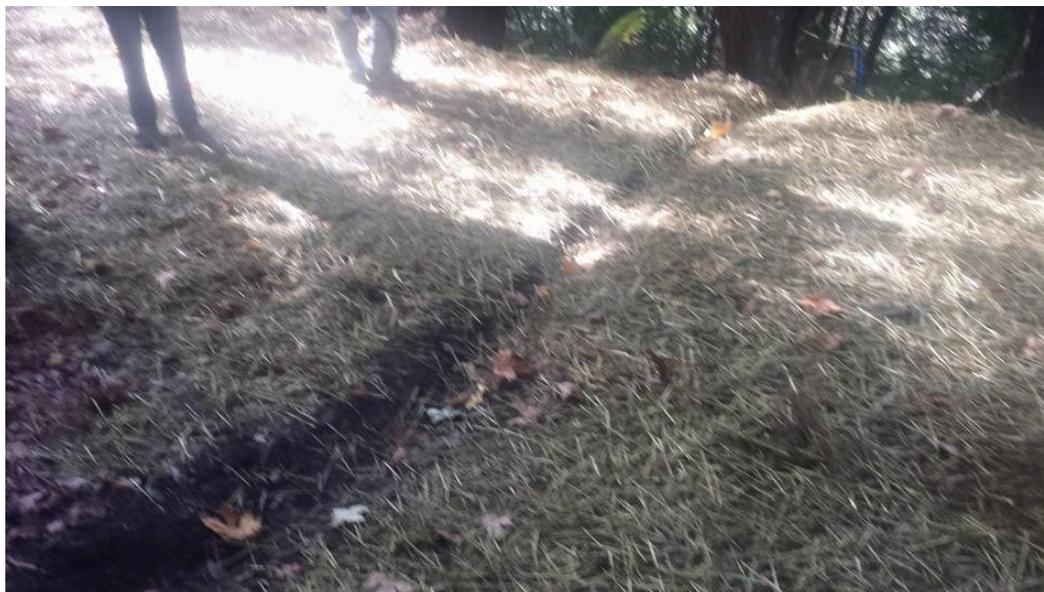
- Site 3.4 is a fill road crossing of a Class III watercourse. Staff observed no rock within the crossing or the outfall. The crossing discharges into a watercourse within 50 feet of a Watercourse and Lake Protection Zone (WLPZ) for a Domestic Water Supply (DWS). A DWS is designated in the Forest Practice Rules as a Class I watercourse and must be provided with Class I protection measures. The NTMP does not identify the DWS as such.

Figure 1. Site 3.4 on November 4, 2015

On November 4, 2015, Regional Water Board staff conducted a follow-up inspection, and observed that straw mulch was placed on the road approaches and a small ditch had been dug across the road (see Figure 1). However, an adequate stream crossing in conformance with specifications as described in the plan has not yet been installed.

Based on review of the NTMP and the June 4, 2014 amendment to include the CDFW BMPs for roads, corrective actions should have been completed prior to October 15, 2015. You must provide to the Regional Water Board, no later than **March 15, 2016**, a description of the sites discussed above and proposed corrective action to control sediment discharge for each site. Implementation of the corrective action must be completed no later than **October 15, 2016**. Within one week following completion of corrective action at the site, you must contact Regional Water Board staff to schedule an inspection so that we may evaluate whether the corrective action has been sufficiently implemented and confirm that the violation has been adequately corrected.

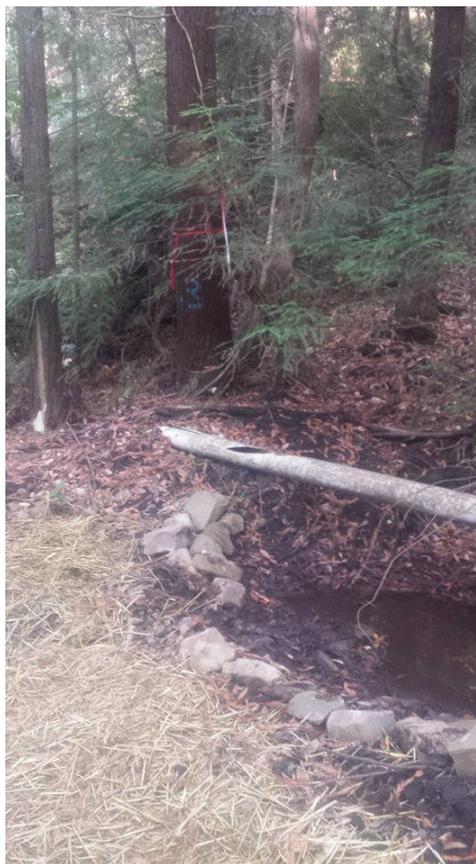
- Site 3.3, located along the same road and to the south of Site 3.4, is a road crossing associated with another DWS. The NTMP identifies this as a Class II watercourse. The crossing appears to be constructed of fill material. An appropriately designed and constructed crossing that prevents or minimizes sediment discharge, including a critical dip to prevent diversion of the stream during high flow events, is needed at Site 3.3. The original NTMP documentation does not specify construction of a critical dip at this site, but does indicate that any crossing that could not contain the flow in the event of culvert plugging must be dipped out. The CDFW BMPs that have been amended into the NTMP specifically require that critical dips must be constructed at all stream crossings.

Figure 2. Site 3.3 on November 4, 2015, looking at the pool upstream of the road. The water diversion was observed just upstream from this pool.

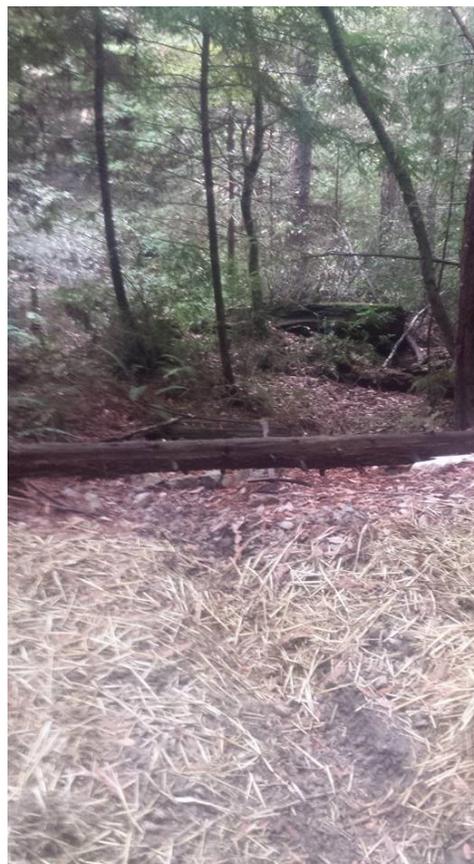
Figure 3. Site 3.3 on November 4, 2015, looking downstream. The crossing is essentially fill with a ditch about a foot wide dug across the road.

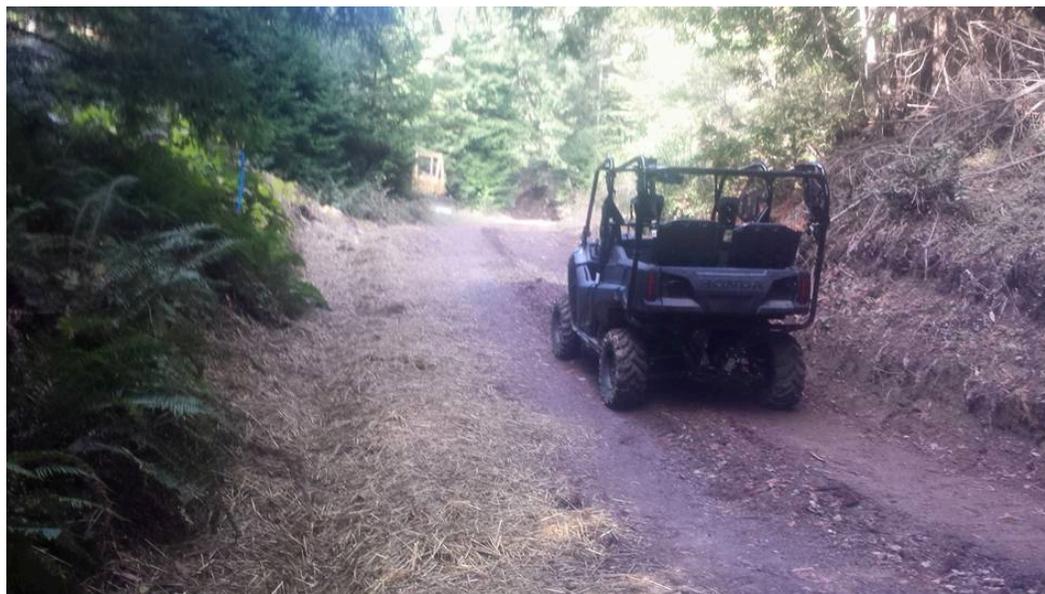
- Site 3.2 is a Class III watercourse that was proposed to be drained properly across the road into the old ditch. The ditch needed to be excavated or re-dug so that flows will be contained in the ditch and prevented from draining down the road. This work had not been completed as of the September 23, 2015 inspection, but was done by November 4, 2015. As with the other 3 sites noted above, this site should have been described in the NTMP GWDR Tier A NTO #9 enrollment package.

Figure 4. Site 3.2 after corrective work had been done. The drainage across the road and the ditch were excavated to carry anticipated winter flows.
