Attachment 1- Supporting Photographs

Figure 1. Location map of the East Side Sewer Phase III and Snyder Lane Widening project, located in Rohnert Park, CA. Highway 101 is approximately a mile and half west of Snyder Lane.

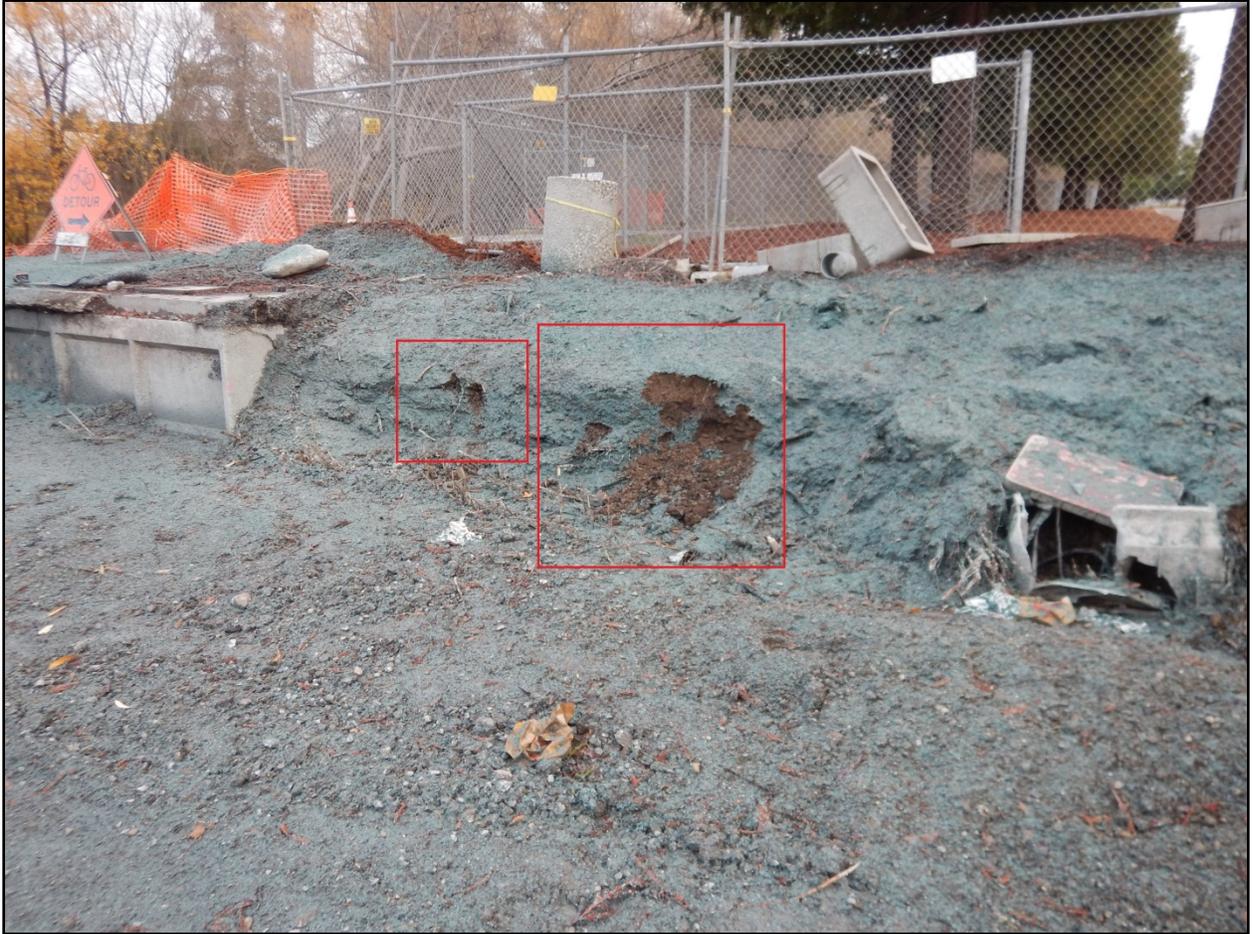
Photo 1A. The red squares outline eroded sections of the slope that likely occurred as a result of the inadequacy of the hydraulic mulch as soil cover. The hydraulic mulch was applied within 24 hours of a rain event, not allowing it adequate time to dry, and therefore, failing to serve as effective soil cover. Photo was taken by Devon Jorgenson on December 10, 2015, at approximately 14:27 facing northeast.

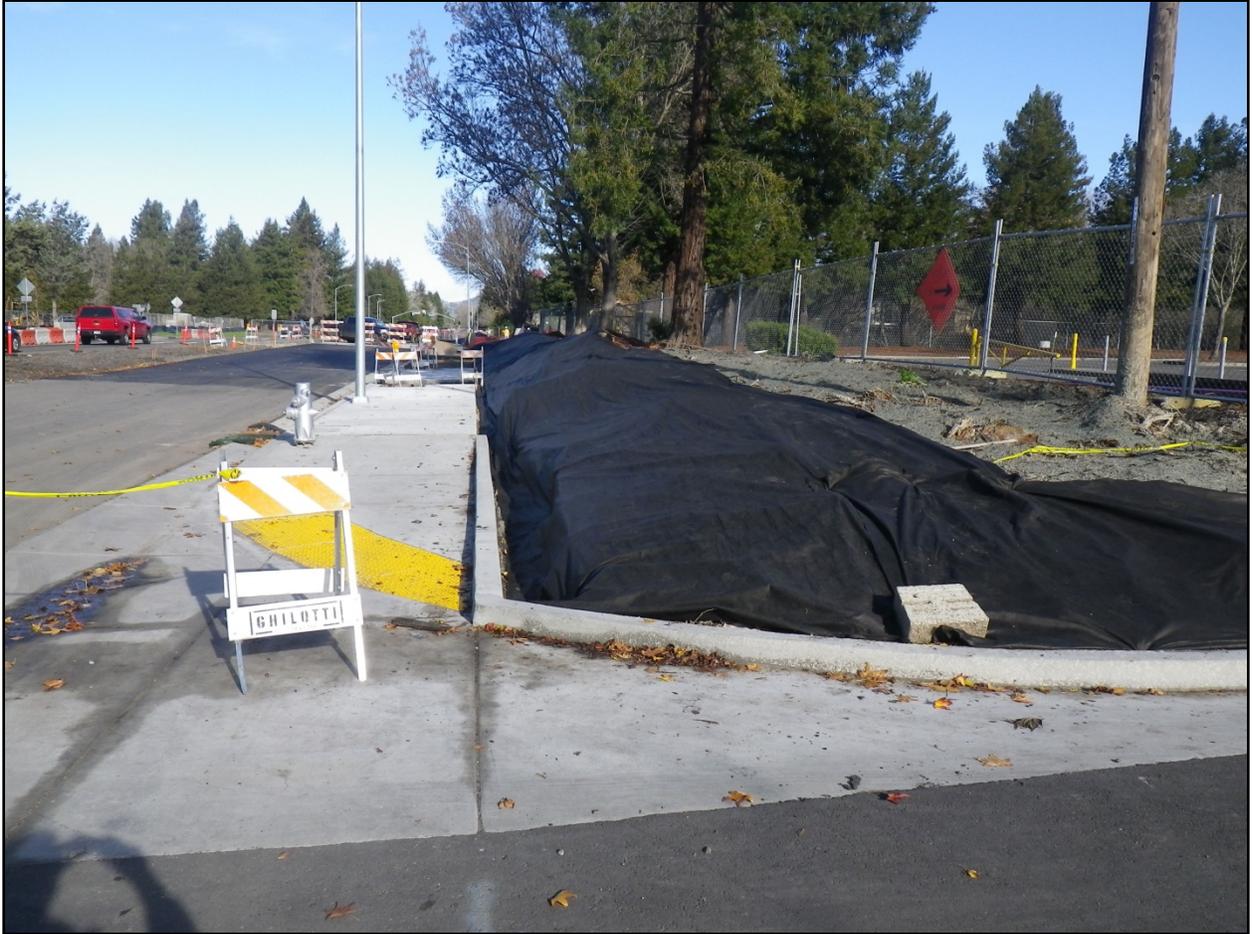
Photo 1B. The southern extent of the slope depicted in Photo 2A. Filter fabric was installed on the slopes in response to Staff expressing that the hydraulic mulch was inadequate soil cover. Photo was sent to Devon Jorgenson on December 28, 2015, at 09:17. Photo is facing north.

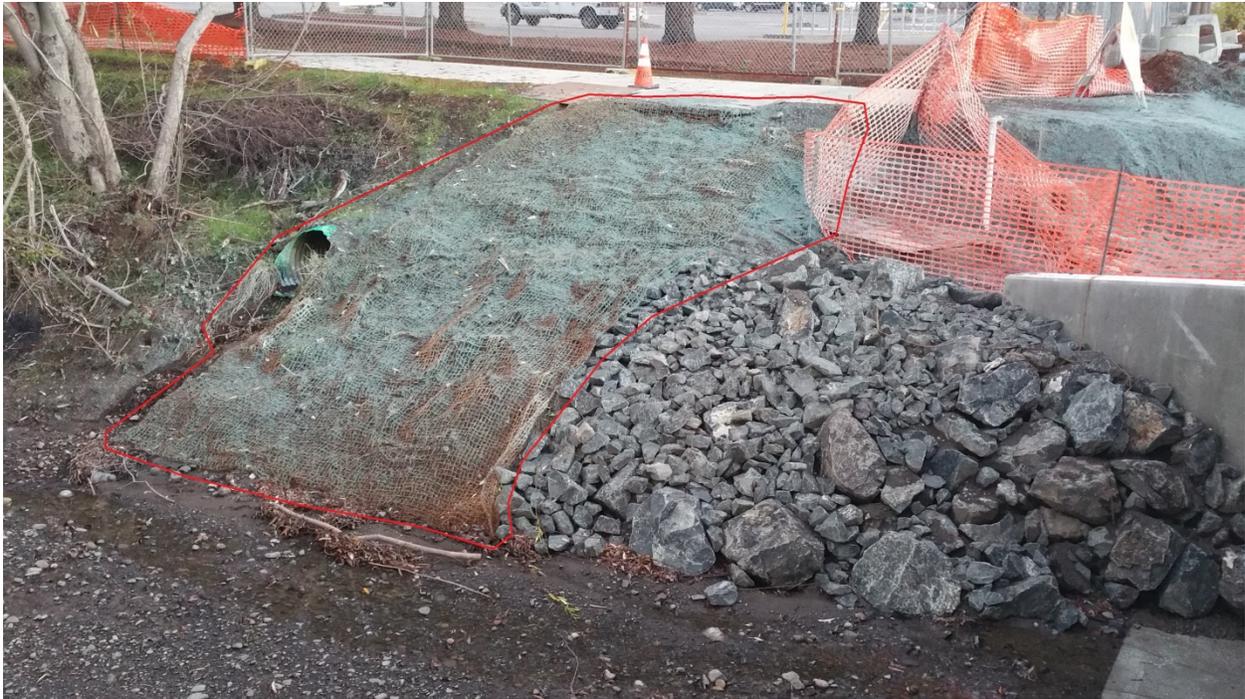
Photo 2A. The red polygon in this photo depicts the extent of the hydraulic mulch that was applied over a fiber blanket on the southern bank of Copeland Creek. Per the California Storm Water Quality Association Best Management Practices Manual (CASQA BMP Manual), hydraulic mulch should not be applied in channels. Photo was taken by Devon Jorgenson on December 10, 2015, around 14:30 facing south.

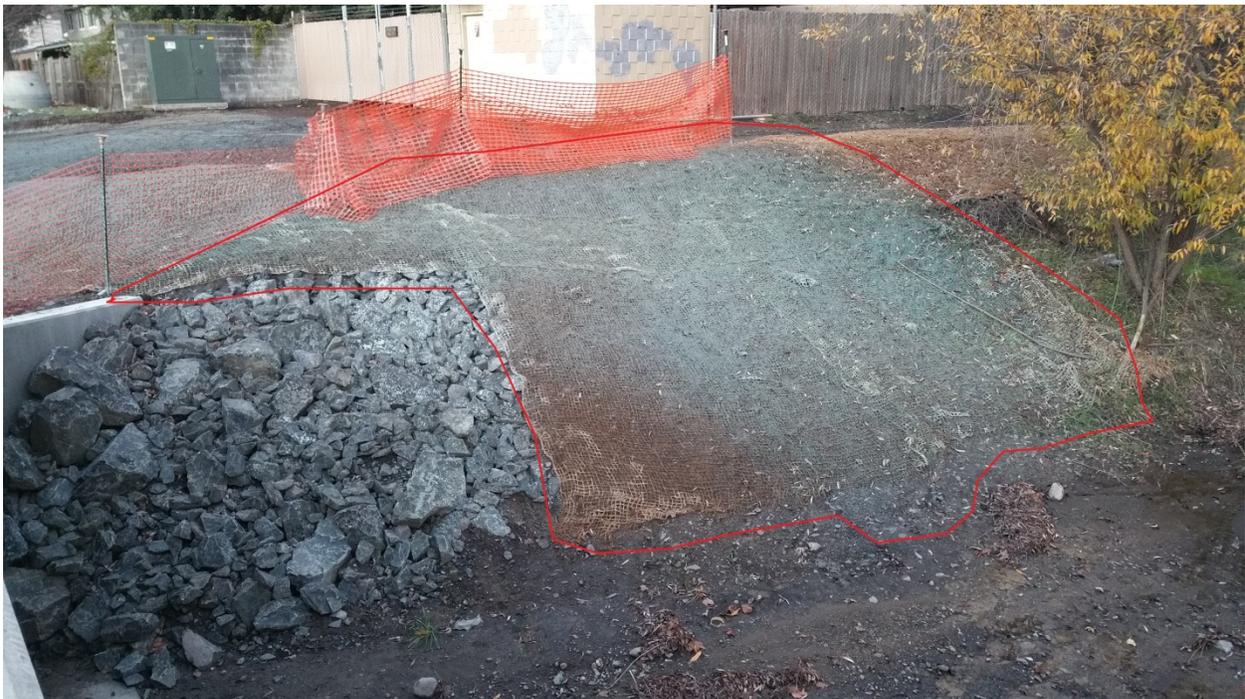
Photo 2B. The red polygon in this photo depicts the extent of the hydraulic mulch that was applied over a fiber blanket on the northern bank of Copeland Creek. Per CASQA BMP Manual, hydraulic mulch should not be applied in channels. Photo was taken by Devon Jorgenson on December 10, 2015, around 14:30 facing north.

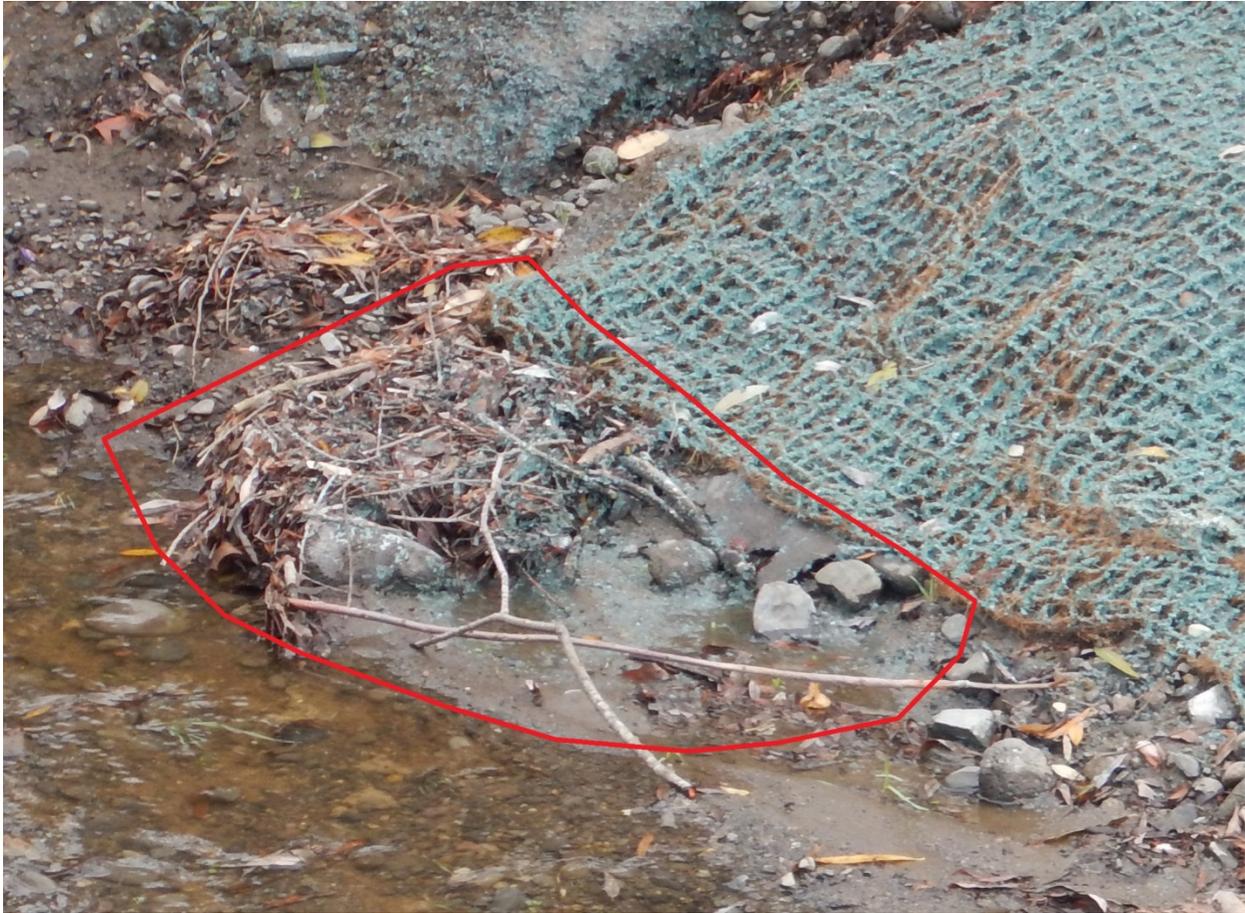
Photo 2C. The red polygon depicts hydraulic mulch in Copeland Creek. This photo serves as evidence of an unauthorized non-storm water discharge. Photo was taken by Devon Jorgenson on December 10, 2015, at approximately 14:28.

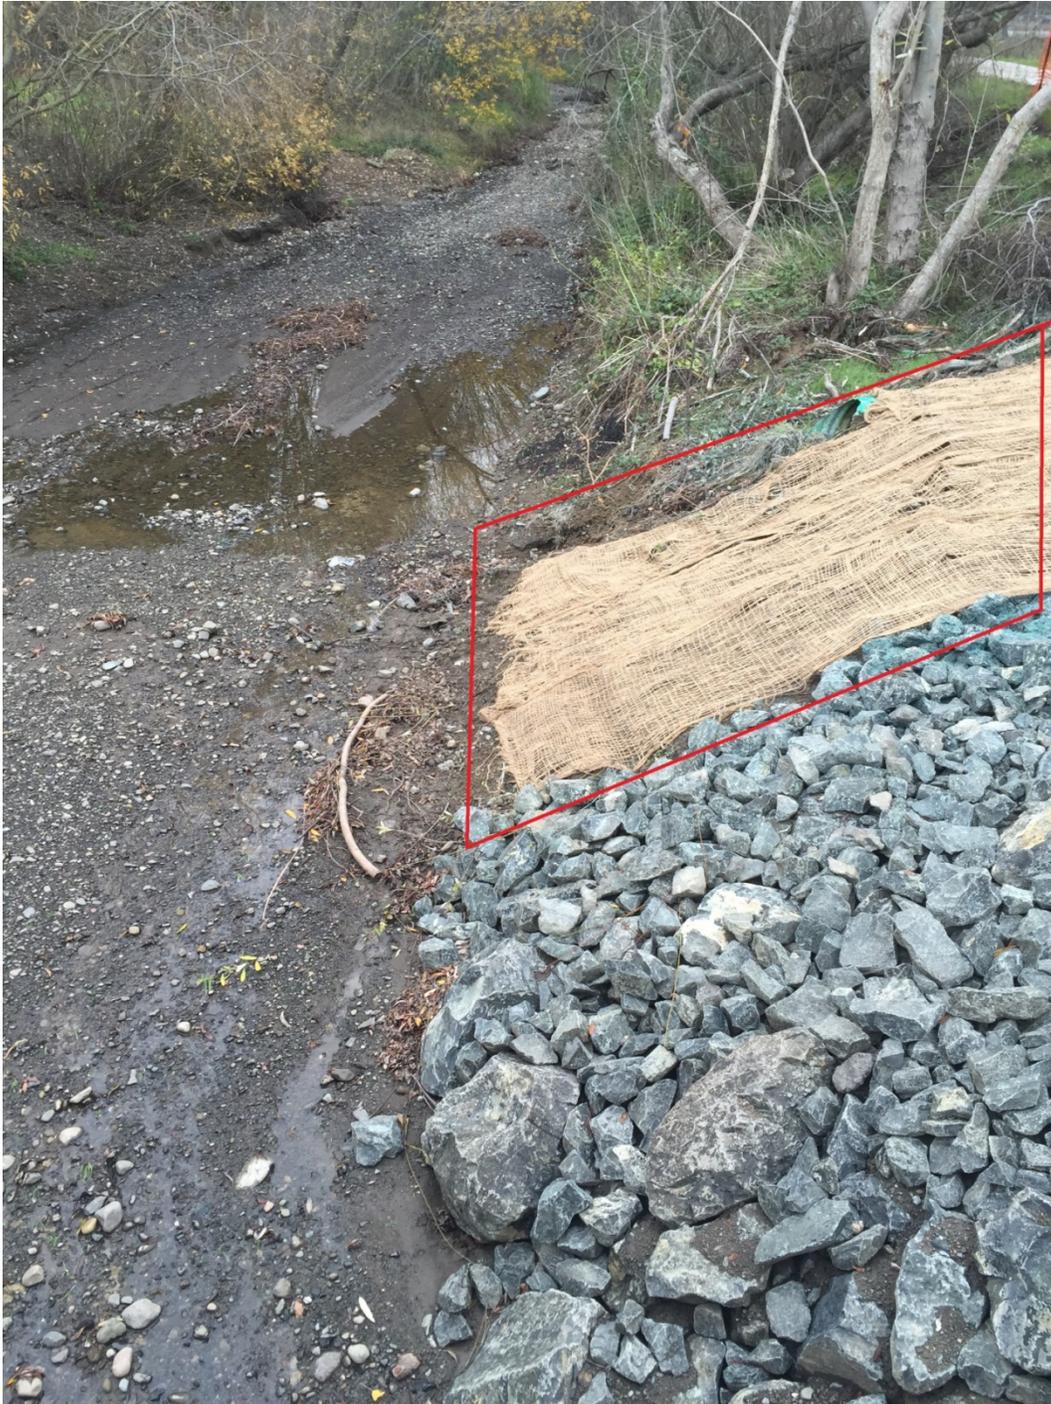
Photo 2D. The red polygon represents the same polygon in Photo 3A. This photo depicts the removal of the hydraulic mulch covered fiber blanket and the installation of a new fiber blanket on the southern bank of Copeland Creek. This photo was sent to Devon Jorgenson on December 16, 2015.

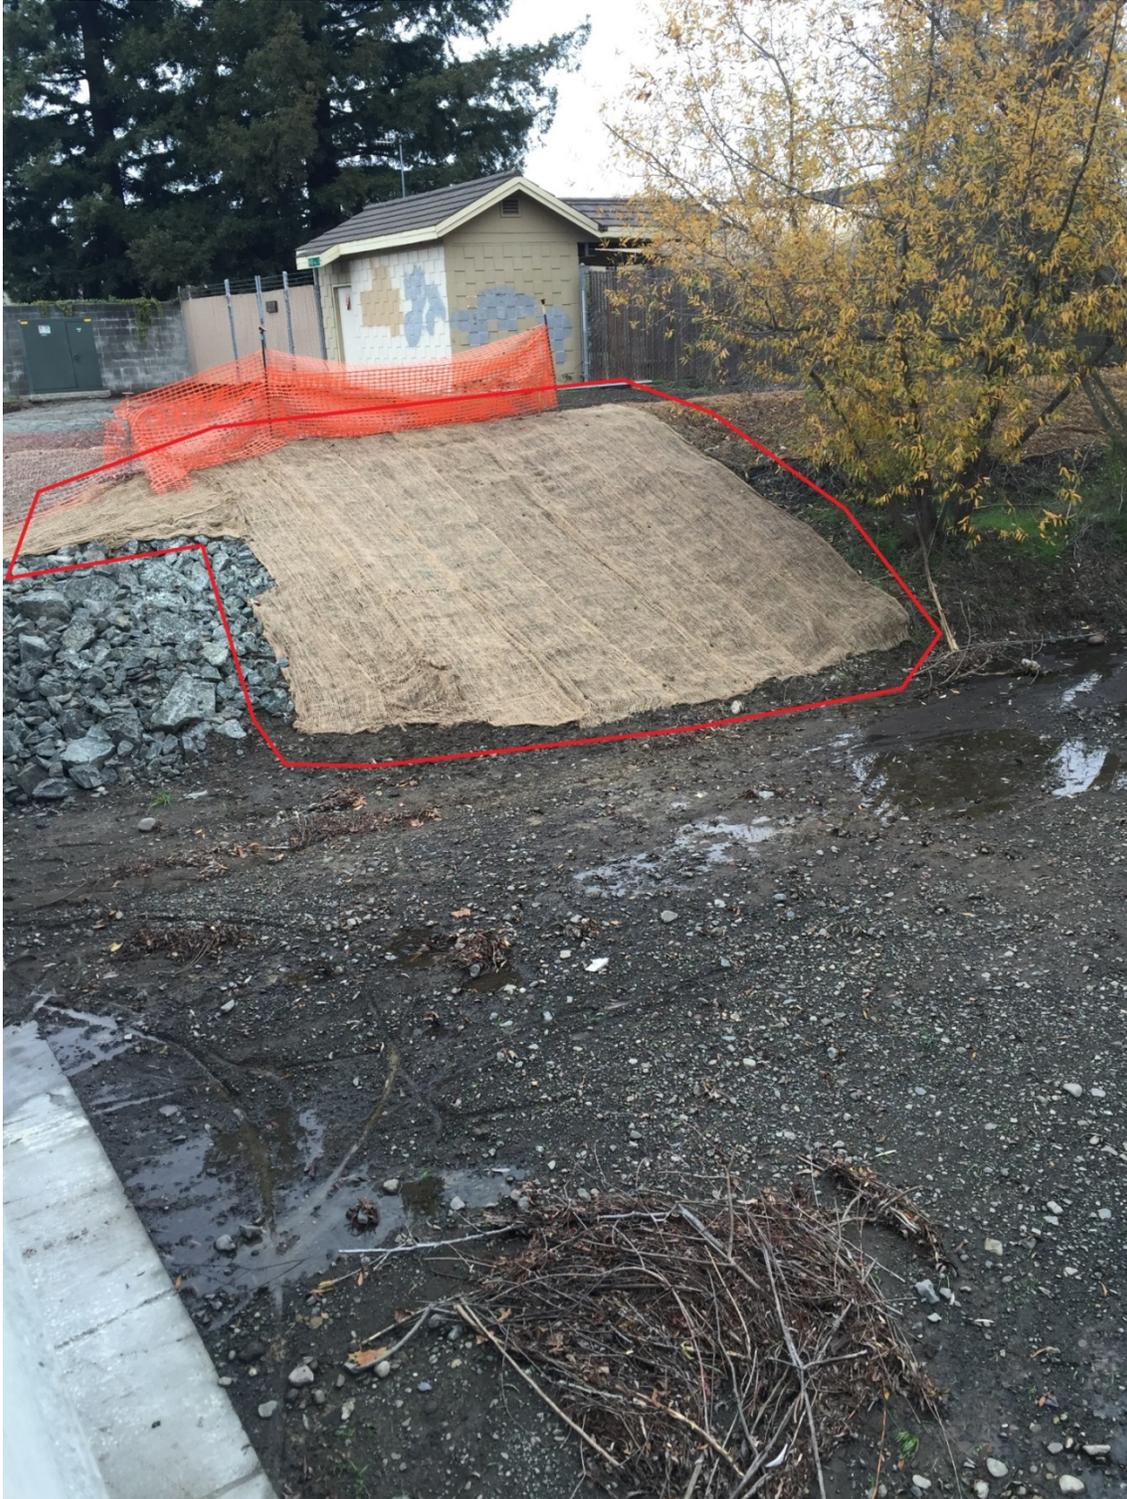
Photo 2E. The red polygon represents the same polygon in Photo 3B. This photo depicts the removal of the hydraulic mulch covered fiber blanket and the installation of a new fiber blanket on the northern bank of Copeland Creek. This photo was sent to Devon Jorgenson on December 16, 2015.
