Attachment A

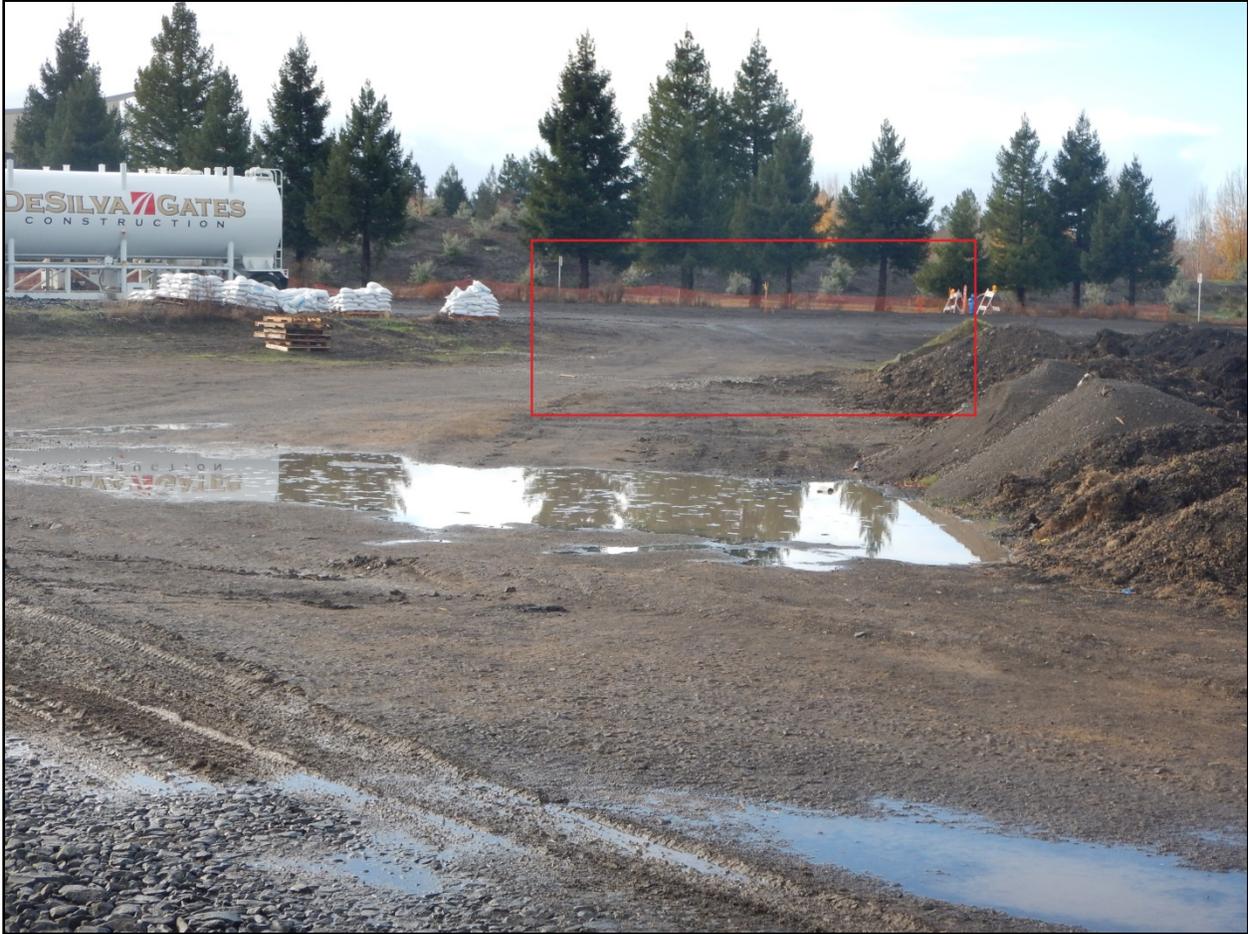
Photo 1A. The red box outlines an entrance to the Project lacking rocky stabilization, which is required pursuant to Attachment D, Provisions B.1.e and E.1 of the Construction General Permit. Photo taken by Colleen Hunt on December 4, 2015, at approximately 10:17, facing south.

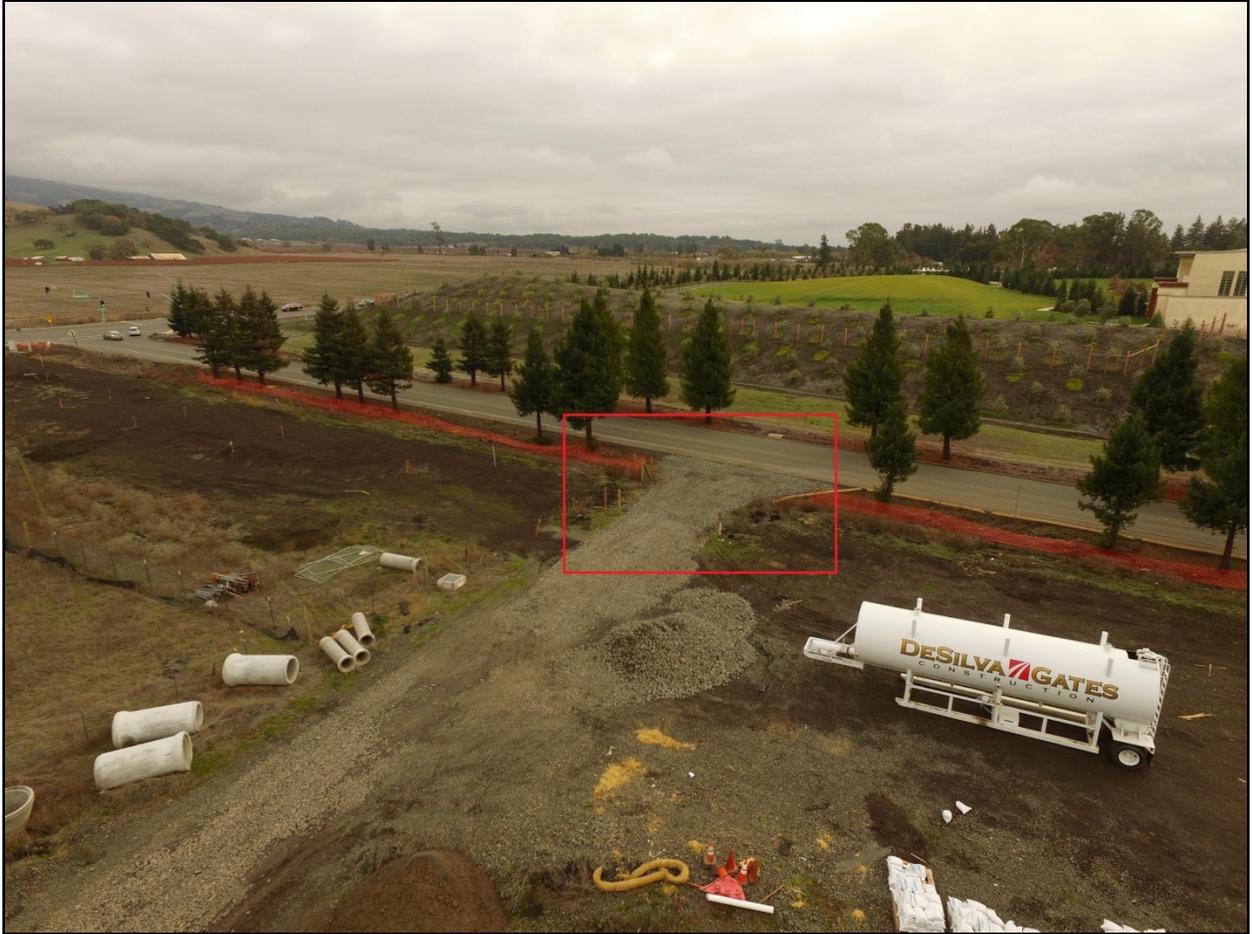
Photo 1B. The red box outlines the same area outlined in Photo 1. This photo depicts that the eastern construction entrance has been stabilized with rock. Photo was sent to Devon Jorgenson from Dan Keith on December 11, 2015. Photo facing southeast.

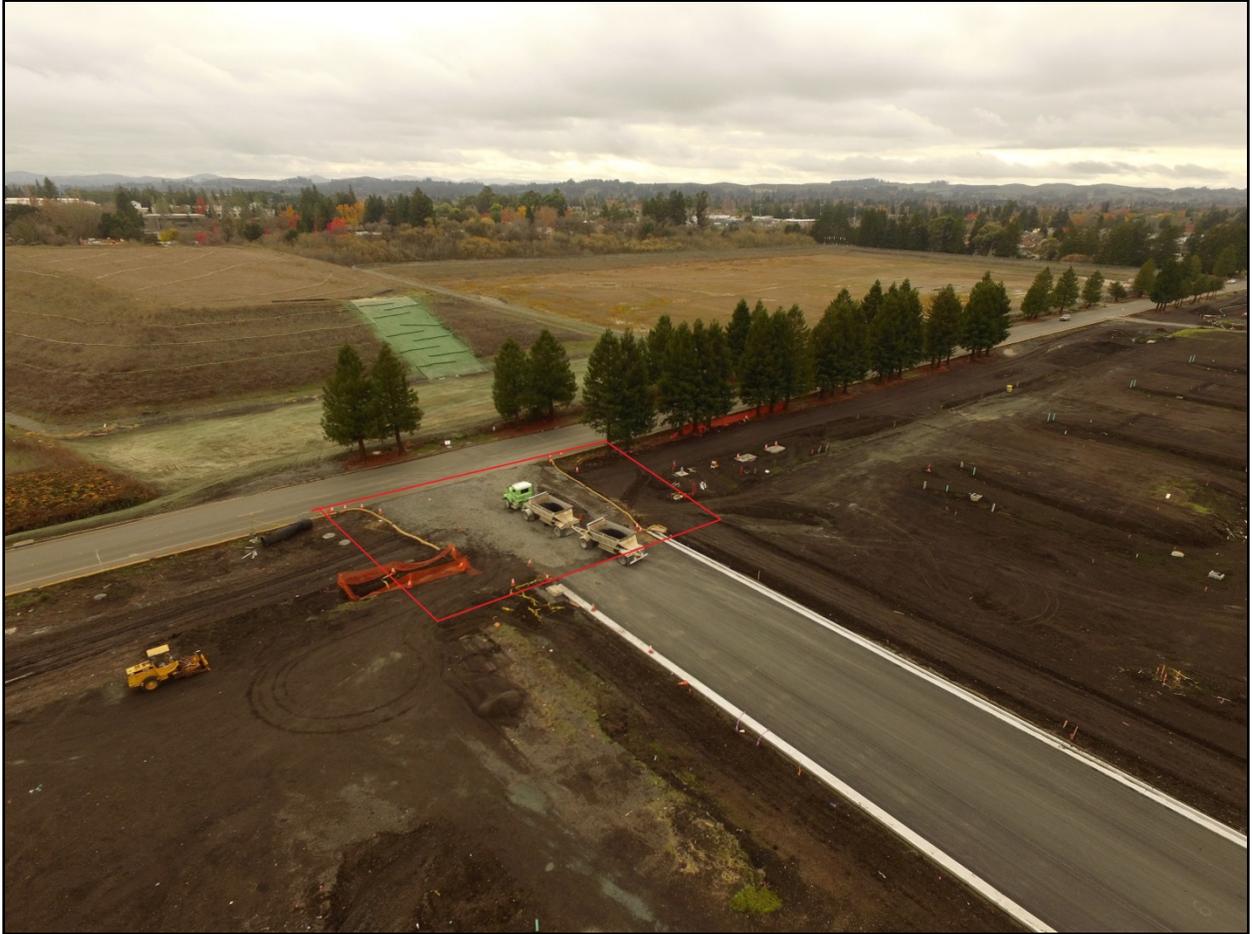
Photo 1C. The red box outlines the intermediate construction entrance along Rohnert Park Expressway. This photo depicts that the entrance has been stabilized with rock. Photo was sent to Devon Jorgenson from Dan Keith on December 11, 2015. Photo facing southwest.

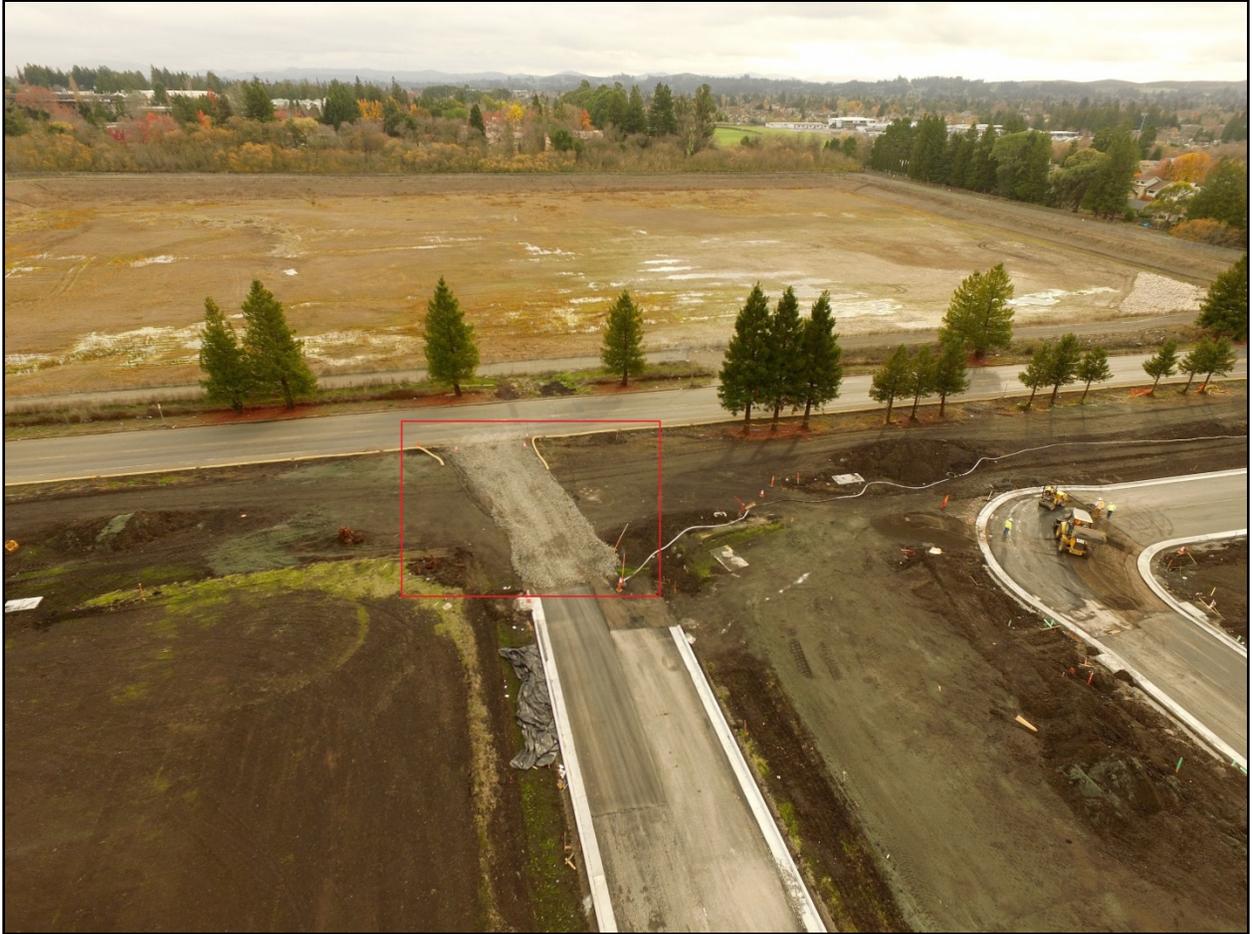
Photo 1D. The red box outlines the western construction entrance along Rohnert Park Expressway. This photo depicts that the entrance has been stabilized with rock. Photo was sent to Devon Jorgenson from Dan Keith on December 11, 2015. Photo facing south.

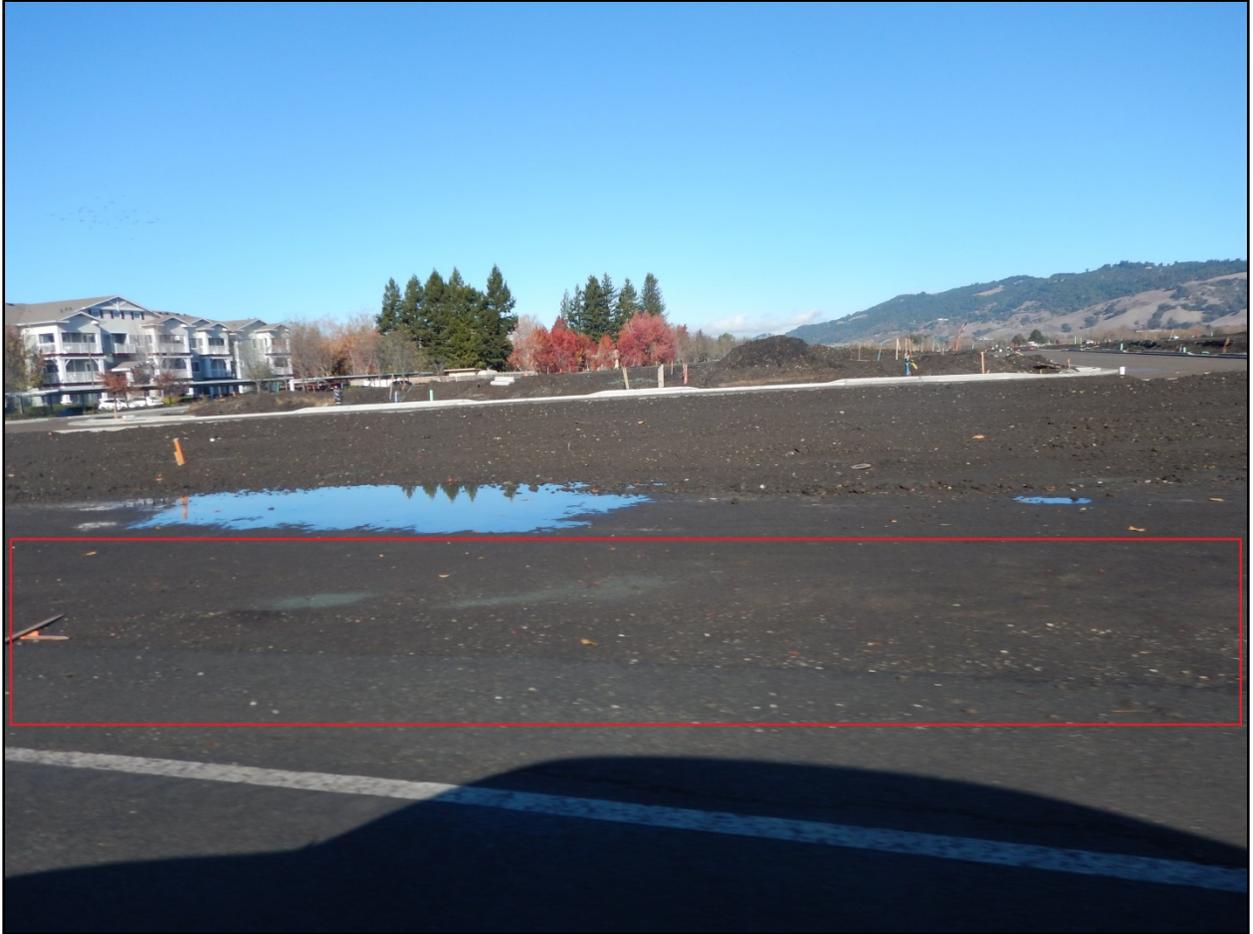
Photo 2A. The red box demonstrates the lack of perimeter controls along Rohnert Park Expressway, which is required pursuant to Attachment D, Provisions B.1.e and E.1 of the Construction General Permit. Photo taken by Colleen Hunt on December 4, 2015, at approximately 11:55, facing north.

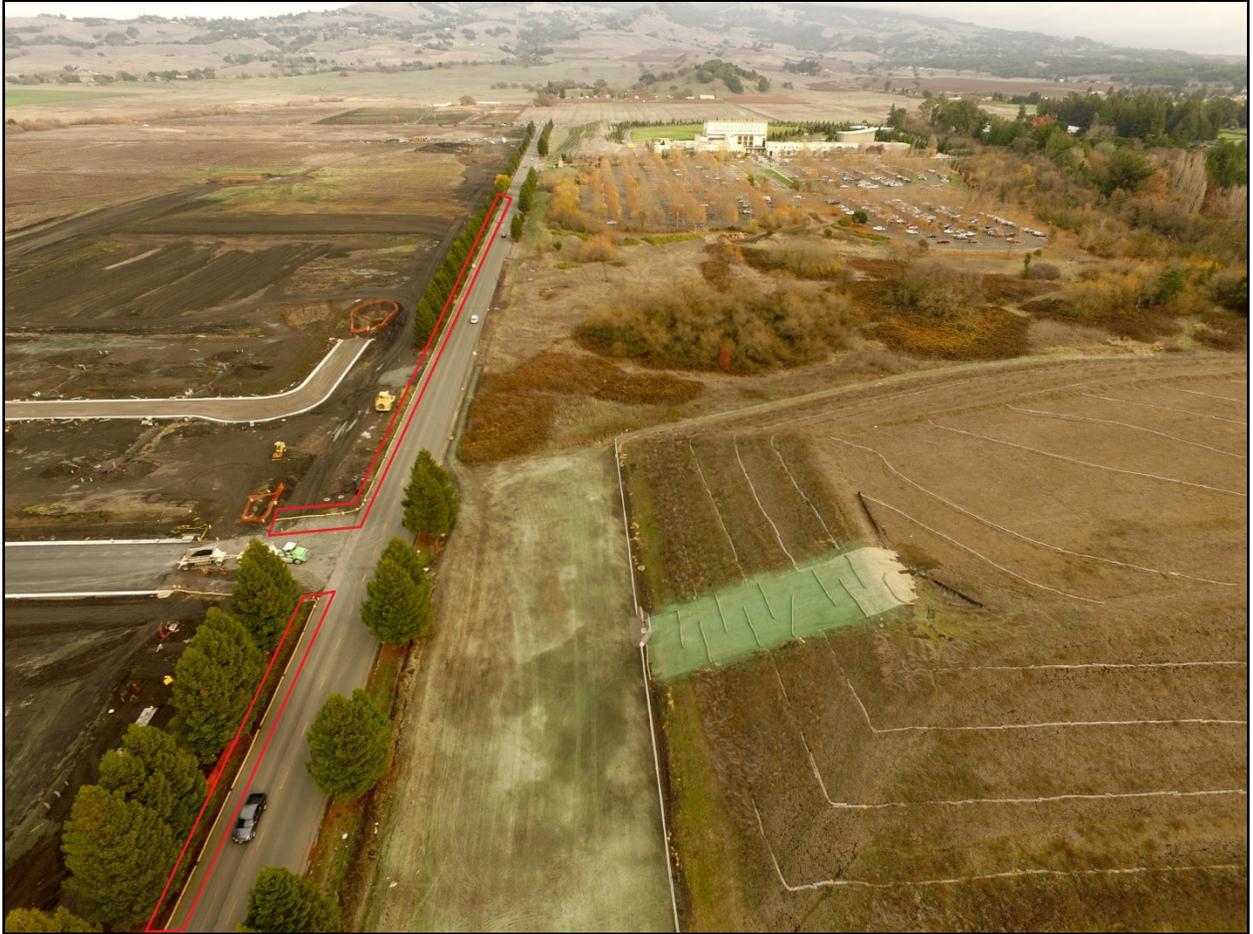
Photo 2B. The red boxes outline wattles that were implemented along RPX as perimeter control. The wattles extend to the west on RPX to Snyder Lane. The location of Photo 2A is just to the west along the bottom-most rectangle. Photo was sent to Devon Jorgenson by Dan Keith on December 11, 2015. Photo facing east.

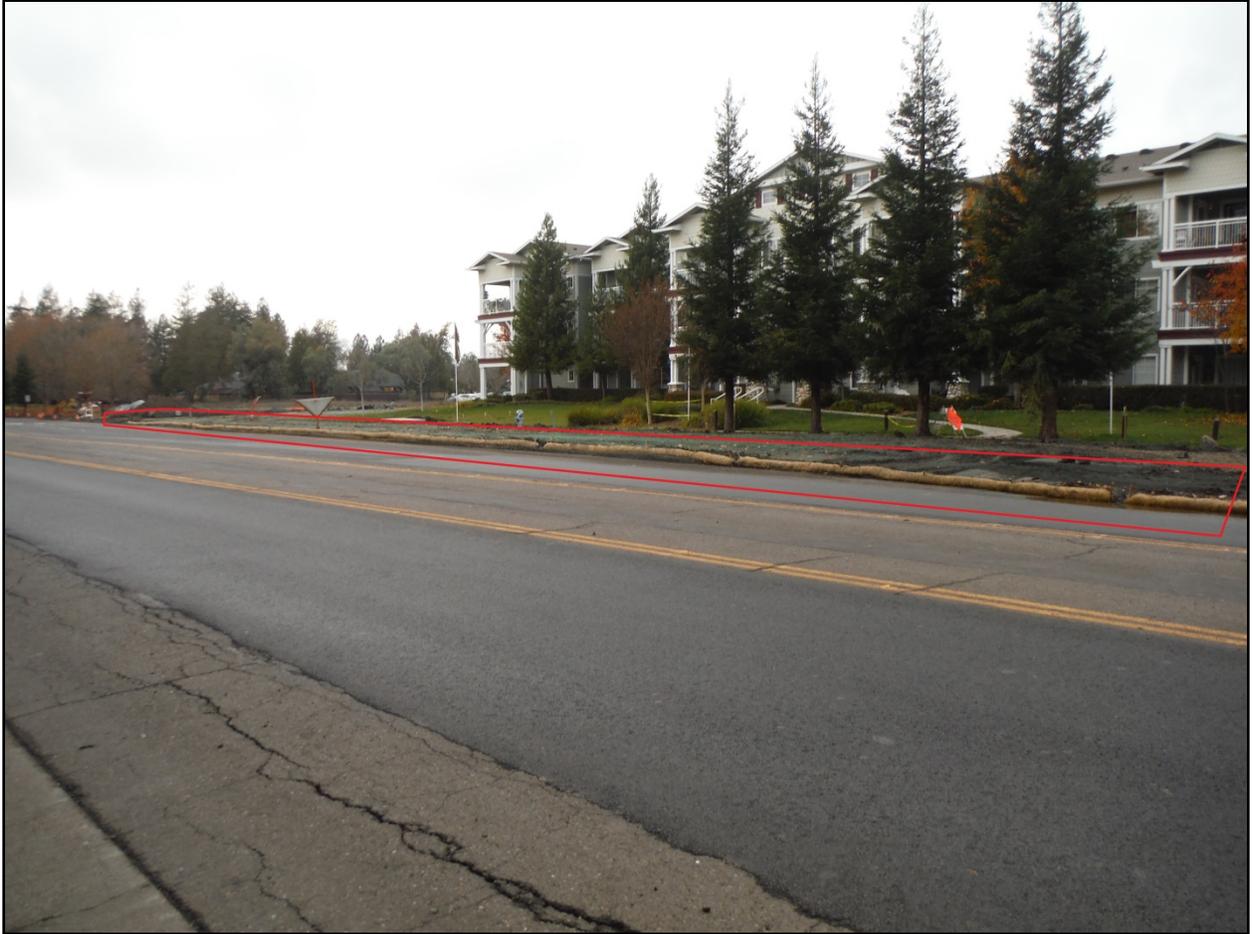
Photo 2C. The red box outlines wattles along RPX used as perimeter control. This photo was taken about 200 feet west of Photo 1. Photo was sent to Devon Jorgenson by Dan Keith on December 11, 2015. Photo facing north.

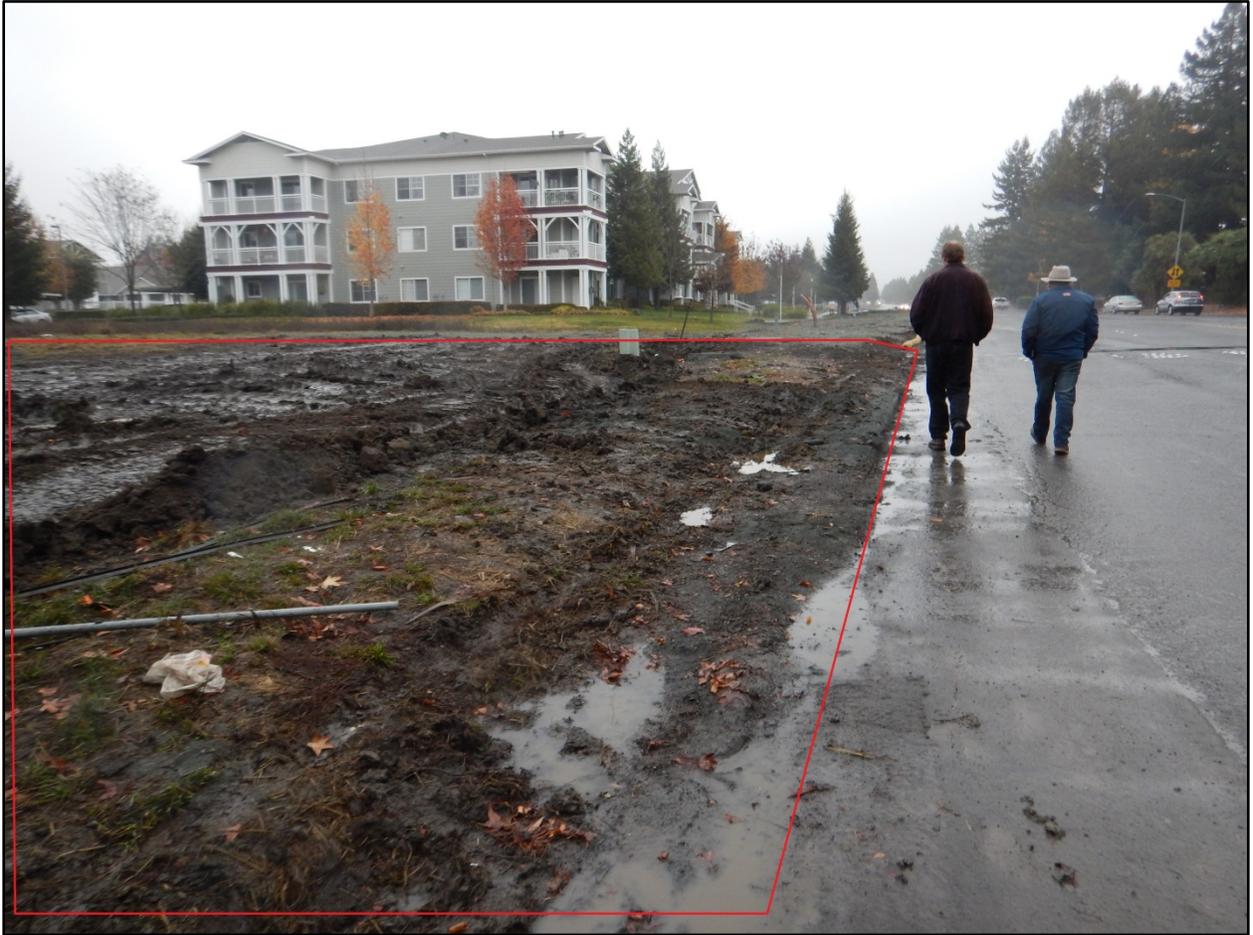
Photo 3A. The red polygon outlines the utility work area of the Project that lacked soil cover, which is required pursuant to Attachment D, Provision D.2. The utility work area is approximately 1.3 acres (SWPPP Amendment No. 1, Section 2.0). This area was muddy and lacked sediment, erosion, and perimeter controls. In addition, this location was not included in the SWPPP. Photo was taken by Devon Jorgenson on December 9, 2015, at approximately 15:14, facing east.

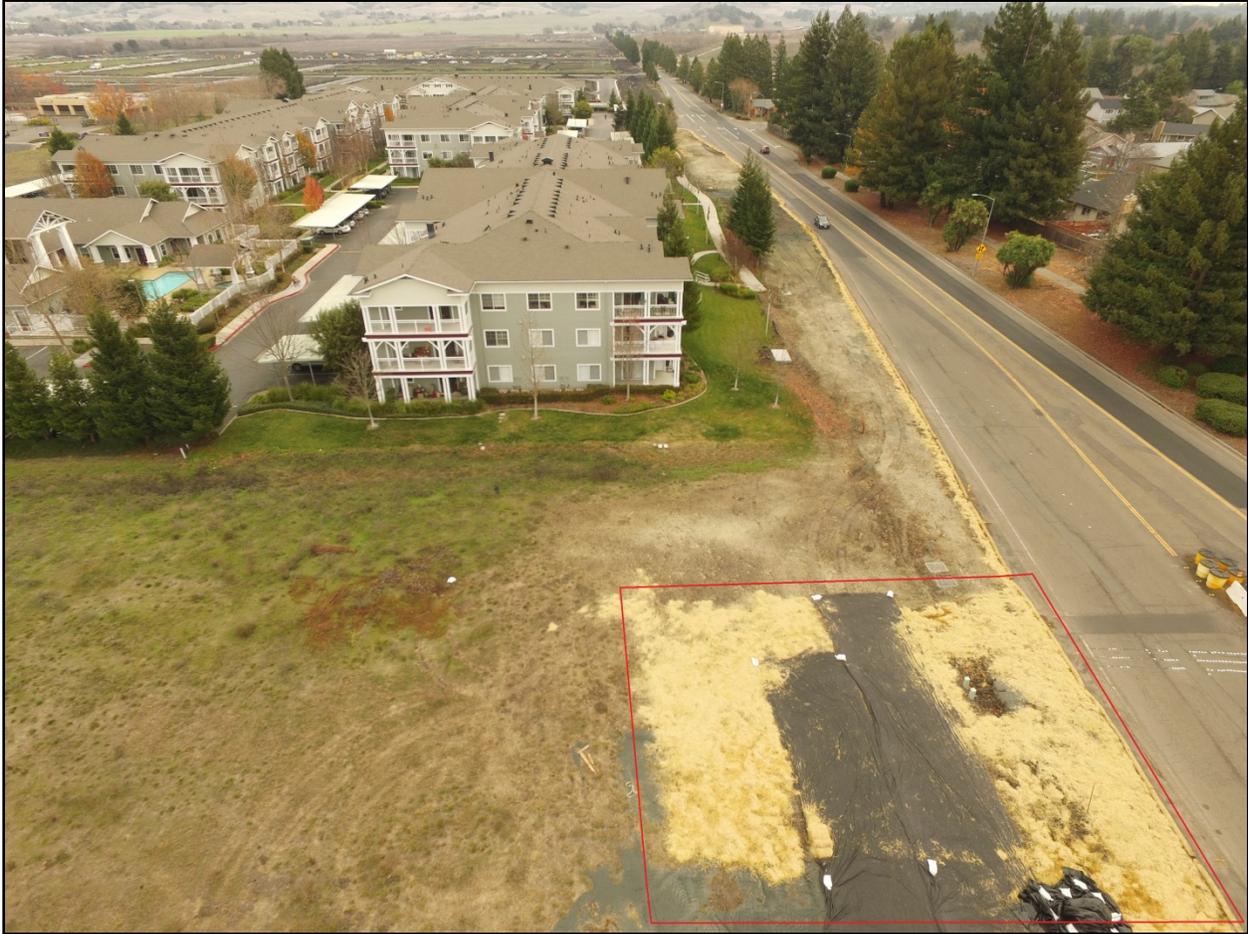
Photo 3B. The red polygon in this photo represents the same polygon in Photo 3A. The photo depicts the installation of straw and filter fabric as soil cover on the utility work area and the installation of wattles as perimeter control. Photo was sent to Devon Jorgenson by Dan Keith on December 11, 2015. Photo facing east.
