## North Coast Regional Water Quality Control Board

**Subject:** Notice of Violation of Order No. R1-2013-0005, General Waste Discharge Requirements for Discharges for Timber Operations on Non-Industrial Timber Management Plans (NTMP) in the North Coast Region

**File:** Nonindustrial Timber Management Plan 1-97NTMP-006 HUM, "Eggel Logging NTMP"

### **February 19, 2016 Site Inspection Compliance Issues**

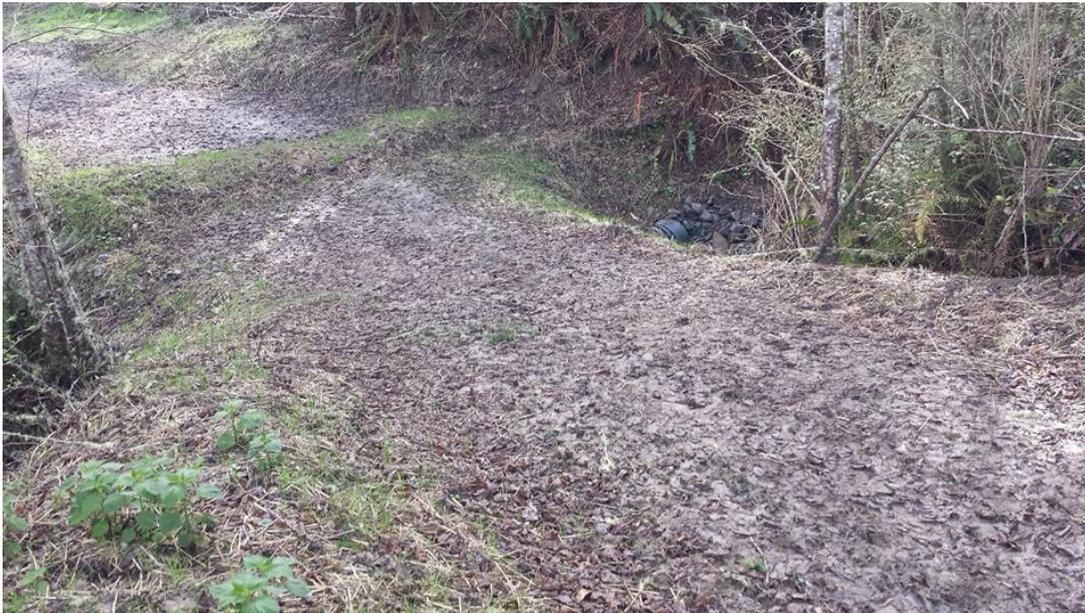
On February 19, 2016, Regional Water Board staff inspected the area associated with NTO #13. During the inspection, as illustrated in Figures 1 and 2, most of the stream crossings associated with this NTO lacked adequate erosion control to prevent and minimize sediment discharges into the adjacent watercourses from surface erosion.

**Figure 1. Site 622 on February 19, 2016. Photo Taken by Joelle Geppert, RWB Staff**

According to the NTMP and the April 10, 2014 amendment to include the CDFW BMPs for roads, all corrective actions and erosion control measures should have been completed prior to October 15, 2015. You must provide to the Regional Water Board, no later than **May 21, 2016**, a description of the sites discussed above and any other site within the NTO area that is discharging or threatens to discharge and proposed corrective action to control sediment discharge for each site. You must apply effective erosion controls immediately to all areas of bare soil where the potential exists for sediment to discharge to watercourses. All other areas requiring corrective actions must be completed no later than **October 15, 2016**. Within one week following completion of corrective action at the site, you must contact Regional Water Board staff to schedule an inspection so that we may evaluate whether the corrective action has been sufficiently implemented and confirm that the violation has been adequately corrected.

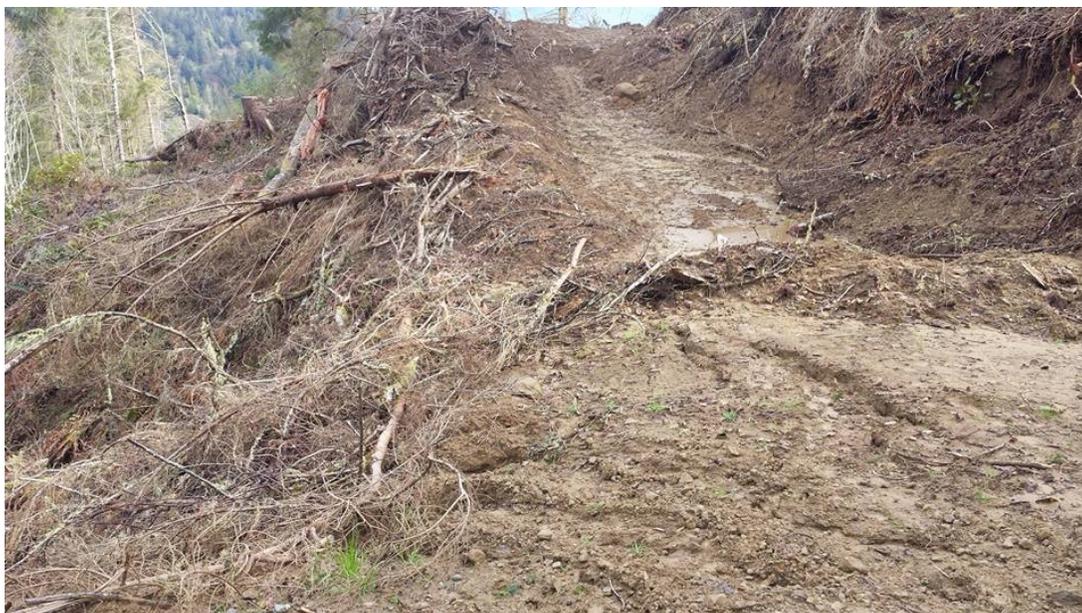
**Figure 2. Unnumbered site along road in the southeastern portion of the NTO#13. Note that the location of the waterbar is the centerline of the watercourse crossing. Photo taken on February 19, 2016 by Joelle Geppert, RWB Staff.**

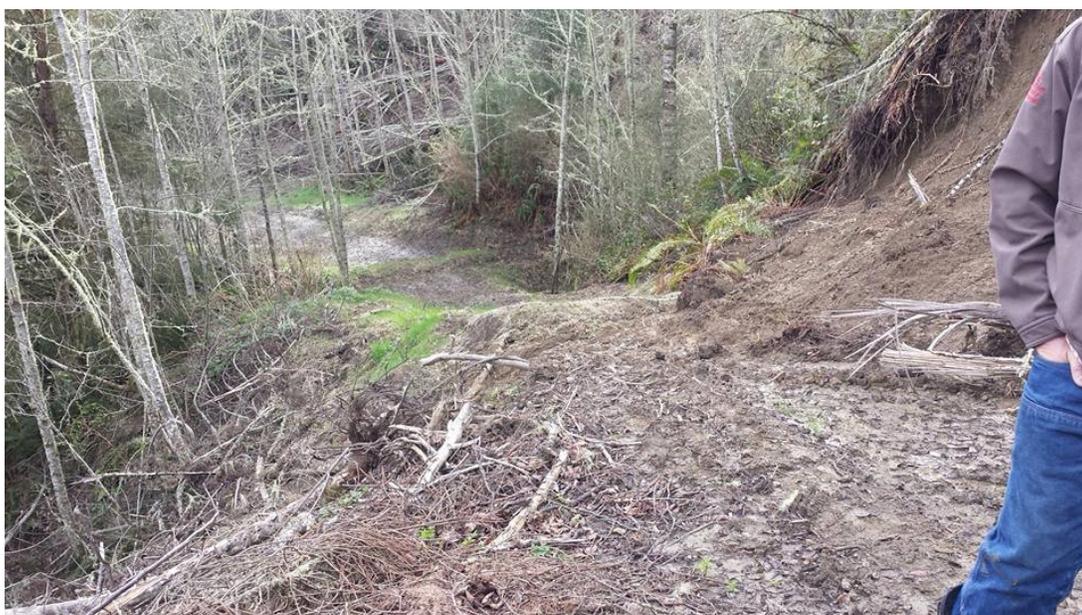
Also during the inspection, staff observed a cut bank and fill slope failure, illustrated in Figure 3, that appears to have developed between Sites 622 and Site 627. Debris from this failure has been deposited approximately 20 feet from of the Class II watercourse. The NTMP maps show an existing unstable area below the road at this location. Staff observed a waterbar on the road that directs runoff onto the unstable area.

**Figure 3. Cutbank and fill slope failure at a mapped landslide from between Sites 622 and 627. Photo taken on February 19, 2016 by Joelle Geppert, RWB Staff.**

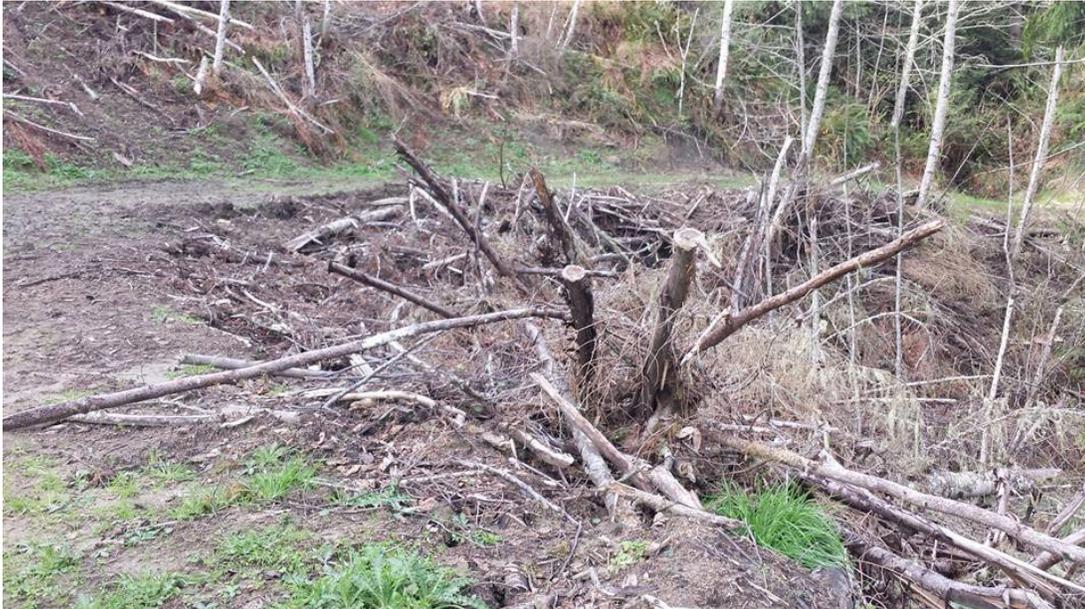
**Figure 4. Tension cracks are developing along the fill slope, threatening sediment discharges to the Class II watercourse associated with Site 627. Photo taken on February 19, 2016 by Joelle Geppert, RWB Staff.**

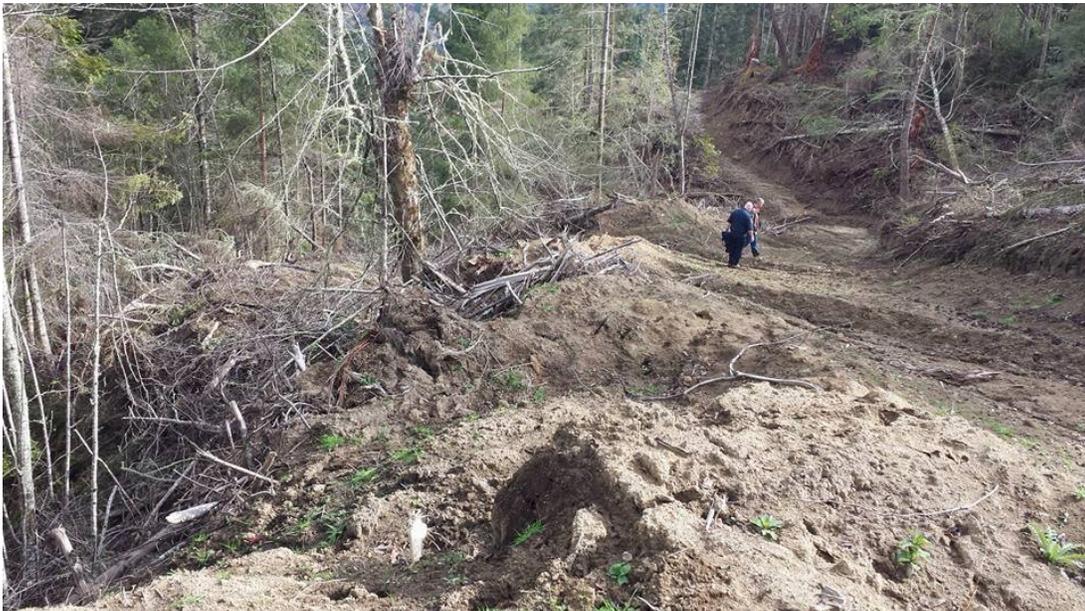
**Figure 5. Road drainage and sediment from perched fills are discharging to the Class III watercourse. Photo taken on February 19, 2016 by Joelle Geppert, RWB Staff.**

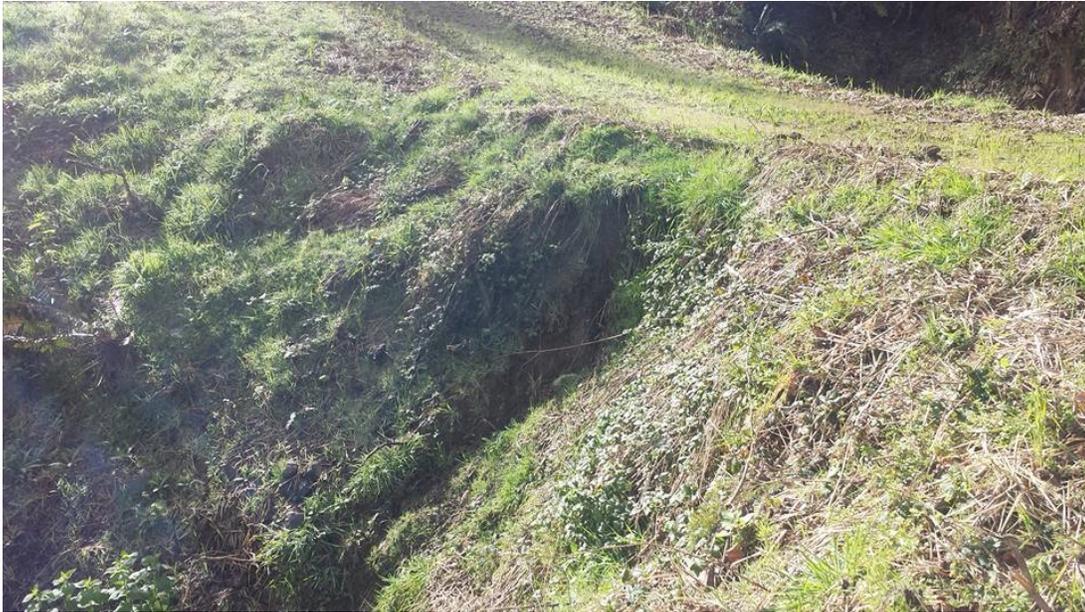
**Figure 6. Runoff discharging from the road at Site 615 is eroding fill material on the slope below the road. Photo taken on February 19, 2016 by Joelle Geppert, RWB Staff.**
